December 27, 2024

RE: Beach Cottage I & II Condominium Association of Indian Shores, Inc. – Milestone Inspection Report
18400 Gulf Boulevard,
Indian Shores, Florida 33785
KEG File #23RT-0766

REPRESENTATIVE PHOTOS

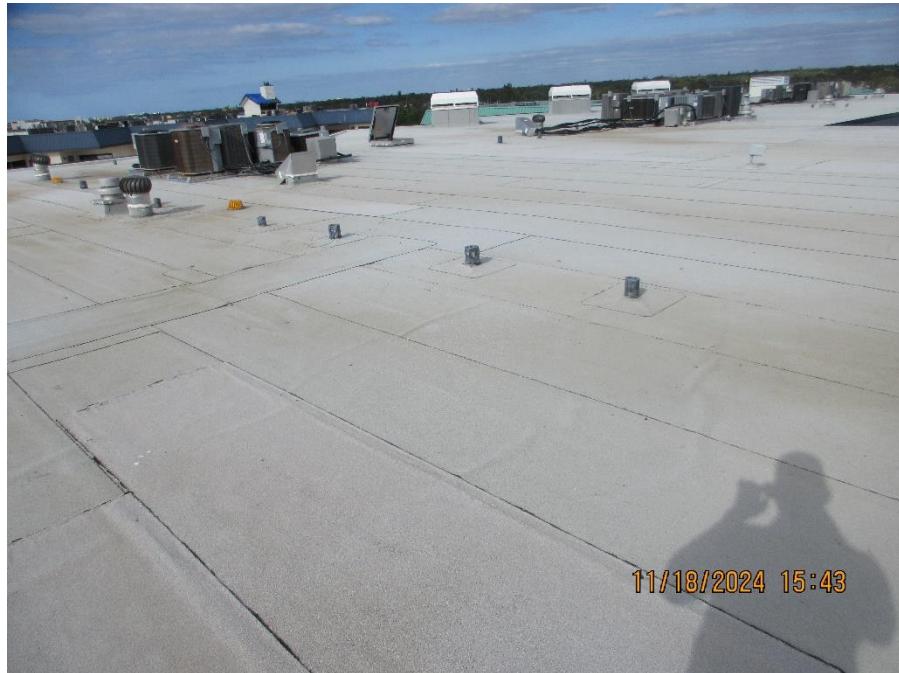
Photo #7 – Typical Overview of Modified Bitumen Roof Systems with HVAC Units @ Beach Cottage I.

1. The existing flat roof at Beach Cottage I made of modified bitumen appeared to be in very good shape for its age and use. Meanwhile, the existing flat roof at Beach Cottage II appeared to have reached the end of useful life because of the substantial damage to the top protective membrane caused by UV rays degrading the reflectivity or R-Value of the roof. There also have been several water ponding areas throughout both roofs with dirt stains, failed sealant at parapet wall, and other observations. The Association should plan for routine maintenance to clean all the gutters, and internal roof drains as well as removing any exposed metals encountered throughout the roof of Beach Cottage I. Meanwhile, the Association should start planning for complete roof replacement at Beach Cottage II in the near future.

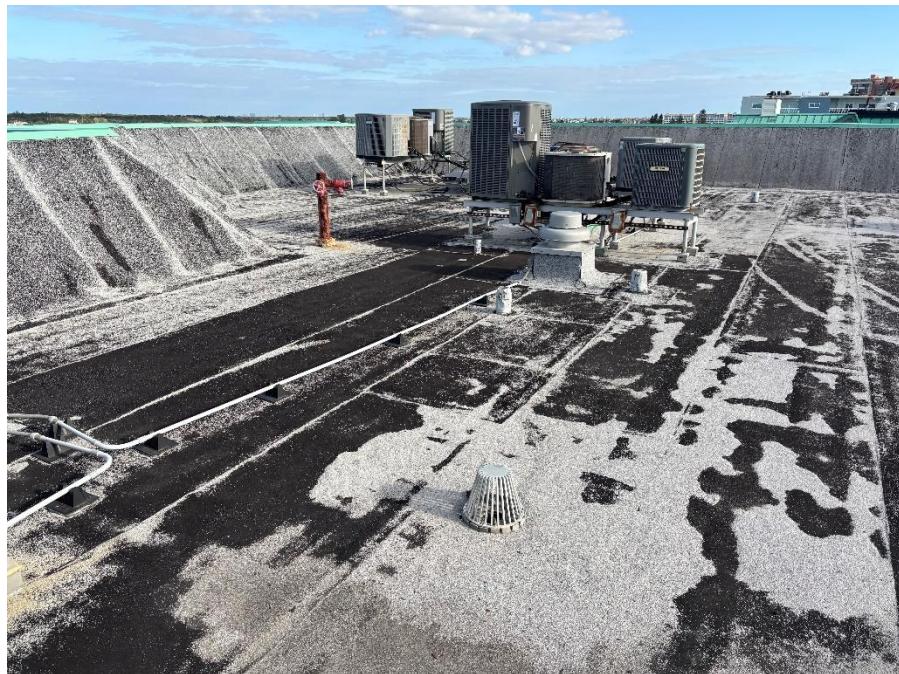
Photo #8 – Typical Overview of Modified Bitumen Roof Systems with HVAC Units at Beach Cottage II.

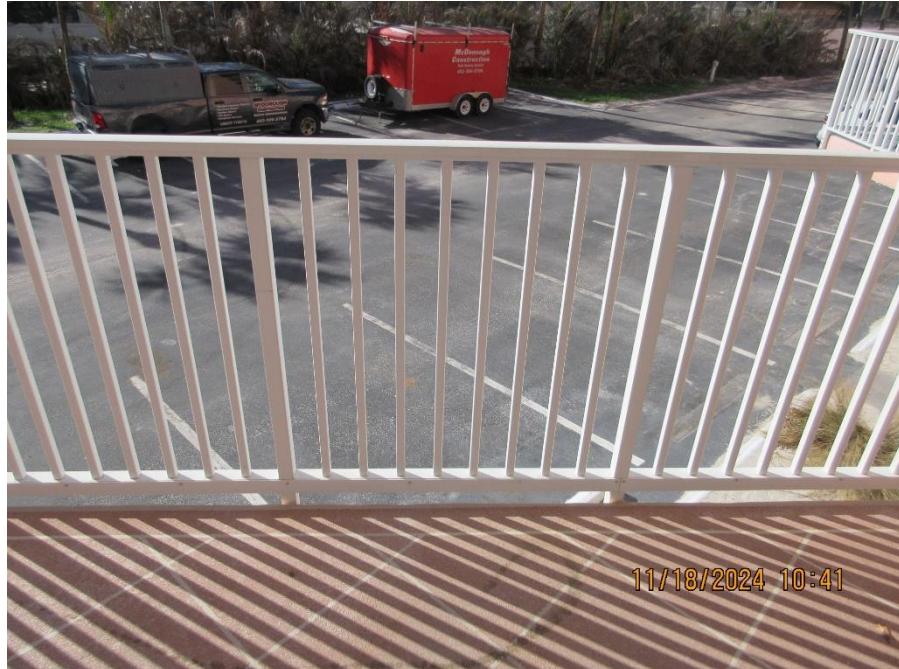
Photo #9 – Typical Code-Compliant Railings at Balconies and Elevated Walkways.
(42 ½" in height – 3 ½" in picket's spacing).

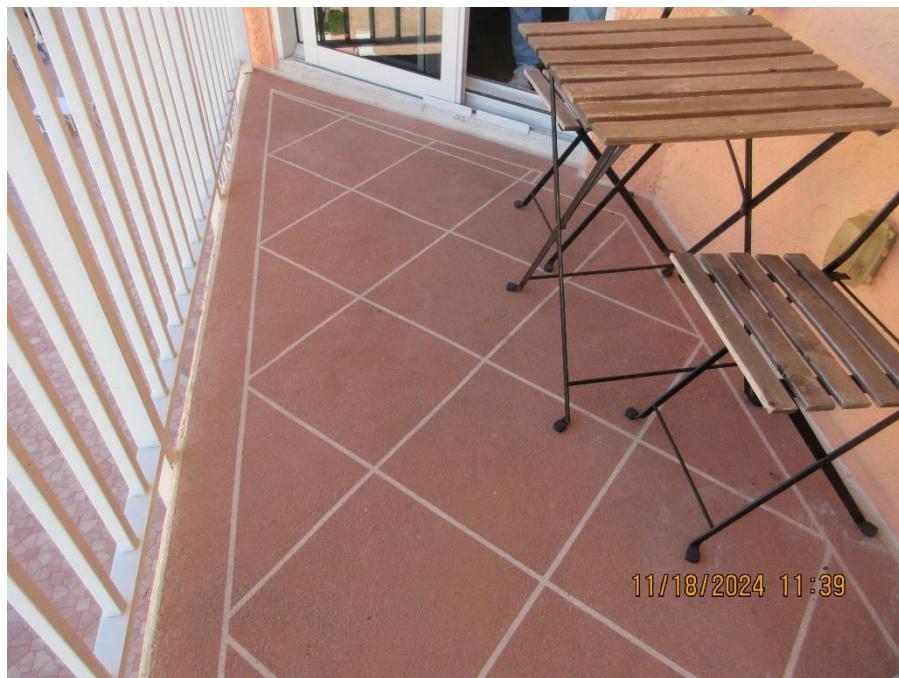
Photo #10 – View of Gemstone Deck Coating Finish at Balconies. (TYP)

5. The protective Gemstone coating on the floor deck of the elevated walkways and balconies appears to be approaching the end of useful life with multiple areas of peeling, scratching, and staining. It is recommended that the deck coating be scheduled for replacement based on the Association's SIRS schedule. Prior to applying the new coat of urethane membrane, proper concrete surface preparation, sounding and repairs may be needed to be completed.

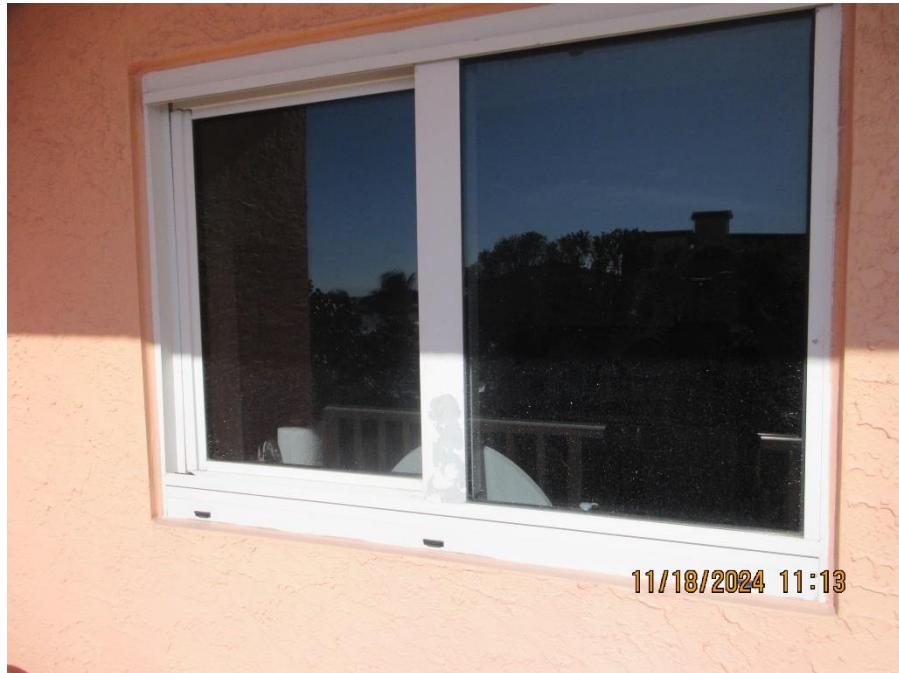
Photo #11 – Sealant Bead Around Exterior Window Perimeter at Elevated Walkways in Good Condition. (TYP)

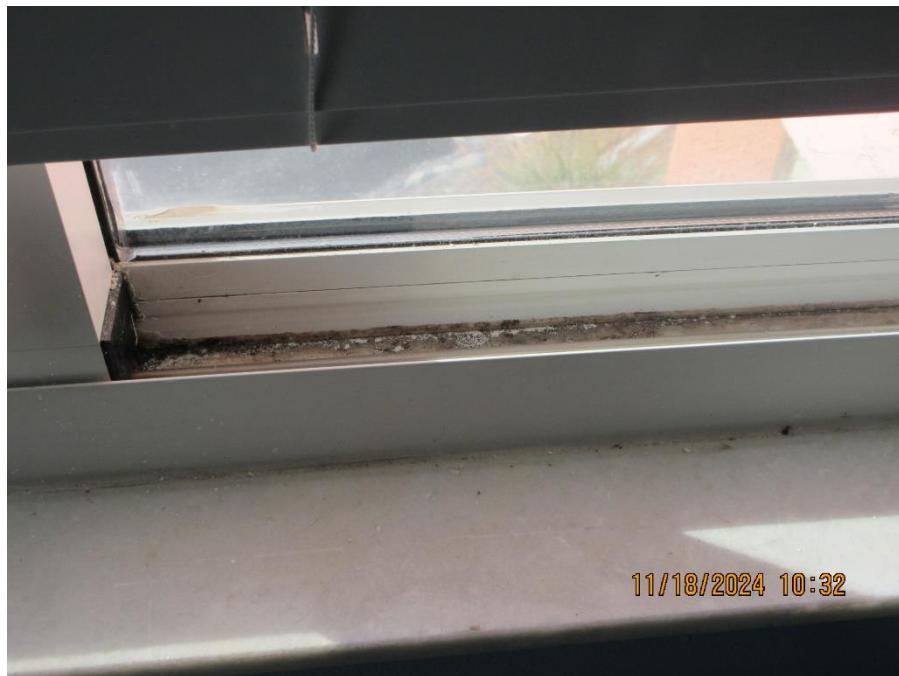
1. During the site visit, KE noted building components went missing or were damaged as a result of Hurricanes Helene and Milton that affected the property. These components vary from existing vinyl siding attached to furring strips on CMU exterior walls at the building's elevations, and soffits at balcony and walkway ceilings. Even though these components are not structurally related to the building, KE recommends that these components be replaced or repaired to further maintain protection to the buildings.
2. KEG discovered several areas of water intrusion or potential framing damage during the visual inspection:
 - Water intrusion in the AC closet and bedroom of Unit #1101
 - Sign of microbial growth on vents of Unit #1101
 - Possible sign of condensation or water intrusion and suspected microbial growth at windows of Unit #2501

Photo #12 – Possible Sign of Condensation and Suspected Microbial Growth at Windows of Unit #2501.

As a result, KEG suggests regular maintenance be performed to determine if the issues are a result of window's perimeter sealants and further investigate Unit #1101.

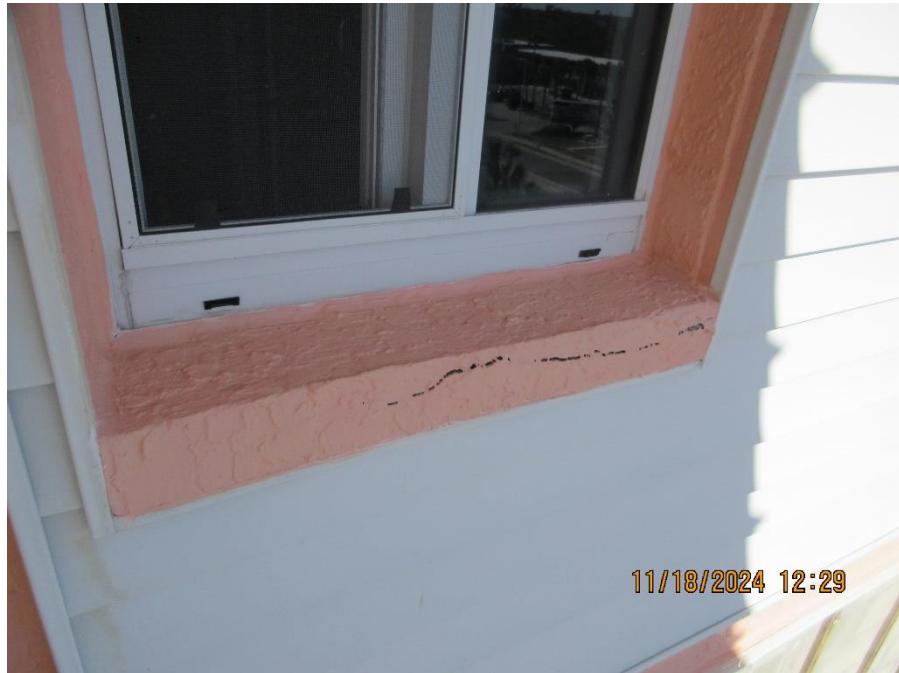
Photo #13 – Crack at Pre-Cast Concrete Window Sill. (TYP.)

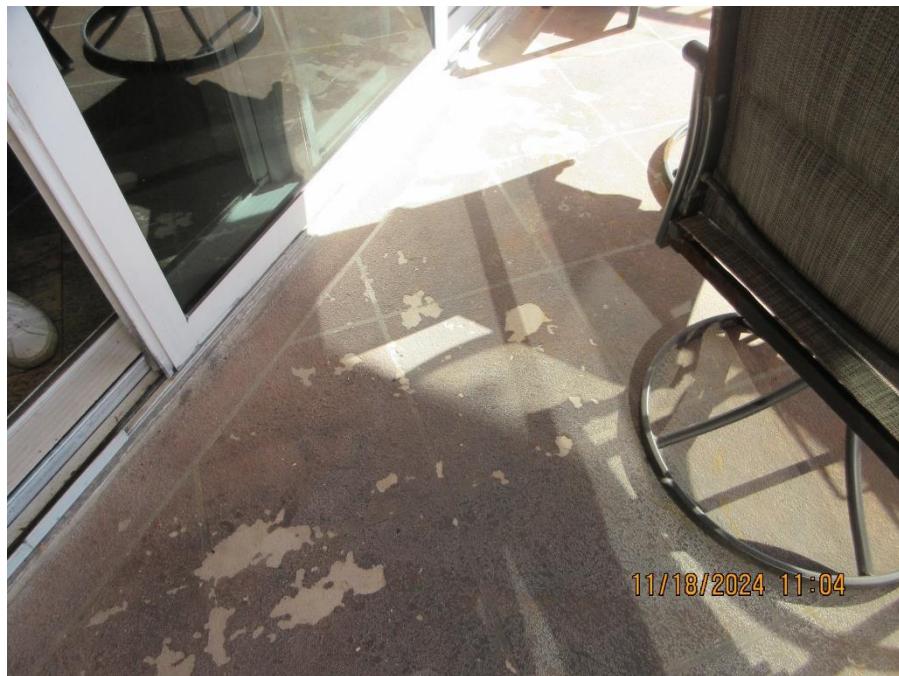
Photo #14 – Deck Coating Finish Peeling at Balcony.

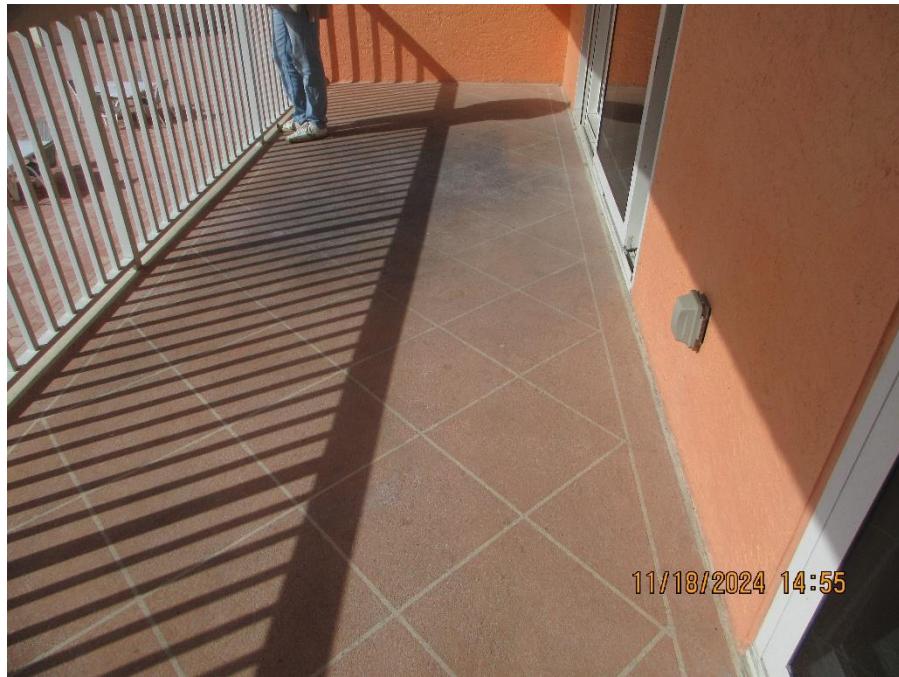
Photo #15 – Typical Stained Balcony Deck w/ Possible Ponding Area.

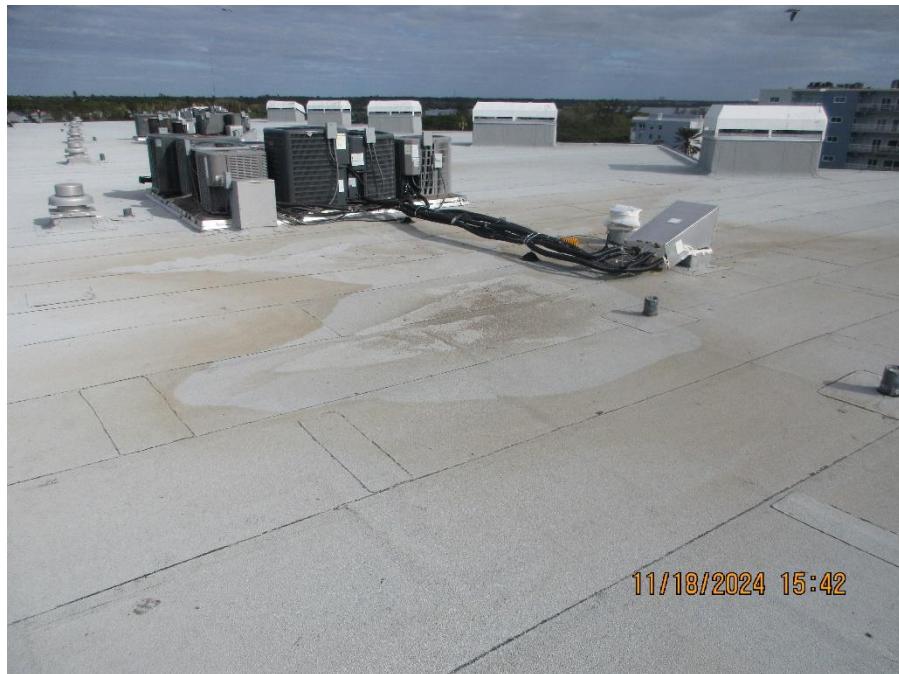
Photo #16 – Sign of Mild Water Ponding on Roof at Building I, Periodic Maintenance Recommended.

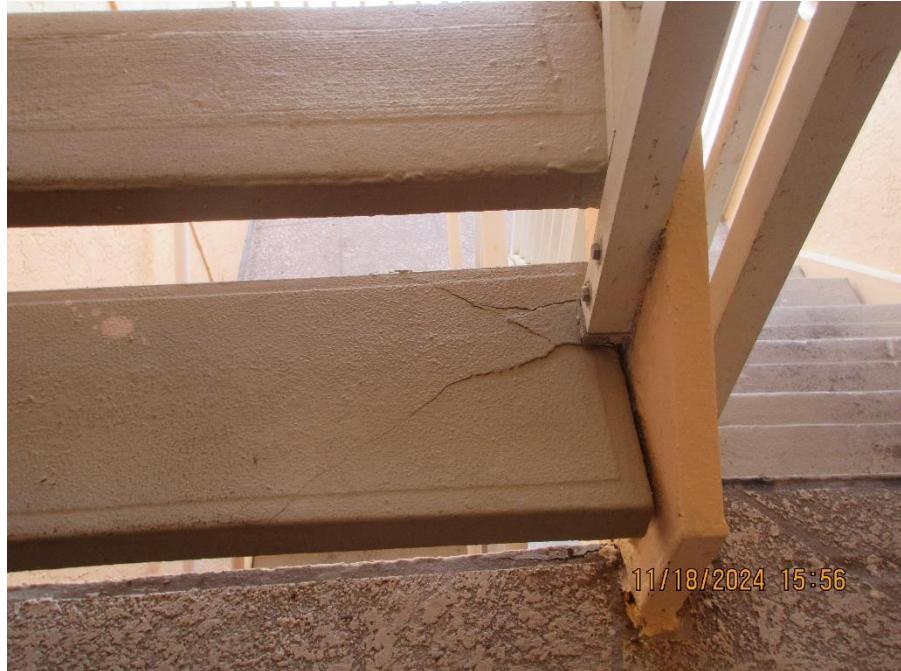
1. During the inspection, KE observed several damaged concrete stair threads that are a critical safety concern to the residents. It is KE's opinion that these components demand immediate attention, as they compromise the structural integrity of the staircase and significantly increase the risk of slips, trips, and falls. In the high-traffic areas or emergency exit routes, such defects can lead to severe accidents, legal liabilities, and disruptions to daily operations. KE recommends that all damaged concrete be repaired in accordance with ICRI and ACI specifications.

Photo #17 – Cracked Stair Threads (North stair tower 1st, 2nd, 3rd + S stair tower 1st floor – Building I)

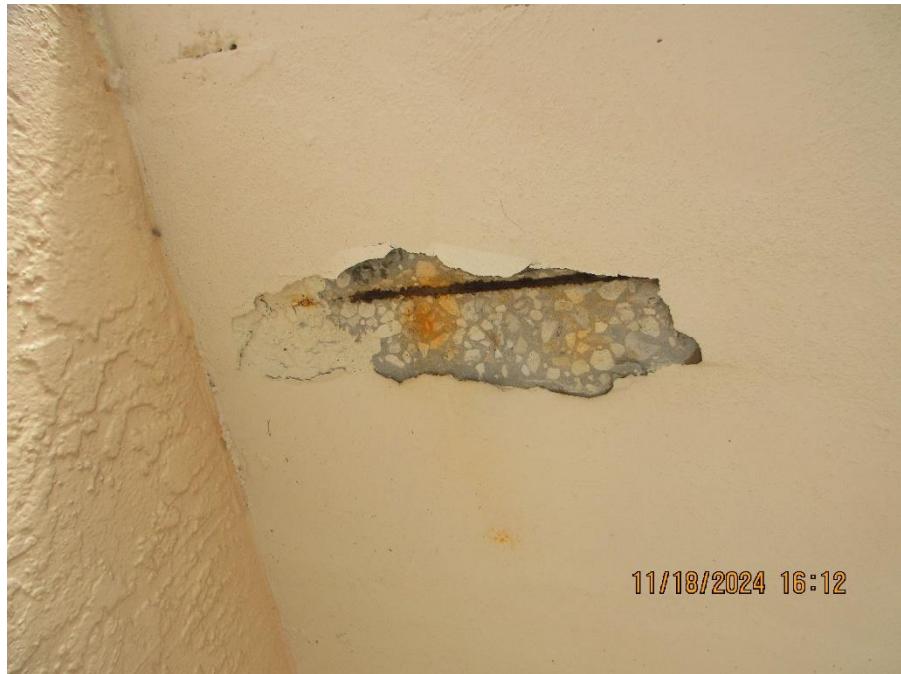
3. Concrete cracks, delaminated stucco, concrete spalls at panel underside, and spalls at columns with exposed reinforcement were observed at several locations throughout the shared under-building parking garage of both buildings. The concrete damage if not repaired soon, can grow exponentially due to the concrete being exposed to chlorine from the pool water and salt from the nearby beaches that are affecting the structural integrity of the slab. It is recommended that all damaged concrete be repaired in accordance with ICRI and ACI specifications. **These damaged and deteriorated locations are scheduled to be repaired as a portion of the swimming pool equipment room and pool shell/beam project for which bids were received on December 17, 2024, based on a Project Manual prepared by KE.**

Photo #18 – Typical Concrete Spall w/ Exposed Reinforcement at Building I Under-building Parking.

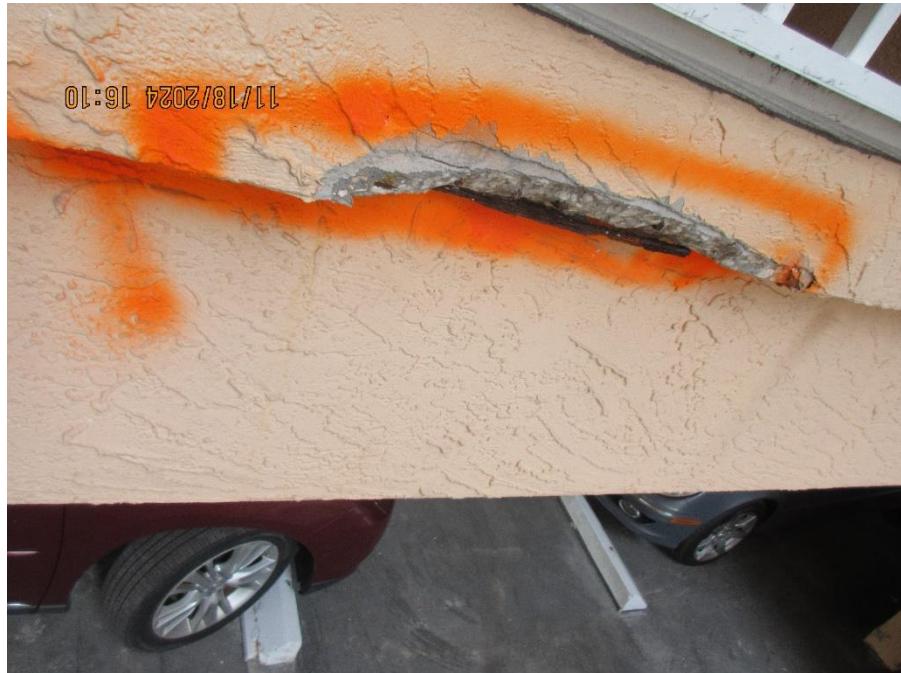
4. Concrete cracks at slab edges and elevated walkways, deck coating peeling, organic growth at edge of stucco at slab edges, and concrete spalls were noted at elevated walkways and balcony decks. KE also noted failed effort of re-sloping repairs at these areas. It is recommended that all damaged concrete be repaired in accordance with ICRI and ACI specifications. **These damaged and deteriorated locations are scheduled to be repaired as a portion of the swimming pool equipment room and pool shell/beam project for which bids were received on December 17, 2024, based on a Project Manual prepared by KE.**

Photo #19 – Concrete Spall with Exposed Reinforcement at Slab Edge of Elevated Balcony, (Building I).

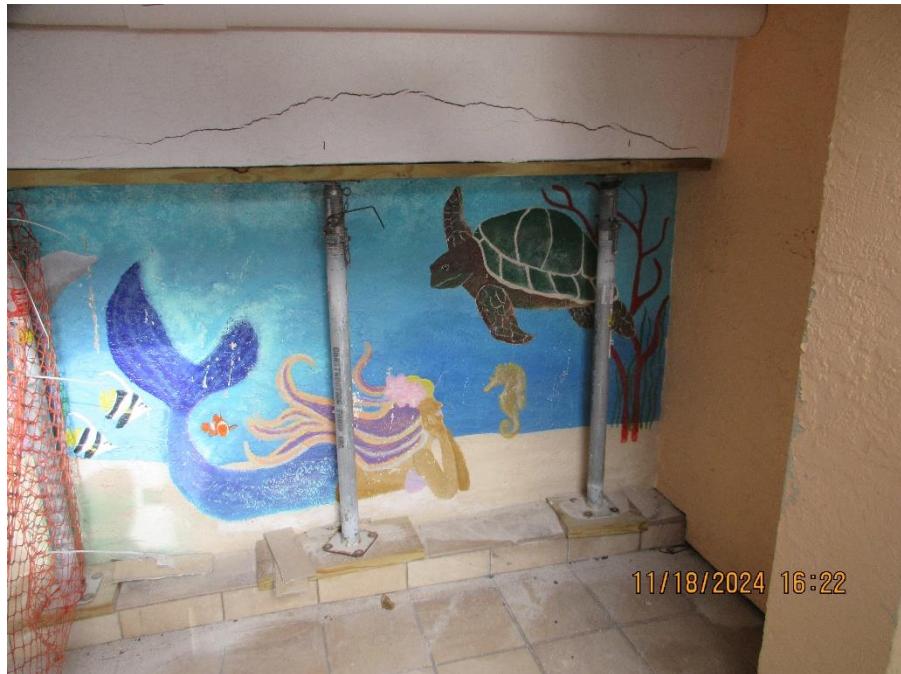
Photo #20 – Concrete Crack at Beam Under Pool Deck Area - Under Repair.

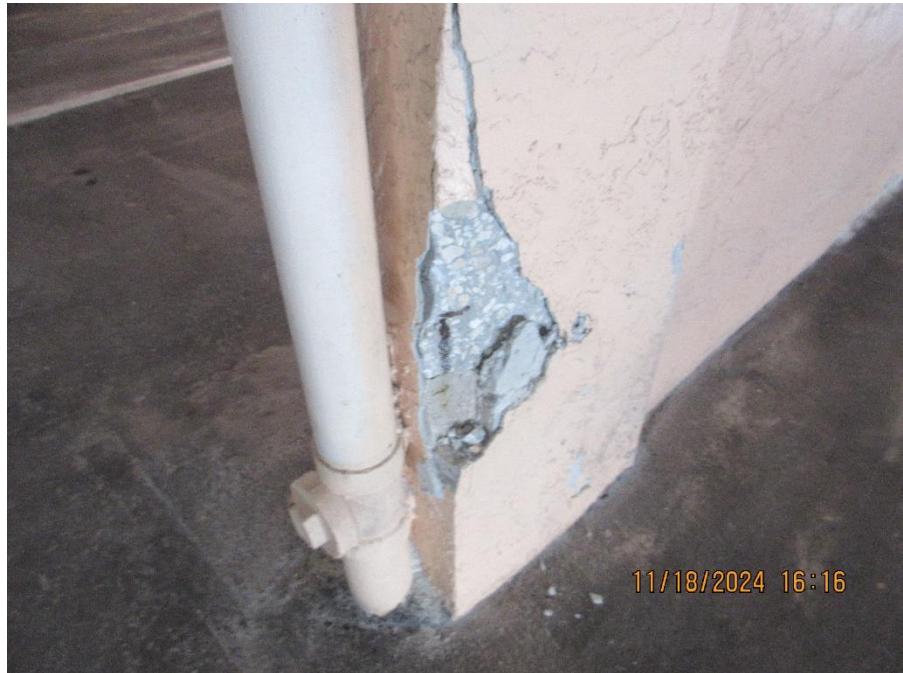
Photo #21 – Typical Concrete Spalls at Columns in Under-building Parking Garage.

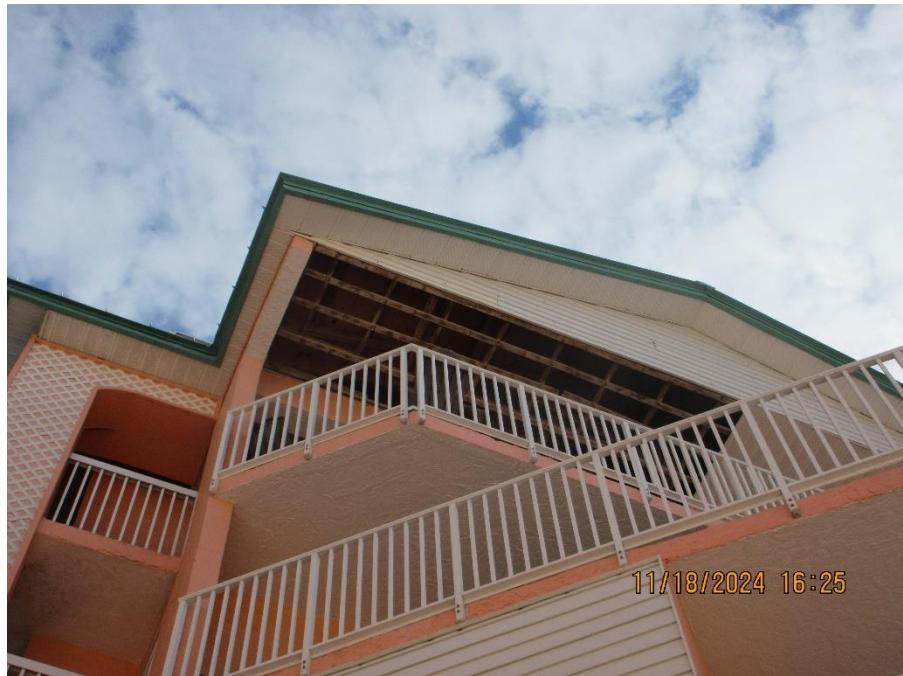
Photo #22 – Typical Missing Soffit at Roofs of Both Buildings, damaged during recent hurricanes.

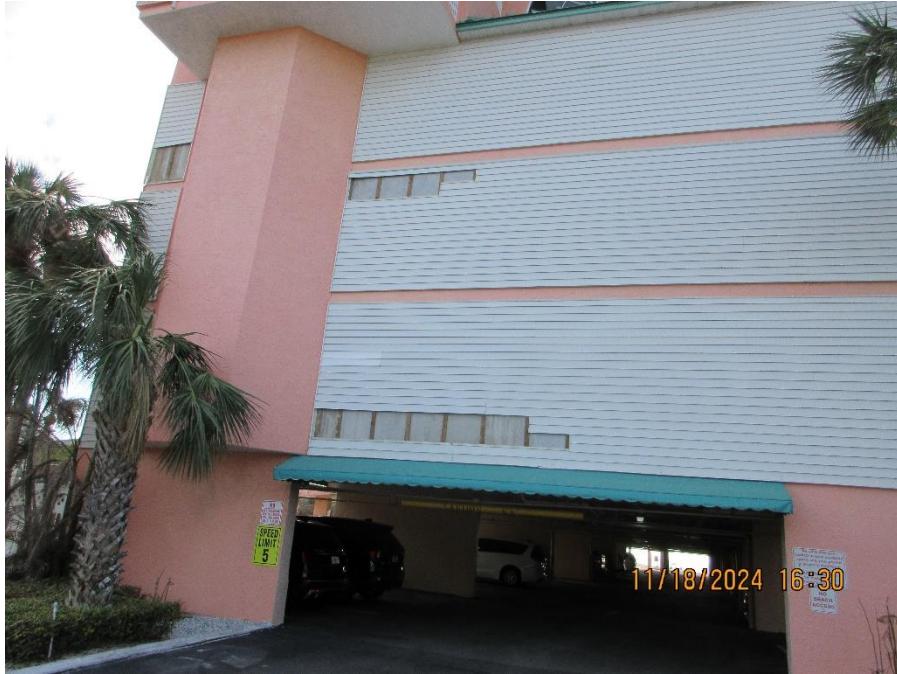
Photo #23 – Typical Missing Vinyl Siding at Both Building's Elevations, from Recent Hurricanes.

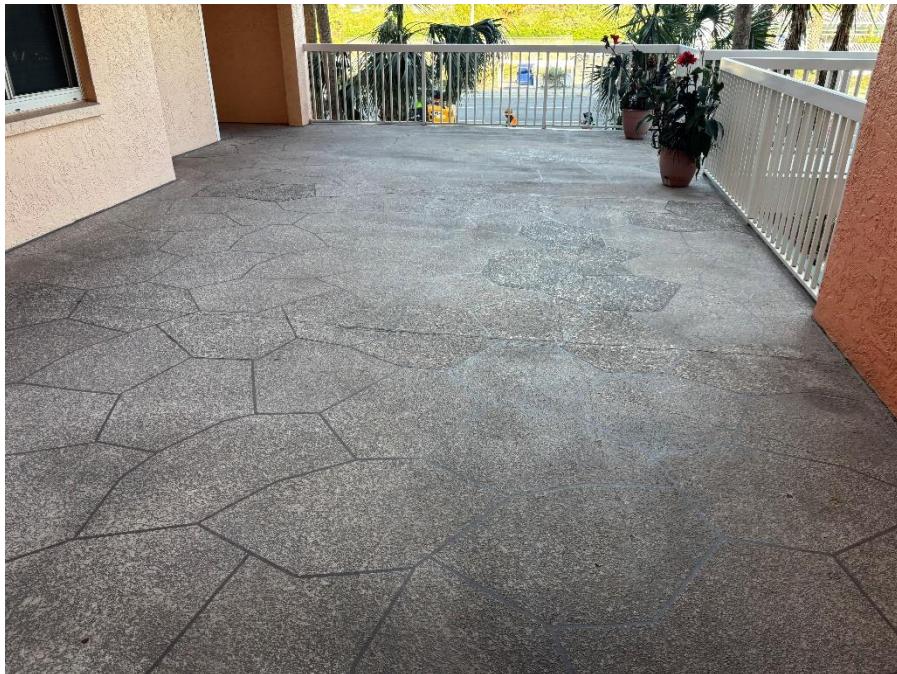
Photo #24 – Stained Deck Coating (1st Floor - Building II)

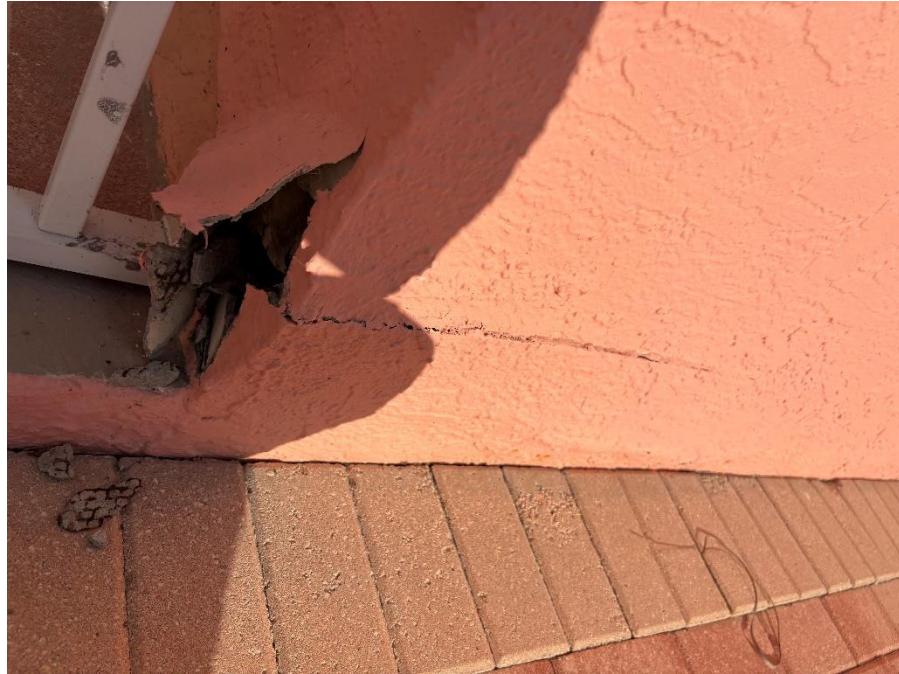
Photo #25 – Delaminated and Cracked Stucco at 1st Floor at Pool Deck. (W Elevation - Building II)

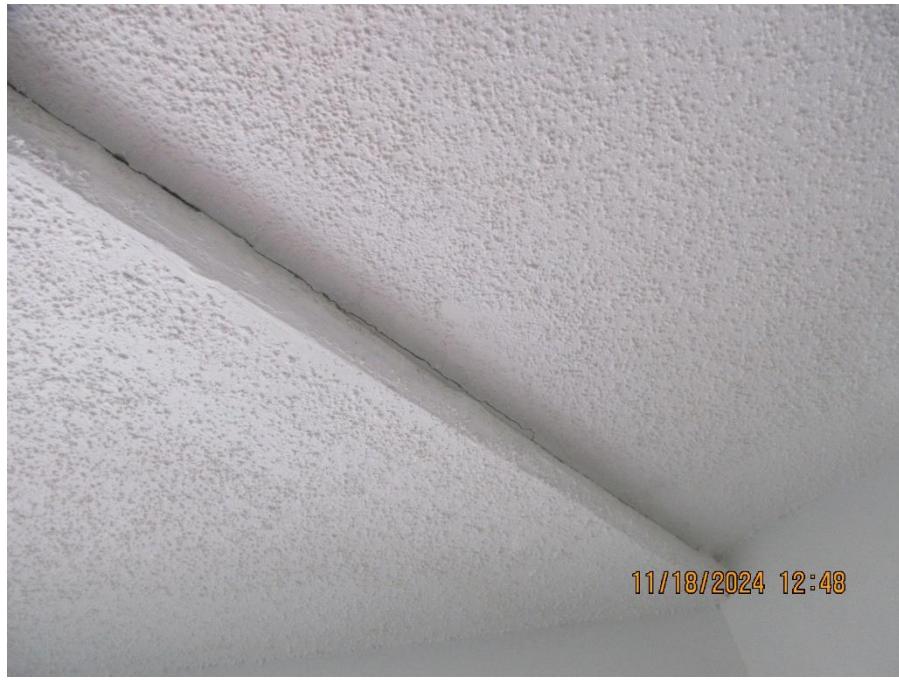
3. Stucco cracks, efflorescence, and spalling concrete were noted at selected building's elevations. KE also observed multiple areas where the joint filler/cover at ceiling of several units is failing where the precast panels align together. Recommendations would include removal and replacement of all spalls and cracks to concrete in accordance with ACI and ICRI Guidelines. This work should be completed during the next restoration and painting project.

Photo #26 – Typical Transition Between Precast Panels at Unit Interior - Beach Cottage II.
