# EMA ENGINEERS, INC.

RE: 18450 Gulf Blvd  
Indian Shores, Fl

Pursuant to your request, I visited the above-referenced property on February 2, 2023 and on February 9, 2023 with regard to the Structural Engineering Milestone Inspection. The purpose of this inspection was to determine the conditions of the building and to provide a report based upon my findings. As you know, I met with you, Mr. Angelo Occhipinti and Mr. Scott Dumas from the Management Company on each of those days. I was able to walk through each unit with Mr. Occhipinti and Mr. Dumas, whereby we viewed the balconies, roofs, staircases, electrical rooms, fire rooms, elevator rooms, private garages, the walkways (breezeway) of each floor and the parking levels of the building. Attached are a total of 82 photographs which identify and describe the areas. These photographs are marked Fig. 1 thru Fig. 82, and are attached to this report.

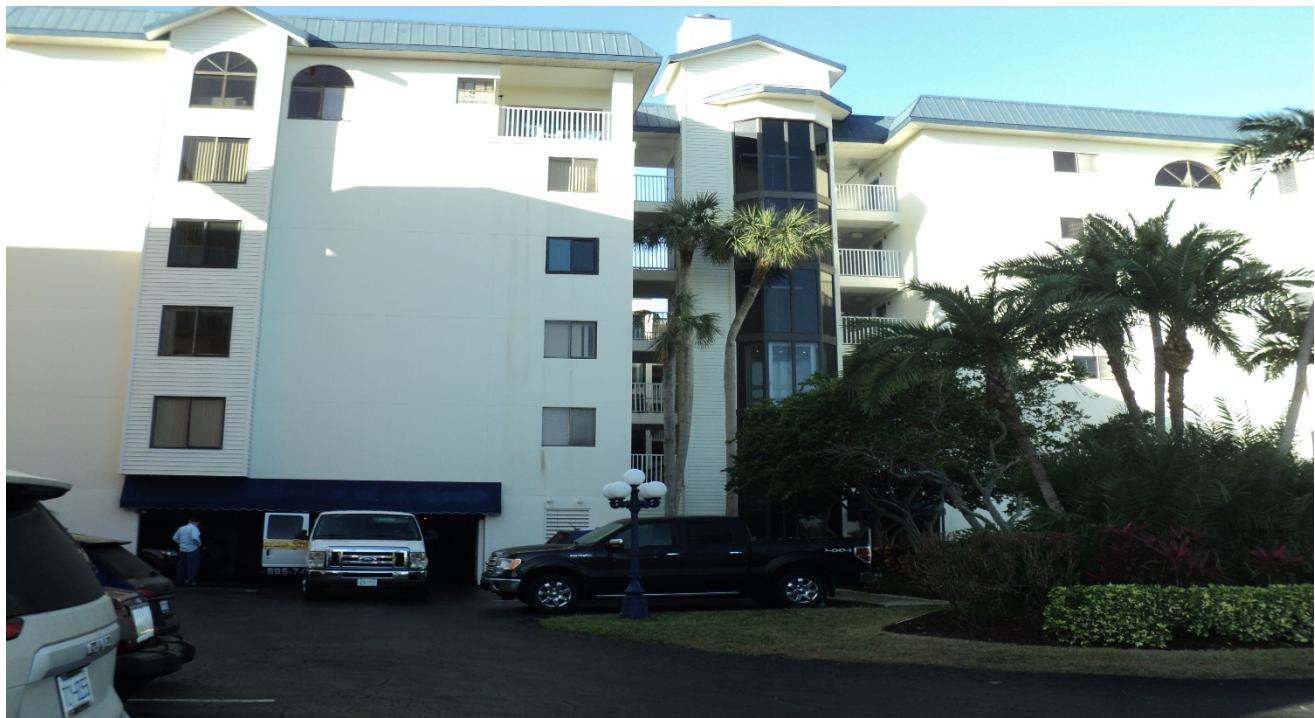
Fig.. 1

The building is a five-story condominium project (see Fig. 1), with parking levels under the building. This condominium project has concrete floors and roof slabs. The building is constructed with post-tension concrete slabs, which were built in 1999, making the building approximately 32-years old. The slab is supported by concrete columns and concrete walls (shear walls). The columns and shear walls are supported by piles (deep foundation) and concrete pile caps. The exterior walls of this building were constructed by metal stud walls and stucco finish. There is a total of 62 units in this condominium complex. There are 10 units on the 5<sup>th</sup> floor and 13 units on each floor (1<sup>st</sup> floor through 4<sup>th</sup> floor). All the units have balconies and some of them have more than one balcony.

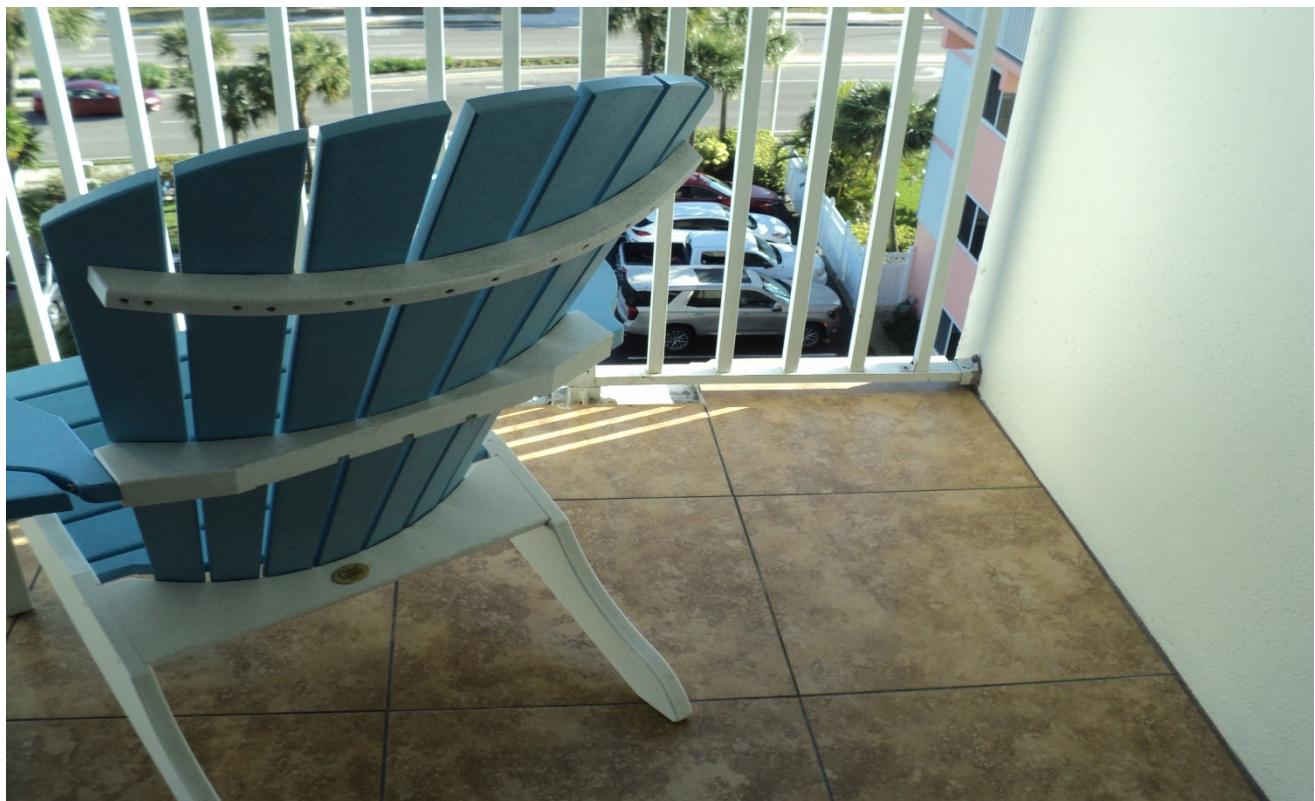
Fig..2

The balconies were covered with tiles. The tiles around the railing post were removed (see Fig. 2). I did not find any defective slabs however; this does not mean the slab is 100% sufficient because it has been covered with tiles.

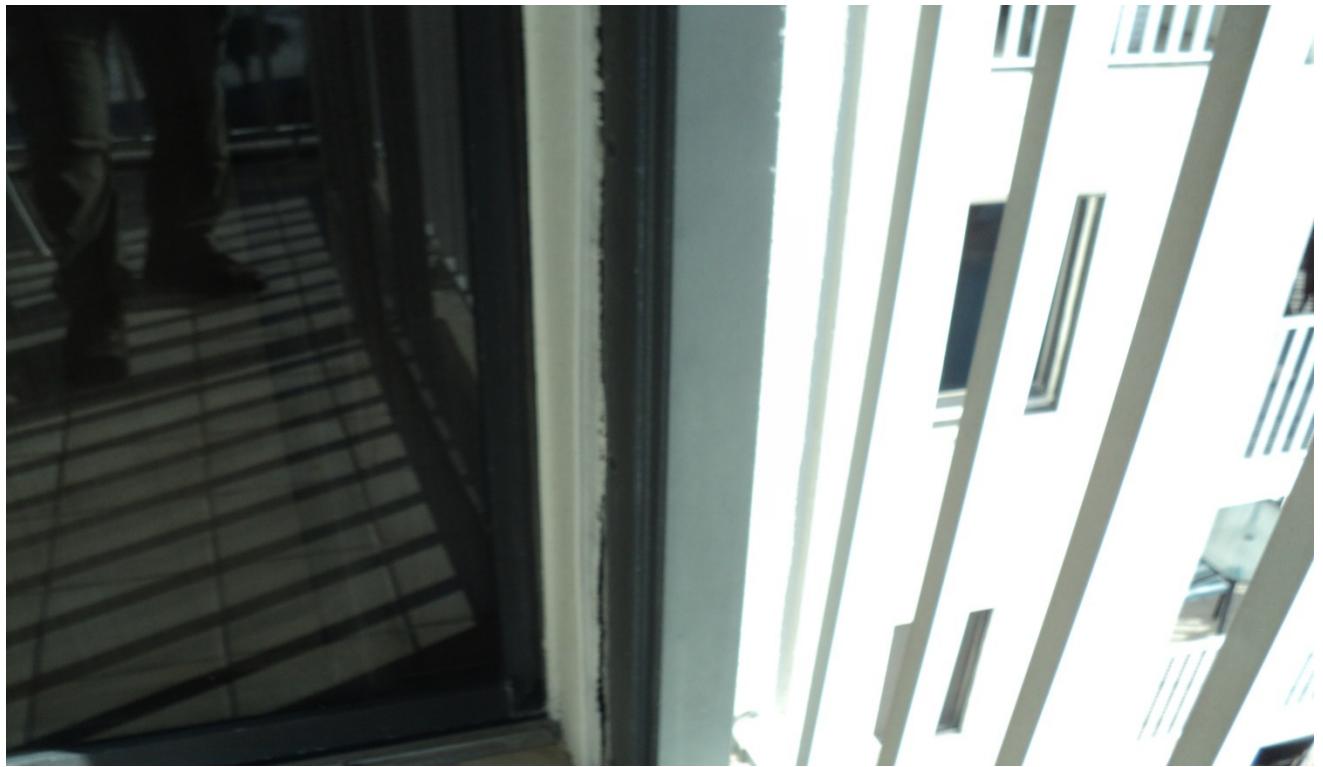
Fig. 3

The balconies were covered with tiles. There is a crack at the corner of the sliding glass door of the living room (see Fig. 3). This crack is at the exterior wall and maybe caused by a lack of good caulking. There is a crack at the master bedroom balcony wall (see Fig. 4). This crack maybe caused by insufficient stucco or from water getting behind the stucco. I did not find any defective slabs; however, this does not mean the slab are 100% sufficient because they have been covered with tiles.

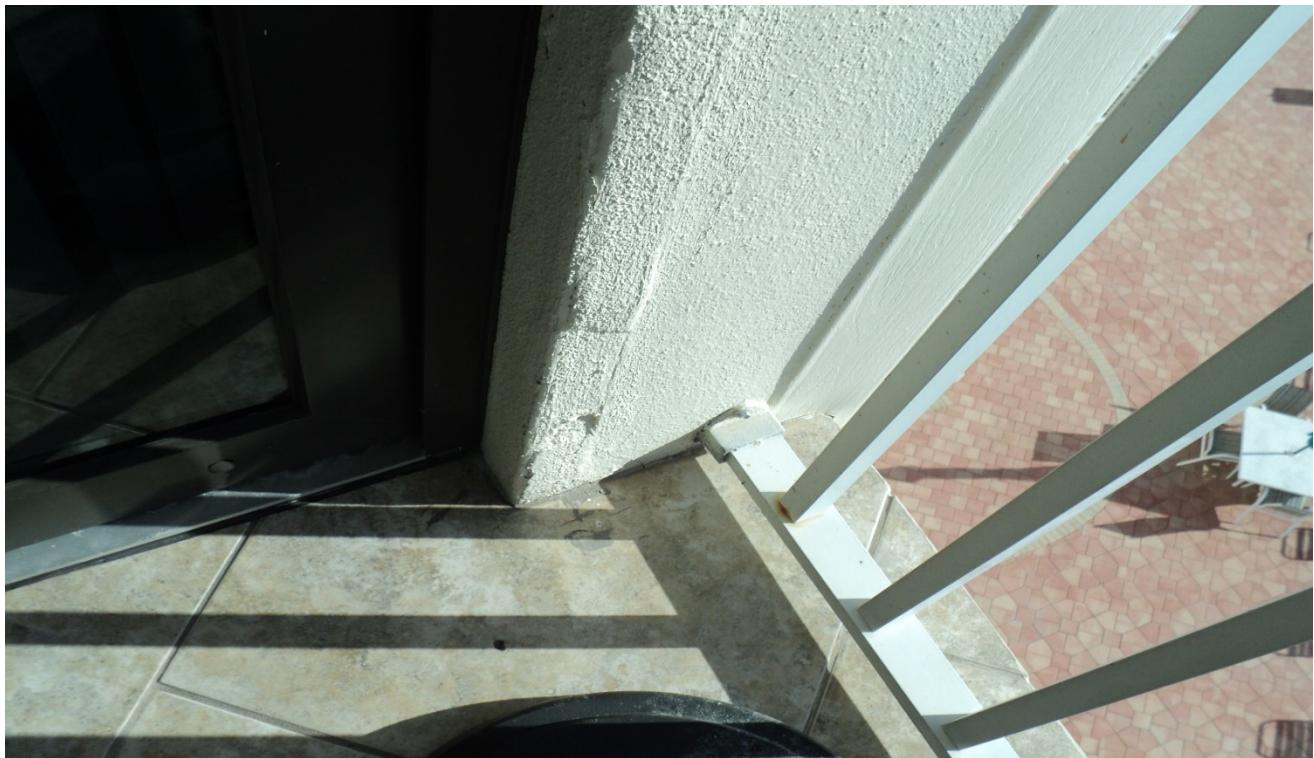
Fig. 5

The balcony was covered with tiles. The stucco at the corner of the balcony is in poor condition and it appears that is has been patched in the past and is losing the bond (see Fig. 5). I did not find any defective slabs; however, this does not mean the slab are 100% sufficient because they have been covered with tiles.

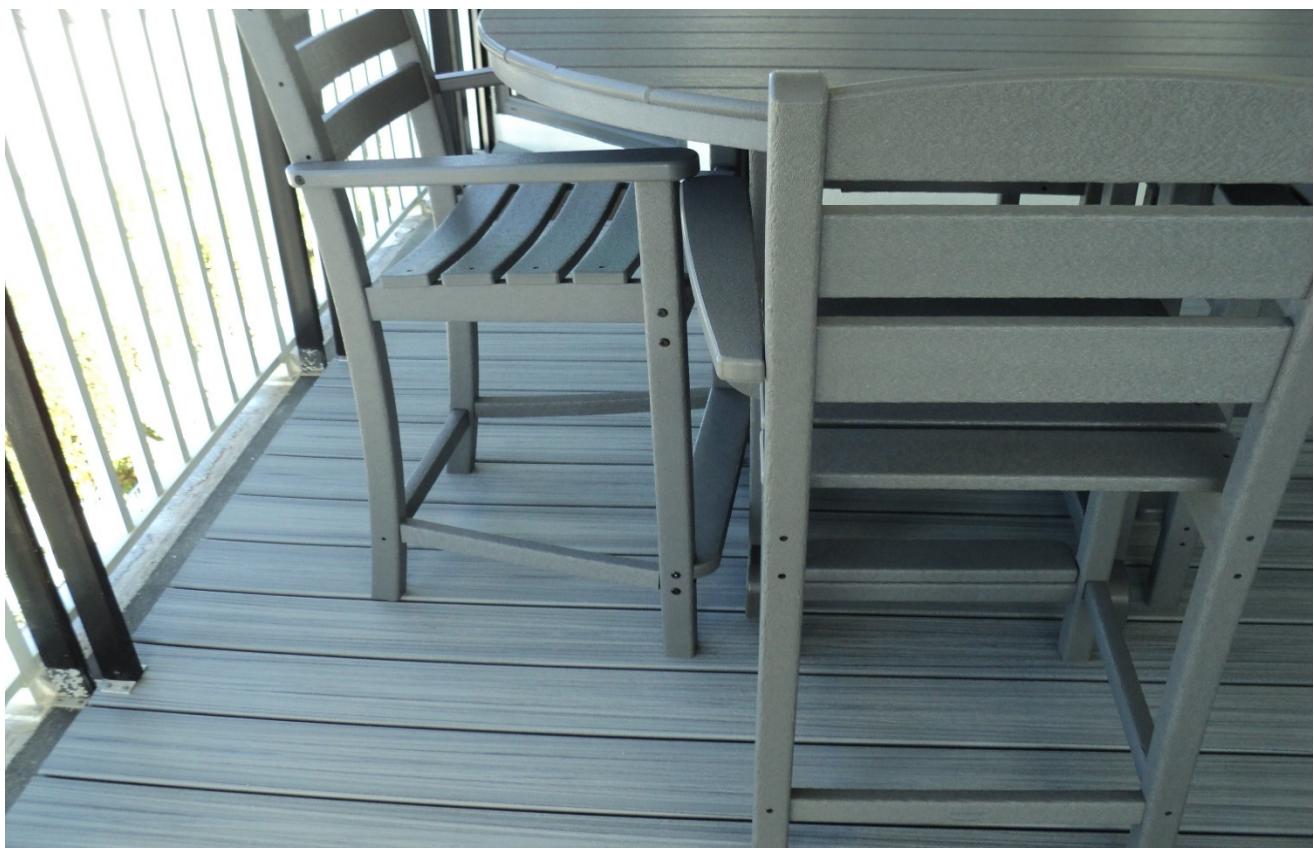
Fig. 6

The balconies were covered with limited flooring (see Fig. 6). The flooring stopped before the edge of the balcony slab and I was able to examine it (see Fig. 6). I did not find any defects in the slab. The framing around the sliding glass door in the living room's balcony has a crack (see Fig. 7). This crack maybe caused by insufficient stucco or possibly a lack of sufficient caulking. I did not find any defects in the slab; however, this does not mean the slab is 100% sufficient because it has been covered with limited flooring.
