MILESTONE PHASE 1 CONDITION SURVEY REPORT Sand Dollar Condominium

18500 Gulf Blvd., Indian Shores, FL 33785

BillerReinhart Project No. 23 - 077

Issue Date: September 25, 2023

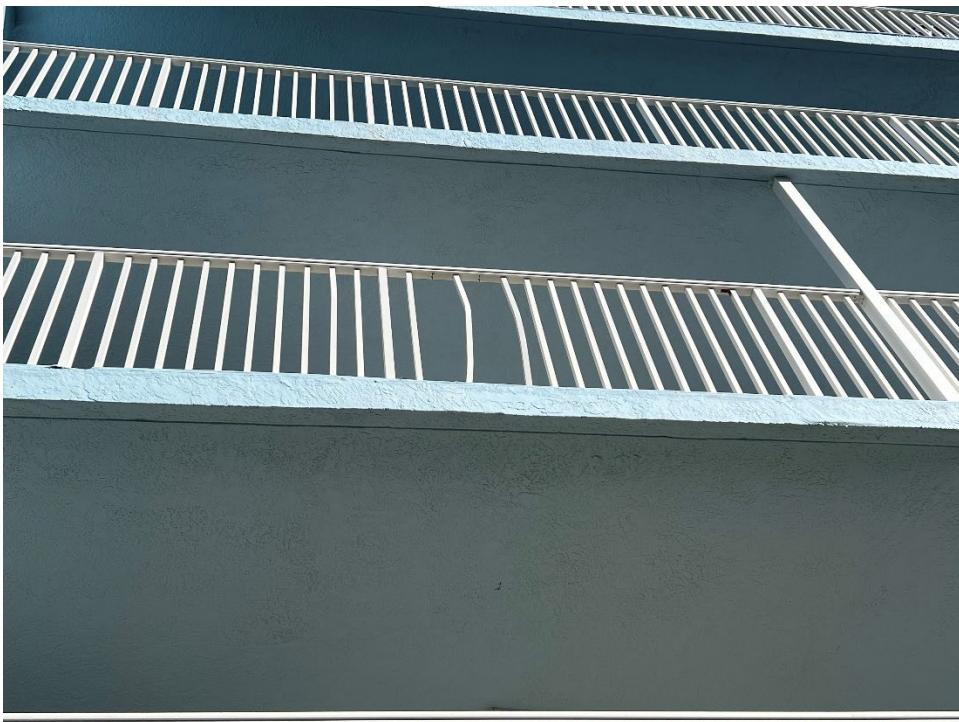
Figure A-5

3. Two detached aluminum pickets and one dislodged aluminum picket were observed at Unit 301 and 201 Southeast balcony areas respectively. Refer to *Figure A-5*.

Unsafe guardrails conditions including two detached aluminum pickets and one dislodged aluminum picket were observed at Unit 301 and 201 Southeast balcony areas respectively. BillerReinhart believes these guardrail conditions are unsafe and recommend immediate attention with access to these areas be prevented or supplementary support provided until repairs are completed.

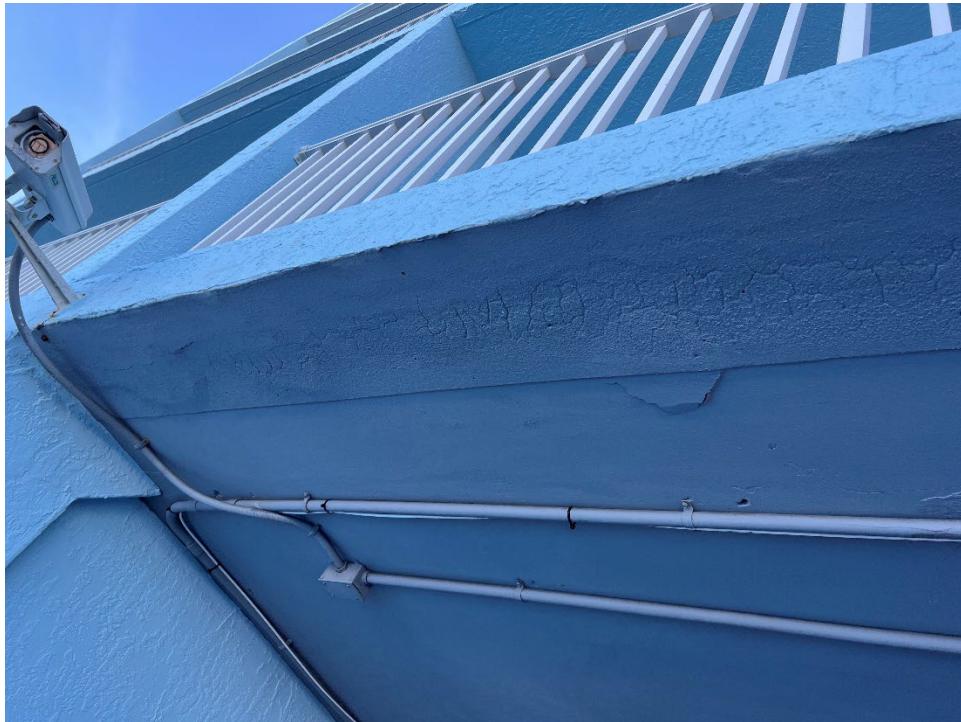
Figure A-6

4. Multiple locations of slab edge spalling and delamination were detected on the accessible slab edges. Refer to *Figure A-6* through *Figure A-9*.
5. Cracking was observed through isolated window lintels. Refer to *Figure A-10* and *Figure A-11*.

Based on the detection of multiple areas of stucco delamination within the exterior walls, cracks on the window lintels and slab edge declamations on walkways and balconies. BillerReinhart recommends a restoration project be undertaken for the repair and maintenance of all the exterior wall surfaces including deteriorated concrete structural elements, stucco, sealants, and building painting. Restoration of the exterior wall areas should mitigate potential moisture intrusion and expose any structural deterioration of underlying structural elements in need of repair. BillerReinhart recommends the exterior wall restoration and waterproofing project be undertaken within the next 3-5 years. Should the frequency of moisture intrusion through the building envelope increase, this scope of work may need to be completed earlier.

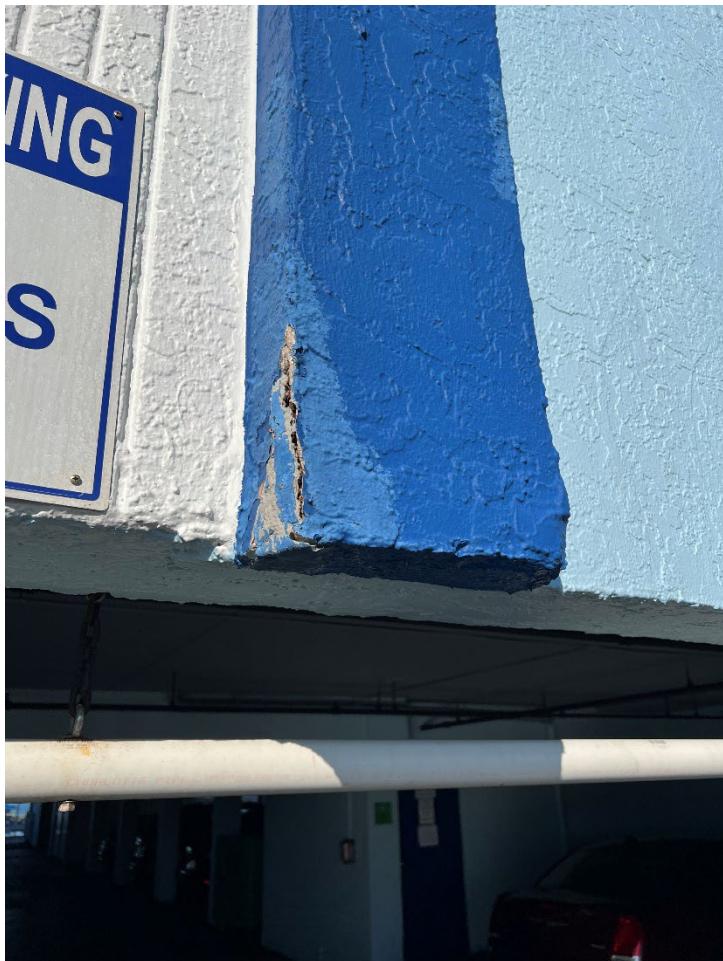
Figure A-12

6. Areas of stucco delamination were detected sporadically throughout the accessible areas of the exterior walls.
7. Foam band at the East elevation was observed to be deteriorated. Refer to *Figure A-12*.

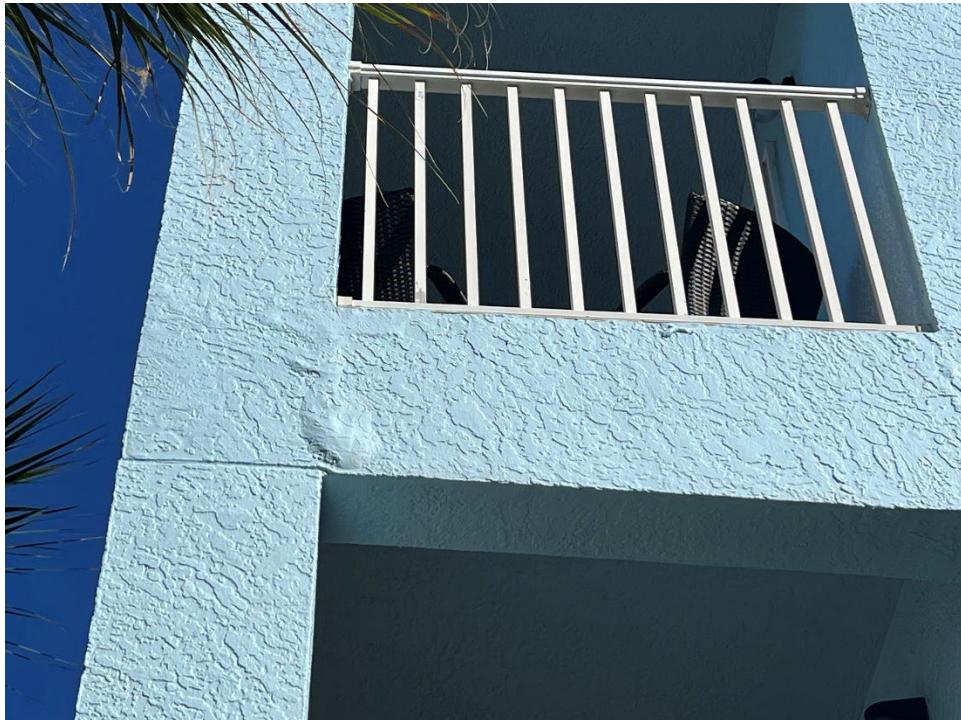
Figure A-13

8. Paint blistering was observed on the walls. Refer to *Figure A-13*.
9. Water was observed to be leaking onto exposed metal wall framing. Refer to *Figure A-14*.

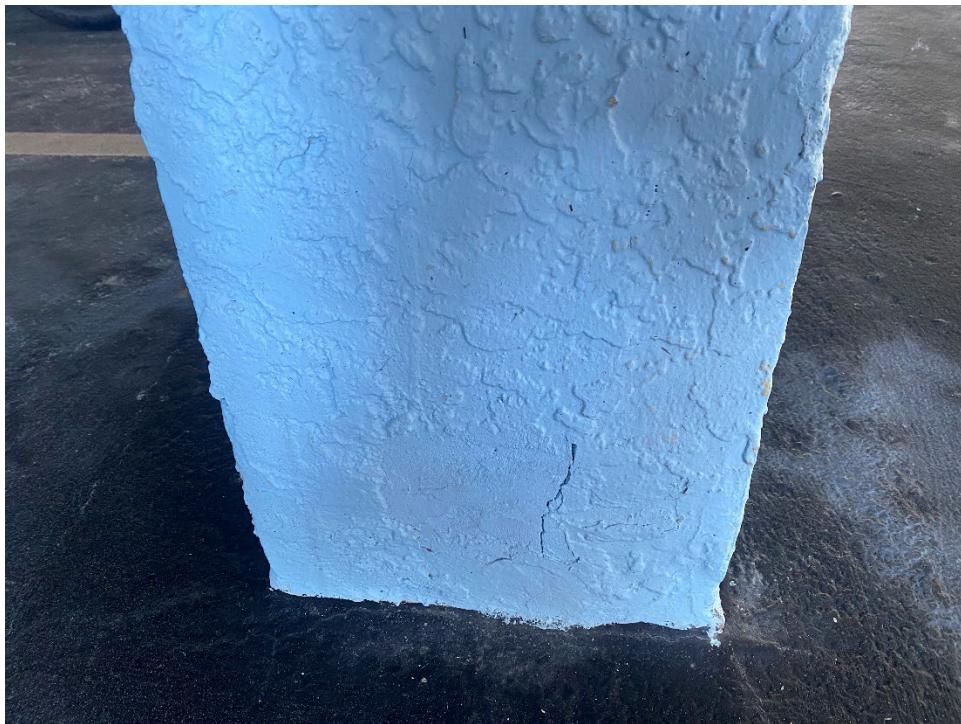
Figure A-15

1. Multiple areas of delamination and spalling were detected on columns. Refer to *Figure A-15 through Figure A-18*.
2. Multiple areas of delamination and spalling were detected on beams. Refer to *Figure A-19 through Figure A-22*.
3. Multiple locations of spalling were detected on the ceiling. Refer to *Figure A-23 through Figure A-25*.
4. Sporadic cracks were observed on the garage ceiling. Refer to *Figure A-26 and Figure A-27*.

The parking garage structures generally appear to be in fair condition, with sporadic concrete spalls and delaminated stucco on the columns, beams and walls. BillerReinhart recommends a restoration project be undertaken for the repair and maintenance of the parking garage areas. BillerReinhart recommends the restoration project be undertaken during the exterior wall restoration and waterproofing project.

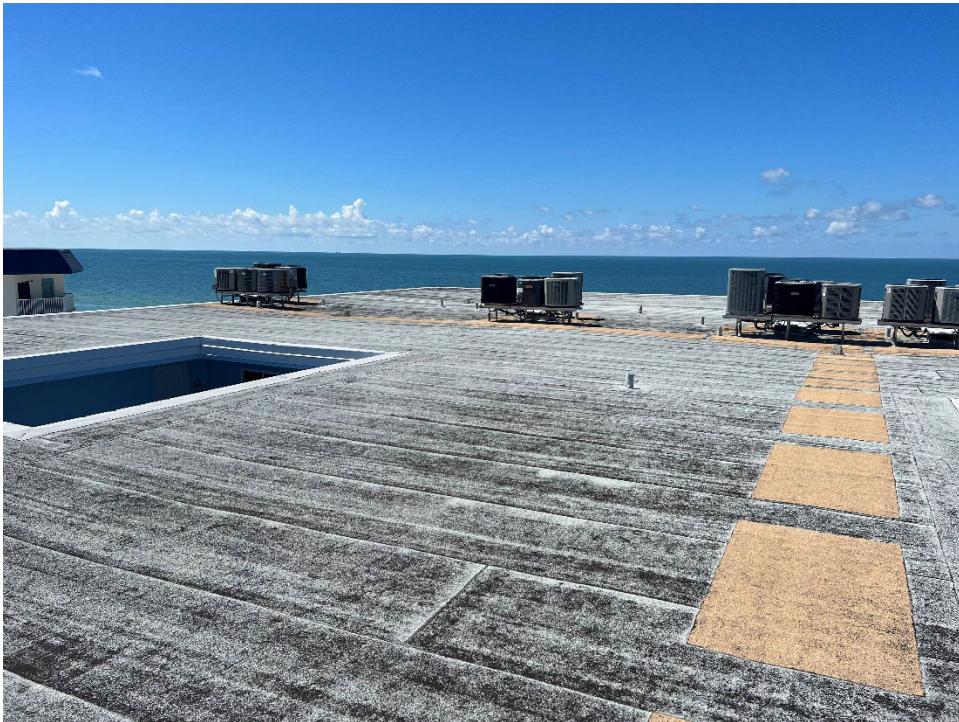
Figure A-30

1. The roof was generally observed to be in fair condition for its age, with significant granular loss throughout. Overall, the general conditions of the roof are shown in *Figure A-30 through Figure A-32*.

The modified bitumen flat roof systems were generally observed to be in fair condition with no reports of water intrusion. BillerReinhart understands, construction was completed in 2005 for the roof over to the existing roof surface with a life expectancy of approximately 20 years. Based on the age of the roof and amount of granular loss BillerReinhart recommends continually monitoring the conditions of the roof and plan for reroof project within the next 1-2 years.

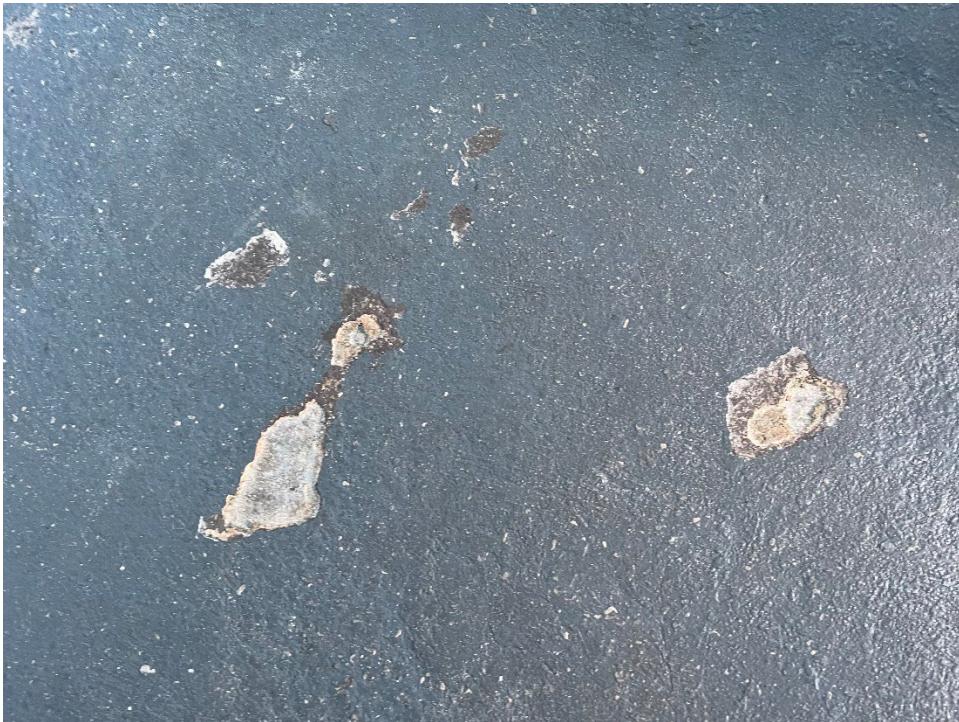
Figure B-1

1. The walkways appear to be covered with a number of layers of paint and cementitious coatings.
2. The guardrails were observed to be core mounted aluminum mechanically fastened and original to construction.
3. Sporadic locations throughout the walkways floor finish were observed to be delaminating from the walkway slab. Refer to *Figure B-1*.

The walkway structures generally appear to be in fair condition. BillerReinhart recommends the board plan for a global walkway waterproofing and restoration project be performed. This would include removing all existing layers of paint and cementitious finishes, restoration of the structural deck and application of a urethane waterproofing membrane. Urethane waterproofing membranes can withstand the pedestrian traffic that occurs on the walkway and provide the flexibility to expand and contract with the building movements to better protect the concrete structure from potential moisture intrusion and any structural deterioration of underlying structural elements. BillerReinhart recommends the board perform a global walkway waterproofing and restoration project within the next 5-7 years.

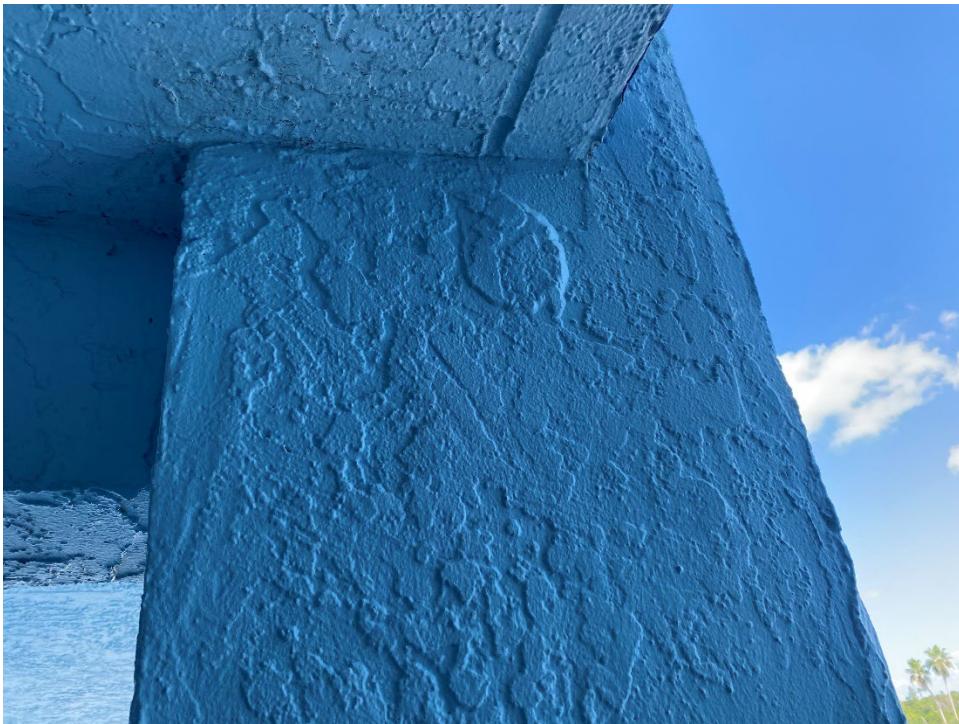
Figure B-2

4. Isolated areas of delamination were detected on the walkway columns. Refer to *Figure B-2 and Figure B-3*.
5. Peeling paint was observed on the guardrails. Refer to *Figure B-4*.
6. Multiple locations of guardrail repairs were noted on the guardrails. Refer to *Figure B-5 through Figure B-7*.

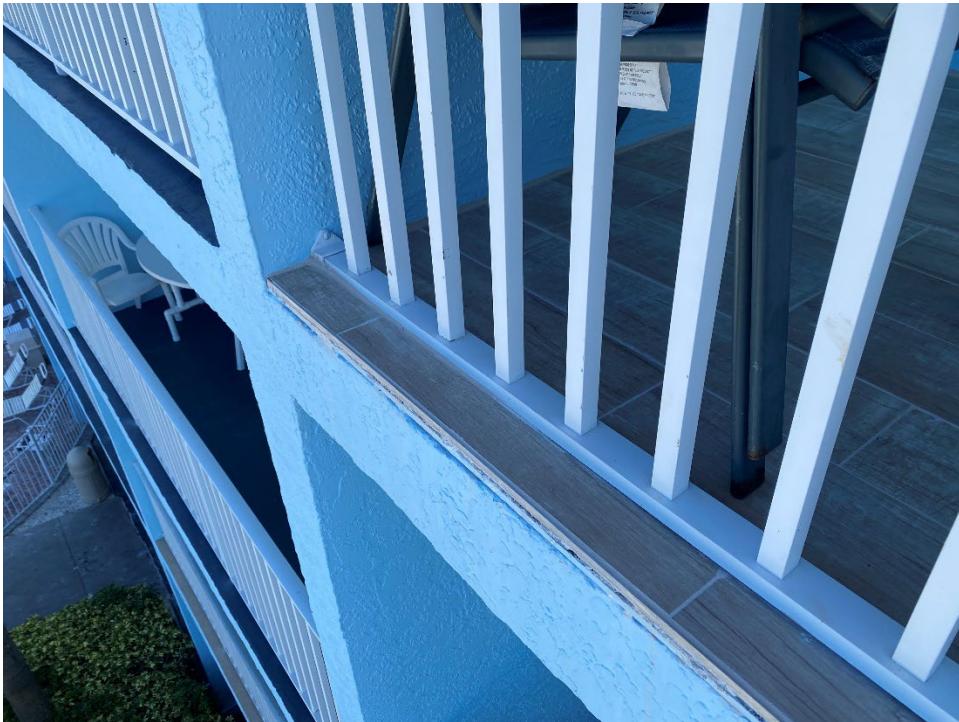
Figure B-8

1. The balconies appear to be covered with tile or paint.
2. The guardrails were observed to be core mounted aluminum mechanically fastened.
3. Multiple slab edge delaminations were detected on the balconies. Refer to *Figure B-8 through Figure B-11*.
4. Sporadic locations of slab spalls were noted. Refer to *Figure B-12 and Figure B-13*.
5. Numerous balcony guardrail pickets were observed to be corroded with section loss. Refer to *Figure B-14 through Figure B-17*.
6. Guardrail repairs were noted on the guardrail pickets. Refer to Figure B-18.

The surveyed balcony structures were observed to generally be in fair condition with isolated locations of concrete spalls on the concrete slabs. BillerReinhart recommends the board plan for a global balcony waterproofing and restoration project be performed. This would include removing all existing tile or layers of paint and cementitious finishes, restoration of the structural deck and application of a urethane waterproofing membrane. Urethane waterproofing membranes can withstand the pedestrian traffic that occurs on the balconies and provide the flexibility to expand and contract with the building movements to better protect the concrete structure from potential moisture intrusion and any structural deterioration of underlying structural elements. BillerReinhart recommends

the board perform a global balcony waterproofing and restoration project within the next 5-7 years.
