MILESTONE INSPECTION REPORT

GULF SHORES CONDOMINIUMS

18650 GULF BOULEVARD
INDIAN SHORES, FL 33785

ISSUE DATE:
10/30/24

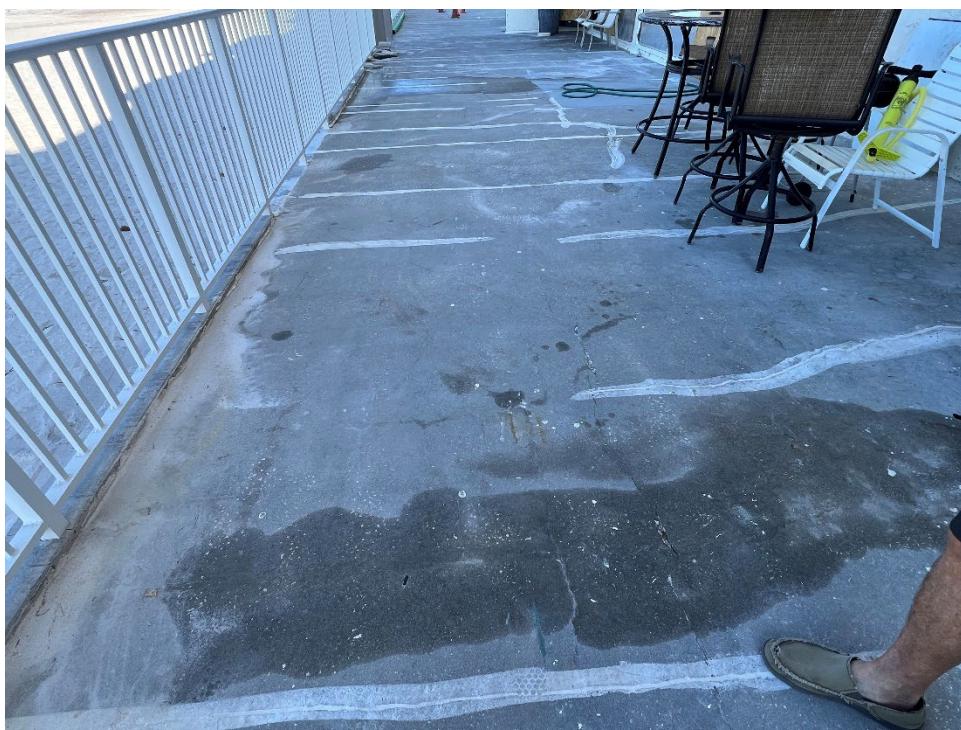
Figure E- 14

- Areas of concrete damage were observed along the 1st floor sundeck slab following recent storm surge event during Hurricane Helene (Refer to Figure E-14 and Figure E-15).

- Regular maintenance of the exterior building paint coating. While not required by the building code, “best practices” for longevity of exterior building paint coatings is recommended to be recoated every 7 years.
- Regular maintenance of the roofing system. Please note maintenance of roofing systems is typically dependent on the age and effectiveness of the roofing system, which is outside of the intent of the Milestone Inspection as Elevated Engineering understands it and therefore no comments on the recommended maintenance of the roofing system is included.
- Regular maintenance of the 1st floor sundeck guardrail Kynar finishes. Maintenance of guardrail finishes are dependent on guardrail coating product manufacturer's specifications/recommendations.
- Repair existing areas of concrete damaged during Hurricane Helene along concrete slab surfaces of the 1st floor sundeck.

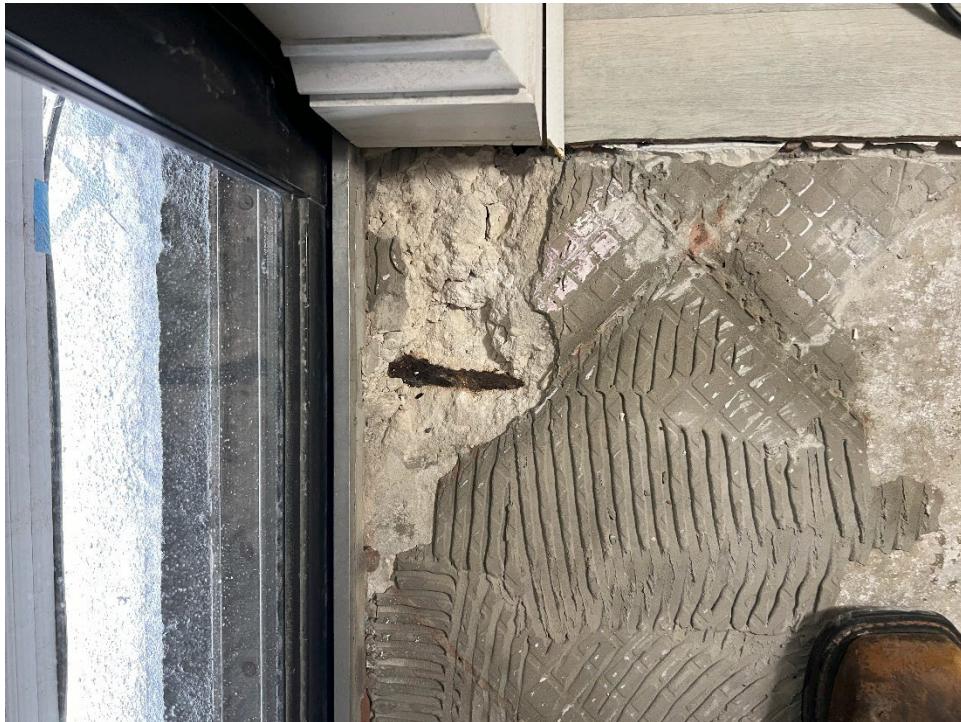
Figure U- 19

- Localized concrete floor slab spall with exposed rusting reinforcement was observed along the interior of the sliding glass door opening at Unit 610 (Refer to Figure U-19).

- Repair existing areas of unsound concrete and concrete spalls along concrete slab surfaces at Unit 610. Currently this condition does not appear to represent a serious structural condition, however, concrete spalls need to be addressed as once concrete spalling starts the rate of additional corrosion increases rapidly, which leads to further concrete deterioration, which may develop into a more serious structural condition.
- Repair and/or replace storefront windows and doors of the clubroom and sliding glass doors of individual units damaged during Hurricane Helene.

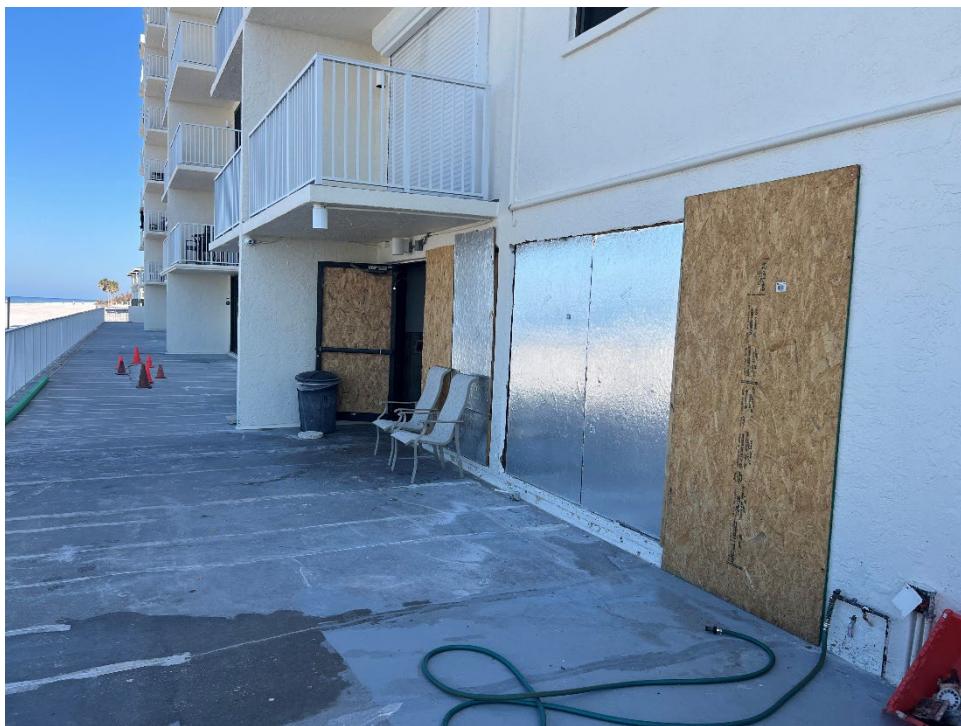
Figure U- 20

- Damaged storefront windows and doors of clubroom and sliding glass doors of individual units along the 1st floor west sundeck were observed following recent storm surge event during Hurricane Helene (Refer to Figure U-20).
