October 10, 2023

Shore Haven Condominiums
18720 Gulf Boulevard
Indian Shores, FL 33785

Regarding: Shore Haven Condominiums – Phase II Milestone Inspection

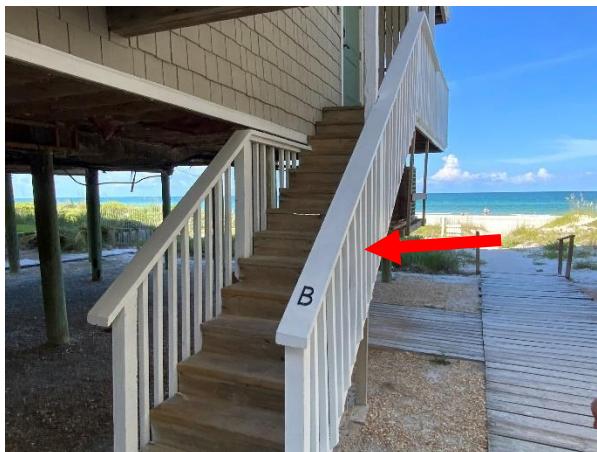
- BE-CI observed loose and unstable hand railings at the staircases of Buildings 1 & 5. BE-CI considers these conditions to be unsafe as the condition can no longer be used for its intended function. ***BE-CI recommends that the existing handrails be replaced which meet 2020 Florida Building Code requirements by a licensed Florida contractor. BE-CI recommends these issues be addressed immediately at the aforementioned locations*** (Reference Photo Exhibit Nos. 1 and 2).

Photo 1
 Building 1 – North Elevation – Overall view of loose railing at stair case.

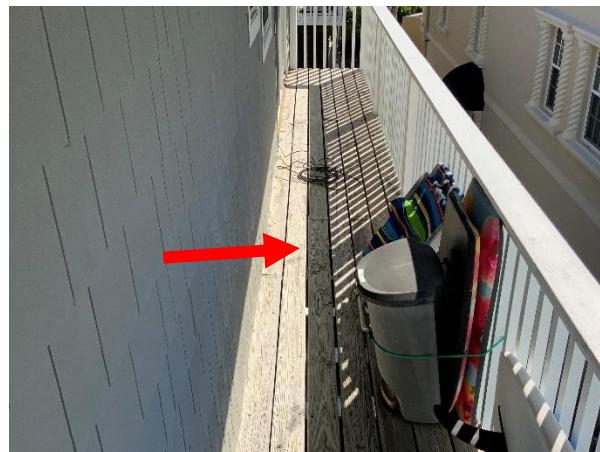
- BE-Cl also observed isolated areas on the South Elevation-Third Floor of Building 1 and the West Elevation-Second Floor of Building 6/7 where the existing balcony decking was deteriorated and unstable. Furthermore, BE-Cl observed deteriorated wood framing at the base of the staircases of Buildings 5 and 8/9. BE-Cl considers these conditions to be unsafe as the condition can no longer be used for its intended function. ***BE-Cl recommends that the existing deteriorated decking be replaced which meet 2020 Florida Building Code requirements and staircase bases be replaced by a licensed Florida contractor. BE-Cl recommends these issues be addressed immediately at the aforementioned locations*** (Reference Photo Exhibit Nos. 3 through 6).

Photo 4
 Building 1 – South Elevation – Overall view of deteriorated decking.

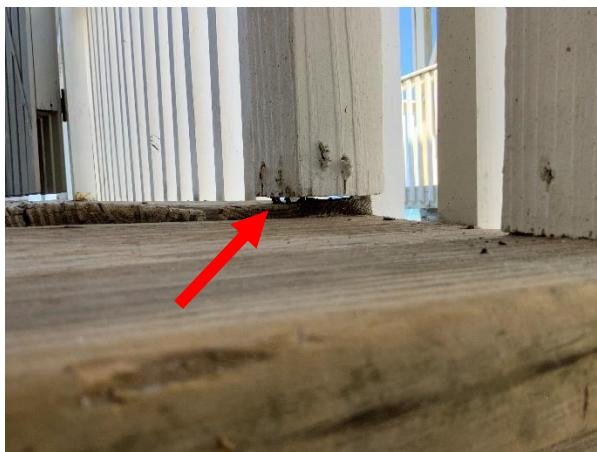
Photo 2
 Building 1 – North Elevation – Overall view of unsecured balcony railing post.

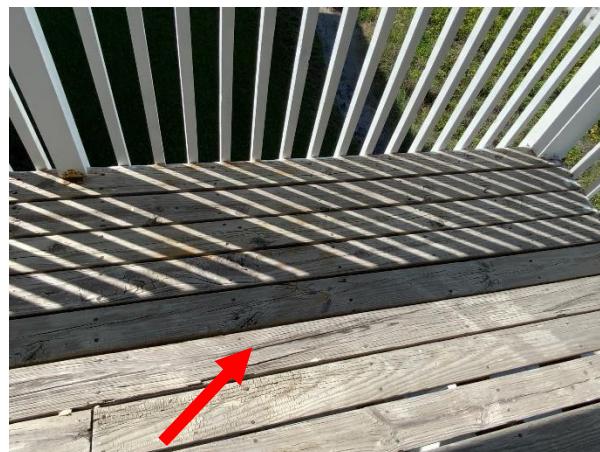
Photo 5
 Building 1 – South Elevation – Overall view of deteriorated decking.

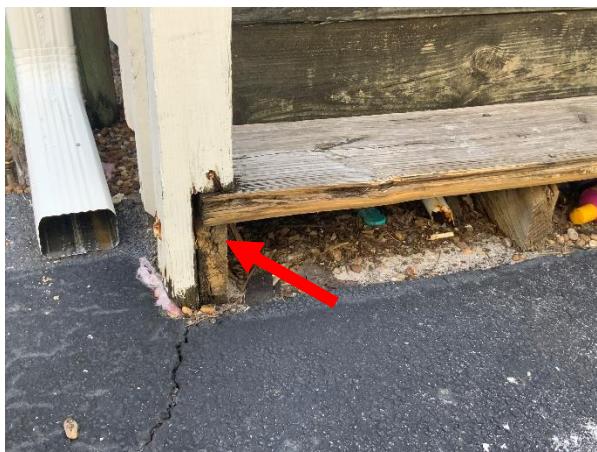
Photo 3
 Building 5 – East Elevation – Overall view of deteriorated wood staircase.

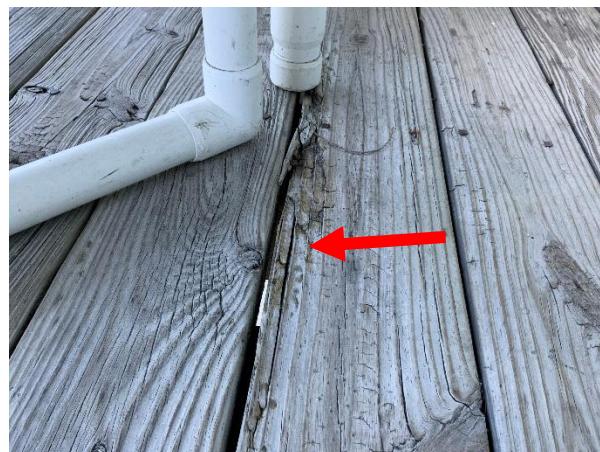
Photo 6
 Building 6/7 – West Elevation – Overall view of deteriorated decking.

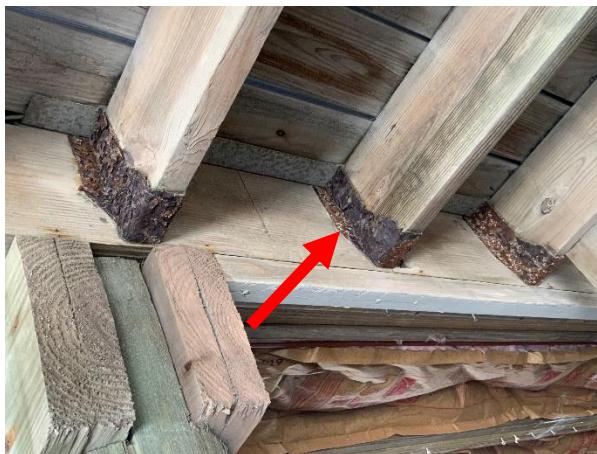
- BE-Cl observed widespread areas of severely corroded balcony joist hangers at Buildings 1 through 5. Furthermore, BE-Cl observed that joist hangers had not been installed in the balcony framing of Buildings 6 through 9. BE-Cl considers this condition to be unsafe due to the severity of the corrosion and lack of structural attachment members. ***BE-Cl recommends that shoring be installed below the balcony joists and the corroded joist hangers be removed and replaced with stainless steel units and that joist hangers be installed at Buildings 6 through 9 by a licensed Florida contractor. BE-Cl recommends this issue be addressed immediately*** (Reference Photo Exhibit Nos. 7 through 12).

Photo 7
Building 1 – West Elevation – Overall view of corroded joist hangers.

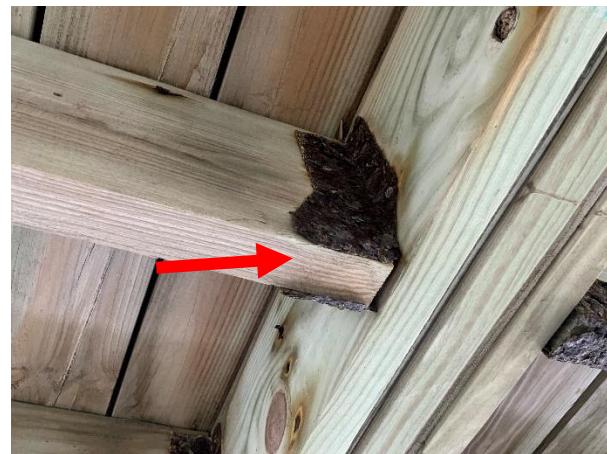
Photo 10
Building 4 – West Elevation – Overall view of corroded joist hangers.

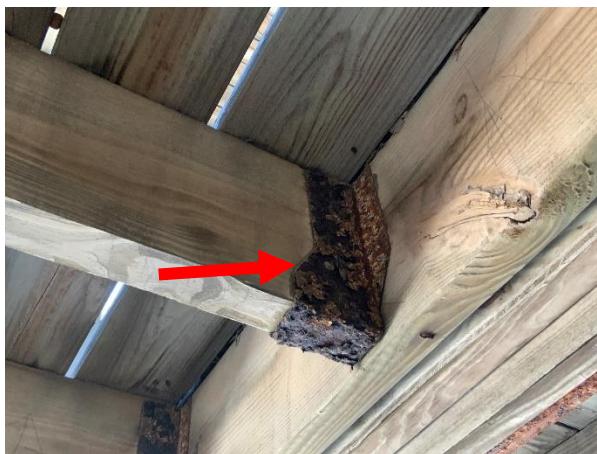
Photo 8
Building 1 – West Elevation – Overall view of corroded joist hangers.

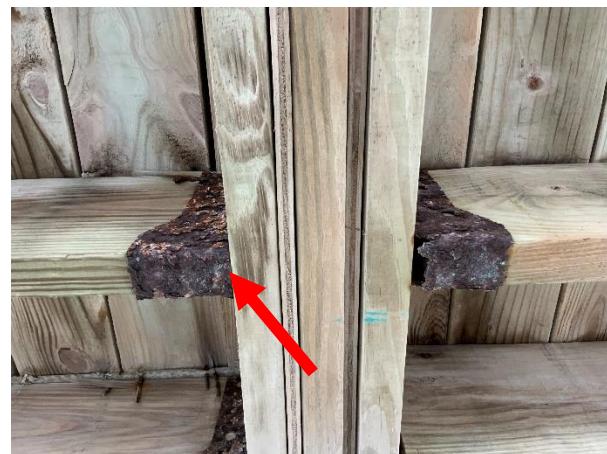
Photo 11
Building 4 – West Elevation – Overall view of corroded joist hangers.

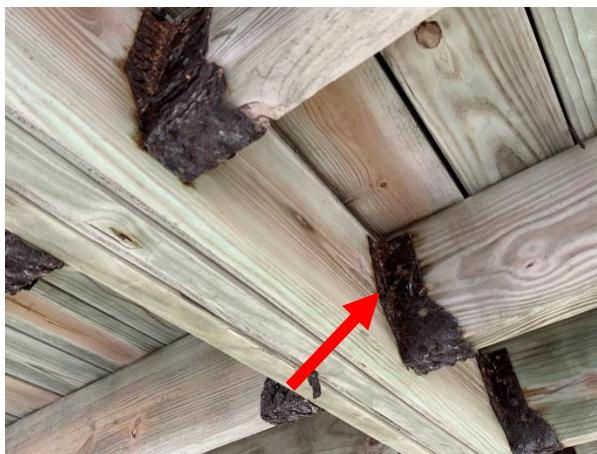
Photo 9
Building 5 – West Elevation – Overall view of corroded joist hangers.

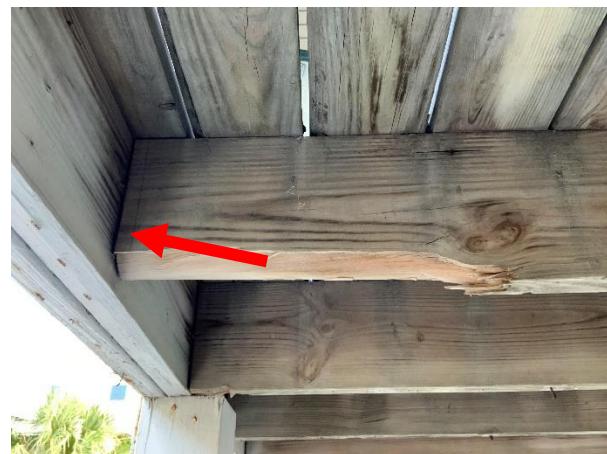
Photo 12
Building 6/7 – West Elevation – Overall view of hangers not installed at joists.

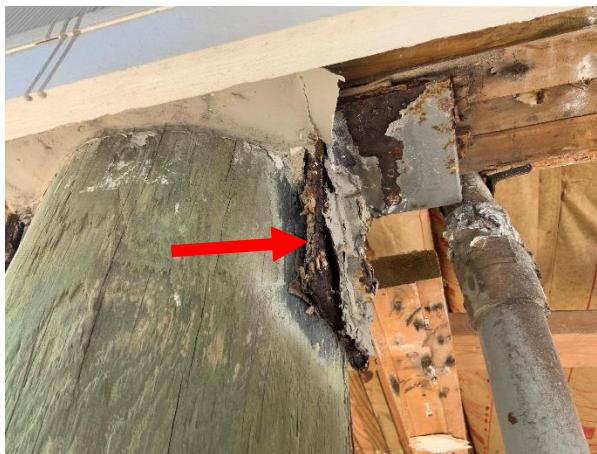
- BE-Cl observed widespread areas of corrosion at the foundation piling metal "L" brackets in the first-floor covered parking areas. ***BE-Cl recommends that shoring be installed under the structural steel support beams, and the brackets be removed and replaced at all buildings by a licensed Florida contractor within the next six (6) months*** (Reference Photo Exhibit Nos. 13 through 18).

Photo 13
 Building 2 – South Elevation – Overall view of corroded L brackets.

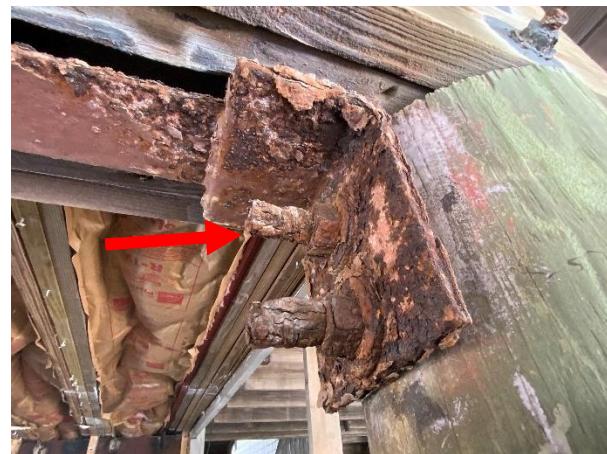
Photo 16
 Building 6/7 – West Elevation – Overall view of corroded L brackets.

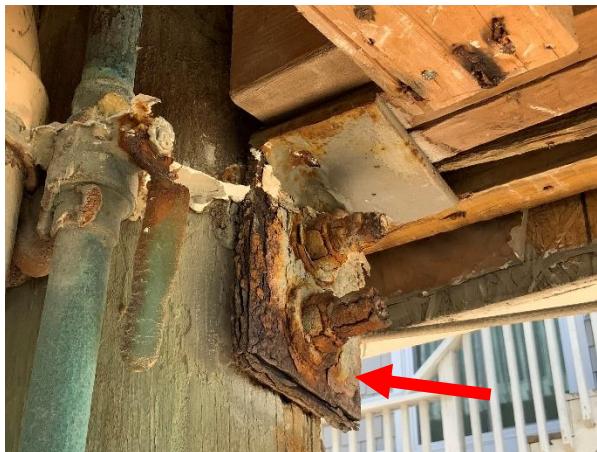
Photo 14
 Building 3 – South Elevation – Overall view of corroded L brackets.

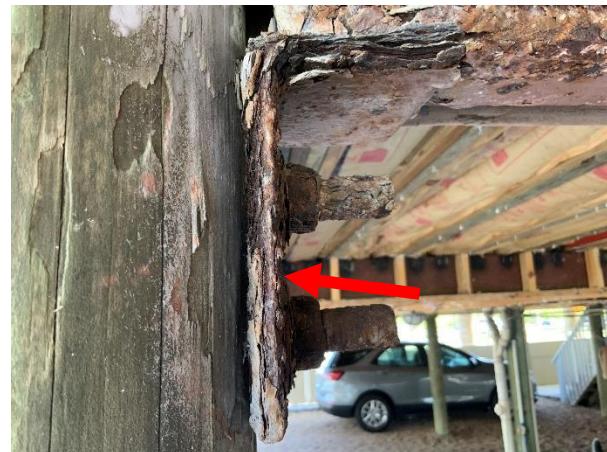
Photo 17
 Building 6/7 – South Elevation – Overall view of corroded L brackets.

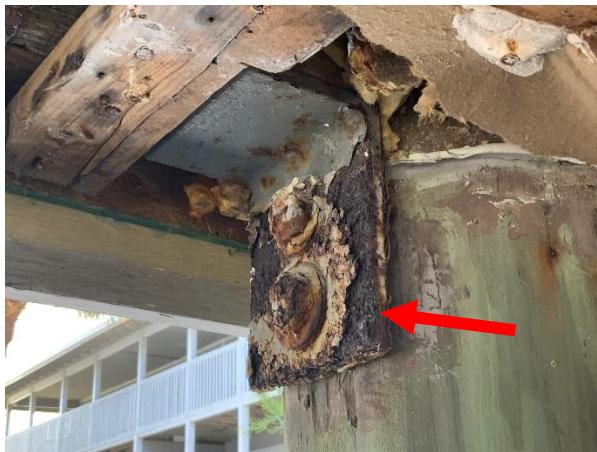
Photo 15
 Building 4 – West Elevation – Overall view of corroded L brackets.

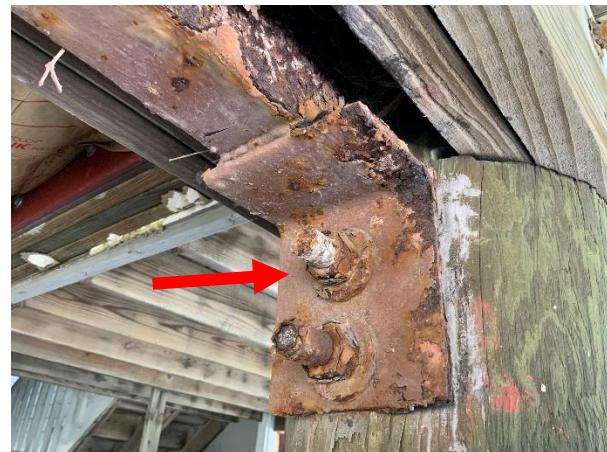
Photo 18
 Building 8/9 – West Elevation – Overall view of corroded L brackets.

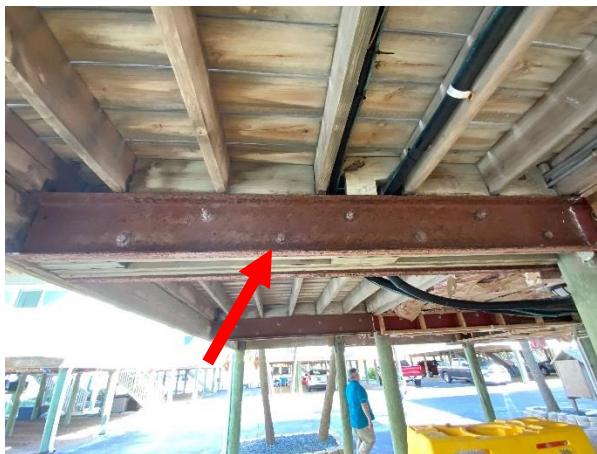
- BE-Cl observed widespread areas of corrosion at the external structural steel support beams at the second-floor balcony overhangs. In heavily corroded areas, BE-Cl observed sections with approximately under 10% section loss. ***BE-Cl recommends that shoring be installed under the external steel beams, and that at the beams be removed, mechanically sanded, new coatings be applied, and beams reinstalled by a licensed Florida contractor within the next six (6) months to avoid further deterioration*** (Reference Photo Exhibit Nos. 19 through 24).

Photo 19
Building 4 – West Elevation – Overall view of corroded exterior steel supports.

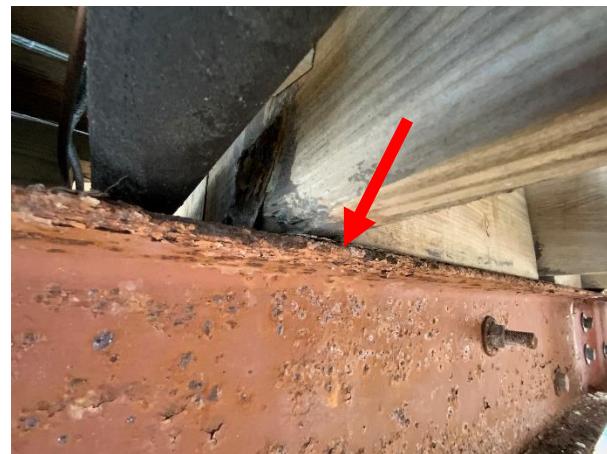
Photo 22
Building 4 – West Elevation – Overall view of corroded exterior steel supports.

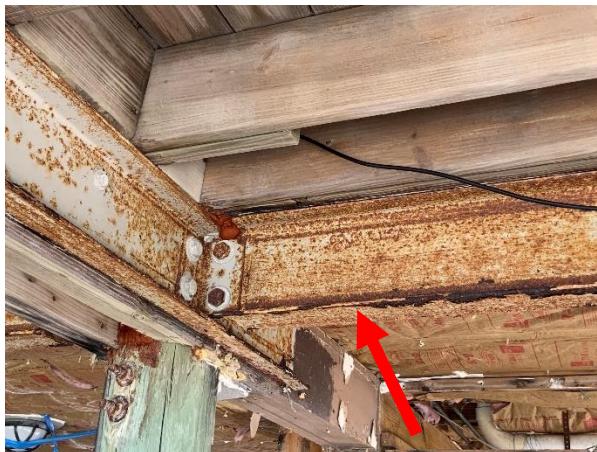
Photo 20
Building 2 – West Elevation – Overall view of corroded exterior steel supports.

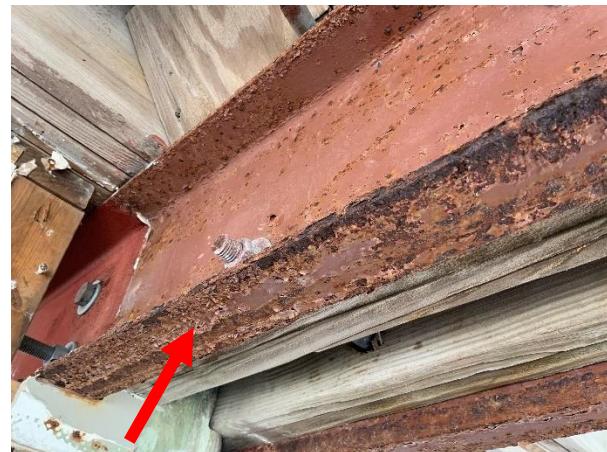
Photo 23
Building 5 – West Elevation – Overall view of corroded exterior steel supports.

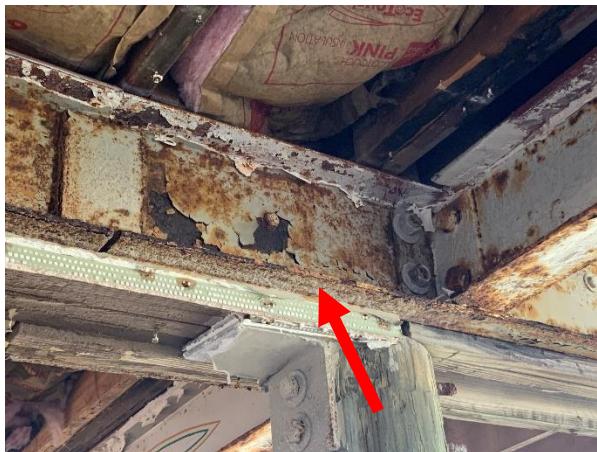
Photo 21
Building 3 – West Elevation – Overall view of corroded exterior steel supports.

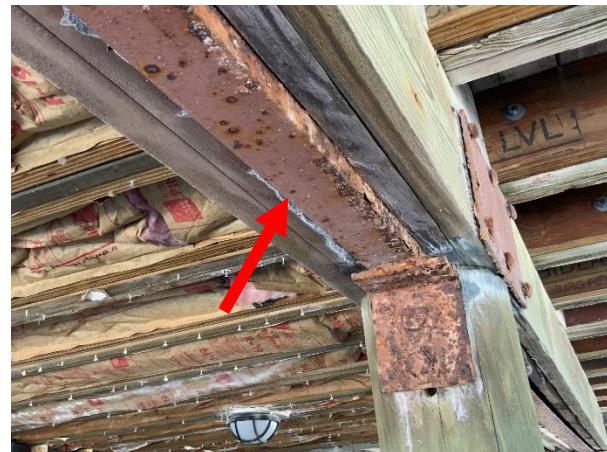
Photo 24
Building 6/7 – West Elevation – Overall view of corroded exterior steel supports.

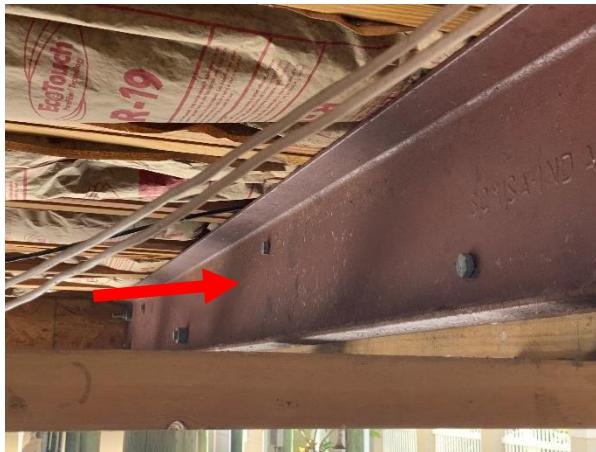
- BE-Cl also observed isolated areas of corrosion at the internal structural steel support beams in the second-floor covered parking. ***BE-Cl recommends that the internal steel beams at the covered parking be mechanically sanded in place, and that new coatings be applied by a licensed Florida contractor within the next year.*** (Reference Photo Exhibit Nos. 25 through 30).

Photo 25
 Building 4 – South Elevation – Overall view of corroded interior steel supports.

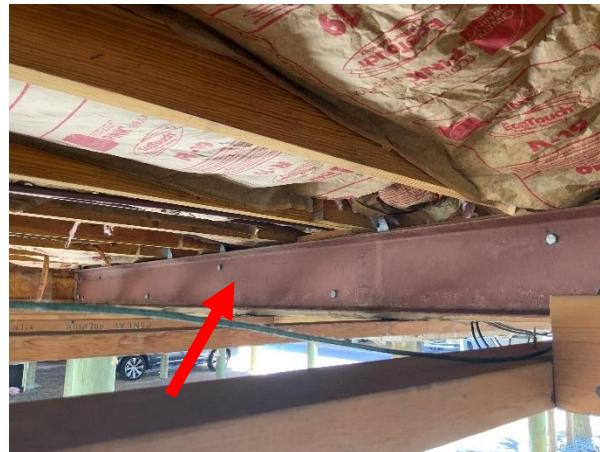
Photo 28
 Building 5 – South Elevation – Overall view of corroded interior steel supports.

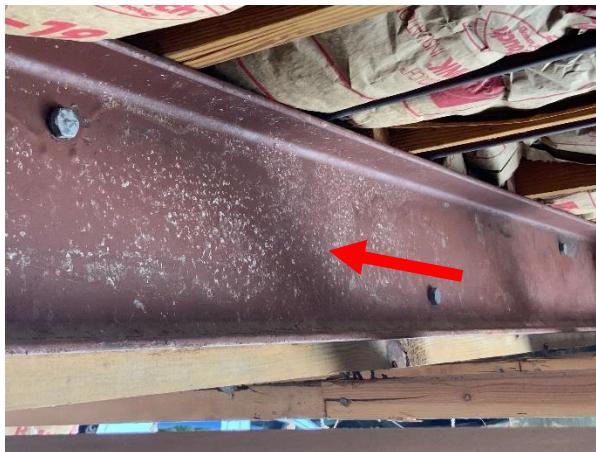
Photo 26
 Building 4 – North Elevation – Overall view of corroded interior steel supports.

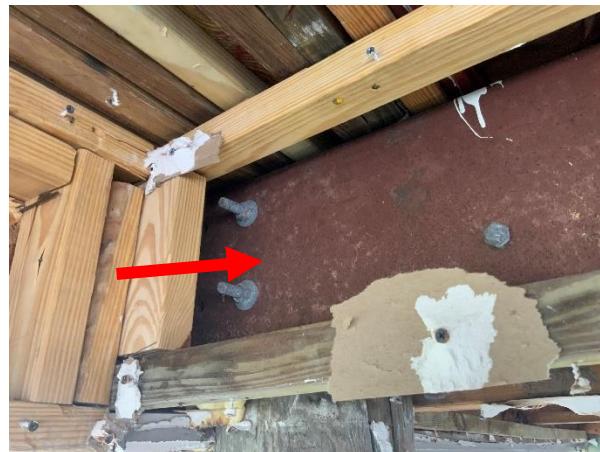
Photo 29
 Building 8/9 – North Elevation – Overall view of corroded interior steel supports.

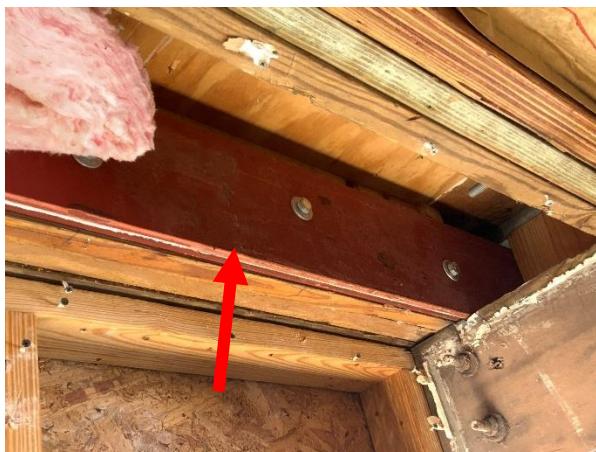
Photo 27
 Building 5 – East Elevation – Overall view of corroded interior steel supports.

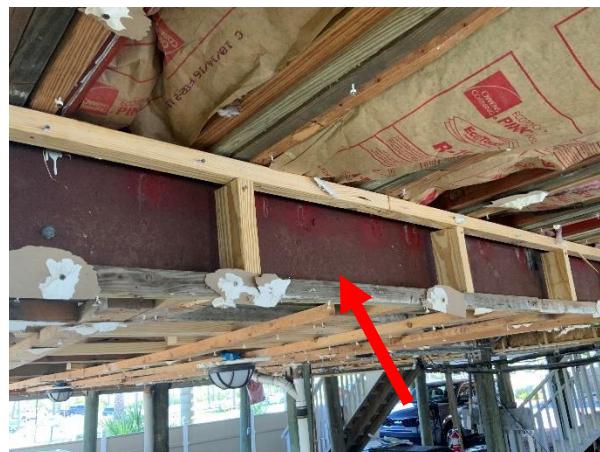
Photo 30
 Building 8/9 – North Elevation – Overall view of corroded interior steel supports.

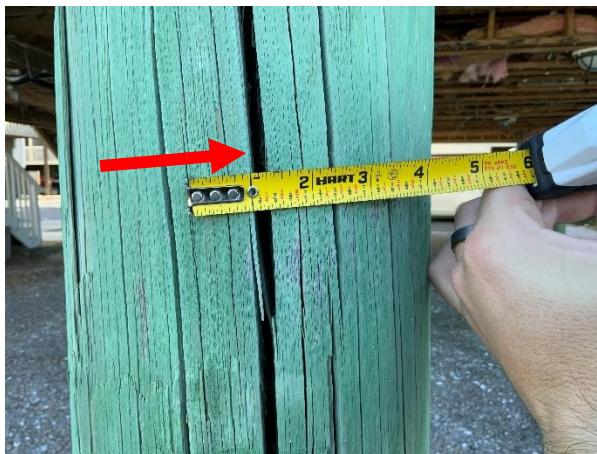
- BE-Cl observed isolated splitting in the wood pilings at the West Elevation of Buildings 1-3. Core samples were taken at select pilings to verify the structural integrity and were observed to be in acceptable condition and no deterioration was observed. ***BE-Cl recommends that all pilings be wrapped in a vinyl sheet good material designed for this type of remediation in a coastal environment by a licensed Florida contractor within the next one (1) to two (2) years to avoid further deterioration*** (Reference Photo Exhibit Nos. 31 through 36).

Photo 31
 Building 1 – West Elevation – Overall view of splitting piling.

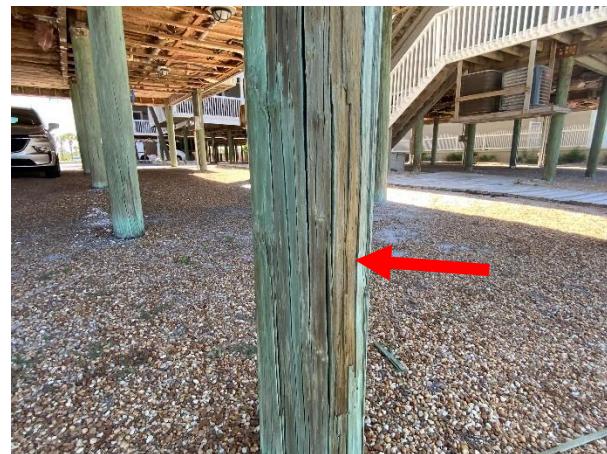
Photo 34
 Building 2 – West Elevation – Overall view of splitting piling.

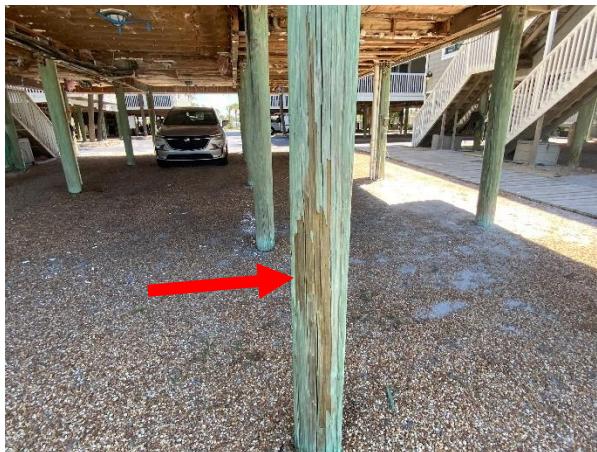
Photo 32
 Building 2 – West Elevation – Overall view of splitting piling.

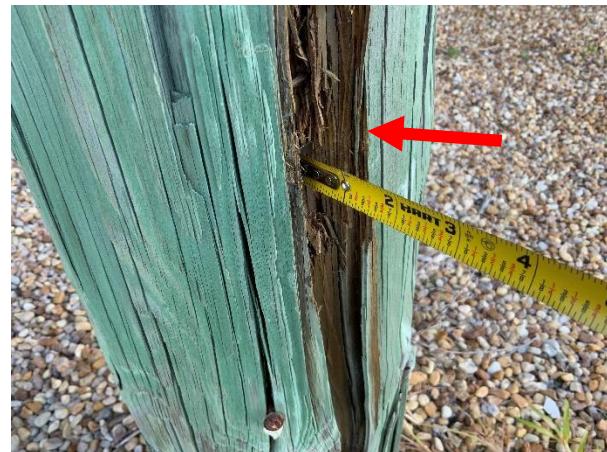
Photo 35
 Building 3 – West Elevation – Overall view of approximately 1" of compromised wood.

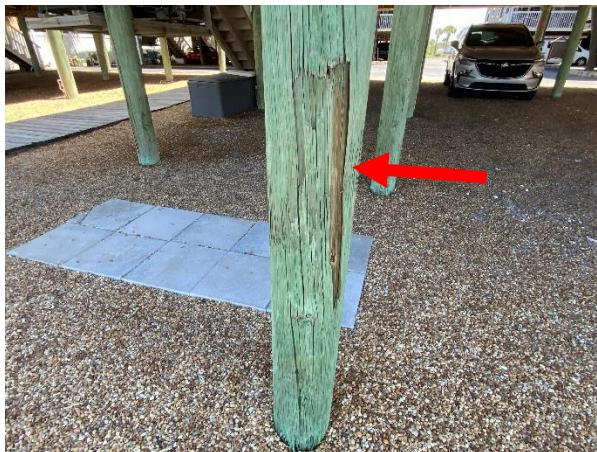
Photo 33
 Building 2 – West Elevation – Overall view of splitting piling.

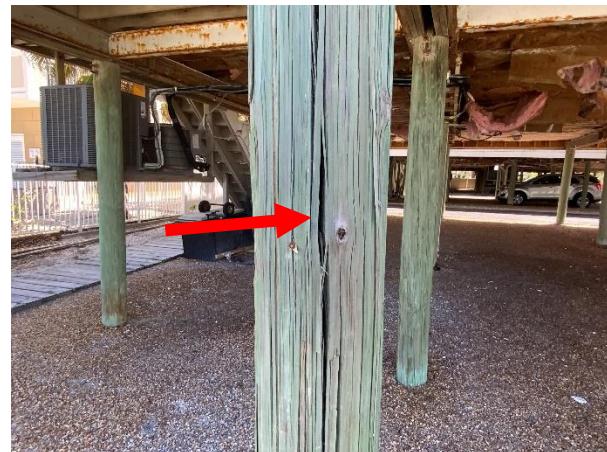
Photo 36
 Building 3 – West Elevation – Overall view of splitting piling.

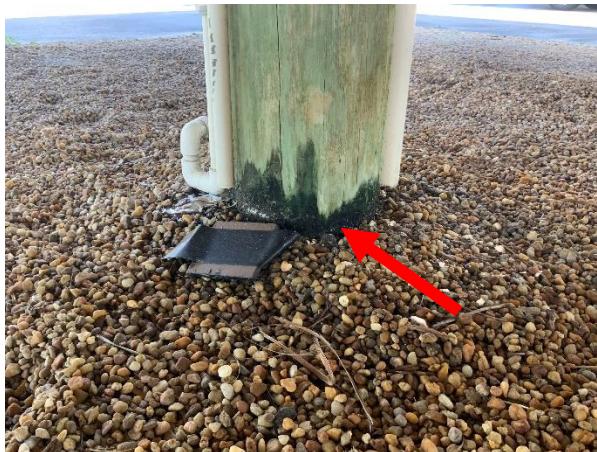
- BE-Cl also observed isolated areas of staining and microbial growth at the piling bases in the covered parking areas. Vinyl wrap was installed by P&R Pro Coatings at the piling bases two (2) feet below grade at pilings where core samples were taken. ***BE-Cl recommends that the air conditioning condensation lines and gutter downspouts be re-routed away from the piling bases by a licensed Florida contractor within the next year to avoid further deterioration*** (Reference Photo Exhibit Nos. 37 through 48).
- Lastly, BE-Cl observed widespread areas of corrosion at the private balcony metal support brackets. ***BE-Cl recommends that the metal support brackets at the balconies be removed and replaced with stainless steel members and or mechanically sanded and coated in place by a licensed Florida contractor within the next year.*** (Reference Photo Exhibit Nos. 49 through 54).

Photo 37
Building 4 – North Elevation – Overall view of staining and microbial growth at piling base.

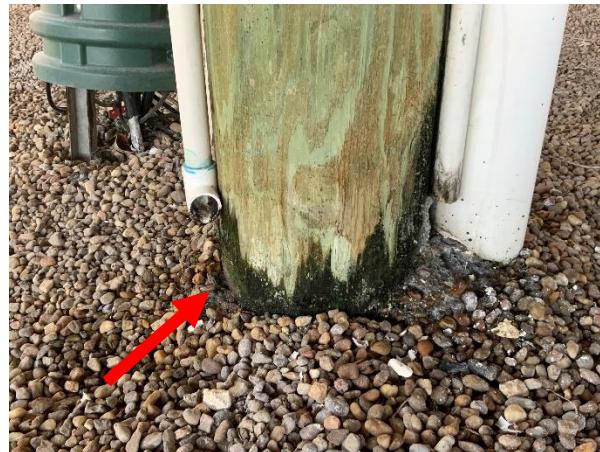
Photo 40
Building 6/7 – North Elevation – Overall view of staining and microbial growth at piling base.

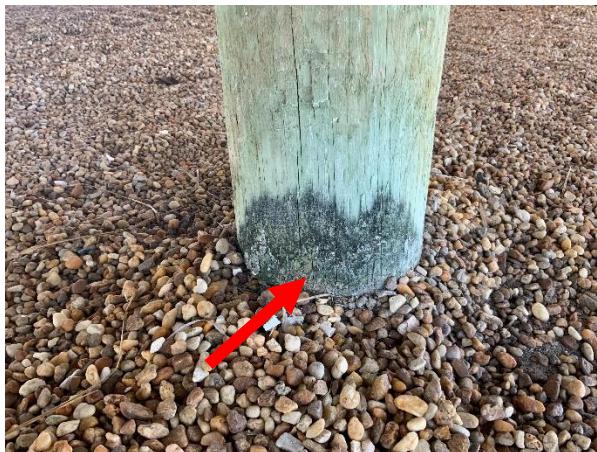
Photo 38
Building 4 – North Elevation – Overall view of staining and microbial growth at piling base.

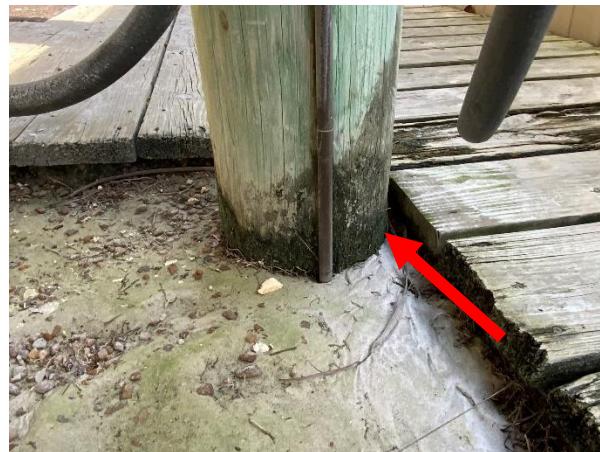
Photo 41
Building 6/7 – East Elevation – Overall view of staining and microbial growth at piling base.

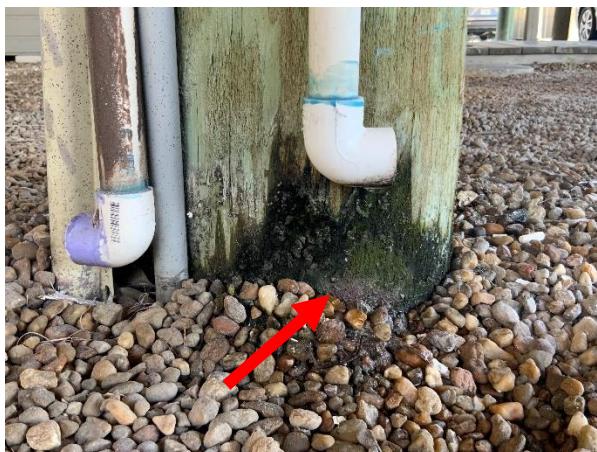
Photo 39
Building 6/7 – North Elevation – Overall view of air conditioning condensation lines at the piling base.

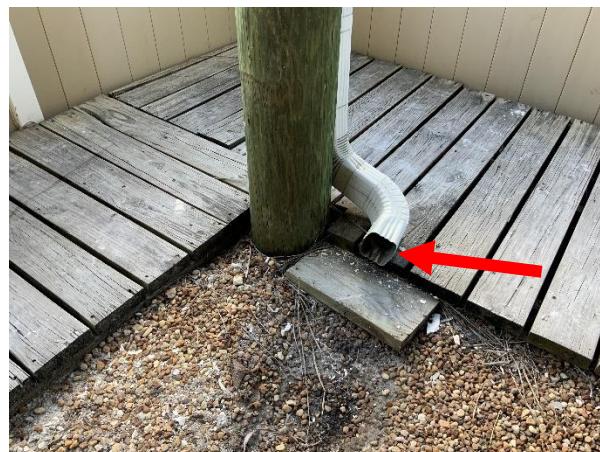
Photo 42
Building 6/7 – South Elevation – Overall view of gutter downspout at piling base.

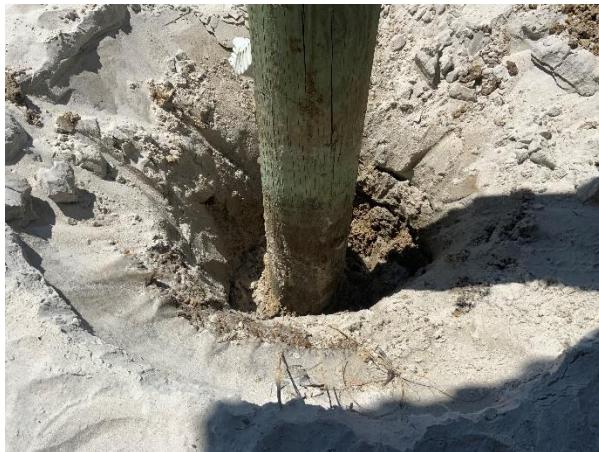
Photo 43
Building 3 – West Elevation – Overall view of excavation at piling base.

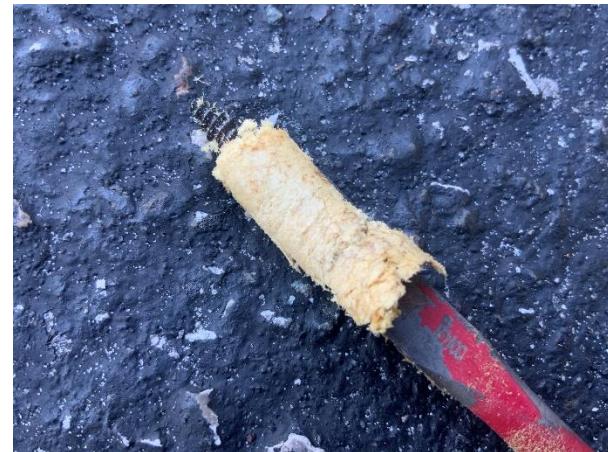
Photo 46
Building 7/8 – West Elevation – Overall view of core sample taken from piling base.

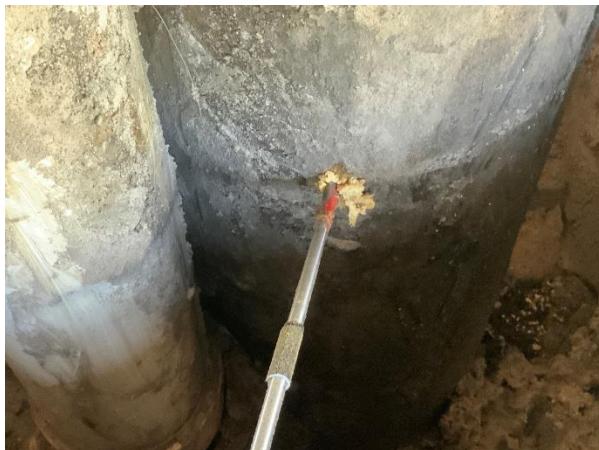
Photo 44
Building 1 – West Elevation – Overall view of core sample of piling base.

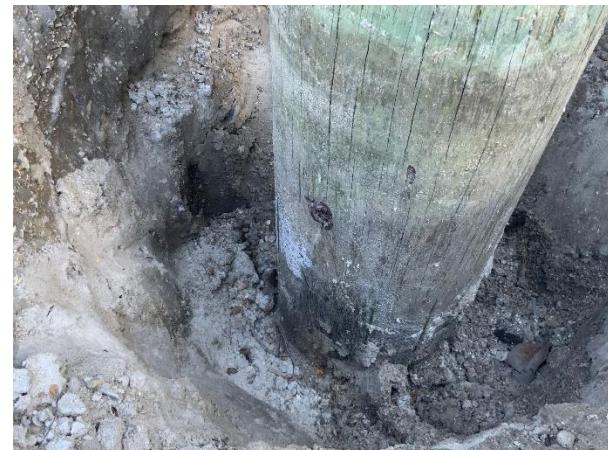
Photo 47
Building 4 – West Elevation – Overall view of sealant applied to piling core sample.

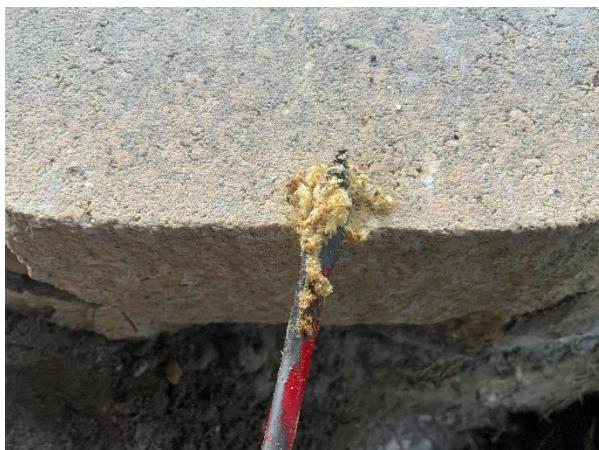
Photo 45
Building 1 – West Elevation – Overall view of core sample taken from piling base.

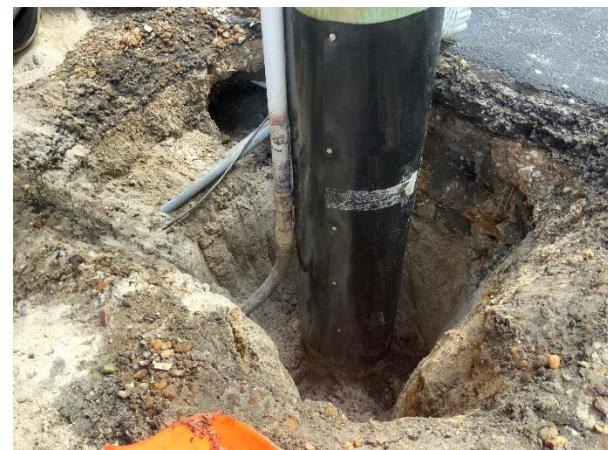
Photo 48
Building 1 – East Elevation – Overall view of Vinyl wrap installation at piling.

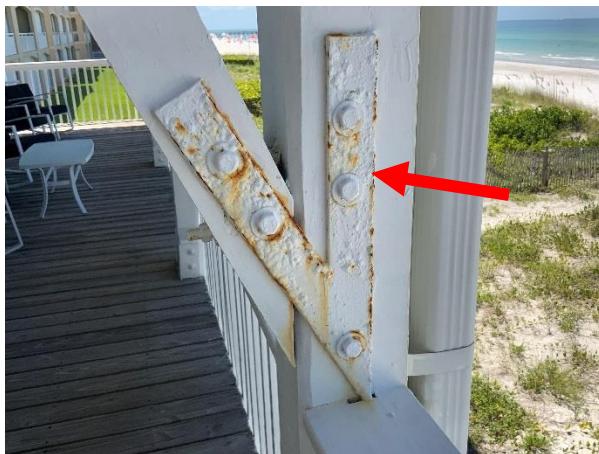
Photo 49
 Building 1 – West Elevation – Overall view of corroded metal balcony brackets.

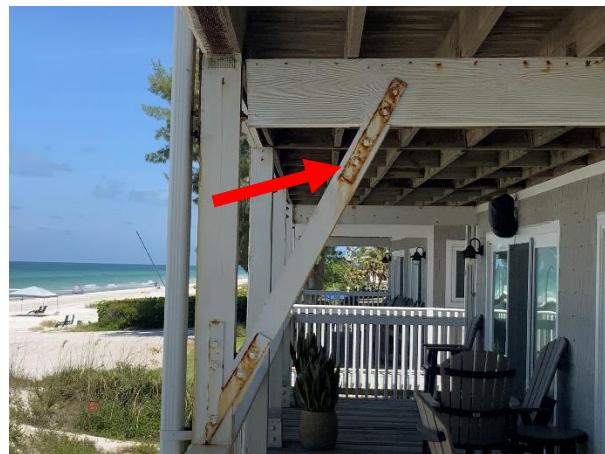
Photo 52
 Building 2 – South Elevation – Overall view of corroded metal balcony brackets.

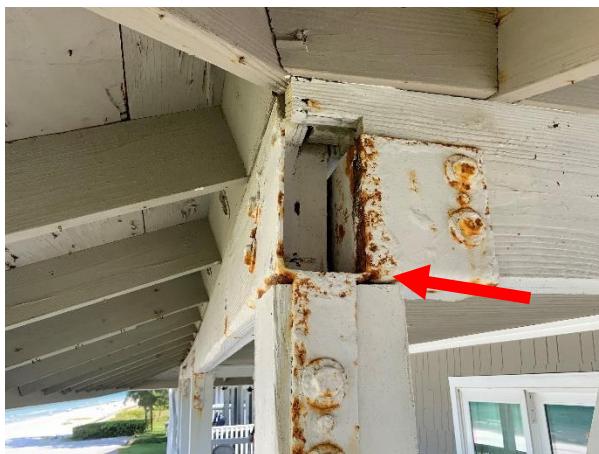
Photo 50
 Building 1 – West Elevation – Overall view of corroded metal balcony brackets.

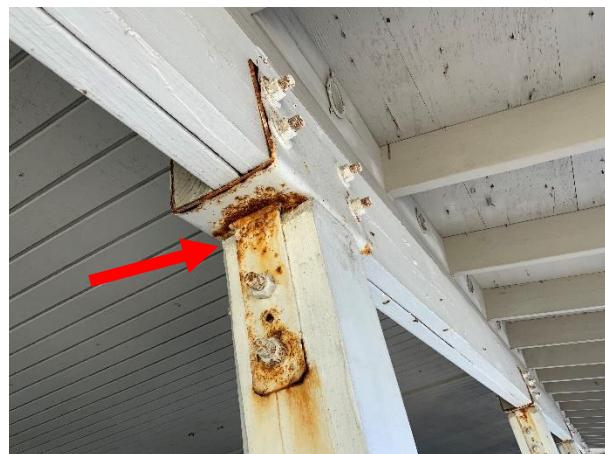
Photo 53
 Building 1 – West Elevation – Overall view of corroded metal balcony brackets.

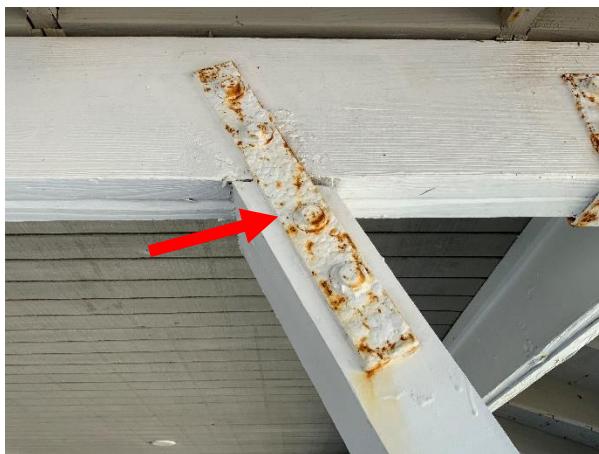
Photo 51
 Building 1 – West Elevation – Overall view of corroded metal balcony brackets.

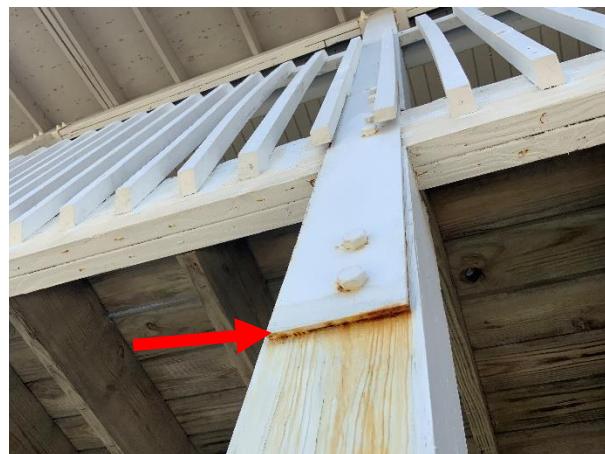
Photo 54
 Building 7/8 – West Elevation – Overall view of corroded metal balcony brackets.
