PHASE I MILESTONE INSPECTION

Sunshine on Indian Shores Condominium
Association, Inc.

UES Project No: 6011.2300401.0000

April 10, 2024

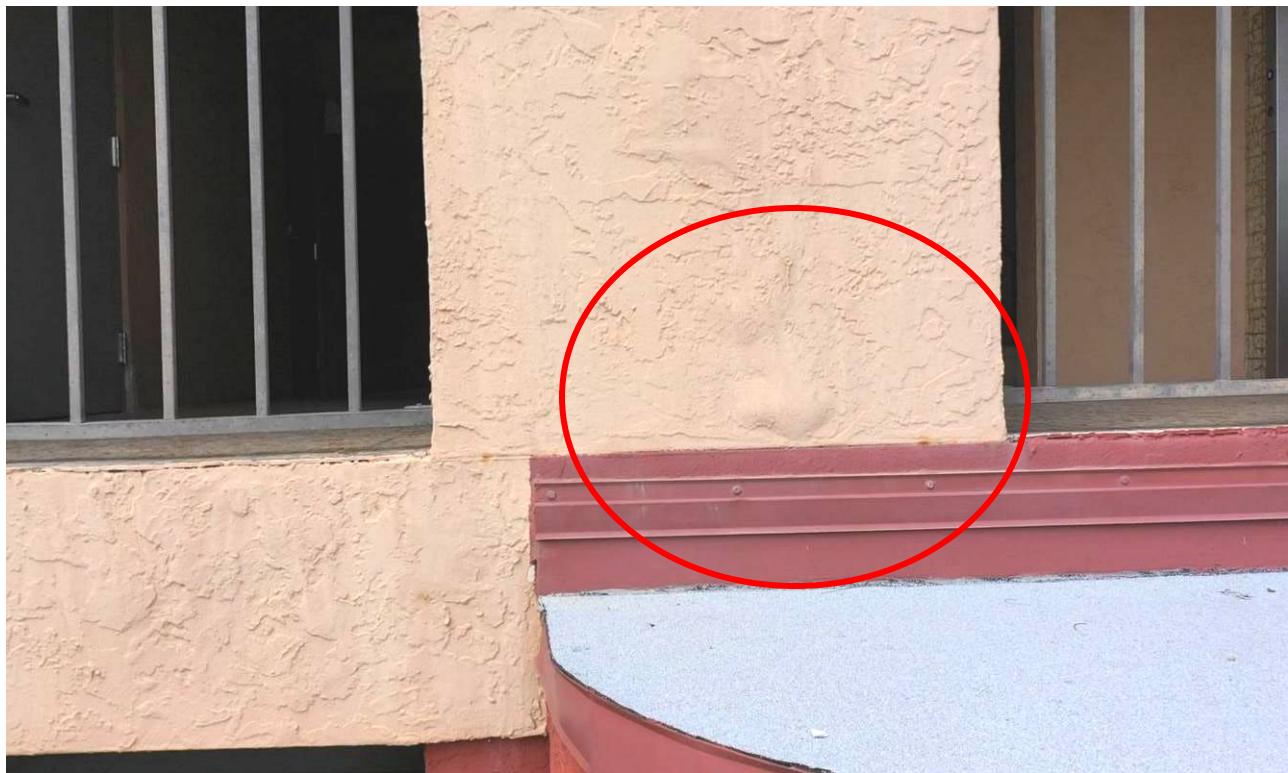
Photograph 5: 1st Level Breezeway near North End – Sample of Blistered Paint.

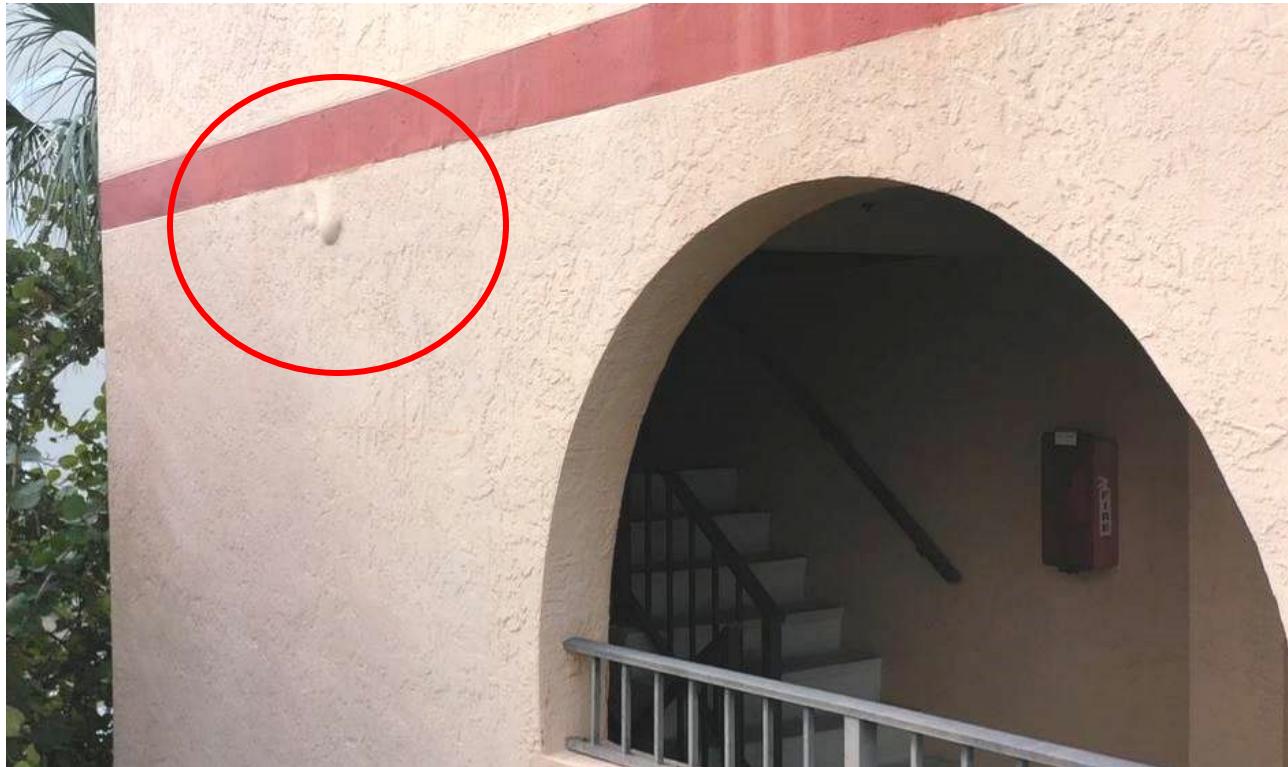
Photograph 6: 2nd Level Breezeway near South Staircase – Sample of Blistered Paint.

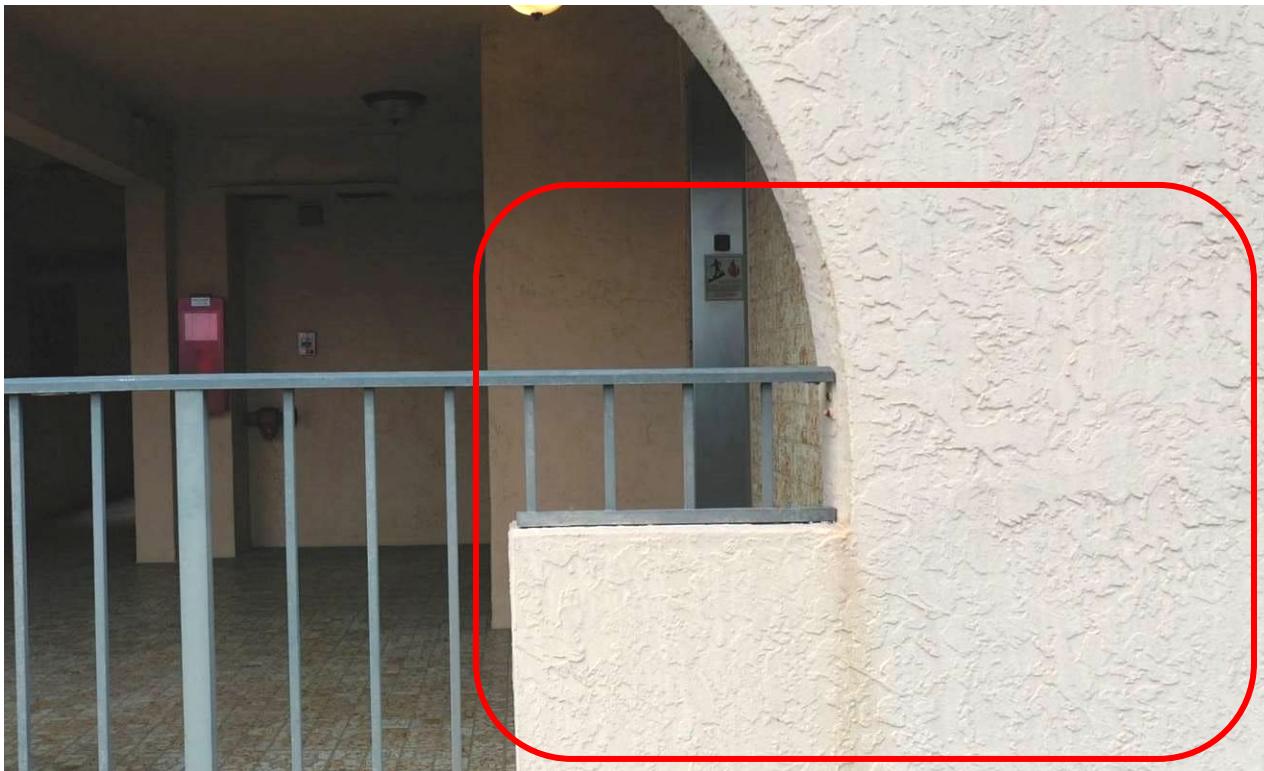
Photogaraph 7: 3rd Level Breezeway near North Staircase – Sample of Faded Paint with Rust Bleeding.

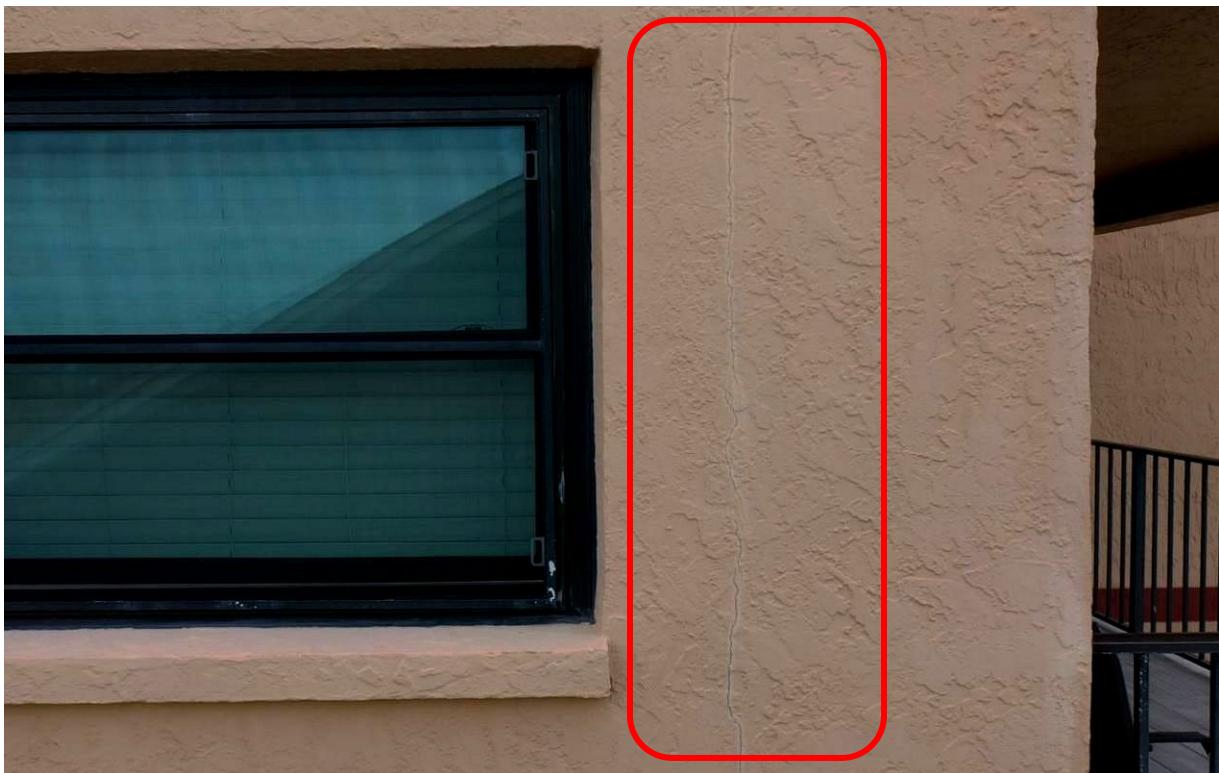
- 1. Location:** Refer to Appendix B for locations.
- 2. Description:** Cracked stucco cladding on many locations throughout the building exterior walls.

Photogaraph 8: North Elevation, 1st Window Stack from the West at the 3rd Level – Sample of Cracked Stucco Cladding.

- Conduct a building envelope project and replace the sealant around all the fenestrations and replace the rusted stucco accessories where existed.
- Remediate all the cracked stucco on the exterior cladding.
- Installed waterproofing membrane at all patio decks where omitted.
- Inspect and remediate the hollow sound and tented tiles inside Unit #1C patio.
- Install waterproofing membrane at all breezeway decks.
- Remediate the spalled concrete locations inside the ground level garage. (Currently is under process).
- Install weep holes with self-leveling sealant inside all the guards posts.

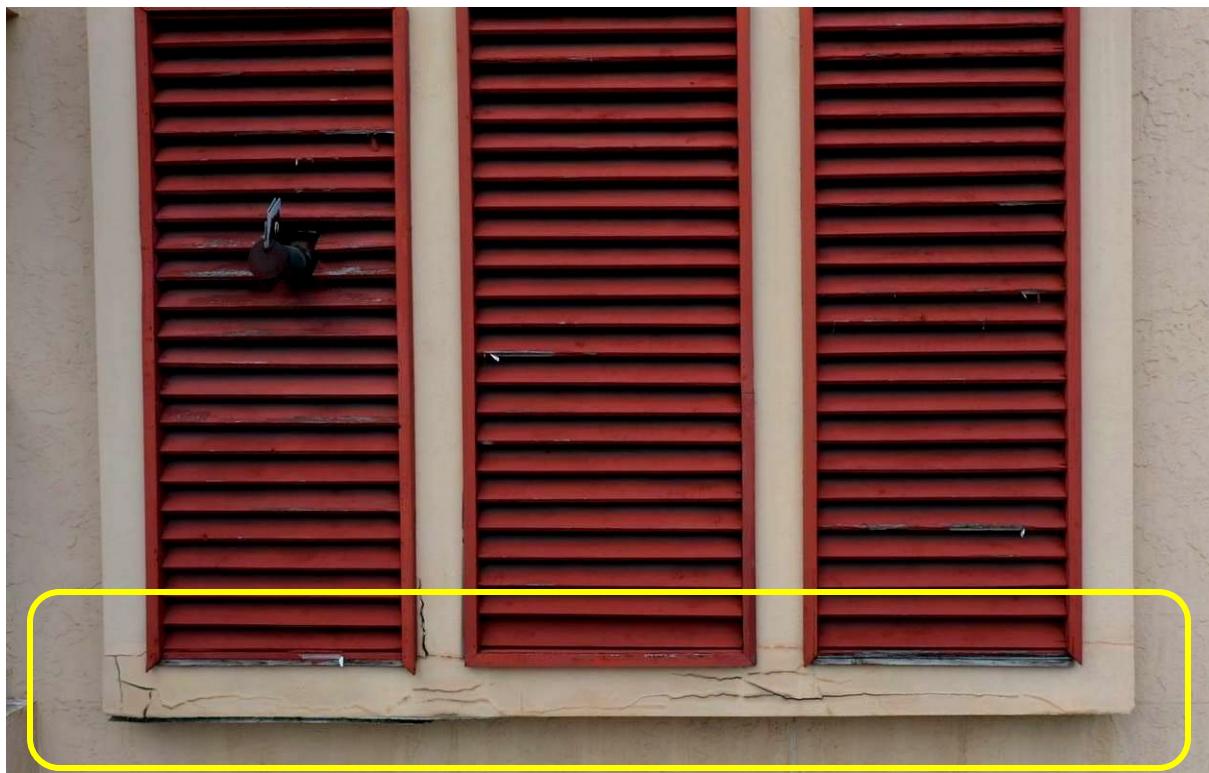
Photograph 9: East Elevation, Architectural Shape Windows on the 1st Level – Sample of Cracked Stucco (NOT STRUCTURAL).

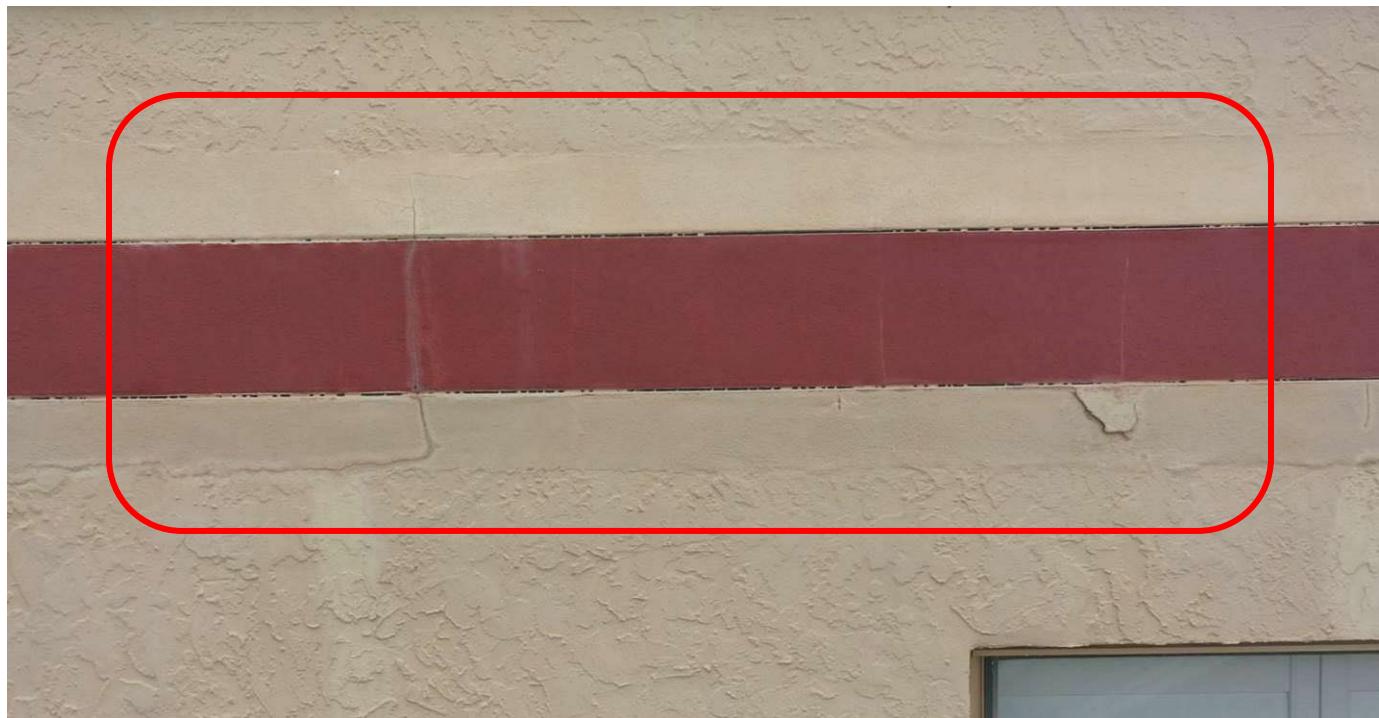
Photograph 10: North Elevation, 1st Window Stack from the East at 4th Level – Cracked Stucco.

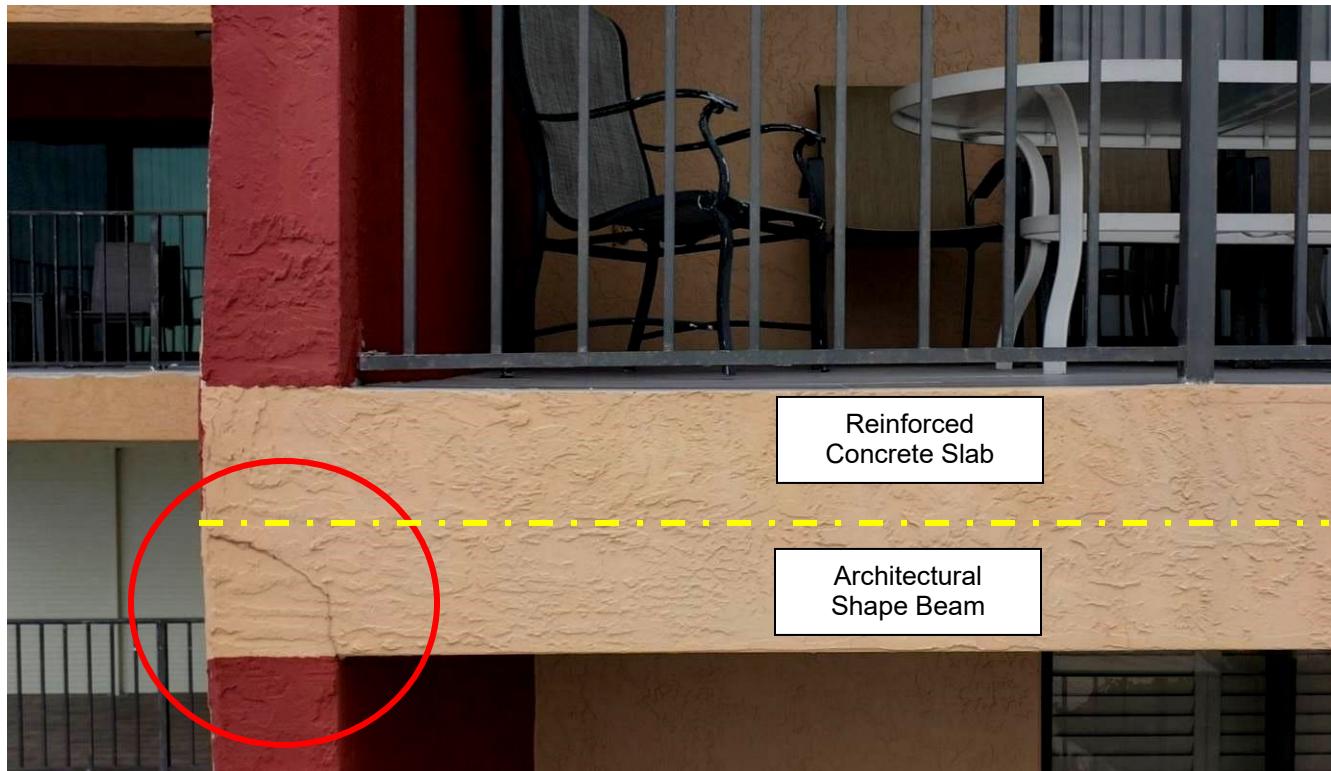
Photograph 11: West Elevation, Central Balcony at 3rd Level – Cracked Architectural Beam Shape (NOT STRUCTURAL).

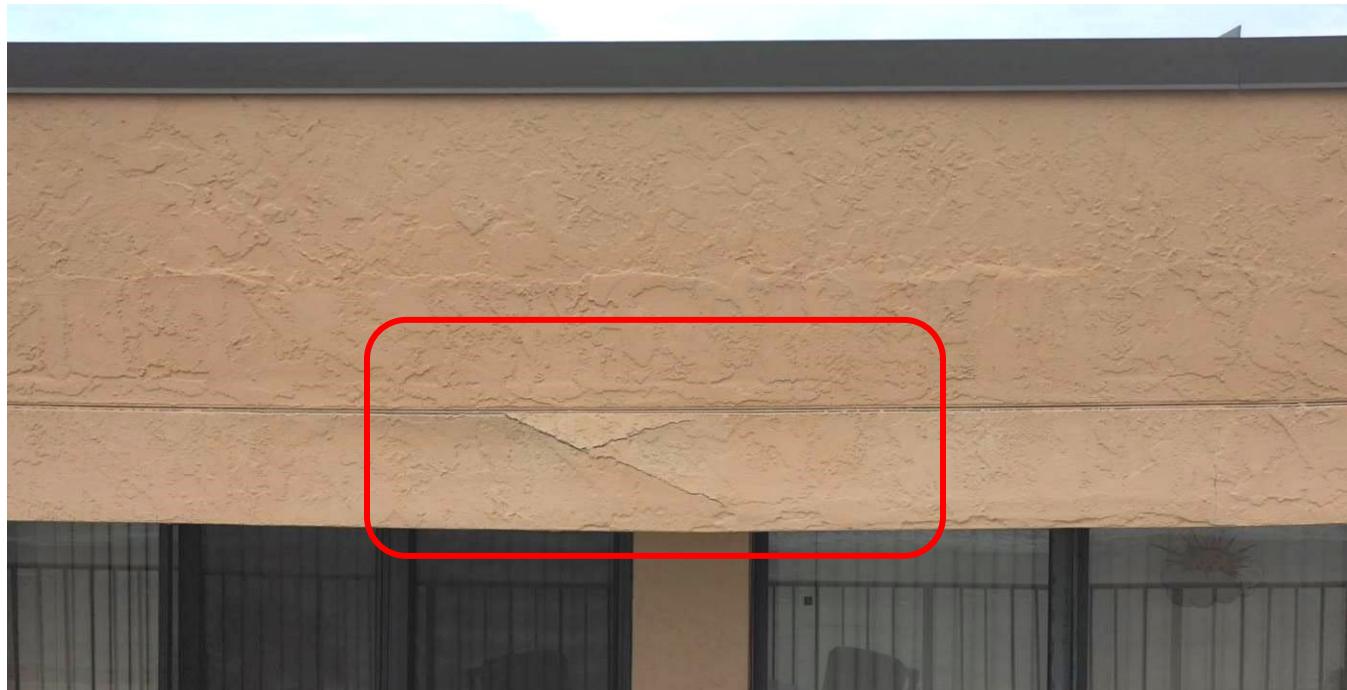
Photograph 12: West Elevation, Central Balcony at 4th Level – Cracked Architectural Beam Shape (NOT STRUCTURAL).

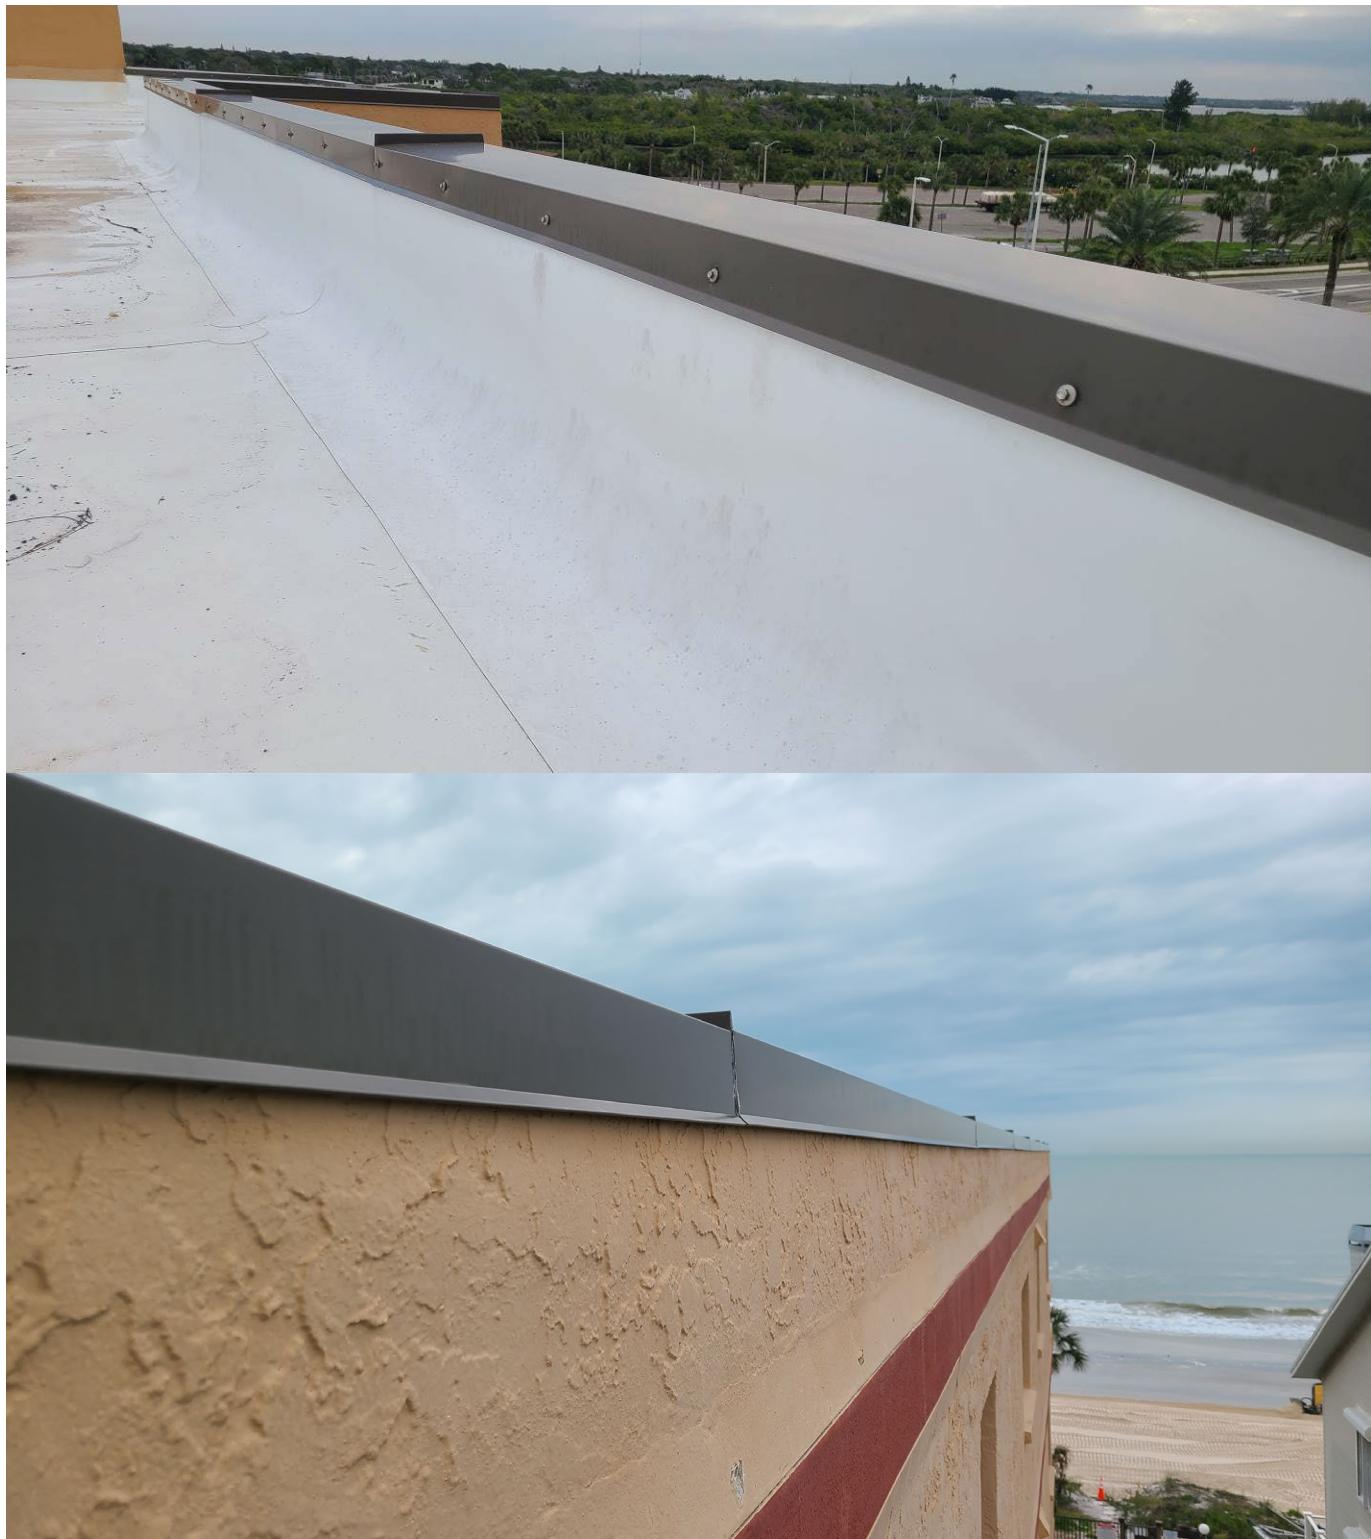
- 1. Describe parapet build and current conditions:** Parapet is 24" CMU wall that runs on the exterior perimeter. The parapet is covered with the TPO roofing on the interior side and finished with painted stucco on the exterior face. A metal coping is installed on the parapet top that runs along the entire perimeter. An

Photograph 14: Exterior Perimeter Parapet and Metal Coping, Current Condition

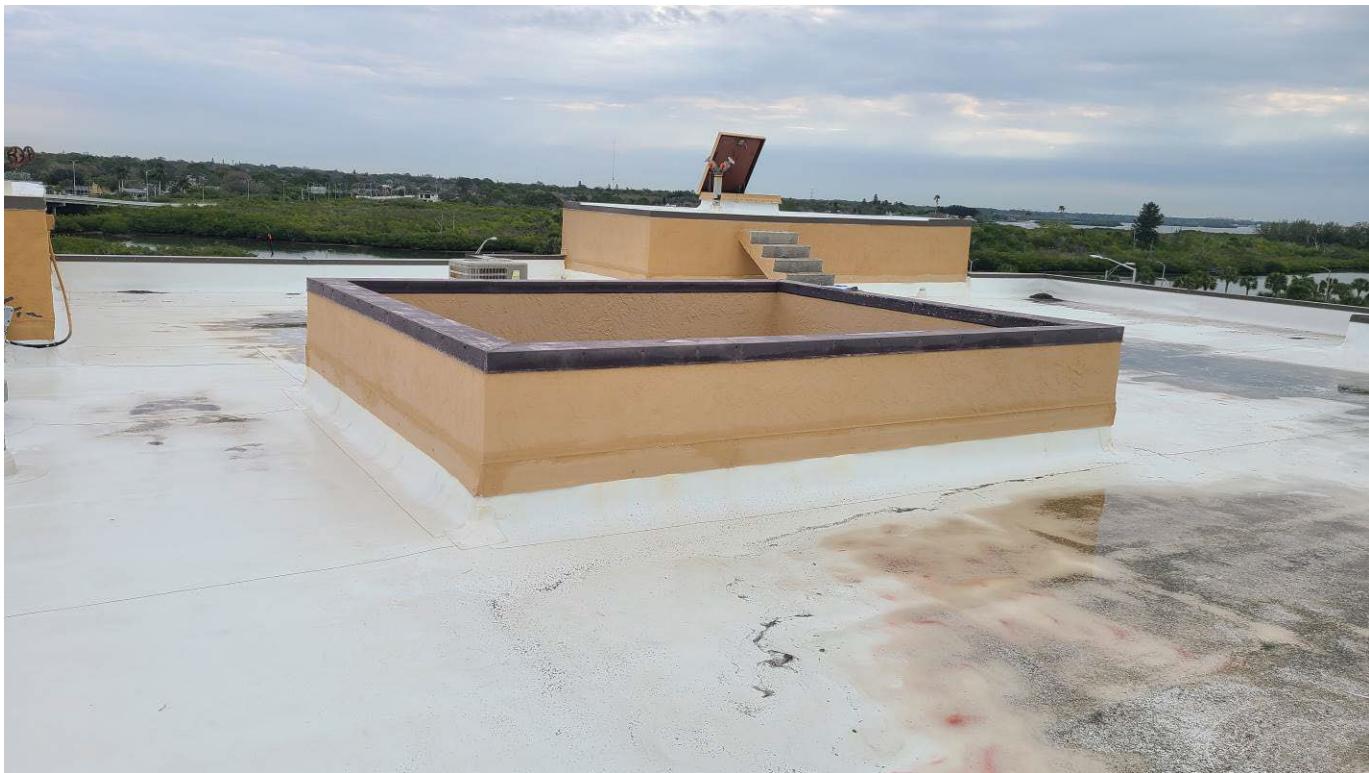
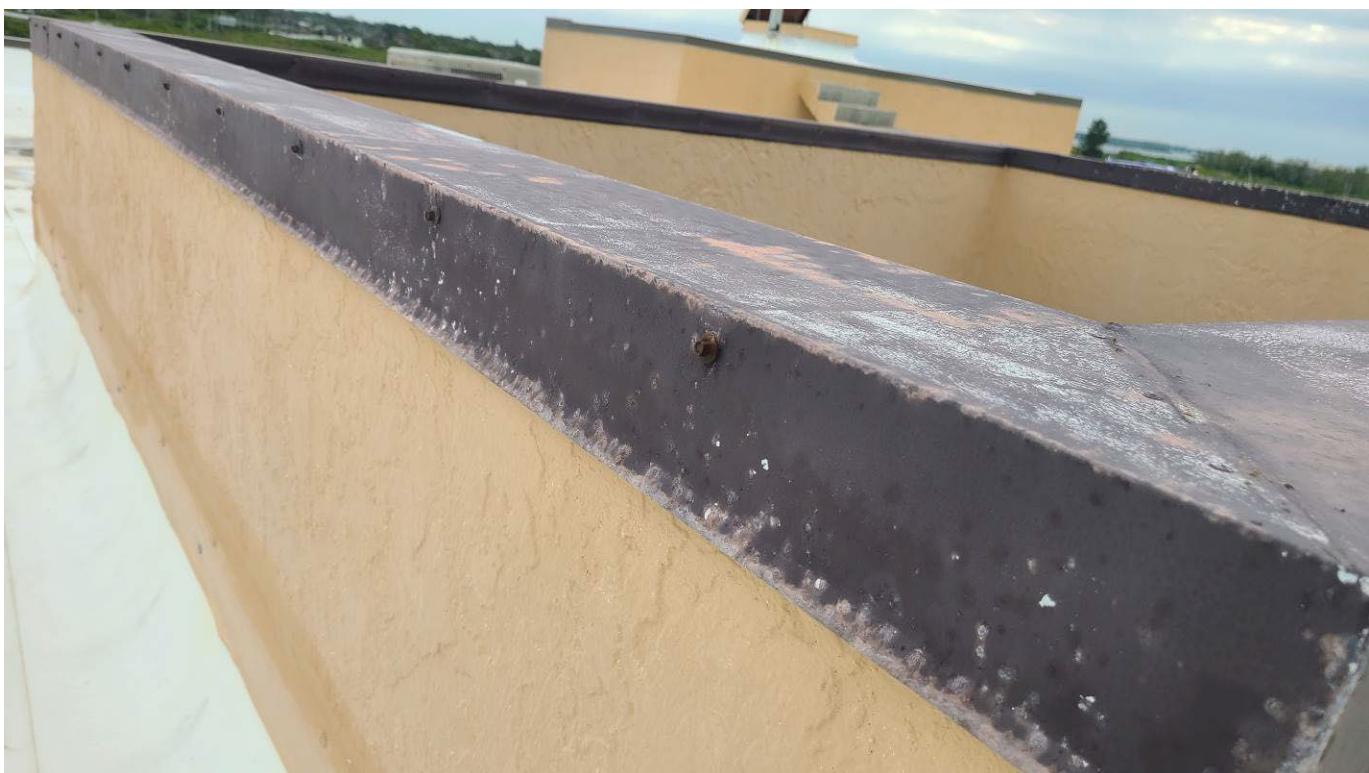
interior parapet was observed in the central roof area, forms an opening to the breezeways below. The interior face of the interior parapet is partially covered with the TPO roofing. The remaining areas are painted stucco. The metal coping at the interior parapet appears to be old.

Photograph 15: Interior (Breezeway) Parapet and Metal Coping, Current Condition.

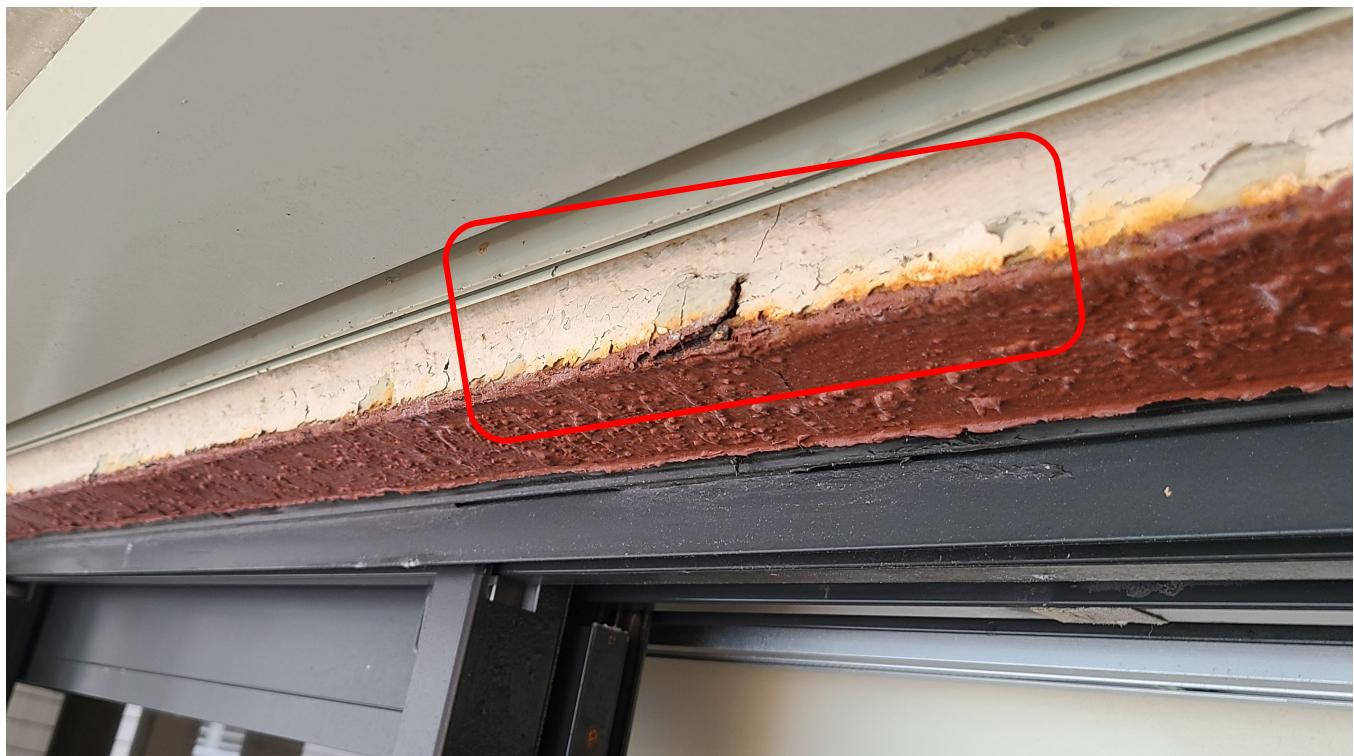
Photograph 21: Unit #2A West Balcony – Example of Corroded Stucco Accessory at the SGD's Header.

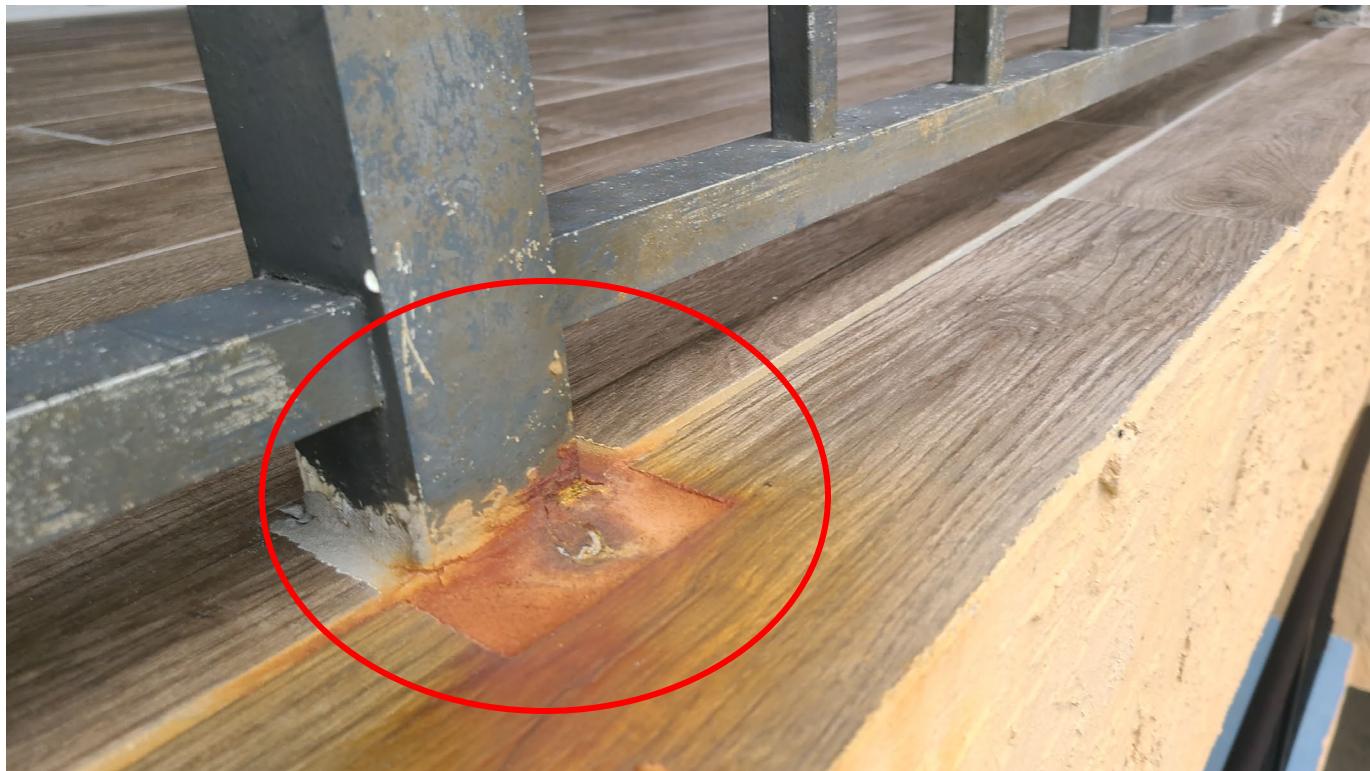
Photograph 22: Unit #2A West Balcony – Lack of Weep Hole at Core Mounted Post with Rust is Bleeding Out

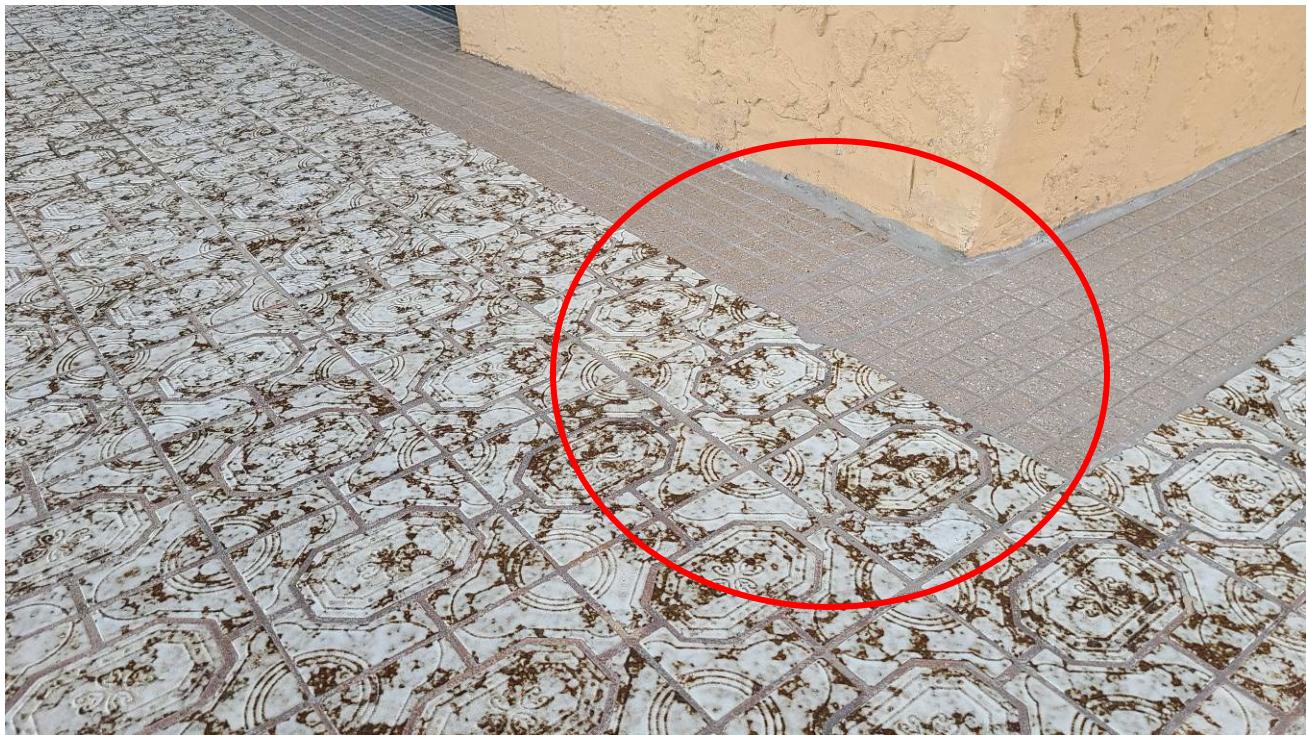
Photograph 26: Unit #1C West Balcony – Tented Tile with Hollow Sound Just Above the Spalled Concrete Ceiling Inside the Garage.

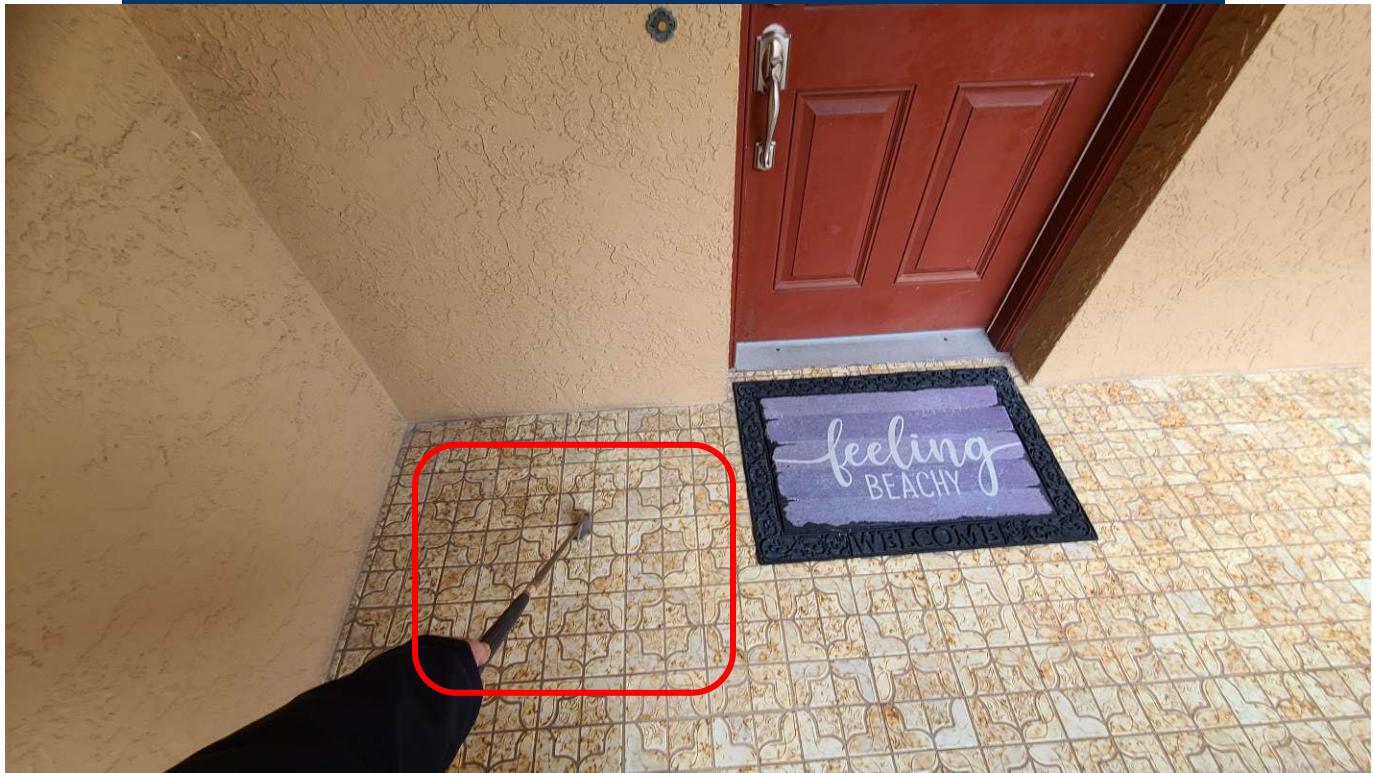
Photograph 31: 4th Level Breezeway – Example of Hollow Sound Breezeway Tiles

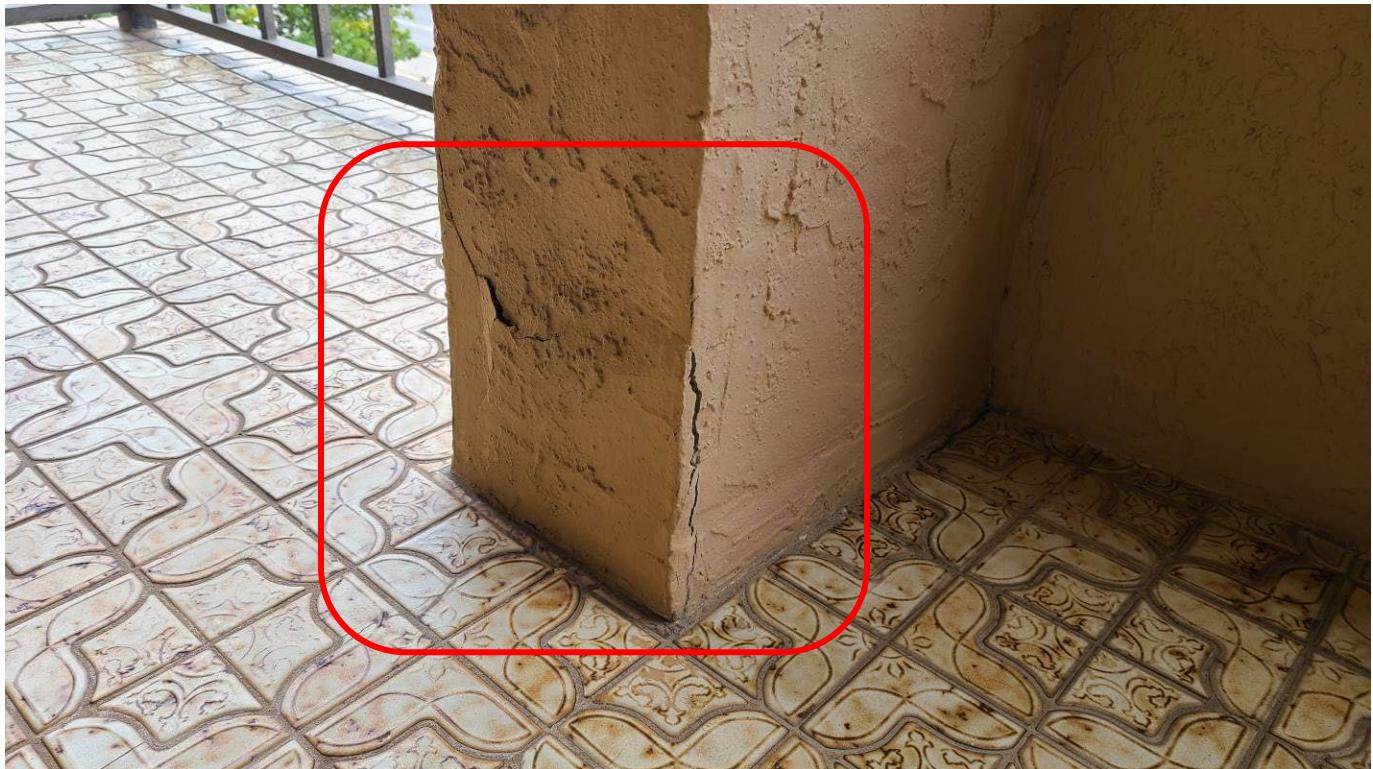
Photograph 32: 3rd Level Breezeway near South Stair – Spalled Bottom of Column.

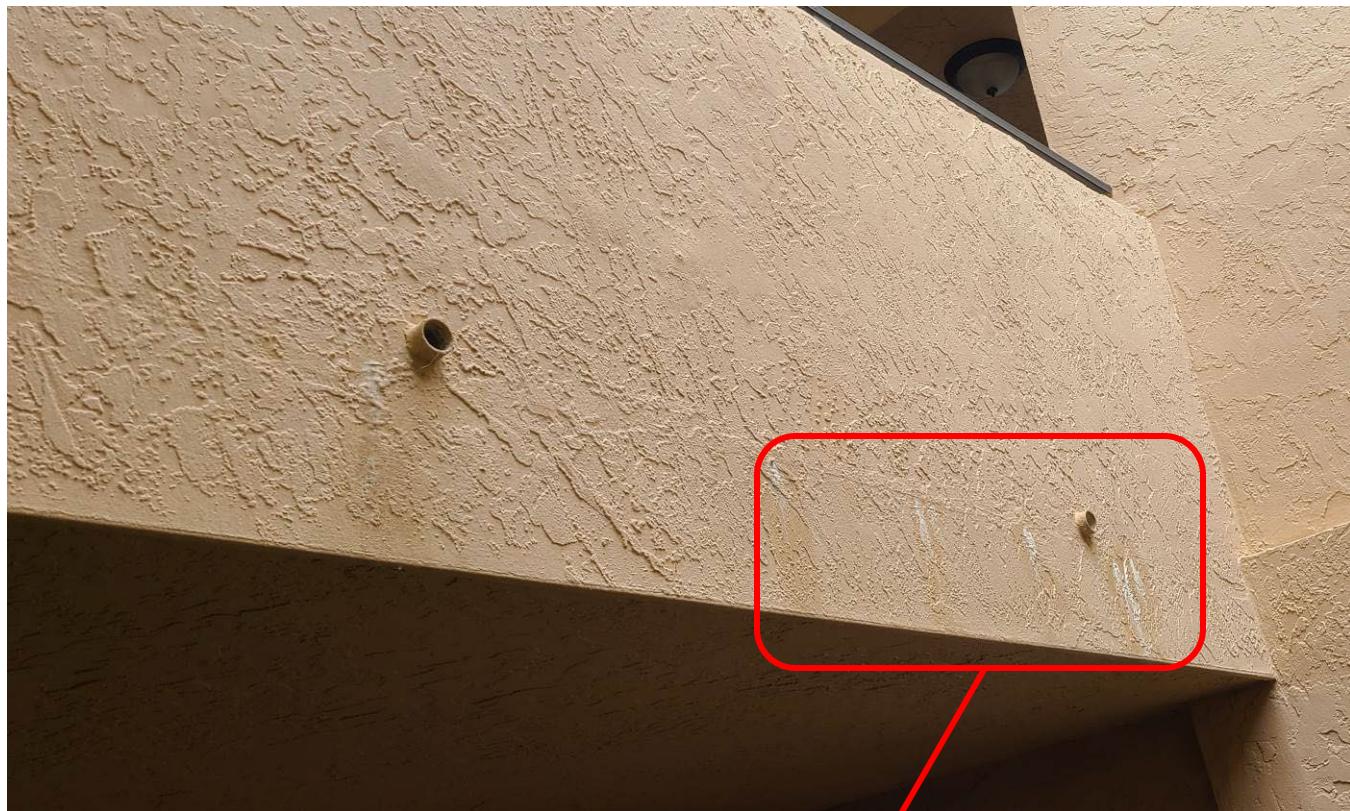
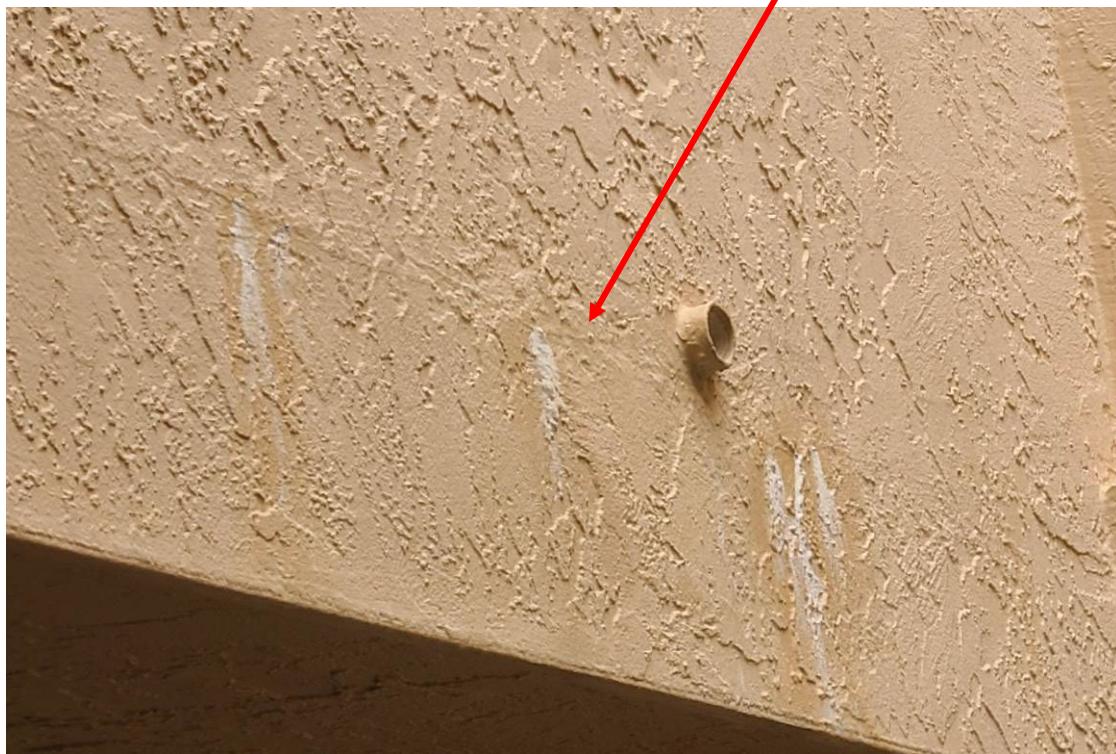
Photograph 33: Exterior Face of 4th Level Breezeway's Guards – Signs of Water Stain and Efflorescence due to Water Infiltration from the Opposite Side.

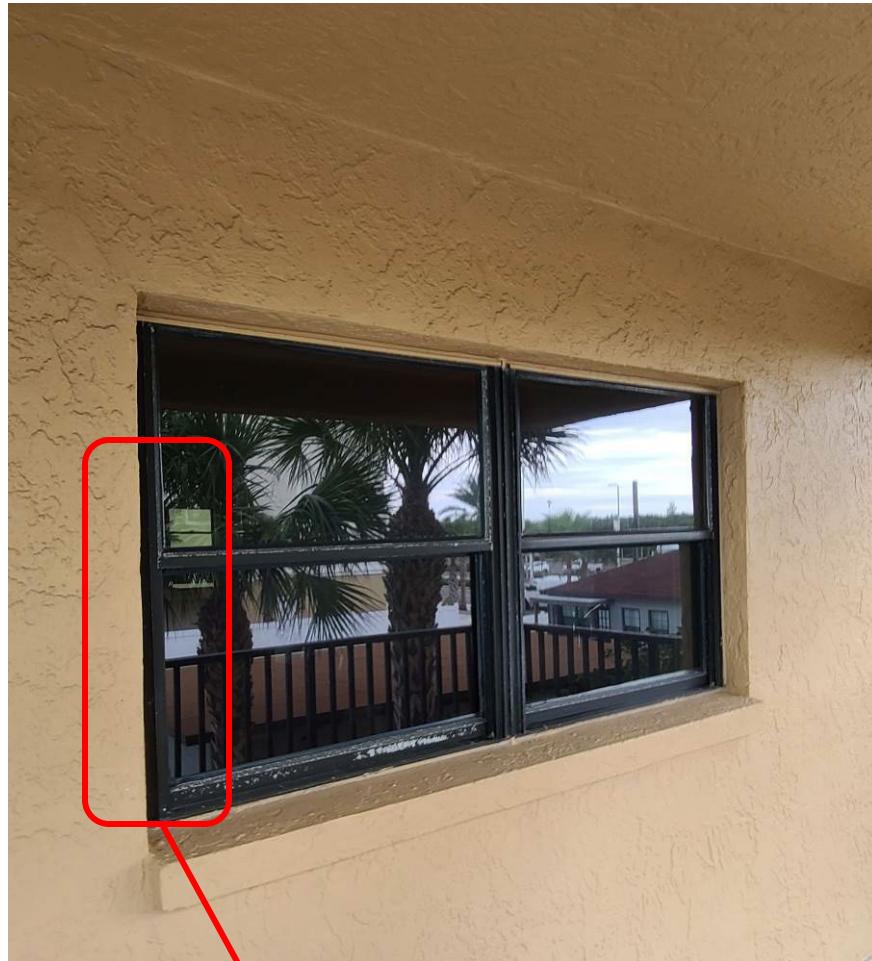
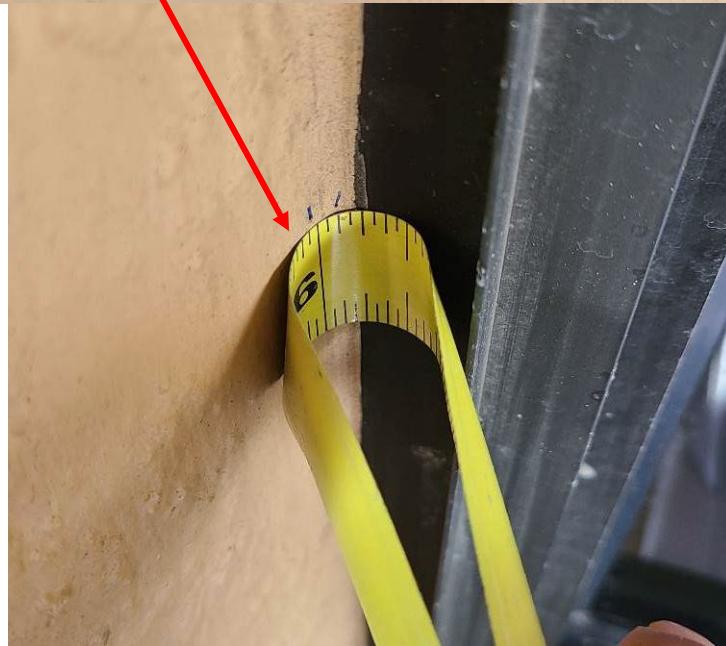
Photograph 34: Existing Sealant Width Installed at Window's Perimeter

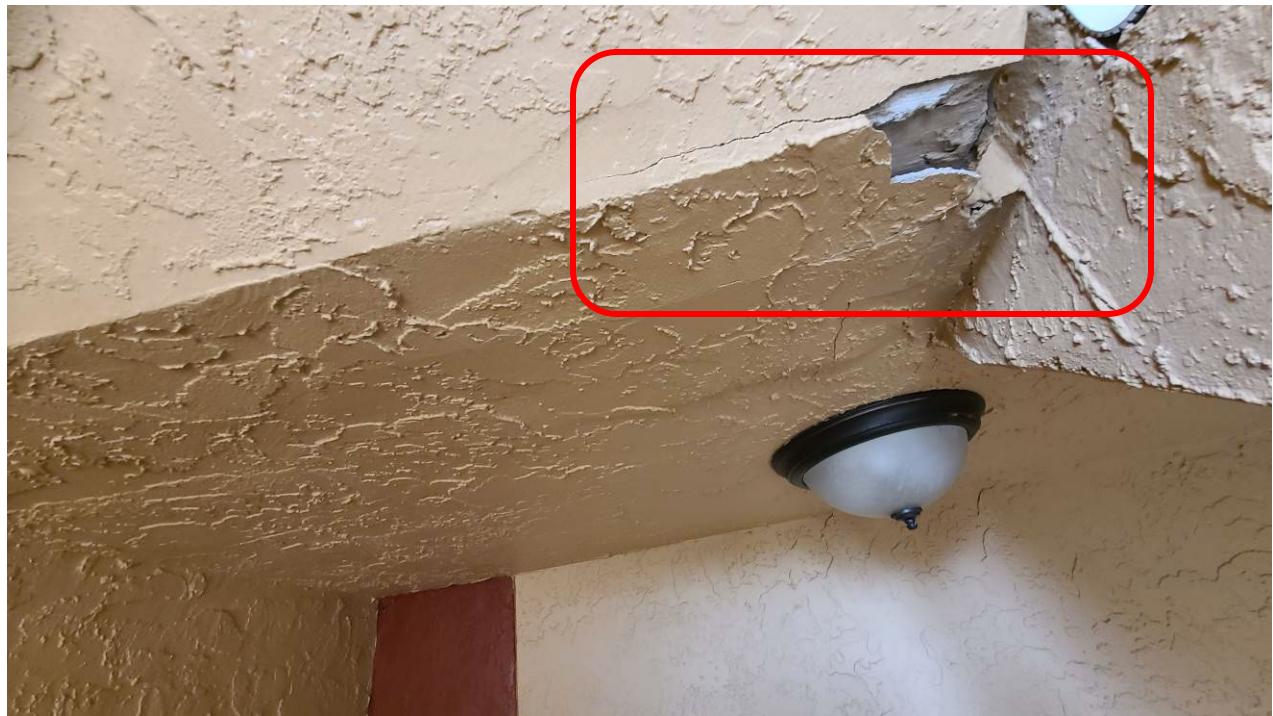
Photograph 36: South Staircase – Cracked Stucco at 4th Level Landing's Ceiling

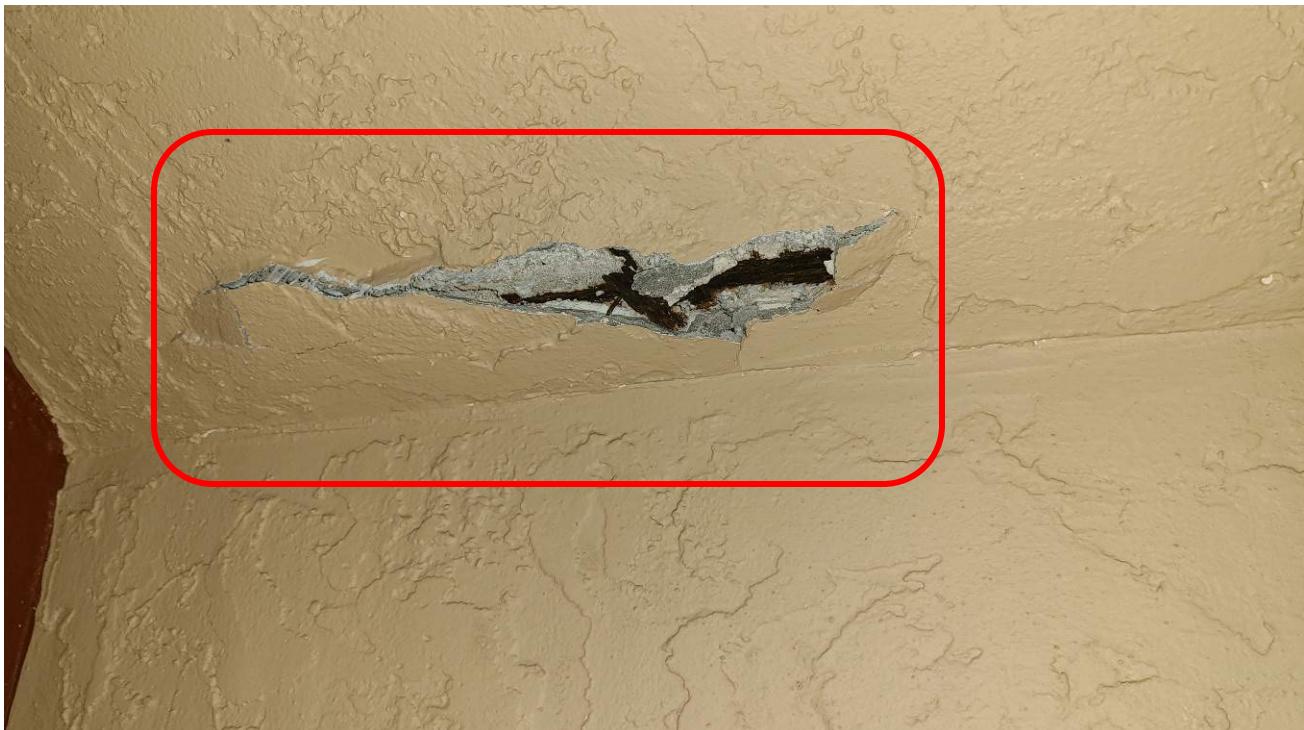
Photograph 37: South Staircase – Spalled Concrete at Bottom of Stair Between 2nd and 3rd Stair's Flight
