PHASE I MILESTONE INSPECTION

Sunshine on Indian Shores Condominium
Association, Inc.

UES Project No: 6011.2300401.0000

April 10, 2024

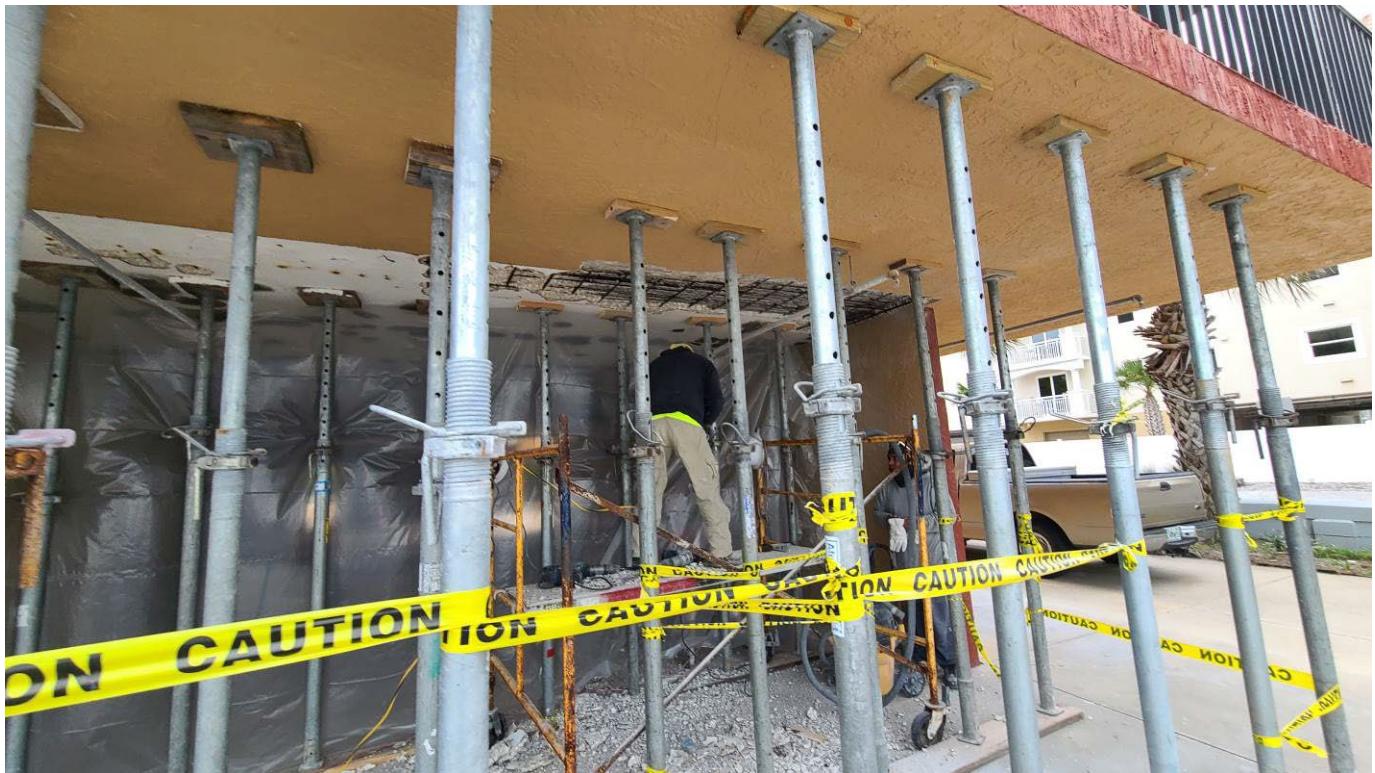
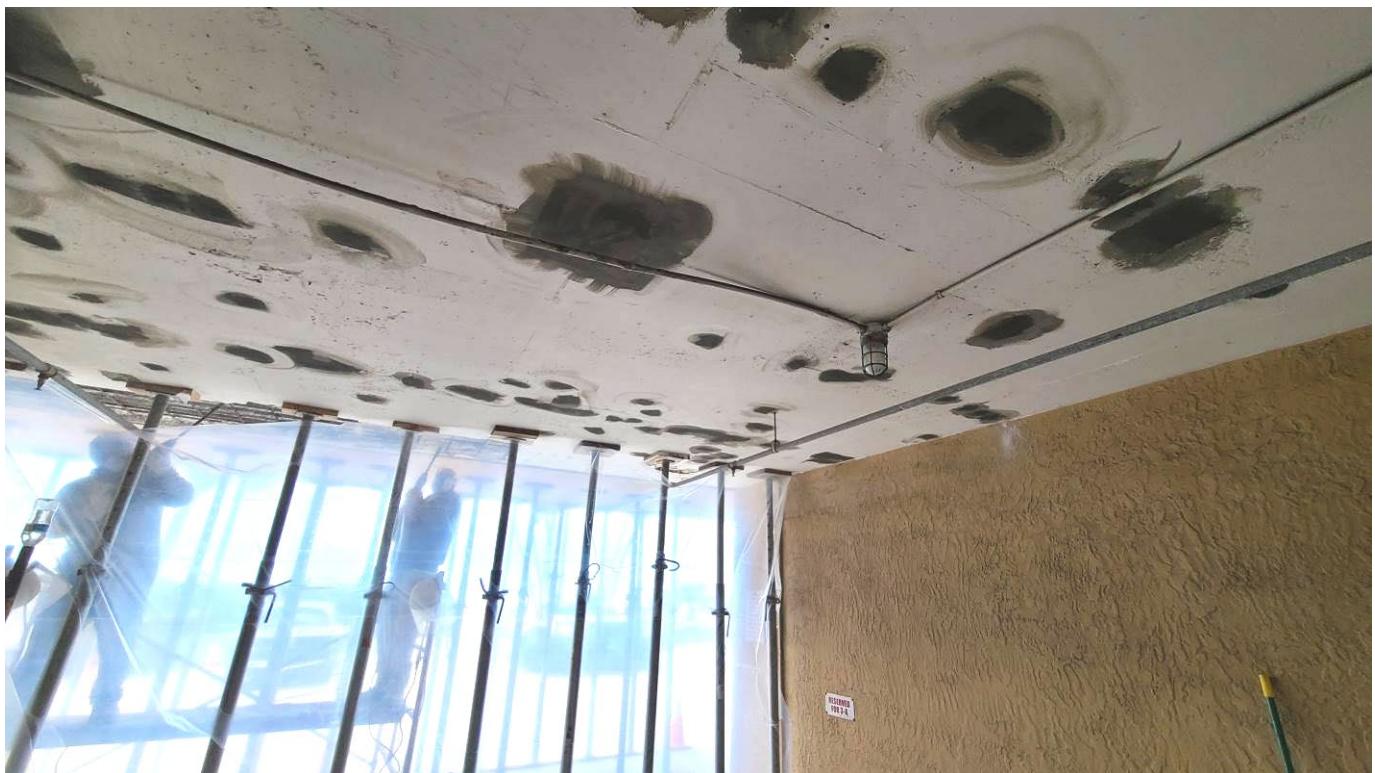
The building has a ground level garage that extends below the building area. Spalled ceiling and shear wall locations were observed at the entire garage slab. The association hired a general contractor to remediate the spalled location. The contractor was at work during the time of our survey.

e. **Portion showing distress: (Note, beams, columns, structural walls, floors, roofs, other):** Spalled concrete ceiling inside the ground level garage.

Photograph 40: Ground Level Garage – Garage's Concrete Ceiling is Under Repair
