RESIDENTIAL REPORT
Gulfshore Townhouses Condominium Association, Inc.
19020 Gulf Blvd.
Indian Shores, FL 33785

Phase One Milestone Inspection

PHASE ONE MILESTONE INSPECTION

11/30/2023

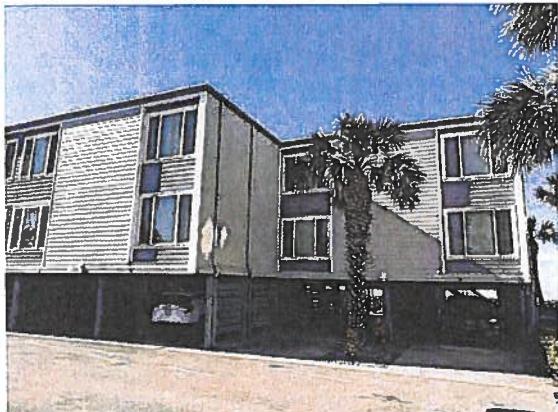
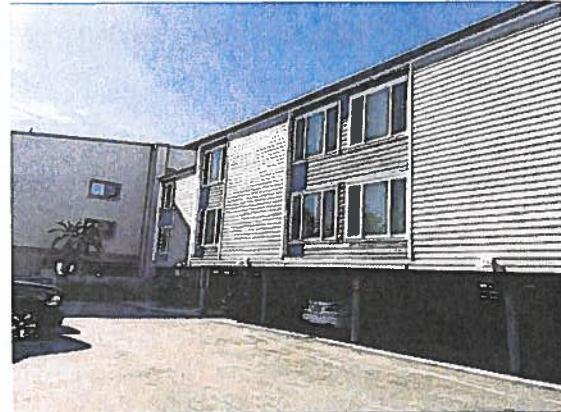
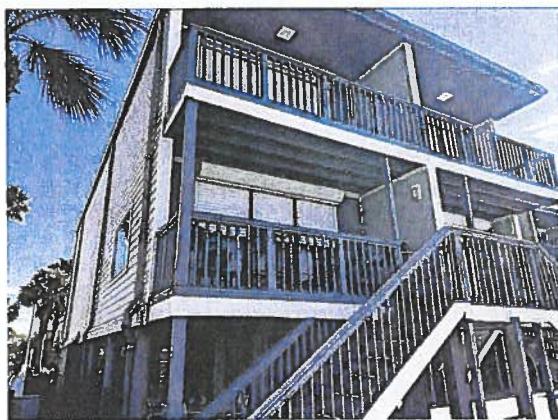
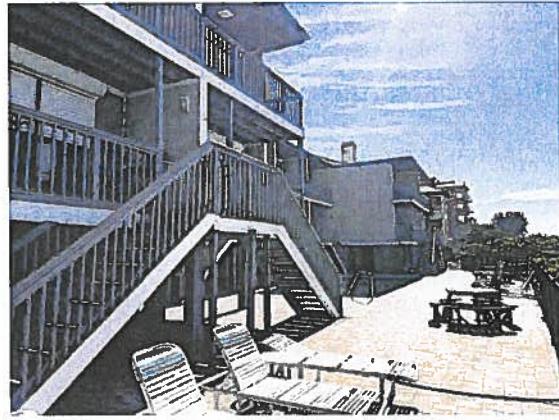
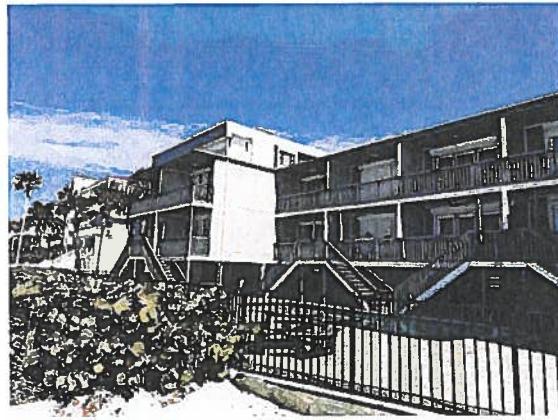
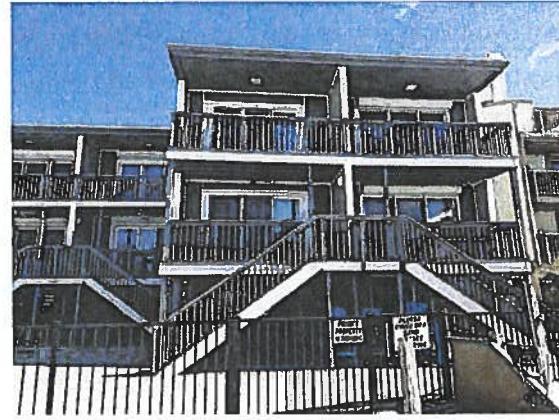
GENERAL EXTERIOR

Wood framed stud walls with hardy board siding. Walls were observed to be in good condition.

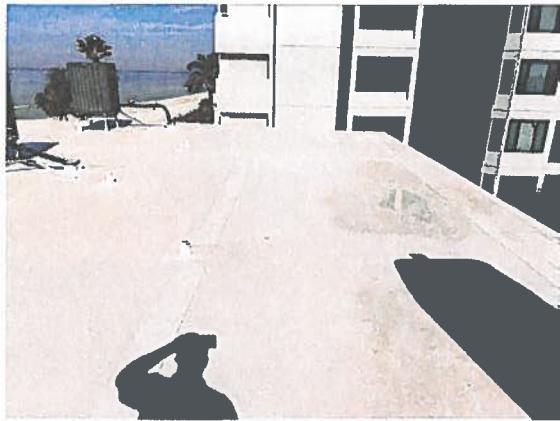
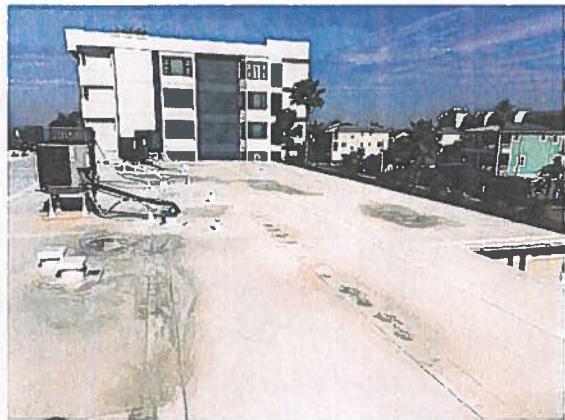
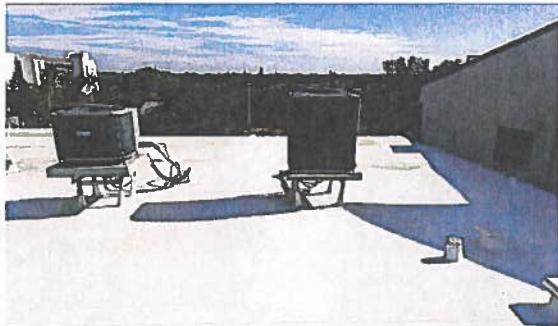
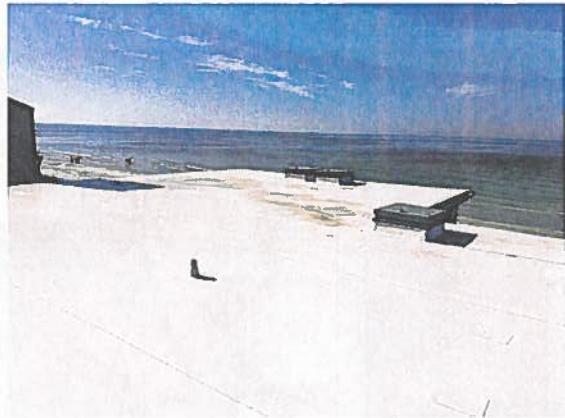
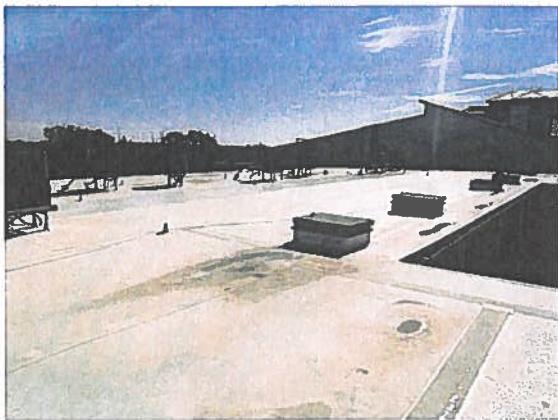
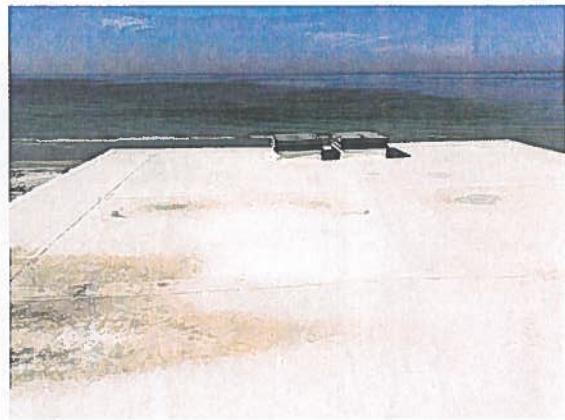
GENERAL ROOFTOP

Wood framed, low sloped roof with TPO covering. TPO covering was replaced in March of 2018. Roof was observed to be in good condition.

A/C condensing units are located on roof top. These are the responsibility of the individual condo owners. Condensing units and supports were observed to be in good condition.
