March 28, 2024

THIS MILESTONE PHASE 1 INSPECTION REPORT WAS PRODUCED FOR SHORE HOUSE CONDOMINIUM ASSOCIATION, INC. LOCATED AT 19106 GULF BLVD., INDIAN SHORES, FL 33785.

SHORE HOUSE

MILESTONE PHASE 1 INSPECTION SURVEY

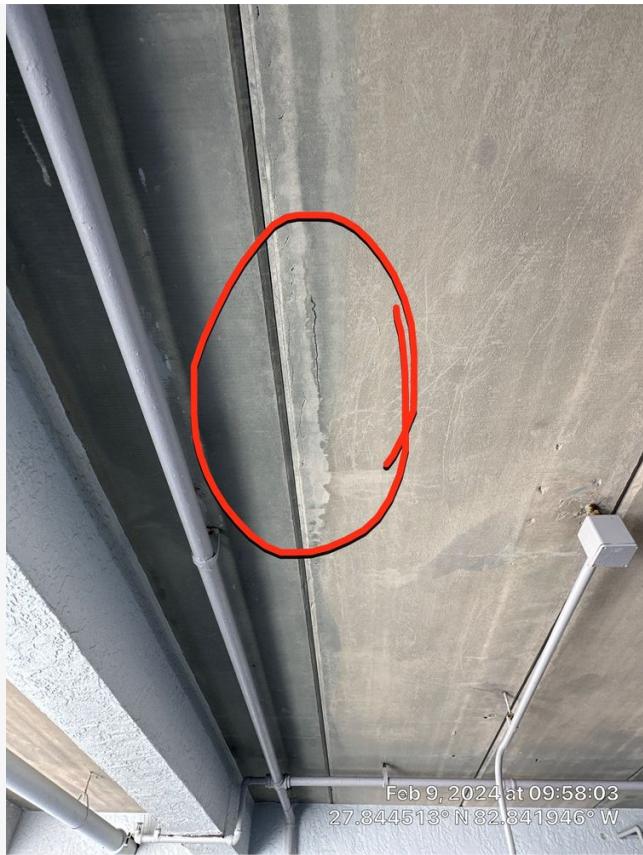
Minor ceiling slab spalling adjacent to elevator in garage. Repair is recommended, although this does not qualify as substantial structural deterioration.

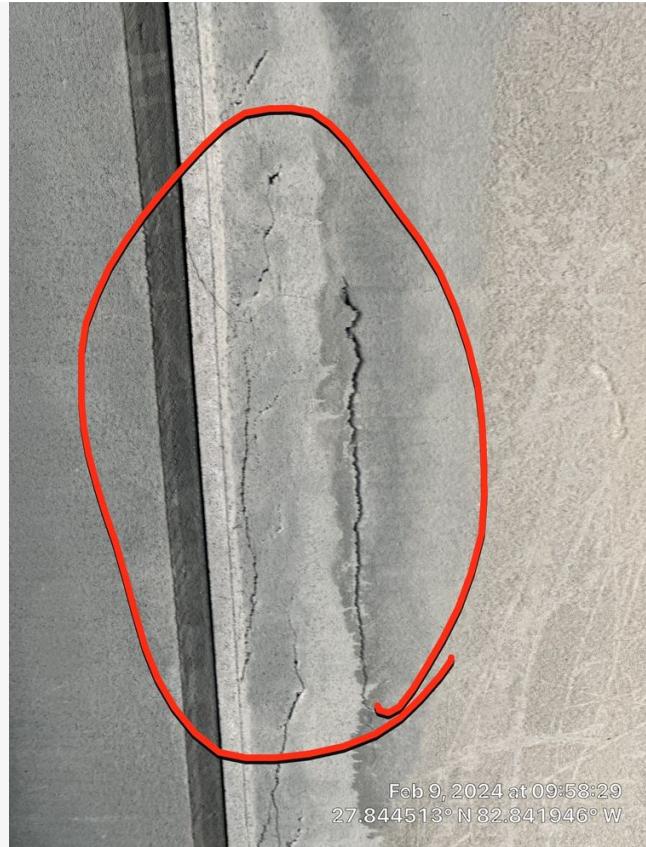
Close-up of minor ceiling slab spalling adjacent to elevator in garage. Repair is recommended, although this does not qualify as substantial structural deterioration.

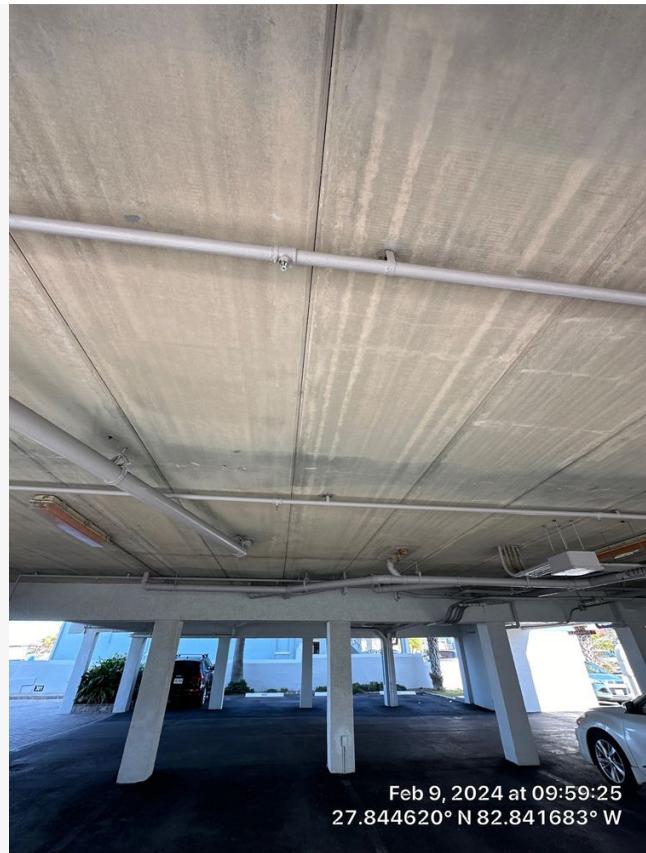
General garage area. Overhead slab, beams and columns are in generally good condition.

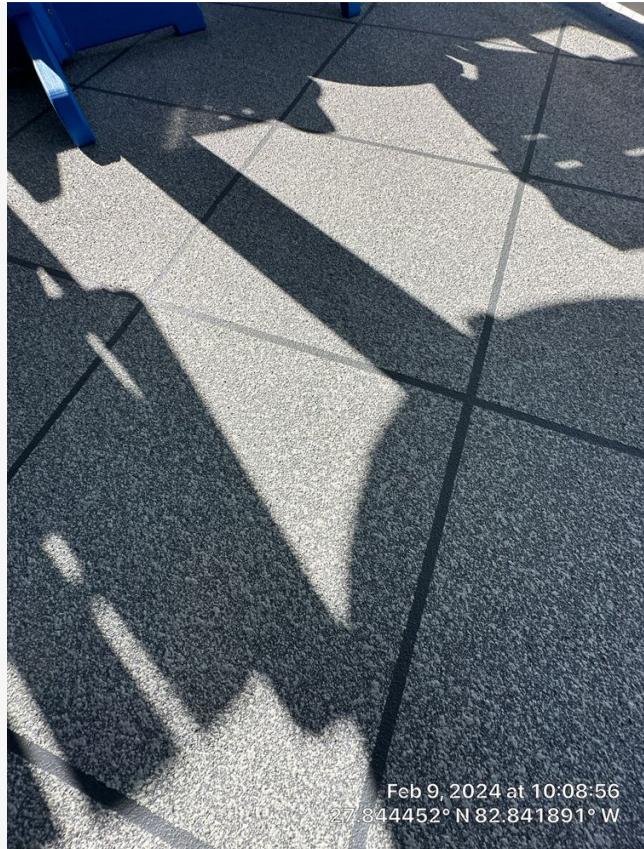
Gemstone coating on 501 balcony. Balcony is in excellent condition.

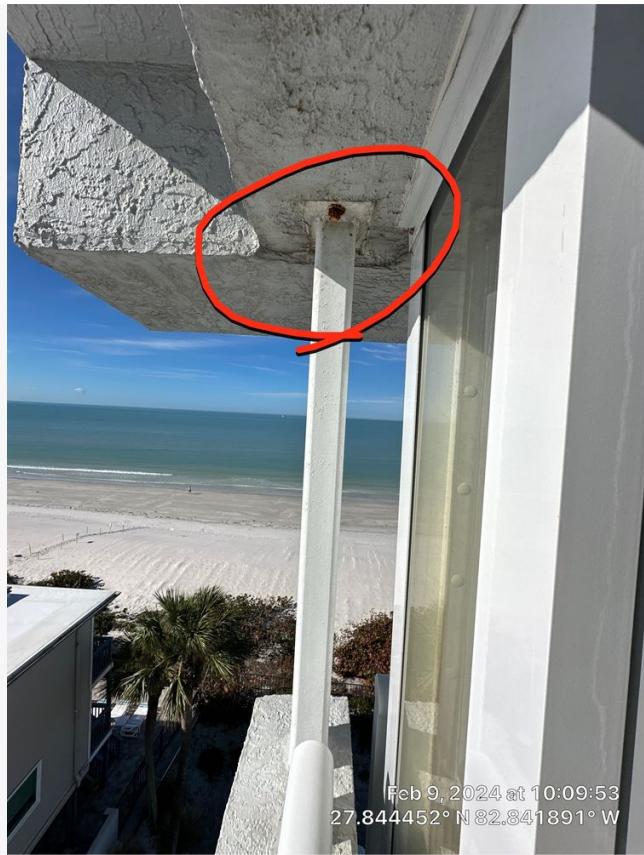
Unit 501. Early-onset corrosion on nut and bolt for balcony support post. This condition is typical throughout the building. As a preventative maintenance item, these fasteners should be cleaned and coated or replaced.

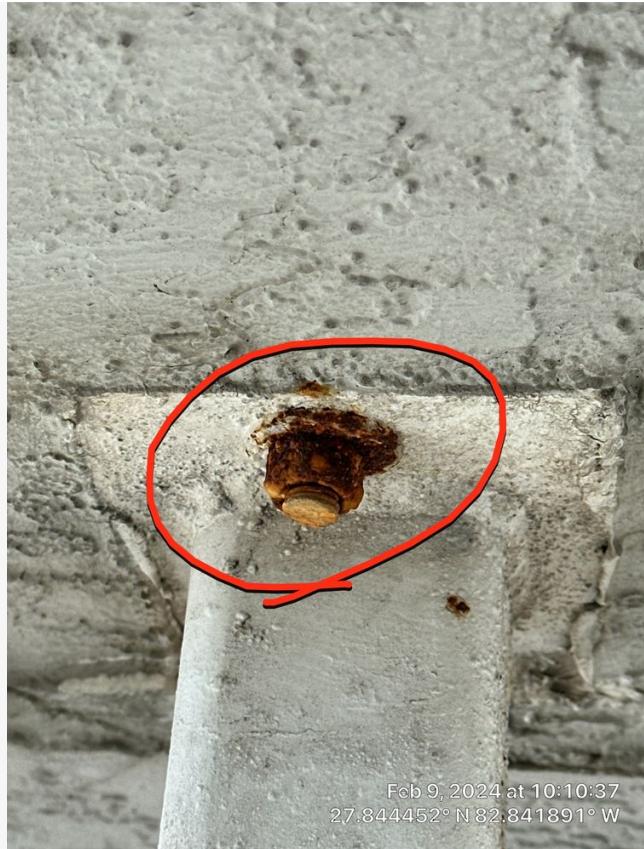
Unit 501. Close-up of early-onset corrosion on nut and bolt for balcony support post. This condition is typical throughout the building. As a preventative maintenance item, these fasteners should be cleaned and coated or replaced.

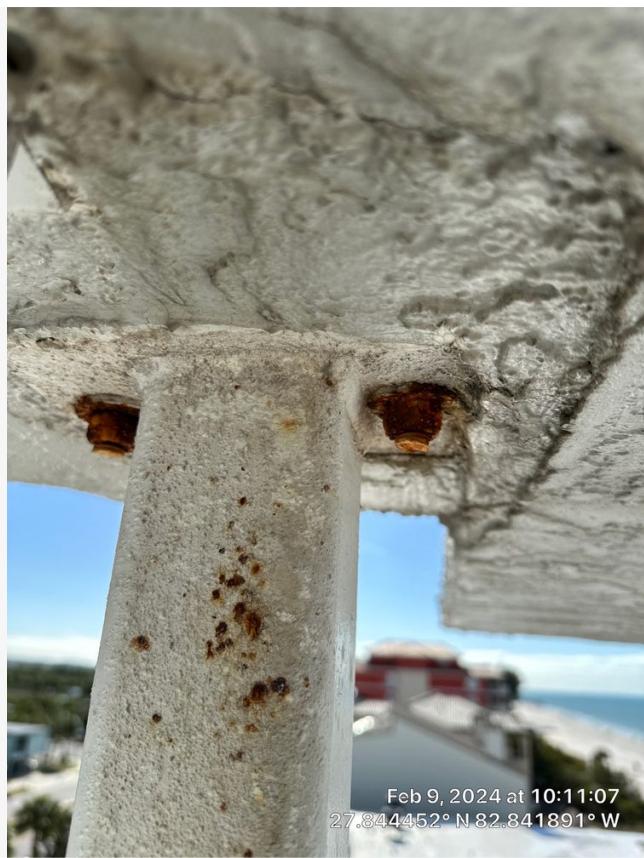
Unit 501. Early onset corrosion of fasteners for nut and bolt as well as post. As a preventative maintenance recommendation, the Association should consider cleaning and coating these steel posts to reduce the severity of further corrosion damage.

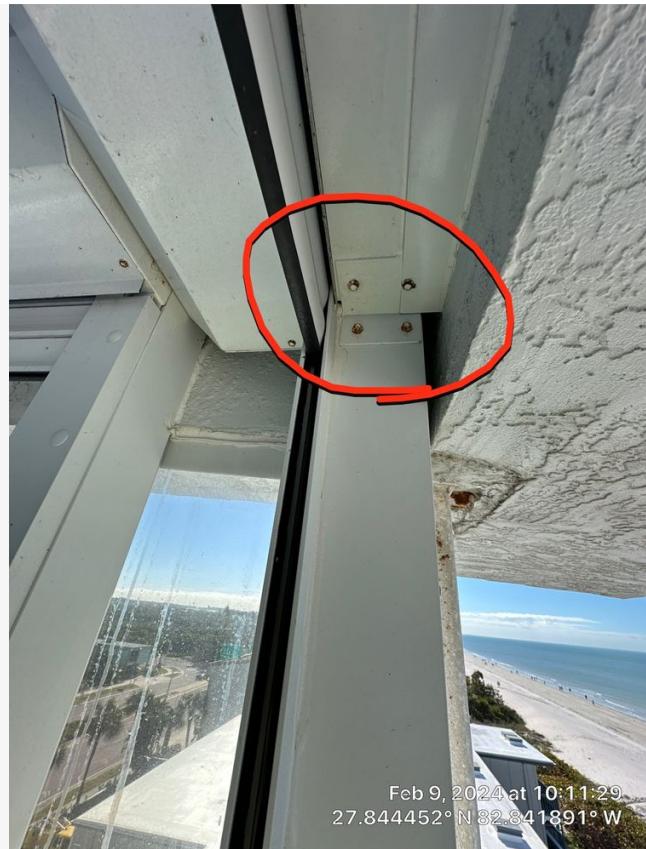
Unit 501. Corrosion of fasteners for storm shutter bracket. This corrosion is fairly minor and typical for the building, although the fasteners should be periodically observed to make sure that they remain in serviceable condition.

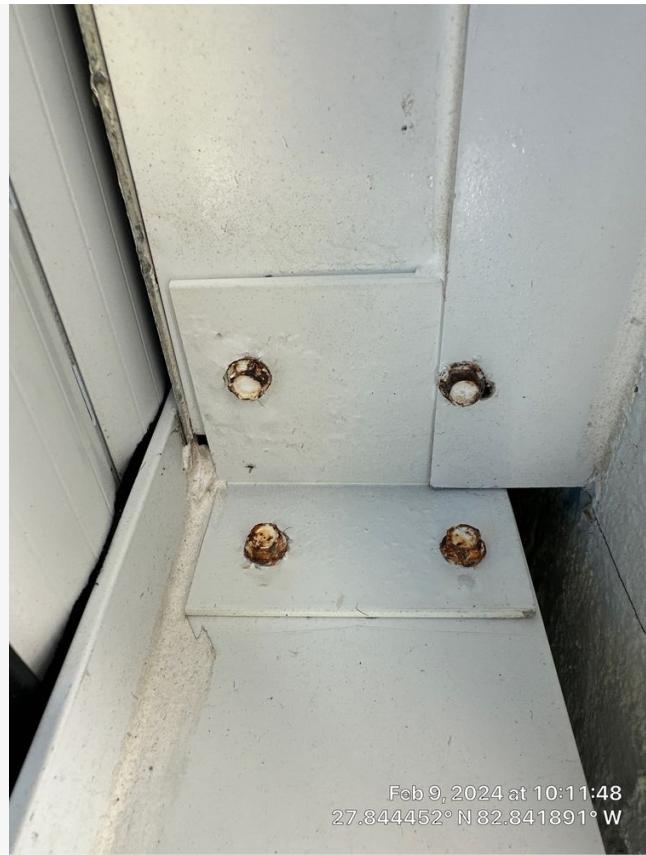
Unit 501. Corrosion of fasteners for storm shutter bracket. This corrosion is fairly minor and typical for the building, although the fasteners should be periodically observed to make sure that they remain in serviceable condition.

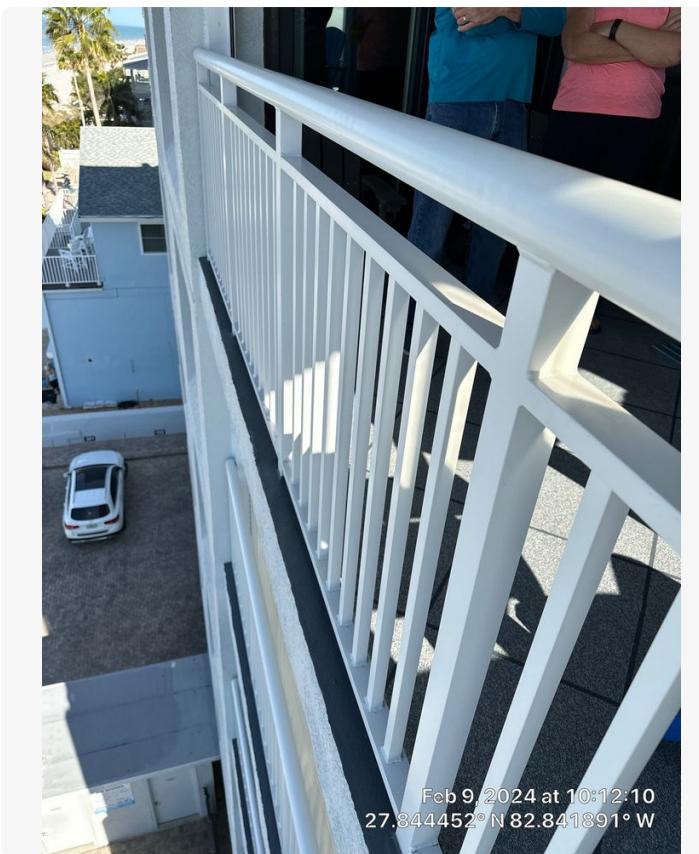
Unit 501 beach-facing balcony railings in excellent condition. This is typical for the building.

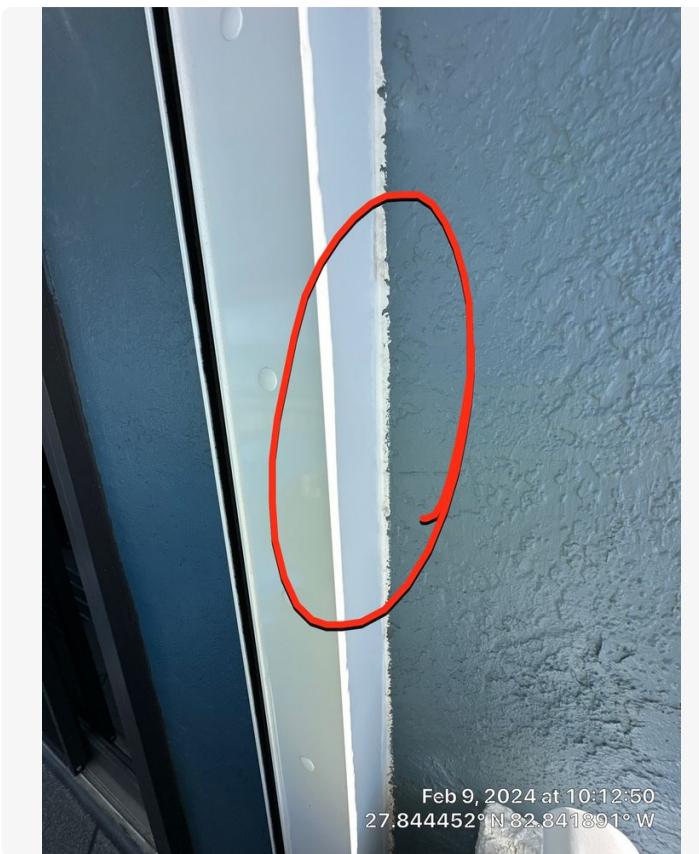
Unit 501. Sealant at storm shutter perimeter is in good condition and pliable.

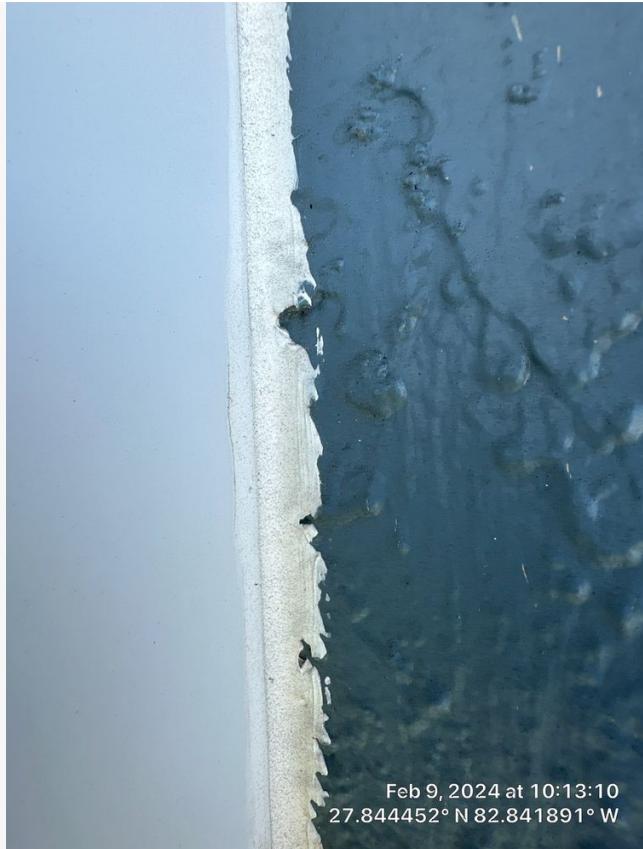
Unit 501. Sealant at storm shutter perimeter is in good condition and pliable.

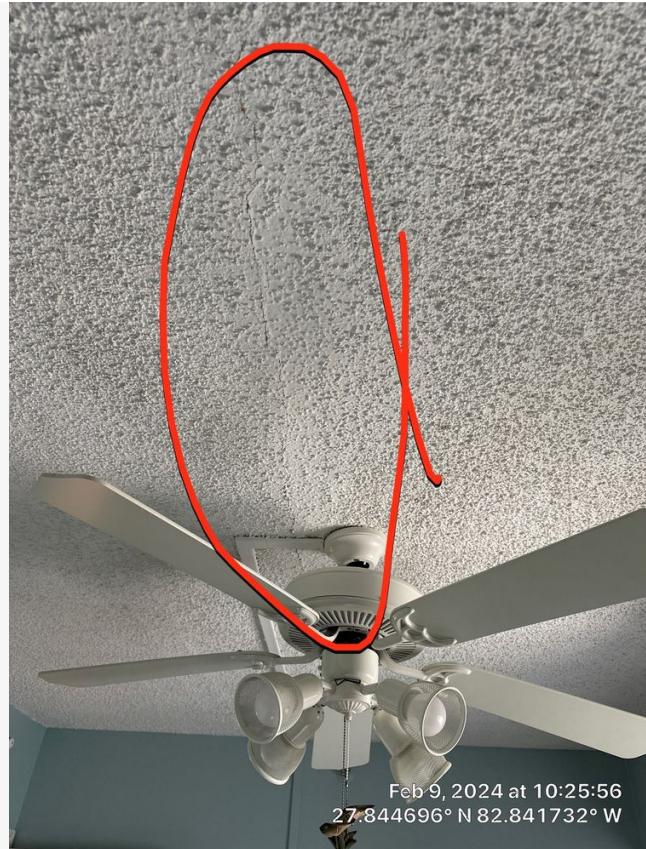
Unit 202. Crack in drywall ceiling. This is not a structural issue and no action is required. The crack is likely related to construction joints between the precast concrete planks.

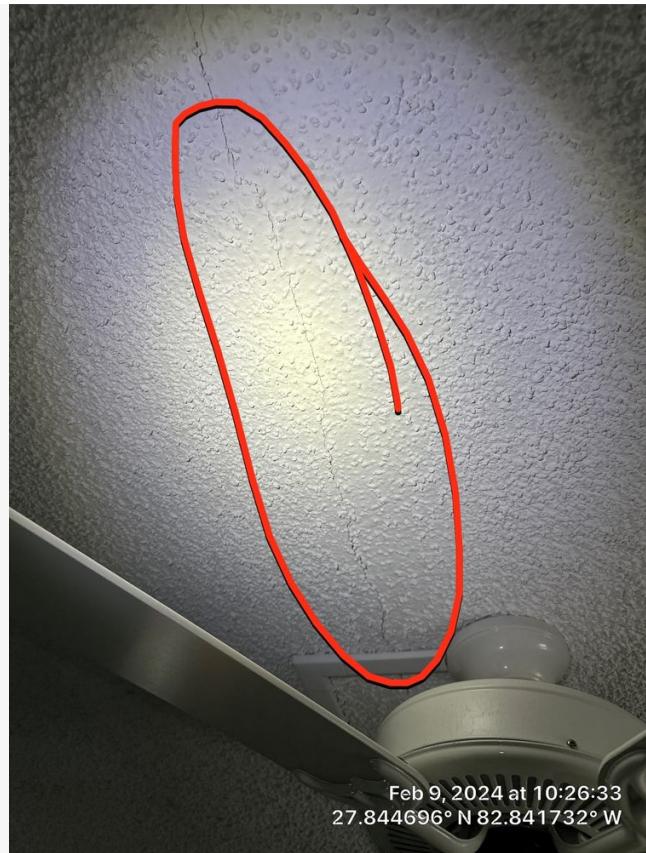
Unit 202. Crack in drywall ceiling. This is not a structural issue and no action is required. The crack is likely related to construction joints between the precast concrete planks.

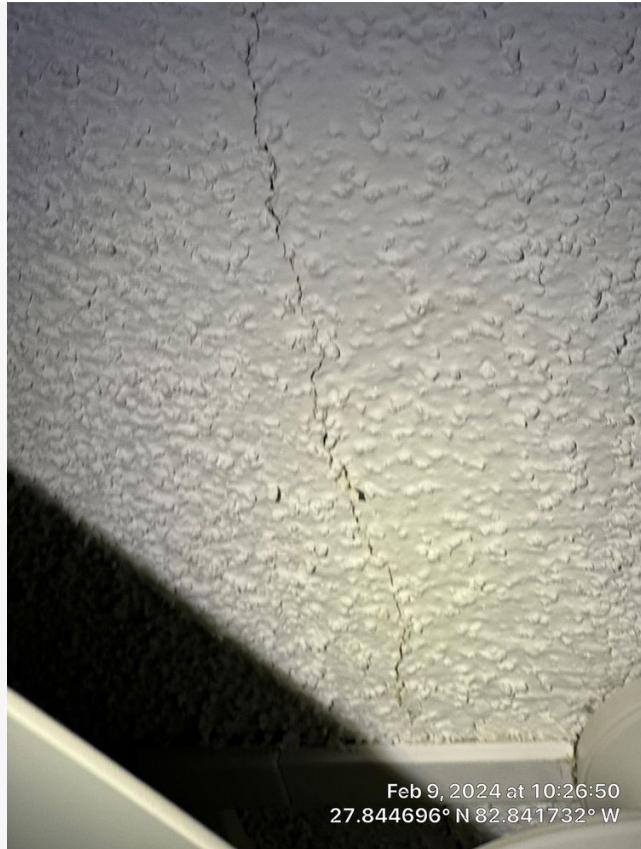
Unit 202. Crack in drywall ceiling. This is not a structural issue and no action is required. The crack is likely related to construction joints between the precast concrete planks.

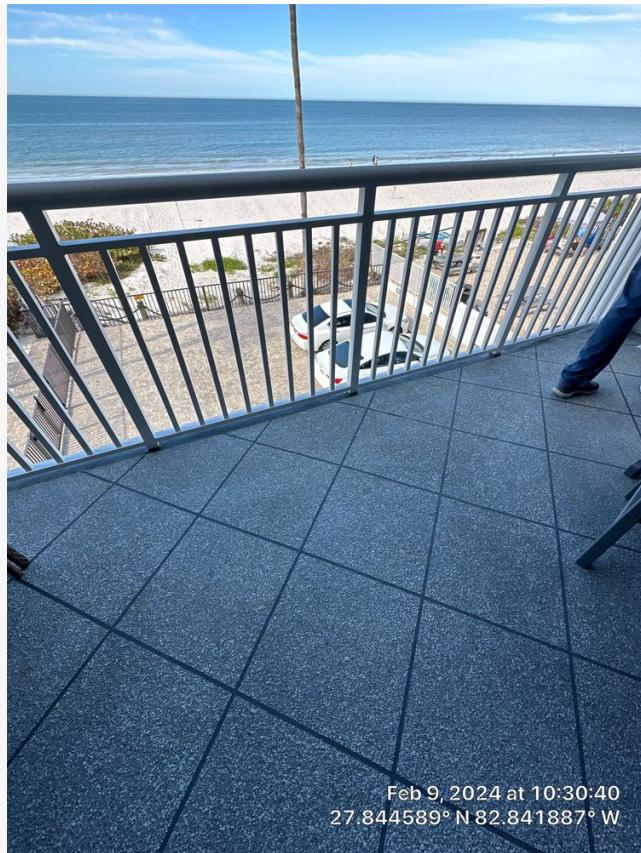
Unit 202 balcony is in excellent condition.

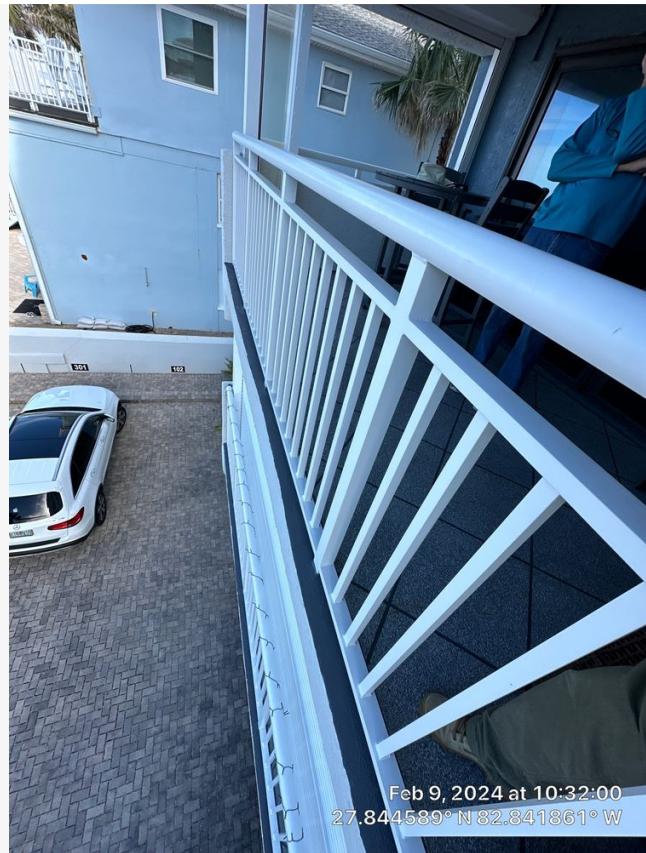
Unit 202. Railings are brand new and in excellent condition. Gemstone deck finish is on all balconies, excellent condition, no issues. See prior notes on rusting fasteners and steel posts.

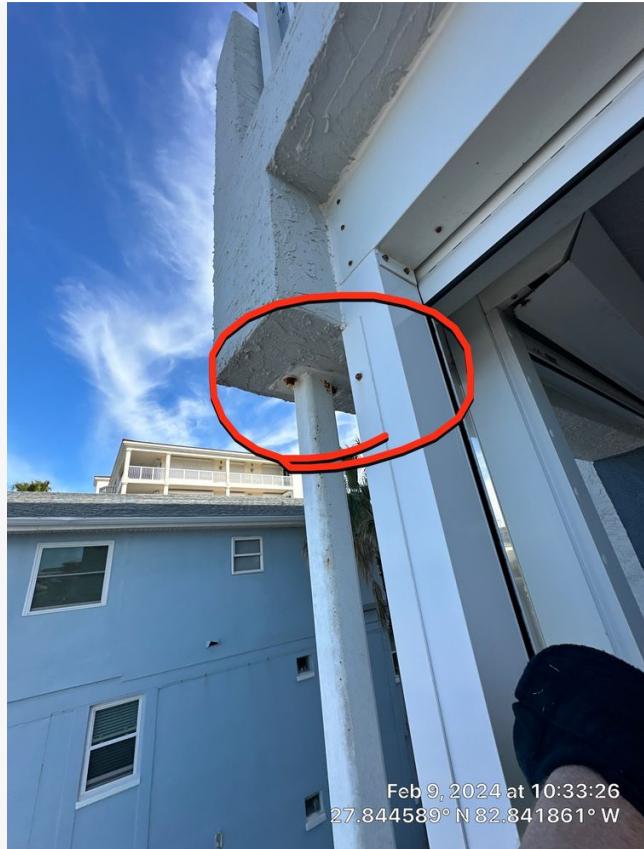
Unit 202. Rusting fasteners observed, typical for coastal environment. This condition is typical at the corners of the balconies--see prior notes recommending cleaning and coating.

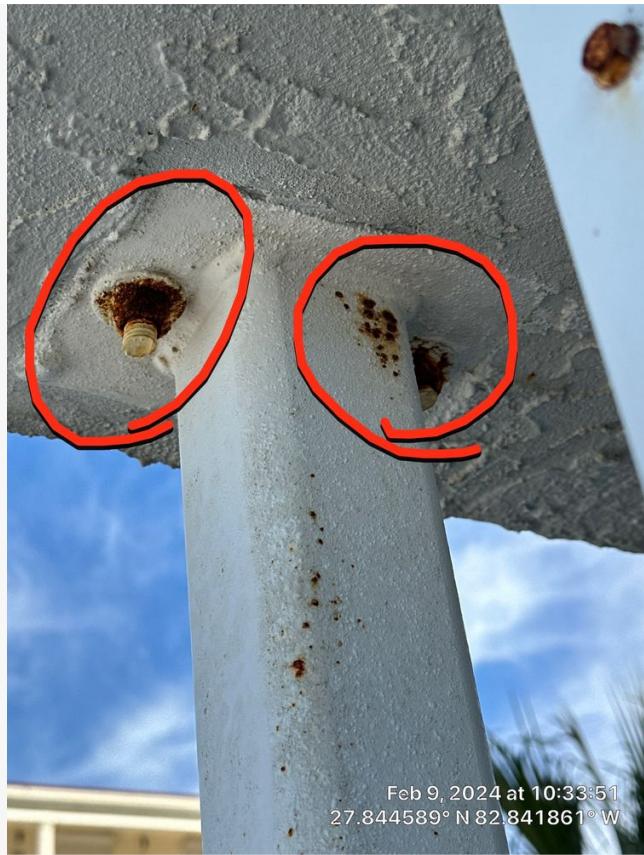
Unit 202. Rusting fasteners observed, typical for coastal environment. These steel components and their fasteners should be cleaned and coated to reduce the severity of further corrosion.

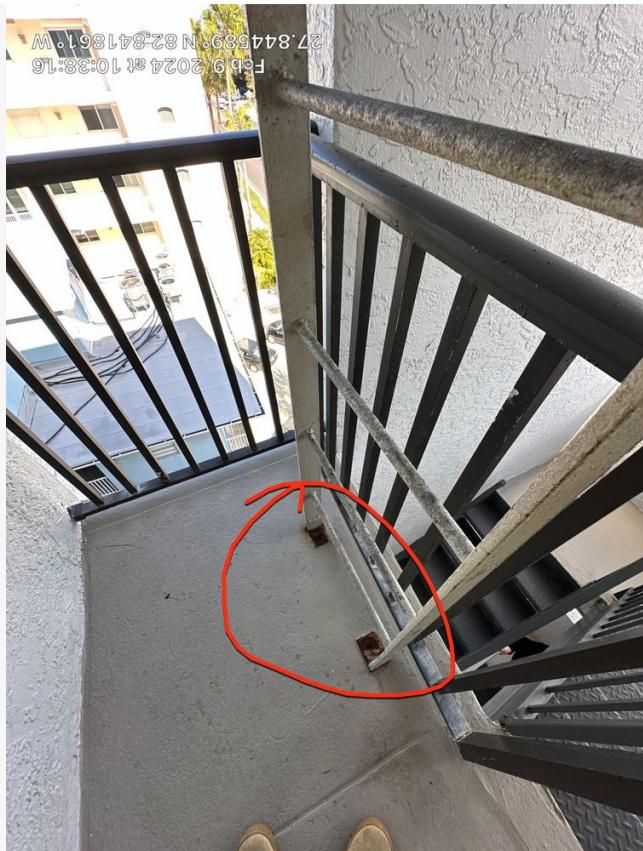
Fifth floor walkway, North side. Base plates at base of roof access ladder are significantly corroded and should be monitored. These base plates may have to be repaired, as the corrosion is likely too far advanced to simply clean and coat.

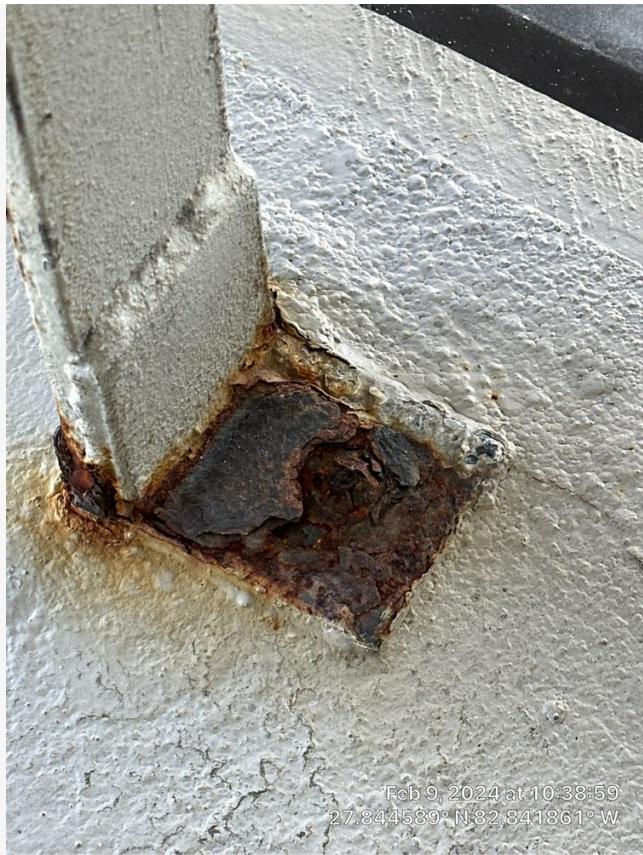
Close-up of roof ladder base plate. Fifth floor walkway, North side. Base plates at base of roof access ladder are significantly corroded and should be monitored. These base plates may have to be repaired, as the corrosion is likely too far advanced to simply clean and coat.

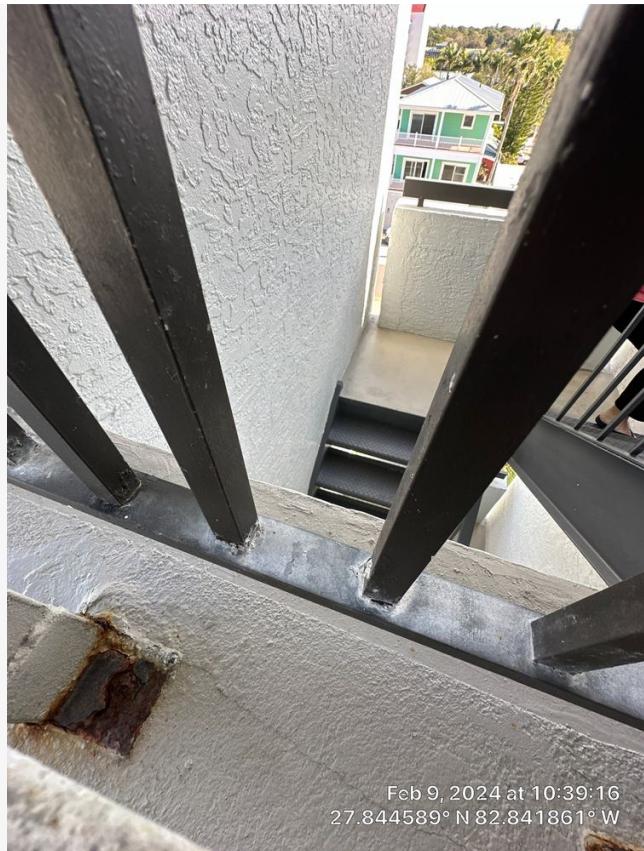
Fifth floor guardrail pickets adjacent to roof access ladder. Corrosion observed at base of pickets. The guardrail picket located at stairwell has to be repaired. In general, the walkway guardrails are reaching the end of their useful lives. Association should begin budgeting for replacement.

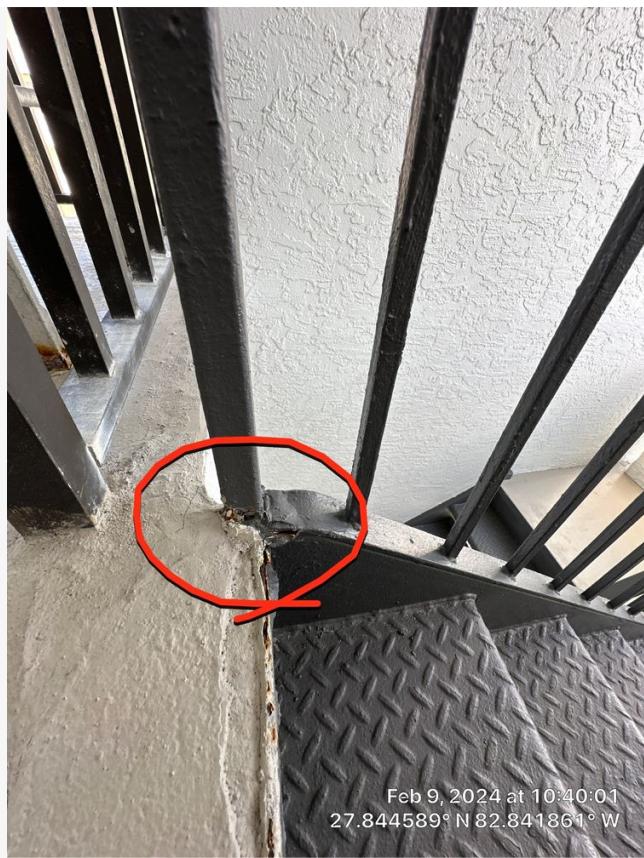
Fifth floor guardrail pickets adjacent to roof access ladder. Corrosion observed at base of pickets. The guardrail picket located at stairwell has to be repaired, and some pickets may require replacement. In general, the walkway guardrails are reaching the end of their useful lives. Association should begin budgeting for replacement.

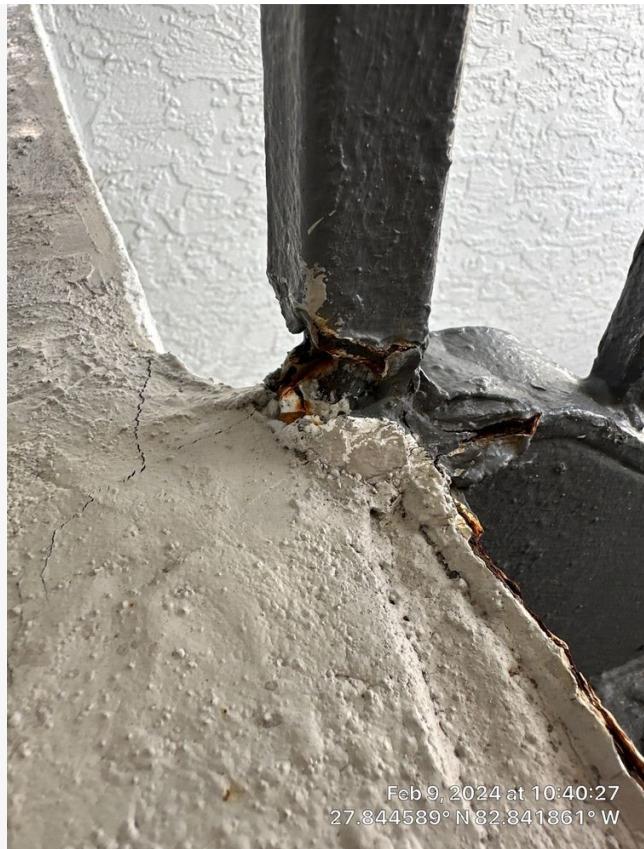
Close-up of bottom of guardrail picket. Fifth floor guardrail pickets adjacent to roof access ladder. Corrosion observed at base of pickets. The guardrail picket located at stairwell has to be repaired, and some pickets may require replacement. In general, the walkway guardrails are reaching the end of their useful lives. Association should begin budgeting for replacement.

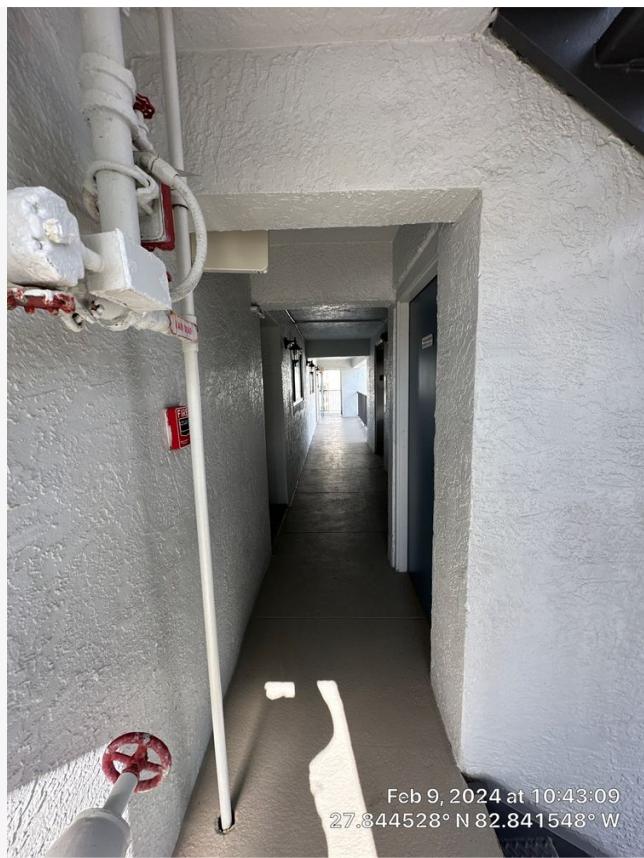
4th floor walkway. The walkways in general are in very good condition.

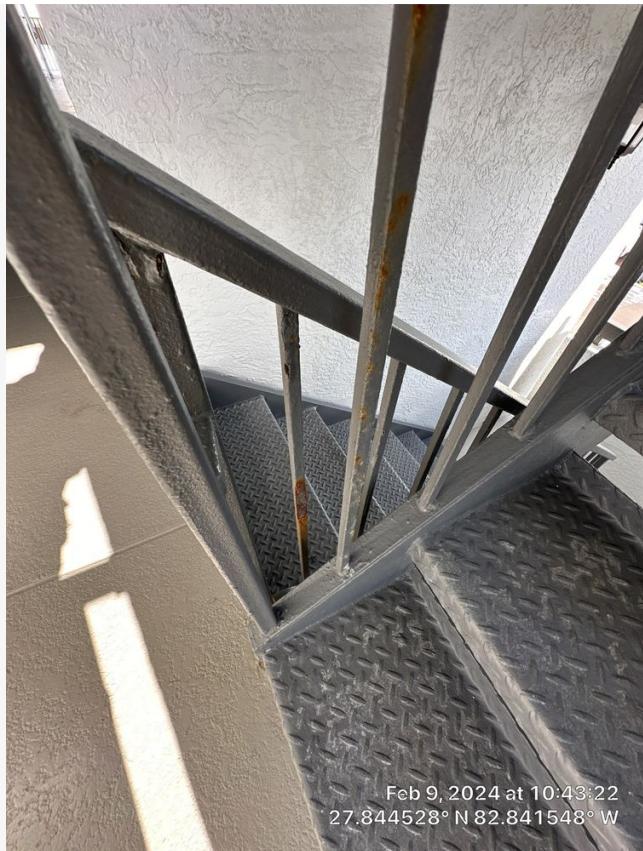
Steel guardrails on stairs--pickets are corroding. Will need repair likely thru welding new pickets into place. This is a typical condition on all steel guard rails in the stairs.

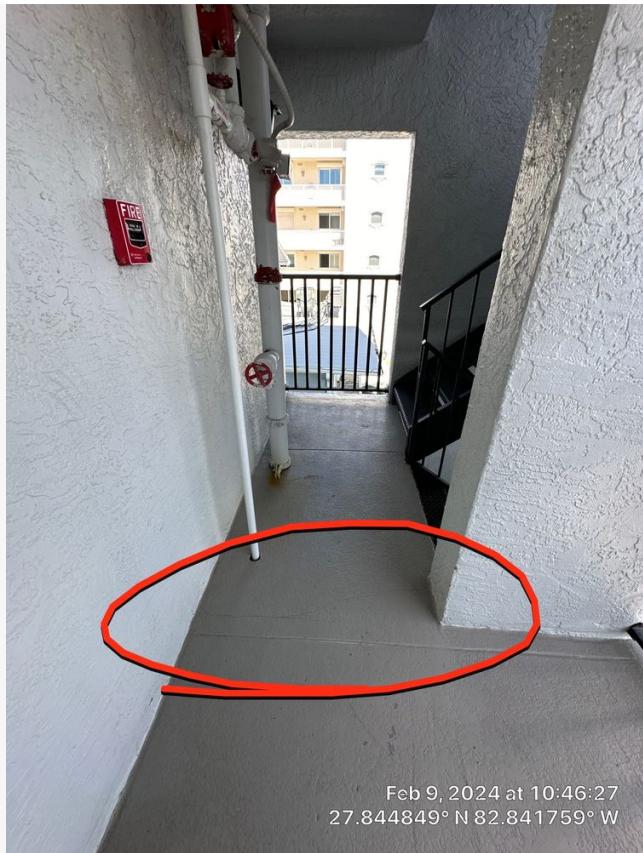
Typical cracking in walkway observed due to omission of crack control joints. This is not a structural issue and no action is required.

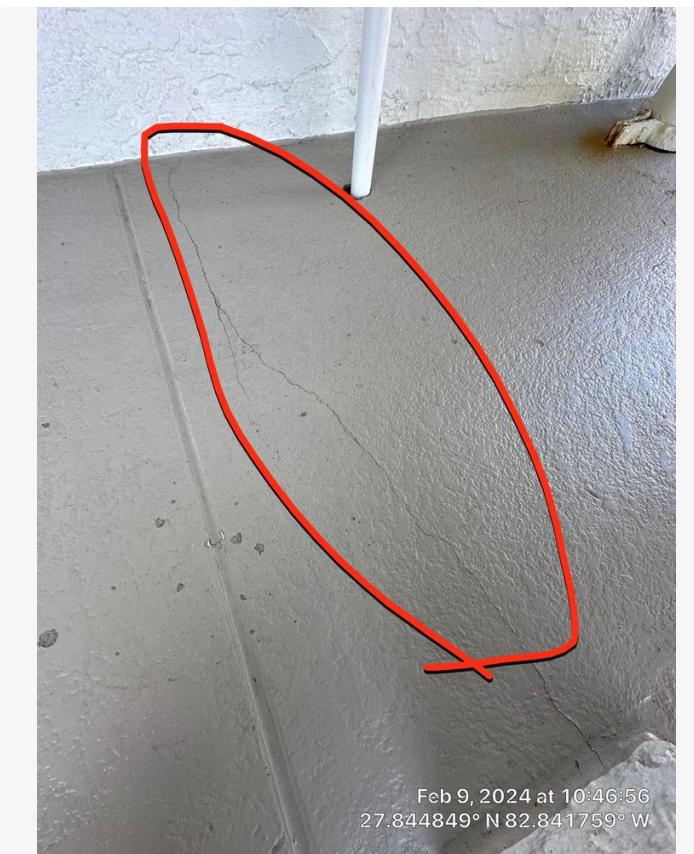
Typical cracking in walkway observed due to omission of crack control joints. This is not a structural issue and no action is required.

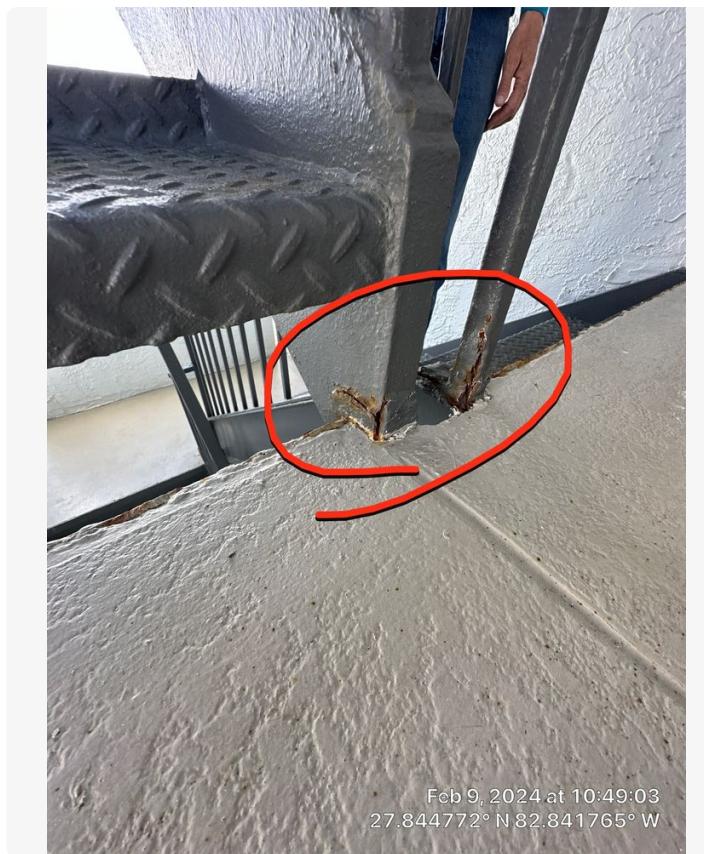
Significant corrosion observed at base of stairs attachment to concrete slab. Recommend cleaning and coating of the steel. However, in some locations as shown here a welding repair may also be required.

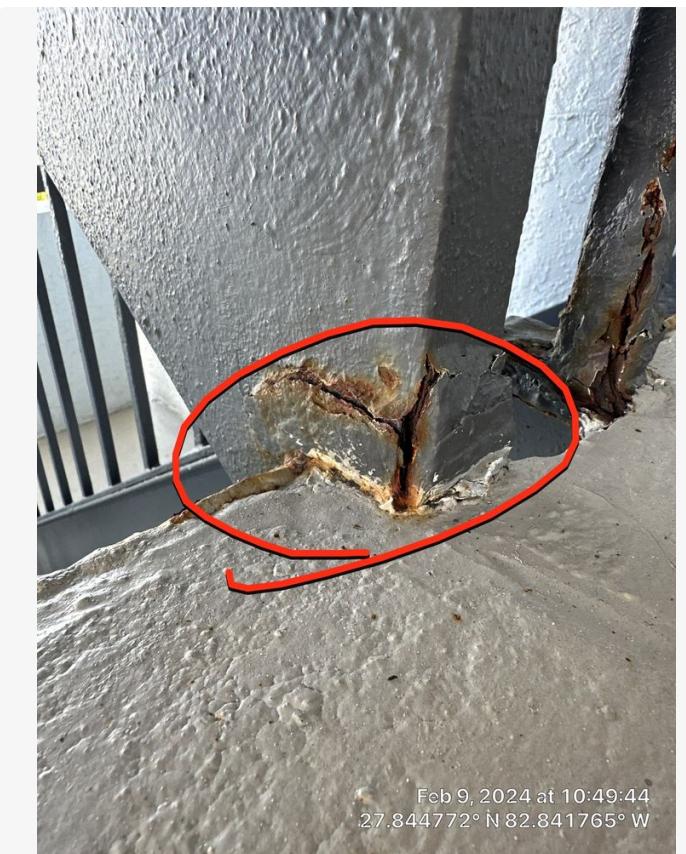
Significant corrosion observed at base of stairs attachment to concrete slab. Recommend cleaning and coating of the steel. However, in some locations as shown here a welding repair may also be required.

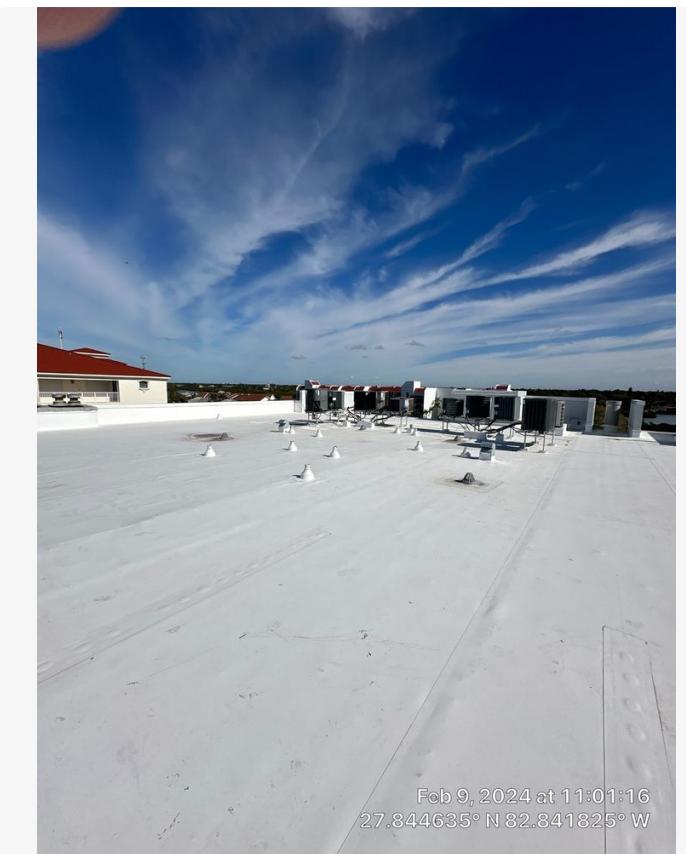
General roof area. This is a low-slope "flat" roof membrane. Flat roof is in excellent condition.

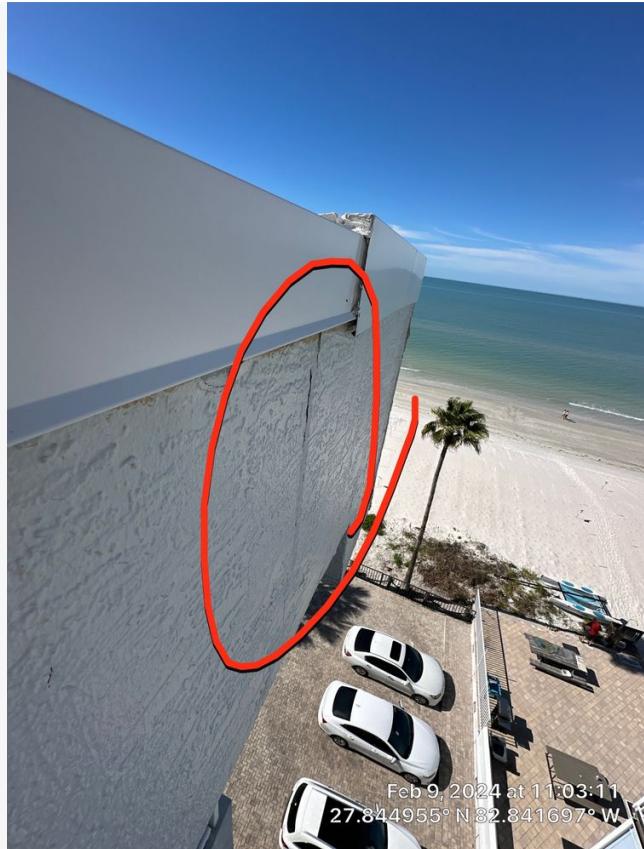
Stucco cracking observed at Northwest corner of building at roof level below parapet. Recommend routing and sealing to prevent water intrusion. A stucco may be required, however.

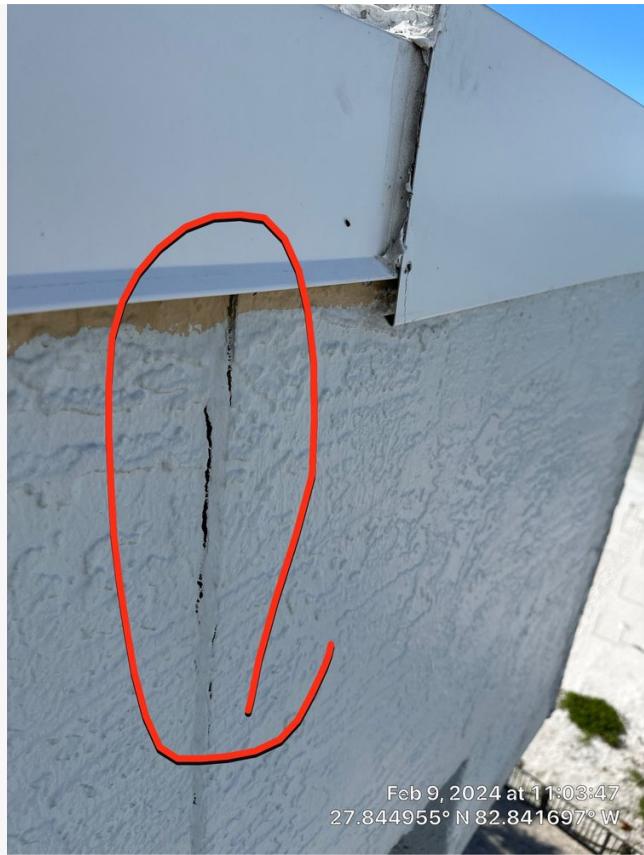
Close-up of stucco cracking observed at Northwest corner of building at roof level below parapet. Recommend routing and sealing to prevent water intrusion. A stucco may be required, however.

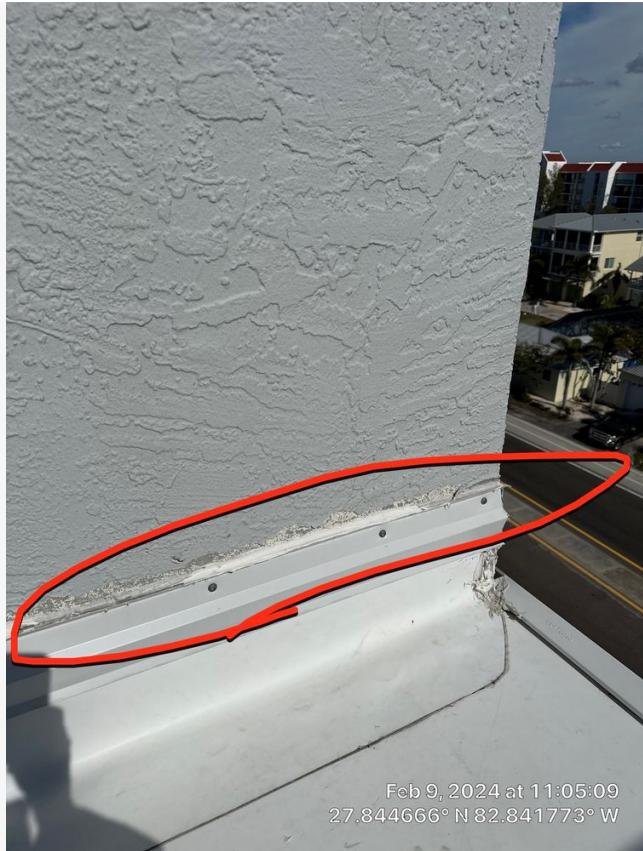
Bare stucco and missing sealant observed at roof counter flashing in several locations on flat roof. Recommend caulking replacement and repainting.

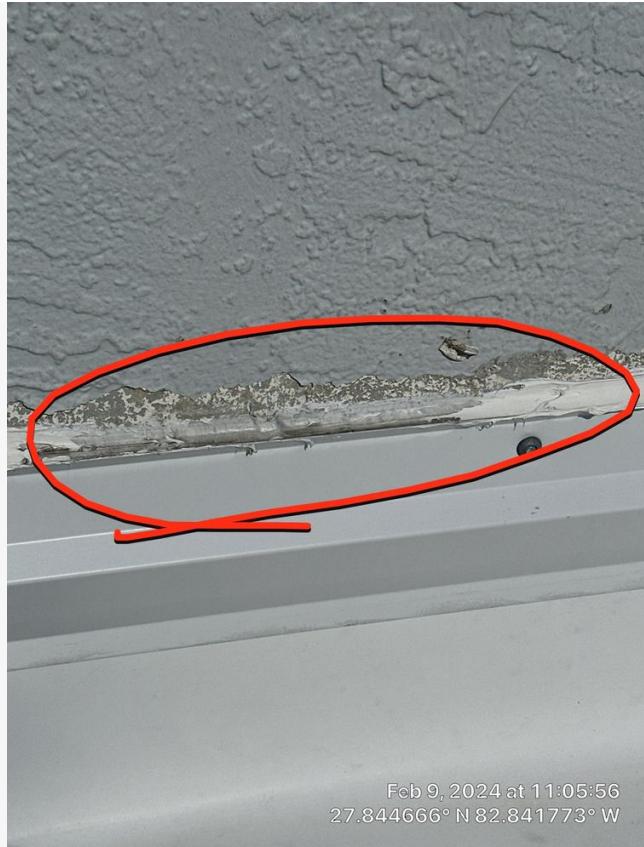
Bare stucco and missing sealant observed at roof counter flashing in several locations on flat roof. Recommend caulking replacement and repainting.

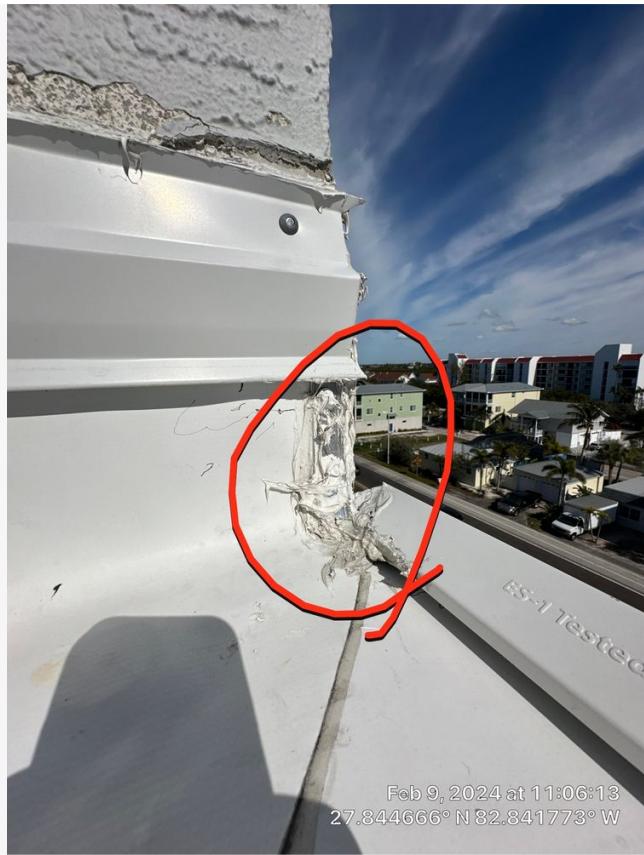
Poor-quality sealant installations at roof should be removed and replaced. This appears to be related to the recent roofing work and was observed in multiple locations.

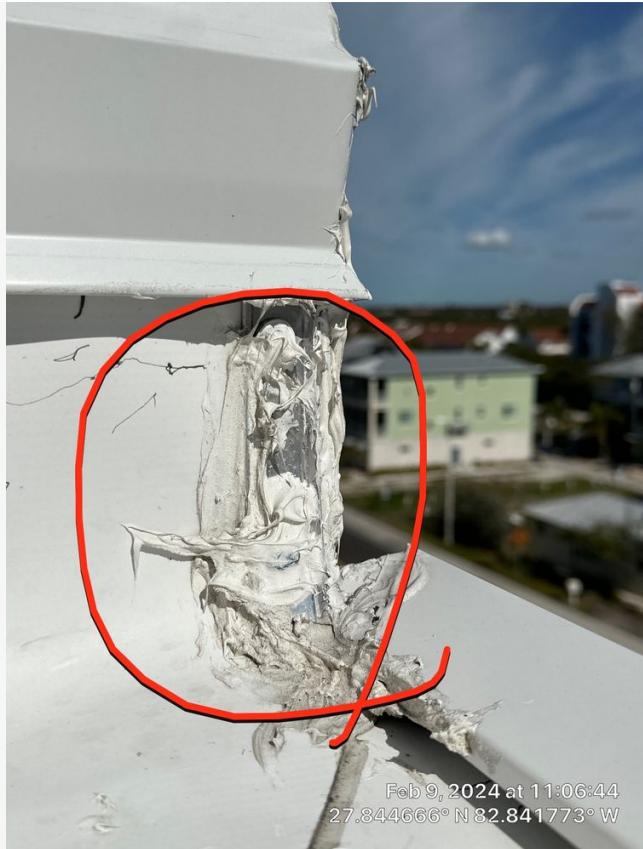
Poor-quality sealant installations at roof should be removed and replaced. This appears to be related to the recent roofing work and was observed in multiple locations. We would recommend contacting the roofer to determine if this is related to their recent work, and request remediation under the terms of the warranty if applicable.

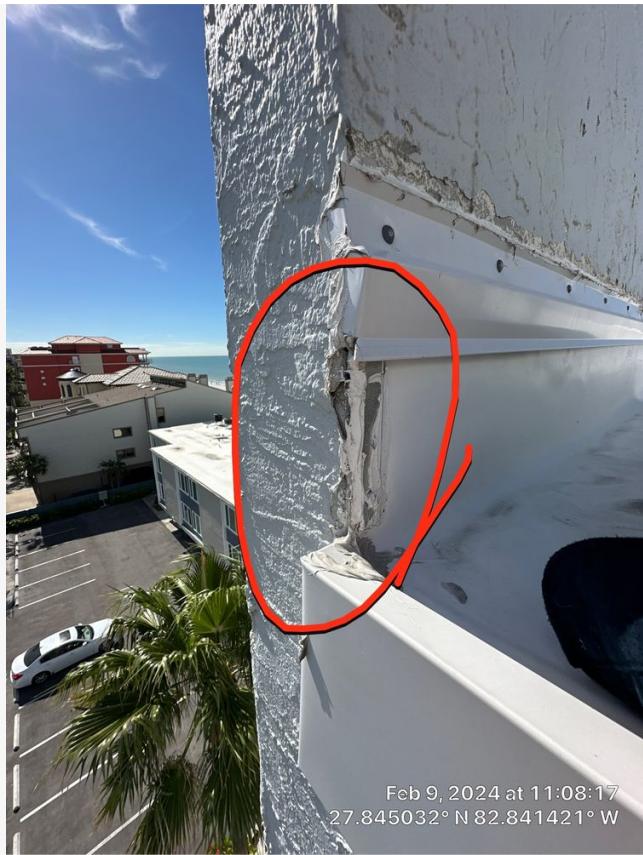
Southeast corner of roof requires stucco, repair and re-caulking. This location is probably leaking into the wall. We would recommend contacting the roofer to determine if this is related to their recent work, and request remediation under the terms of the warranty if applicable.
