March 28, 2024

THIS MILESTONE PHASE 1 INSPECTION REPORT WAS PRODUCED FOR SHORE HOUSE CONDOMINIUM ASSOCIATION, INC. LOCATED AT 19106 GULF BLVD., INDIAN SHORES, FL 33785.

SHORE HOUSE

MILESTONE PHASE 1 INSPECTION SURVEY

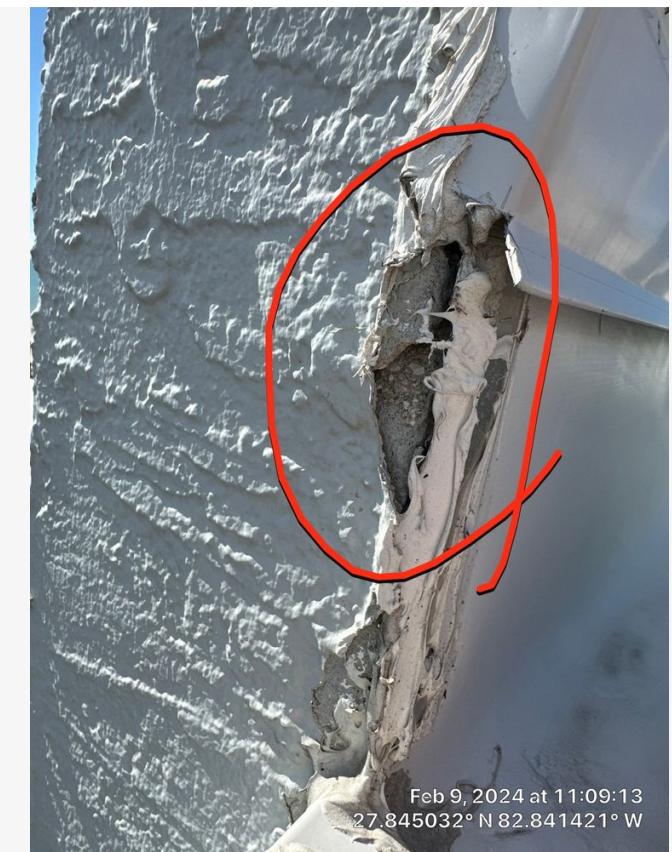
Southeast corner of roof requires stucco, repair and re-caulking. This location is probably leaking into the wall. Although we can't be certain, it would appear that the roofer left the wall in this condition while working on the building. The stucco and block wall damage appears to have been caused by the roofer's installation of the counter-flashing material.

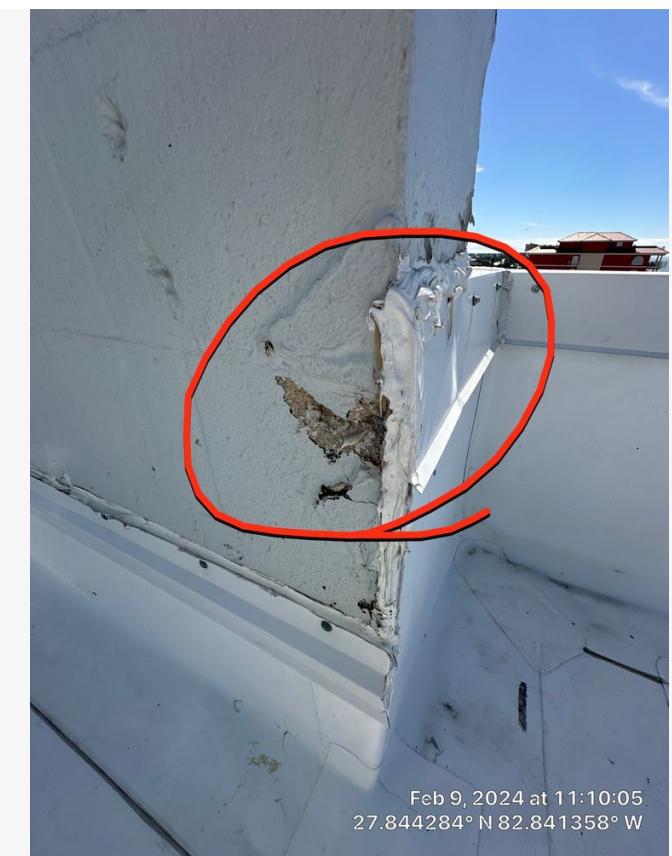
Southeast corner of roof requires stucco, repair and re-caulking. This location is probably leaking into the wall. Although we can't be certain, it would appear that the roofer left the wall in this condition while working on the building. The stucco and block wall damage appears to have been caused by the roofer's installation of the counter-flashing material.

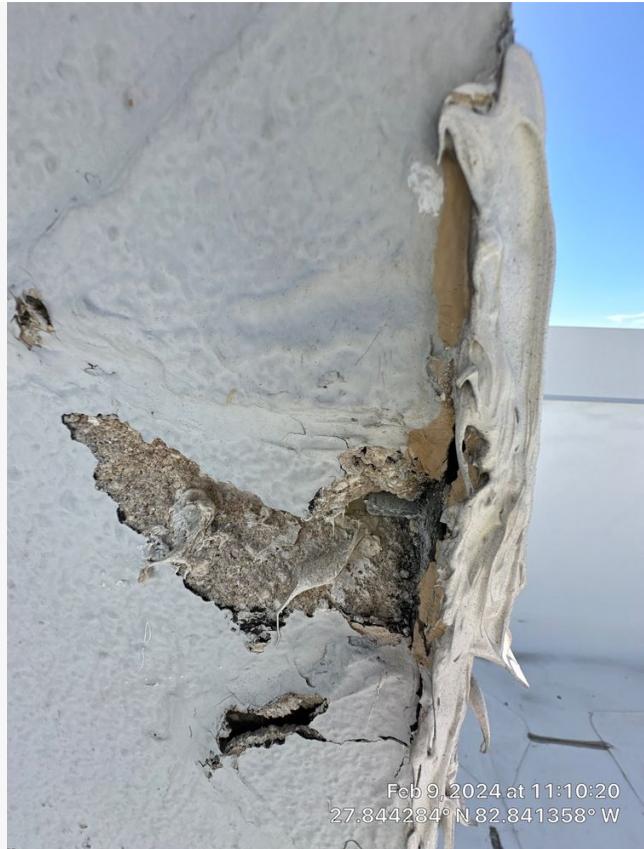
Southeast corner of roof requires stucco, repair and re-caulking. This location is probably leaking into the wall. Likely caused by insertion of metal fasteners into outside corner of block wall during counter-flashing installation by roofer.

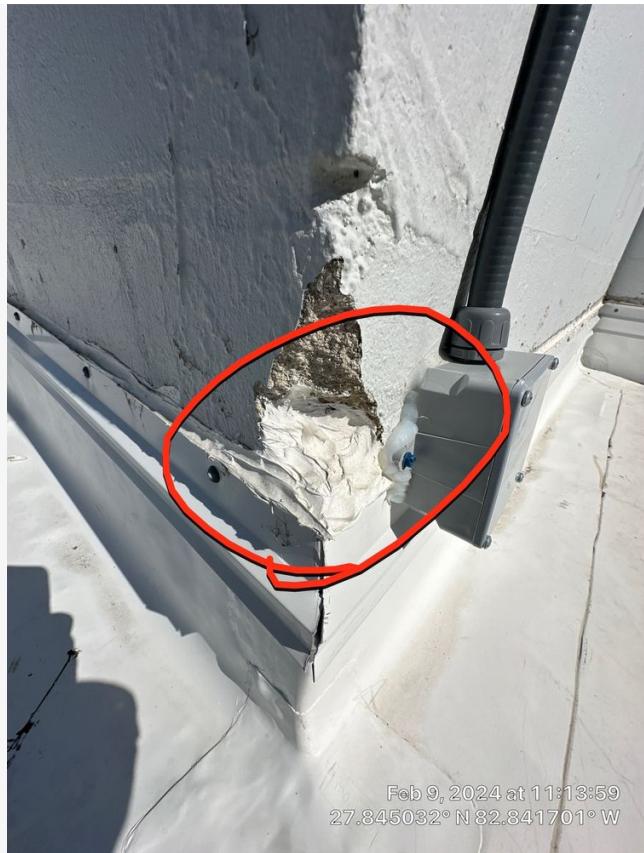
Southeast corner of Roof, block wall appears to have been repaired attempted by filling up with caulk. This location is probably leaking into the wall. Likely caused by insertion of metal fasteners into outside corner of block wall during counter-flashing installation by roofer. It looks like the roofer damaged the block wall in several locations.

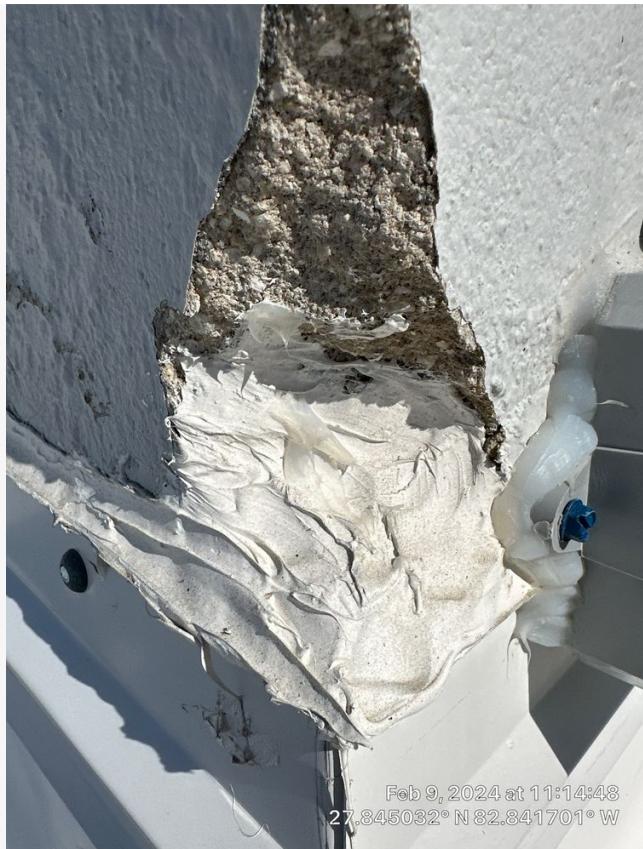
Southeast corner of Roof, block wall appears to have been repaired attempted by filling up with caulk.

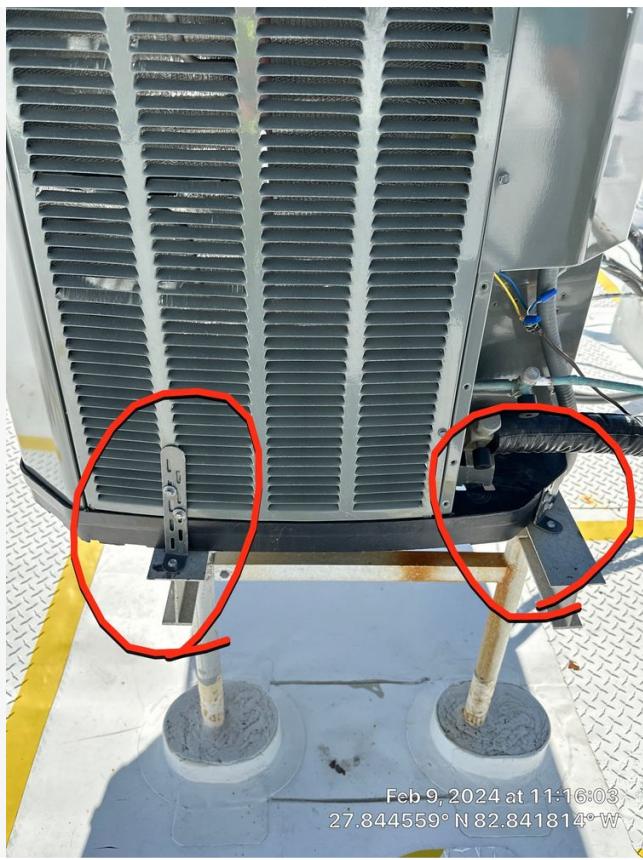
Rooftop condensing units are strapped to equipment racks with hurricane clips. This is appropriate and good practice.

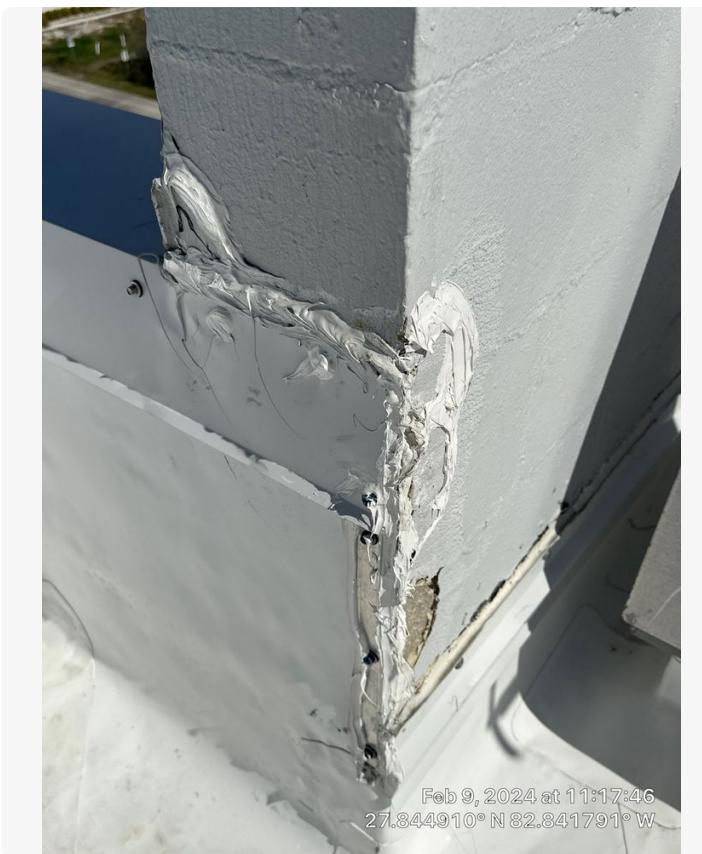
Unworkmanlike sealant and block wall repairs on roof. Many of these block wall corners are probably leaking into the wall below. They need to be repaired. It appears that the roofer caused this damage. It is possible, though unlikely, that this damage was pre-existing. However, either way the roofer had a duty to notify the Owner that a repair was required in this area.
