PHASE 2 MILESTONE INSPECTION

La Mer Condominiums

UES Project No: 0811.2400053.0000

January 10, 2025

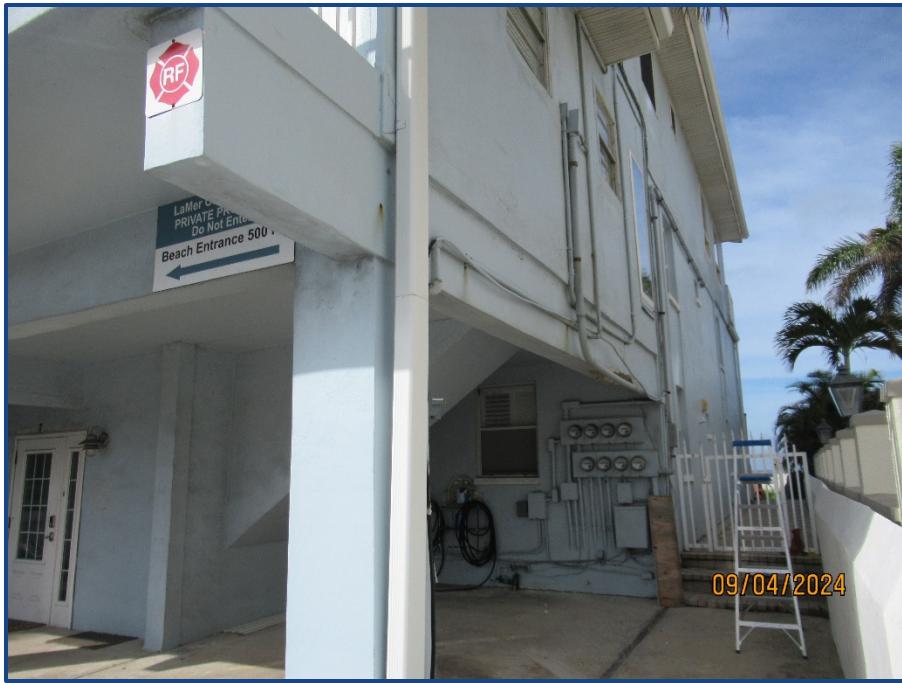
Photograph No. 1: General view of area of repair.

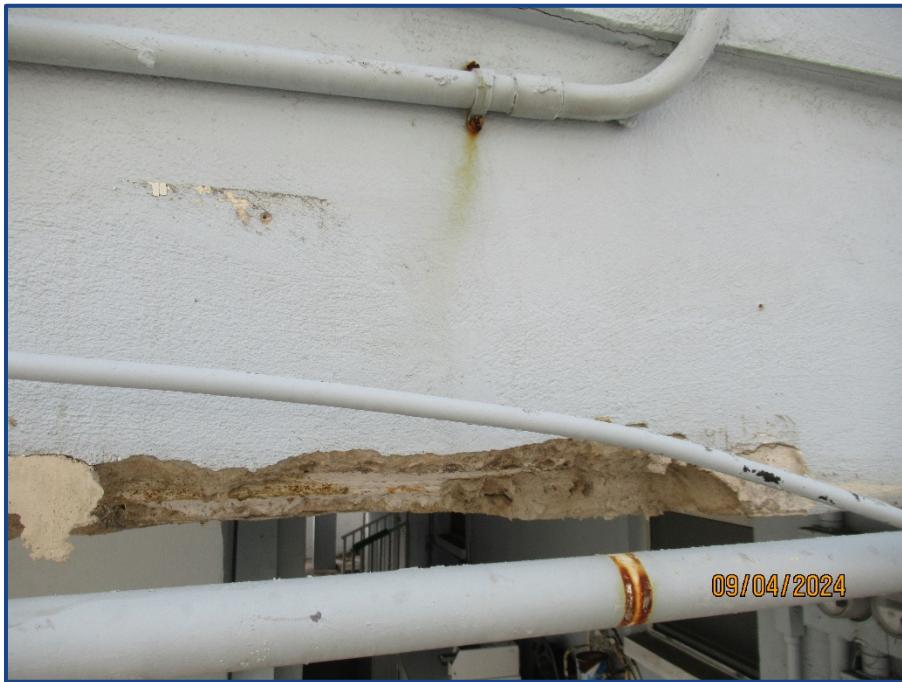
Photograph No. 2: Substantial structural deterioration in the concrete beam.

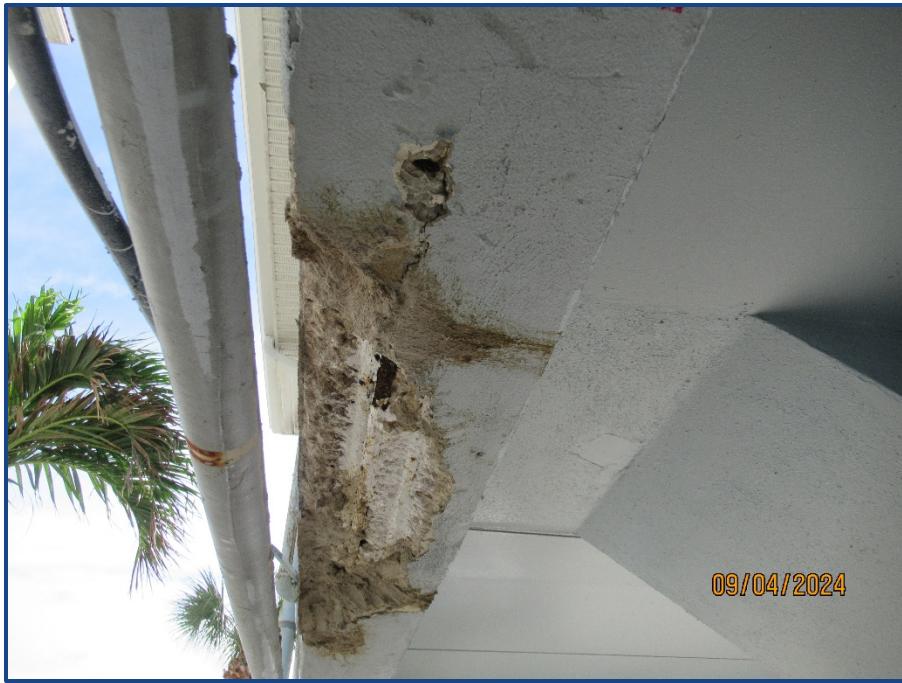
Photograph No. 3: Substantial structural deterioration in the concrete beam.

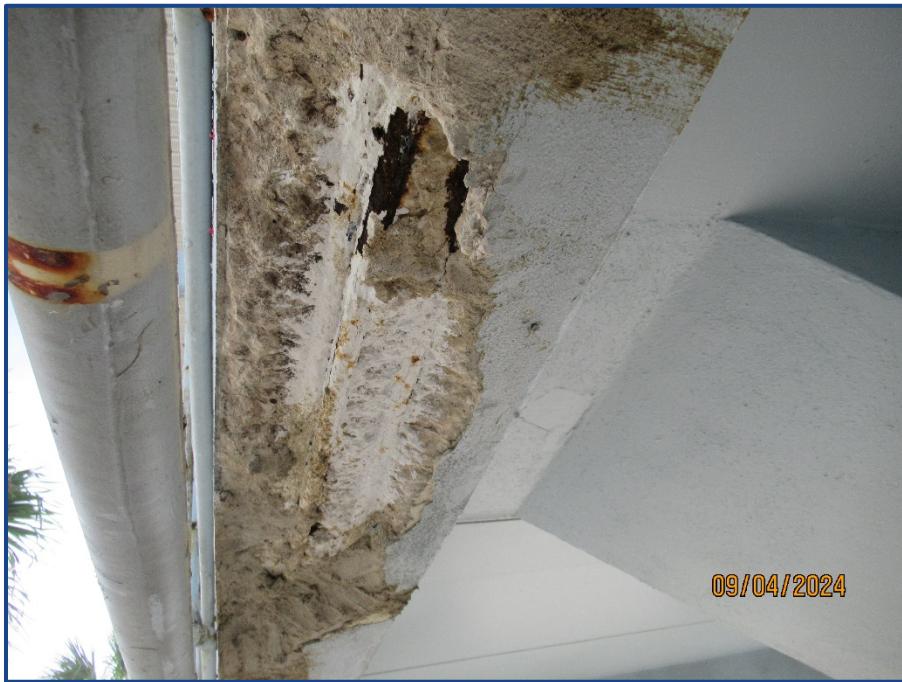
Photograph No. 4: Substantial structural deterioration in the concrete beam.

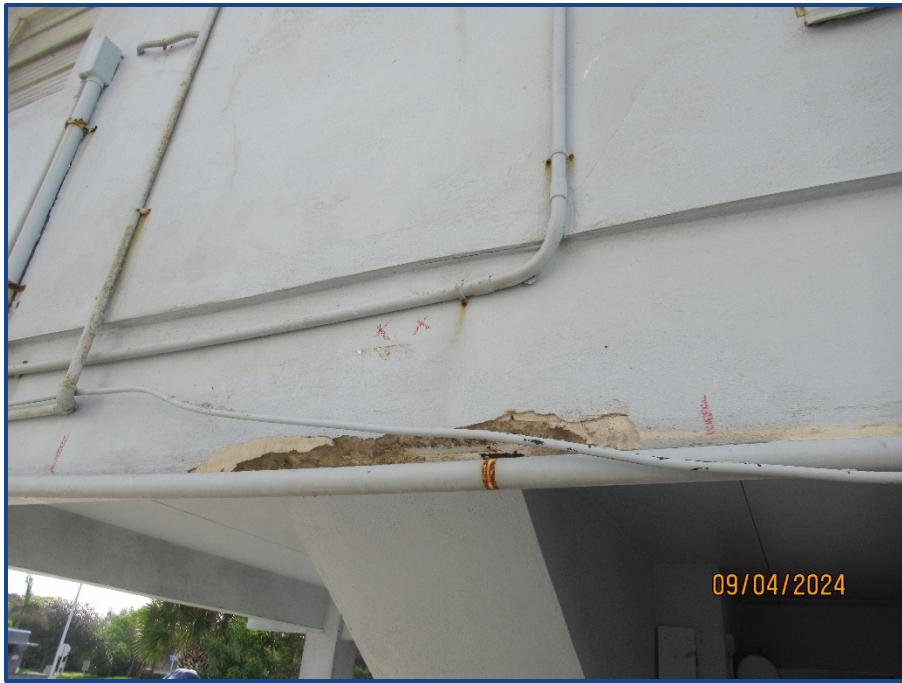
Photograph No. 5: Approximate repair area of the damaged concrete beam and unsound concrete.

1. This area was investigated in detail during this Phase 2 inspection (**Appendix A** – Photographs 1 through 5) and UES was able to conclude the extent of substantial structural deterioration was limited to an isolated area which has been quantified. Refer to **Appendix B** for Key Plan and Damage Schedule. UES recommends the following program for fully assessing and repairing distressed and damage portion of the building; Hiring a licensed structural engineer to provide concrete restoration drawings and specifications including repair

details and temporary shoring requirements during repair to restore the integrity of the individual concrete structural component. Repairs shall be completed by March 27, 2025, to help prevent further additional deterioration. Repair as soon as possible is highly recommended.

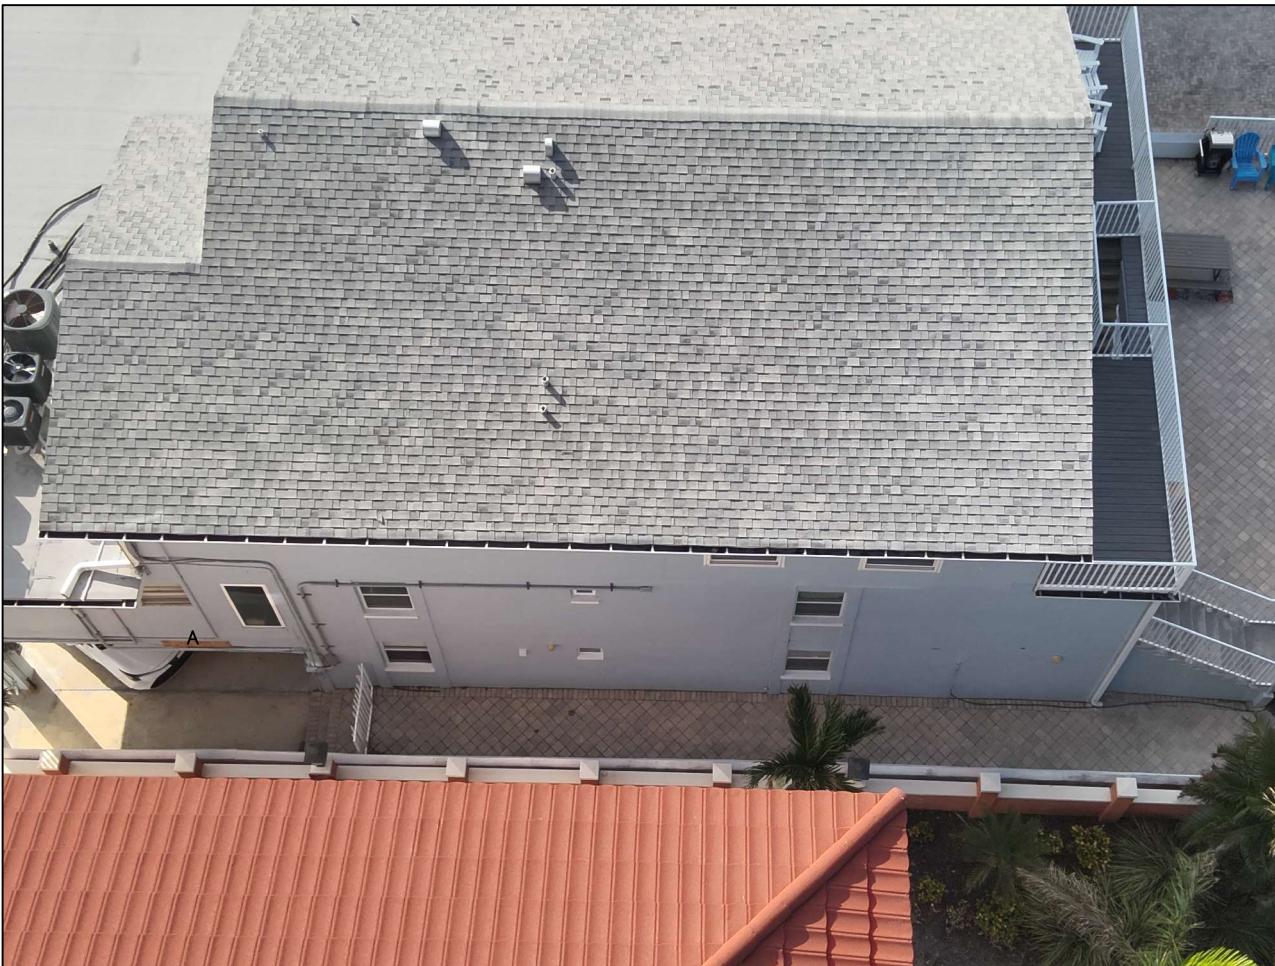
KEY PLAN AND DAMAGE SCHEDULE

| DAMAGE SCHEDULE | | | |
|---|--|---|---|
| A | SPALLED CONCRETE, EXPOSED CORRODED STEEL REINFORCEMENT, & UNSOUND CONCRETE | CONCRETE BEAM | 6'-0" x 0'-8" x 0'-8" |
