Milestone Phase I Report
The Rose Condominium Owners Association

Report Date: ⌚ 7/28/24

Inspection Date: ⌚ 7/12/2024

19222 Gulf Blvd, Indian Shores, Florida 33785

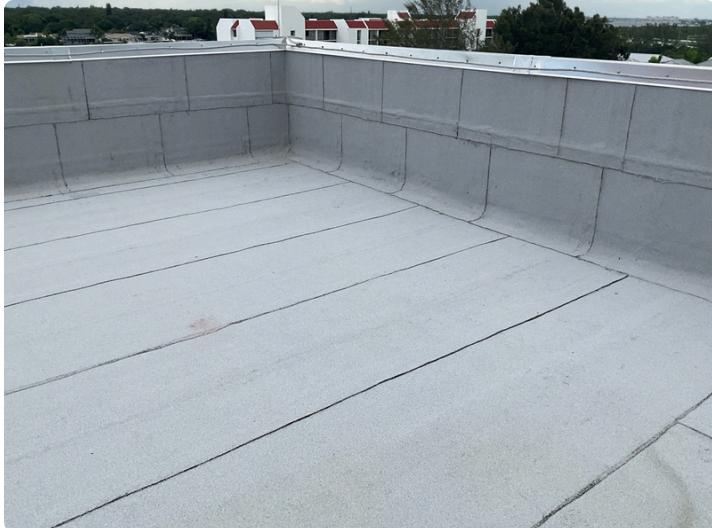
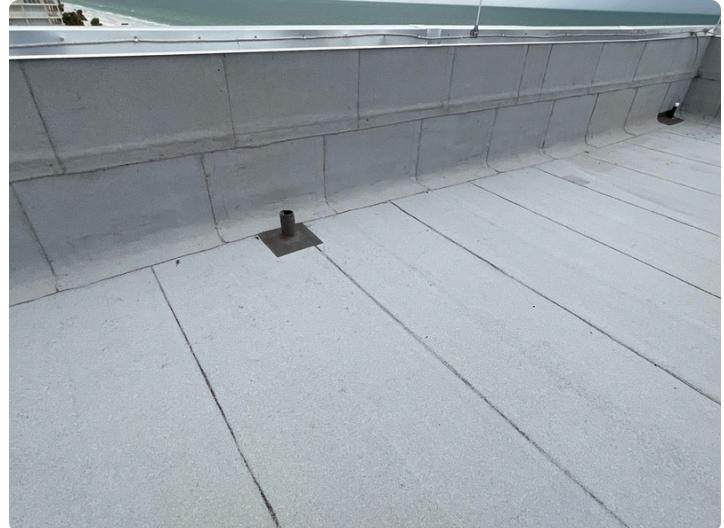
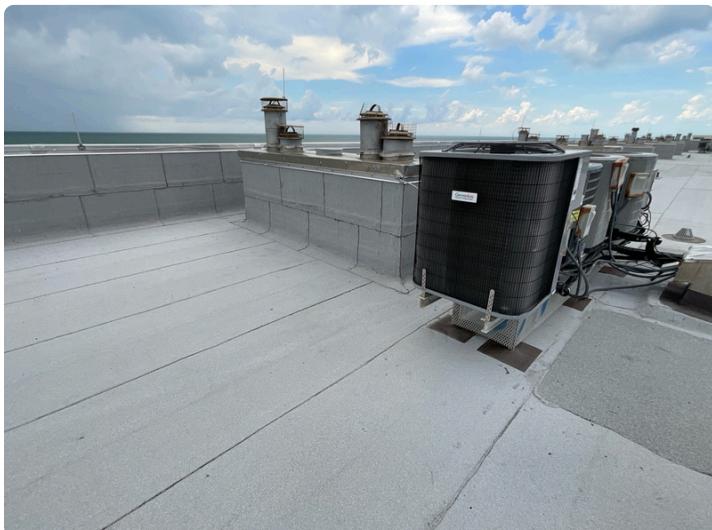
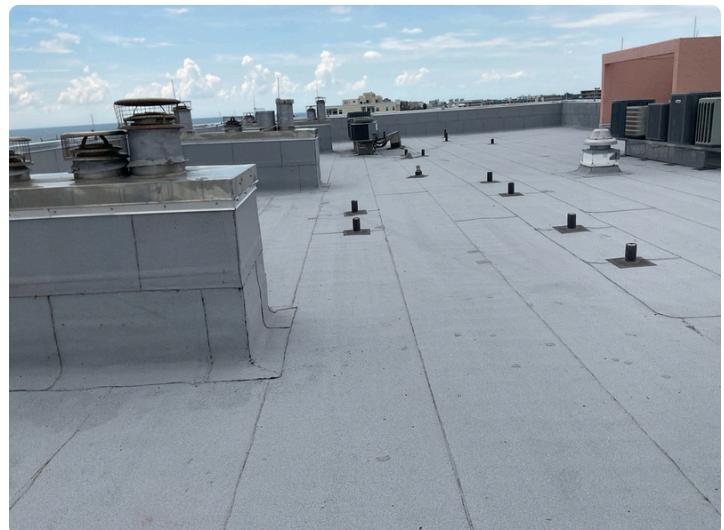
Modified bitumen roof overview

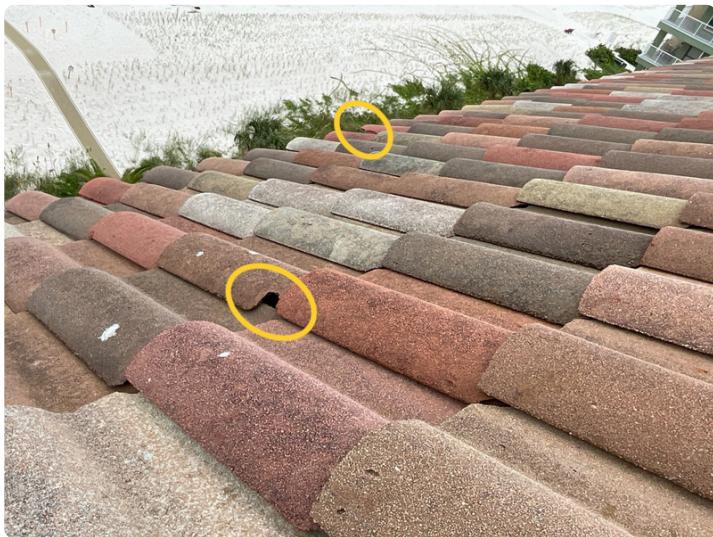
Maintenance	Chipped tiles identified on rear elevation mansard roof. Recommend monitoring chipped tiles and replacing them during the next mansard roof repair or replacement.
Condition	Modified bitumen flat roof in good condition. Tile mansard roof in average condition.

Chipped tiles on rear elevation mansard roof

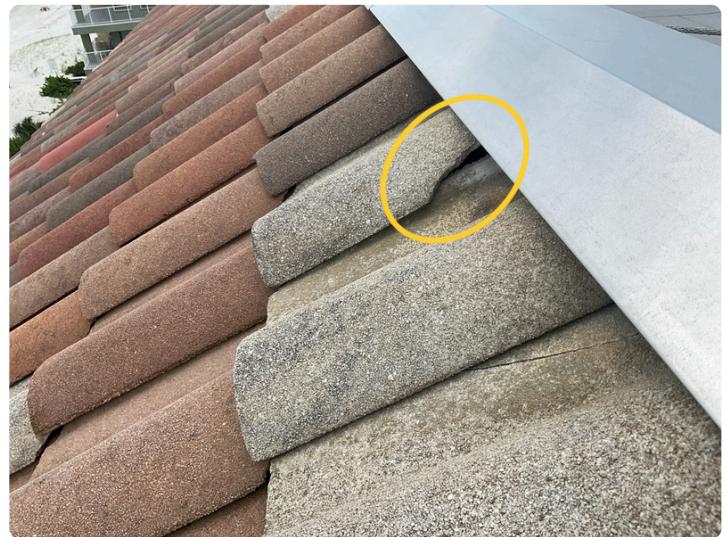
Chipped tile on rear elevation mansard roof

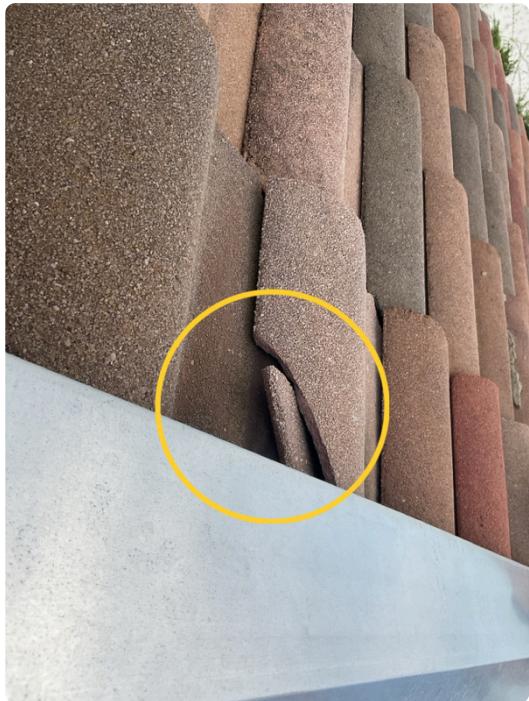
Chipped tile on rear elevation mansard roof

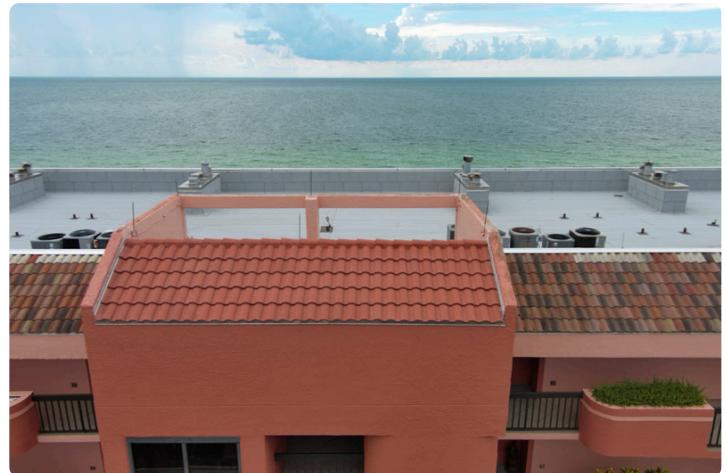
Front elevation mansard roofs overview

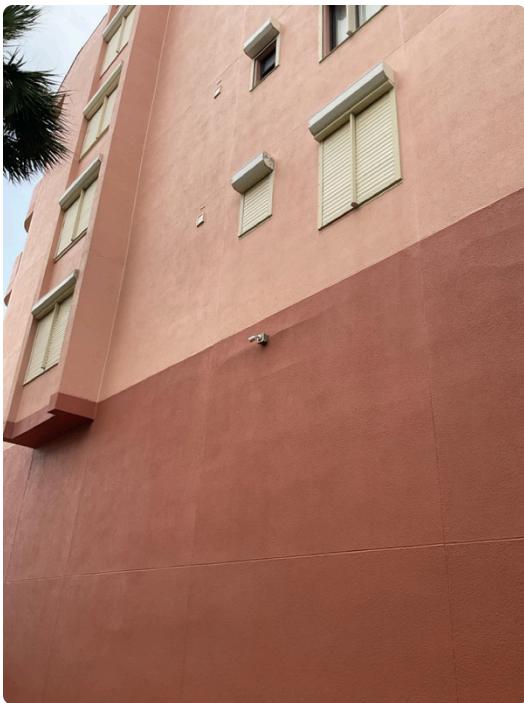
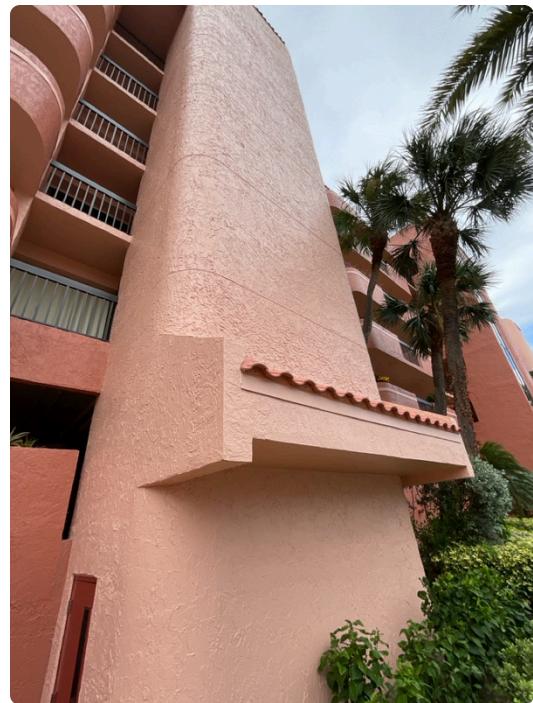
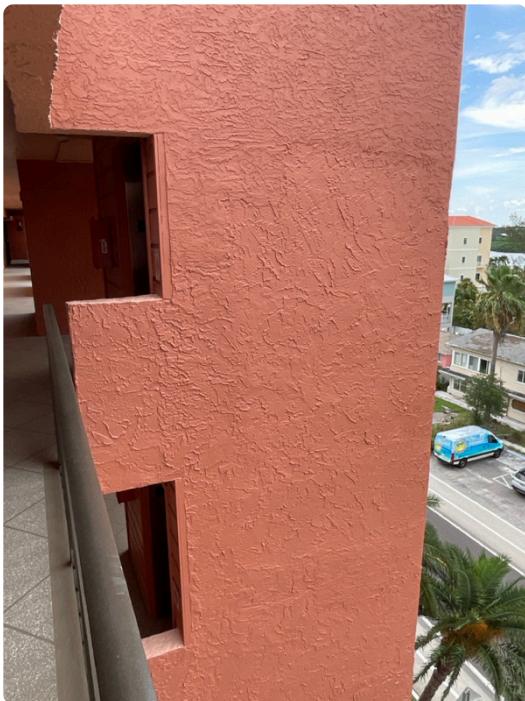
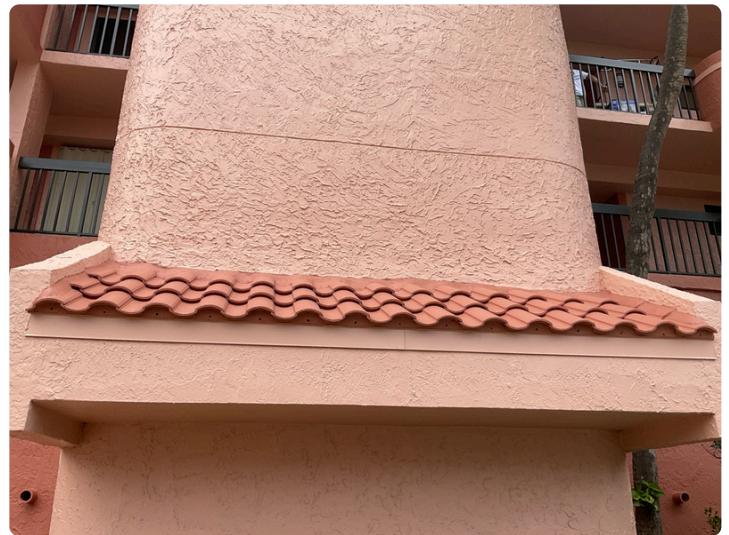
Condition	Exterior walls in good condition
-----------	----------------------------------

Typical exterior wall

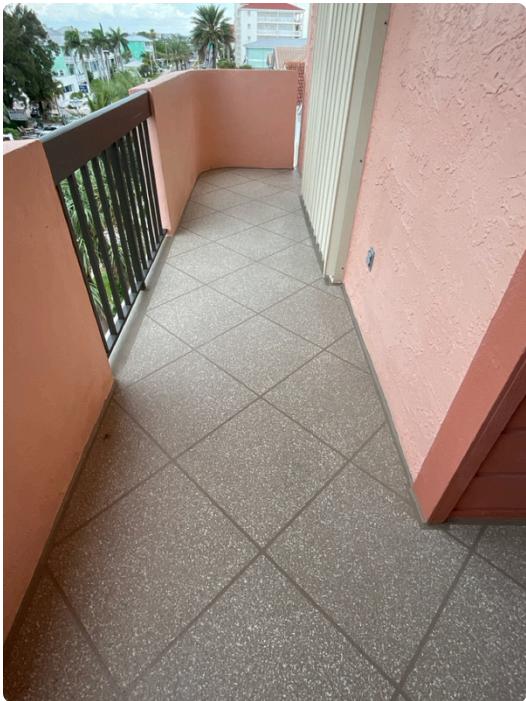
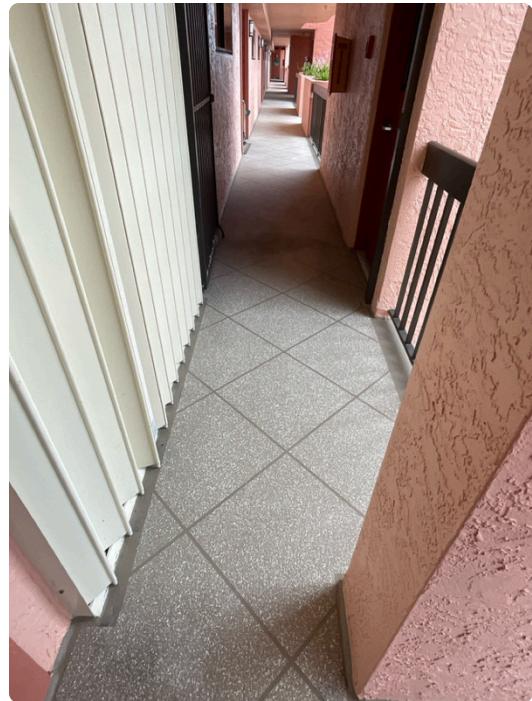
Walkways in good condition.

Typical walkway

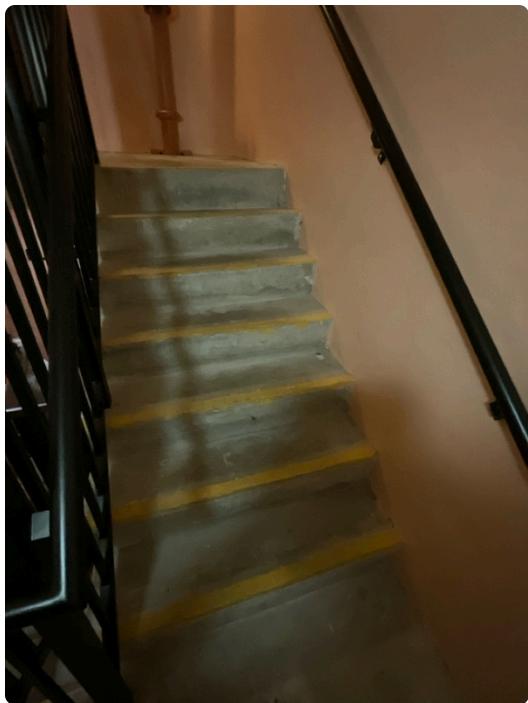
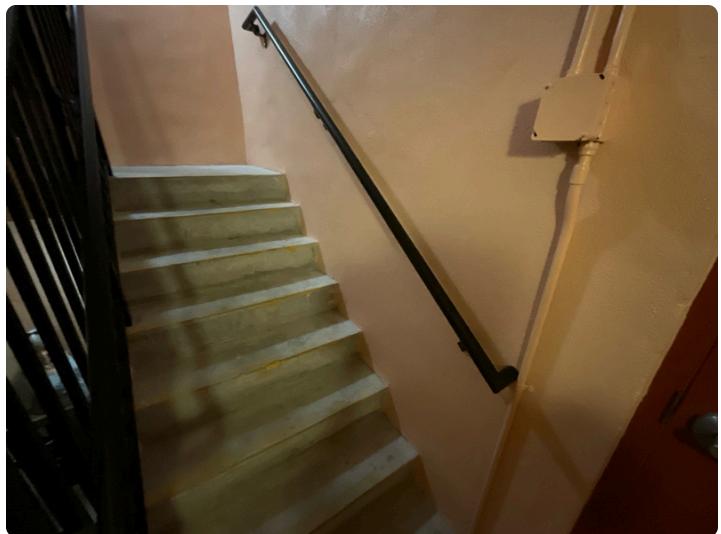
Stairs in good condition.

Typical concrete stair section

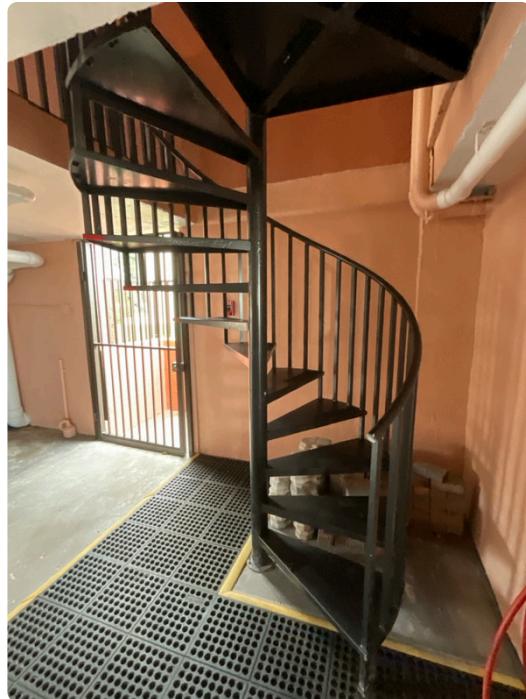
Metal spiral staircase

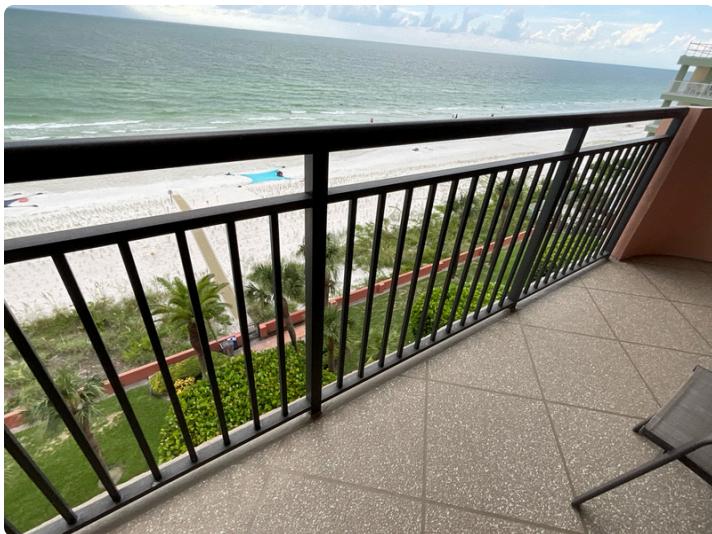
Typical balcony railings

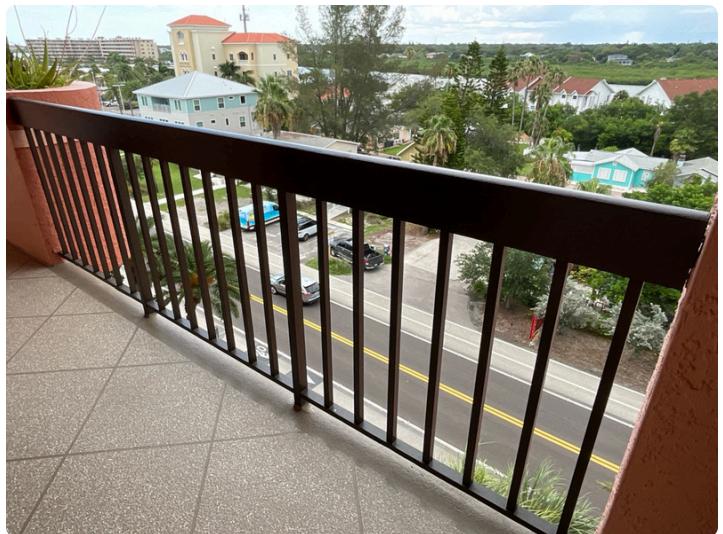
Typical walkway railings

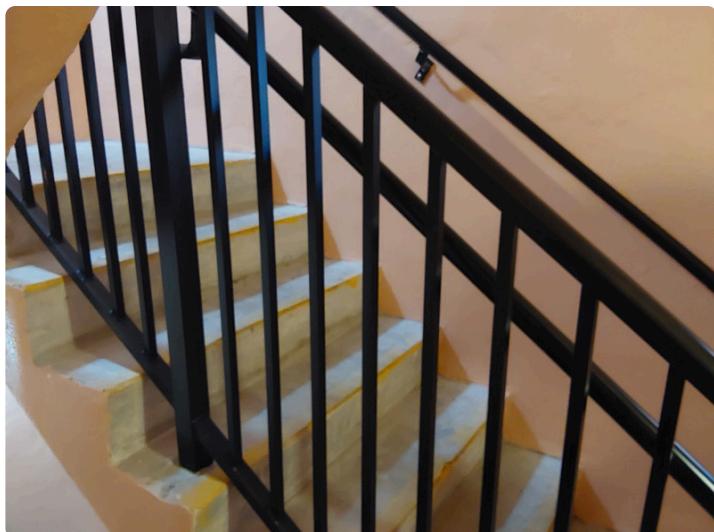
Typical stair railings

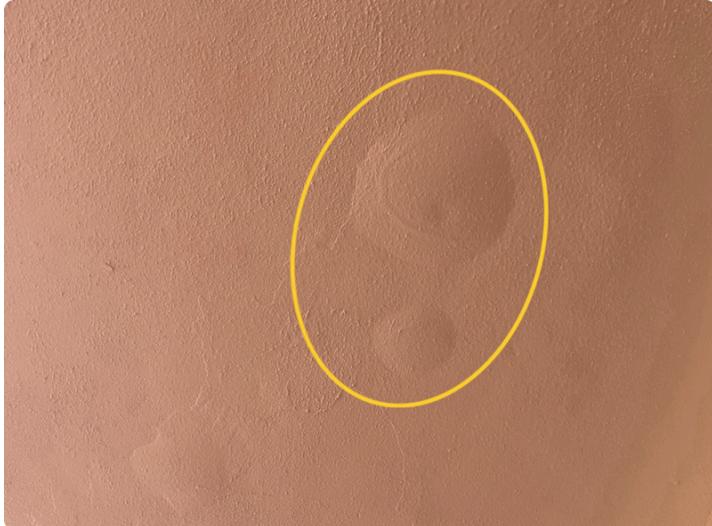
Maintenance	Paint bubbling identified on multiple balcony soffits. No water was detected in the paint bubbles. Building was painted recently and association indicated that the contractor is coming back to repaint areas with bubbles.
Condition	Waterproofing in average condition.

Paint bubbling on Unit 501 balcony. No water in bubble.

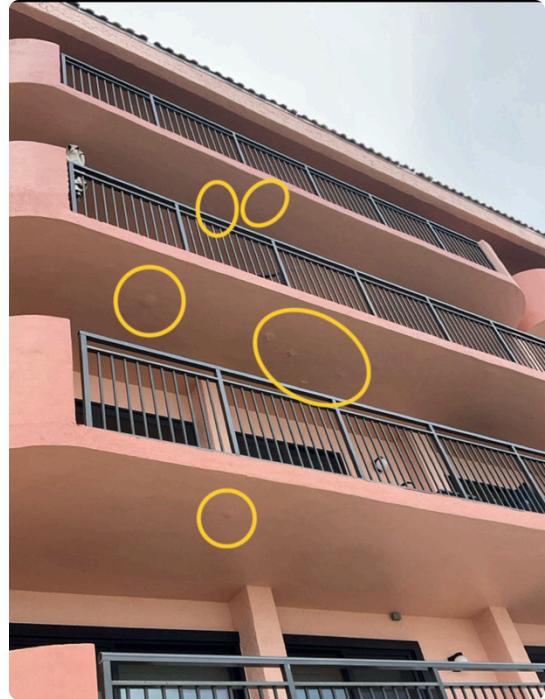
Paint bubbling on Units 403,503, and 603 balcony soffits

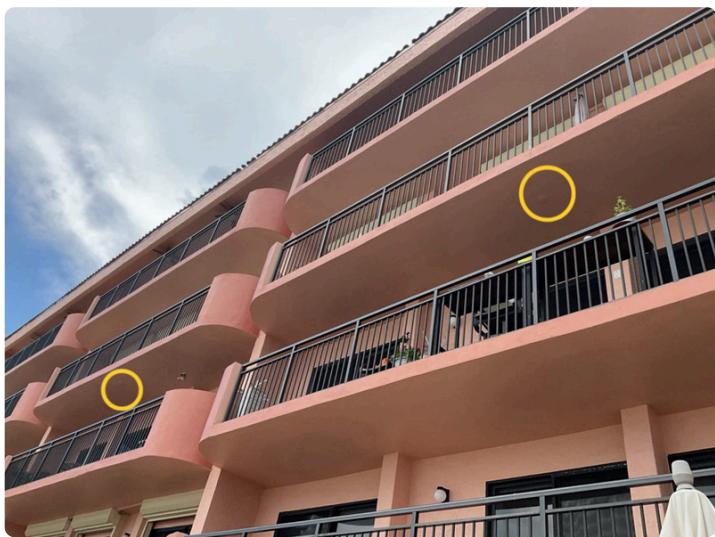
Paint bubbling on Units 504 and 505 balcony soffits

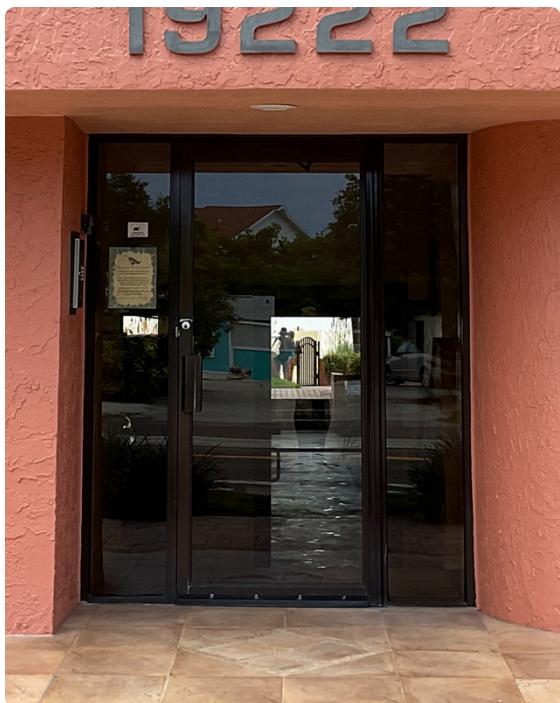
Front entry door

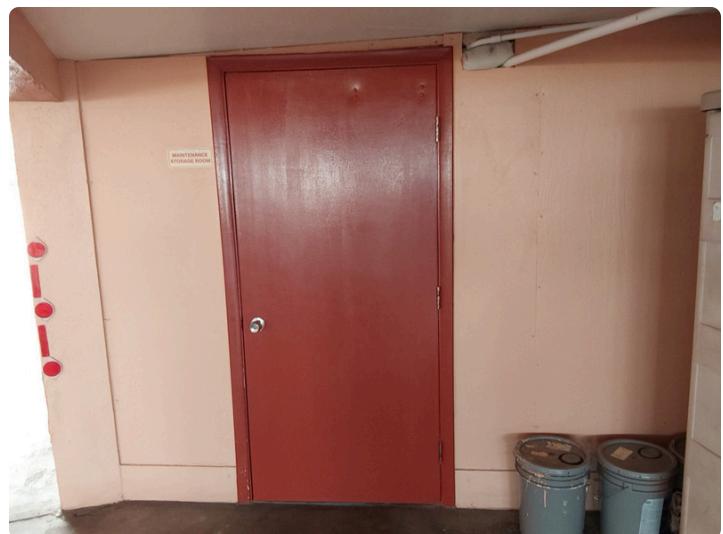
Typical single fire door

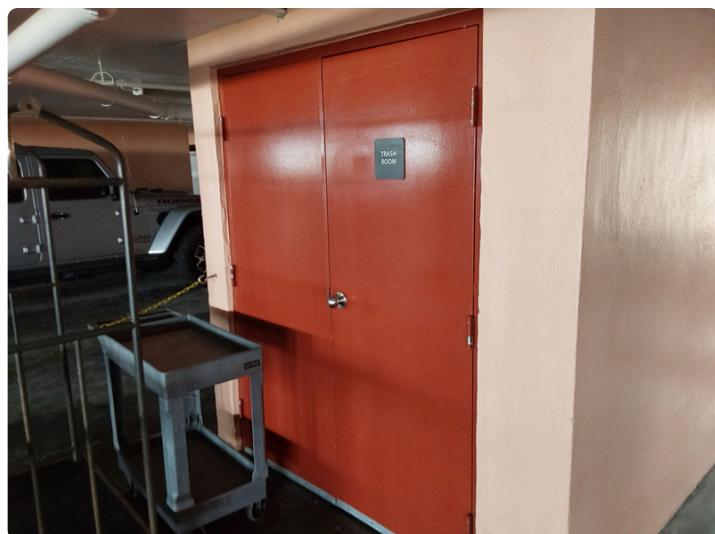
Typical double fire door

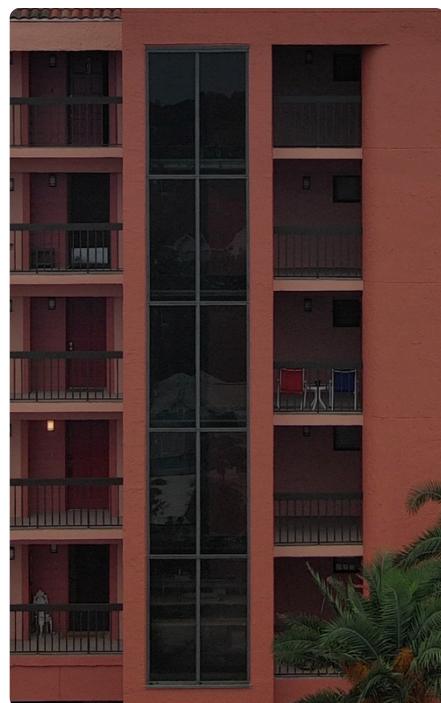
Elevator window

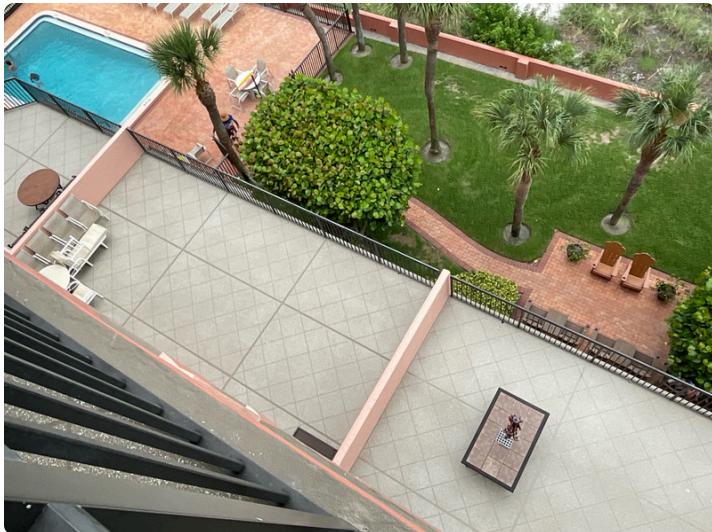
Typical third floor balcony

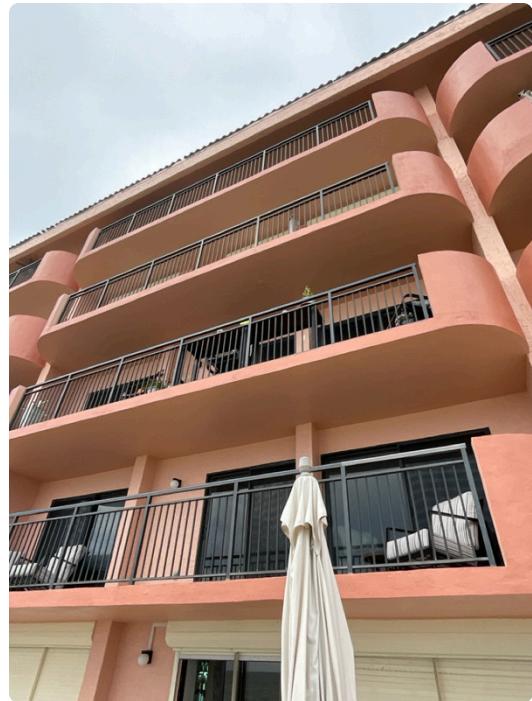
Typical balcony stacks

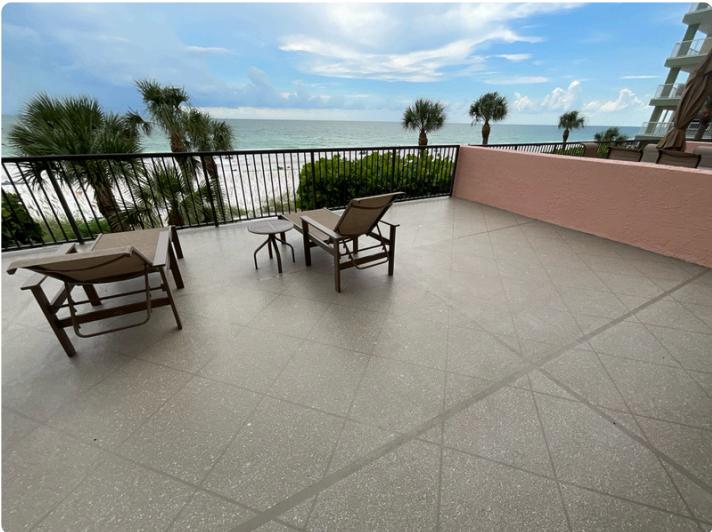
Overview of third floor balcony

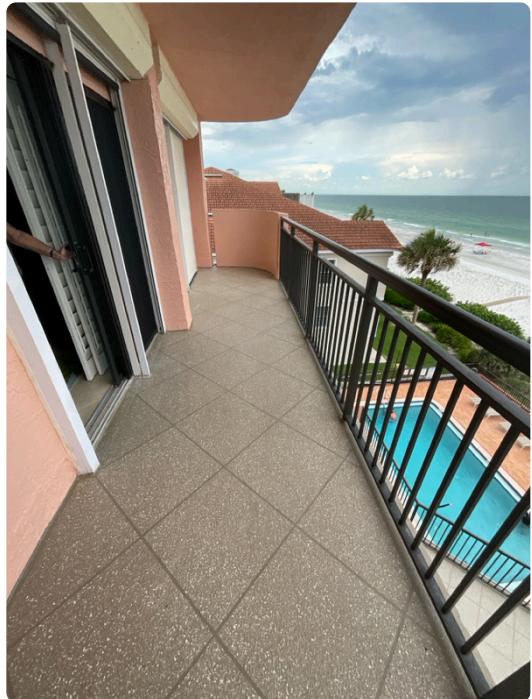
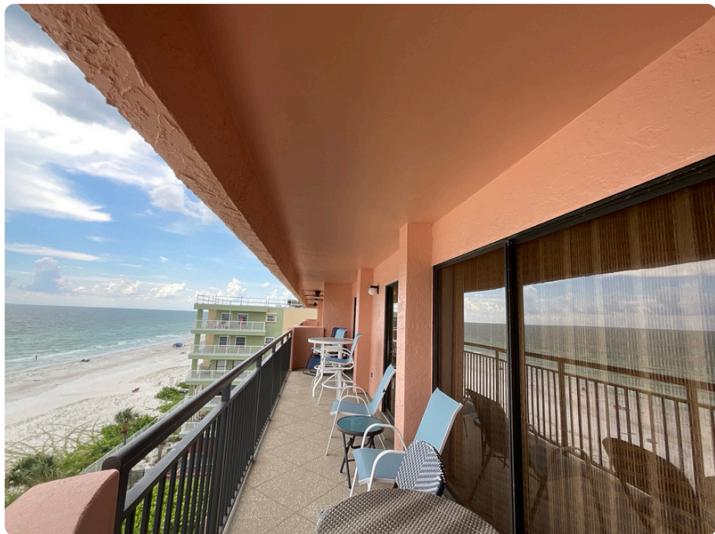
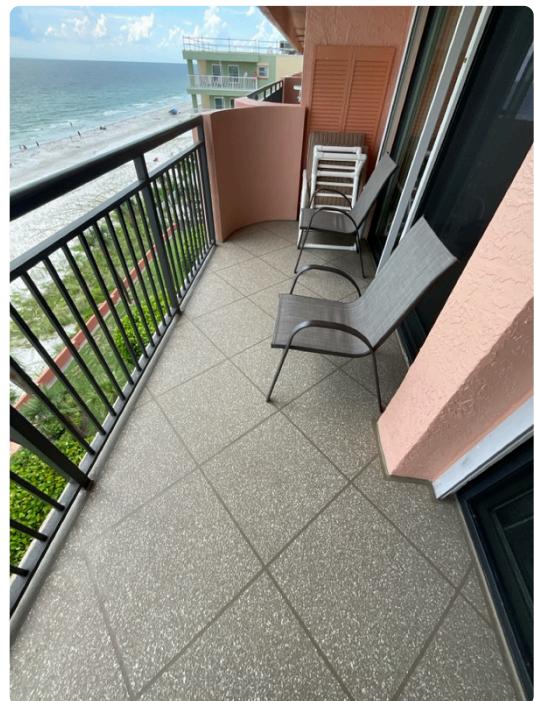
Typical balcony

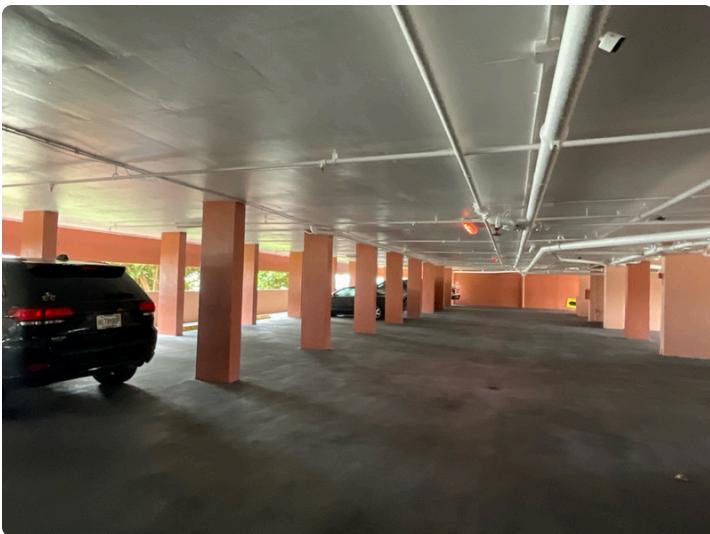
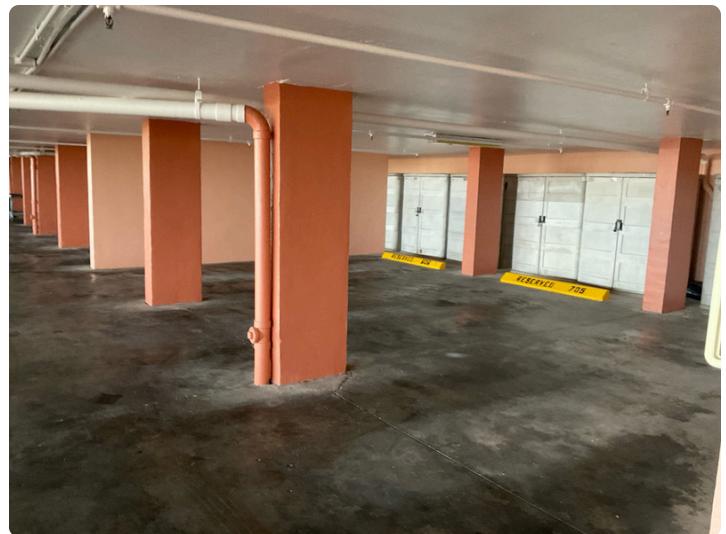
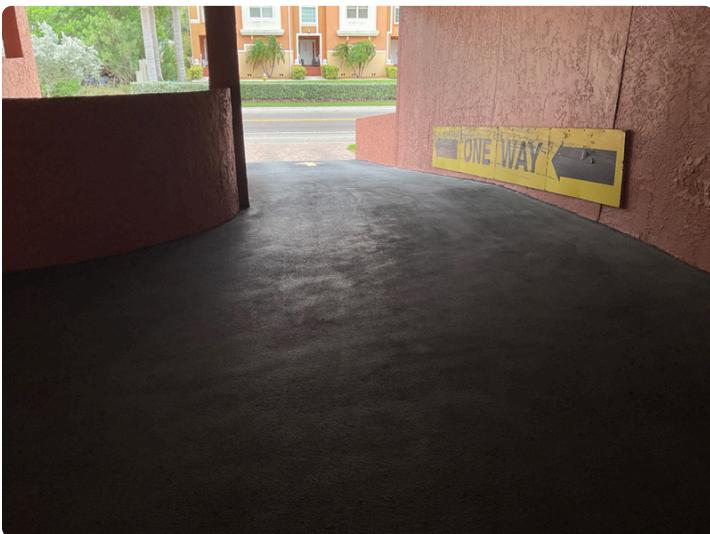
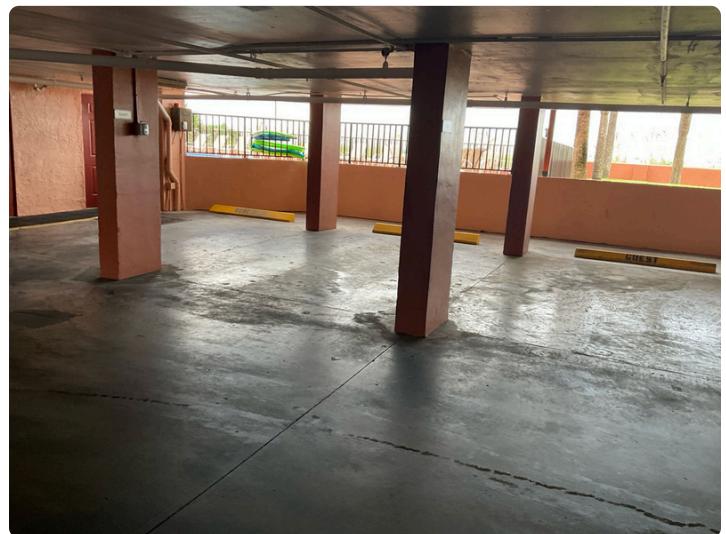
Parking garage in good condition.

Parking garage overview

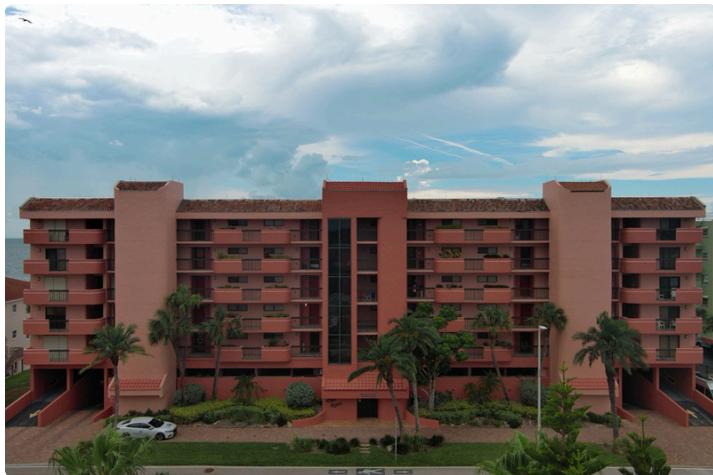
Front elevation

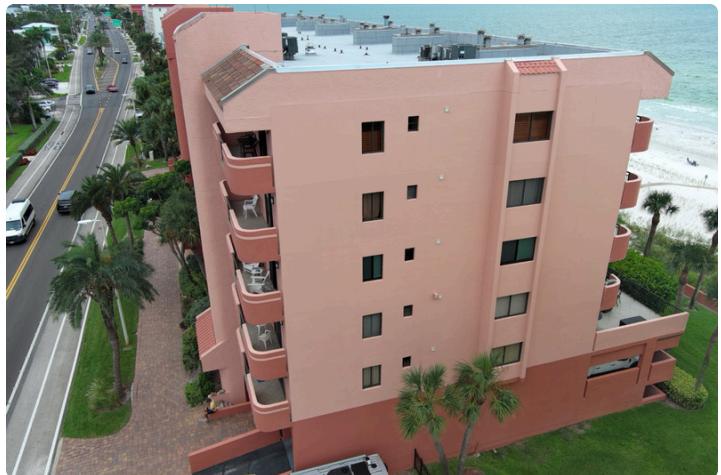
Right elevation

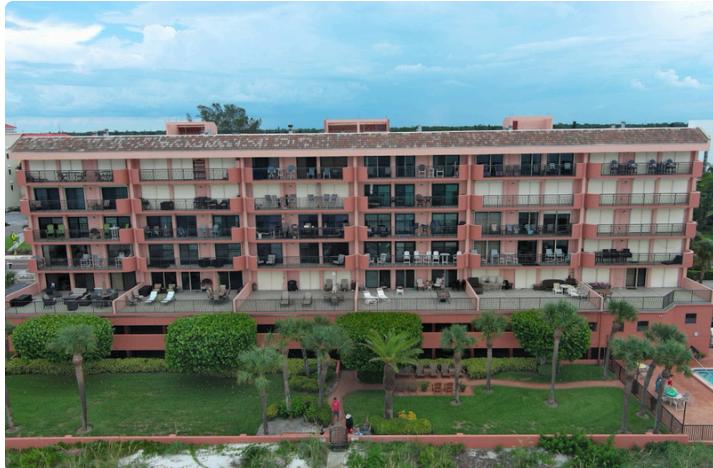
Rear elevation

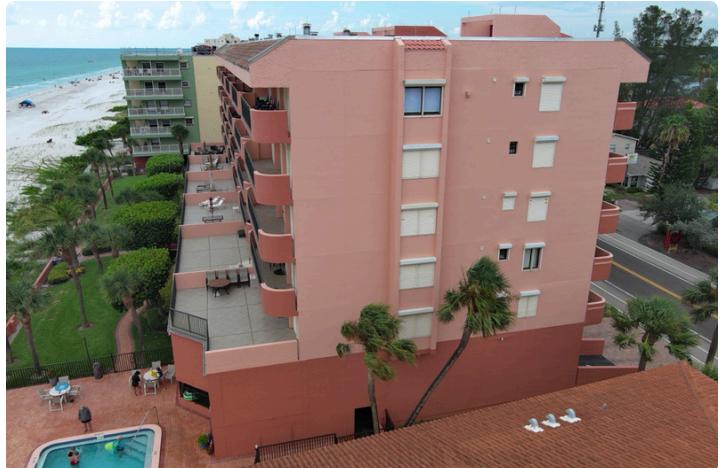
Left elevation
