August 30, 2024

**RE: Seagate Condominium – Milestone Inspection Phase 1  
19418 Gulf Boulevard, Indian Shores, FL  
KEG File# 22RT-1380**

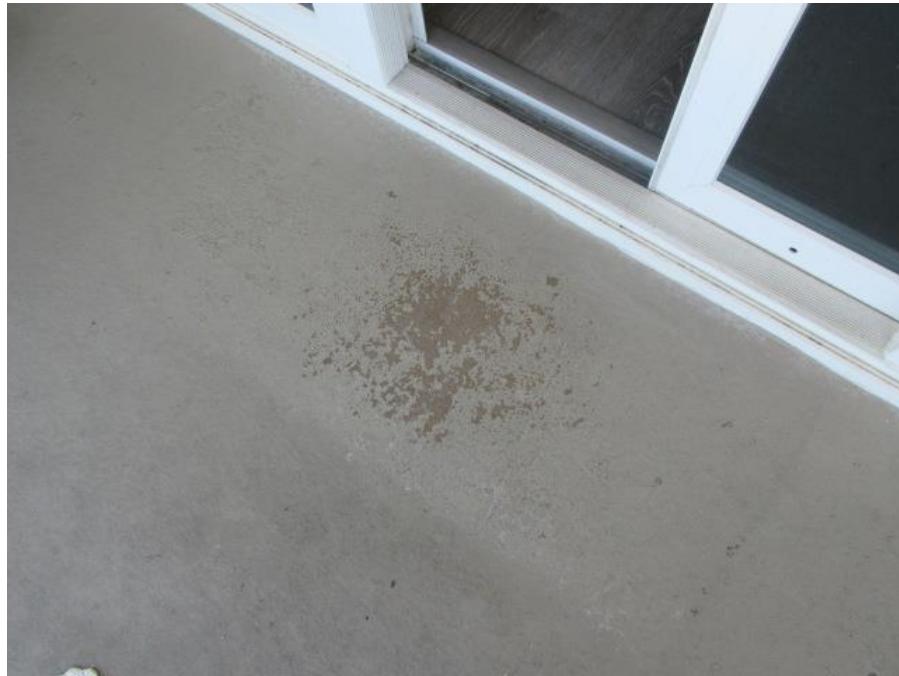
Failed Acrylic Coating over Brown Floor Paint on Balconies (TYP).

1. Existing waterproofing membranes on balconies and common walkways appear to be approaching the end of useful life and have failed at numerous locations. It is recommended that all reinforced horizontal concrete in proximity to the Gulf of Mexico be protected with a waterproof membrane system due to the corrosive environment typical in coastal areas.

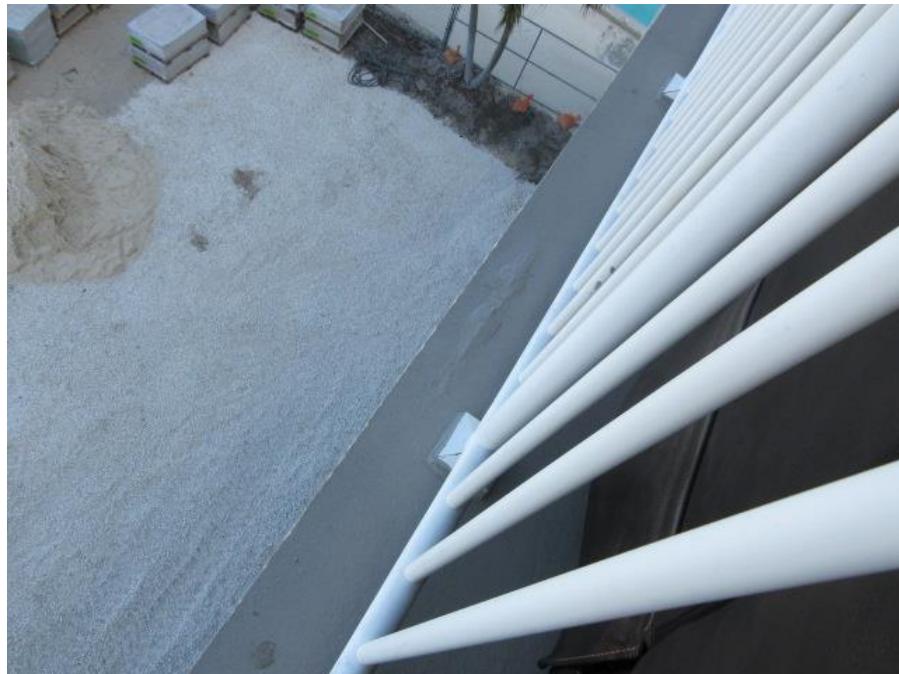
Small Concrete Spalls at Slab Edge on Walkways (TYP).

1. Spalling concrete and failed previous concrete repairs were observed at isolated areas throughout the building. It is recommended that all damaged concrete be repaired in accordance with ICRI and ACI specification.
2. PVC Guardrails located at balconies, walkways and stairway landings are not in fair serviceable condition due to heavy corrosion attacking the base plates, associated fasteners and steel pickets and posts installed under the PCV coverings. Furthermore, the stairway guardrails do not meet Florida Building Code height requirements, picket spacing requirements and do not have required grabrails. (42" Height, 4" Picket Spacing). KE recommends that all existing PVC Guardrails on the property be replaced as quickly as possible and also recommends that the aluminum guardrails installed within the open-air stair towers be replaced with new code compliant guardrails.

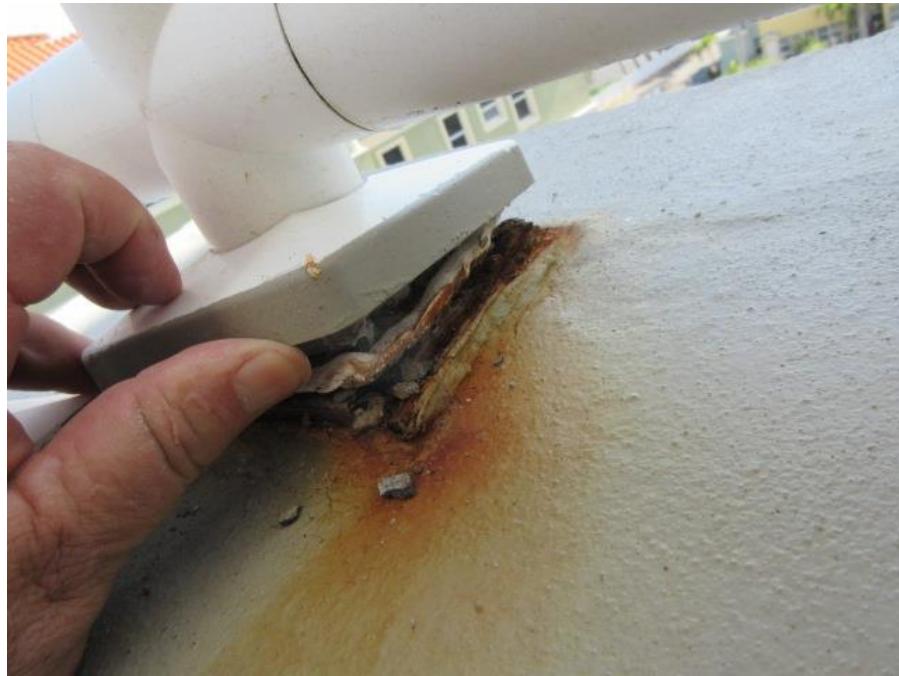
Typical Heavily Rusted Base Plate at Balcony Guardrail

Upon inspection of the above listed elevated balconies, KEG observed that several balcony steel guardrail base plates and associated deck fasteners were heavily corroded. KEG recommended to the Association that all balconies be inspected so that any heavily rusted/corroded guardrail system components could be identified. It took some time to schedule access to every balcony on the building. KEG inspected the remaining twenty-six residential units and associated elevated balconies between January 17-24, 2024. KEG documented all locations where heavy rusting of guardrail base plates and fasteners was observed on residential balconies as well as at all elevated common walkways. All guardrail system posts where heavy corrosion was observed or where heavy corrosion was presumed to be present due to rust stains observed to be discharging from below the PVC over steel base plate covers were subsequently reinforced by the installation of a 5,000-psi post shore and clamping system designed by KEG and installed by a Florida Licensed General Contractor. It should be noted that none of the base plates observed were found to be completely detached from the concrete deck below. The installation of the post shores at each identified location was meant to be provided as a preventive measure in case the corrosion advances at any observed location causing any post to become detached from the concrete decks prior to the installation of a new code compliant guardrail system.

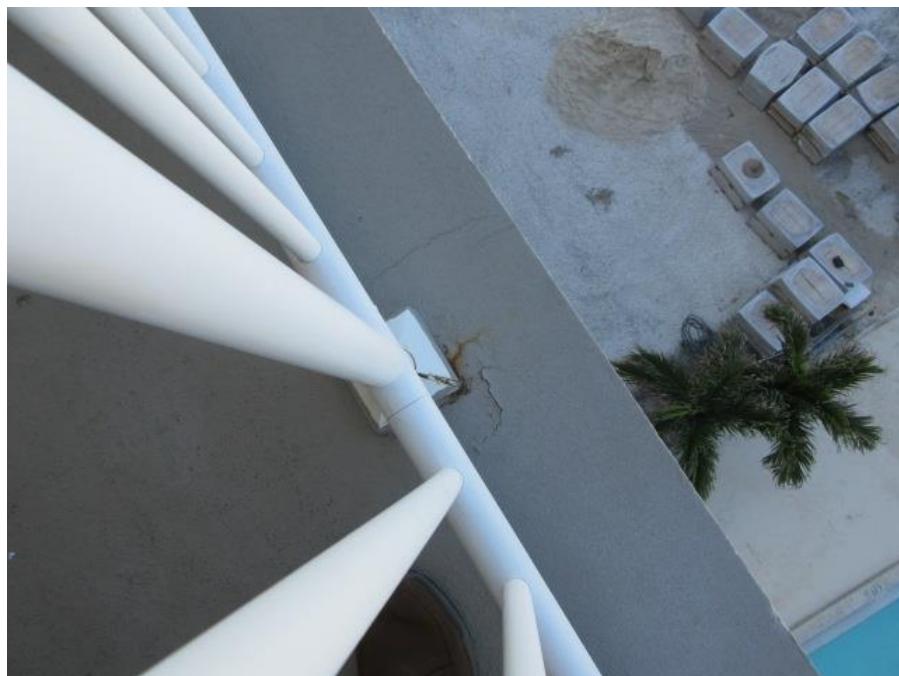
Typical Rusted Railing Post, Spalling Concrete and Cracks at Slab Edge.

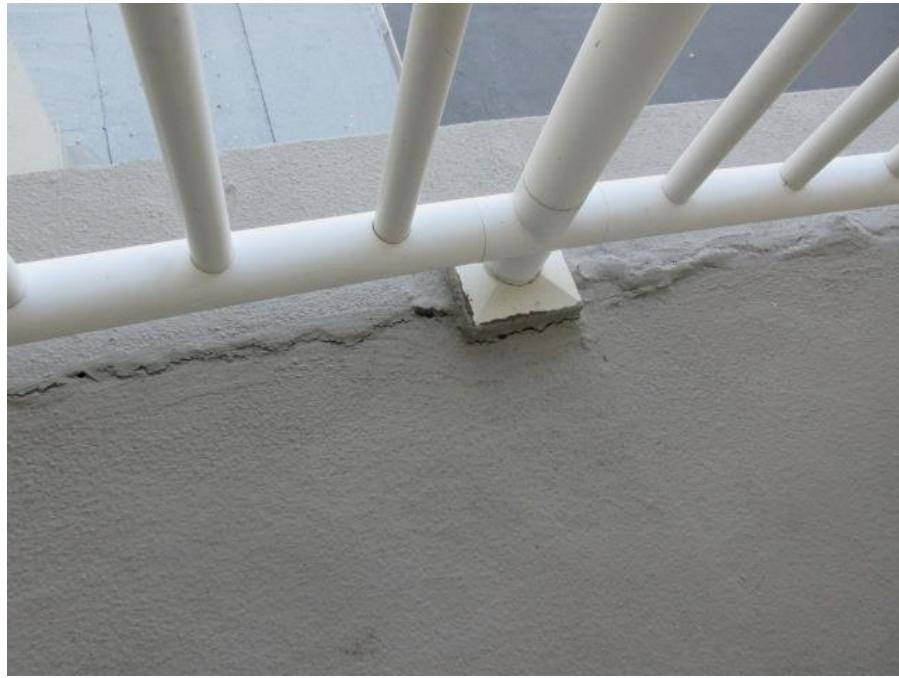
Failed Bond Line at Previous Slab Edge Repair on 4<sup>th</sup> Floor Walkway.

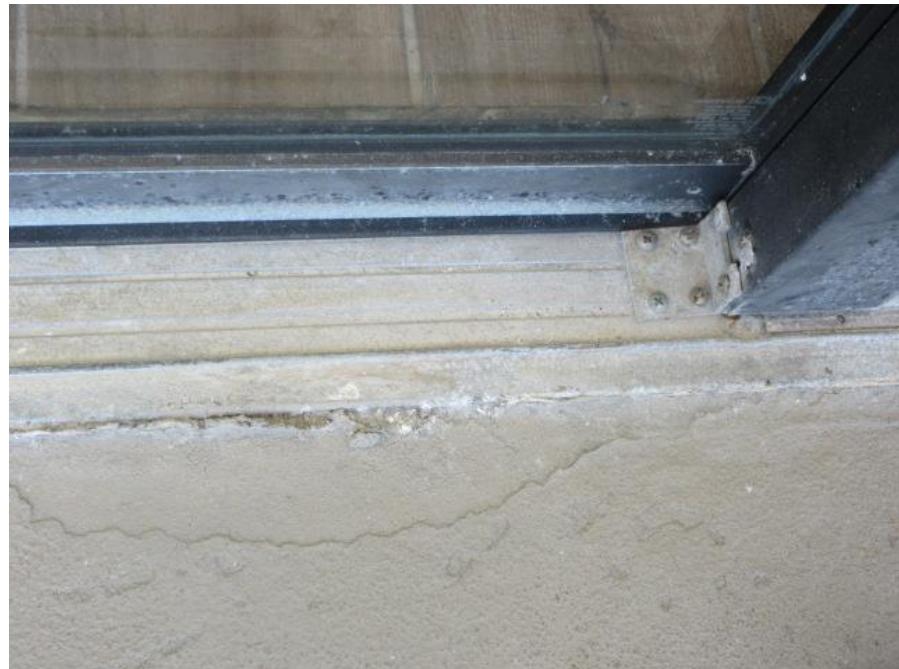
Sliding Glass Door Installed Lower Than Balcony Deck in Unit #406 with Missing/Failed Track Perimeter Sealant and Peeled Floor Coating

2. The condition of perimeter sealants at existing windows and doors should be inspected. Sealant should be applied to all window, door and sliding glass door frames as well as at all sliding glass door tracks and entry door thresholds to prevent water intrusion into the units.

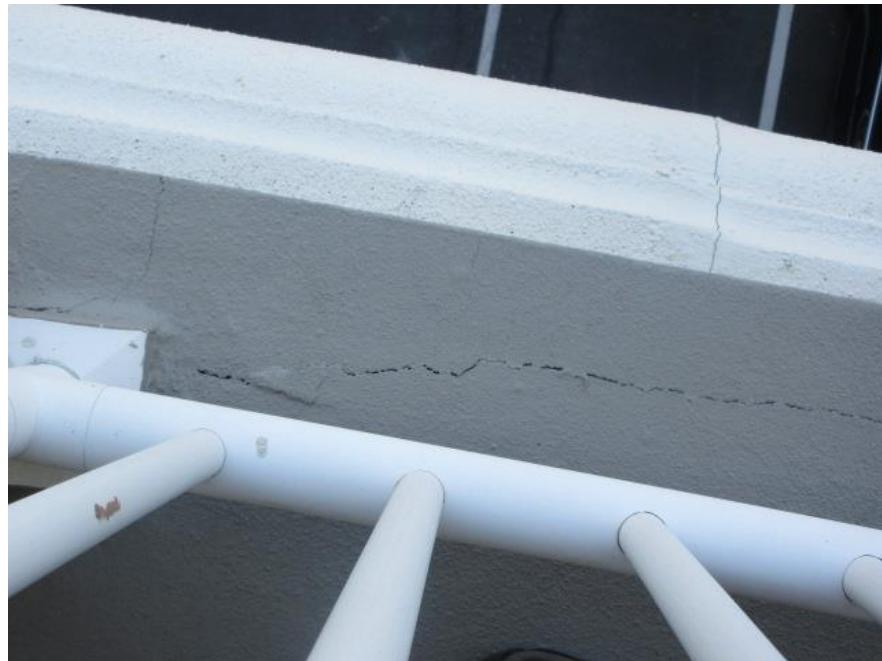
Typical Concrete Cracks Along Slab Edge on Walkways.

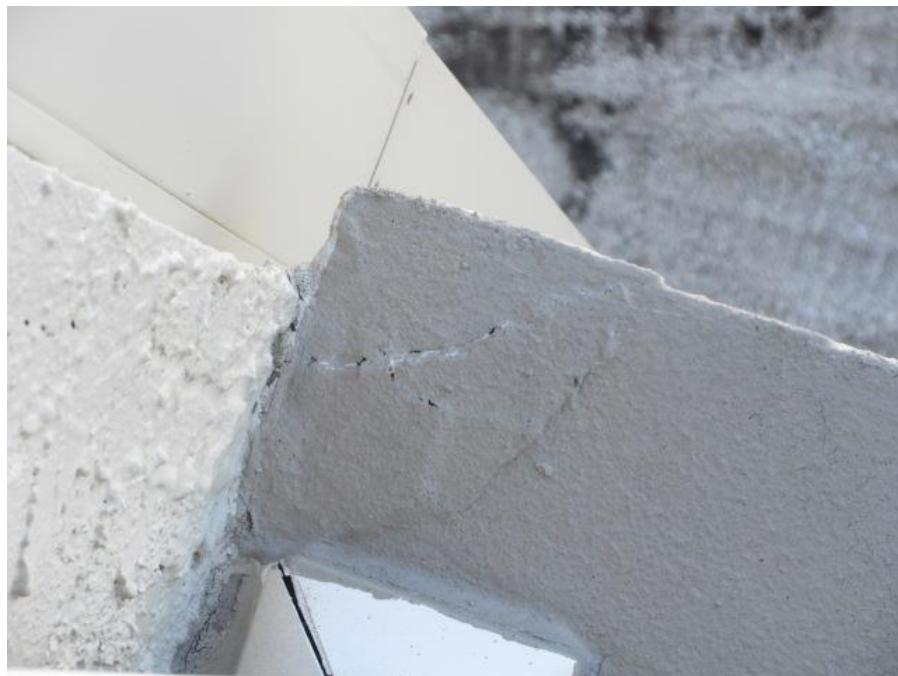
Concrete Spalls at Corner of Railing Post on 4<sup>th</sup> Floor Walkway.

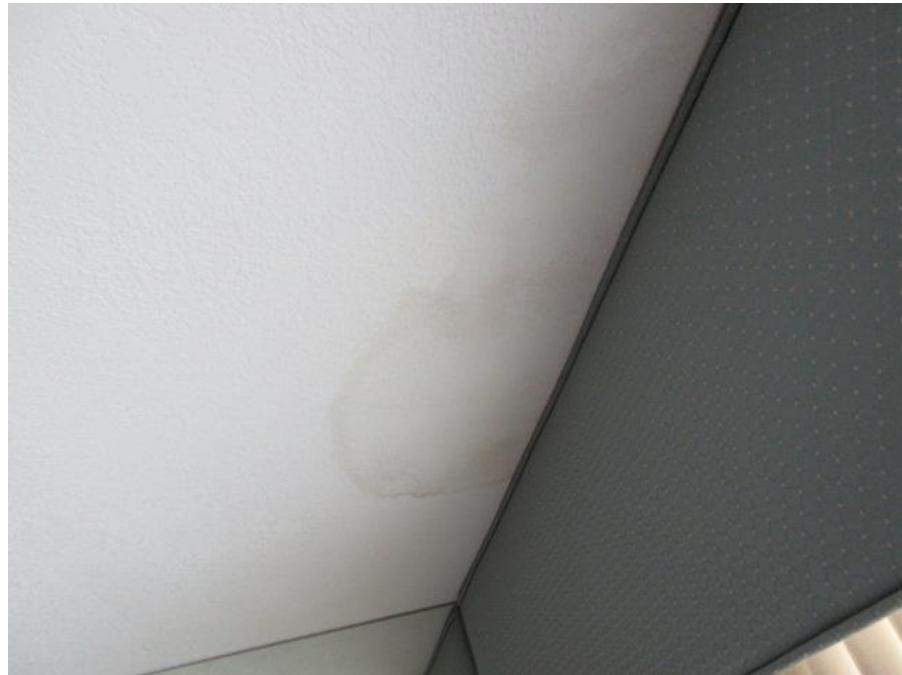
Water Stain on Ceiling at SGD South End in Unit #403.

4. Some residential units have reported water intrusion and/or water staining above their sliding glass doors. This is typically attributed to unsealed sliding glass door (SGD) fasteners or unsealed SGD end dams leaking from the unit above. All unit owners that report water staining or water intrusion at these areas should have the unit above's SGD components inspected and resealed as needed. This is typically a unit owner's responsibility and does not necessarily pertain to the requirements of the Association however, if left unattended could cause structural damage to the building which is an Association concern.

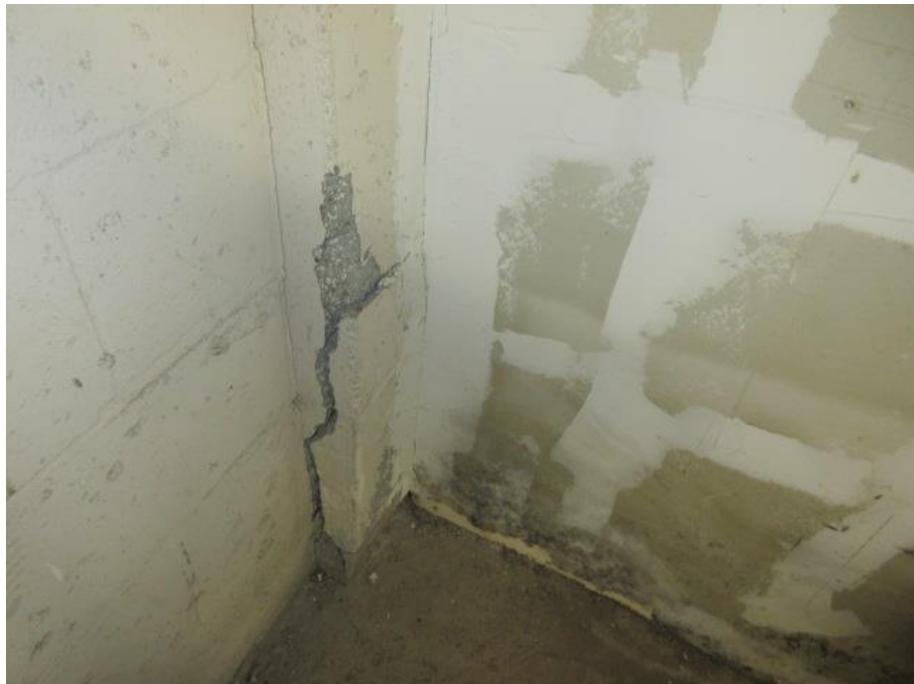
Concrete Spalls at the Top and Bottom of Corner Columns in Electrical Room.

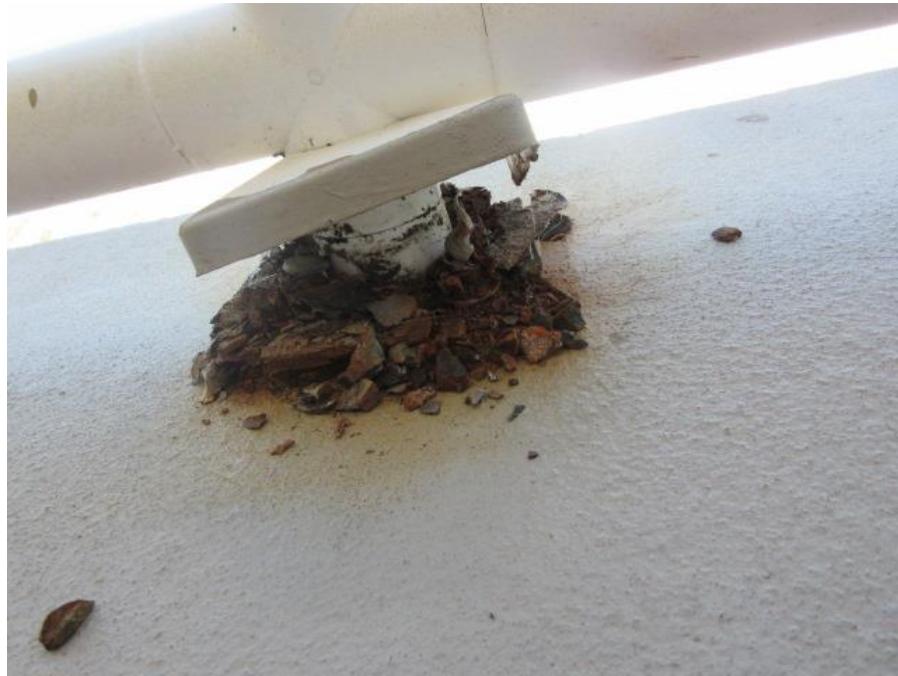
Desintegrated Base Plate due to Rust at Unit #201.

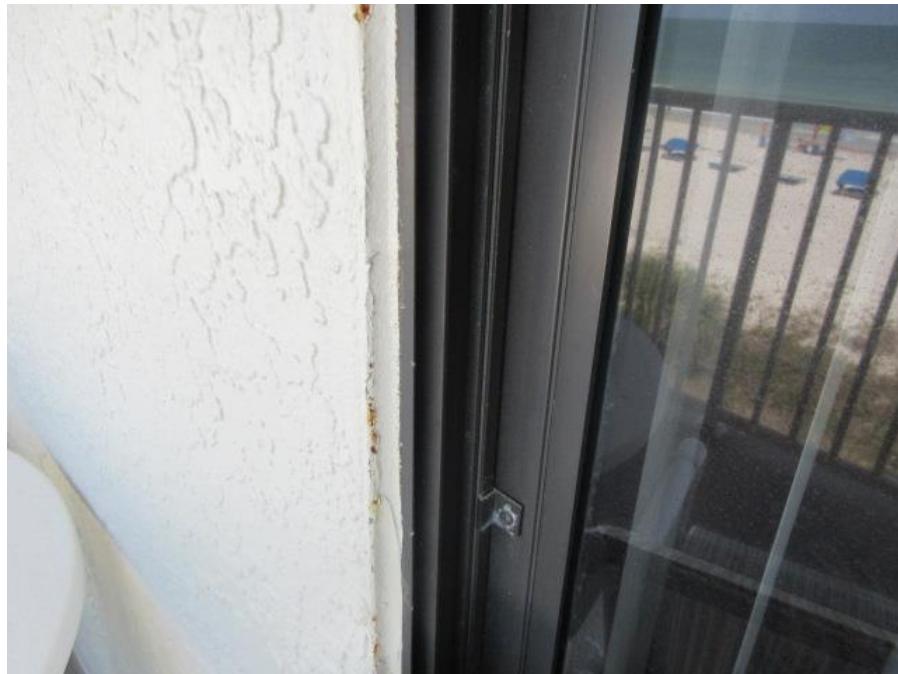
Rusted Corner Bead Stucco at SGD at Unit #201.

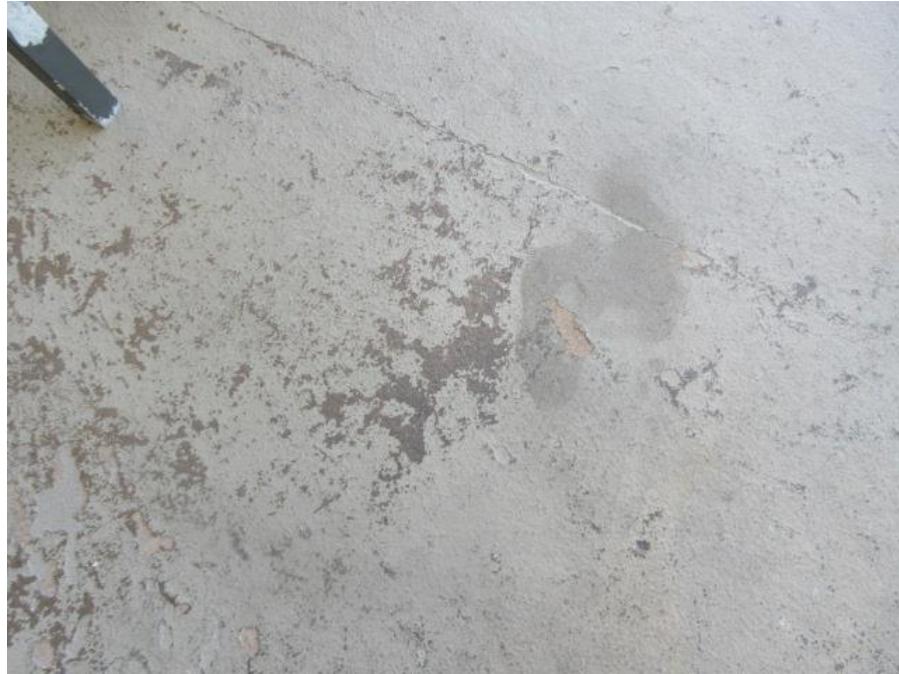
Example of Peeling Floor Paint on Walkways.

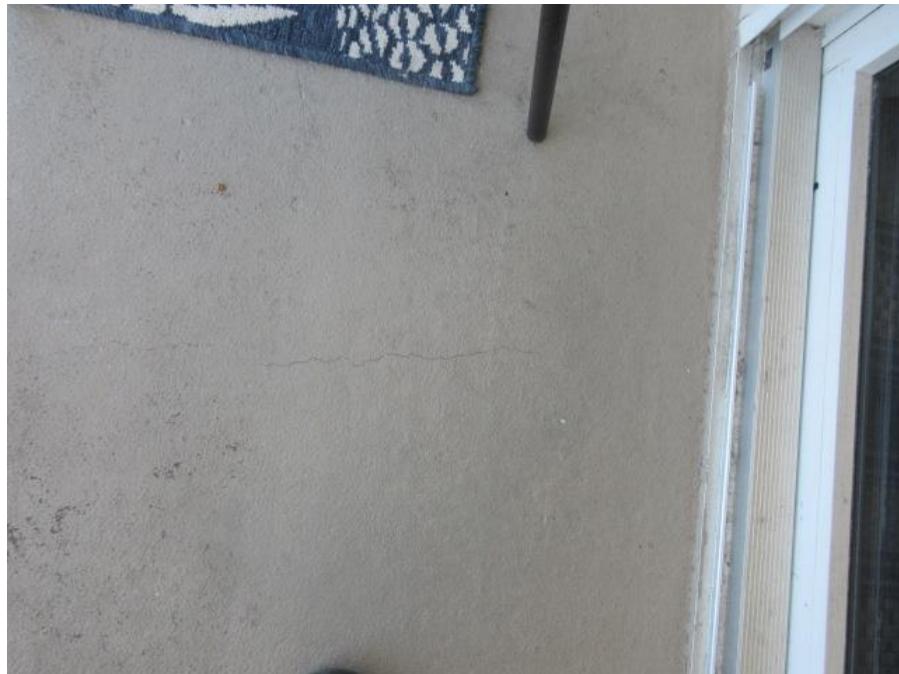
Typical Deck Crack in Front of SGD's Balconies.

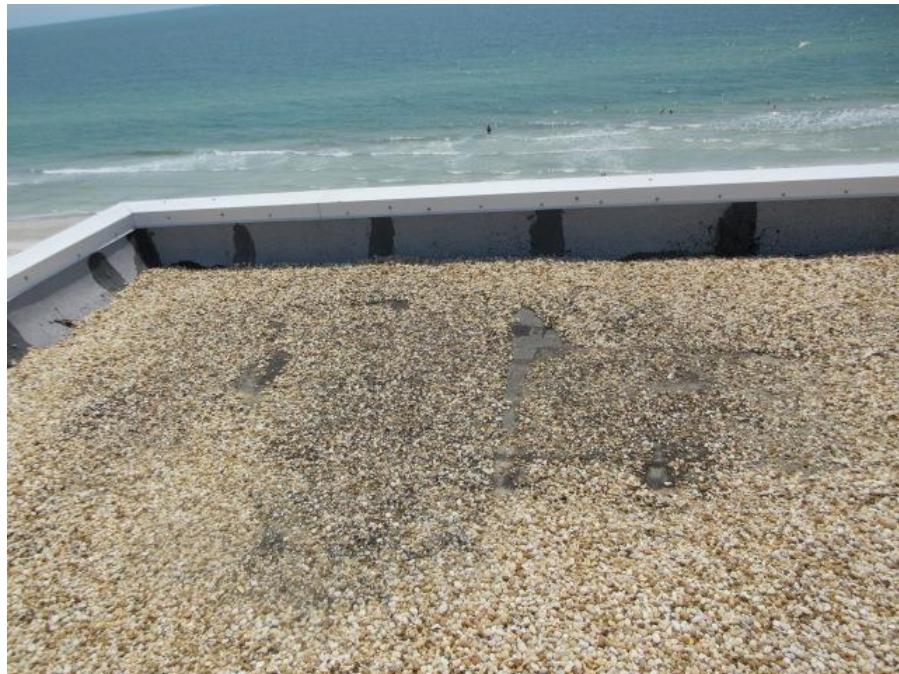
Sign of Water Ponding on Roof Materials.

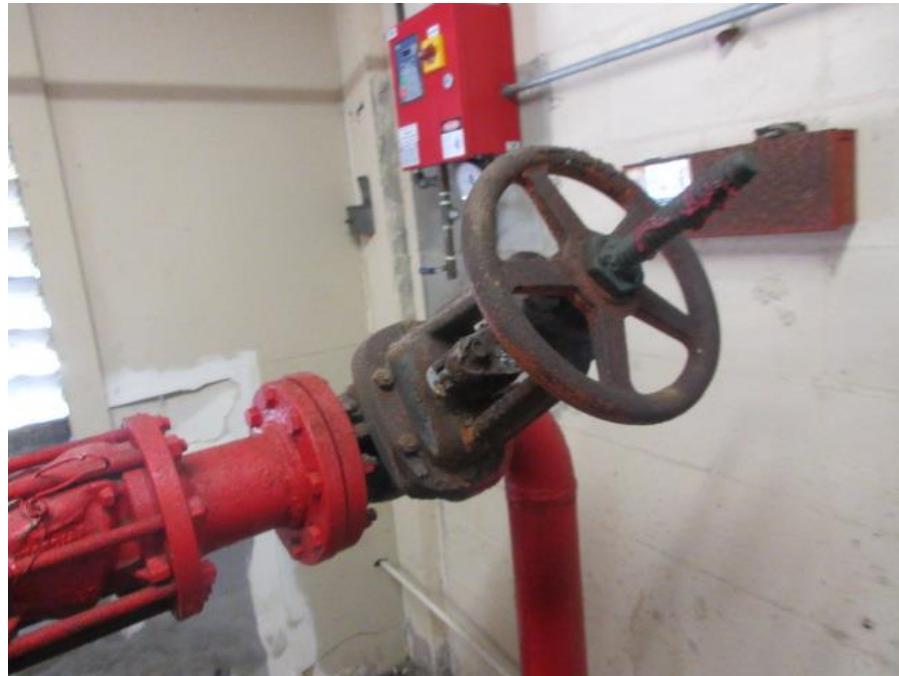
Water Valves with Surface Rust at Fire Pump Room.

4. All mechanical, electrical and plumbing (MEP) equipment should be inspected by an MEP Engineer and all rusted or deteriorated MEP components should be replaced in mechanical rooms and at exposed exterior locations.

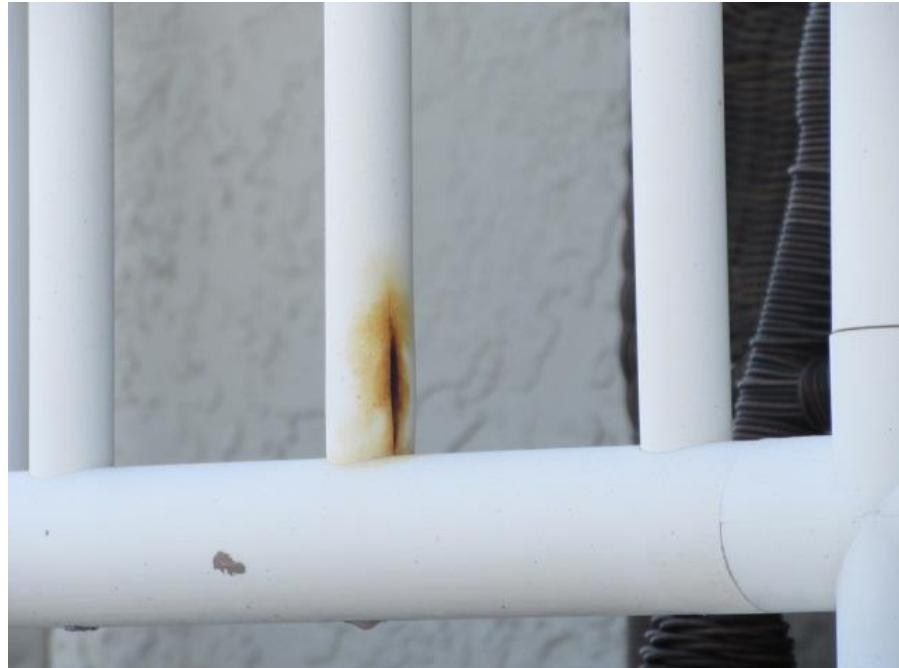
Typical Splitting of PVC Railing Due to Rusted Steel Posts within

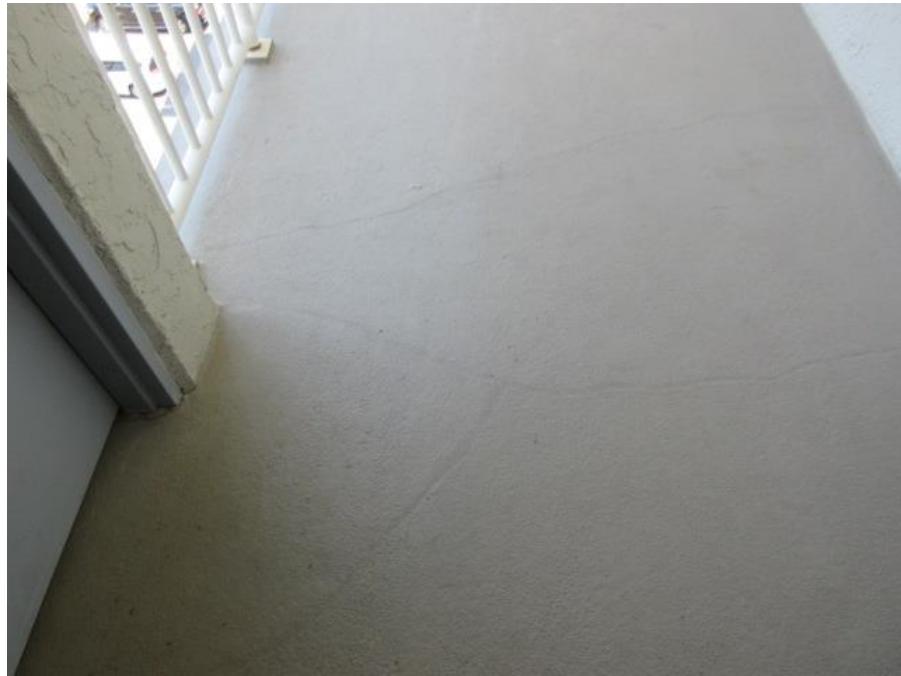
Failed Previous Deck Crack Repairs on Common Walkways (TYP).

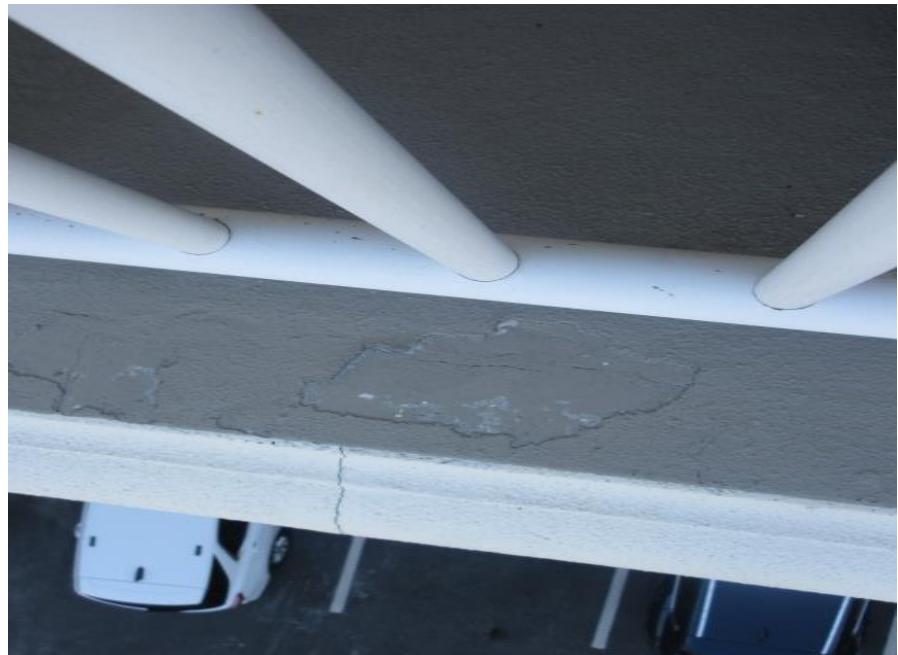
Concrete Delamination and Crack at Slab Edge on Common Walkways(TYP).

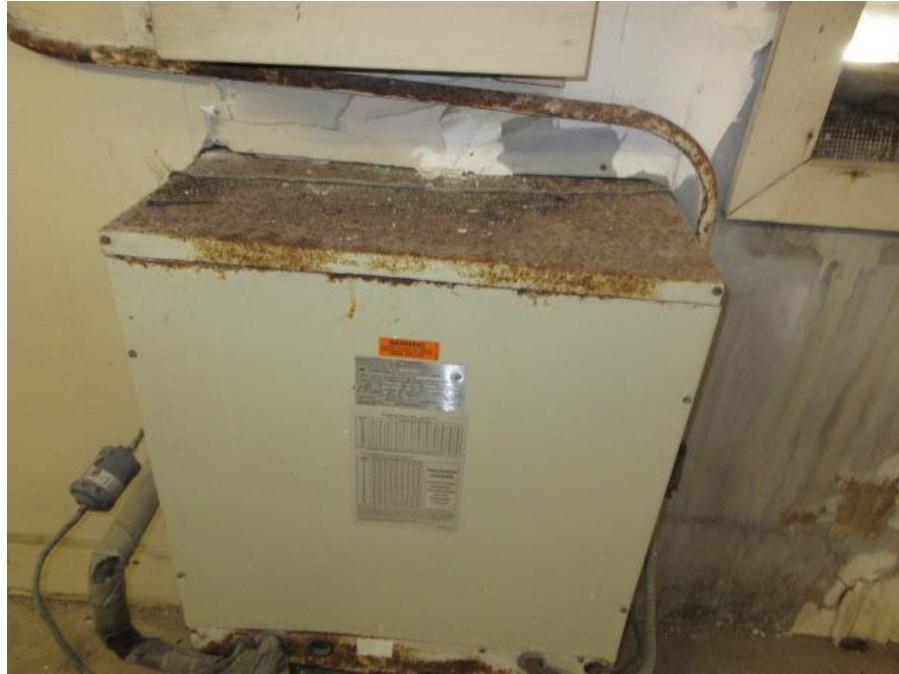
Heavily Rusted Electrical Components (TYP).

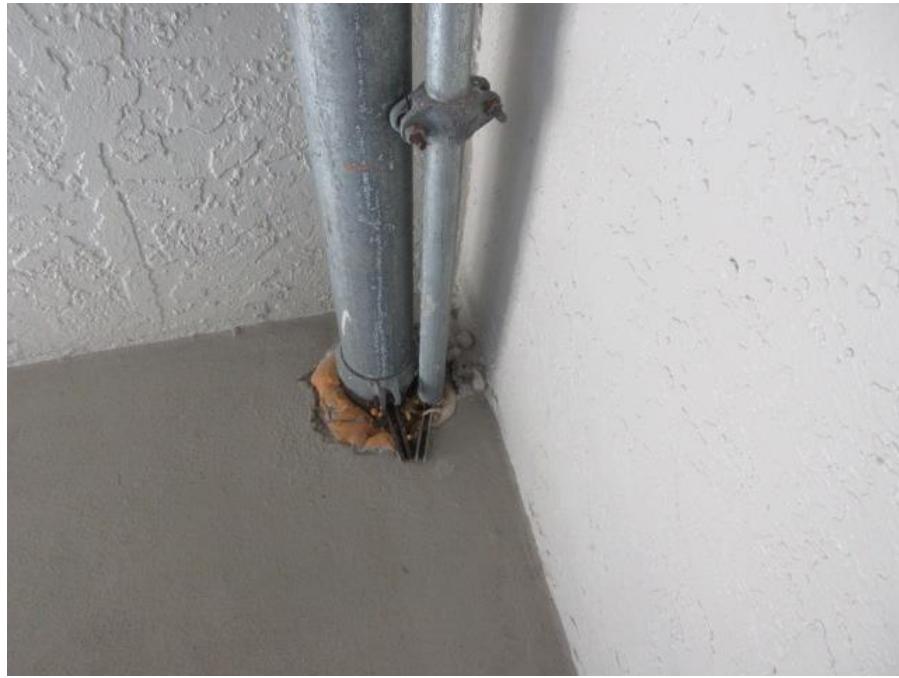
Stand Pipes Holes Filled with Spray Foam on Emergency Stairwells (TYP).

3. Inspect and seal, as necessary, all through wall penetrations within the exterior building envelope. This includes light fixtures, electrical outlets, conduit and plumbing pipes, railing attachments, etc.
