RE: Chateaux, A Condominium, Inc. – Milestone Phase 1 Inspection Report Summary
19440 Gulf Boulevard,
Indian Shores, Florida 37785
KEG File# 21RT-0715

EXECUTIVE SUMMARY:

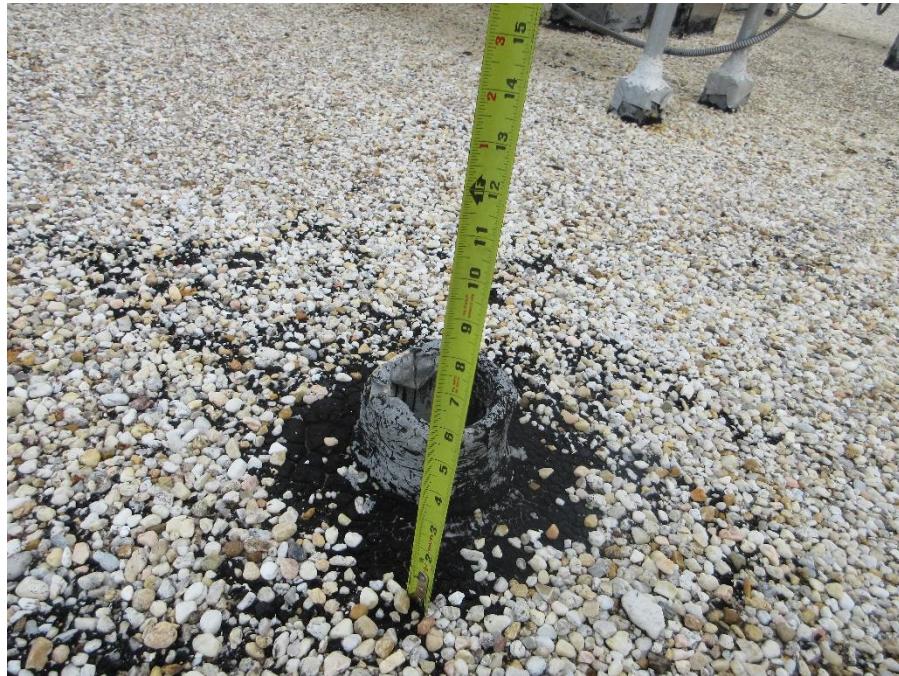
Photo #7 – Roof Vent Pipe Is Shorter than Allowed per FBC.

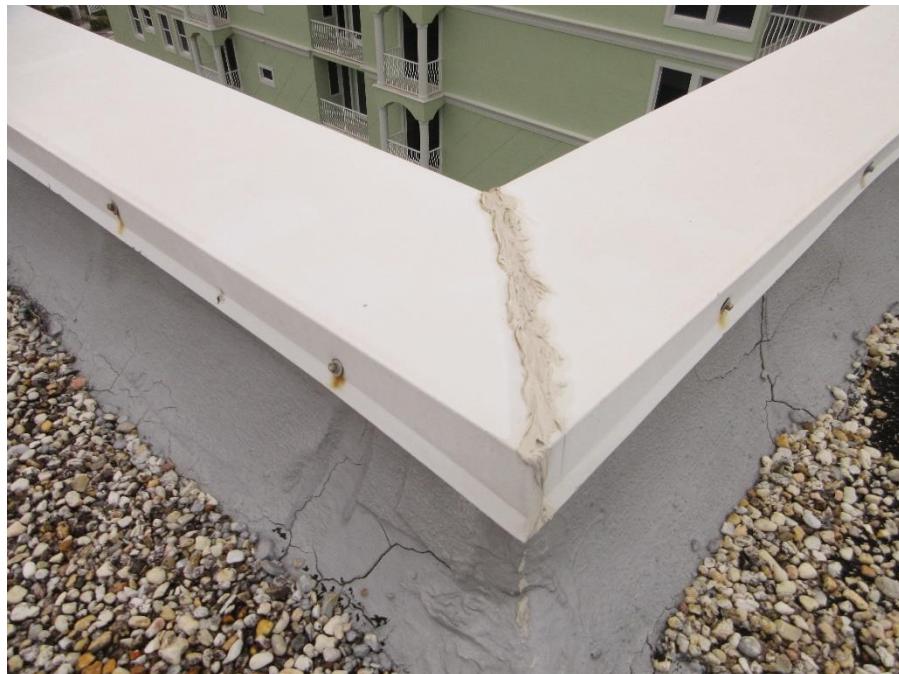
Photo #8 – Rusted Fasteners and failing sealant at Coping Caps (TYP.)

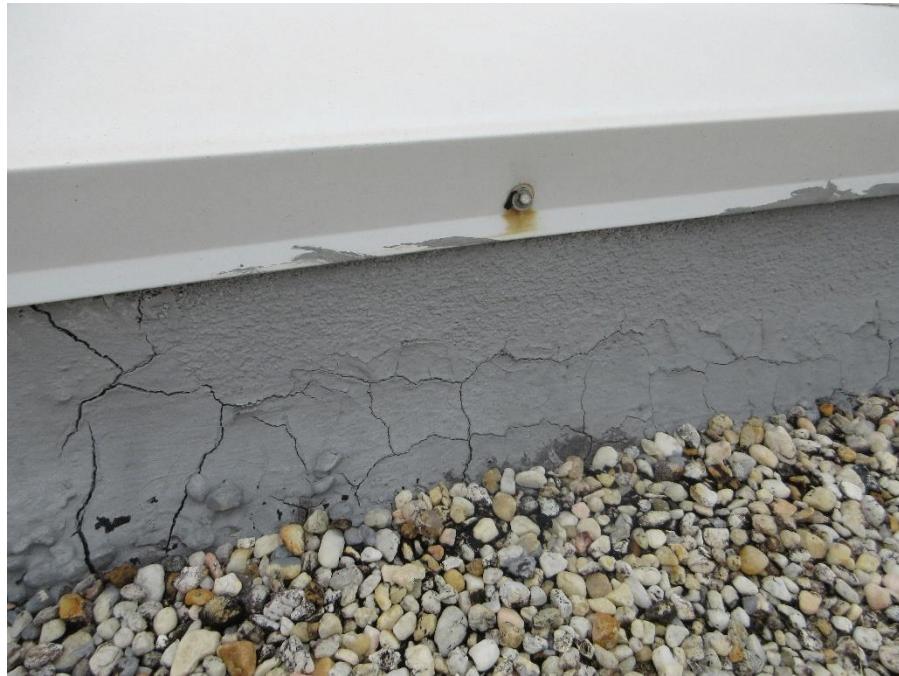
Photo #9 – Loose Fasteners and Scarred Flashing Membrane at Roof Perimeter (TYP.).

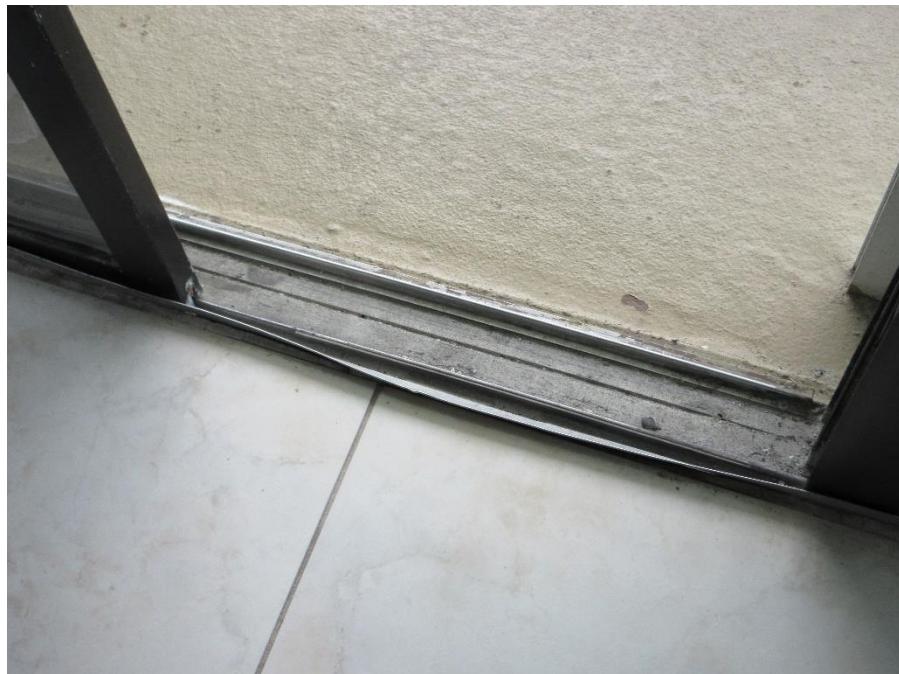
Photo #10 – Damaged and Low Door Threshold (TYP.).

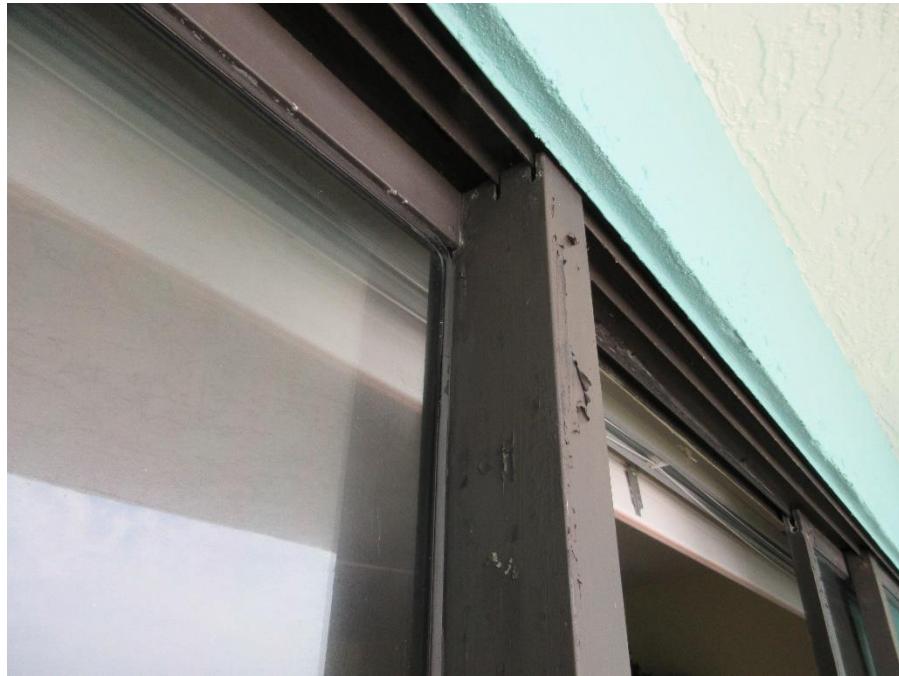
Photo #11 – Peeling Paint at Older Sliding Glass Door (TYP.)

1. Select sliding glass doors at balconies and the exterior windows at individual units have recently been updated to adhere to the code during recent repairs. However, most of the windows and doors installed at Chateaux are typically outdated and currently show heavy signs of rust, scratches, and peeling paint. Due to the building age of approximately 42 years old, it is recommended that all original windows and doors in the building be considered for replacement.

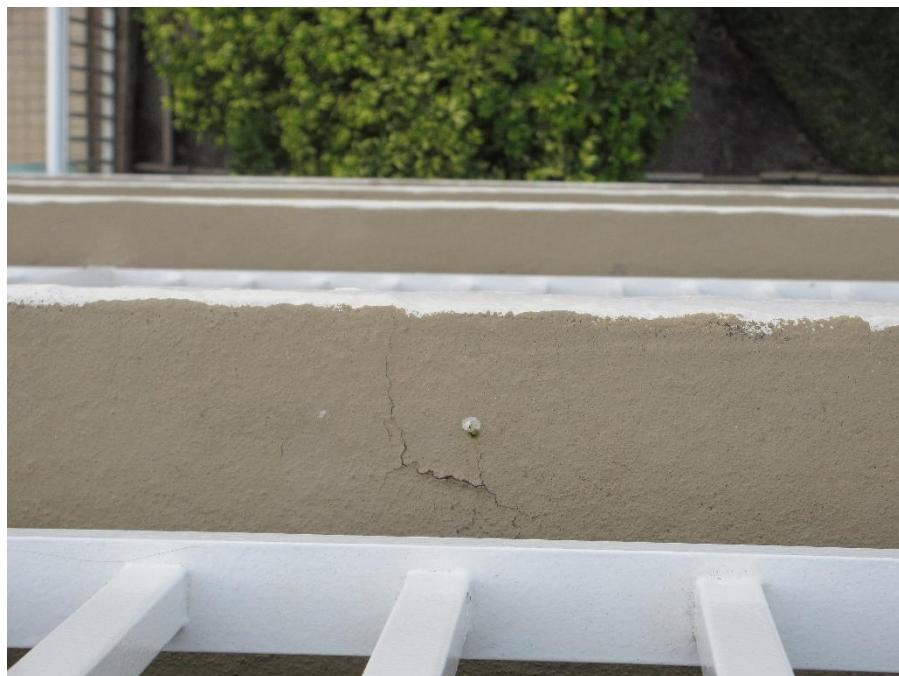
Photo #12 – Hairline Crack Perpendicular to Slab Edges (TYP.)

1. Minor concrete spalling and cracking was noted at the private unit balconies, windowsills, and common walkways. KE recommends that these areas be addressed during the next restoration project. The Board may want to consider repairing these areas at the same time as the Contractor is performing repairs in the parking garage area.

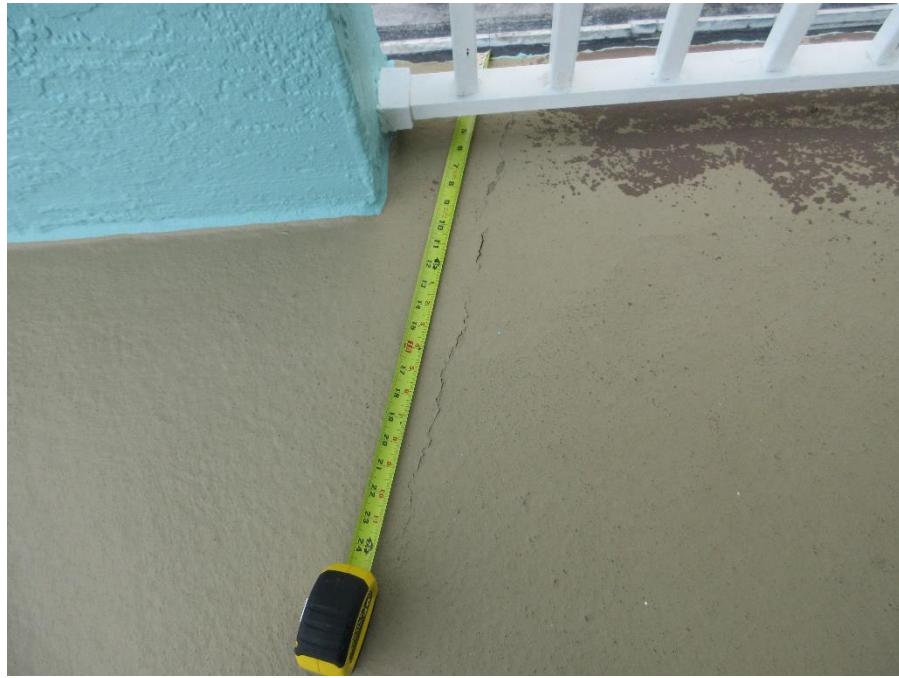
Photo #13 – 45-Degree Crack at NW Edges of Balcony Slabs (TYP.)

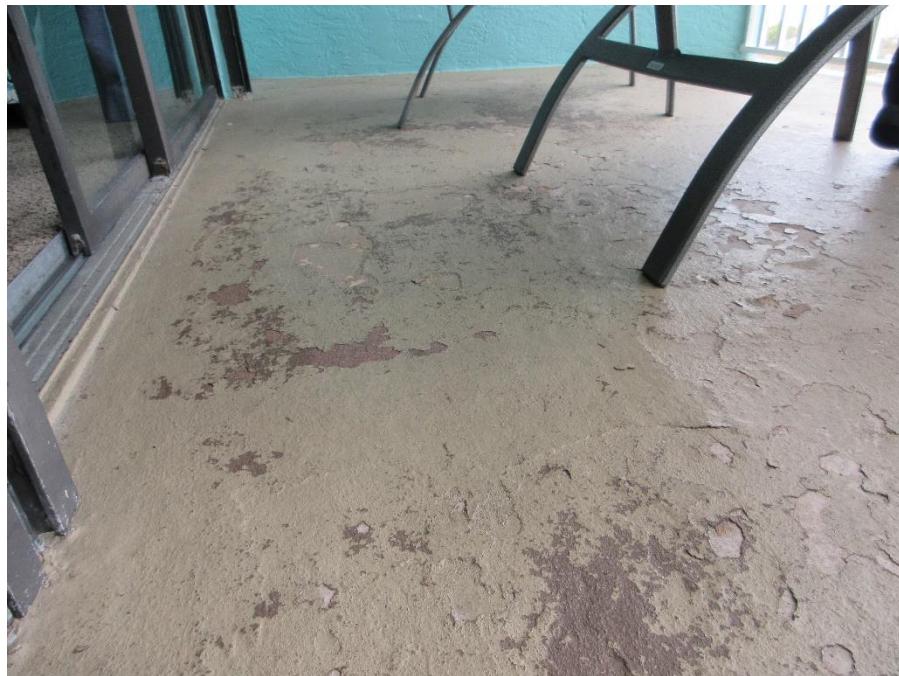
3. Existing waterproofing membranes/coatings at the balconies and common walkways appear to be approaching the end of useful life. It appears that a secondary coating/paint was installed on top of the previously installed membrane during the last painting project. All the coatings are currently failing and providing limited protection to the concrete

Photo #14 – Deteriorated Deck Membrane at Unit's Balconies (TYP.)

slabs below. It is recommended that all reinforced concrete in proximity to the Gulf of Mexico be protected with liquid applied urethane membrane due to the corrosive environment typical in coastal areas. It is recommended that all balconies be waterproofed, including all balconies with original or existing tile that pre-dated the installation of the newer style aluminum guard rails. It is KEGs understanding that at locations with original tile and/or tile installed prior to the installation of the balcony guardrails do not have a waterproofing membrane and/or the time elapsed since the tile install exceeds any reasonable warranty period or useful life of typical materials used for these applications. KE recommends that the floor coatings be relaced with the next 1 to 2 years.

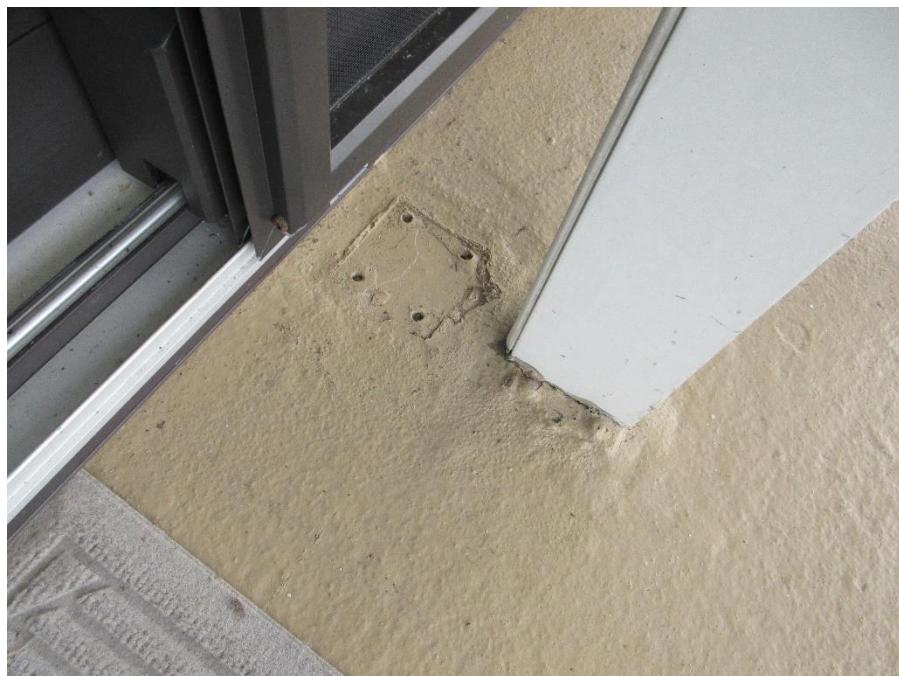
Photo #16 –Unfilled Holes Left in Balcony Deck.

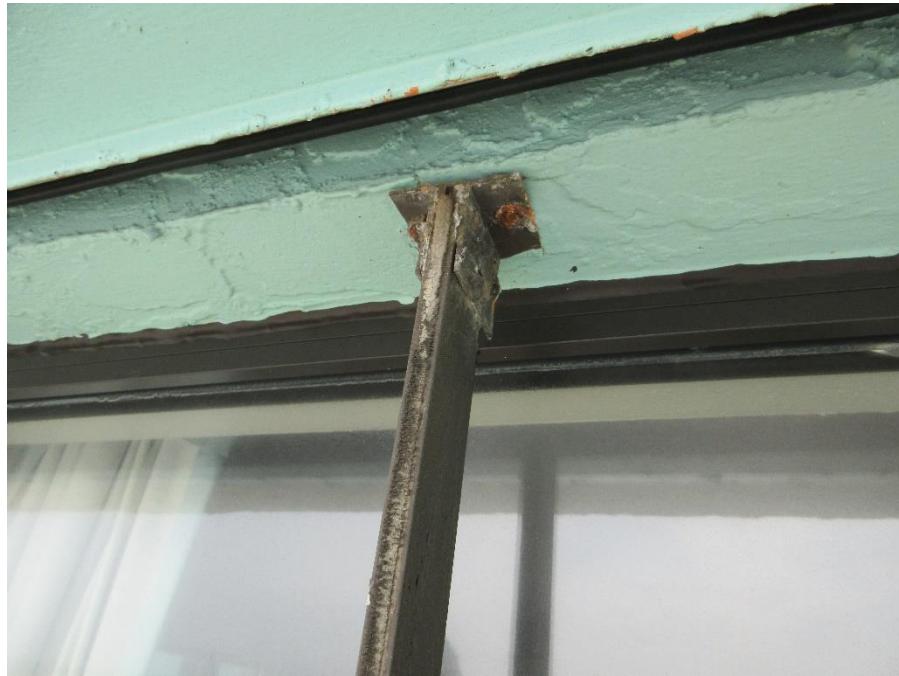
Photo #17 –Corroded Shutters Framing (TYP.)

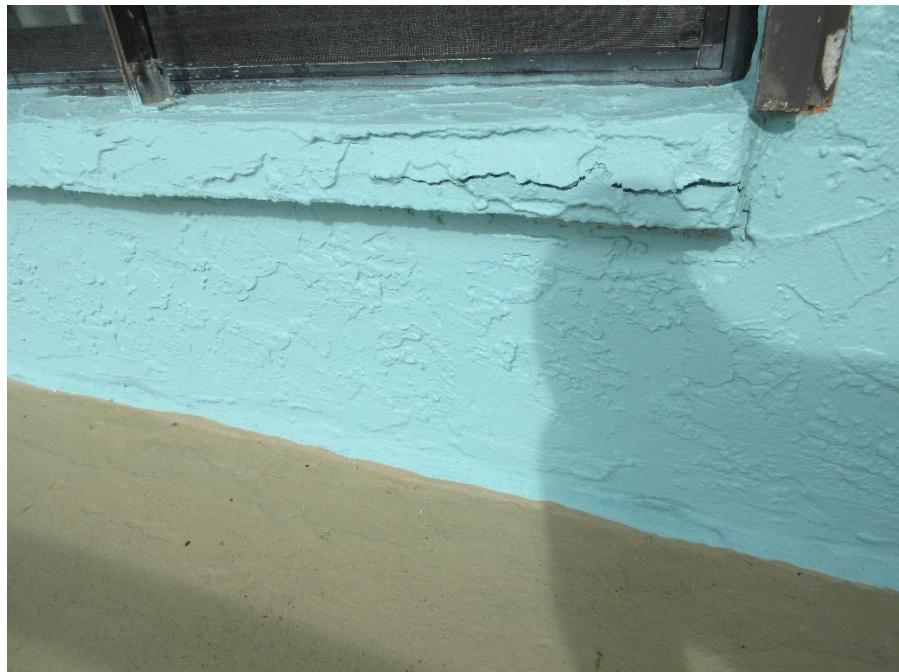
Photo #18 – Broken Windowsill at Unit #501.

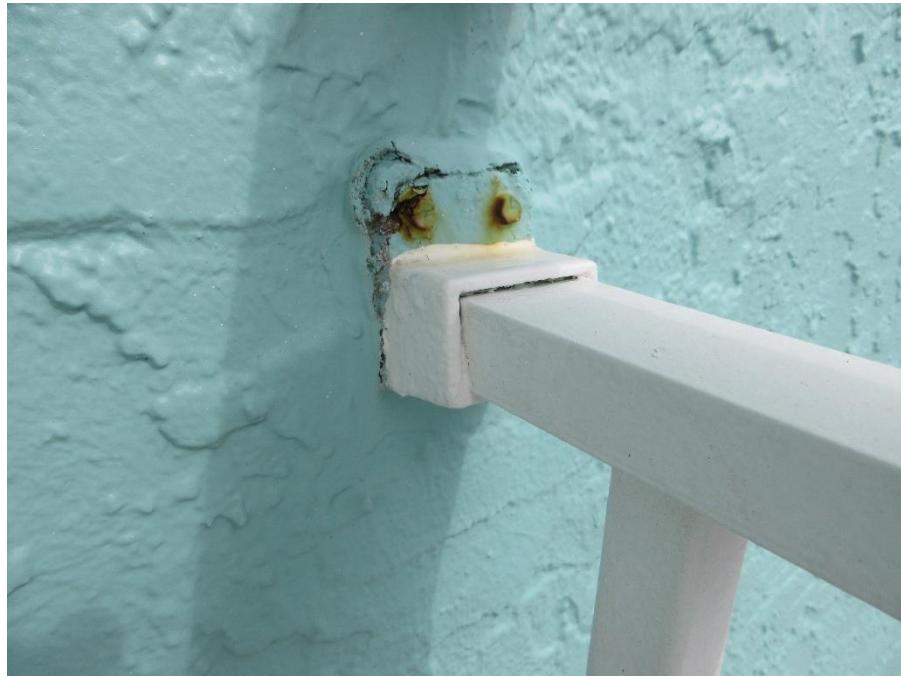
Photo #19 – Broken Railing End Bracket at Walkways due to Rust. (TYP.)

2. KEG noted a number of locations where railing fasteners were either missing or corroded. Given that railings are an important life safety aspect of the building, KEG recommends any missing and/or corrode fasteners be replaced with new same sized 316 stainless steel fasteners as soon as possible. This work should be completed by a licensed General Contractor that specializes in concrete restoration.

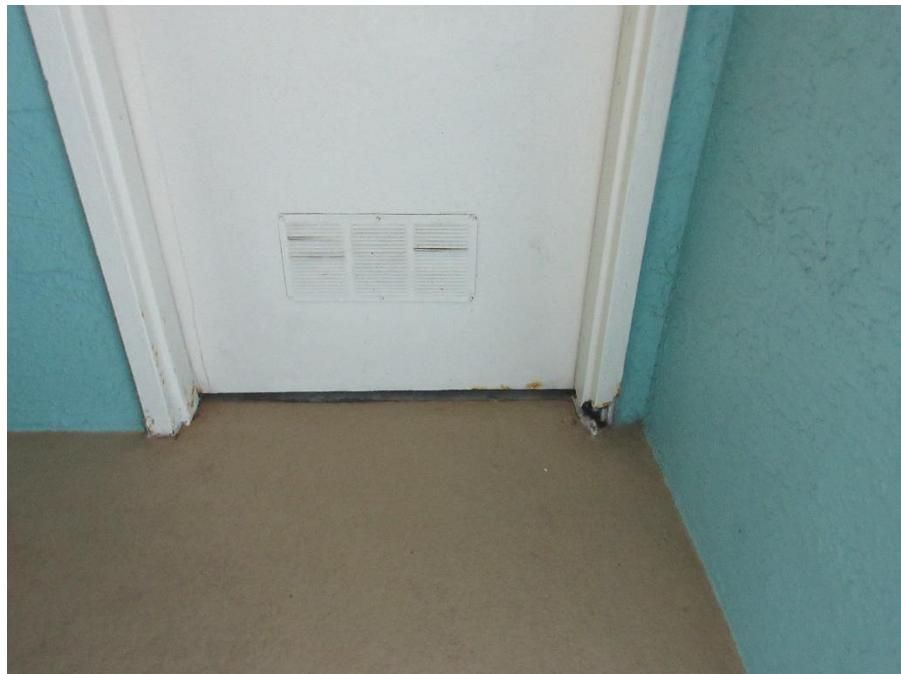
Photo #20 – Corroded Door Jambs at Storage Room (TYP.)

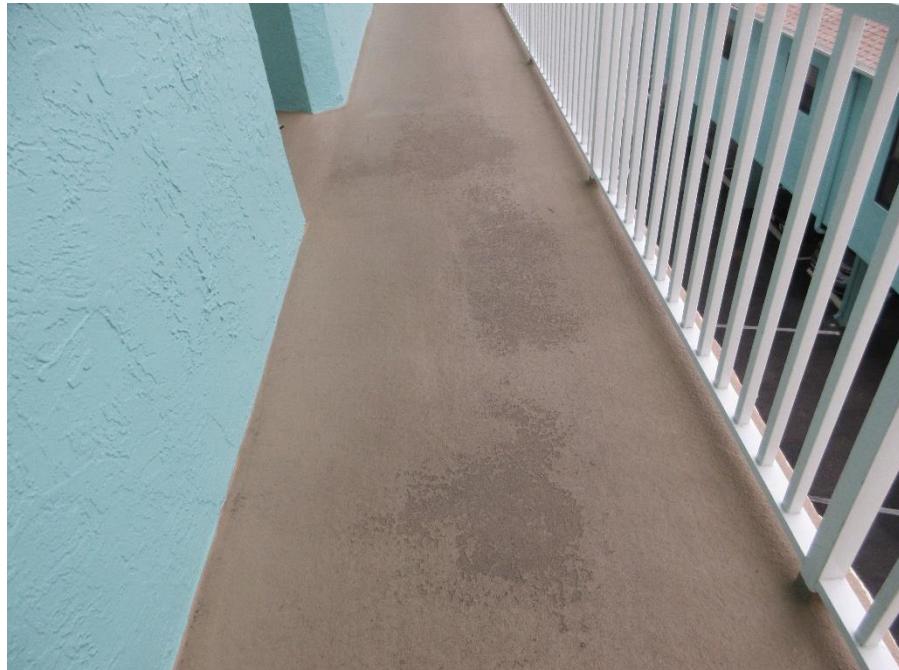
Photo #22 – Typical Concrete Slab Surface Damages or Spalls Covered with Floor Paint (TYP.)

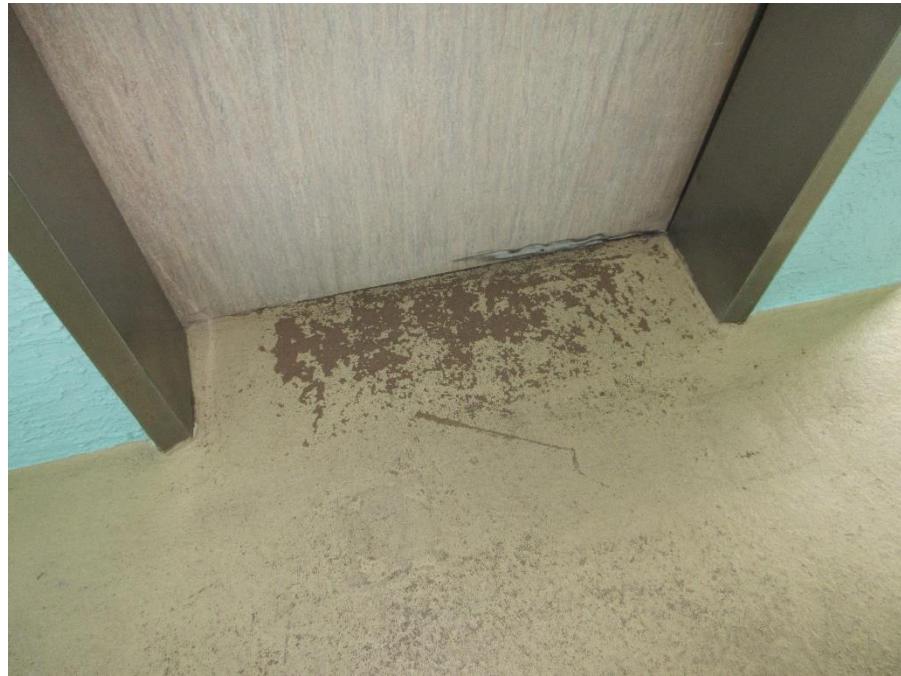
Photo #23 – Deck Coating Peeling at Elevator Room Door (TYP.)

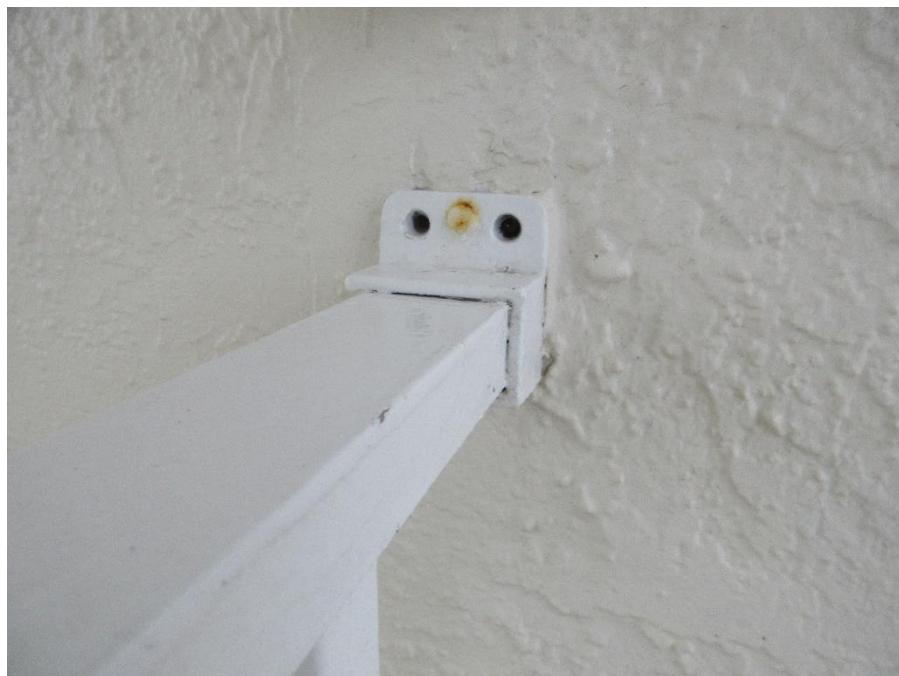
Photo #24 – Missing Fasteners at Railing Ends Brackets (TYP.)

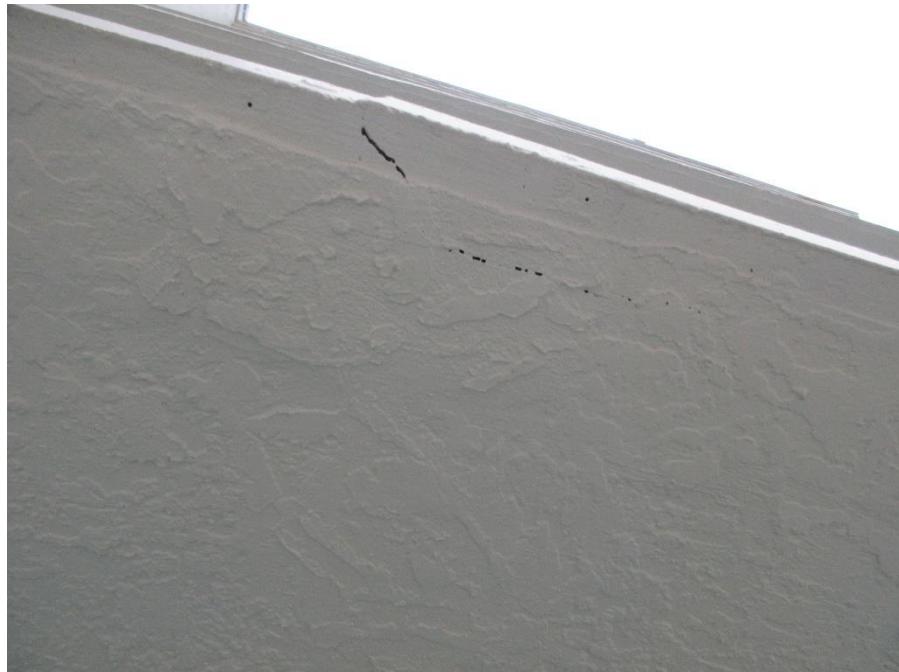
Photo #26 – Concrete Edge Crack at 2nd Floor Slab on East Side of Building.

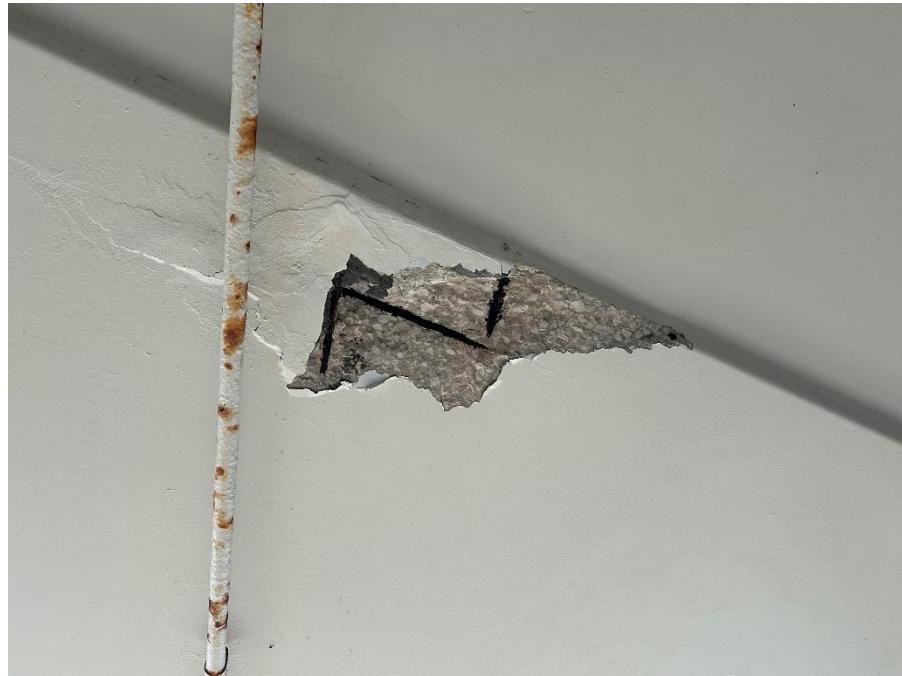
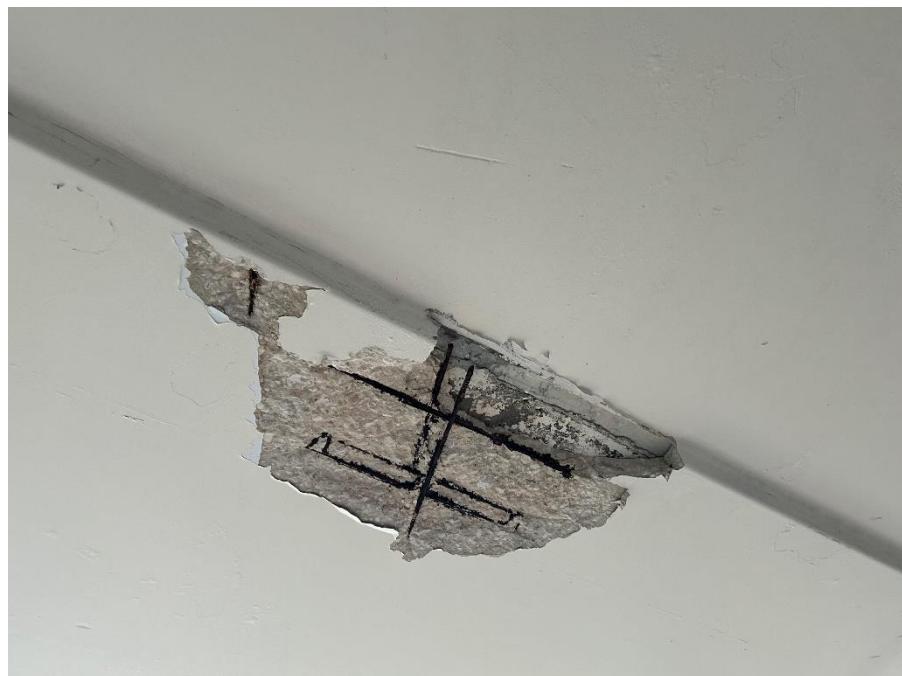
1. Corroded exposed metals/hangers, cracks and large spalling concrete were noted in the underbuilding parking's ceiling. Some areas were roped off for the residents' safety. Recommendations would include removal of all unused metal fasteners, exposed metals, and the repair of the precast concrete panels in accordance with ACI and ICRI Guidelines. As the failing concrete poses a life safety risk if it falls on residents and guests, this work should be completed as soon as possible by a licensed General Contractor that specializes in concrete restoration.

Photo #27 – Concrete Spalls on Underbuilding Parking's Ceiling (TYP.)

Photo #28 – Concrete Spalls on Underbuilding Parking's Ceiling (TYP.)

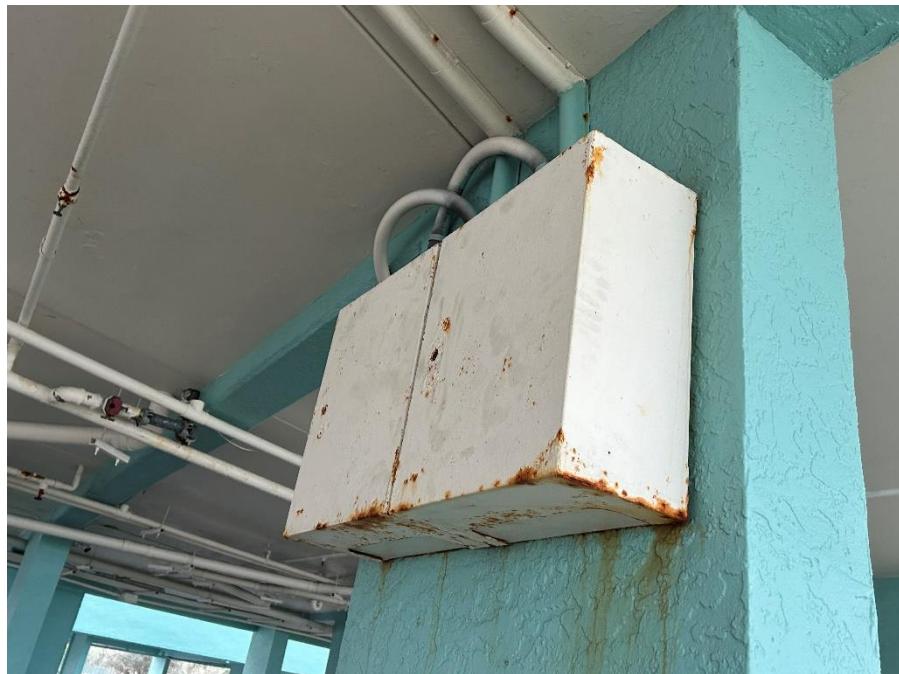
Photo #30 – Rust and Efflorescence at Electrical Meter Box in Garage.
