TAHITIAN TOWERS CONDOMINIUM

Structural Condition Survey Report

Inspection Date: March 14&15, 2022
Report Issue Date: April 26, 2022

RE: Tahitian Towers Condominium Association – Structural Condition Survey Report
19450 Gulf Blvd
Indian Shores, FL 33785

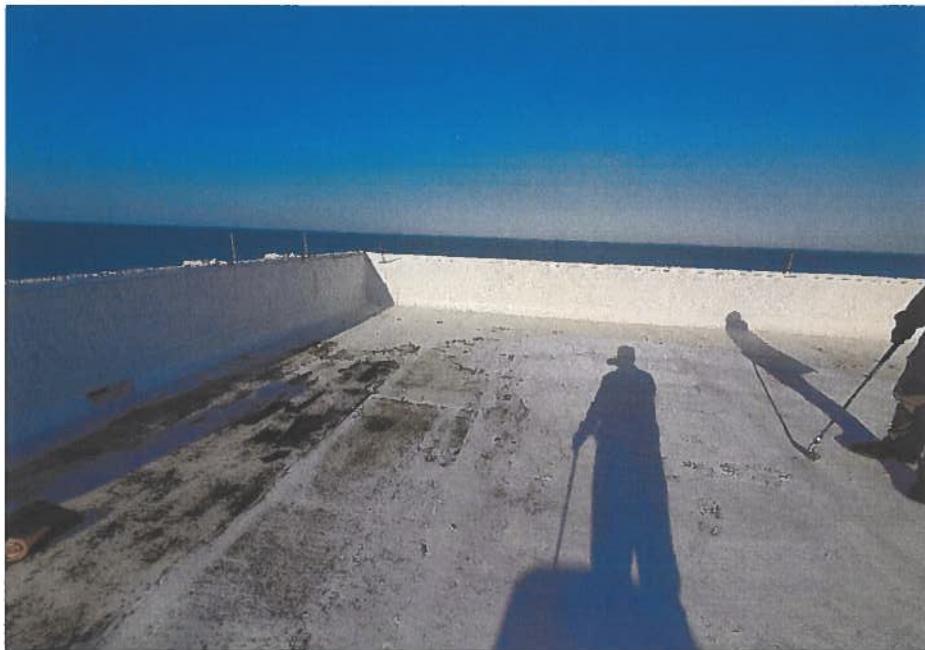
1. High roof ponding water.
2. Corroded metal door frames
3. Concrete spalling and rebar exposure at the wall of communications room.

Figure A- 2: Observation of signs of typical roof ponding water.

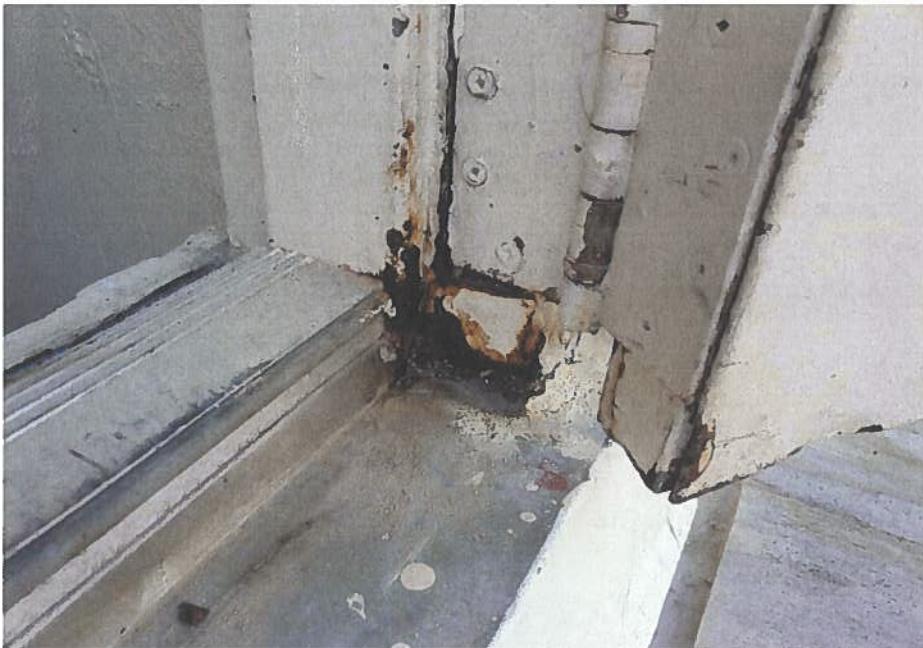
Figure A- 4: Typical rusty metal at the door frame on the roof area.

7. Repair all cracking at CMU walls with routing a sealant
8. Replace stucco or apply sealant to all penetrations through exterior walls to prevent water intrusion.
9. Remove all corrosion from metal surfaces at the building
10. The entire exterior of the building and all of the elements should be repainted and sealed at the end of the restoration project outlined above.

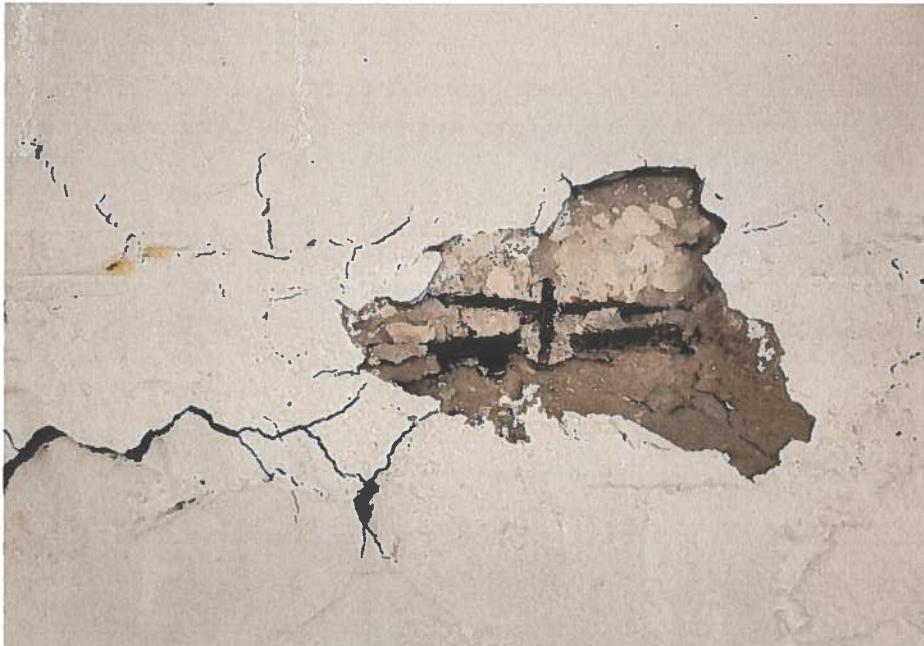
Figure A- 6: Observation of 1SF of concrete spalling and rebar exposure at the wall of communications room.

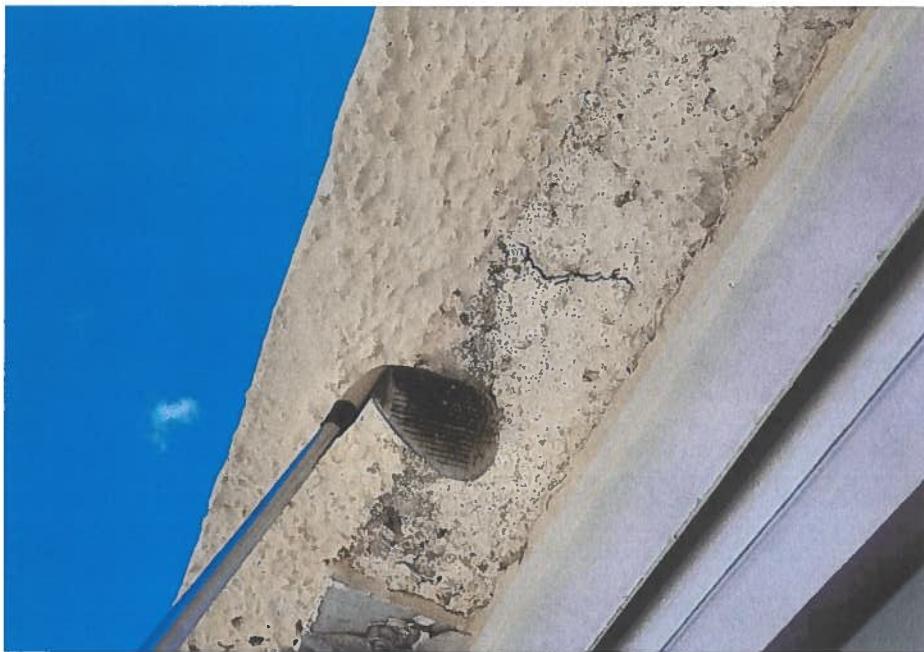
Figure A- 8: Typical spalled area at balcony slab edge.

1. Remove delaminated stucco to verify that structural members beyond are not damaged and then replace stucco.
2. Remove popped or cracked tile areas to verify that structural concrete balconies are not damaged.
3. Remove existing balcony and corridor floor waterproofing membranes
4. Repair delaminated and spalled concrete slabs
5. Repair all typical spalling, delamination, and cracking at balconies walls.
6. Install new waterproofing membrane at balconies and corridor floors

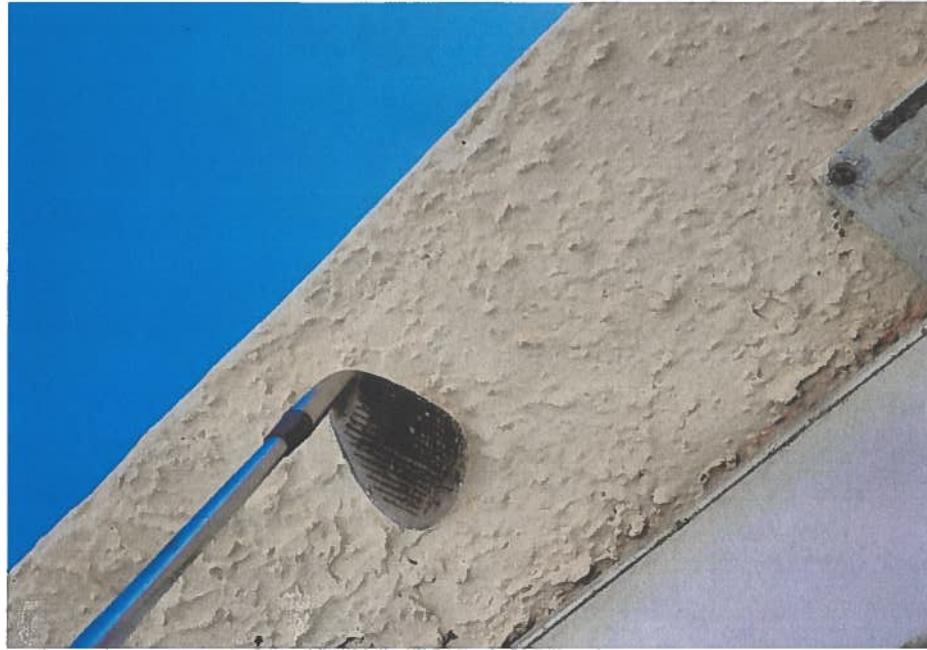
Figure A- 9: Typical delaminated area at balcony slab edge.

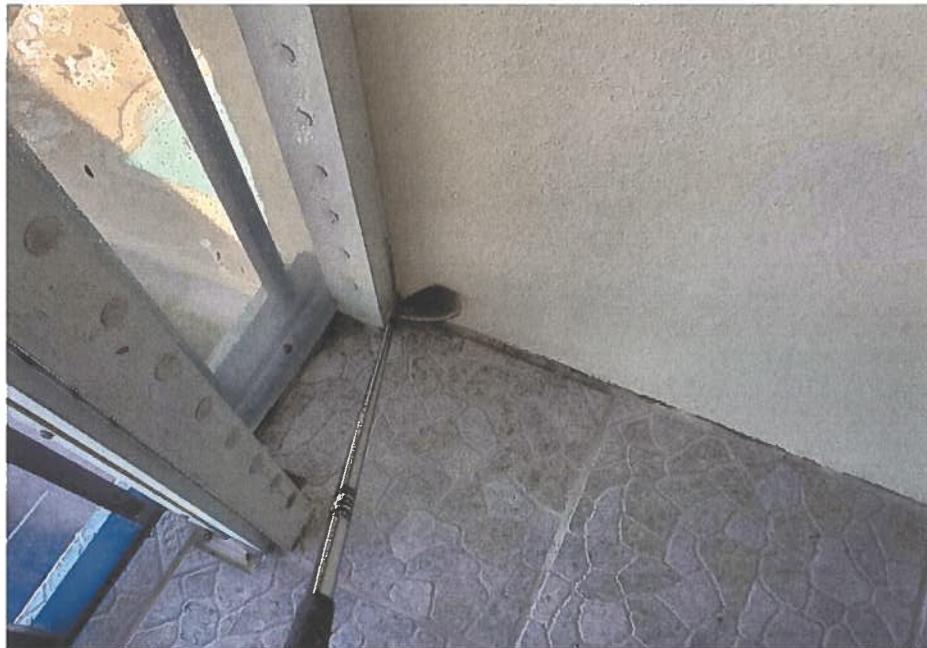
Figure A- 10: Typical delaminated stucco area on side of concrete wall.

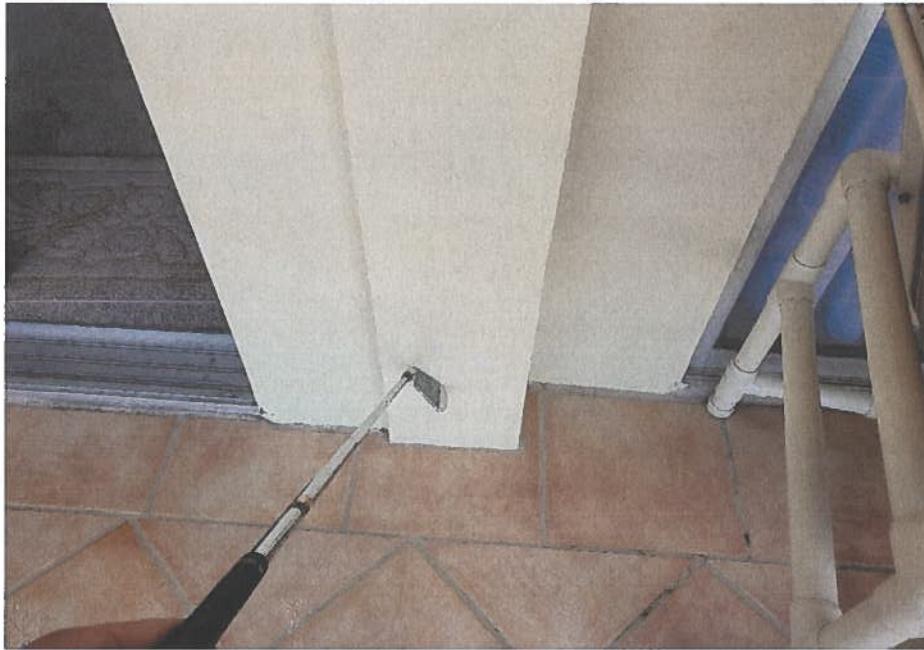
Figure A- 11: Typical delaminated area at the bottom of concrete column.

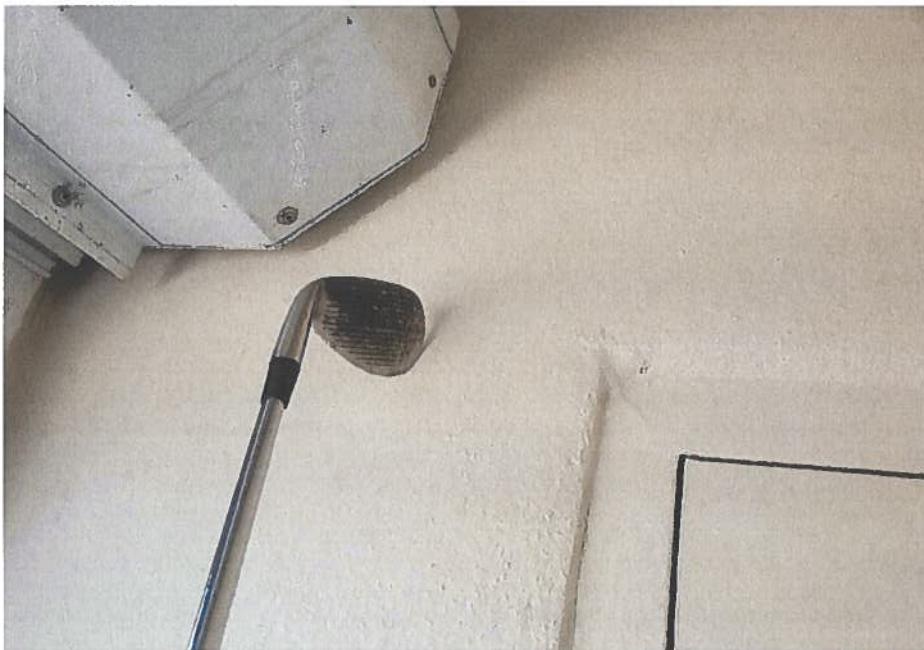
Figure A- 12: Typical delaminated area on side of exterior storage wall.

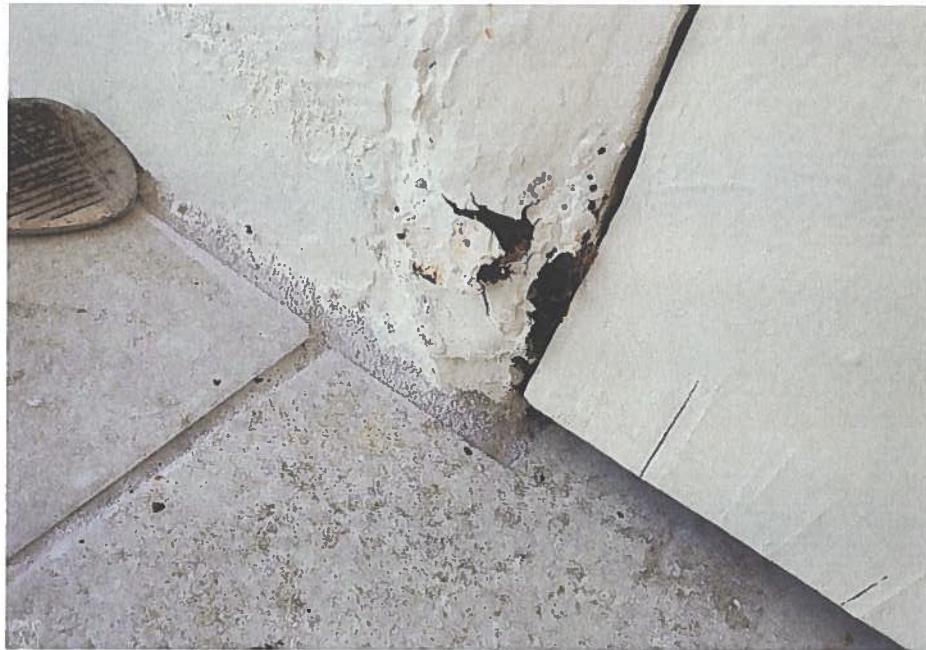
Figure A- 13: Typical rusty metal at the door frame on balcony storage.

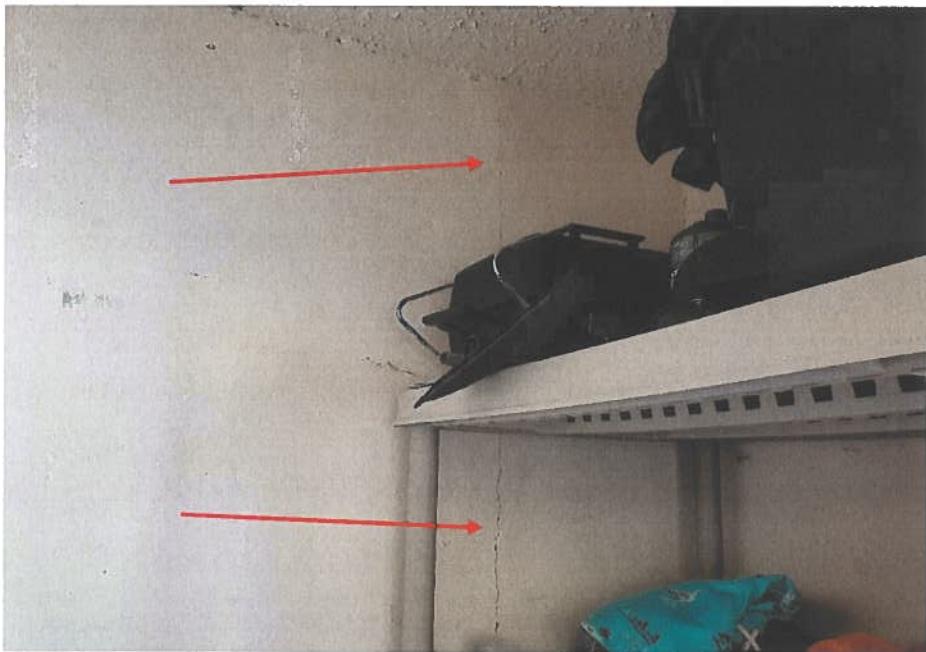
Figure A- 14: Typical hairline cracks on the interior CMU wall of the Storage room at the balcony

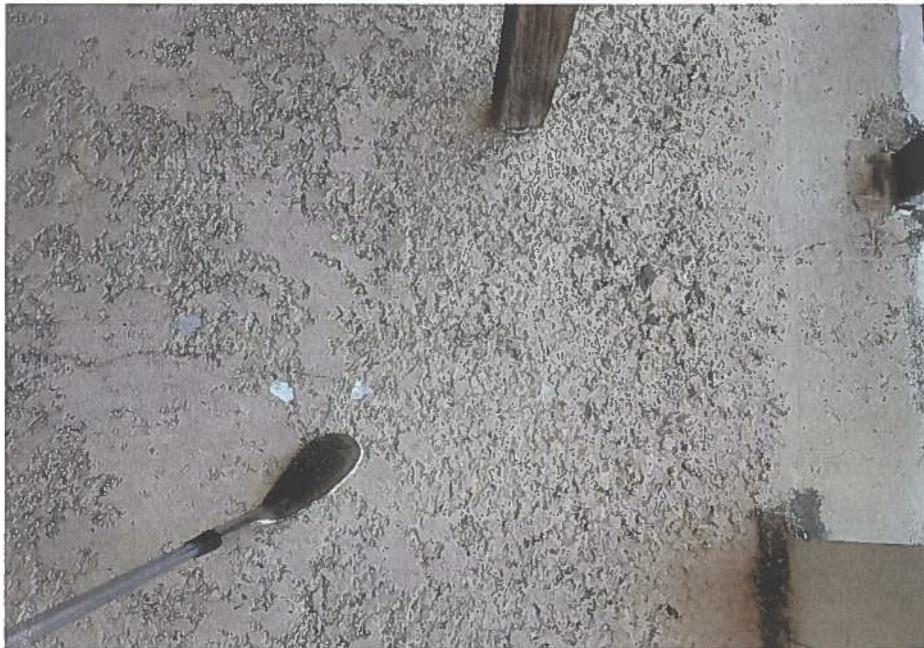
Figure A- 15: Typical hairline cracking on top of concrete slab on balcony surface.

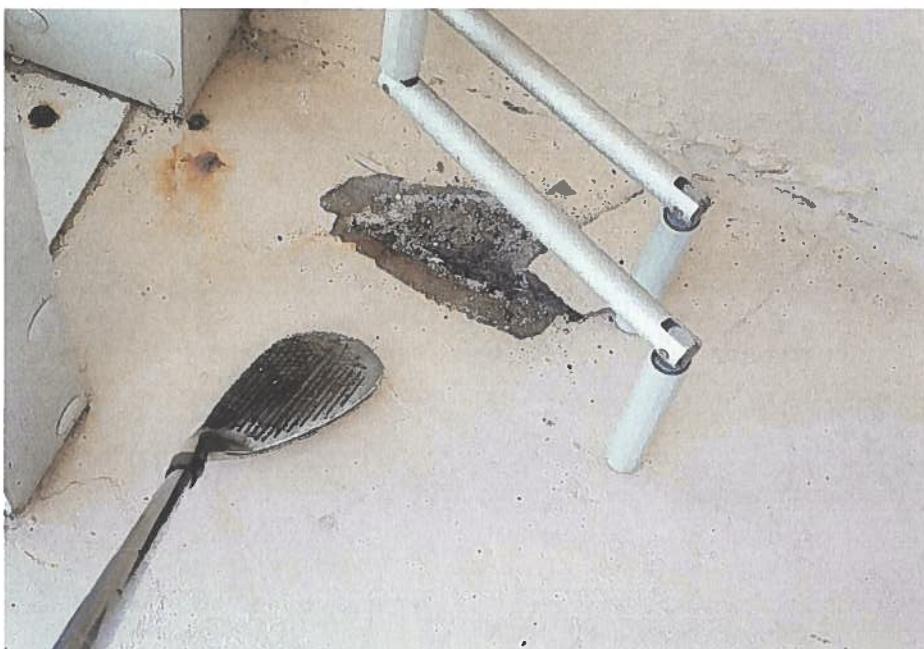
Figure A- 16: View of spall area on balcony surface with corroded rebar and penetration through waterproofing.

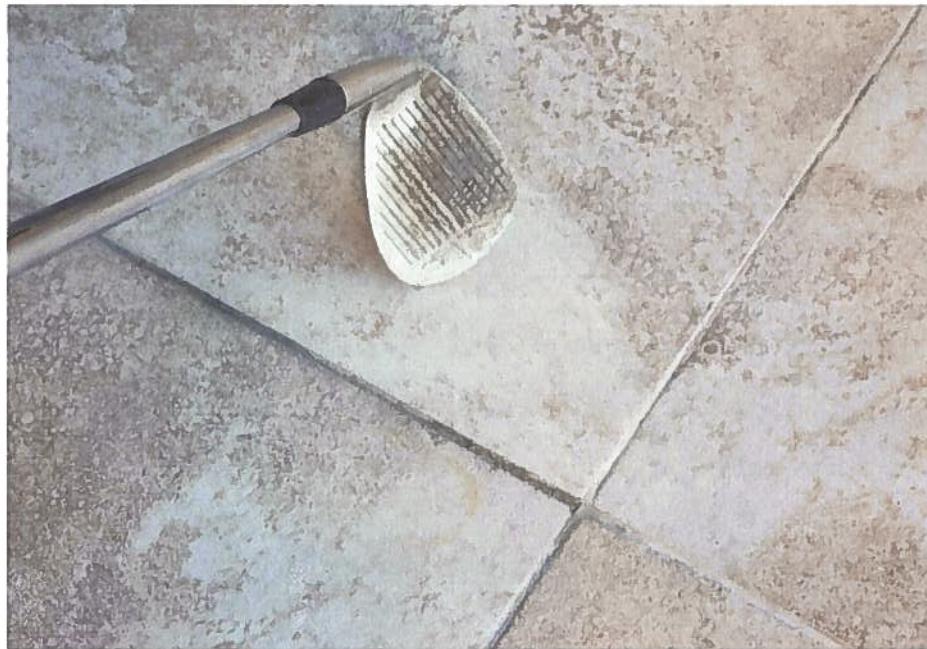
Figure A- 17: Observation of popped up tile on balcony surface.

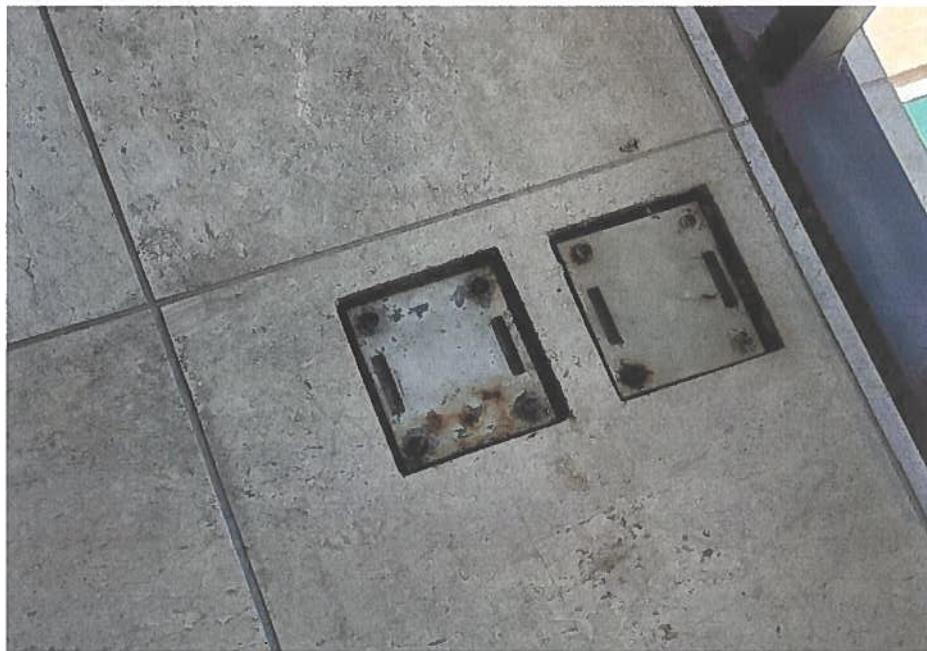
Figure A- 18: Observation of tiles with openings that allows water intrusion on the balcony surface.

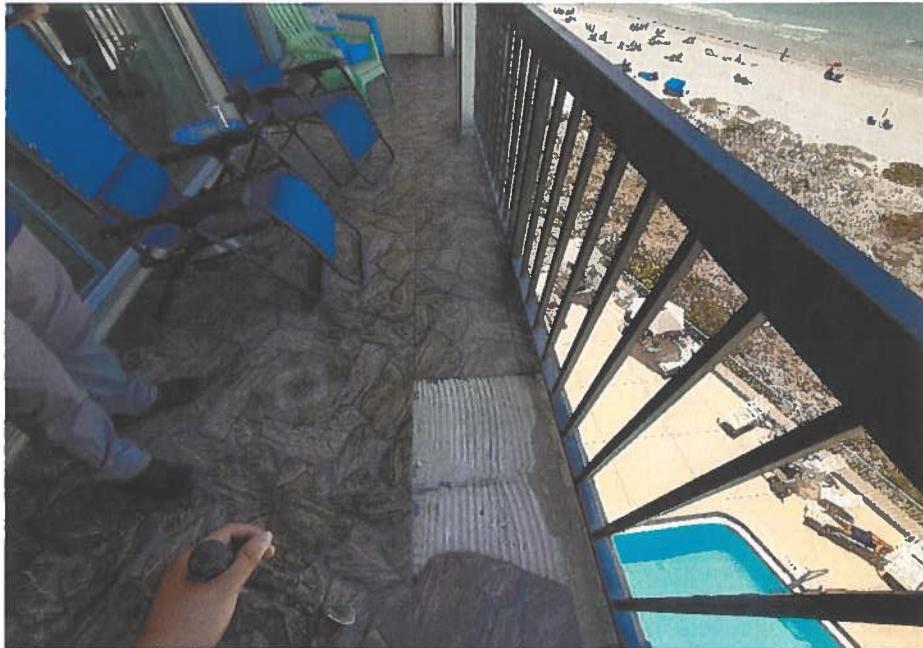
Figure A- 19: Observation of missing tiles on the balcony surface that allows the entry of water beyond the tile.

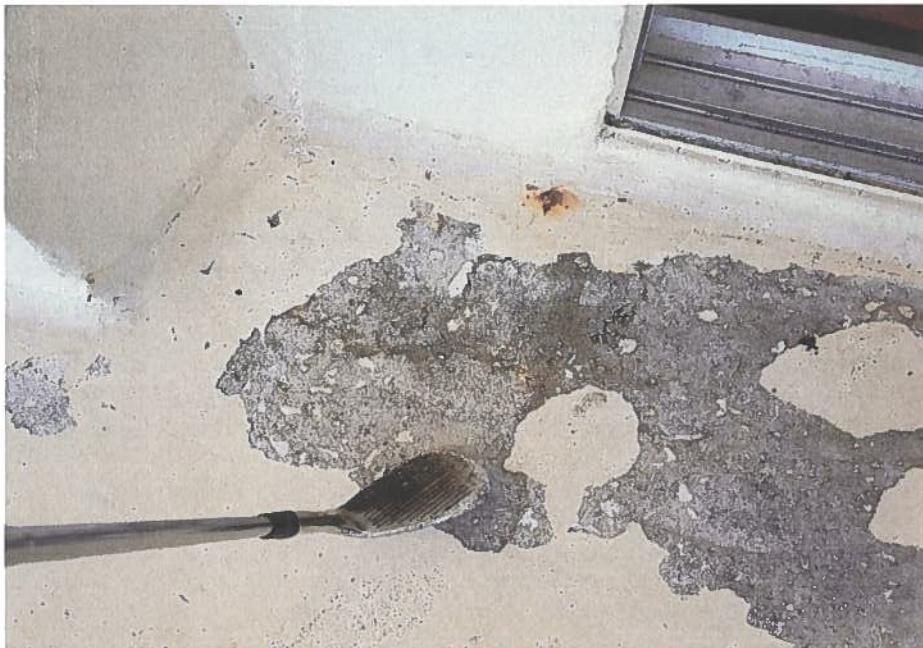
Figure A- 20: Spall on balcony surface with missing waterproofing

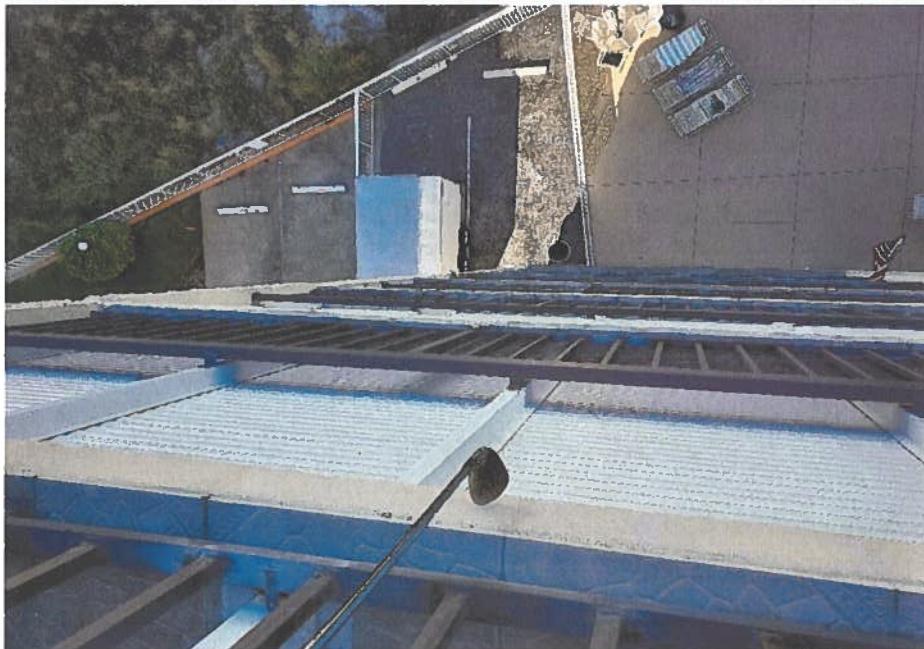
Figure A- 21: Typical delaminated area at slab edge.

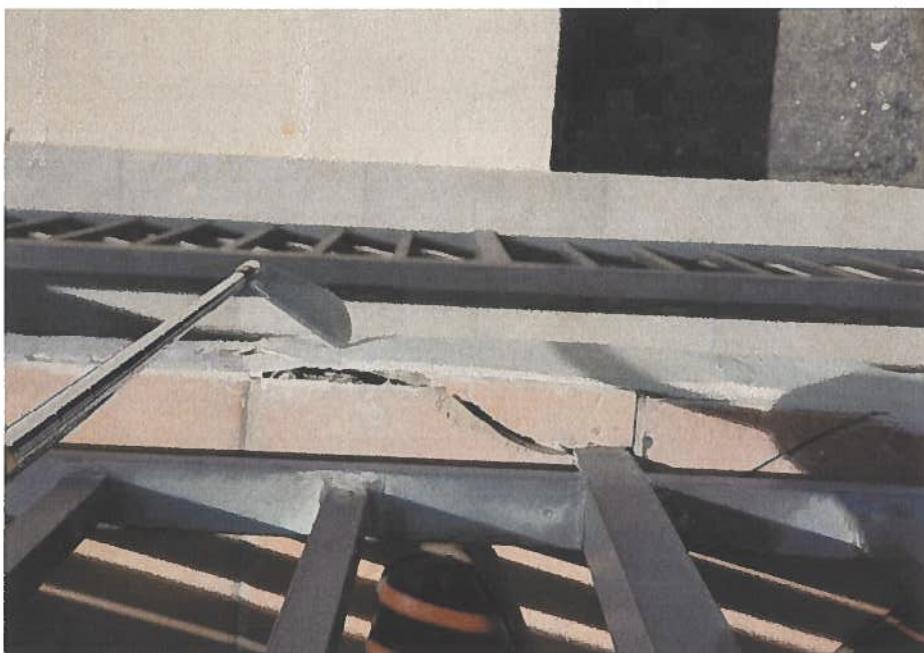
Figure A- 22: Typical spalling area at slab edge with cracked tiles

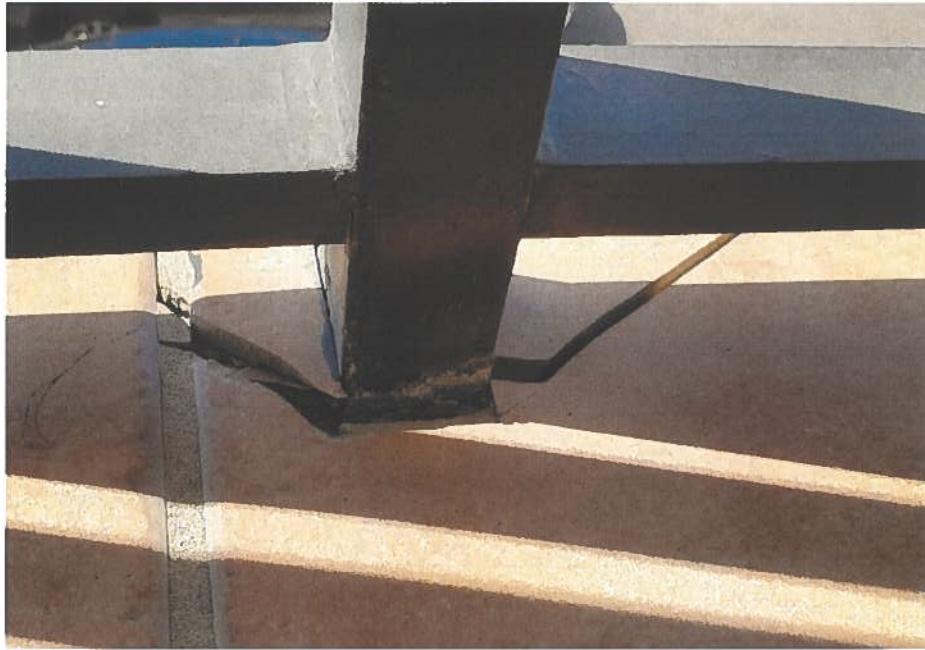
Figure A- 23: Typical spalling area on top of balcony slab surface with Cracked tiles around guardrail post

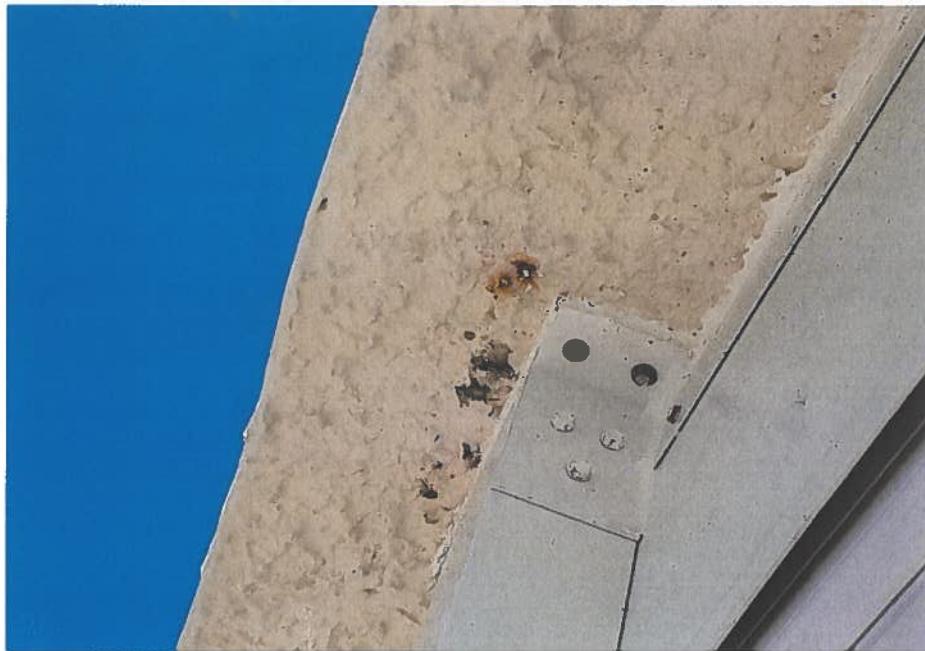
Figure A- 25: View of corroded metal on balcony ceiling.

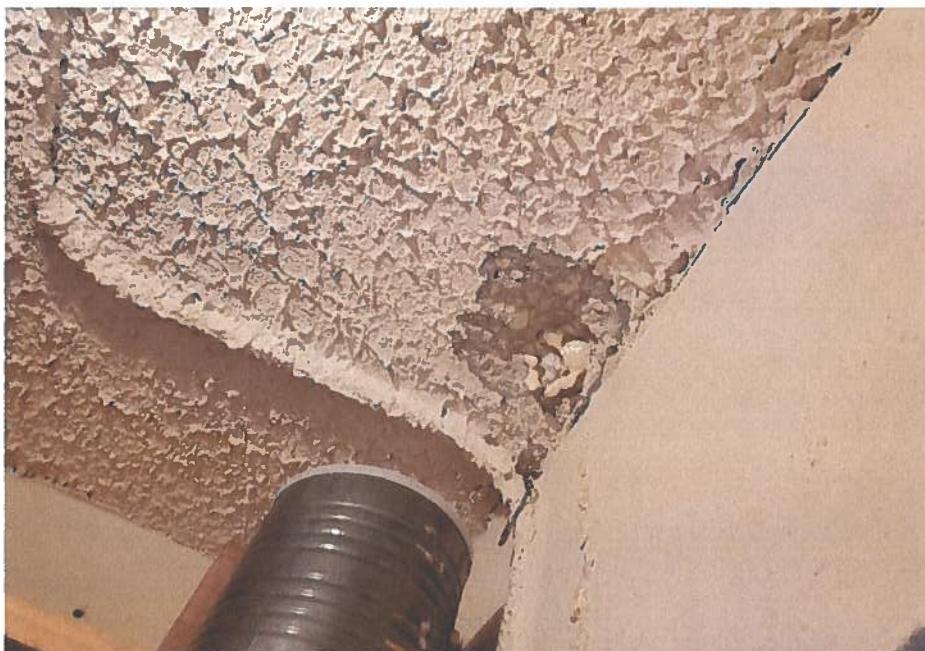
Figure A- 26: Typical concrete spall on storage ceiling.

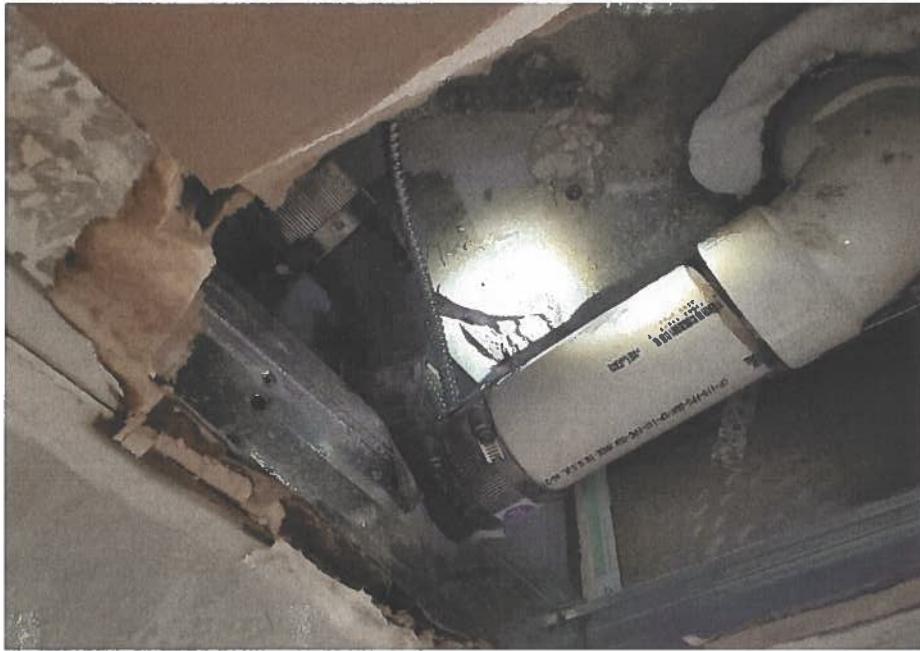
1. Unit #402: The unit had concrete damage at the ceiling caused from water intrusion from plumbing fixture coming from Unit #502 apparently caused by improper installation.
2. Unit #302: The drywall was opened up at the ceiling and it was stated to Belt Engineering that there was water intrusion, but at the time of our site visit there was no signs of apparent water intrusion or damage.

Figure A- 27: Unit #402 with concrete damage from leaks from the upper unit.

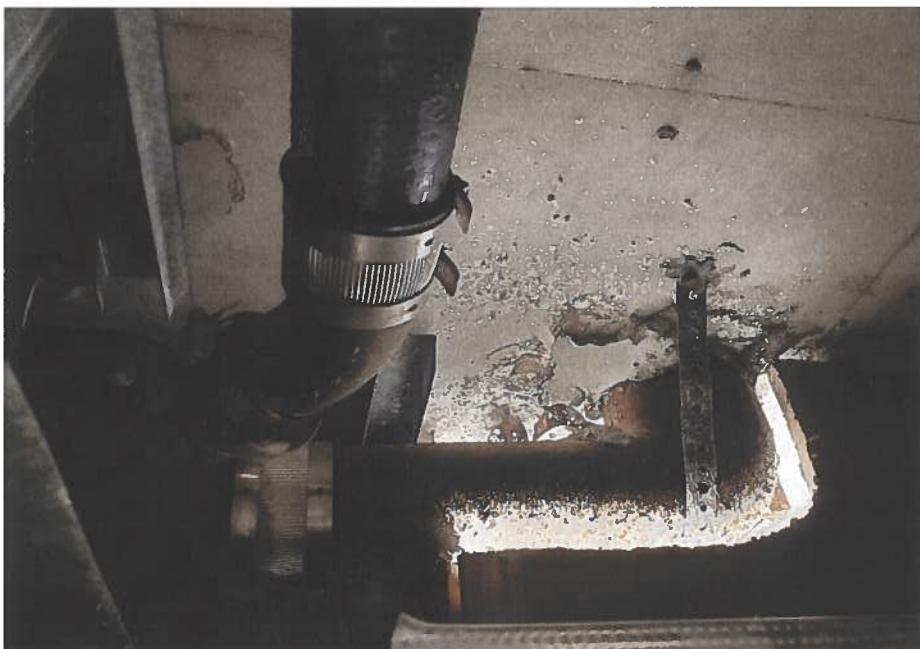
Figure A- 28: Unit #302 had the drywall was opened up at the ceiling and it was Stated to Belt Engineering that there was water intrusion, but at the time of our site visit there was no signs of water intrusion

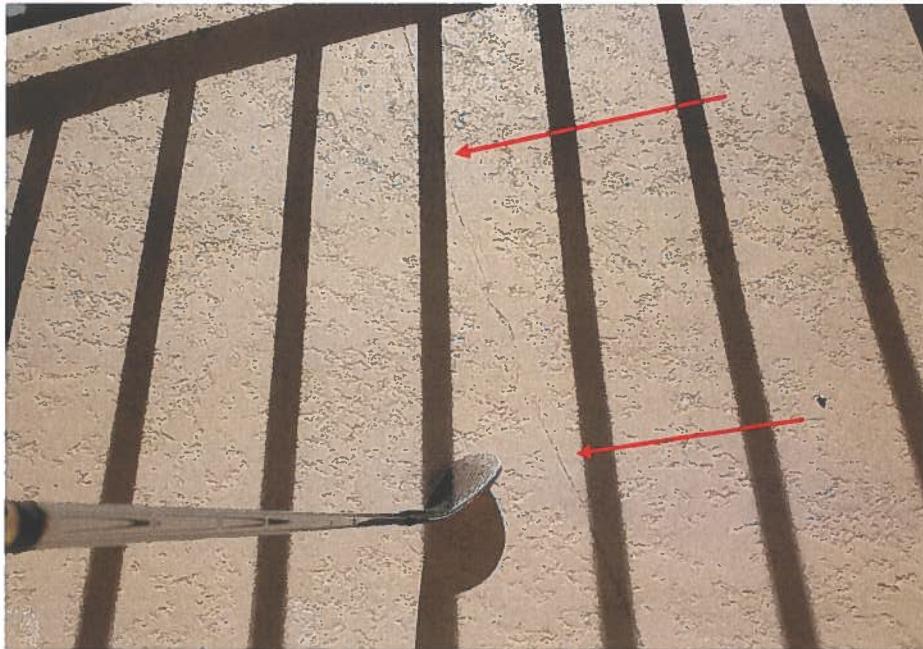
Figure A- 29: Typical full-length cracking on top of slab surface at the corridor.

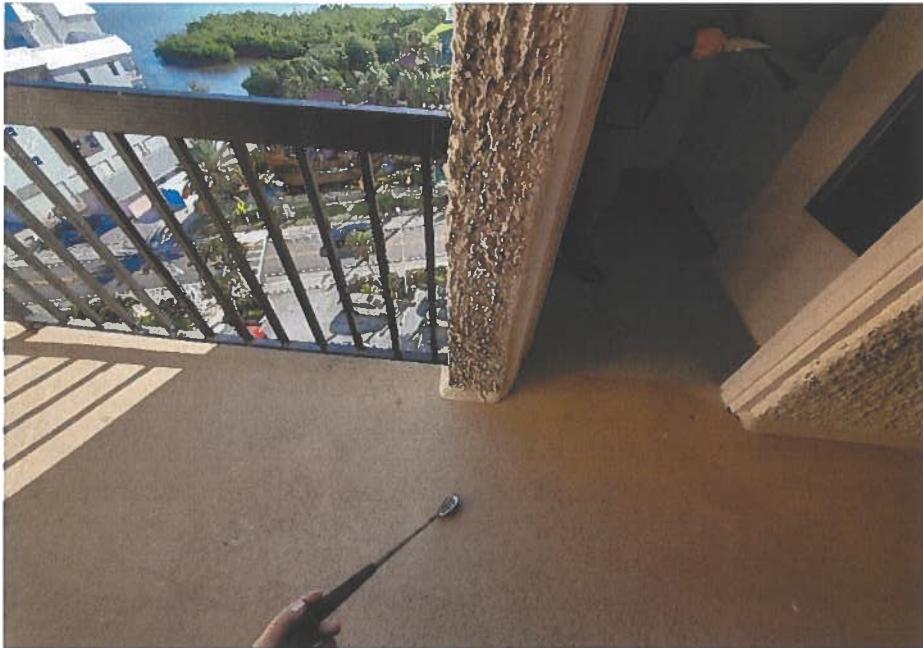
Figure A- 30: Typical delaminated area in front of laundry entrance.

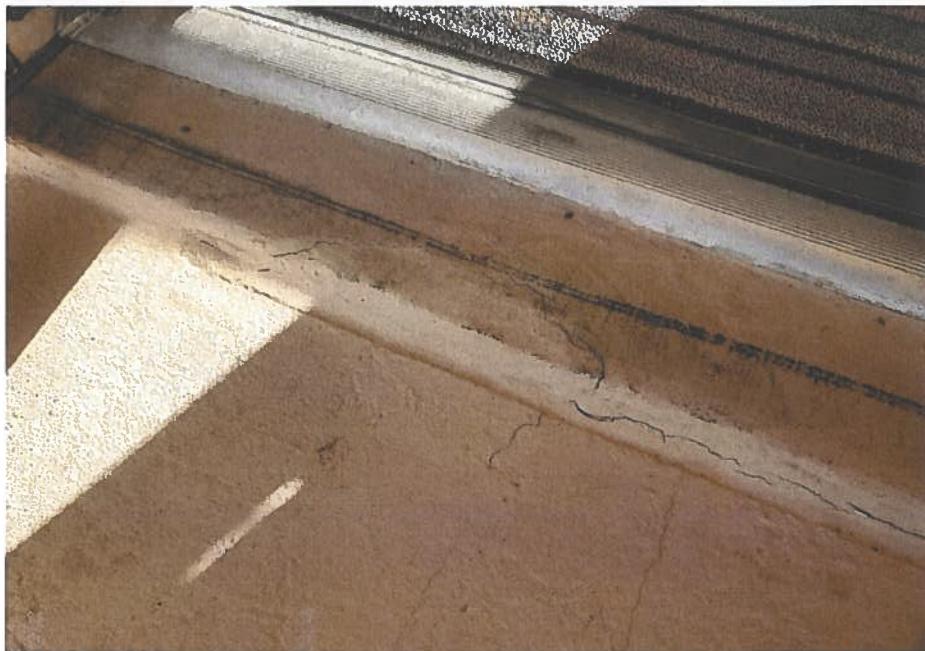
Figure A- 31: Typical hairline cracking with spalling in front of a unit entrance.

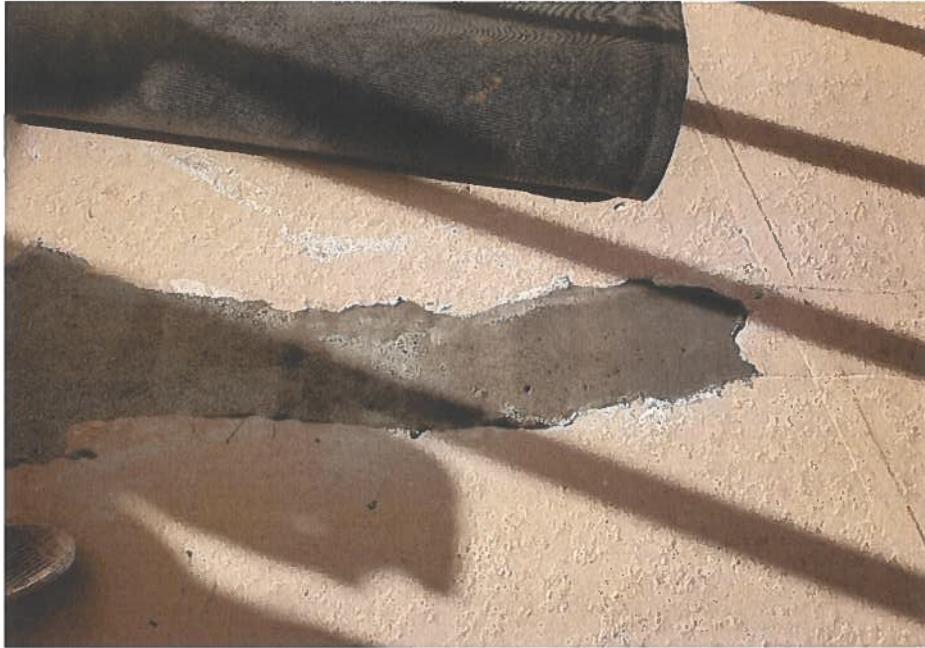
Figure A- 32: Typical hairline cracking over apparent repair on corridor surface.

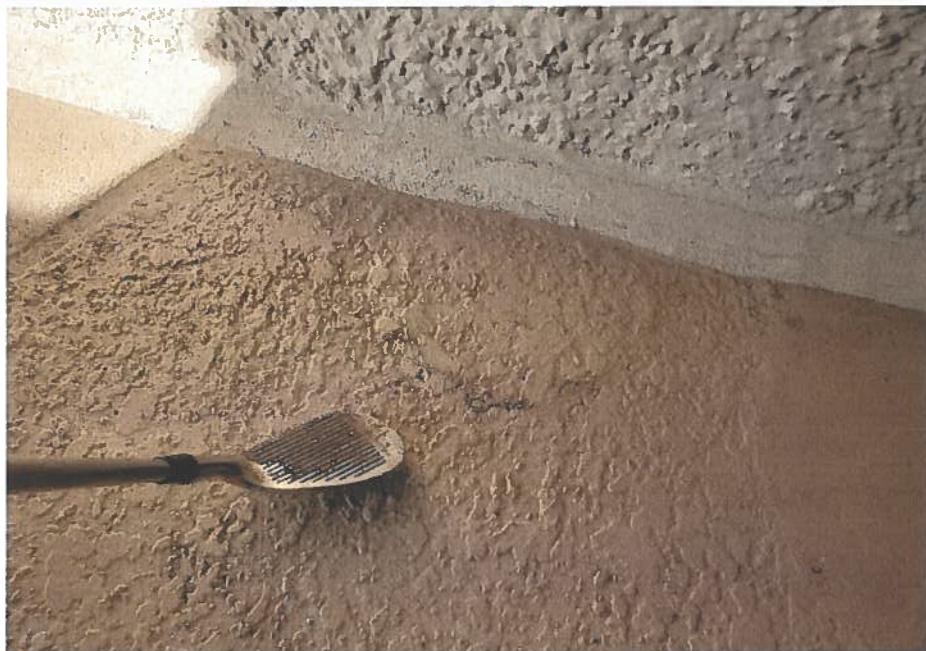
Figure A- 33: Typical spalled area at corridor surface.

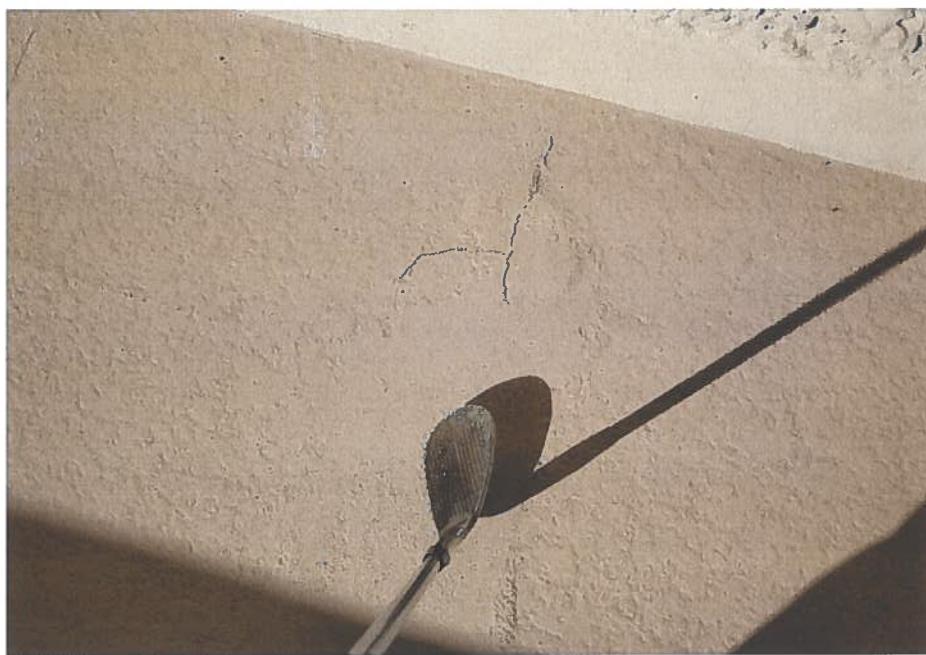
Figure A- 34: Observation of spalling over knee wall scupper

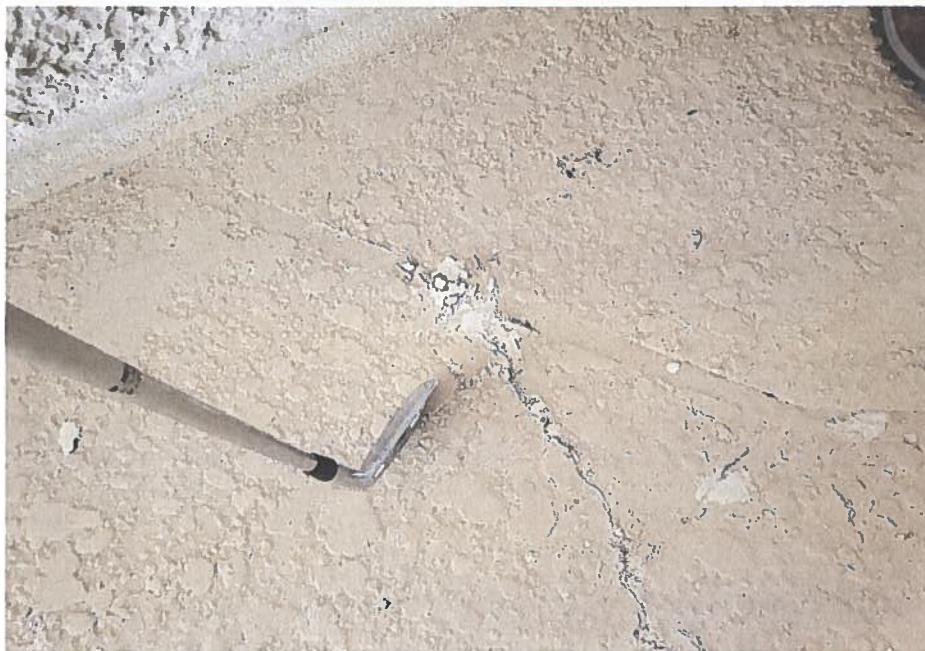
Figure A- 35: View of worn hallways waterproofing membrane

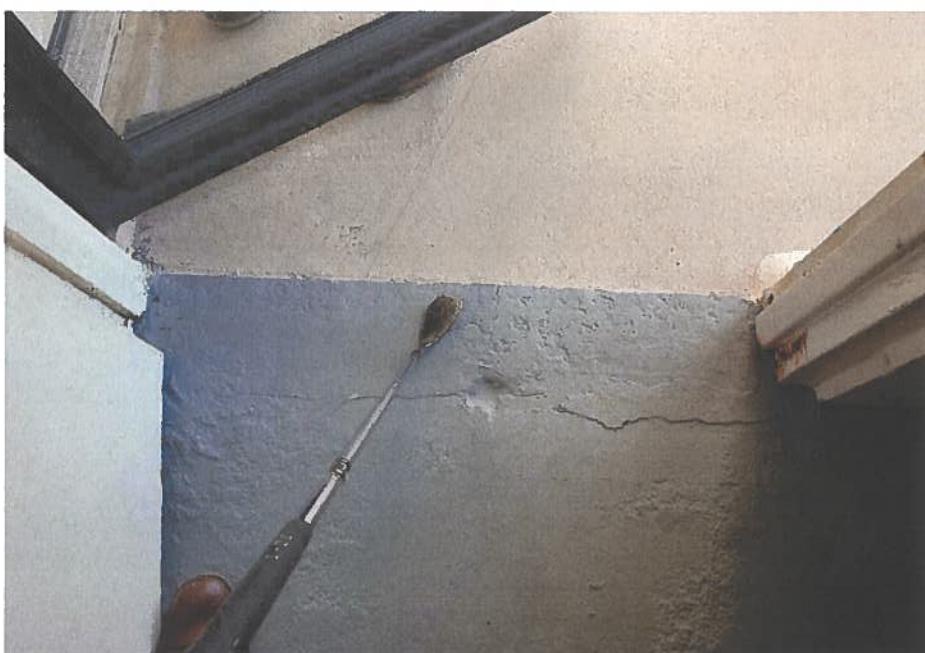
Figure A- 36: Typical hairline cracking on slab surface at the entrance of the stairs.

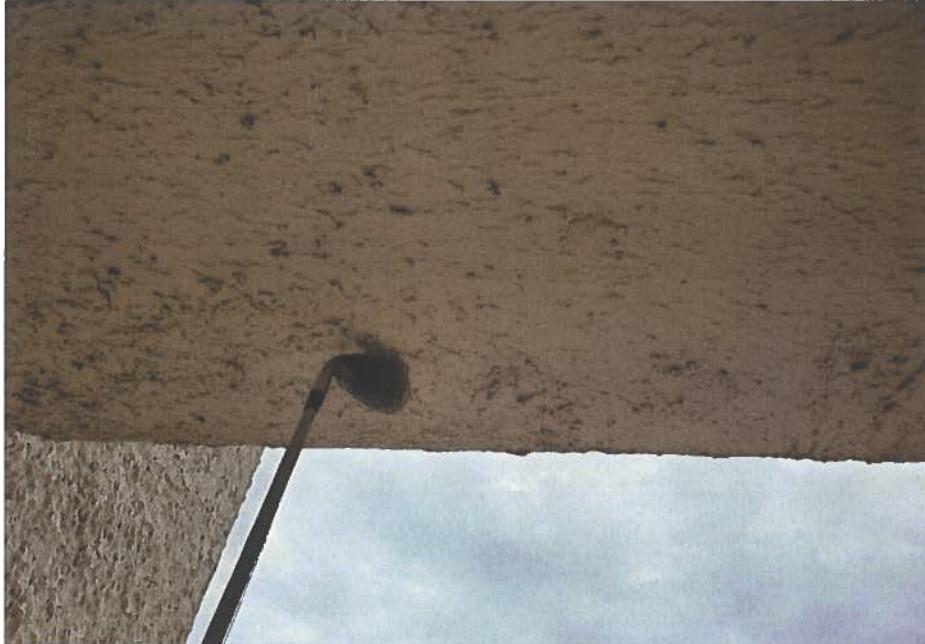
Figure A- 38: Delaminated area at corridor ceiling slab.

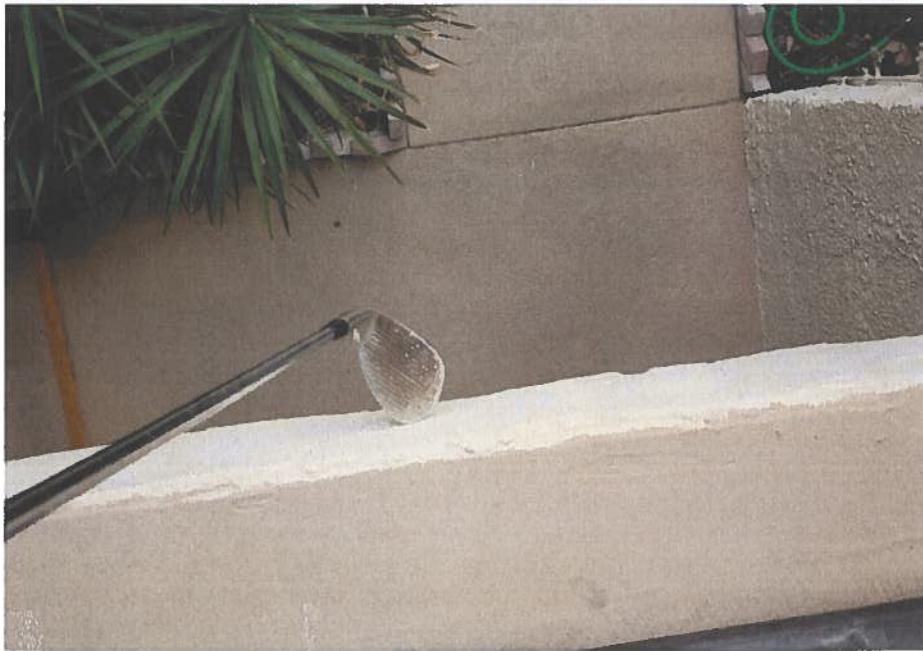
Figure A- 39: Typical delaminated area at corridor slab edge.

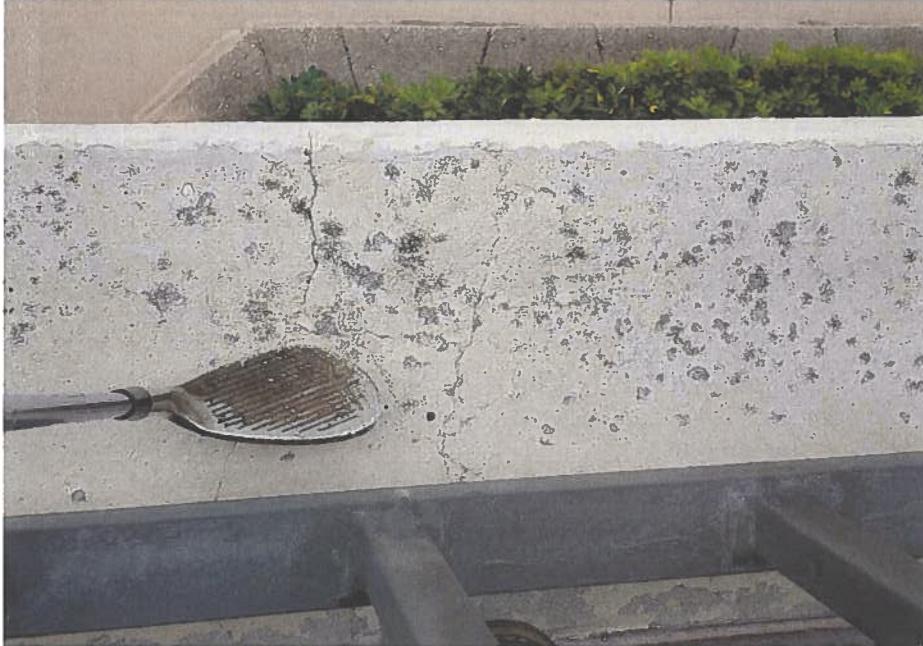
Figure A- 40: Typical cracking around slab edge.

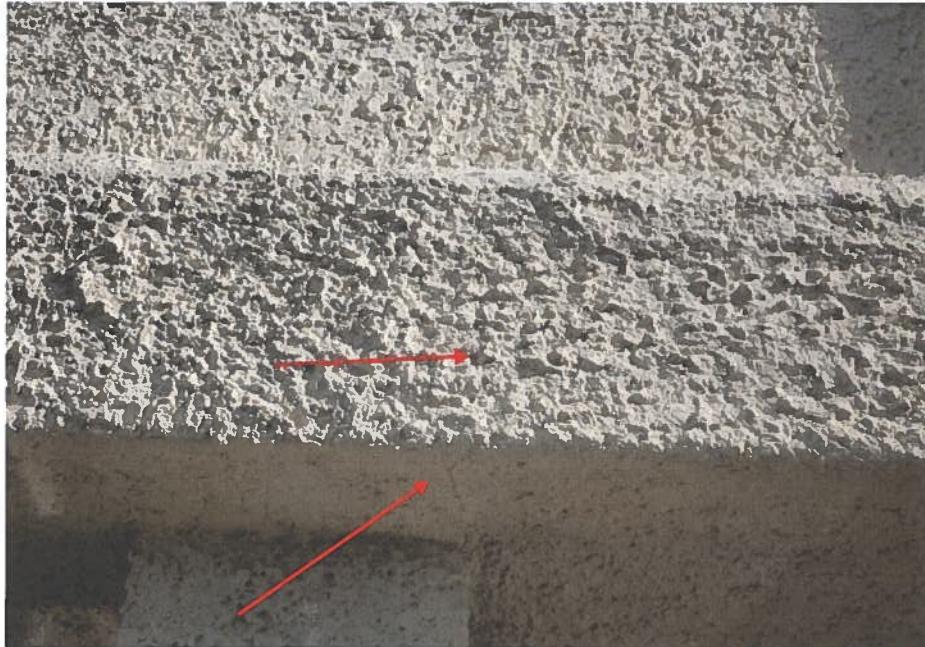
Figure A- 41: Stucco cracking at the left garage entrance ceiling slab.

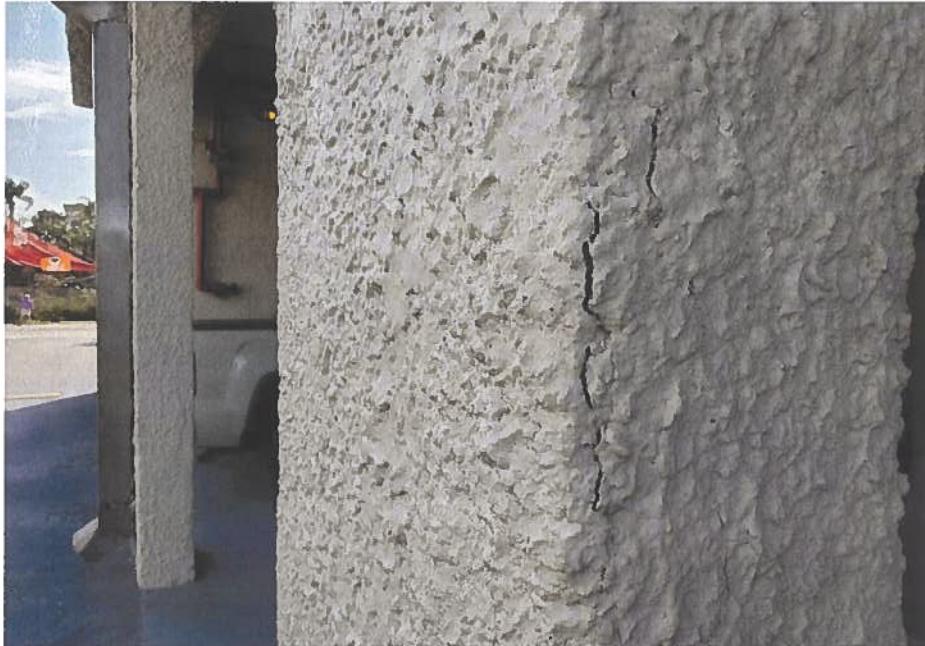
Figure A- 42: Typical vertical hairline stucco cracking at the column side.
