TAHITIAN TOWERS CONDOMINIUM

Structural Condition Survey Report

Inspection Date: March 14&15, 2022
Report Issue Date: April 26, 2022

RE: Tahitian Towers Condominium Association – Structural Condition Survey Report
19450 Gulf Blvd
Indian Shores, FL 33785

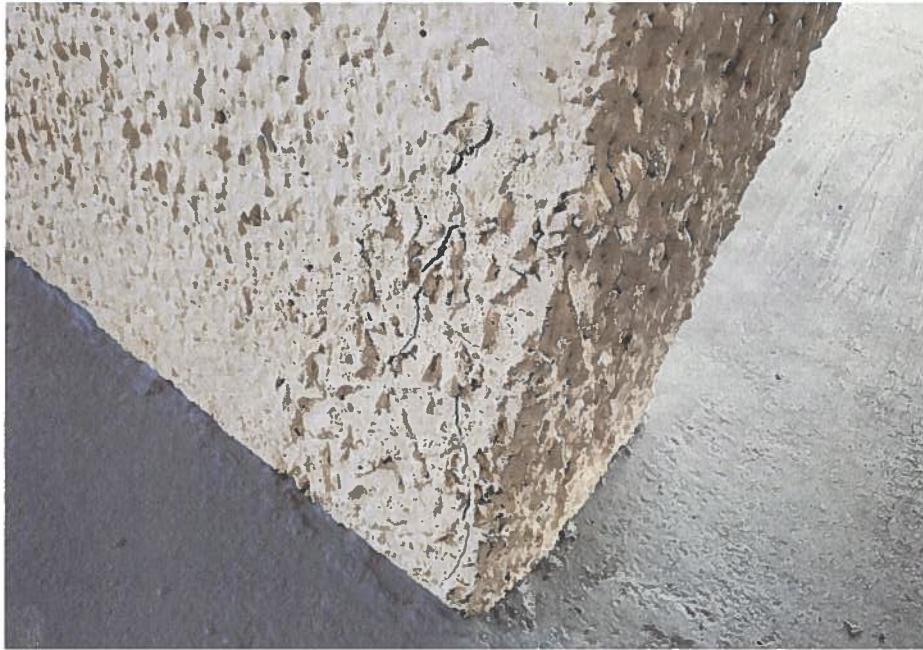
Figure A- 43: Typical cracking at base of wall on parking garage entrance.

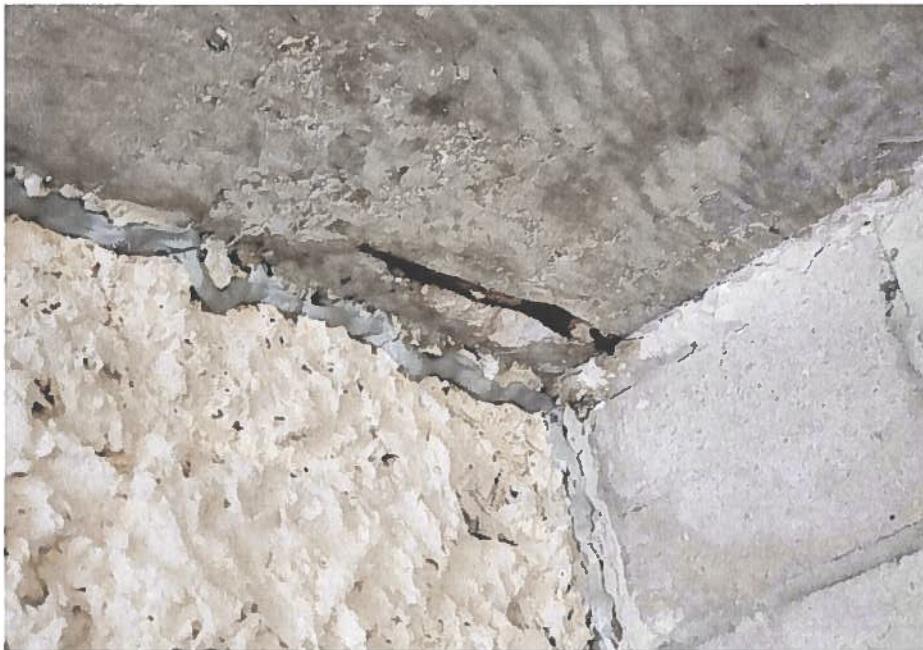
Figure A- 44: Spalling with reinforcement corrosion and exposed at the elevated slab on pump room ceiling.

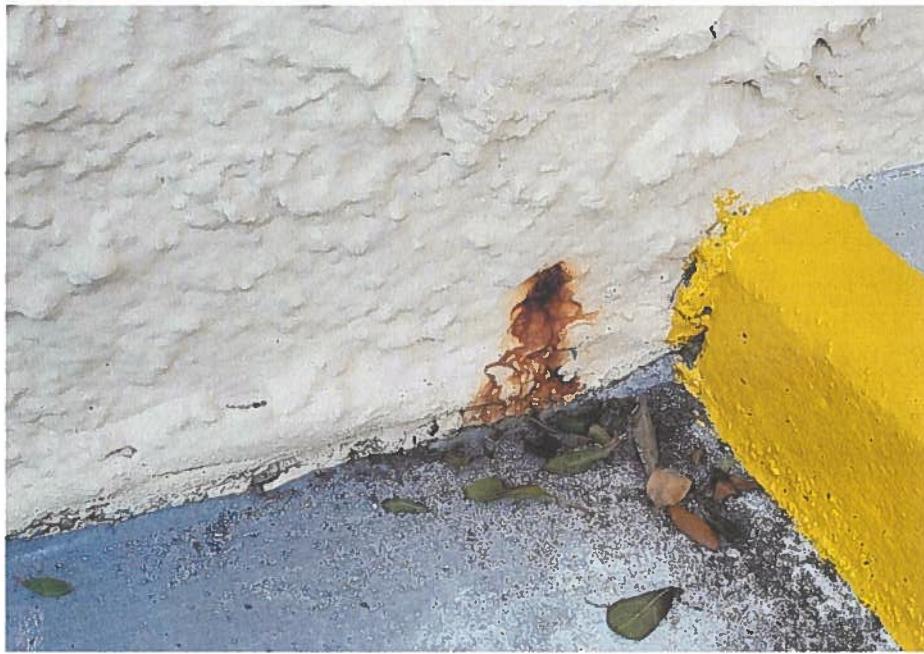
Figure A- 45: View of corroded metal and spalling on the exterior stucco finish.
