October 26, 2022

*RE: Bay and Beach Club Association, Inc.
19508 and 19509 Gulf Boulevard
Indian Shores, Florida 33785
KEG File #22RP-0561: Milestone Inspection*

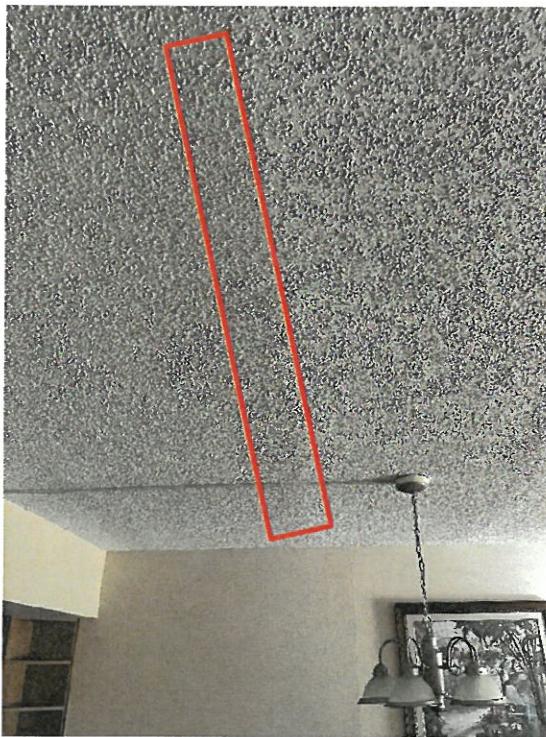
KEG performed inspections for 100% of the unit interiors at Building 19508 and 19509 with the specific intent of documenting the finishes for evidence of moisture intrusion, water damage, or major cracks within the interior finishes. These types of damage can indicate a failure of the weatherproofing installed on the exterior of the building, such as roof systems, sealants and paint. The interiors unit appeared to be in generally good condition. The ceilings were observed to have a crack running parallel with the span of the hollow core precast slabs. These locations appear to be at the location of the bottom side of the construction joints of the hollow core precast slabs. Many of the cracks had no visual signs of water damage at the cracks in the ceiling or reports from the tenants or management about active water intrusion, the cracking is more than likely due to the construction joint, improperly installed finishes, older finishes, and/or normal movements within the structure.

Figure 1: Hollow Core Precast Crack in Ceiling, Unit 101

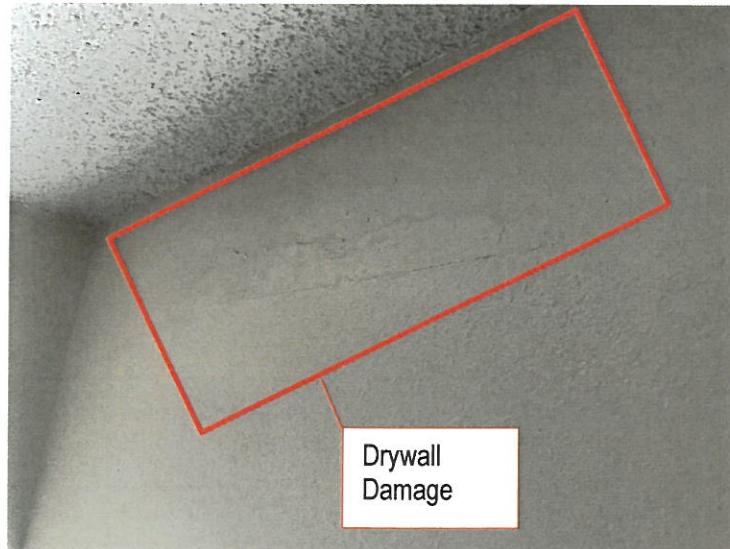
Water intrusion appeared to be occurring in some of the units upon visual inspections of the ceilings and walls. Water stains in the corners of ceilings and some drywall damage were observed in 202, 204, 303, 304, and 404 for Building 19508. Units 106 and 305 in Building 19509 were also observed to contain signs of water intrusion. Most of these areas

appeared to have been previously patched. Management stated that these areas were likely prior to the exterior of the building being sealed and the patches do not match the existing ceiling finishes.

Figure 2: Visualization of Drywall Damage, Unit 204-08

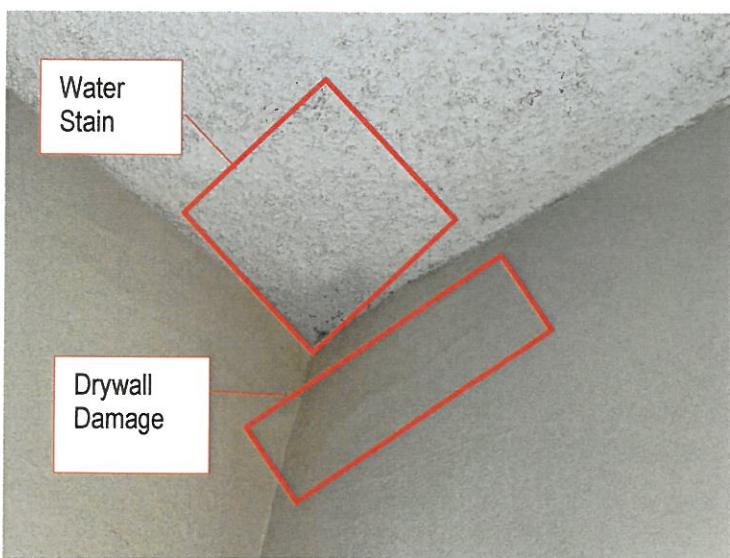
Figure 3: Visualization of Water Stain and Drywall Damage, Unit 303-08

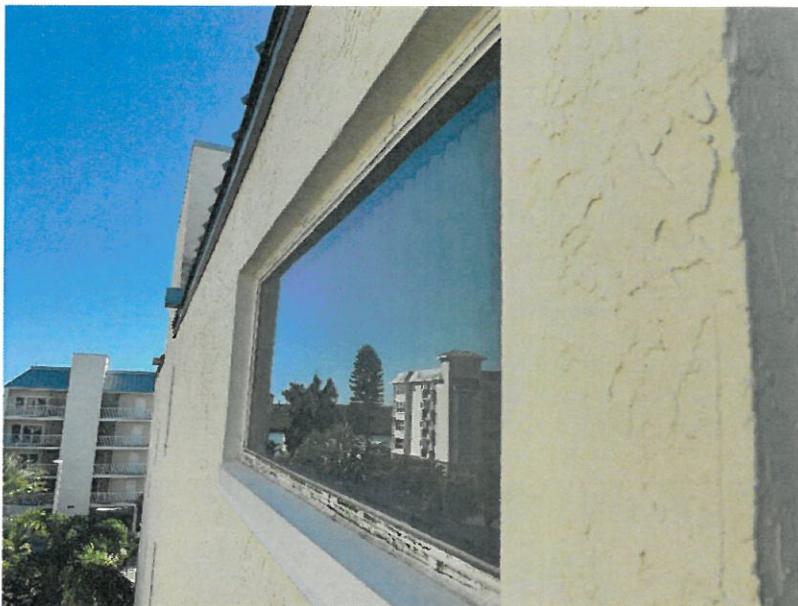
KE was able to observe all the windows from the interior of units. Reports from the Association were that the windows were replaced around 12 years ago. Visual inspections of the windows were to be in generally good condition, KE would recommend redoing the sealants around the perimeter of the windows due to the cracking and deterioration observed. The existing sealants have likely exceeded the useful life. This replacement of the sealants with a hybrid sealant would help the windows maintain its waterproofing around the opening reducing the chance for water intrusion into the units leading to future issues and more costly repairs.

Figure 4: Exterior of Window at Unit 404-08

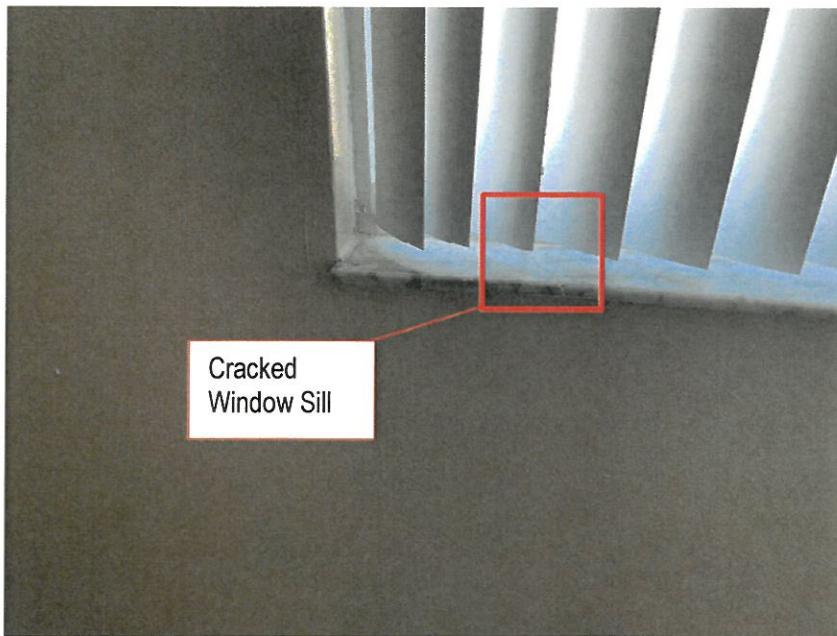
Figure 5: Cracked Sill Observed at Unit 305-09

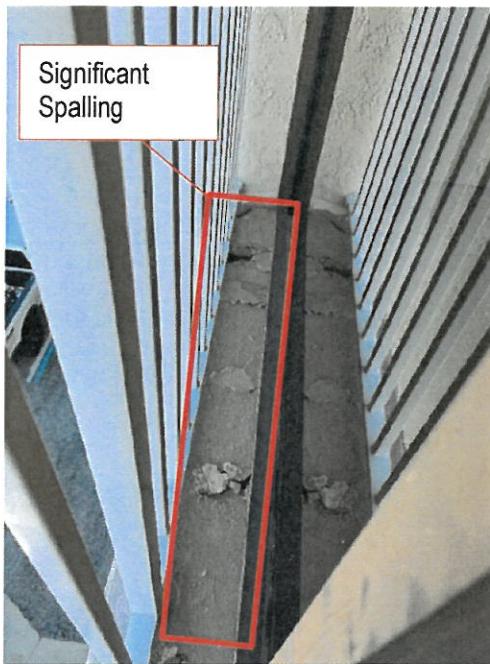
KEG observed Unit 306 at Building 19509, front balcony was observed to have significant spalling and exposed reinforcement occurring at the concrete slab edge, in front of the glass wall. Significant spalling like this could lead to future structural issues or possible failures, unless properly repaired per the ICRI and ACI guidelines.

Spalling concrete is the breakaway of concrete surface which often extends to the top layers of reinforcing steel. The steel is exposed due to the break away of the concrete surface causing the steel to oxidize. Steel oxidizes when exposed to atmospheric moisture (saltwater air) and causes a chemical reaction to the metal surface that causes the steel to corrode inside the concrete.

Figure 6: Significant Spall Occurring at Slab Edge, Unit 306

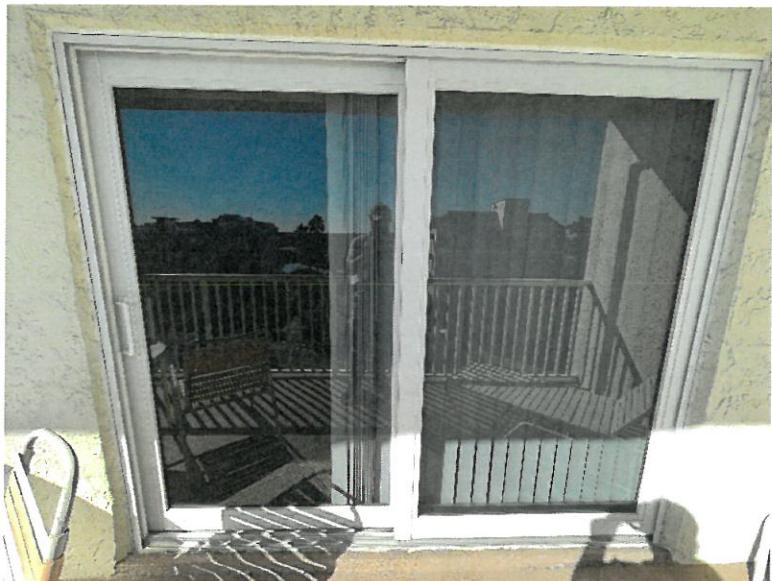
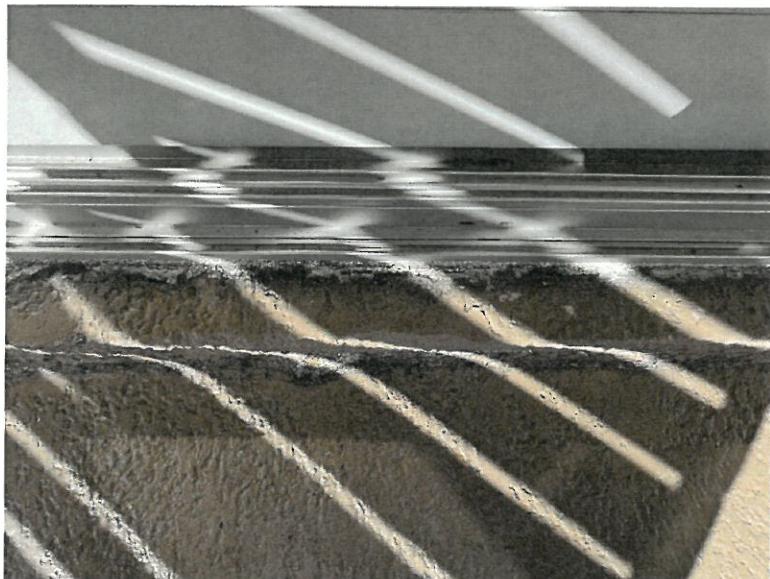
KEG observed every balcony contained one or more sliding glass doors. According to management personnel the sliding glass doors were replaced back in 2016. After visual inspection of the sliding glass doors it appears that the sealants around the perimeter of the sliders are experiencing major cracking and deterioration due to the age and exposure of the harsh Florida environment. Sealants are not only the most widely used waterproofing materials, but also the most incorrectly used. Although sealants are a relatively minor cost item, they constitute a major factor in moisture control during a building's life cycle. Applied from below grade to roof areas and used as components of complete waterproofing systems as well as for detailing junctures and terminations, sealants act as direct waterproofing barriers. As such, sealants are important in constructing successful watertight building envelopes. Sealants are also used to prevent air from infiltrating into and out of a building. Sealants thus have a dual weatherproofing role, the primary role of waterproofing and the secondary role of environment controls.

Figure 7: Visualization of Sliding Glass Door

Figure 8: Sliding Glass Door Sealant Deteriorating

In our professional opinion, Building 19508 and Building 19509 of Bay and Beach Club as a whole are in good condition for the age of the structure, however has areas of concern. The structures do not appear to have any substantial structural deterioration but will require remedial and preventative repair to maintain the condition of the building. KEG observed several areas where repairs should be performed as part of the scope of work for the next maintenance project. This would include the repairing of concrete and stucco spalling and cracking, replacement of sealants and paint coatings, and disposing of the generator on the roof of Building 19508. KEG recommends the sealants shall be removed and replaced at all existing sealant locations of windows, sliding glass doors, and building transitions.

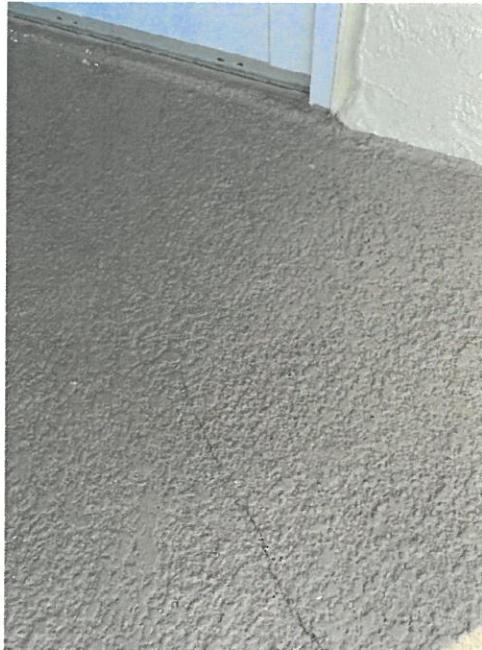
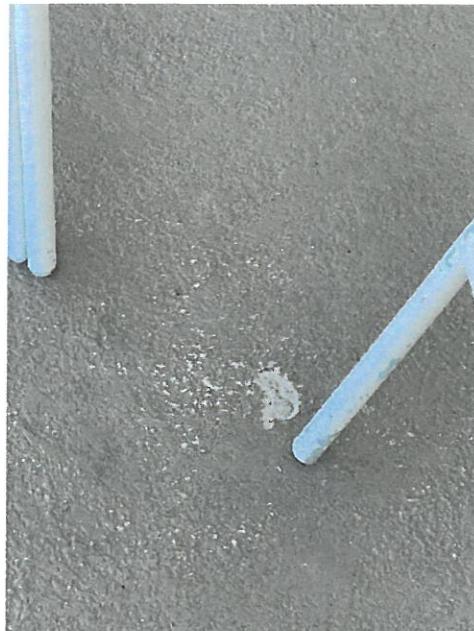
Upon KEG's visual inspection of the concrete balconies, the deck coatings were to be in generally good condition. There appeared to be minimal cracks, spalls and deterioration of the current deck coating occurring. However, the cracking and deterioration of deck coatings could potentially lead to spalling and future structural issues if not repaired in a timely matter. KE would recommend patching the cracks and installing a new waterproofing system at all concrete balcony decks to help protect them from water intrusion into the structure of the building after any necessary repairs to be made at the concrete balcony decks. The use of metal chairs, rugs and carpets should be prohibited.

Figure 9: Visualization of Cracking at Balcony Deck

Figure 10: Visualization of Deteriorating Balcony Deck Coating

The association may wish to consider new waterproofing of the concrete surfaces be included for the balcony decks with the scope of work for painting, sealants and concrete repair. This process must include removal of the existing systems down to the concrete substrate and addressing any cracks and spalling prior to the installation of new coating systems. KEG also recommends that the balconies be water tested in order to confirm the slope testing observed on site. The manufacturer for the coating systems should be contacted to provide specifications for the proper preparation of the existing surfaces. This addition to the scope of work helps to extend the lifespan of the concrete elements and to reduce the exposure to the concrete elements to the airborne salts and moisture that can penetrate the concrete if not properly protected.

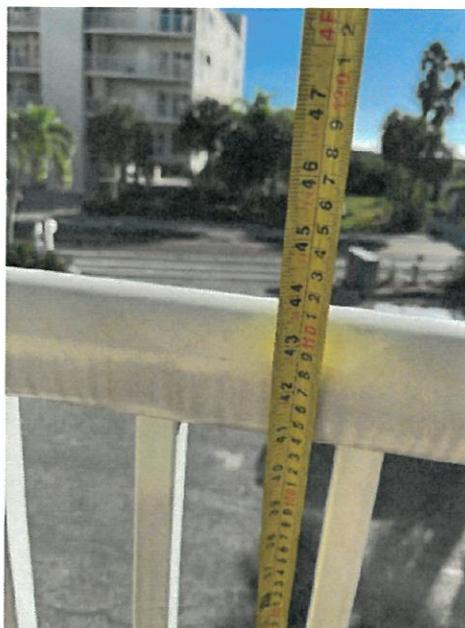
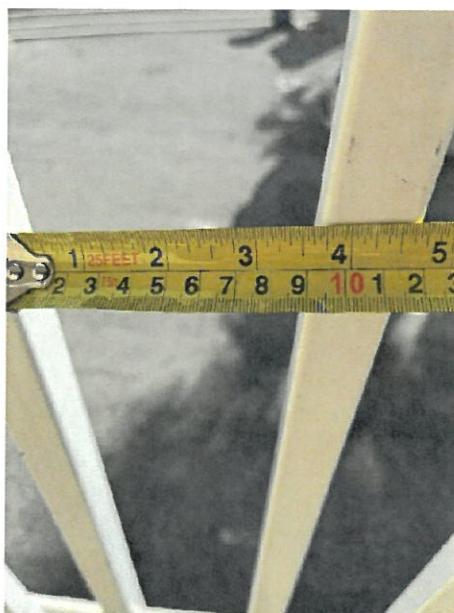
KEG observed guard rails installed for all balconies at Building 19508 and 19509. The guard rail appeared to be in generally good condition. After taking measurements of the guard rails, it was determined that they are indeed within code for the Florida Building Code 2020, 7th Edition. According to Section 1015 of the Florida Building Code 2020, 7th Edition, the height of the guardrail shall not be less than 42 inches measured vertically and shall not have openings that allow passage of a sphere 4 inches in diameter. The guard rail on the balcony measured greater than 42 inches vertically and less than 4 inches between the openings. The guard rails were observed to be sturdy in place and the fasteners were also in good condition for being exposed to the harsh Florida environment.

Figure 11: Visualization of Guard Rail Being to Code Vertically

Figure 12: Visualization of Guard Rail Being to Code for Openings

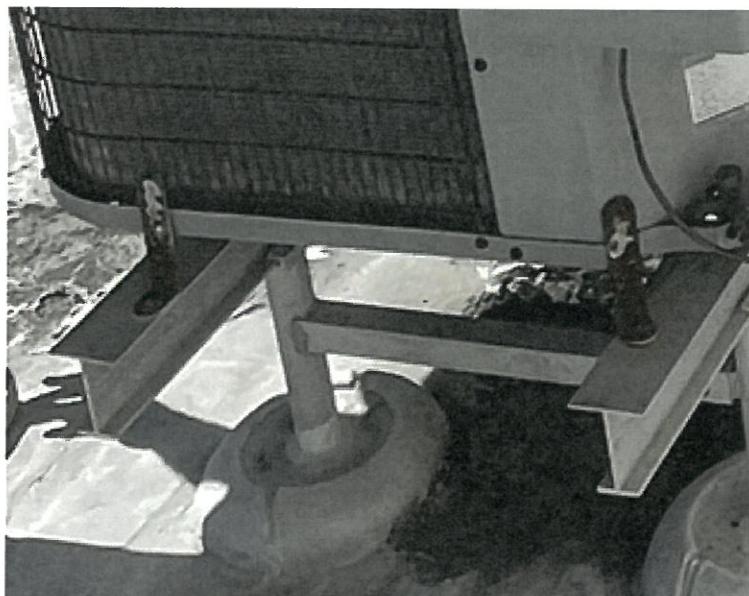
The HVAC systems installed directly on what appeared to be installed on HVAC stands. These systems primarily consisted of the condensers for the individual condo unit air conditioning equipment. KEG observed that the hurricane straps appeared to be in fair to poor condition as oxidation of the fasteners and straps were observed. Over time, the oxidation may become an issue that will affect performance of holding down the units during high wind events. These items should be replaced as necessary or new straps added.

Figure 13: Hurricane Strap with Corroded Fasteners and Metal Straps

The roof appears to be generally in good condition. Routine maintenance of clearing roof drains shall be performed daily or weekly and annual inspections to repair any deficiencies shall be conducted to maintain the condition of the building. Corroded components on the roof and anywhere else on the building should be replaced with stainless steel metals.

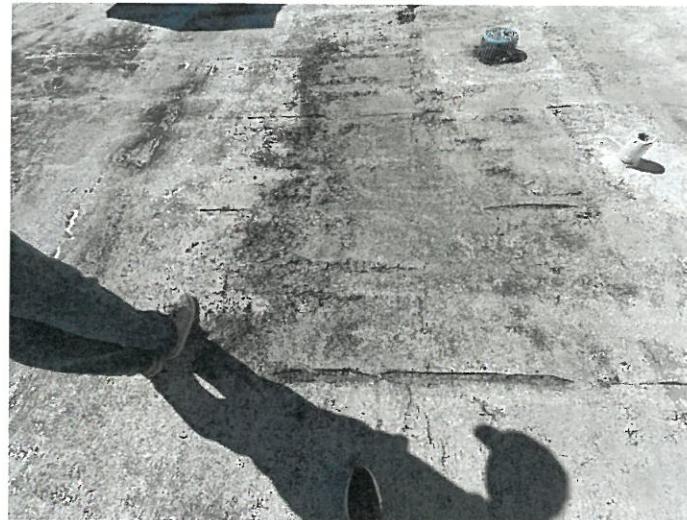
Drainage for the roofs consisted of scuppers and roof drains. Based on the observed condition of the roof, the current design appears to be performing moderately well as KEG did not note any major signs of ponding water on the main flat roof, as there appeared to be no signs of clogging happening around the roof drains.

Figure 14: Visualization of Roof Drain

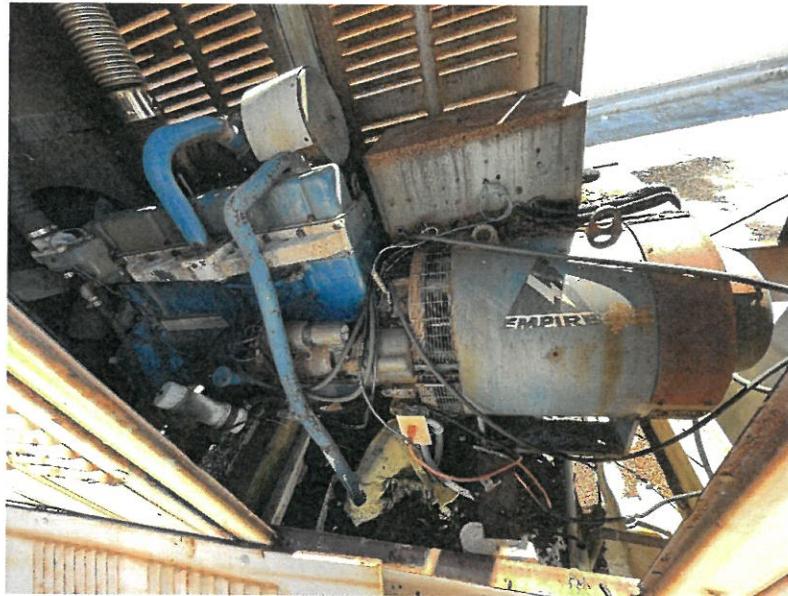
In addition to the roof systems, KEG noted a corroded generator at Building 19508. The generator itself appeared to be out of commission with rust holes in the generator itself. The metal encasement for the generator is rusted out and panel doors laying on the roof top. KEG would recommend disposing of the generator and replacing, this could turn into a safety hazard if a wind event occurs.

Figure 15: Rusted out Generator at Roof of Building 19508

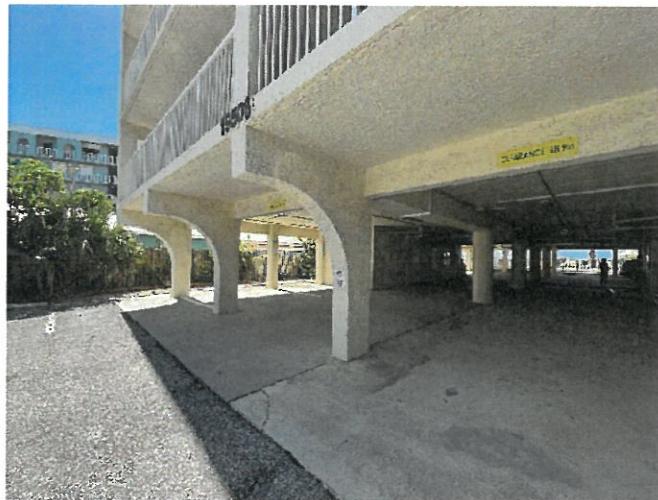
KEG's visual observation included the columns, beams and supports at the parking garage for Building 19508 and 19509. The parking garages appeared to be made up of a hollow core precast ceiling, reinforced concrete columns and reinforced concrete beams. Building 19509 appeared to have very minimal to no issues with cracks, spalling, stucco and delamination of paint, however Building 19508 was observed to have multiple spalling spots, cracking or bubbling stucco and delamination of paint. KEG believes this is because Building 19508 is closer to the water of the Gulf of Mexico with a direct path for wind driven salt laden rain.

KEG also noted the corroded hanger and pipes in the garage, corrosion at the pipe supports is one of the leading causes of piping failures. Rusting at the supports could lead to water being trapped or held in contact with the paint coating on the pipe as well as the paint coating on the support element. Once the paint system fails it causes the pipe to be exposed directly to water, leading to softening or pitting on the pipe, which would eventually lead to a pipe failure. KE would recommend replacing steel pipes with a non-corrosive pipe, where applicable and cutting the corroded hangers out of the hollow core precast slabs then patching over the exposed voids. Hangers should be replaced with stainless steel hangers.

Figure 16: Visualization of Parking Garage at Building 19508

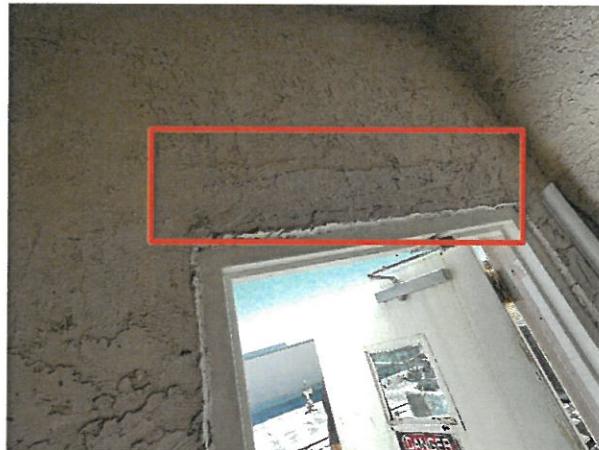
KEG inspected both stairwells at Buildings 19508 and 19509, it appeared to be in generally good condition, however visual spalling was observed above the door jambs at the roof access doors.

Figure 17: Visual of Spalling at Roof Access Door Lintel 19508

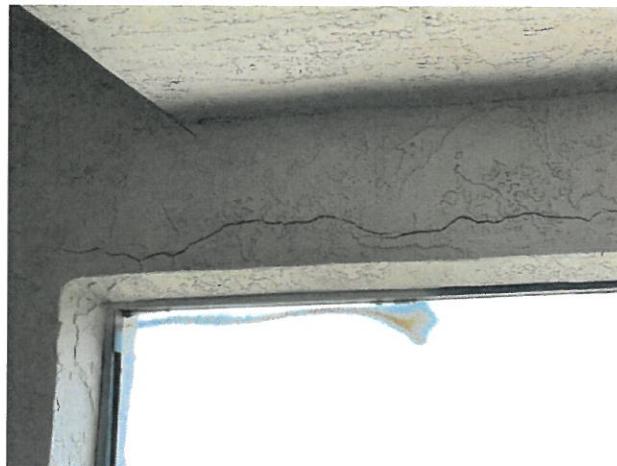
Figure 18: Visual of Spalling / Crack of 4th Floor Landing South Stairwell of 19509

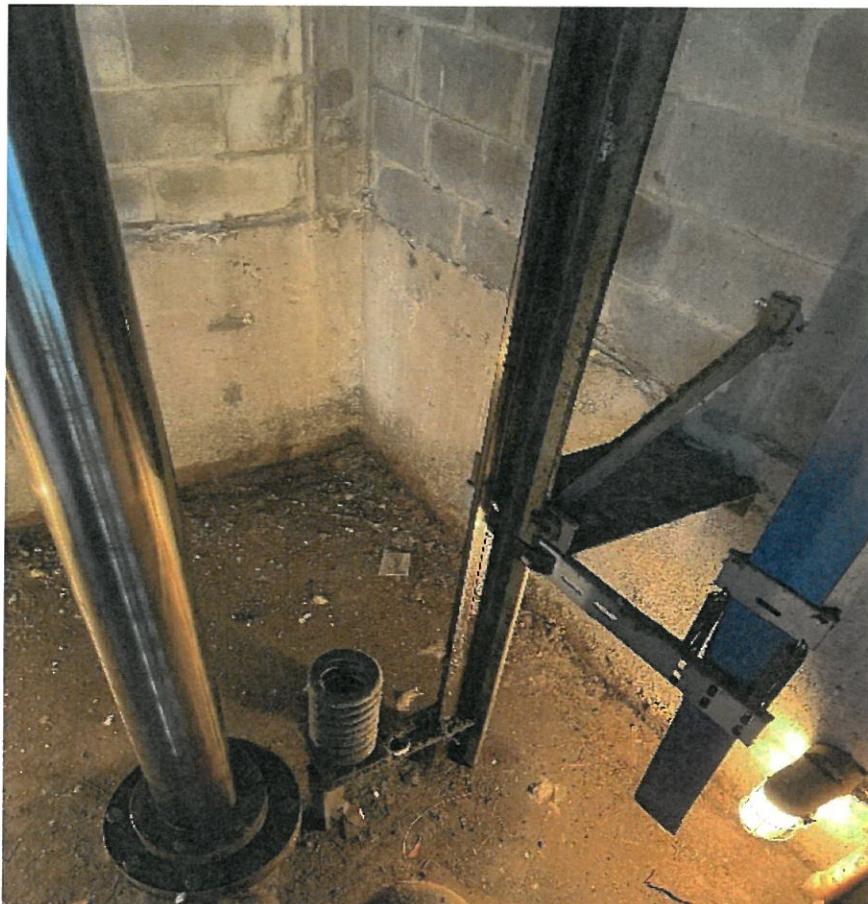
KEG sounded and visually inspected the elevator pits for both buildings as well as visually inspecting the elevator shaft. During the inspection, KEG was provided access to the elevator pit to closely observe the walls of the elevator pit and determine the current state of the equipment. The elevator pit appears to be clean and KEG did not observe any areas that showed signs of spalling concrete.

Figure 19: Elevator Pit 19509
