Beach Place of Indian Shores Condominium Association, Inc.

Milestone Phase 1 Inspection Report

September 10th, 2024

Client: Beach Place of Indian Shores Condominium Association, Inc.
Site Address: 19526 Gulf Blvd, Indian Shores, FL 33785 Parcel ID: 24-30-14-05924-000-0024
Attention: Edward Gerecke, Vice President Contact: Eboiler1978@aol.com

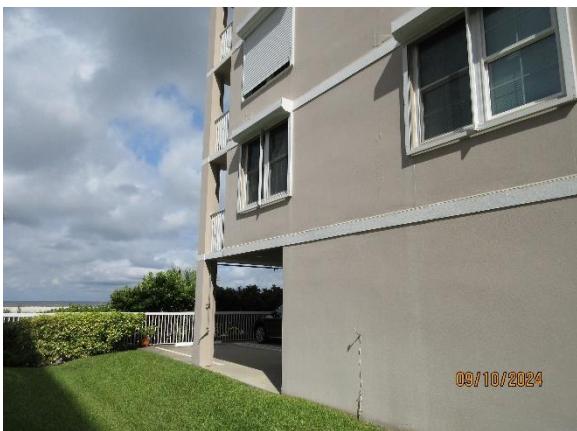
Column @ Balcony Stack at SW Corner of Building

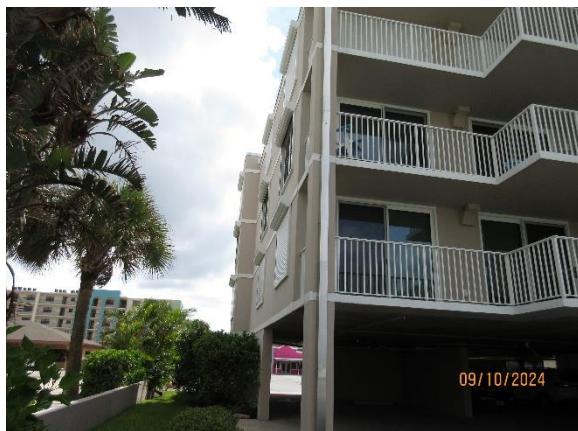
Column @ Balcony Stack at NW Corner of Building

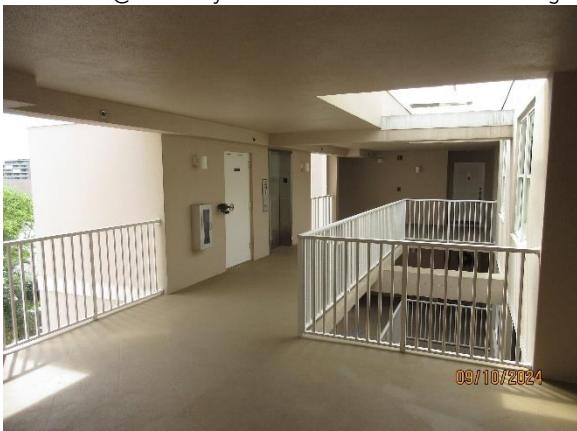
Typical Overview Elevated Walkway

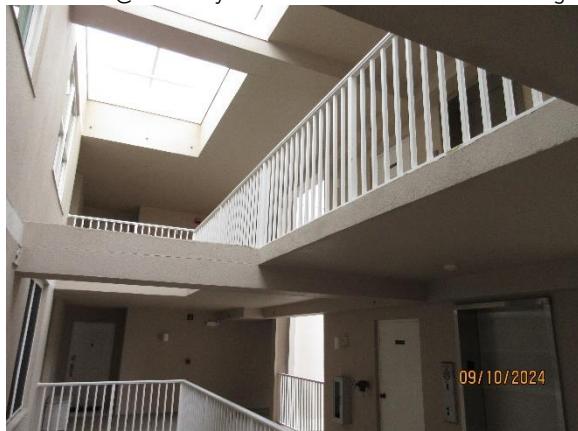
Atrium Roof, Walkway Slab and Beams

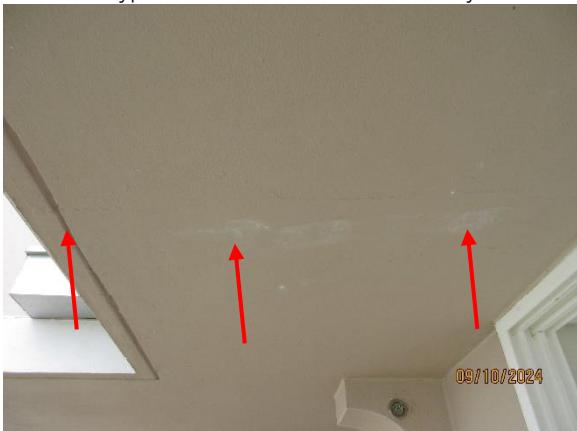
Observations: MSC performed visual observation from the ground and the roof as well as at all elevated walkways and stair towers of the building. Additionally, observations from 55% of unit interiors and the associated exterior balconies were performed at units 1A, 1B, 2C, 2D, 3E, 3F. MSC noted the buildings accessible structural components and systems to generally to be in a good condition, consistent with the boards description and available records of prior maintenance and restorations projects, and no dangerous or unsafe conditions were noted. MSC noted a hairline crack with efflorescence staining at unit 3E balcony ceiling, along with cracking concrete in the drip edge along the slab edge, apparently an isolated concrete spall.

Unit E Balcony Ceiling Efflorescence and Hairline Crack

Recommendations: MSC recommends the damage observed at unit 3E be repaired as soon as reasonably practicable, noting that damage did not constitute substantial structural deterioration, however if repairs are not performed in a timely manner damage to structural concrete and the underlying steel reinforcement will continue to worsen and may present future unsafe and/or dangerous conditions. MSC also recommends the building perform routine maintenance, coating, sealant and waterproofing projects on intervals recommended in the Structural Integrity Reserve study by others.

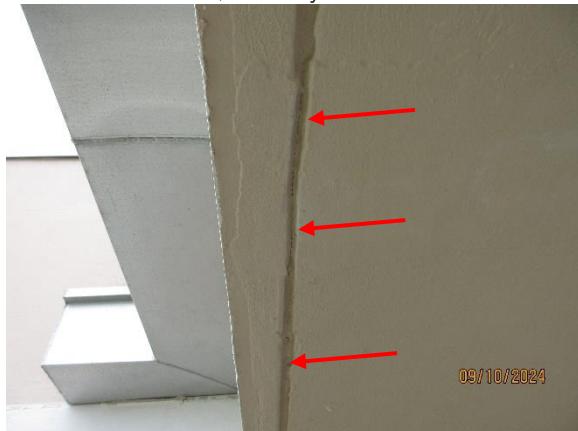
Close-Up Crack at Slab Edge/Drip Edge

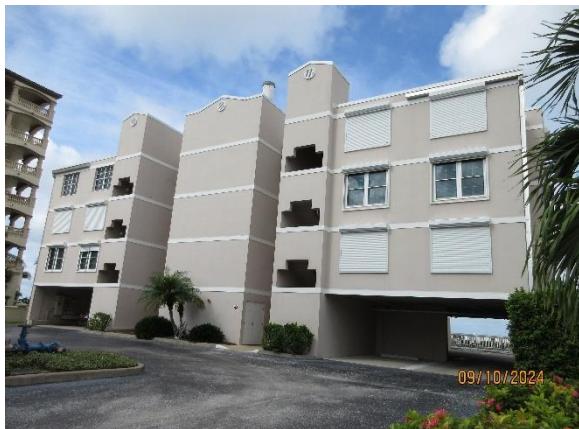
Front (East) Elevation of Building

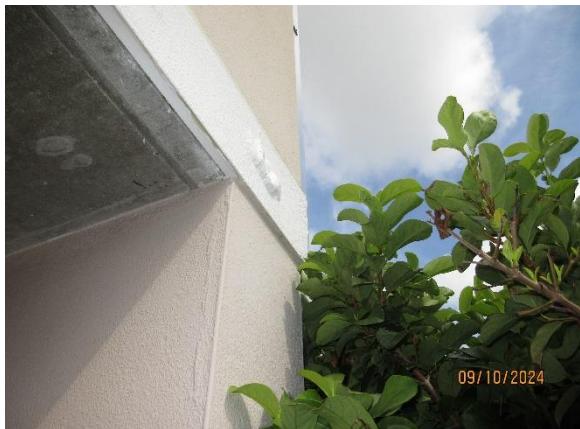
Observations: MSC observed exterior paint coating to be in fair condition, consistent with the age of the coating. Isolated areas of bubbling paint and other isolated areas with water intrusion indicators were present. West elevation paint was observed to be in a similar condition. Walkway and stair waterproofing was observed to be in a fair condition, nearing the end of its useful service life with indicators of areas of delamination and failed coatings and previous repairs. Balcony waterproofing at the first elevated floor was observed to be in good condition consistent with MSC understanding of recent work performed. Waterproofing at other balconies was observed to be in fair condition consistent with the age of the components.

Close-Up Paint Bubble NE Garage Entrance

Recommendations: Existing stucco veneer, paint coatings, and sealants were observed to be nearing the end of their intended useful life and should be replaced in accordance with the recommendations in the Structural Integrity Reserve Study by others. Paints exposed to corrosive coastal environments should be replaced every 7 years and sealant applications every 7-10 years, along with stucco repairs performed as needed.

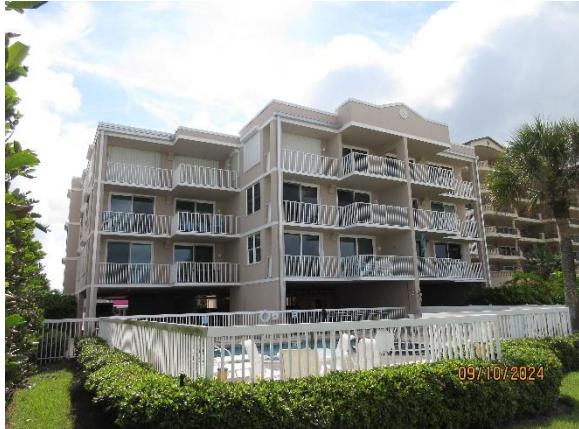
Rear Elevations (From NW)

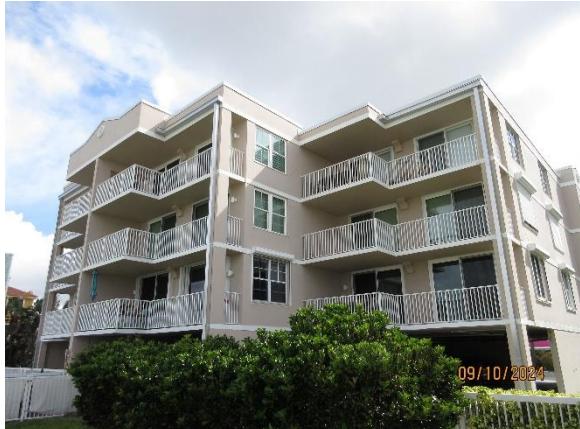
Rear Elevations (From SW)

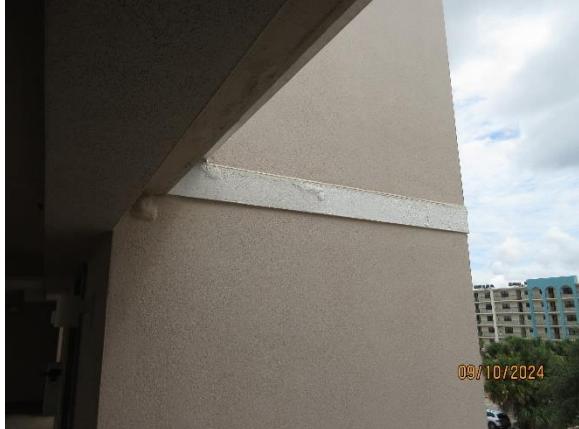
Paint Bubbles at Elevator Tower Band

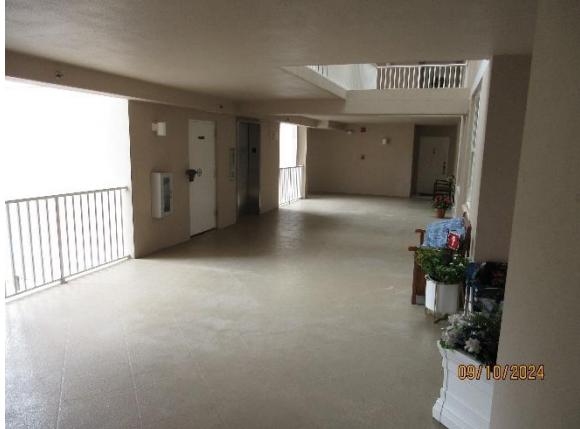
Overview 1st Elevated Walkway

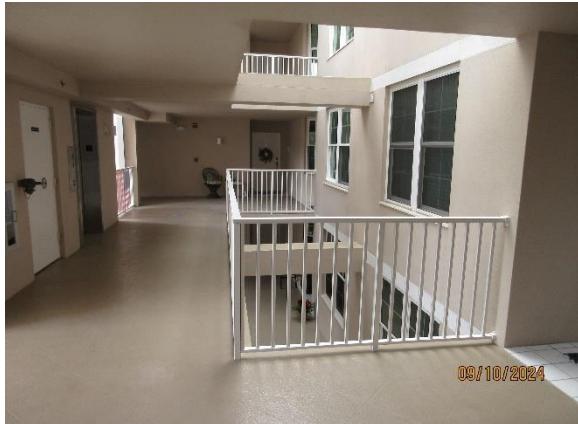
Overview 2nd Elevated Walkway

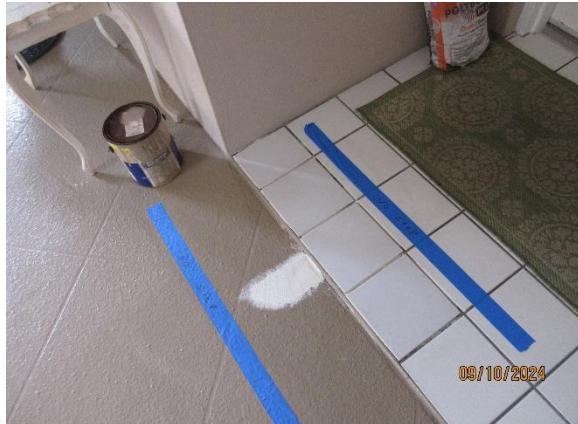
Damage to Waterproofing at Unit Entrance

The waterproofing at walkways, balconies, and stair towers is currently in fair condition but is nearing the end of its intended useful life. For a urethane pedestrian traffic system, this is typically 5-10 years depending on the system. MSC recommends that the board prioritize replacing the walkway waterproofing due to its age and condition. This waterproofing is essential for protecting the underlying structural concrete and should be replaced at standard intervals as recommended in the Structural Integrity Reserve Study (by others). Doing so will help prolong the useful life and structural integrity of the building and its components.

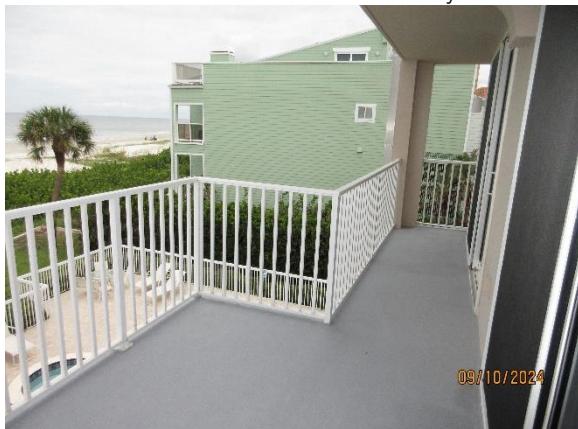
Overview Typical Balcony Waterproofing

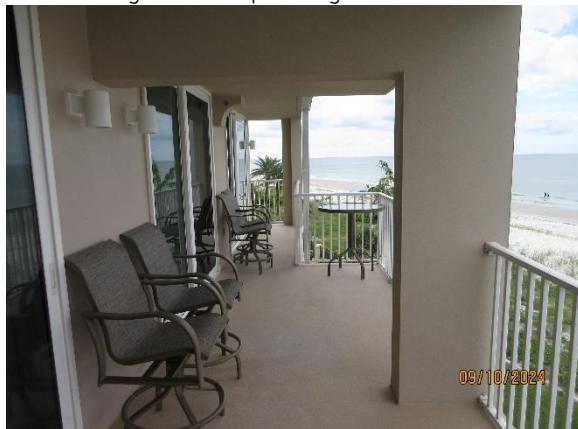
Unit E Balcony Overview

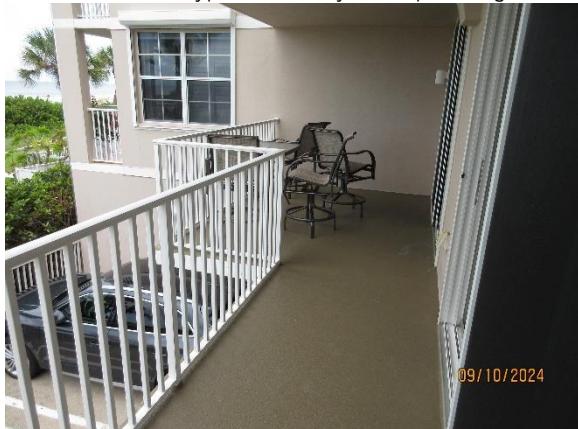
Overview 2nd Floor Balcony (New Waterproofing)

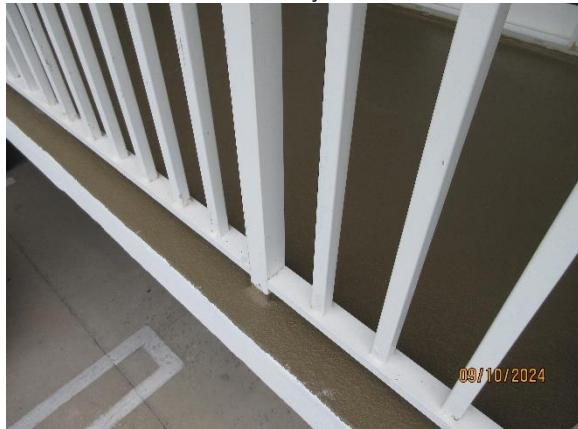
Close-Up New Waterproofing at Railing Post Pocket

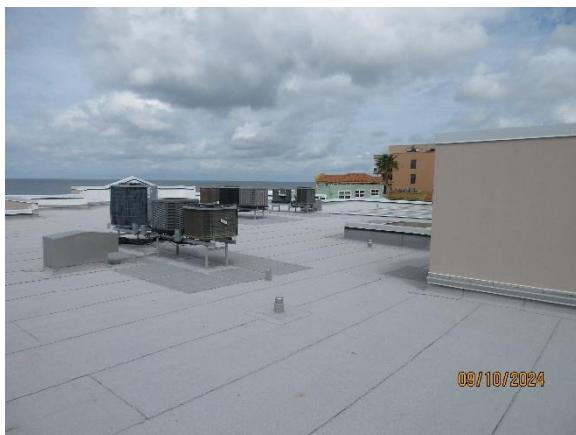
Roof Overview (SE to NW)

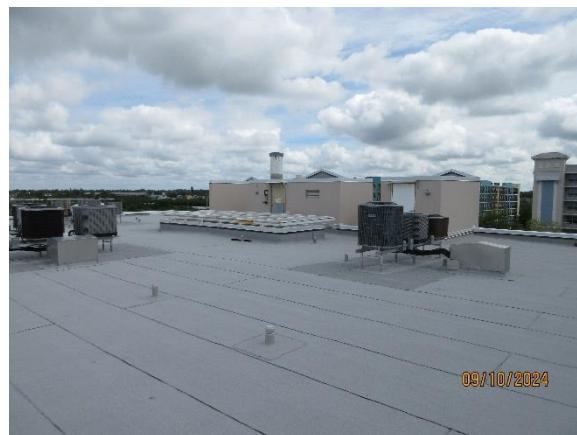
Roof Overview (SW to NE)

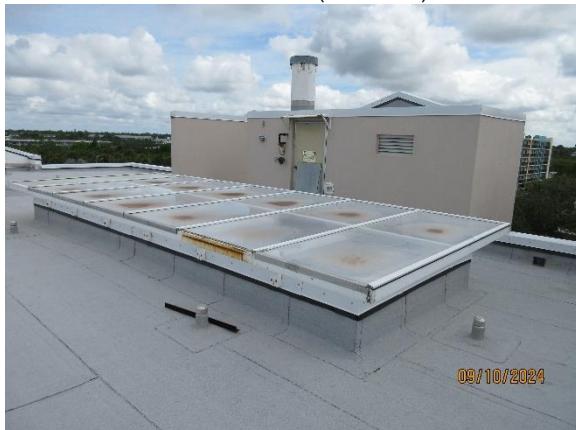
Atrium Roof Overview

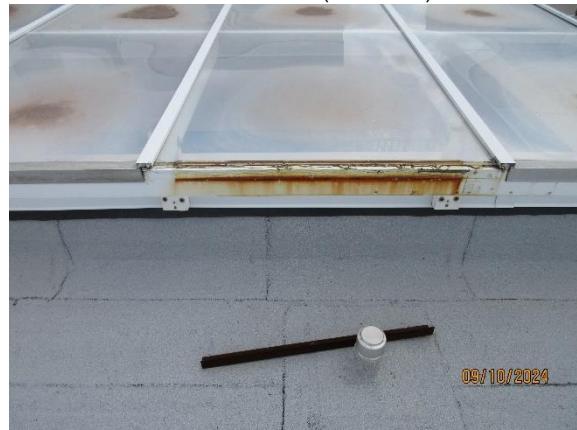
Observations: MSC performed visual observation on top of the roof accessed by the south stair tower. The roof was observed to be in good condition, as expected with the age of the elements. MSC noted an area of corrosion and missing fasteners at the atrium roof at the edge of one of the panels. No dangerous or unsafe conditions were noted.

Corrosion and Damage to Steel Angle at Panel Edge

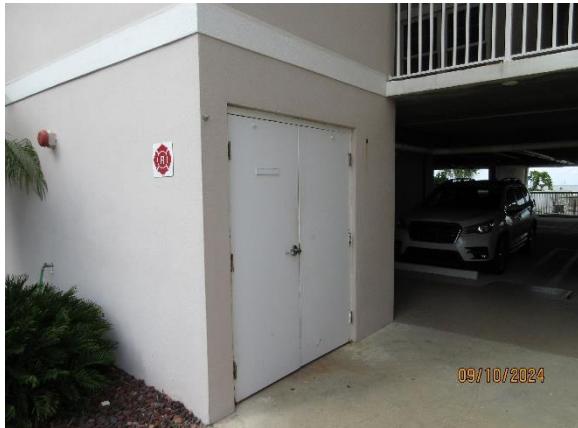
Trash / Fire Pump Utility Room Door

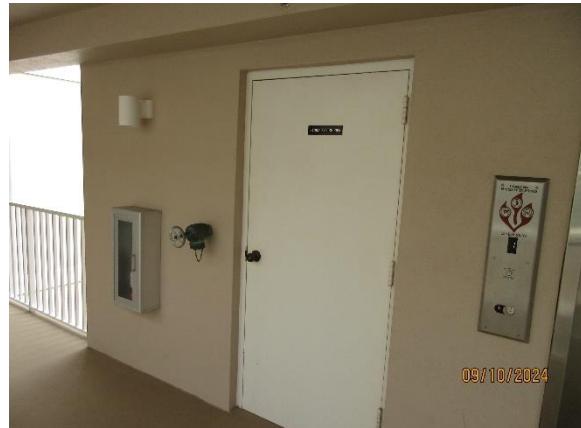
Typical Utility Room Door

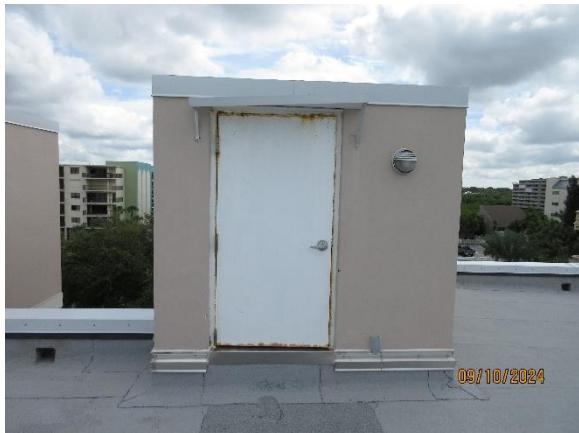
Observations: Steel utility and storage room doors were observed to be in fair condition in general, with varying degrees of corrosion present. The door at the south stair tower roof access frame and elevator equipment room doors were observed to be in serviceable but weathered condition, as expected due to the age and direct exposure to the coastal environment. Unit windows and sliding glass doors were observed to be in varying condition based on age of the components, multiple locations have newer style doors and windows in good condition and other units have components in a fair and operable condition. No dangerous or unsafe conditions were noted.

Typical Stair Tower Roof Entrance Door

Recommendations: Community owned doors were in operable condition and should be replaced in accordance with their remaining useful life as described in the Structural Integrity Reserve Study (by others). MSC recommends the doors at the roof level be replaced with priority due to the advance corrosion present and the direct exposure to corrosive environment.

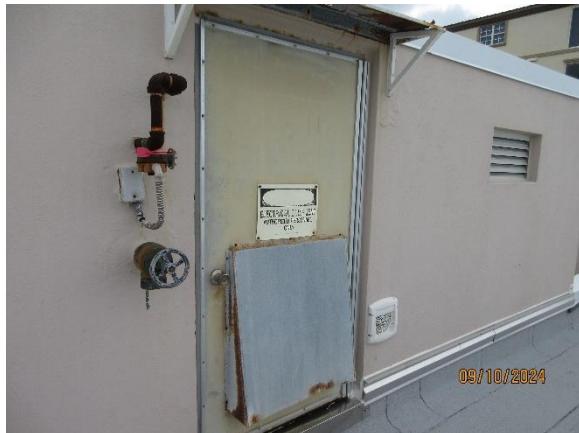
Elevator Equipment Room Door

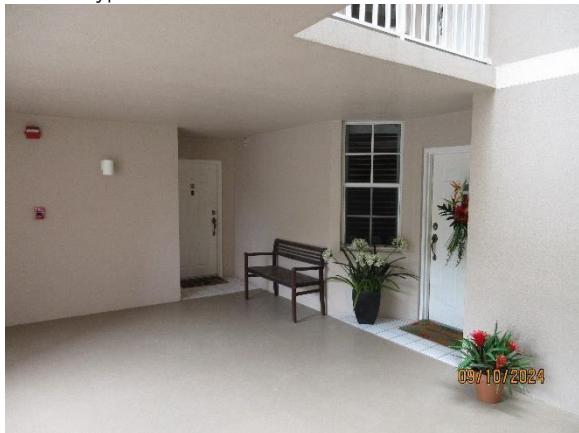
Typical Unit Entry Doors

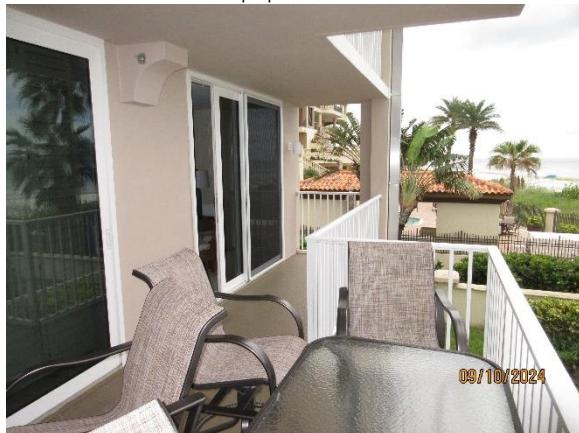
Typical Balcony Access Sliding Glass Doors

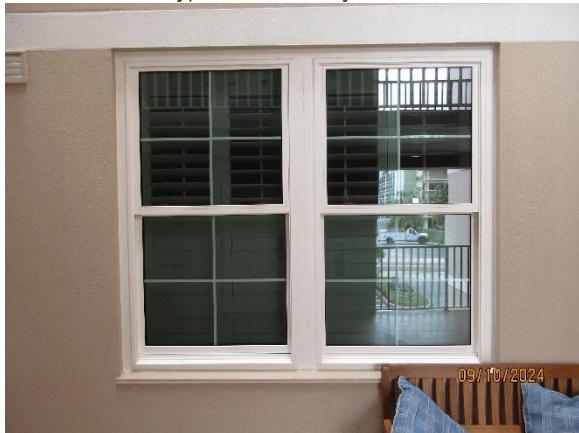
Typical Private Unit Window

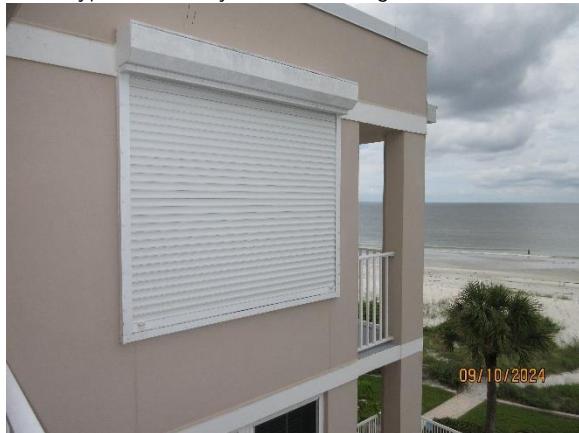
Storm Shutter at Window

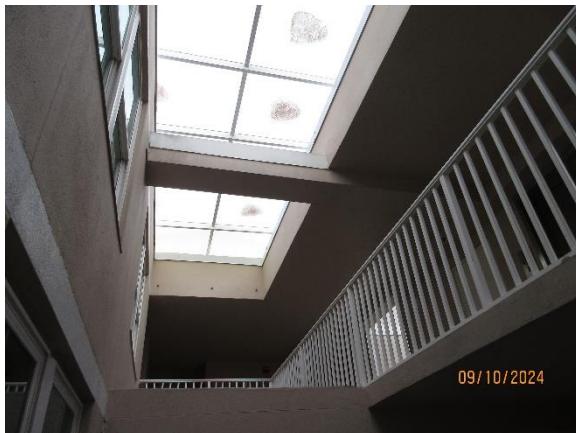
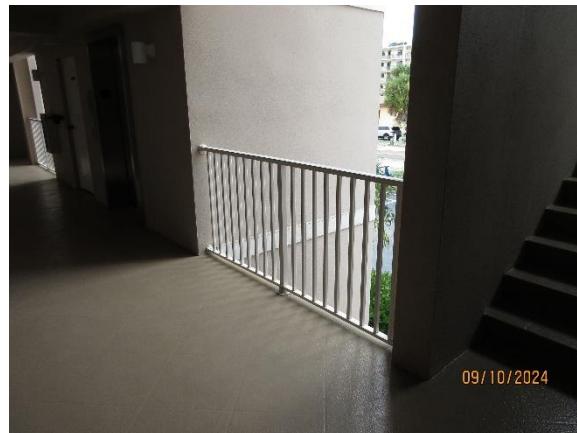
Typical Walkway Railings

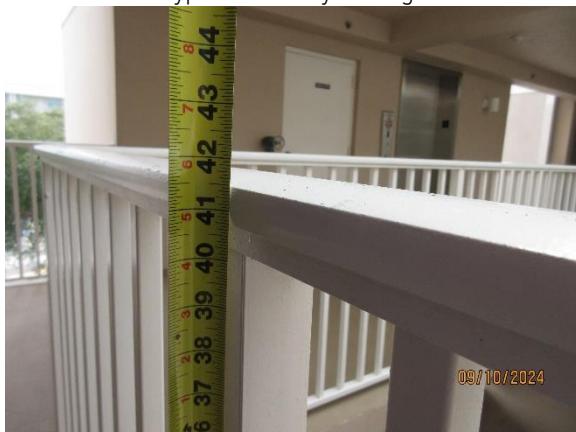
Walkway Railing Measurement

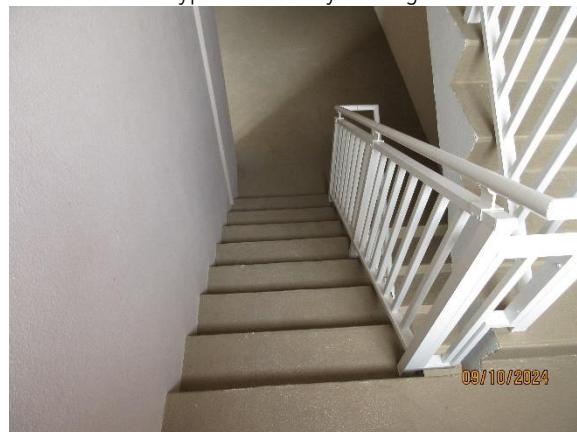
Typical Stair Railings

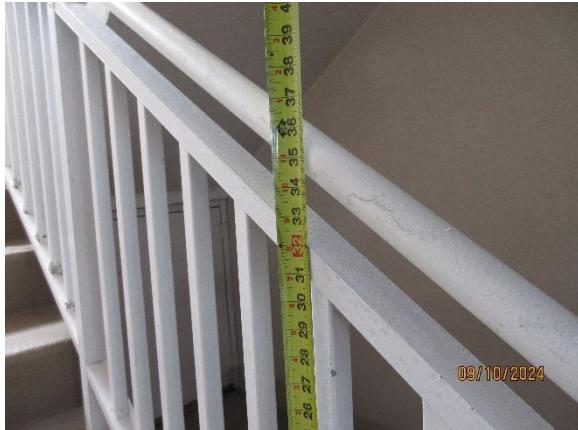
Stair Railing Measurement

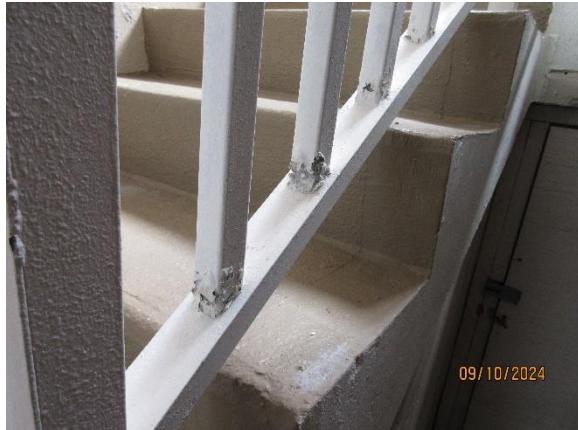
Observations: Guardrails were observed to be in a good to fair condition considering the age of the components. No dangerous or unsafe conditions were noted. The railing coatings did show signs of wear and at select locations missing and peeling coatings were observed. At upper balcony locations, corroded fasteners and rust staining was observed at select locations. MSC also noted railing at the stairs at ground floor have multiple damaged pickets and do not meet current FBC requirements.

Damage to Railing Pickets at Stairs

Recommendations: MSC noted multiple areas where railing pickets require repairs due to damage and degradation of the aluminum and failed coatings. Additionally, the railing coatings in general were beyond their useful service life and it is recommended that a new coating be applied to aid the components achieve their full useful service life until their scheduled replacement per the Structural Integrity Reserve Study (by others). Aluminum railings, especially in coastal environments, have a typical service life of 30 - 40 years depending on coatings, materials and maintenance. MSC also recommends all corroded fasteners be replaced with like sized stainless-steel fasteners set in sealant.

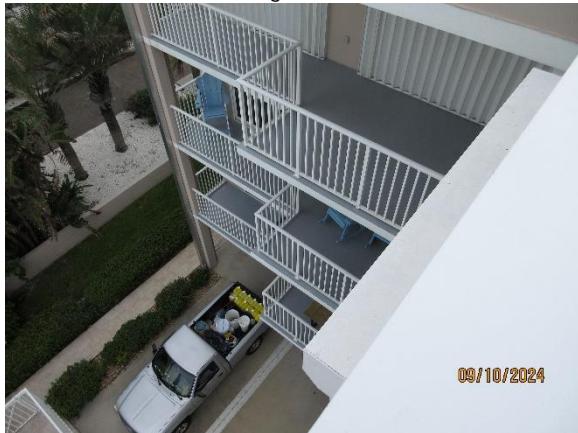
Typical Balcony Railings (North)

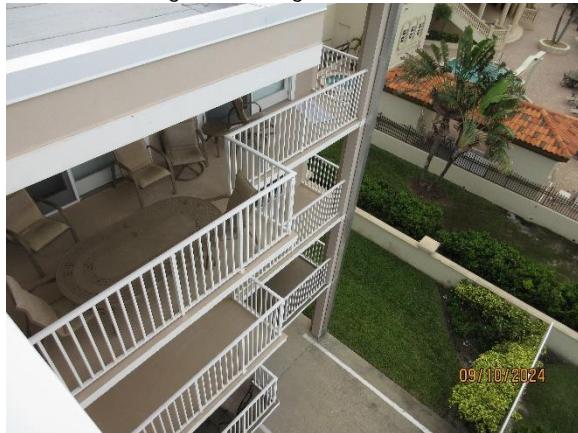
Typical Balcony Railings (South)

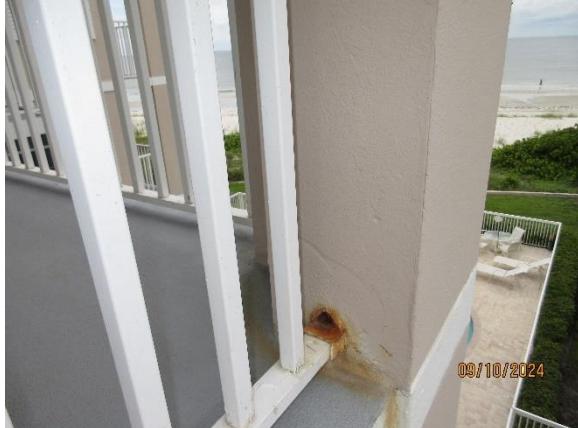
Corroded Fastener at Balcony Railing

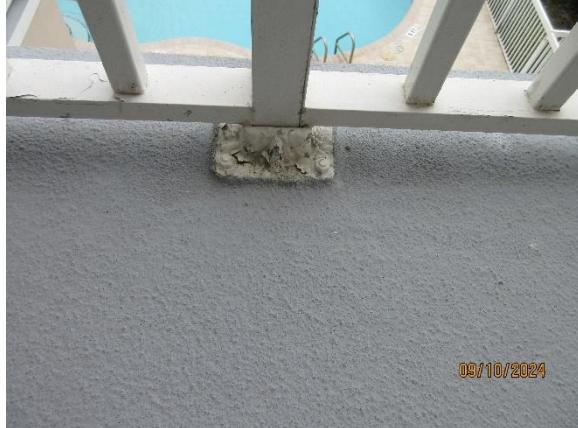
Railing Coating in Poor Condition at Base Plate

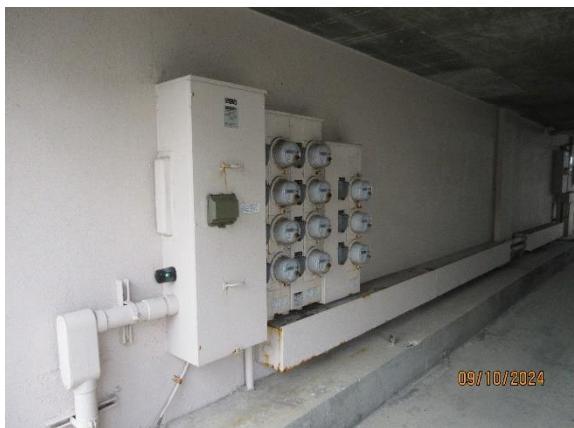
Overview Residential Meter Bank

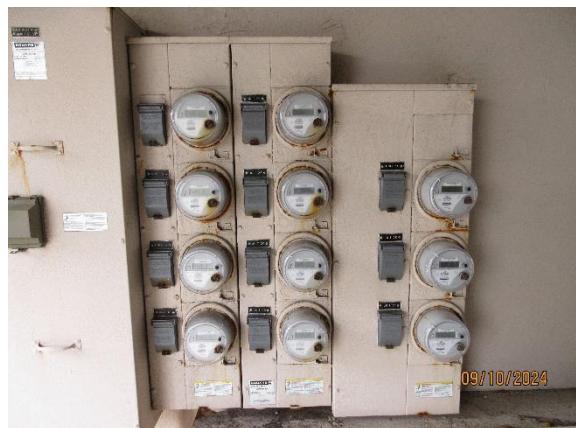
Observations: MSC observed all accessible MEPF components to be in visually working order. MSC noted the electrical bank to be in fair condition with moderate corrosion present. MSC also noted conduits in the garage and through deck plumbing components to have moderate corrosion. Similar corrosion was noted at the roof level fire sprinkler piping outside of the elevator equipment room.

Close-Up - Moderate Corrosion Present

Recommendations: MSC recommends continued annual service performed by a licensed fire protection service company to maintain the fire alarm and protection systems. MSC also recommends that a licensed electrician performs a survey of the electrical meter bank to verify the corrosion does not present issues to the system. Due to the age of the electrical system components, along with the exposure to the coastal environment, replacement/modernization of components should be considered especially after Hurricane Helene and Milton in 2024. MSC also recommends the association look into feasibility of moving electrical to the second elevated floor due to the hurricane prone region and storm surge possibilities.

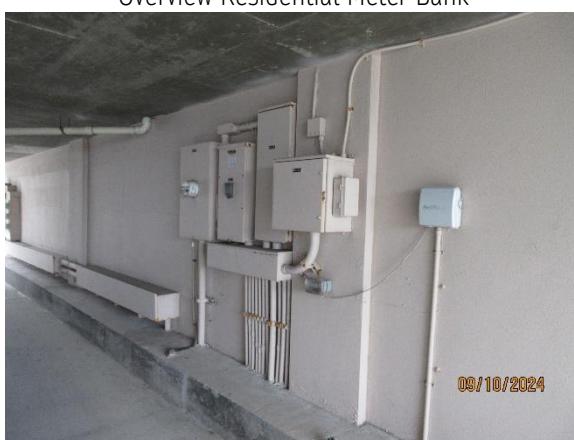
Overview Common Electrical

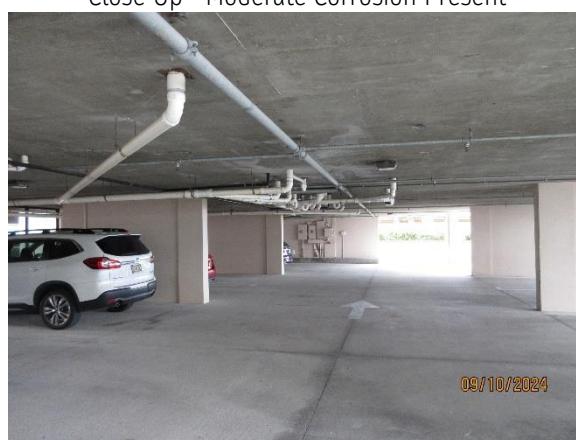
Overview Exposed Plumbing in Garage

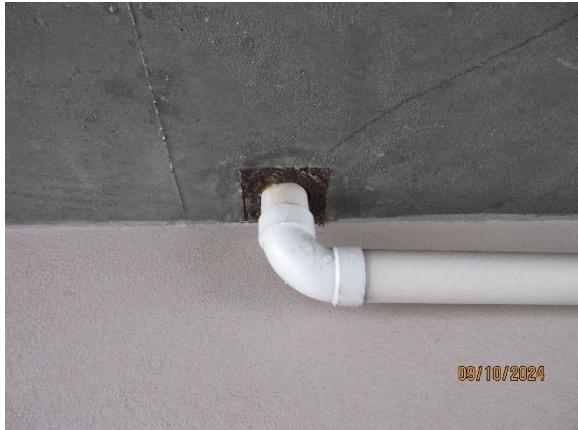
Close-Up Corrosion at Plumbing Penetration

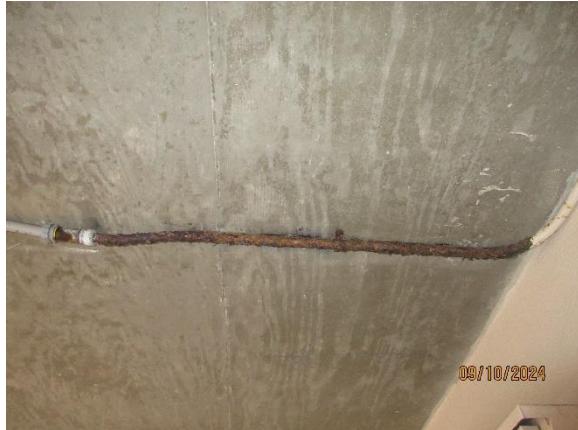
Corrosion at Conduit Garage

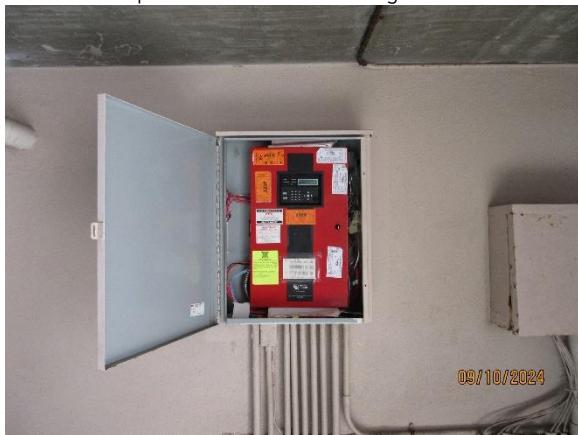
Fire Alarm System Control Panel

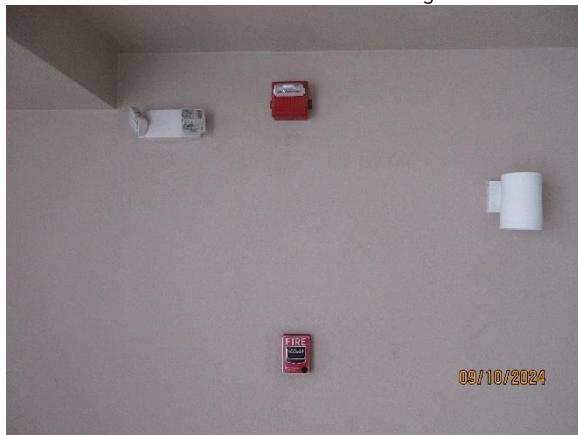
Typ. Pull Station, Flasher, Sounder, Emergency Lights

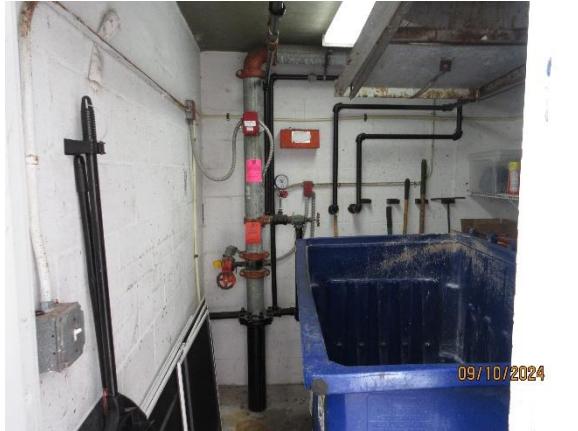
Fire Sprinkler Pipe

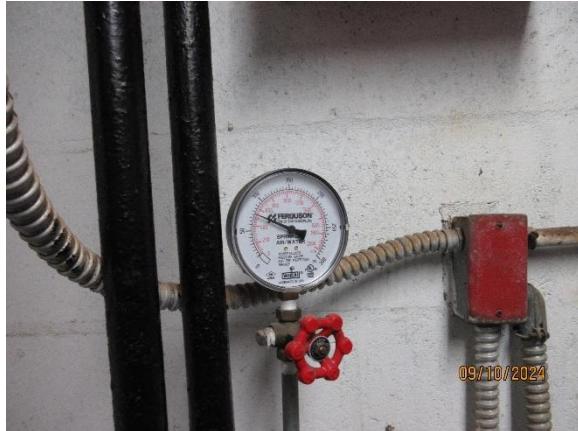
Pressure Gauge at Sprinklers

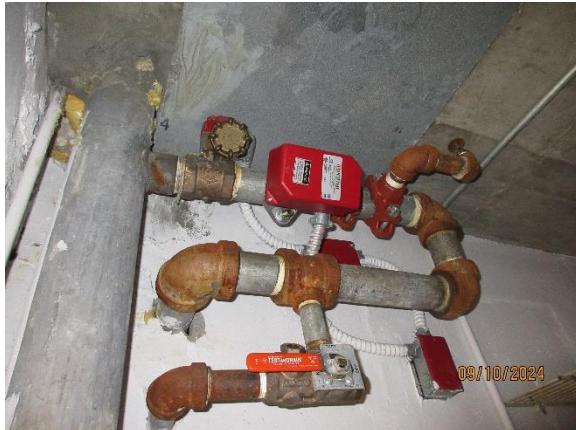
Fire Sprinkler Plumbing at Utility Closet

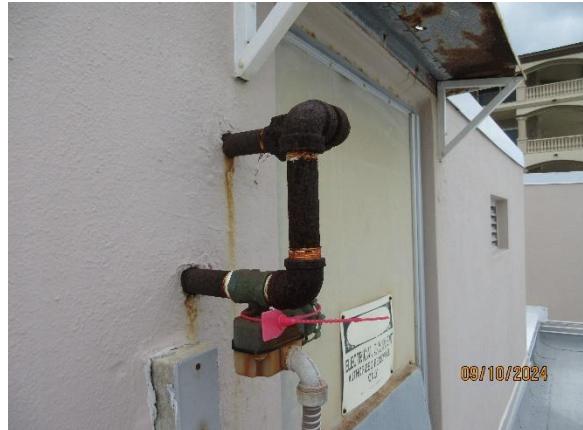
Corrosion at Fire Sprinkler Pipe Roof

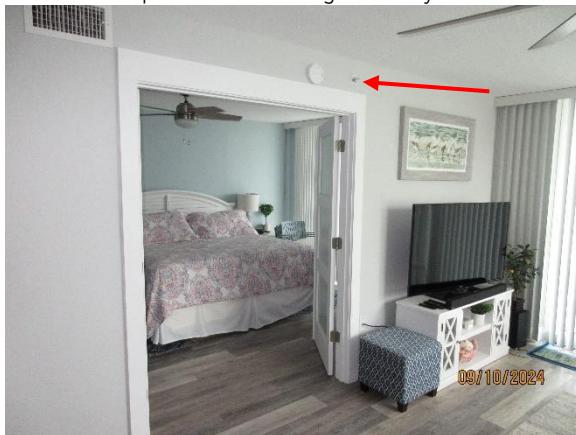
Residential Fire Alarm and Sprinkler

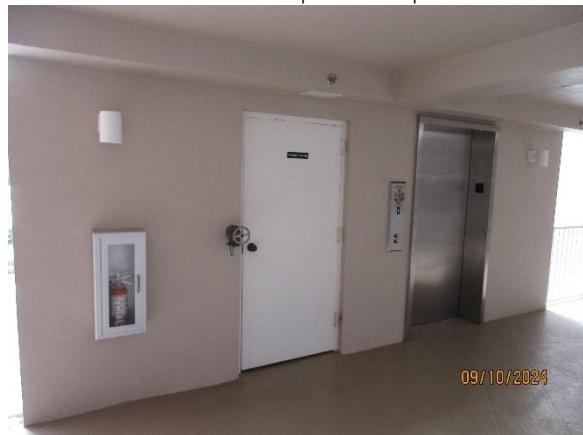
Overview Elevator at Typ Floor

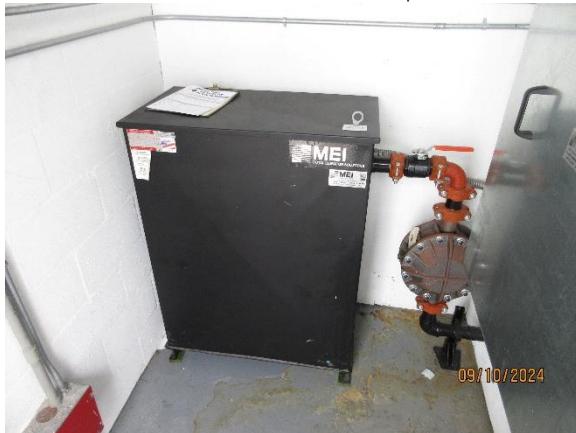
Hydraulic Elevator Power Unit

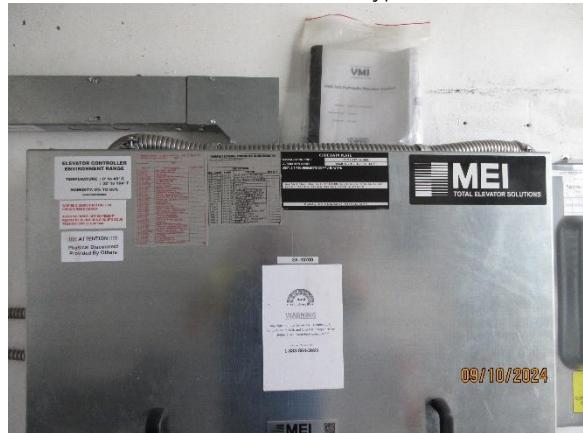
Hydraulic Elevator Control
