August 22, 2023

**Subject: Building Condition Survey
Milestone Inspection
19531 Gulf Blvd.
Indian Shores, Florida**

**Building Condition Survey
Golden Shores Condominium
Indian Shores, Florida**

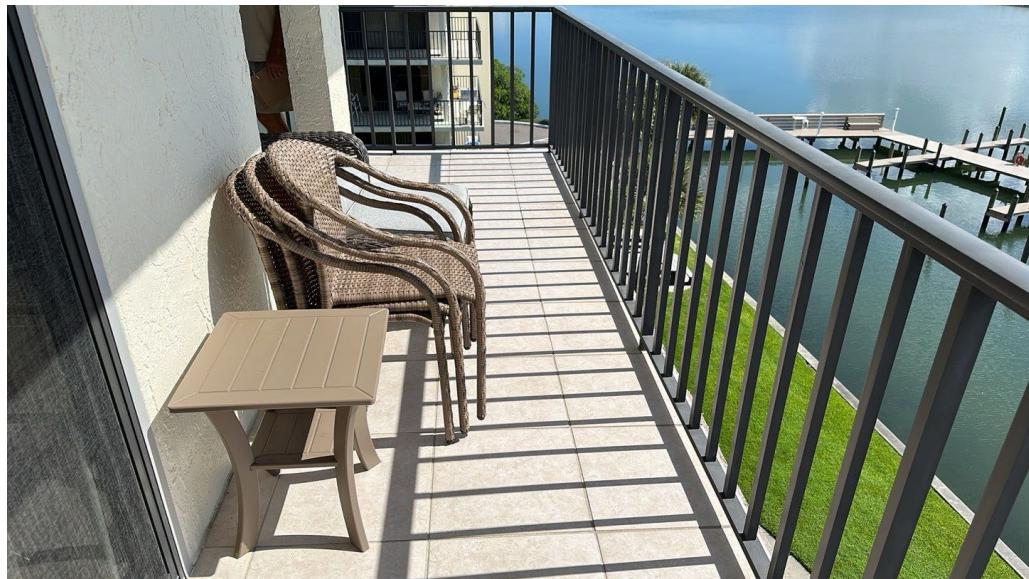
Figure 1

1. The flooring on the balconies consisted of either a urethane coating or ceramic tile. Refer to *Figure 1*.

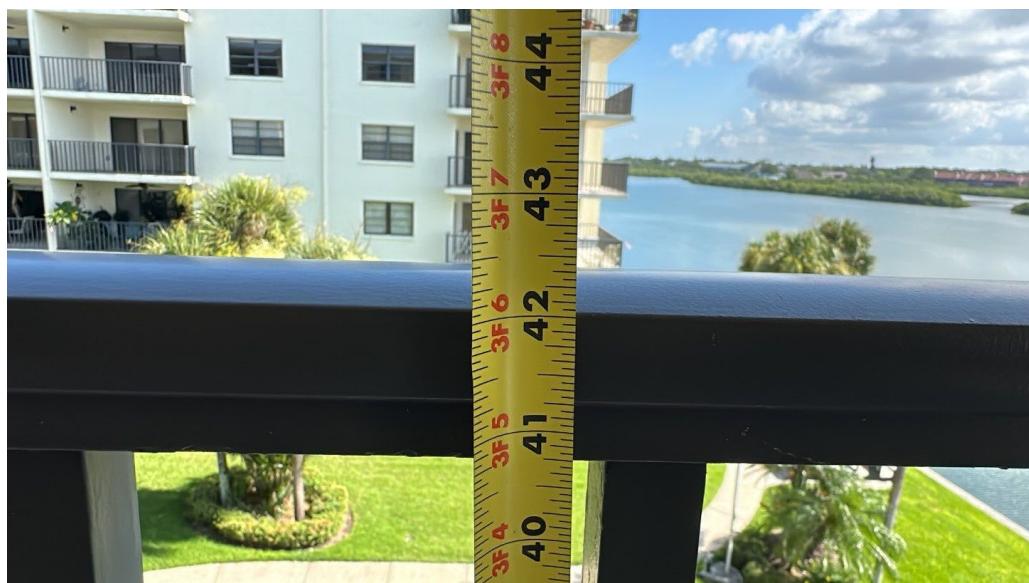
Figure 2

2. The railing of the balconies was found to be 42.25 inches in height, which is in compliance with the current building code. Refer to *Figure 2*.

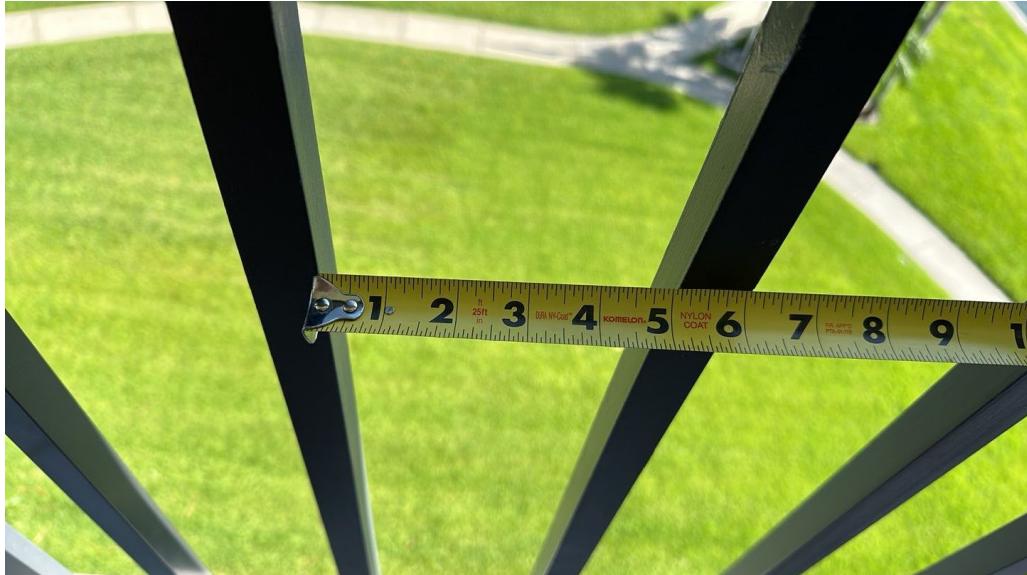
Figure 3

3. The clear opening between the pickets in the guardrail on the balconies was found to be 5 inches. The current building code requires a clear opening of less than 4 inches. Refer to *Figure 3*.

1. The balconies with localized delaminated tiles should be monitored and if the delamination is found to increase, or tenting develop, the tiles should be removed and a waterproofing membrane installed. PE does not recommend tile be reinstalled. For improved aesthetics a Gemstone coating can be applied to look similar to tile.
2. The walkways and decks with urethane finish should be resealed as according to the manufacturer.
3. The rail system on the walkways evidenced widespread corrosion, supplemental clipping and were not in compliance with current code. If the noncompliant railing is ever removed from the structure it will be required to be replaced with new code compliant railing.

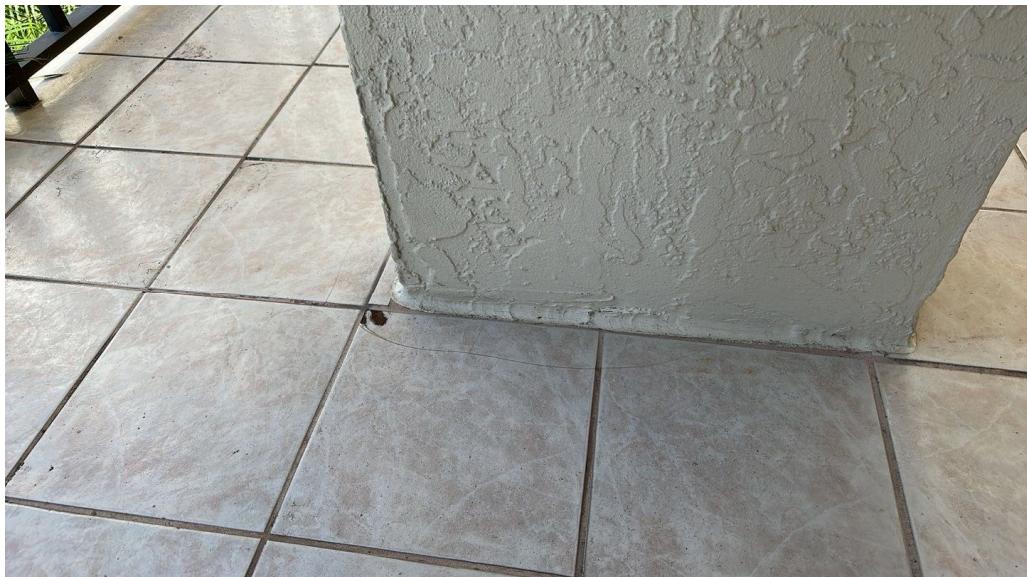
Figure 4

4. Tiles in the area of balcony columns evidenced widespread delamination and tile cracking. Refer to *Figure 4*.

- g. Application of an appropriate concrete repair material
2. The balconies with widespread delaminated tile and tented tiles should have the tile removed and a new waterproofing membrane installed. PE does not recommend tile be reinstalled. For improved aesthetics a Gemstone coating can be applied to look similar to tile.

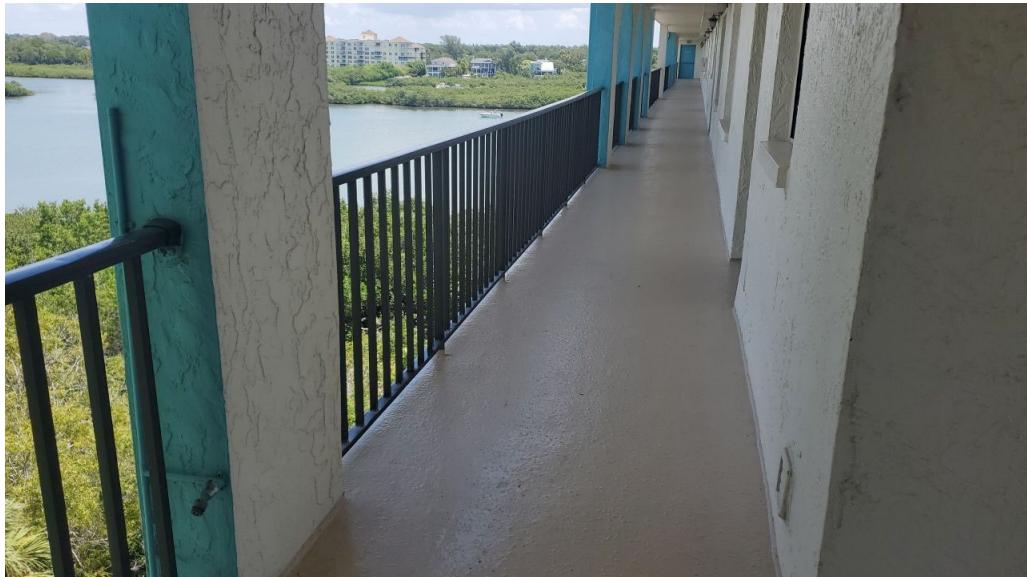
Figure 5

6. The flooring on the walkways consisted of a waterproofing membrane that was recoated with a rethane circa 2020. Refer to *Figure 5*.

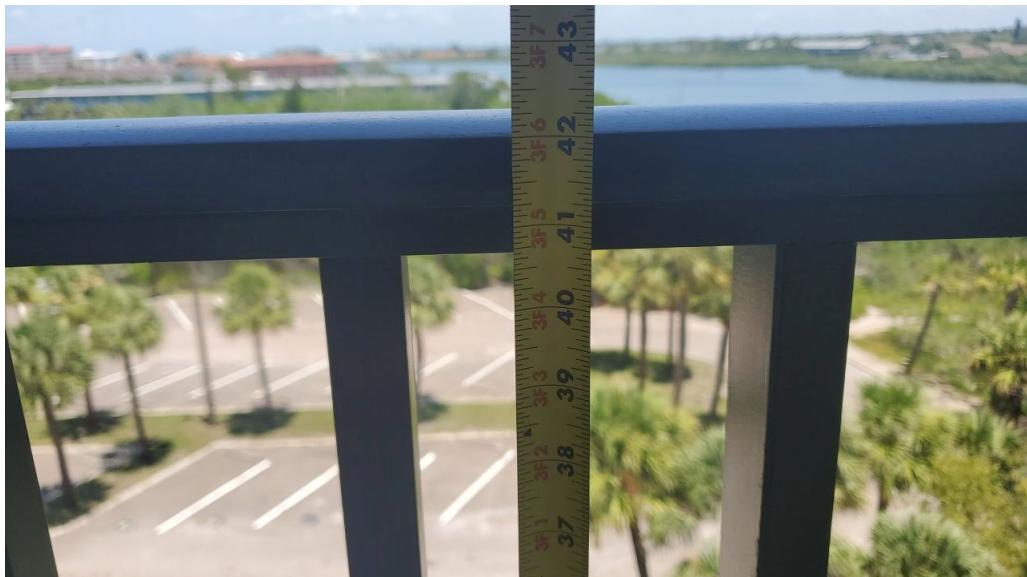
Figure 6

7. The railing of the walkways was found to be 42.25 inches in height, which is in compliance with the current building code. Refer to *Figure 6*.

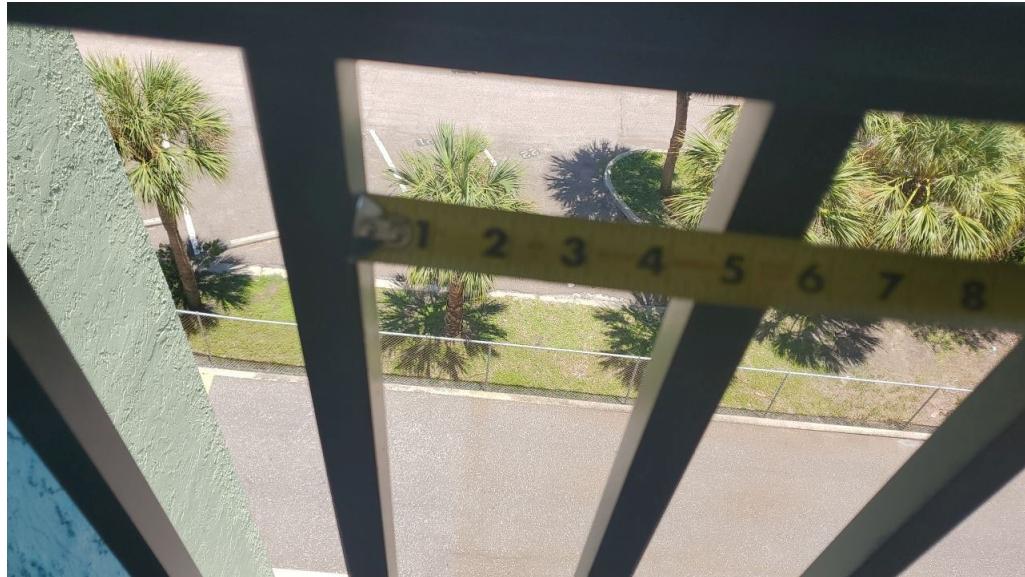
Figure 7

8. The clear opening between the pickets in the guardrail on the balconies was found to be 4.75 inches. The current building code requires a clear opening of less than 4 inches. Refer to *Figure 7*.

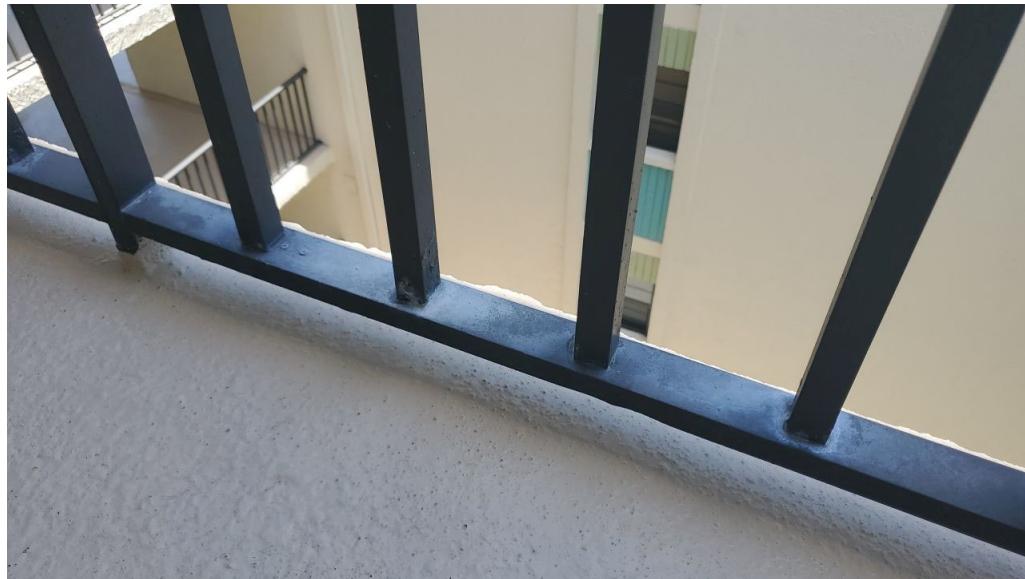
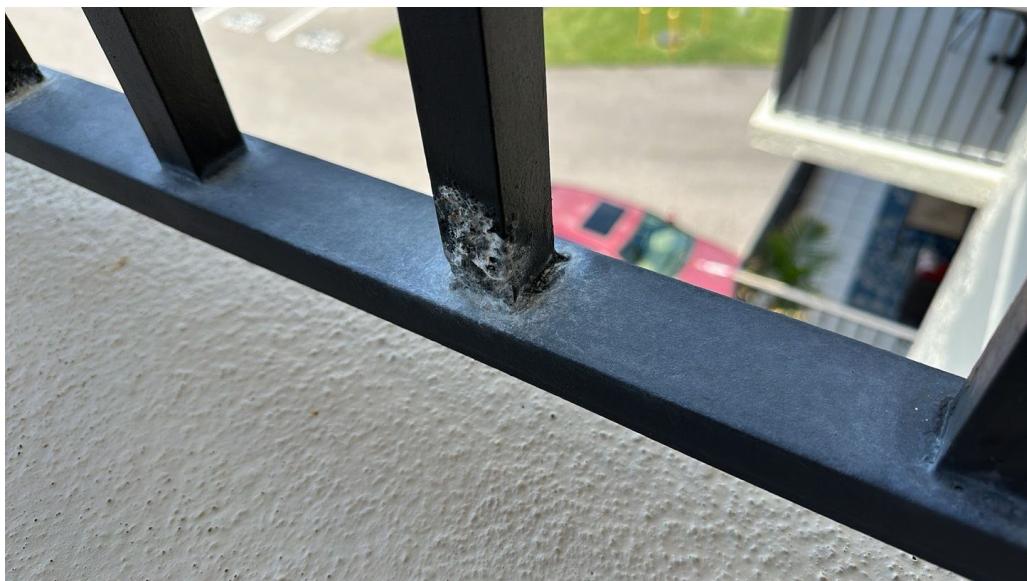
9. The walkway railings evidenced corrosion and coating failure. Refer to *Figure 8* and *Figure 9*.

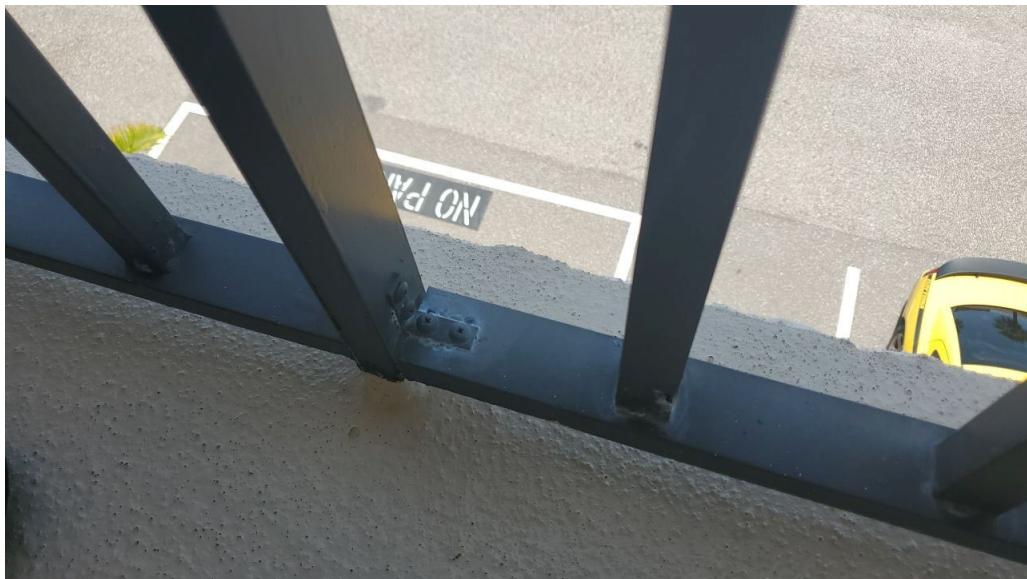
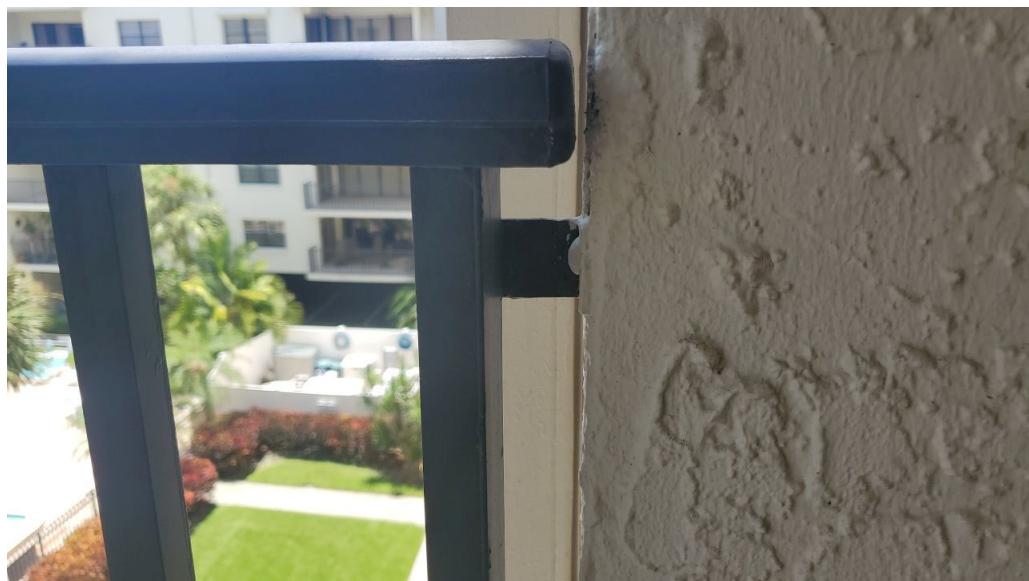
10. The walkway railings evidenced multiple locations of supplemental clipping. Refer to *Figure 10* and *Figure 11*.

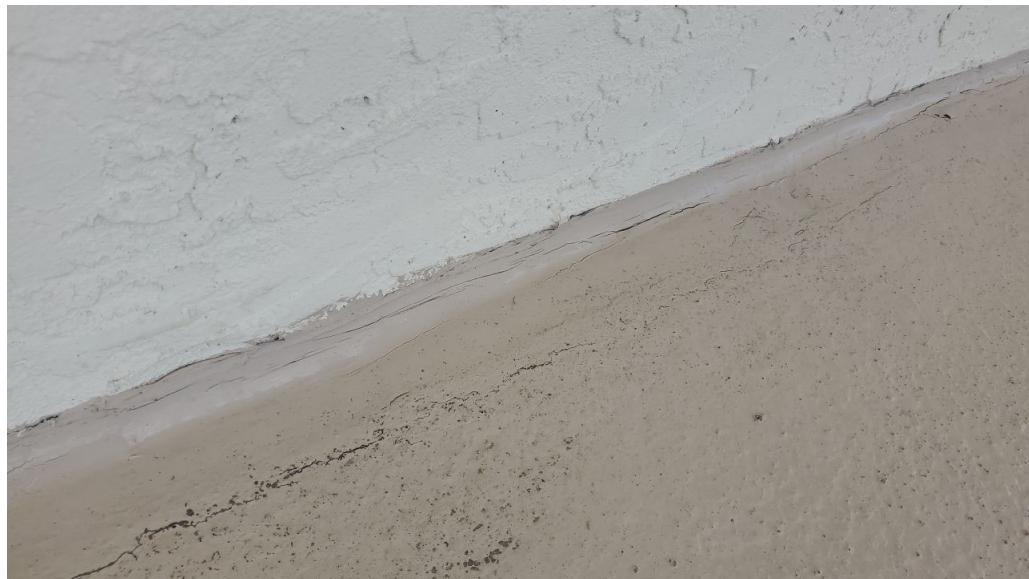
Figure 12

11. The walkway sealant at the slab to wall interface evidenced cracking. Refer to *Figure 12*.

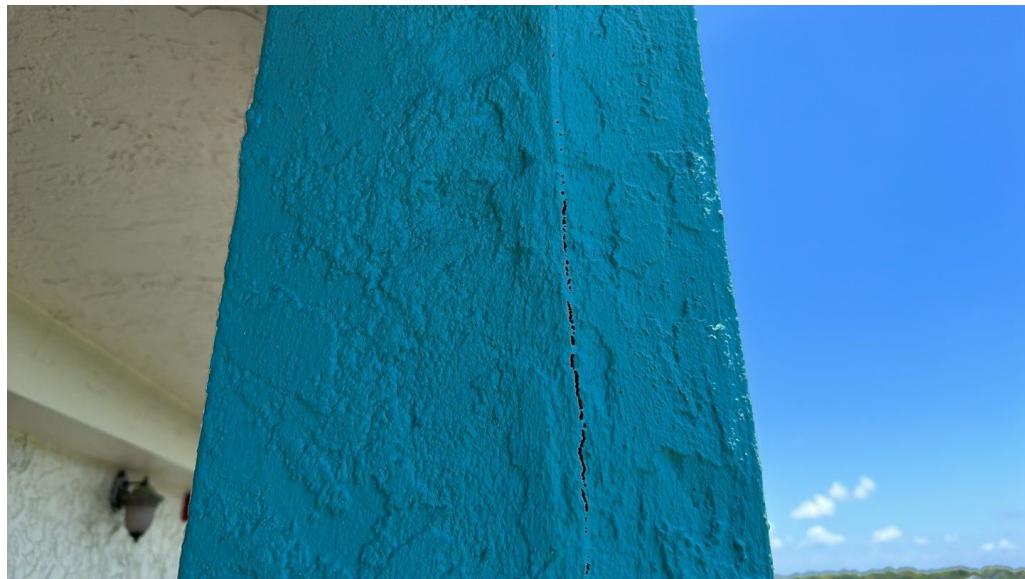
Figure 13

12. Several faux columns on the walkway evidenced cracking in the stucco. Refer to *Figure 13*.

3. The faux columns on the walkways with cracking present should be repaired.

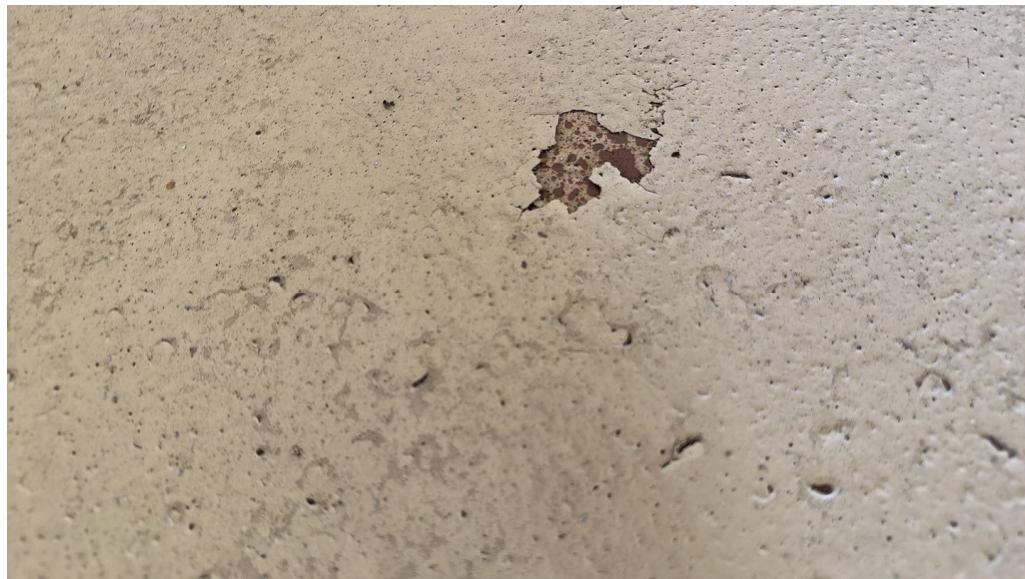
Figure 14

13. Some areas of the walkway coating evidenced failure and exposure of the previous coating below. Refer to *Figure 14*.

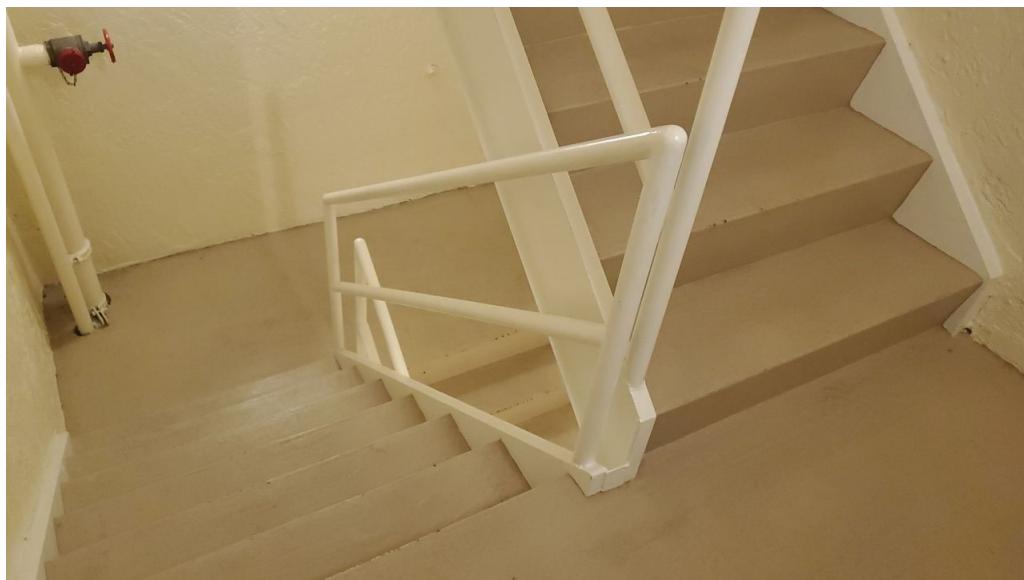
Figure 15

10. The stairs were observed to consist of a concrete stair system and concrete landings. Refer to *Figure 15*.

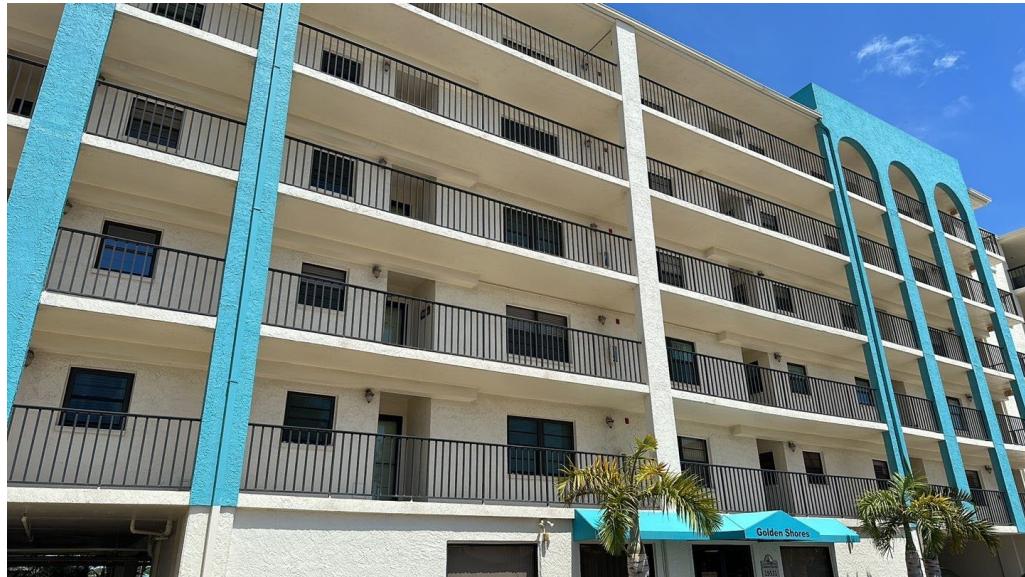
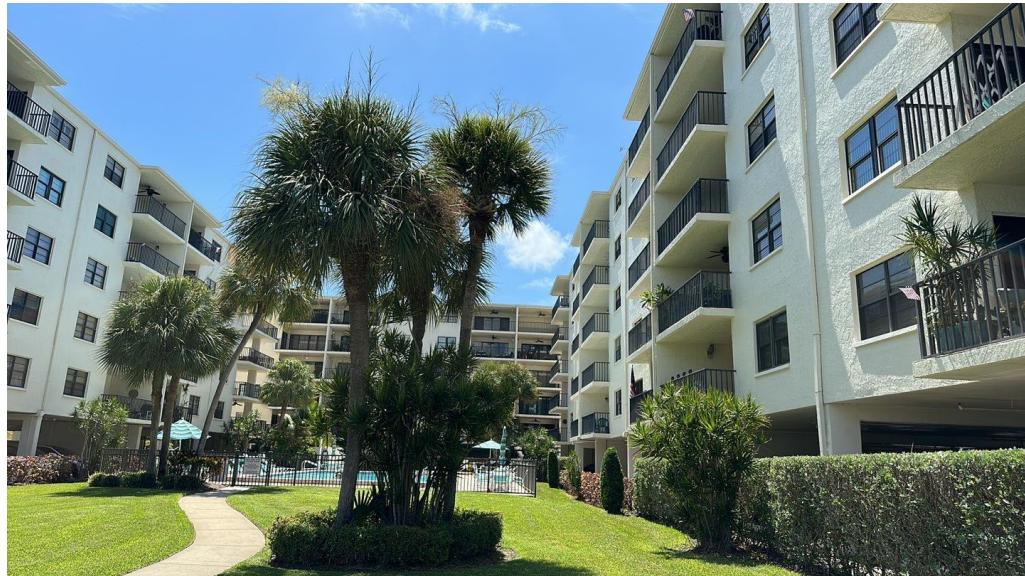
15. The majority of the exterior walls of the structure appeared to be stucco overtop concrete and/or concrete masonry units (CMU) in-fill walls. No widespread cracking was observed within the majority of walls of the structures. Refer to *Figure 16* and *Figure 17*.

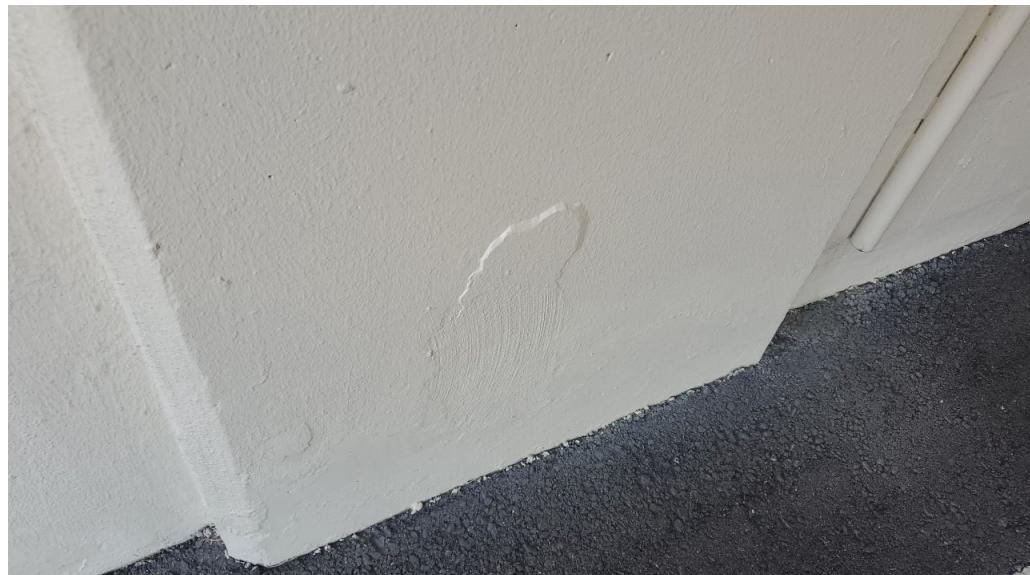
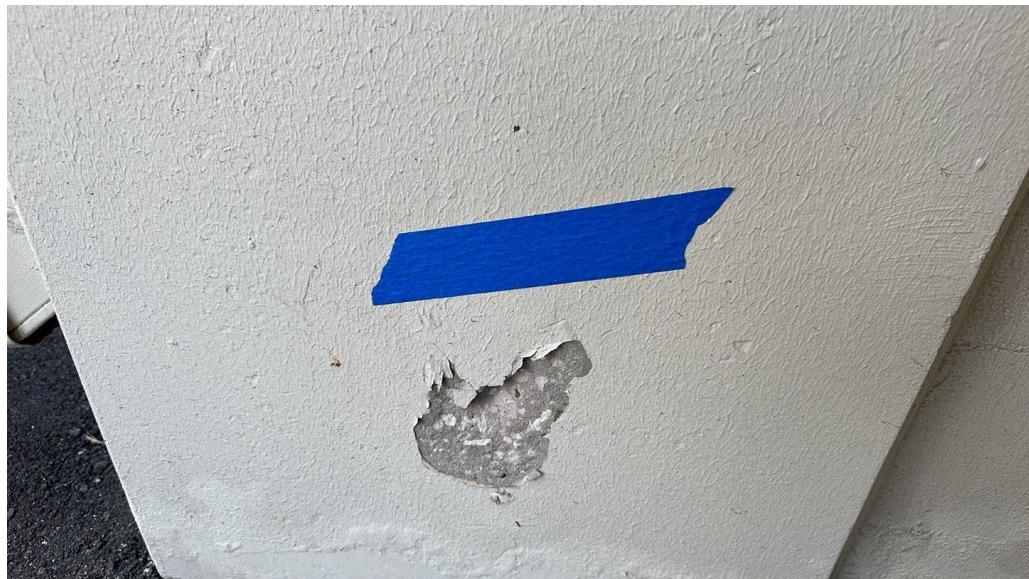
16. Spalling and/or stucco delamination was detected, by mechanical sounding, to be present in 15 locations of the garage. Refer to *Table 3, Figure 18 and Figure 19*.

Spalling occurs when moisture and chlorides from the ocean are able to penetrate the deck and reach the reinforcing bars. When exposed to moisture and chlorides the reinforcing bars will corrode. The corrosion causes the reinforcing bars to expand which in turn creates internal stresses in the concrete. These internal stresses cause areas of the concrete to break loose and expose the reinforcing bars. The breaking loose of the concrete is what is referred to as "spalling". Spalling generally affects older buildings near the water more than it affects newer construction that is inland. Periodic maintenance and application of a quality waterproofing membrane on the balconies can significantly reduce the amount of repairs that are needed in the future. It appears that the majority of the balconies do not currently have a waterproofing membrane installed under the tiles.

1. The spalling on the balconies and garage columns should be repaired in accordance with guidelines prepared by the International Concrete Repair Institute (ICRI). This includes the following:

- a. Square cutting repair areas
 - b. Removal of concrete back to uncorroded reinforcing bars
 - c. Supplementation of deteriorated reinforcing bars exhibiting significant section loss

- d. Proper surface preparation of the repair area
 - e. Installation of sacrificial anodes
 - f. Application of corrosion inhibitors to the exposed portions of reinforcing steel

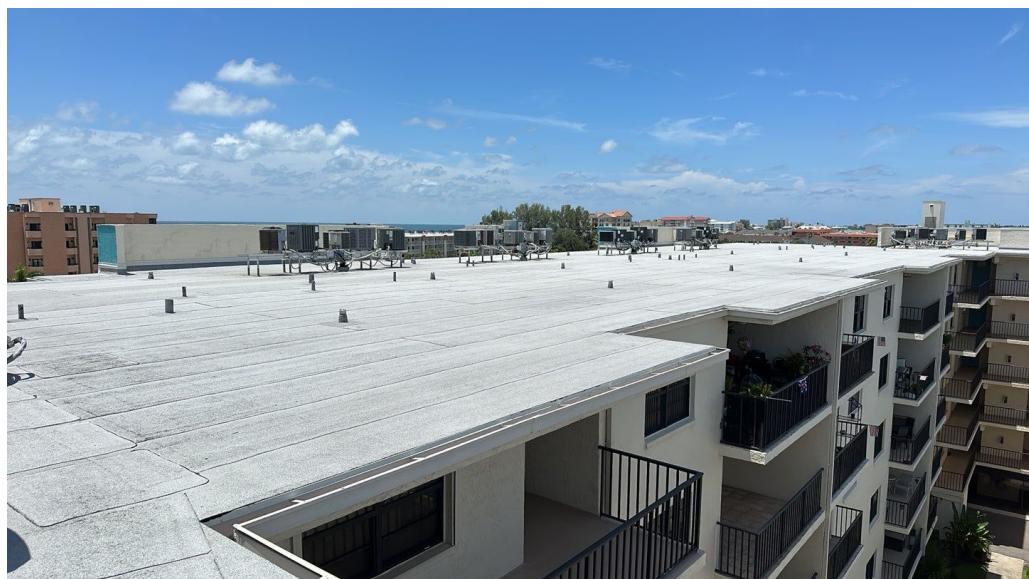
Figure 20

17. The roof was observed to consist of a modified bituminous roof membrane. Refer to *Figure 20*.

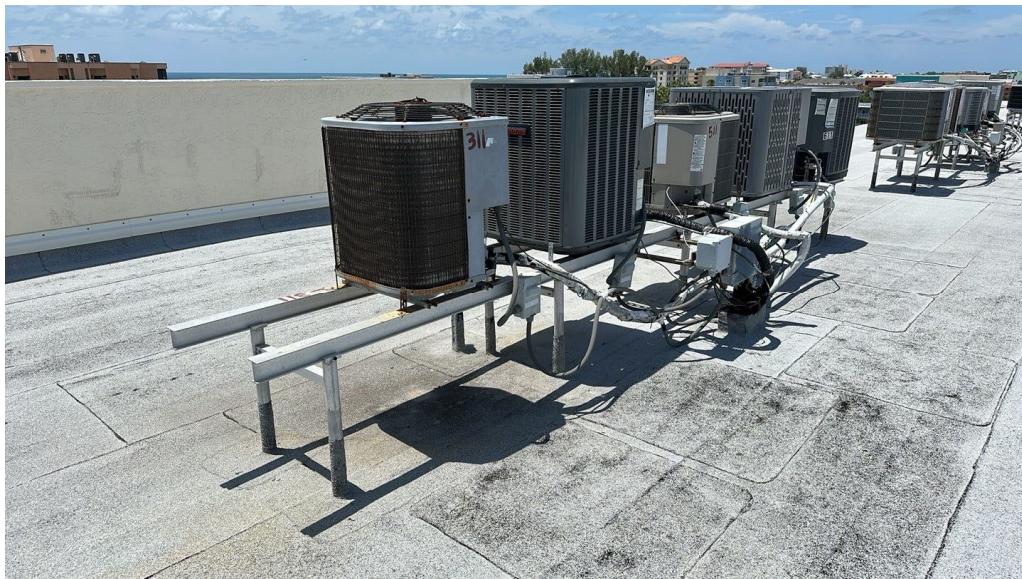
Figure 21

18. The rooftop air conditioning units were observed to be currently mounted on aluminum stands. Refer to *Figure 21*.

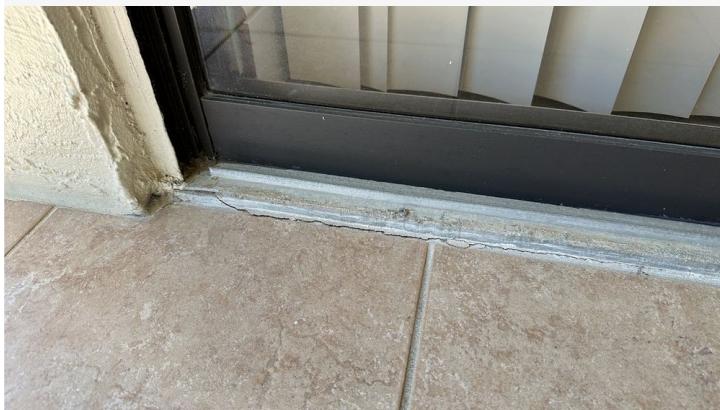
1

Crack in tile grout beneath sliding glass door track.

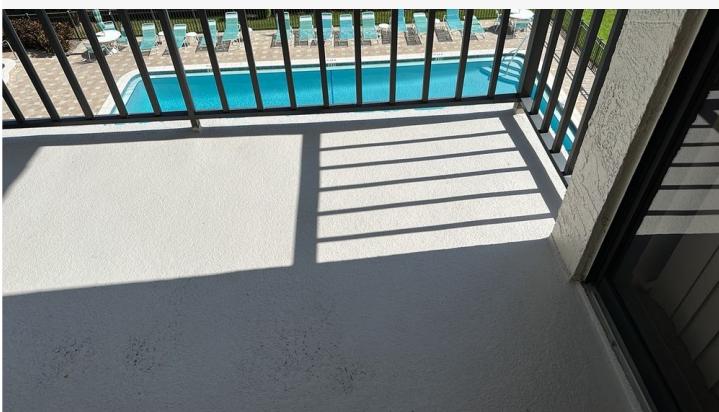
2

Balcony with urethane coating.

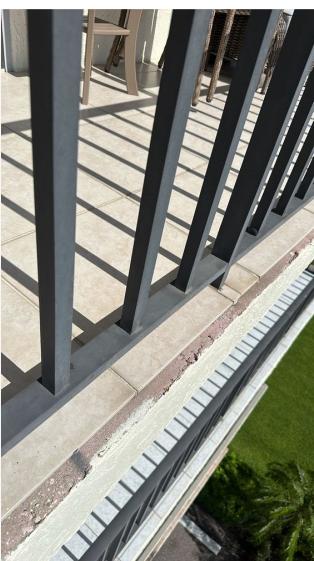
3

Tile installed short of exposed slab edge.

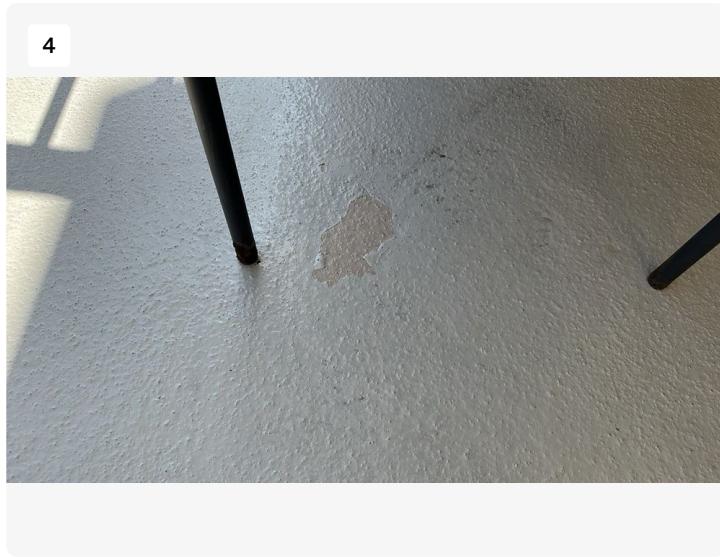
Peeling of urethane balcony coating

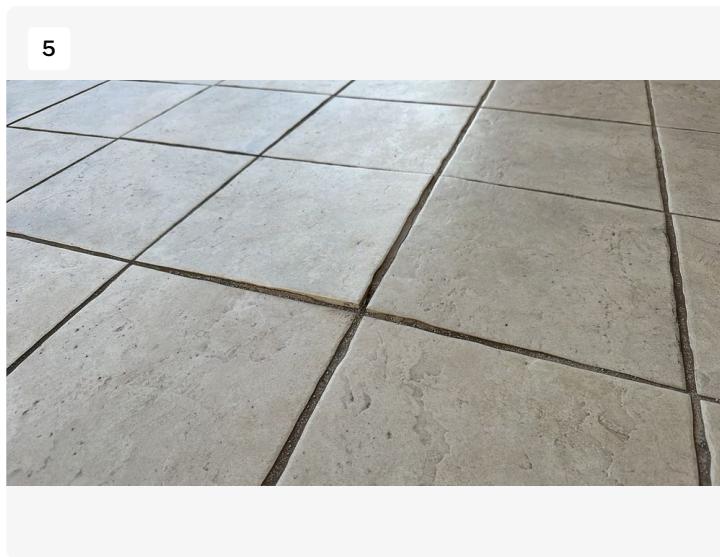
Tented tile.

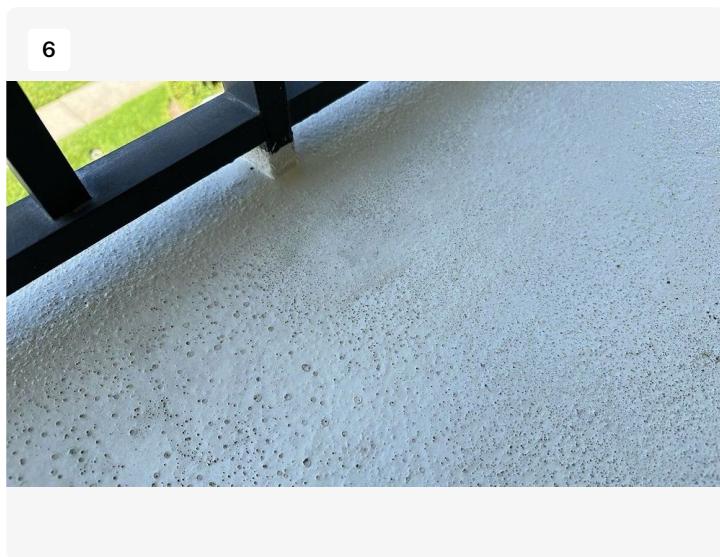
Blisters in coating.

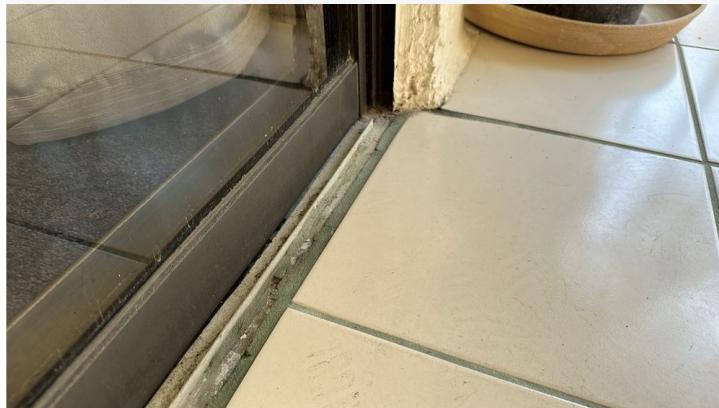
7

Tile installed higher than sliding glass door track.

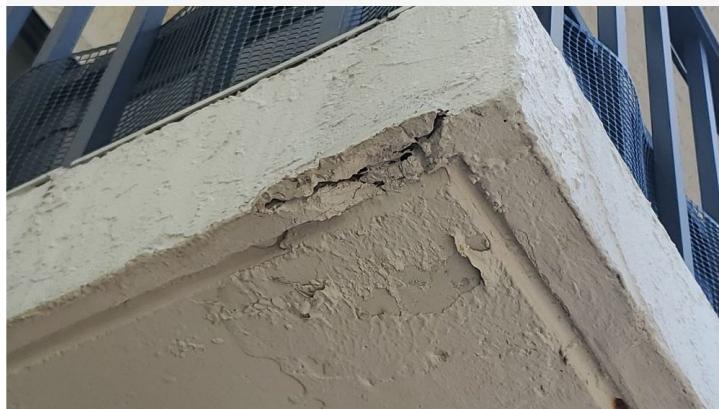
8

Slab edge spall.

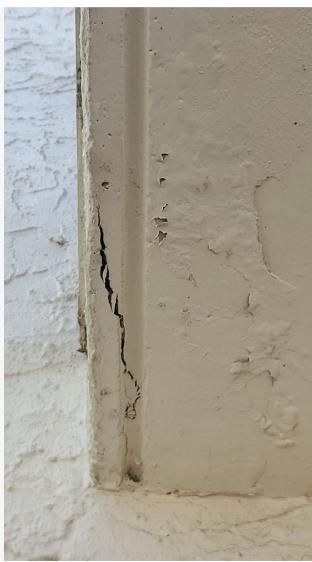
9

Slab edge spall.

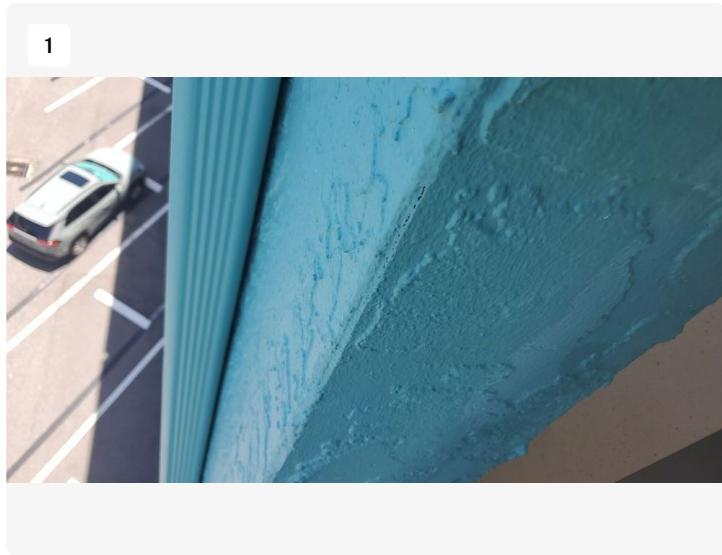
Crack in column stucco

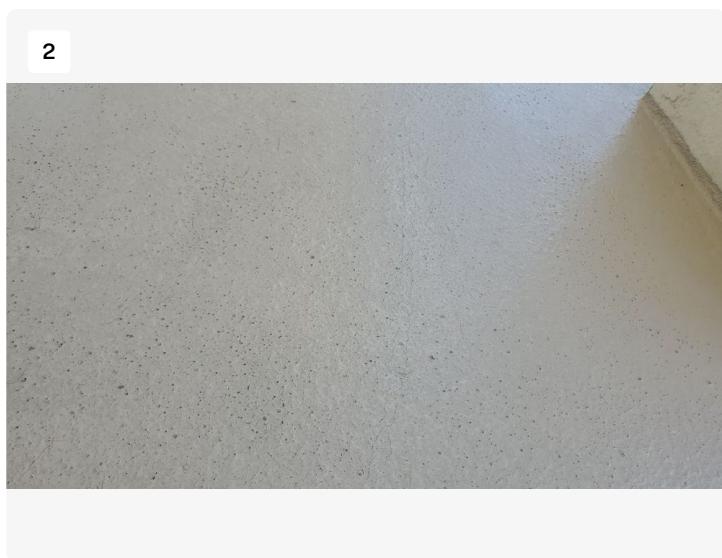
Cracks in walkway coating

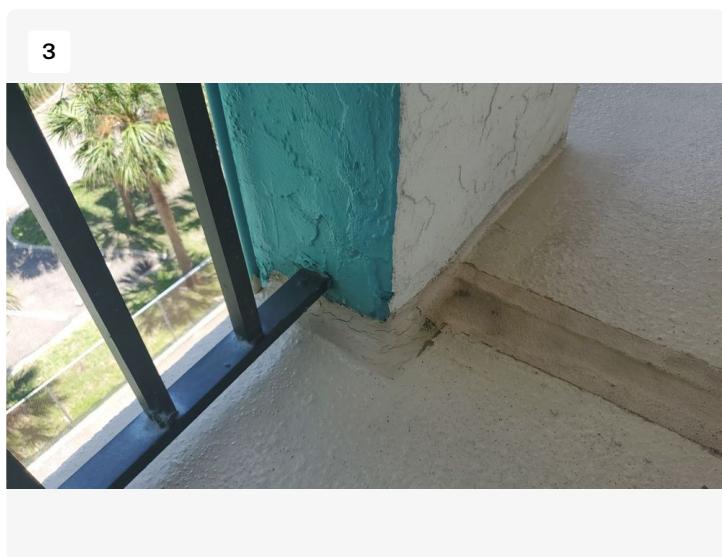
Cracking in expansion joint sealant coating.

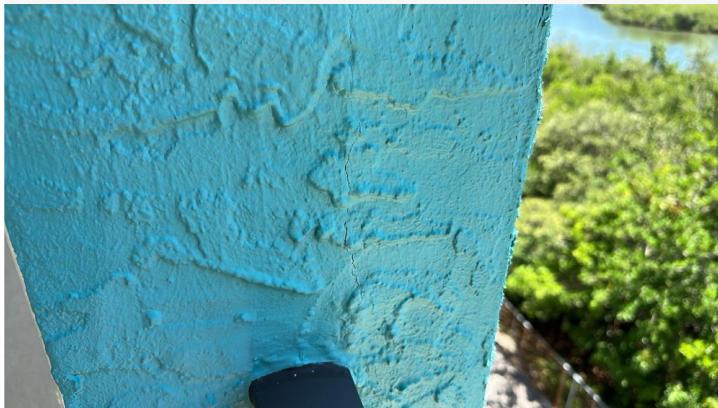
4

Crack in column stucco

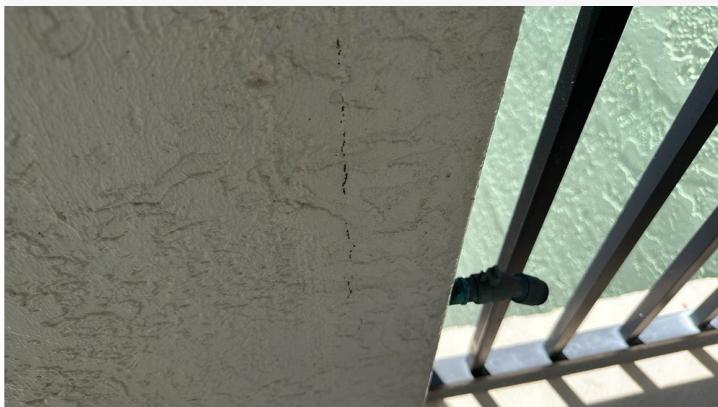
5

Crack in column stucco

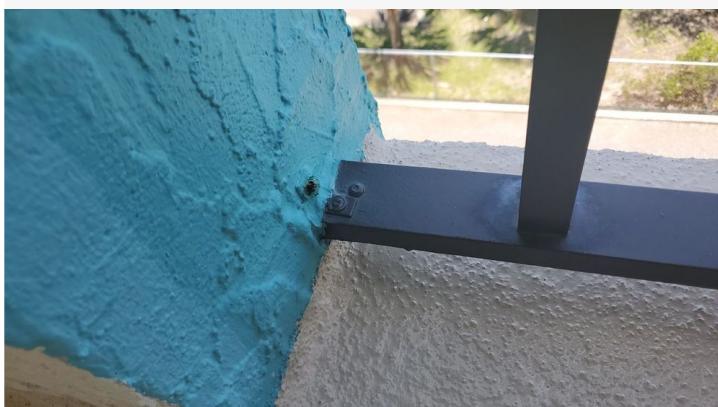
6

Supplemental clips on rail system

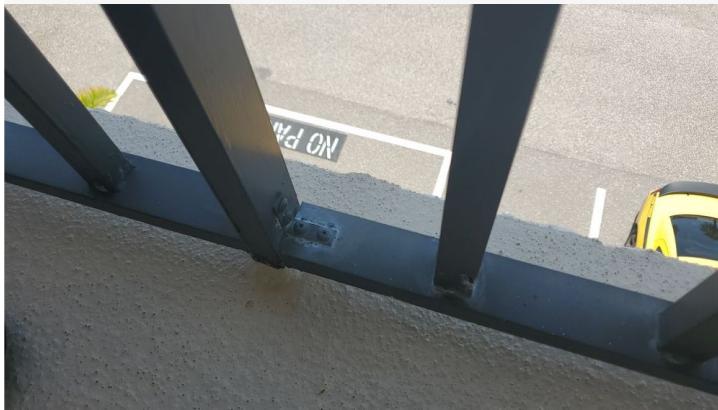
7

Supplemental clips on rail system

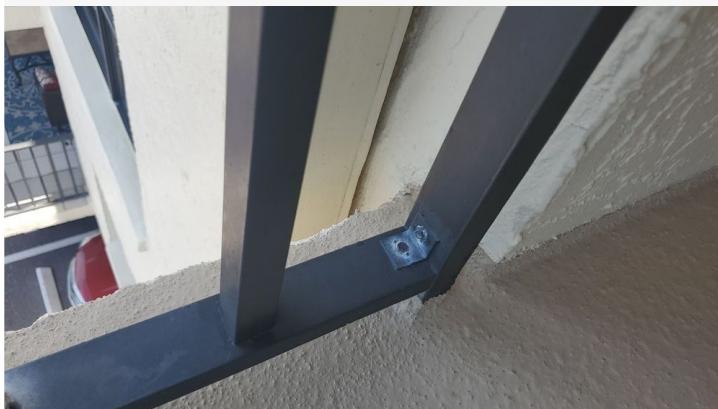
8

Supplemental clips on rail system

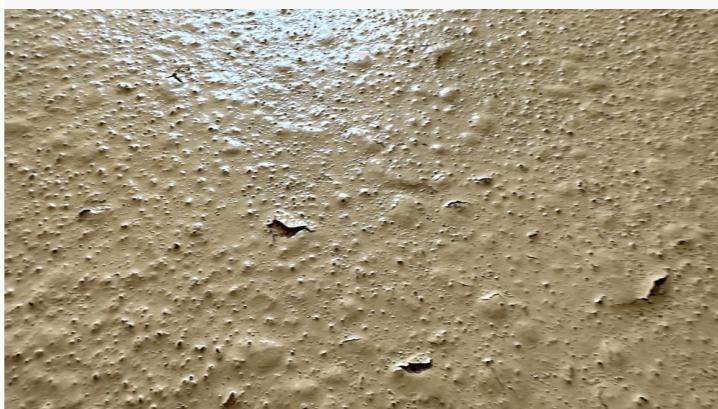
9

Peeling walkway coating

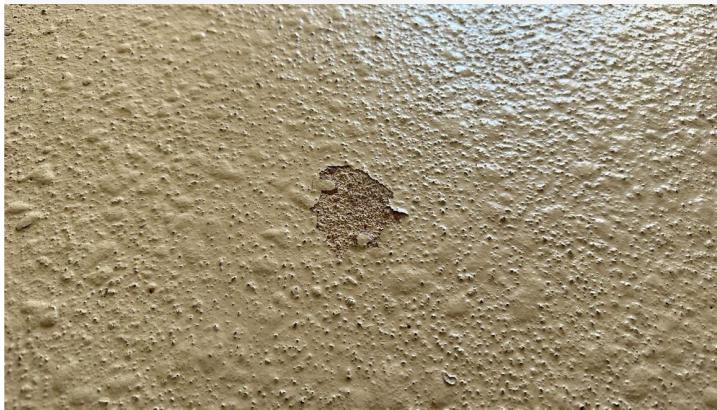
10

Peeling walkway coating

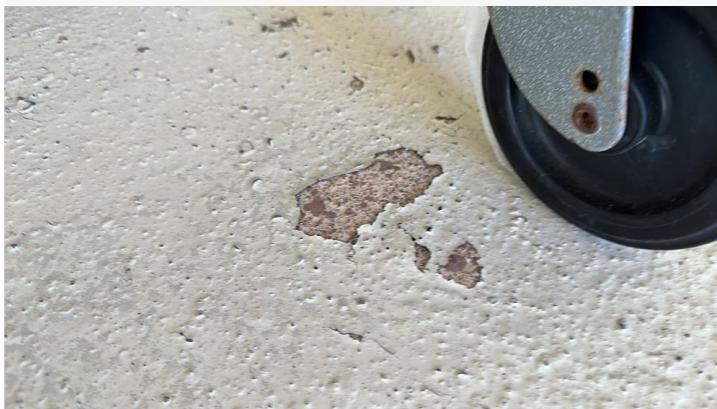
11

Peeling walkway coating

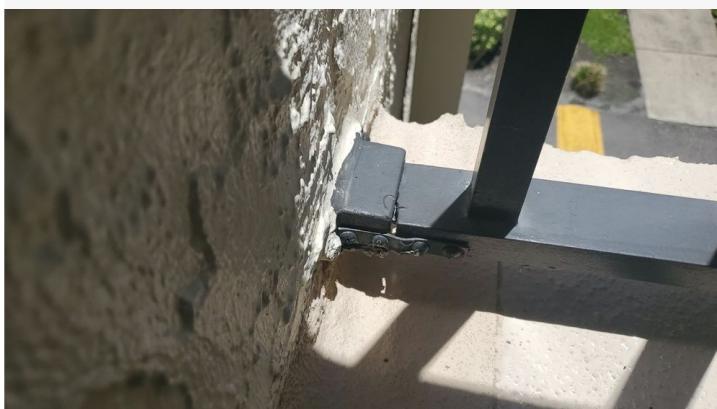
12

Supplemental clips on rail system

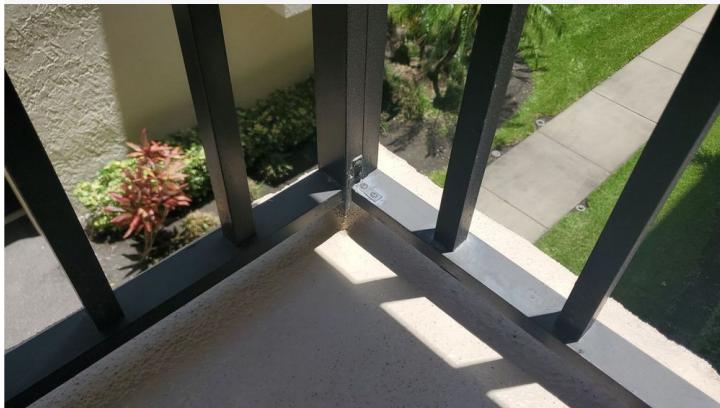
13

Supplemental clips on rail system

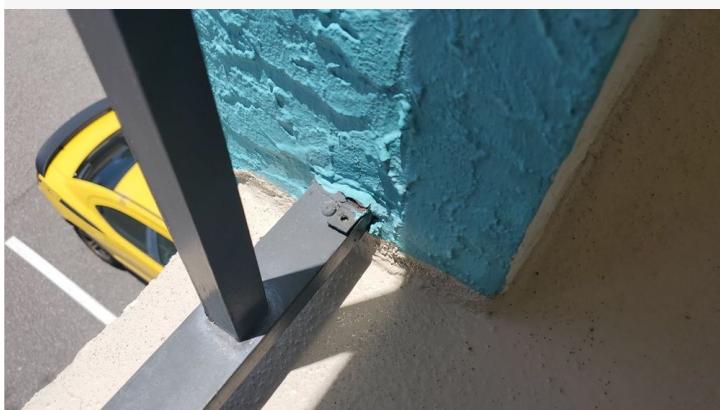
14

Supplemental clips on rail system

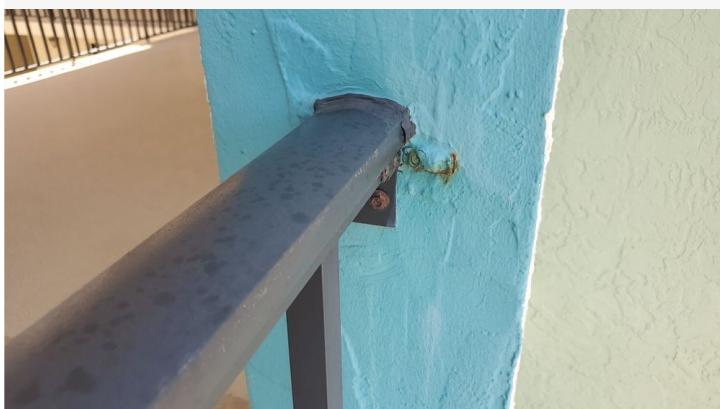
15

Corroded fasteners and supplemental clip

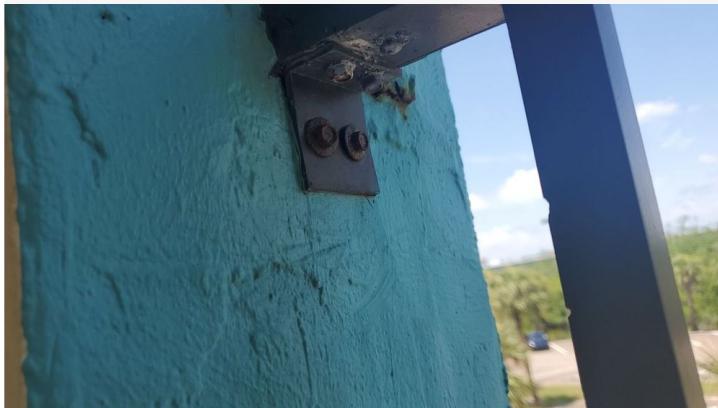
16

Corroded clips

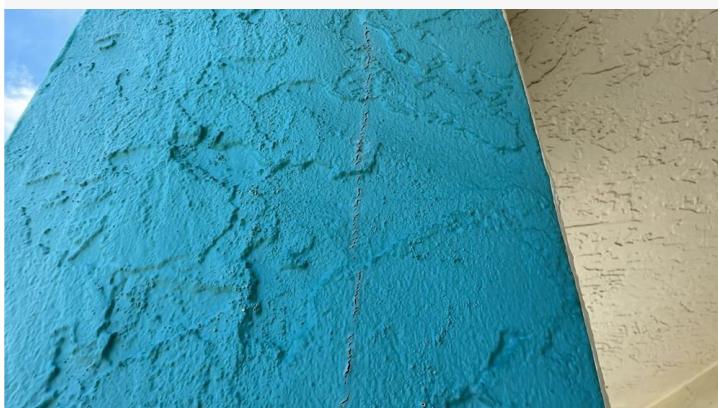
17

Crack in column stucco

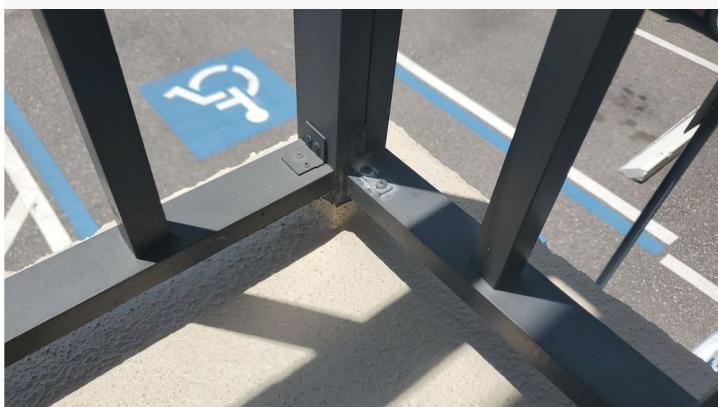
18

Supplemental clips on rail system

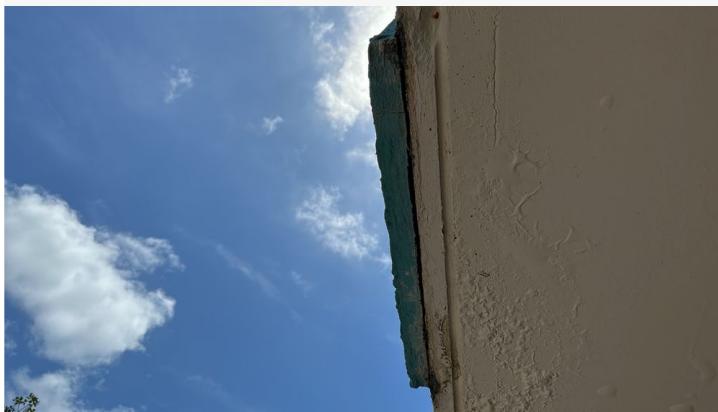
19

Drainage gap in base of faux columns

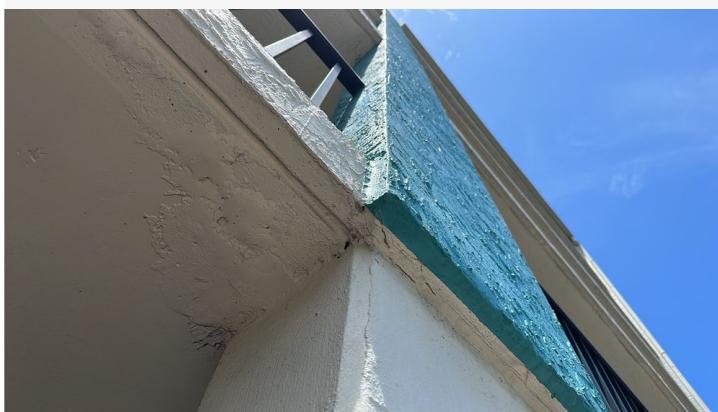
20

No drainage gap in base of column
