August 22, 2023

**Subject: Building Condition Survey
Milestone Inspection
19531 Gulf Blvd.
Indian Shores, Florida**

**Building Condition Survey
Golden Shores Condominium
Indian Shores, Florida**

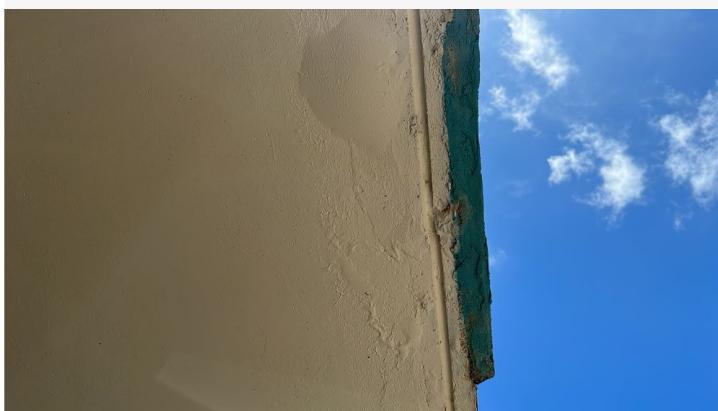
21

Paint blister and no drainage gap in base of column

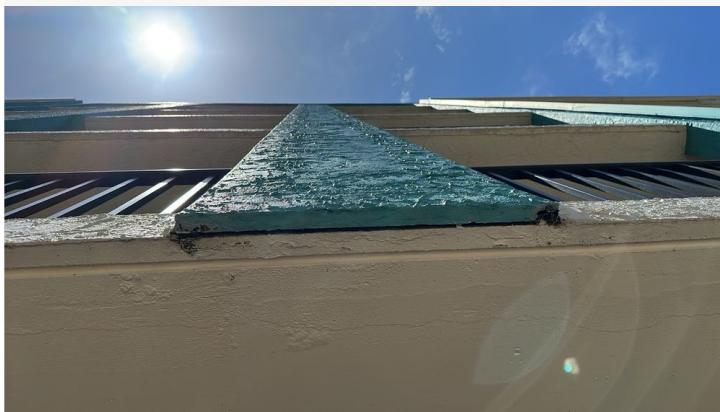
22

Drainage gap in base of column

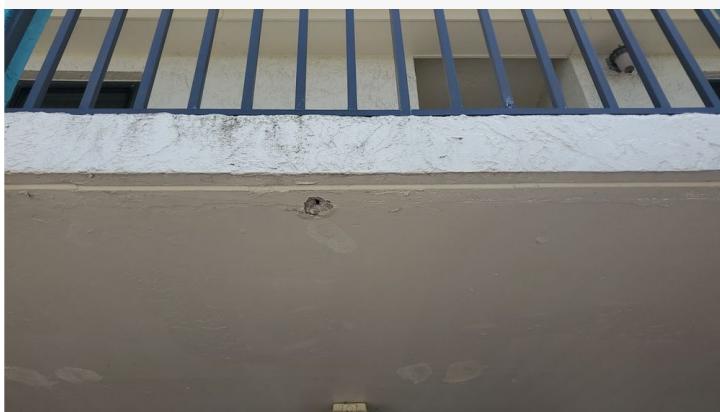
23

Spall beneath walkway.

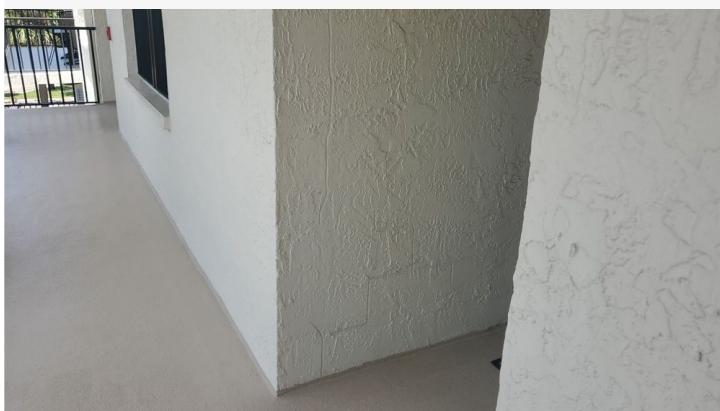
24

Previously repaired wall cracks

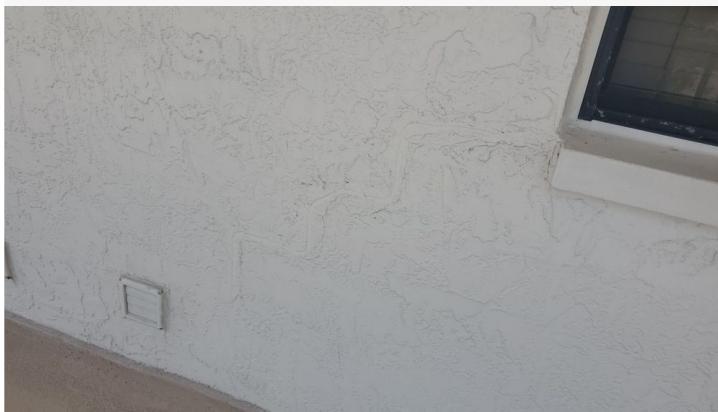
25

Previously repaired wall cracks

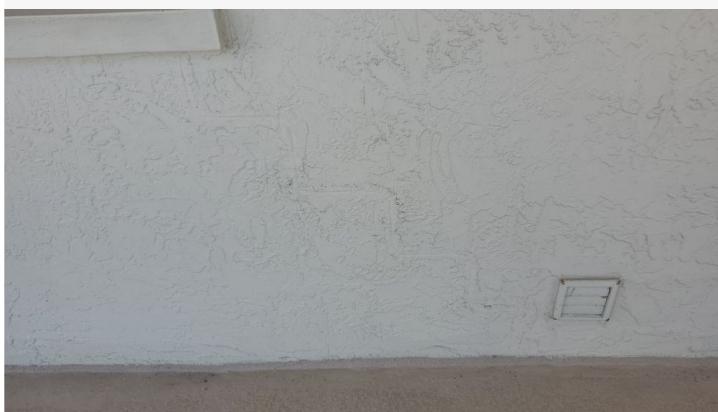
26

Previously repaired wall cracks

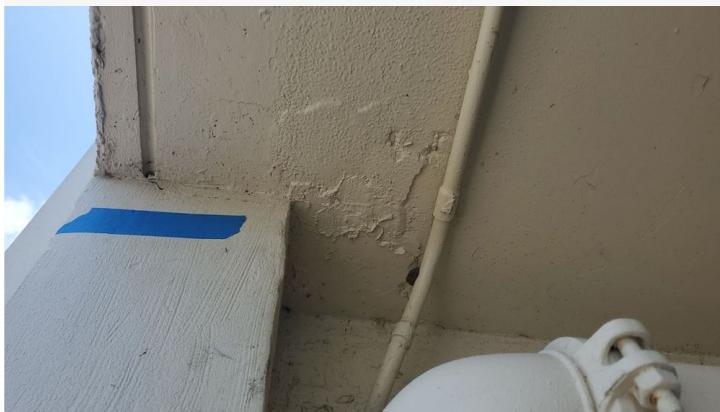
1

Overhead spall.

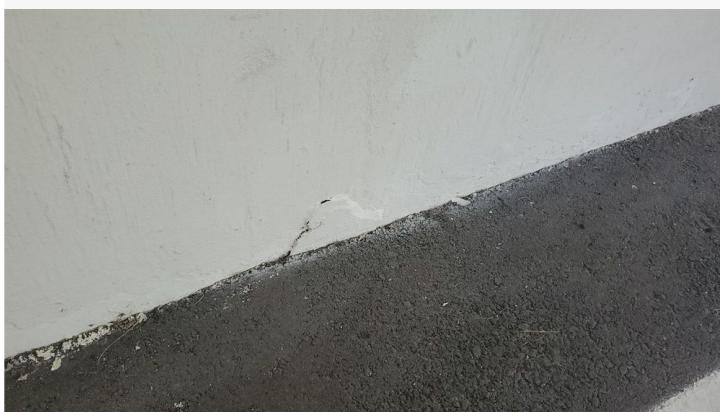
2

Vertical spall.

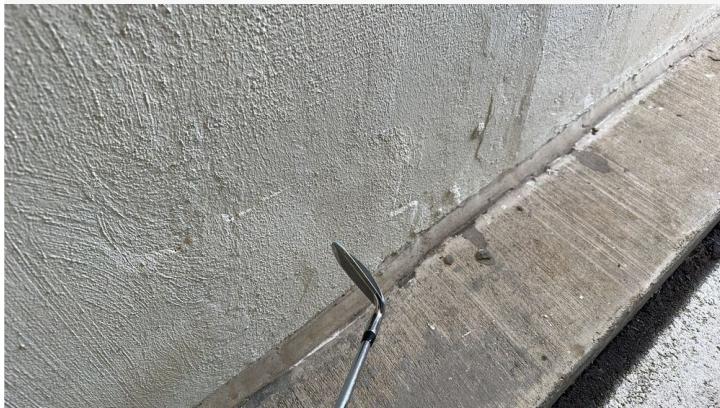
4

Vertical spall

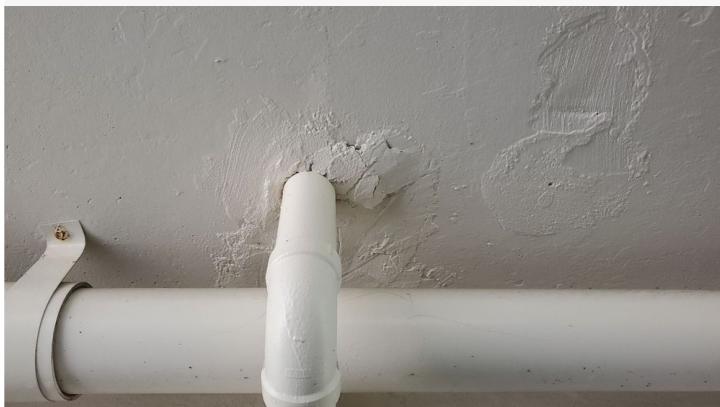
5

Overhead spall

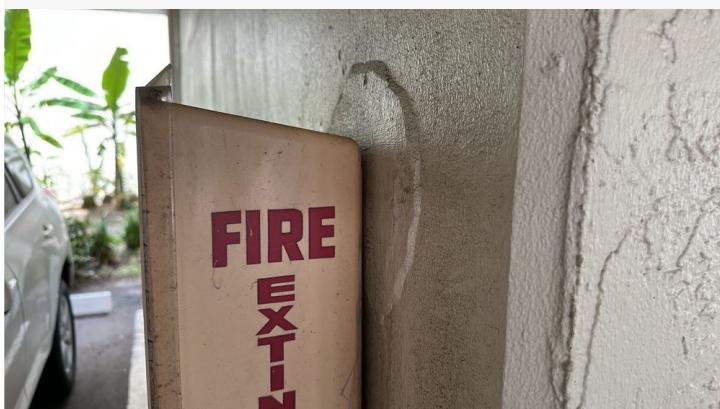
6

Vertical spall

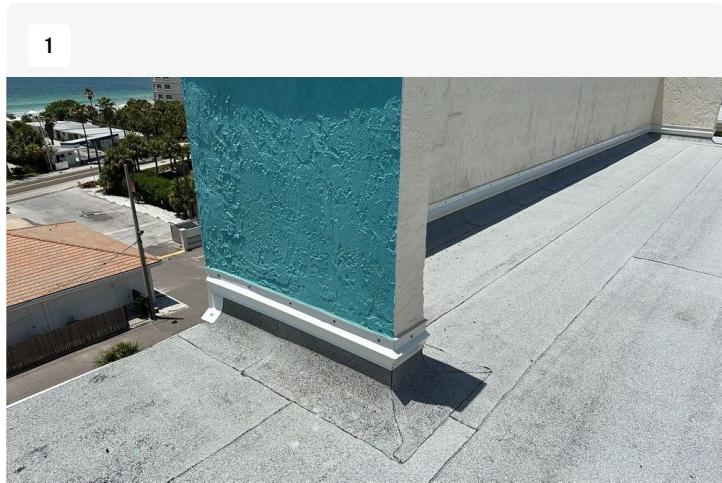
1 Surface mounted counterflashing.

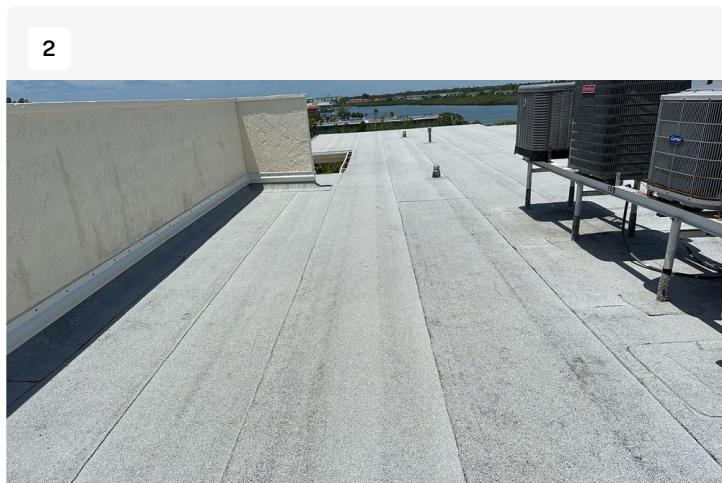
2 Modified bituminous membrane

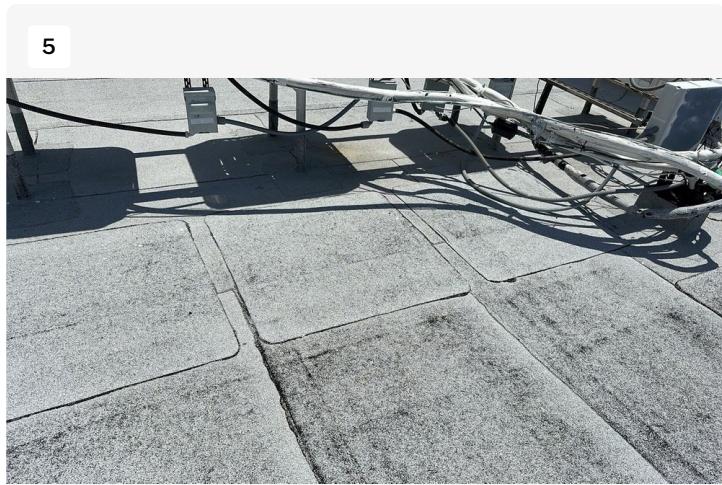
A/C lines on supports
