RE: **West Shore Place Condominiums**  
**19534 Gulf Blvd,**  
**Indian Shores, FL 33785**  
**KEG File# 23RT-0005**

## 1.0 INTRODUCTION

## 6.0 MILESTONE INSPECTION

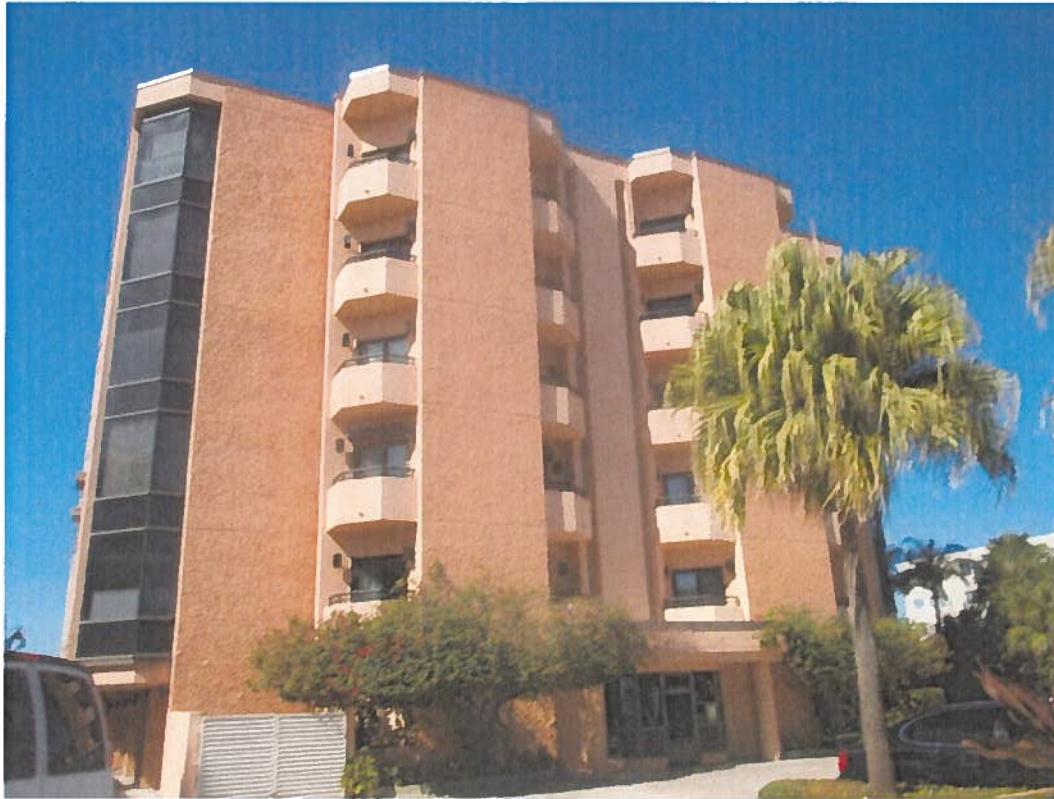
**Figure 1: Front view of the property**

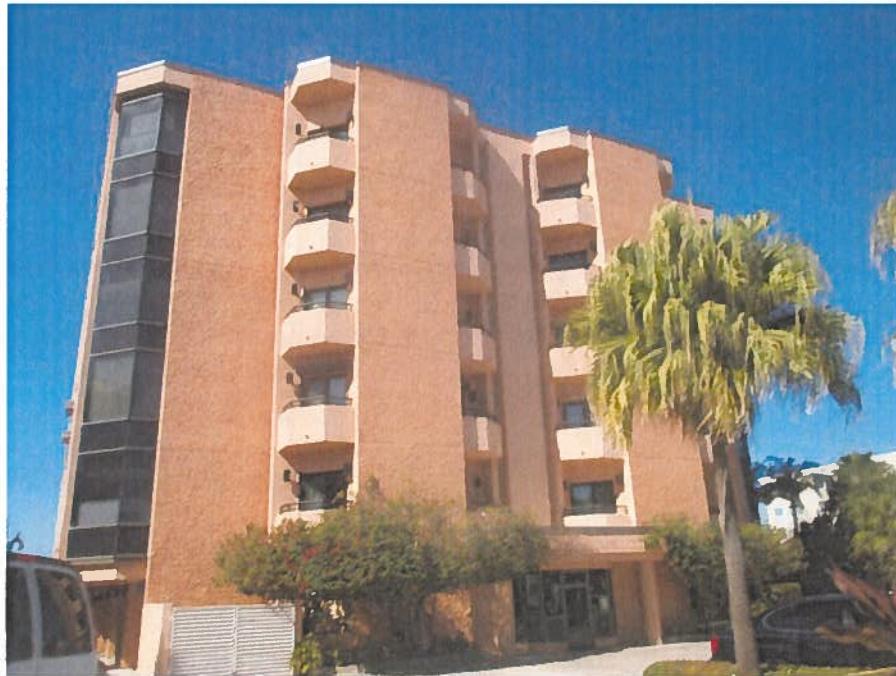
**Photo #1** – Overview of front elevation

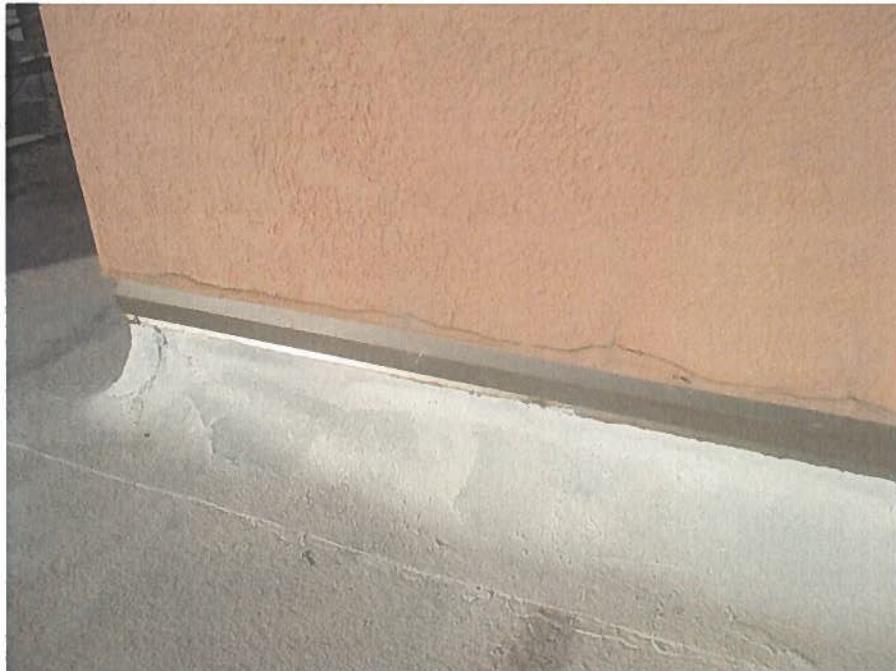
**Photo #2** – Stucco delamination and crack at the transition with the flashing at bottom of walls at the west stair tower and elevator penthouse

1. Repair stucco delamination and cracks at the transition between stucco and flashing at the base of the elevator penthouse.
2. Repair spalls at the ceiling of some of the small balconies
3. Roof has a heavy loss of granules, and a white coating was applied suggesting that this element has surpassed its useful life span.
4. Pool plaza has several cracks at the transition between slab and masonry and on the slab surface. Delamination and/or hollow concrete areas were also noticed on the slab surface.
5. Stucco on the exterior walls presents delamination and cracks.
6. Stucco has some exposed and non-exposed metallic elements that present corrosion staining the surface in some areas on the back of the building.
7. Exterior densglass to densglass and/or to masonry transition present cracks.

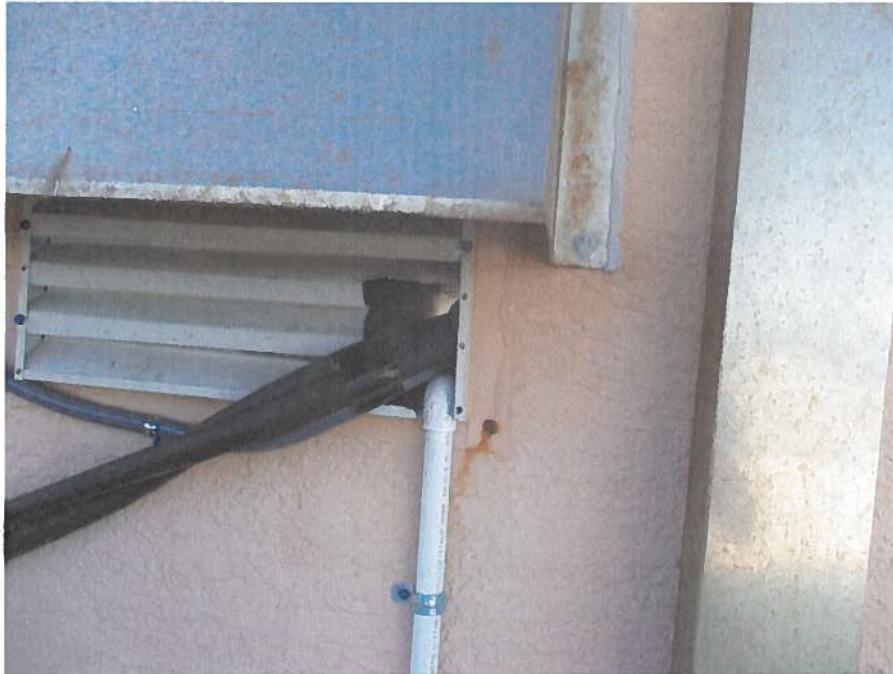
**Photo #3** - Rusted fastener at the elevator penthouse louver.

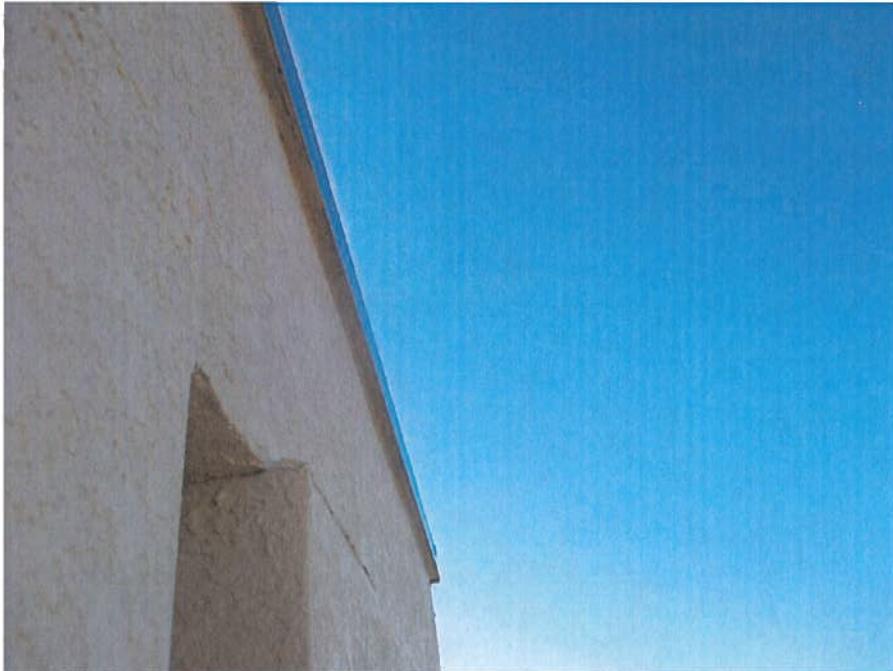
**Photo #4** – Stucco crack at the transition of walls.

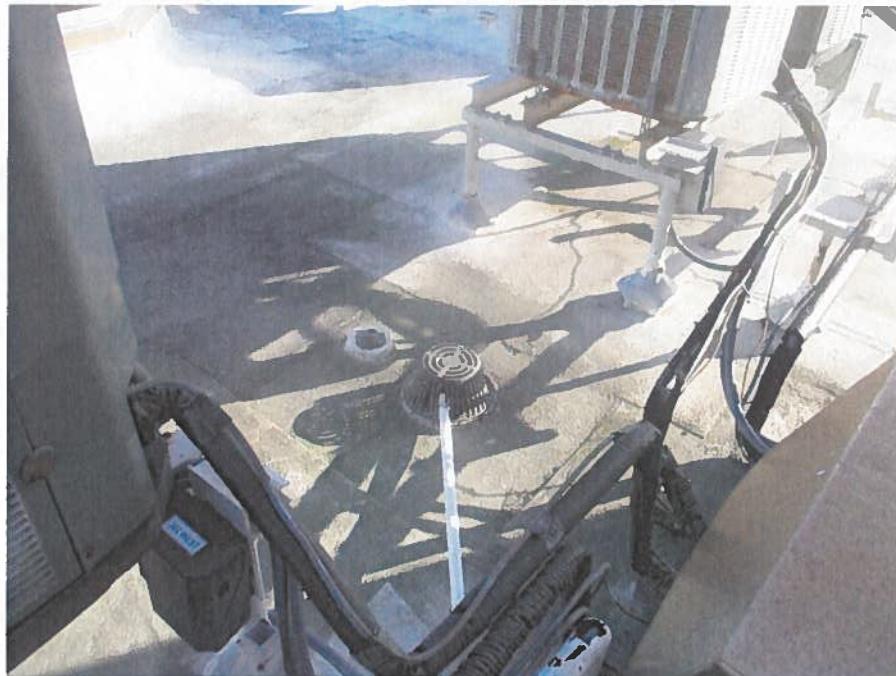
Photo #5 – Roof and penetrations typical condition

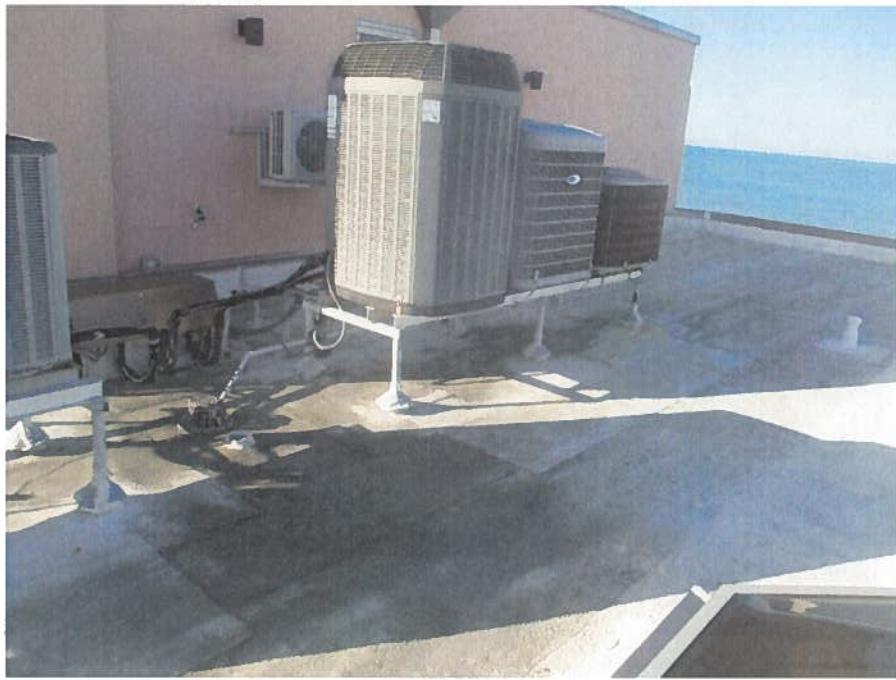
Photo #6 – Roof and penetrations typical condition.

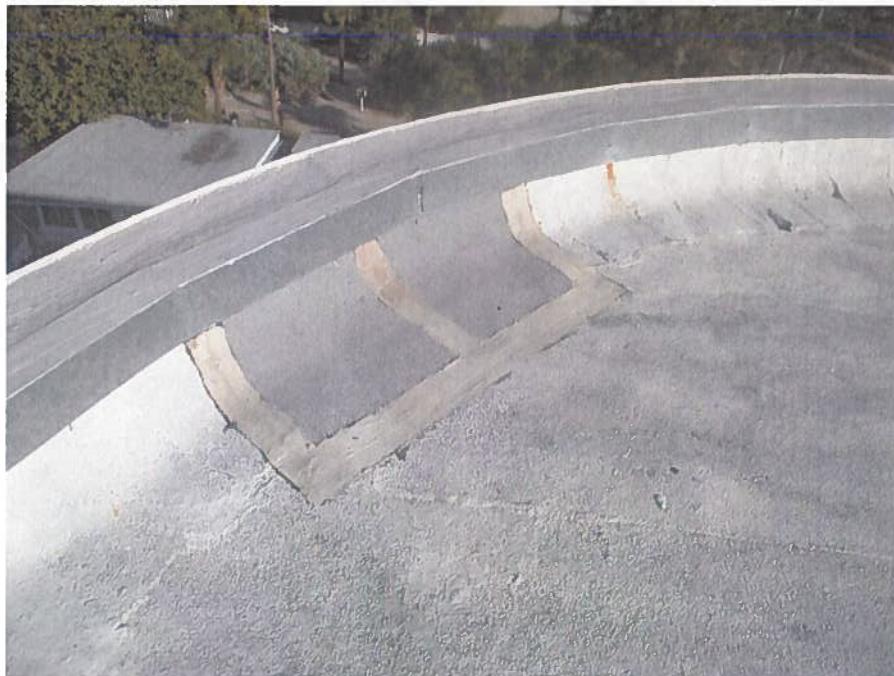
**Photo #7 – Roof coated and previously patched**

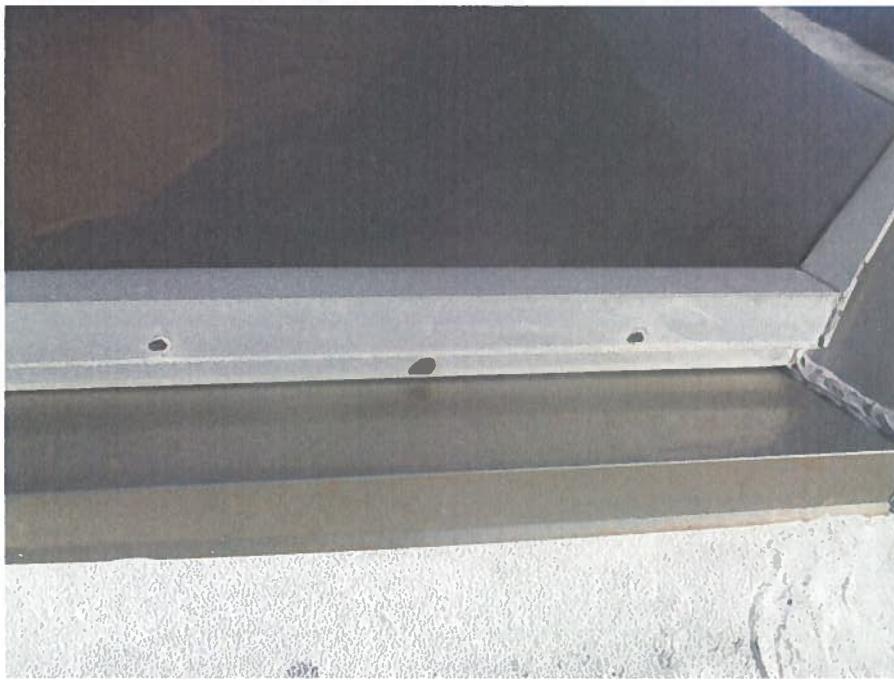
- Rusted fasteners at the solar openings on the roof
- Windows and doors have good sealants in general. Some exceptions are the sliding glass doors at the small balconies of units 301, 302, 401, 501, 502
- Unsealed and rusted fasteners/hangers attaching electric conduits to the wall/slab around the pool area
- Weathered sealants covering seams of metallic elements on the roof (fair condition)
- Failed sealant at the transition between walls and slabs

**Photo #8 – Rusted fastener at solar opening**

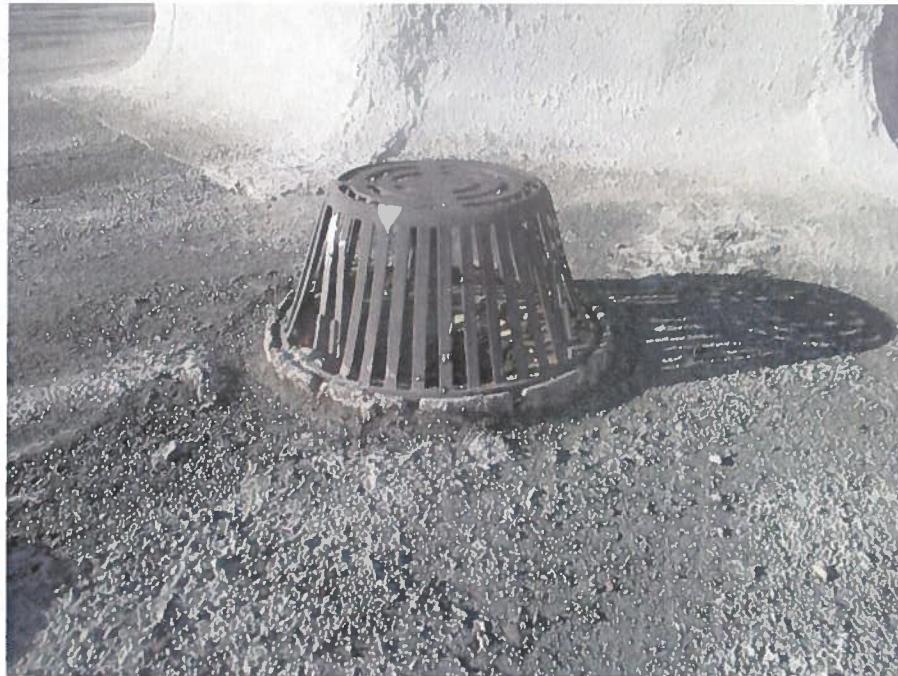
- Existing drains are higher than the roof surface. Some water pounding areas were observed around the roof showing drainage issues.
- Heavy efflorescence on the ceiling of the west stair tower indicates water intrusion from the roof above
- Possible water intrusion was reported at one solar opening above the bathroom of unit 502
- Stucco is hollow and cracked around transition flashings at the bottom of walls
- Roof surface membrane cracked and dried from UV exposure and age
- The potential for water intrusion is increased by the dry, cracking condition of the roof surface subjecting the roof deck below to long term water damage if not corrected

Photo #9 – Raised drain

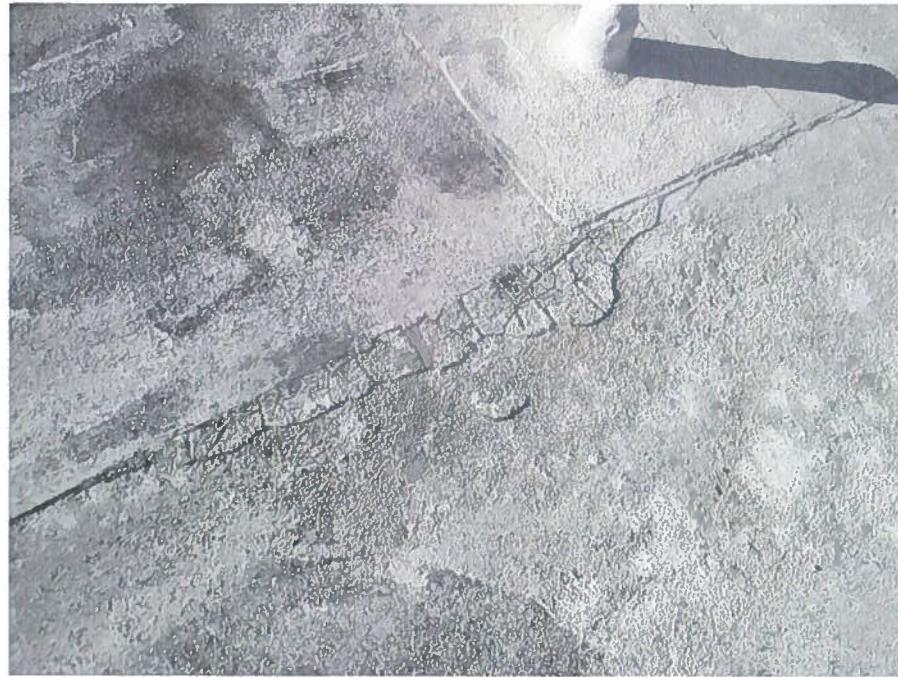
Photo #10 – Roof matt transition cracked.

In regards to the roof system, KEG recommends that a moisture survey be performed by a third-party testing company. The moisture survey will accurately show the areas of the roof that are saturated and the overall percentage of the roof experiencing moisture damage. Based on the results of this testing, a re-roofing and/or repair project can be formulated. Please note that if the testing shows that over 25% of the roof surface area is saturated, the entire roof system will need to be replaced.

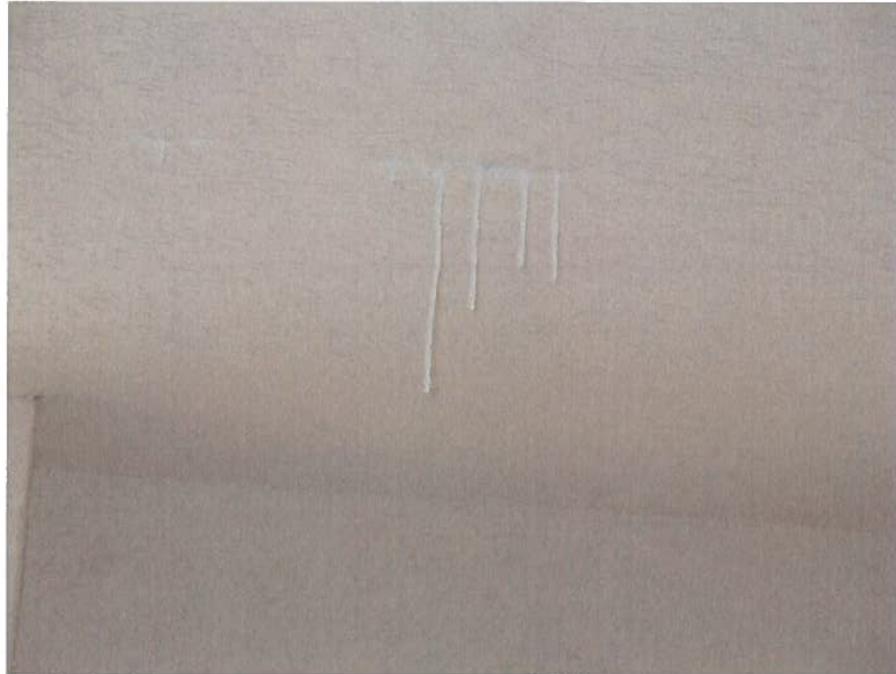
1. Water intrusion from the roof is causing heavy efflorescence on the ceiling at the west stair tower.

Photo #11 – Efflorescence at west stair tower

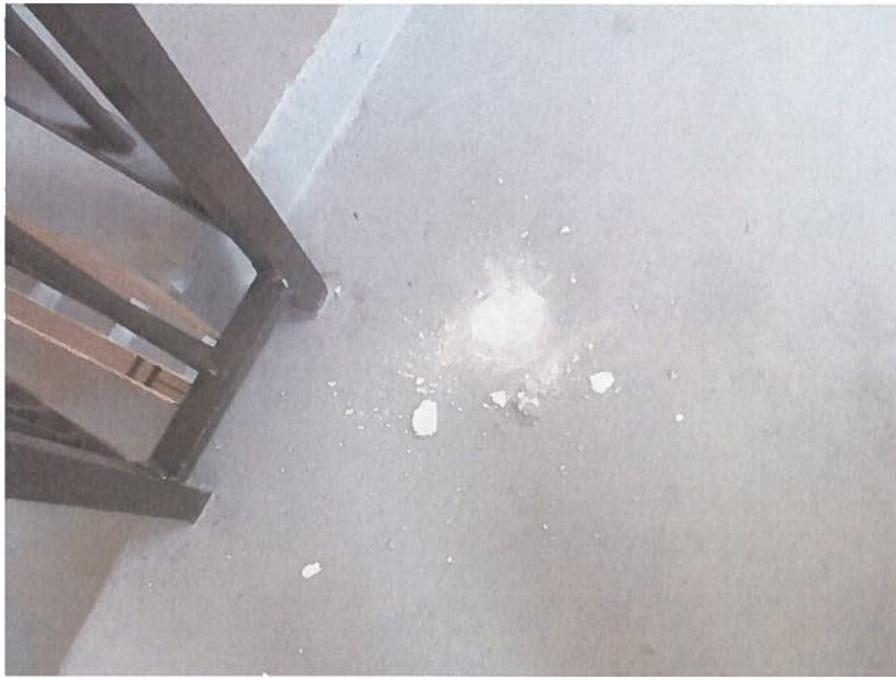
Photo #12 – Landing painted over built-up efflorescence residue

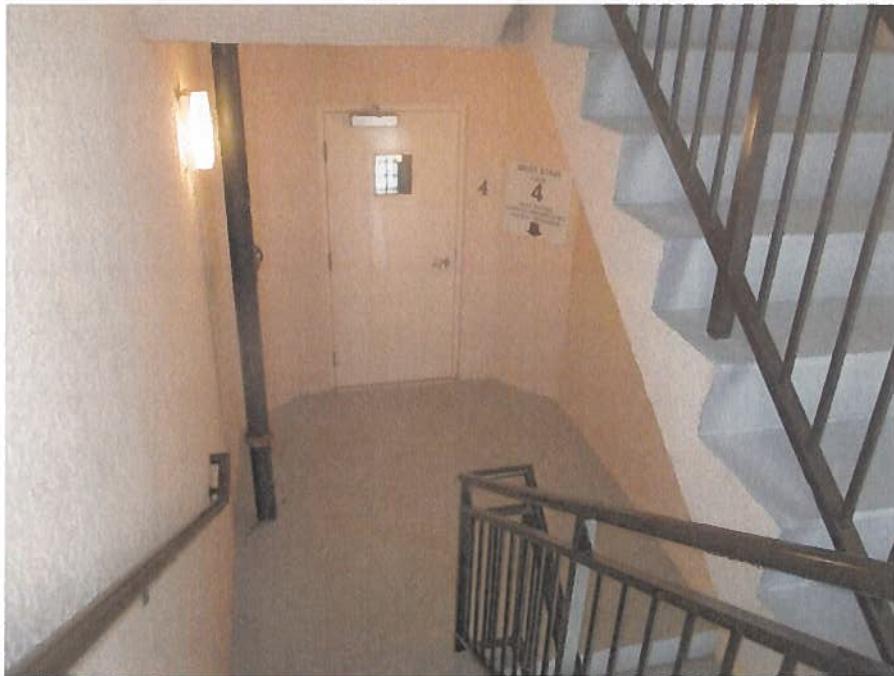
Photo #13 – Stair towers generally in good condition

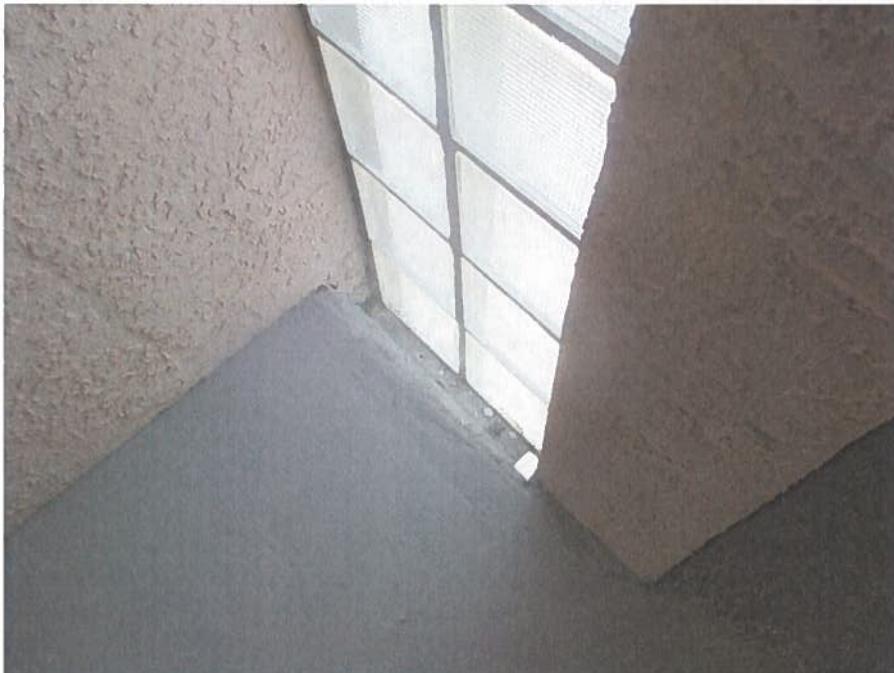
Photo #14 – Brackets holding glass wall in good condition

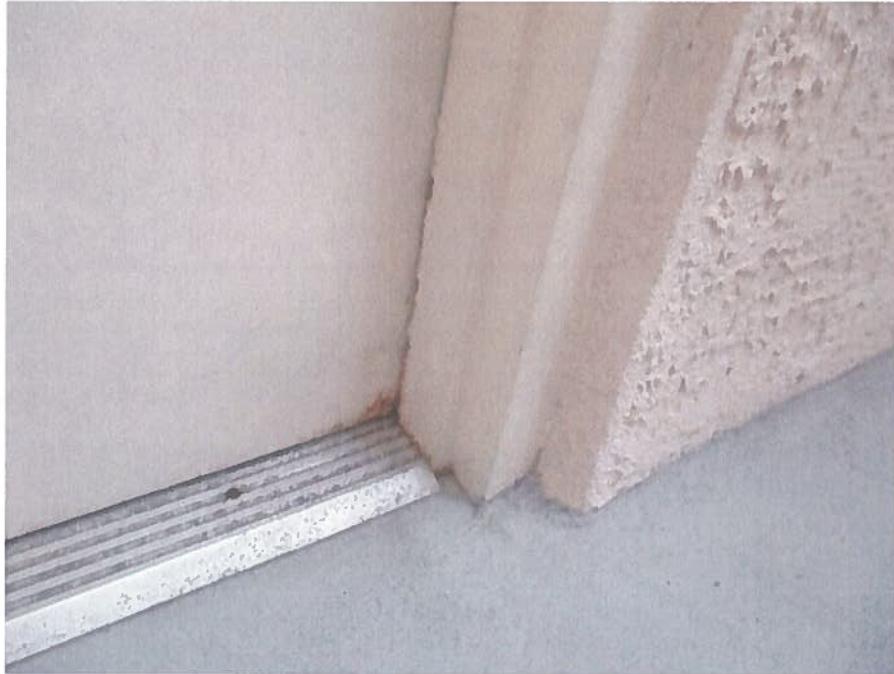
Photo #15 – Rusted base of steel wall

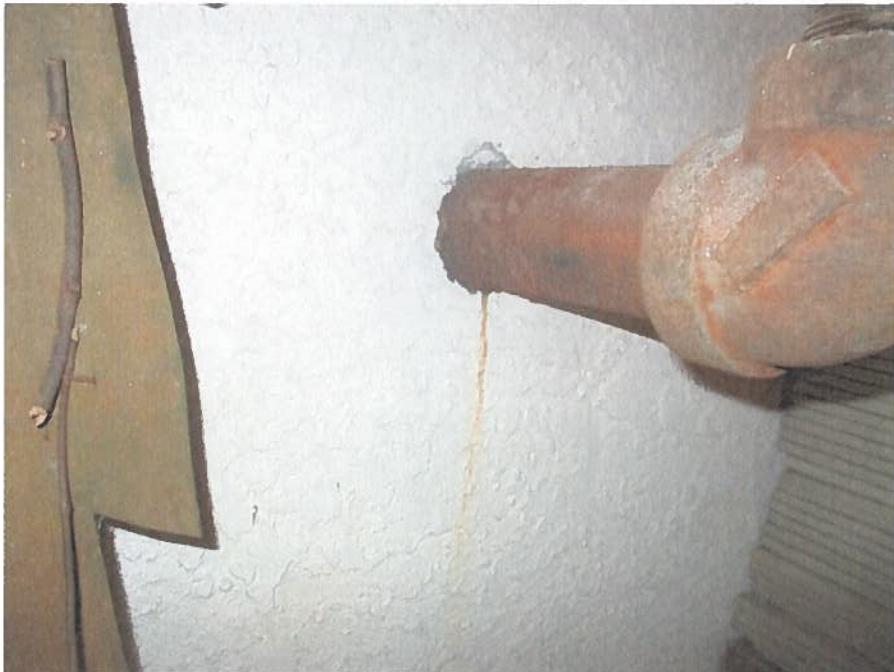
1. The exposed section of the discharge pipe coming from the fire protection system presents corrosion in the garage 501.
2. All four decorative lamps at the pool area present corrosion at the exposed elements and at the section attached to the concrete slab.

Photo #16 – Galvanized pipe (fire protection system) rusting at the exterior wall

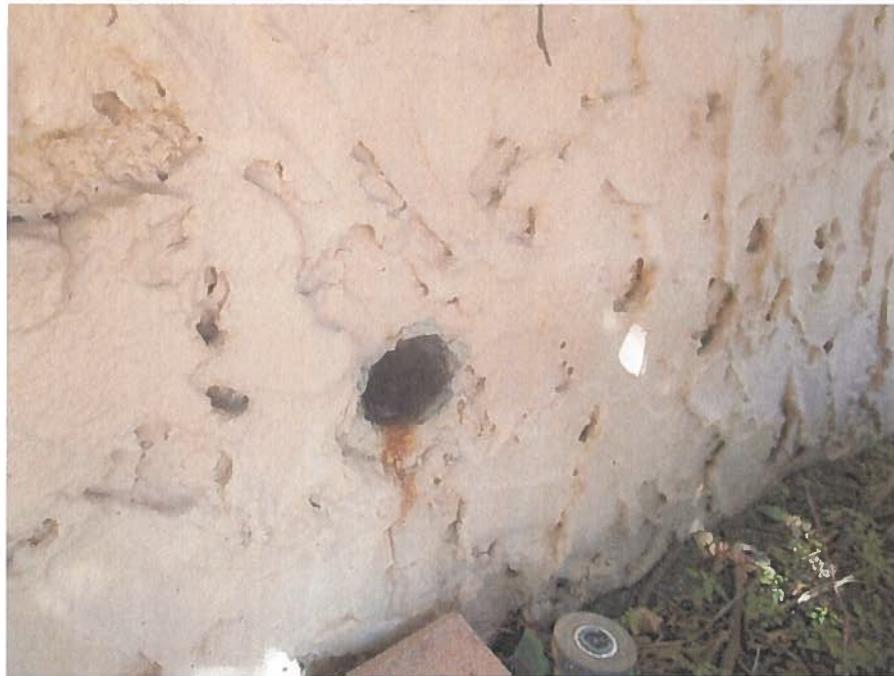
Photo #17 – Galvanized pipe rusting at the exterior wall

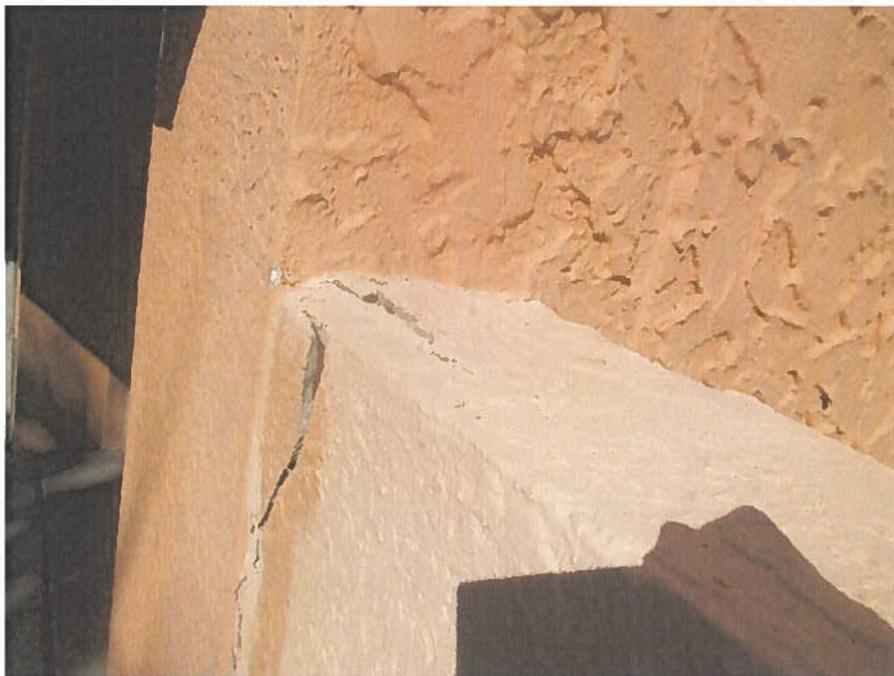
Photo #18 – Sealant failed at expansion joint

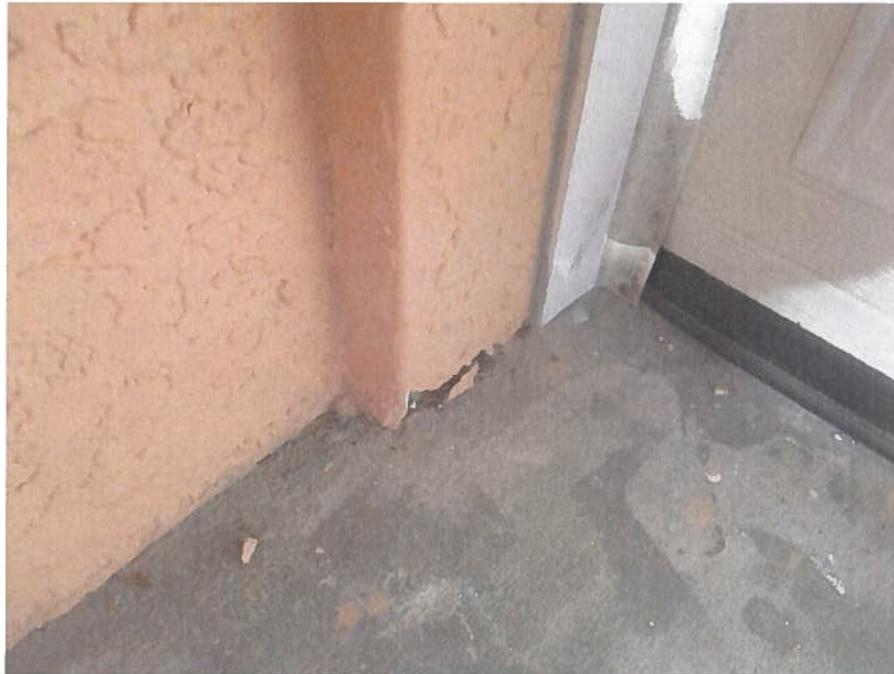
Photo #19 – Stucco failed at transition with slab

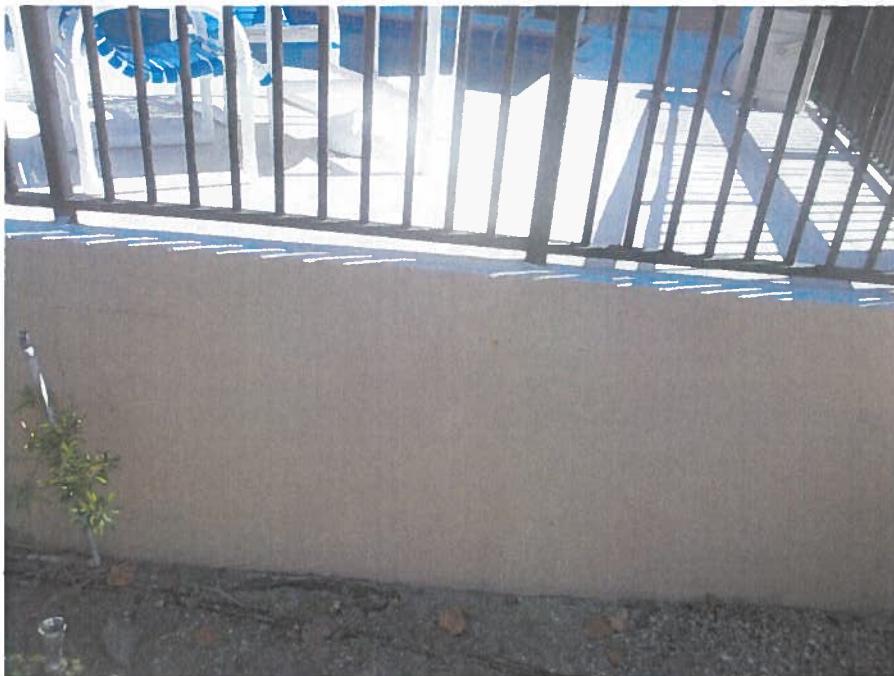
- Cracks around the pool plaza perimeter at the interface between wall and slab
- Pool plaza slab has typical crack and hollow concrete
- Railing paint has fair condition with some deteriorated areas

Photo #20 – Cracks at the perimeter of pool plaza

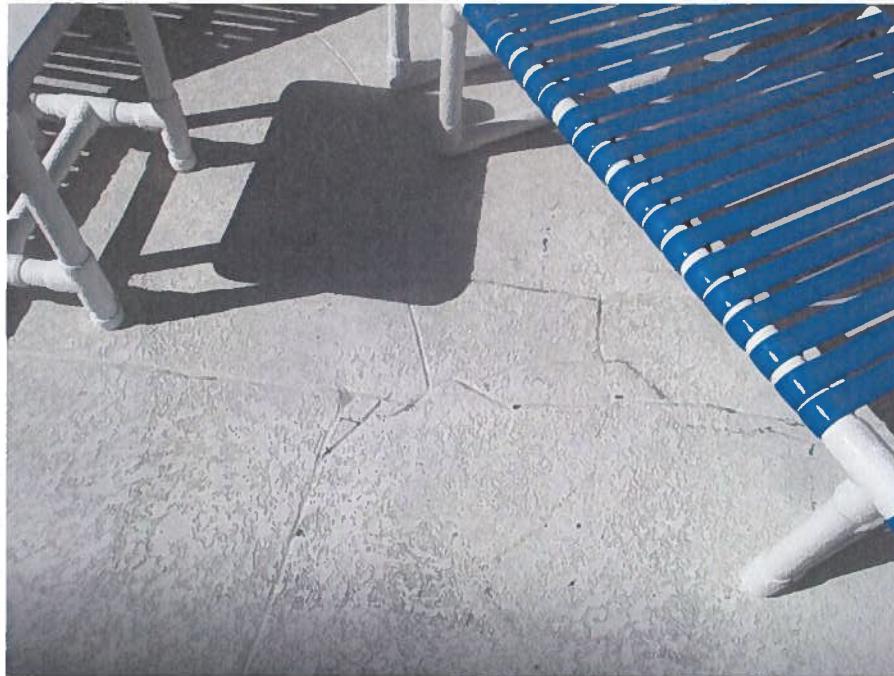
Photo #21 – Cracks and spalls at the pool plaza slab

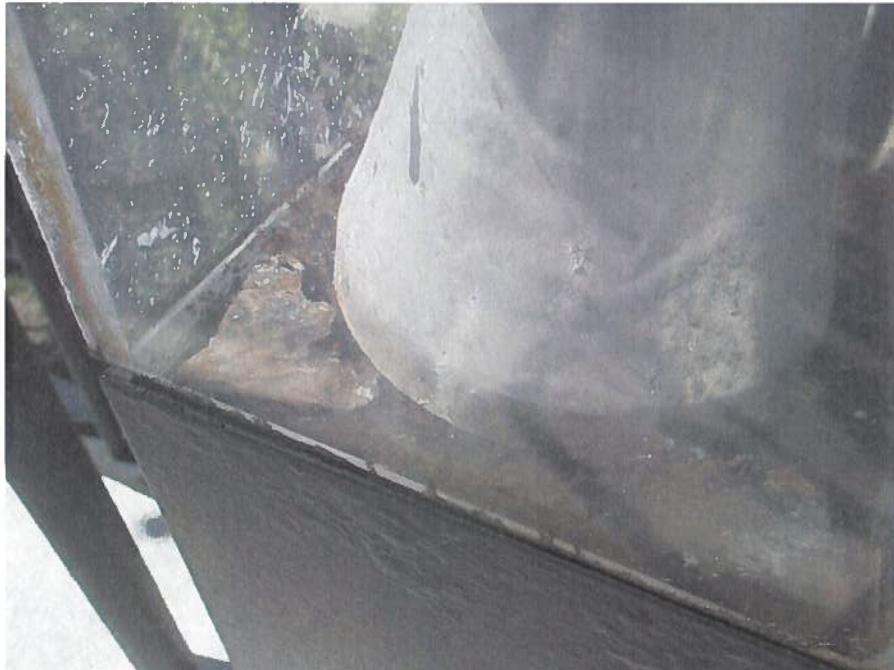
- All four decorative lamps at the pool area present corrosion at the exposed elements and at the section attached to the concrete slab

Photo #22 – Decorative lamps at pool plaza rusted. That includes the sections into the concrete slab

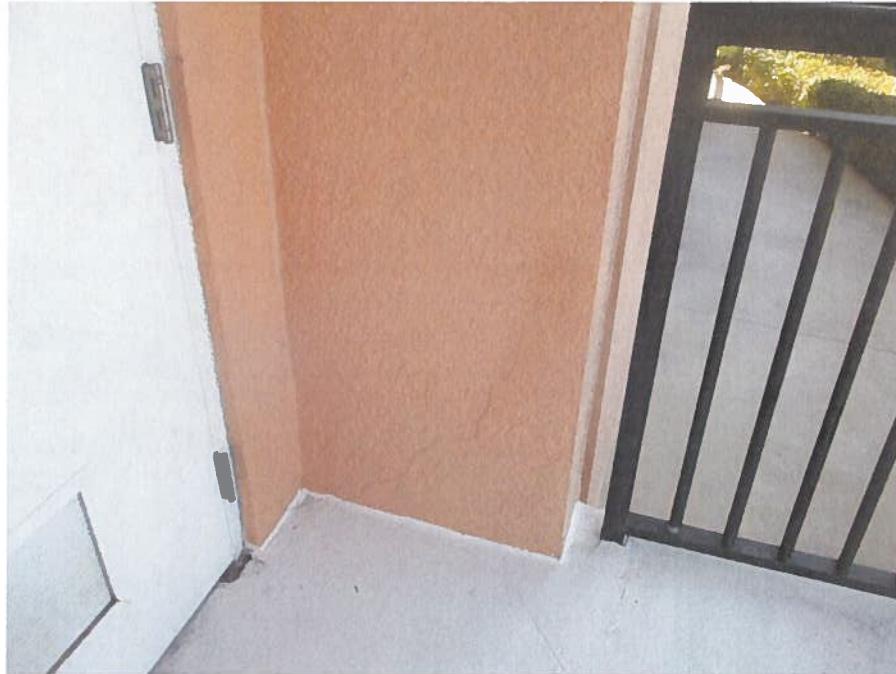
Photo #23 – Cracks at stucco and at wall to slab transition

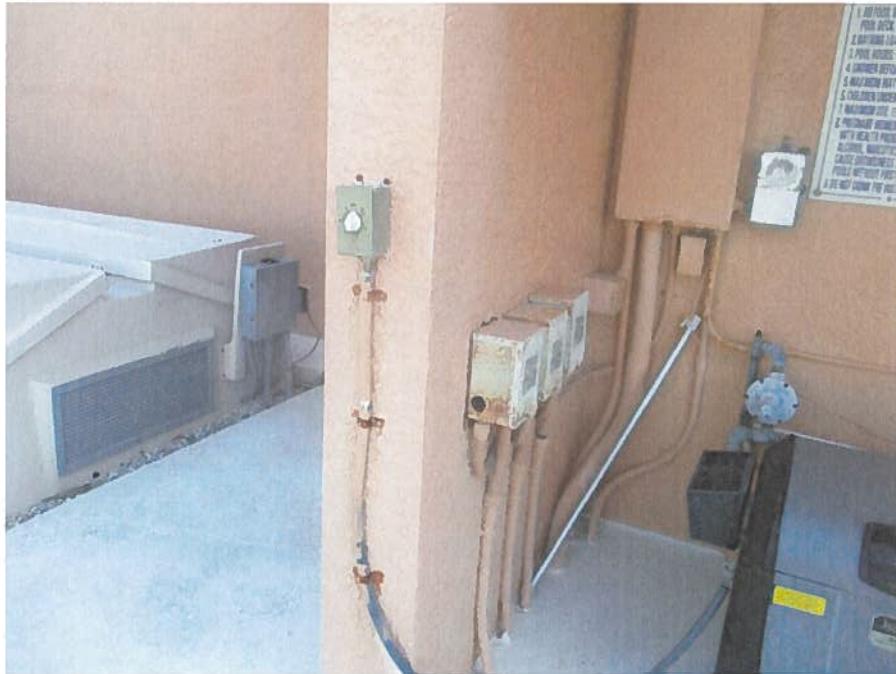
Photo #24 – Rusted fasteners

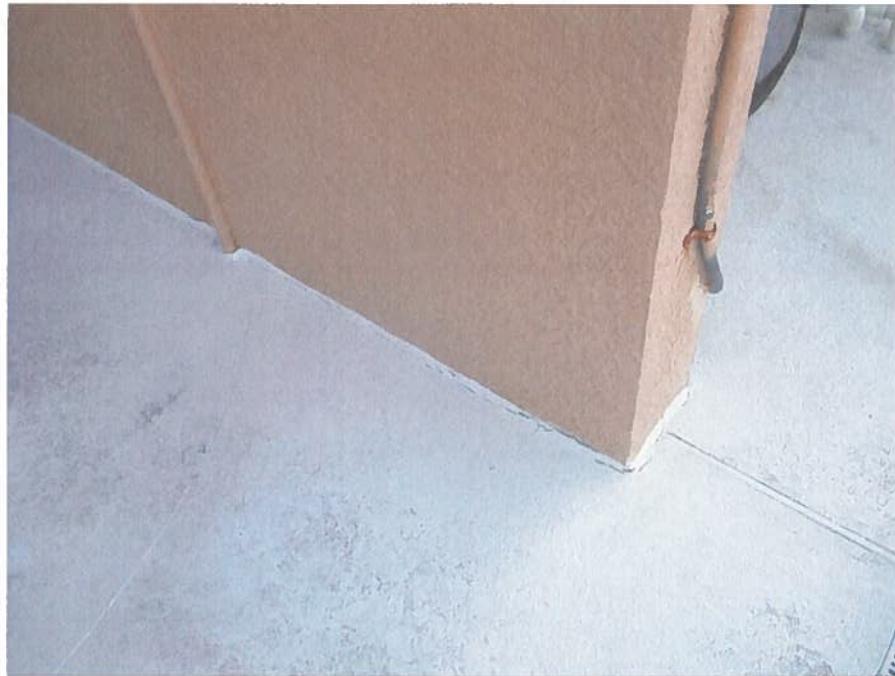
Photo #25 – Failed sealant

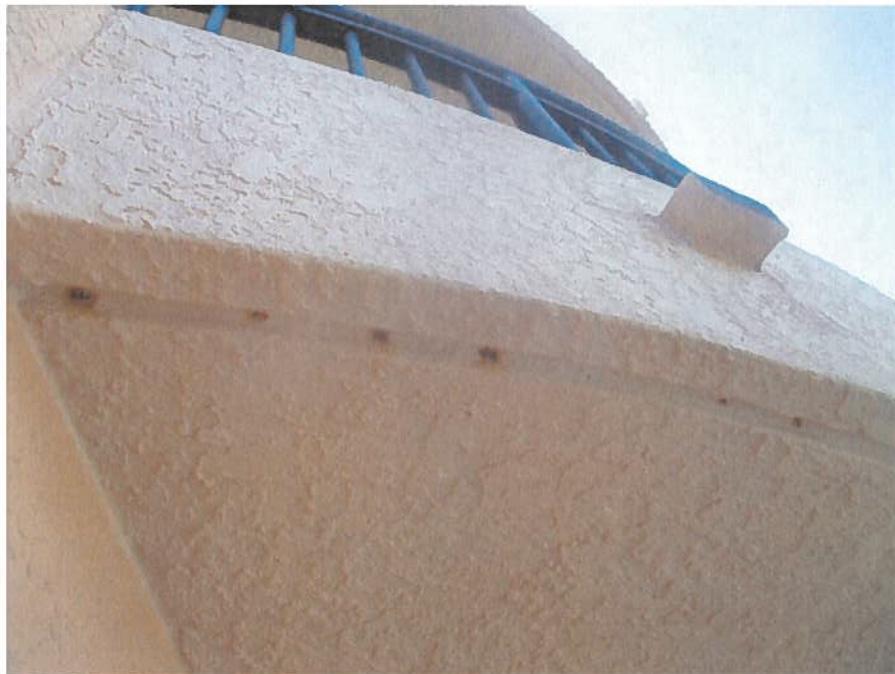
Photo #26 – Shallow reinforcement under stucco

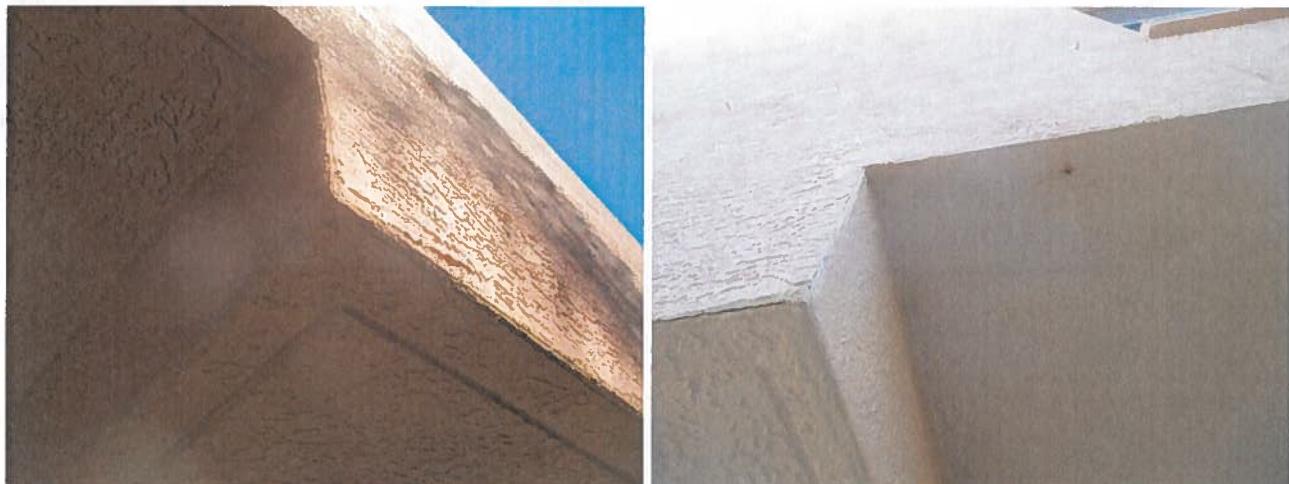
Photo #27 – Cracks at the transition of different materials

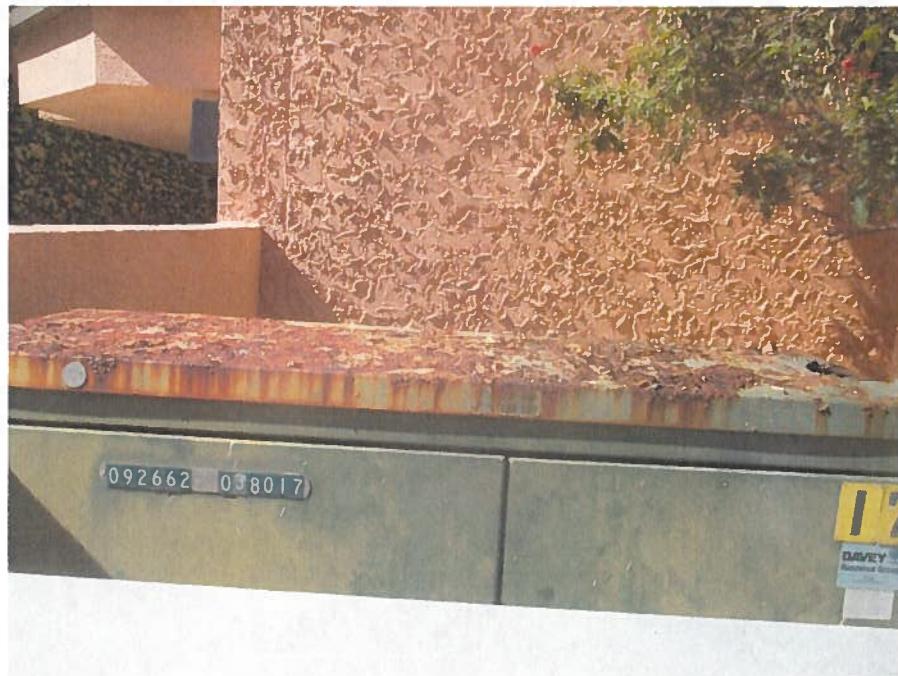
Photo #28 – Rusted electric panel

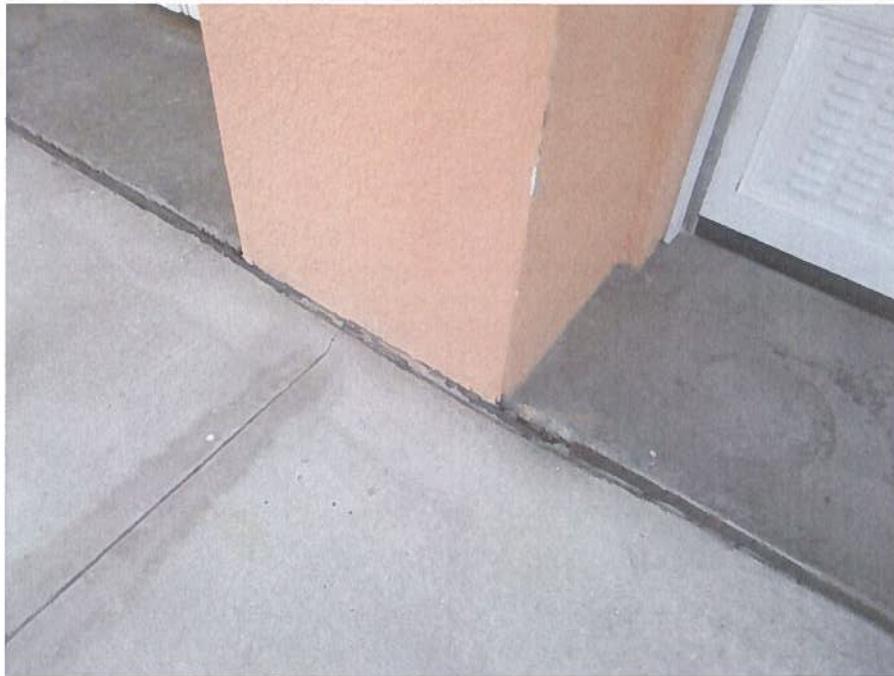
Photo #29 – Failed sealant at transitions

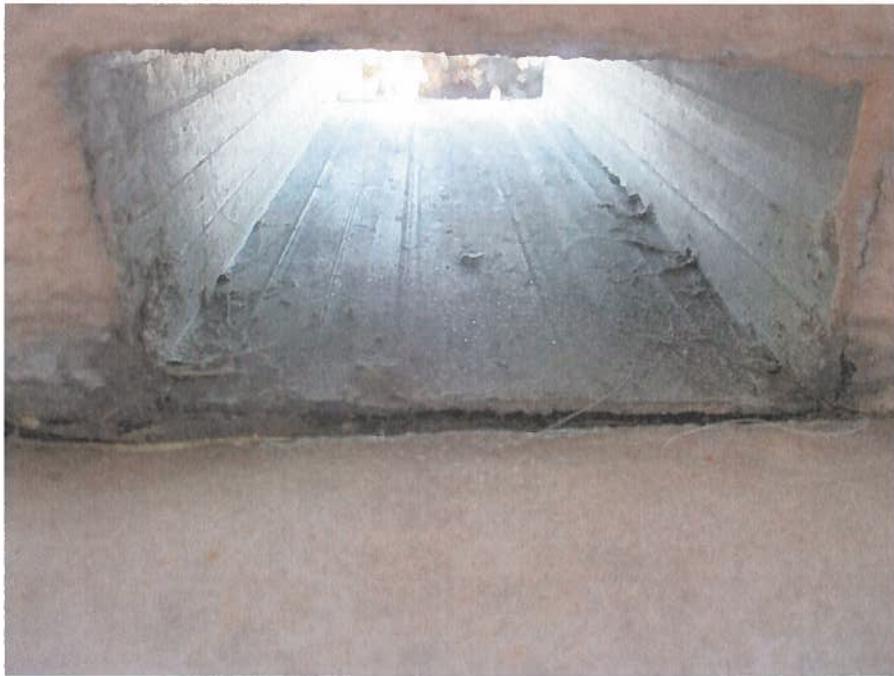
Photo #30 – Gap between scupper and tile

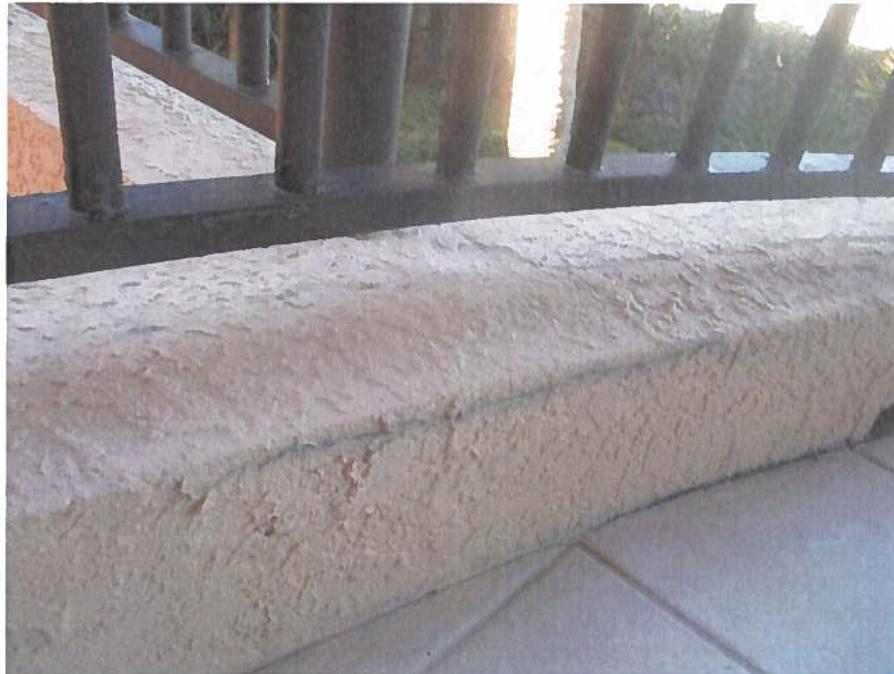
Photo #31 – Delaminating stucco at the balcony

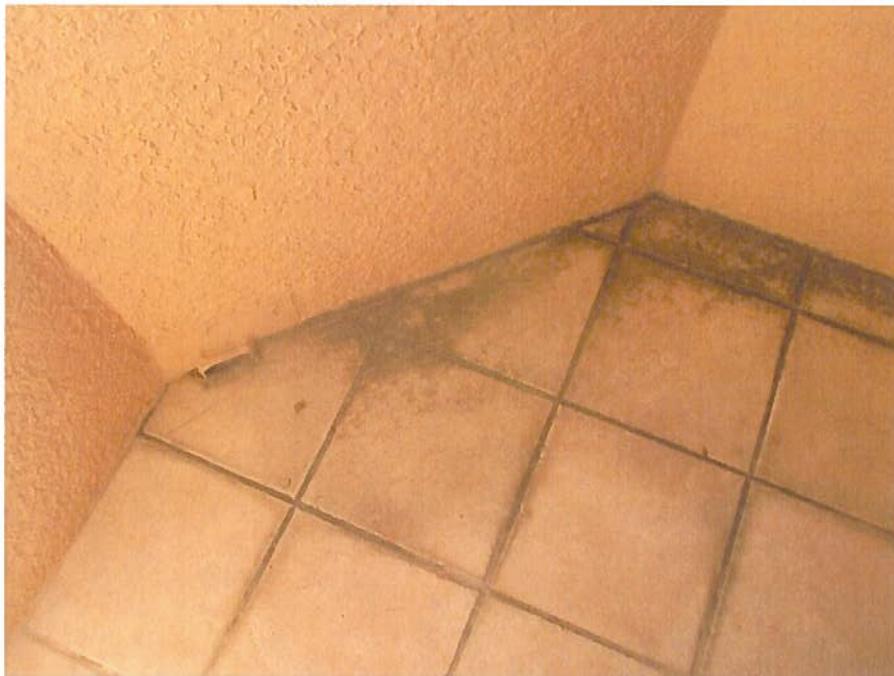
Photo #32 – Pounding water on the small balcony

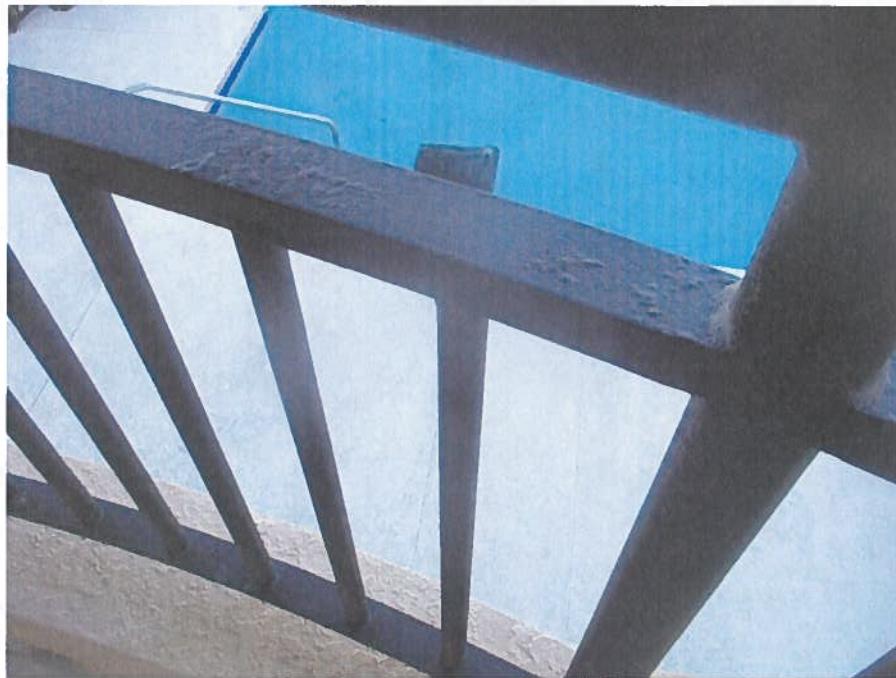
Photo #33 – Railing with some paint peeling

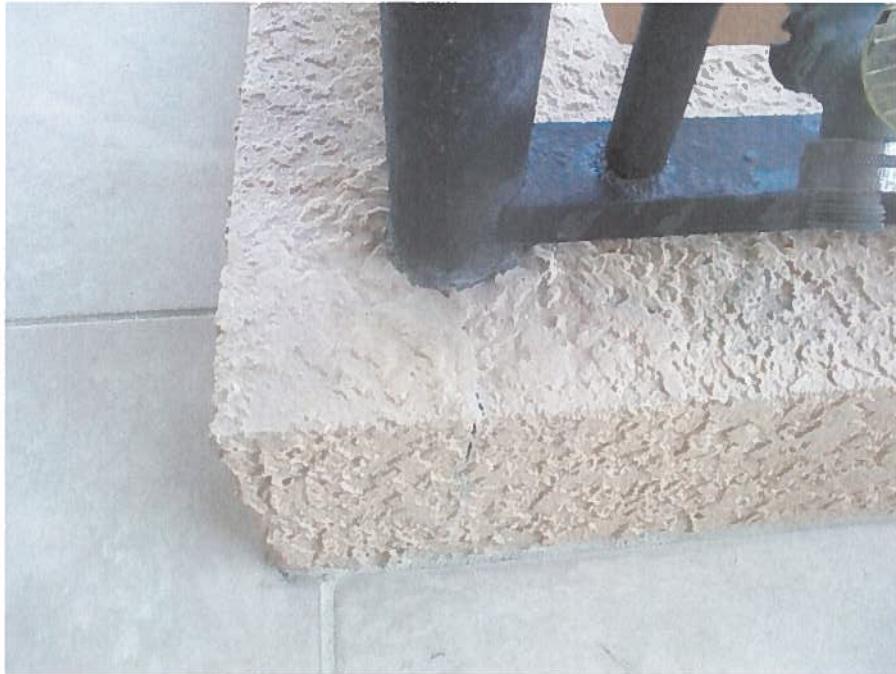
Photo #34 – Hollow post pocket
