RE: **West Shore Place Condominiums**  
**19534 Gulf Blvd,**  
**Indian Shores, FL 33785**  
**KEG File# 23RT-0005**

## 1.0 INTRODUCTION

## 6.0 MILESTONE INSPECTION

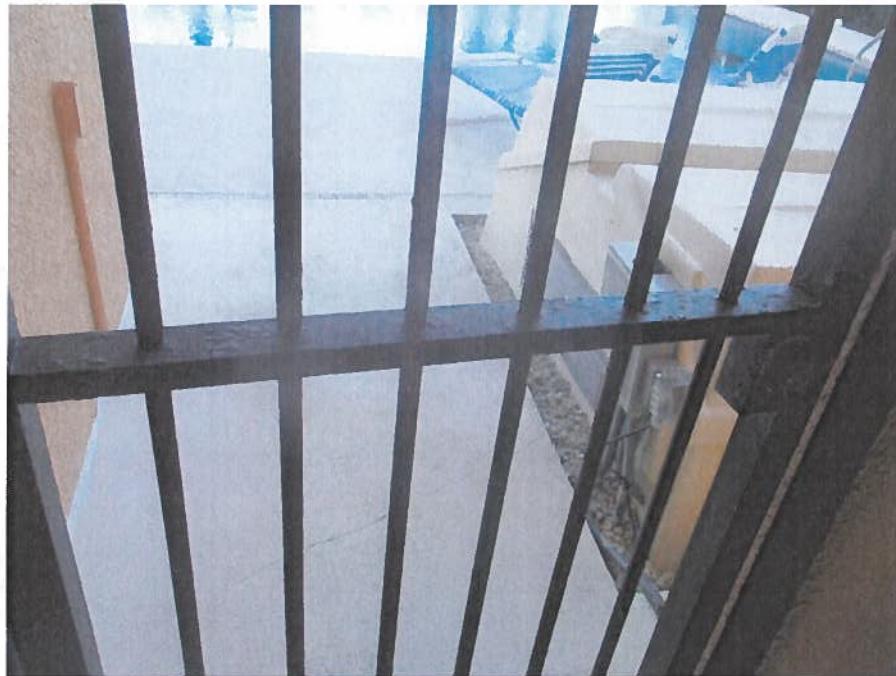
Photo #35 – Some paint peeling at gate

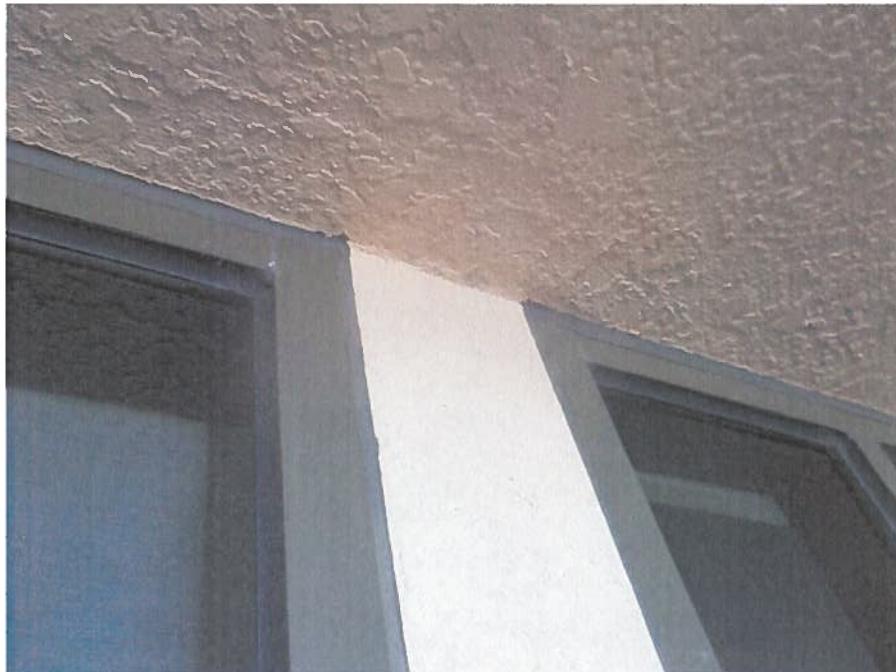
Photo #36 – Typical good sealant around windows

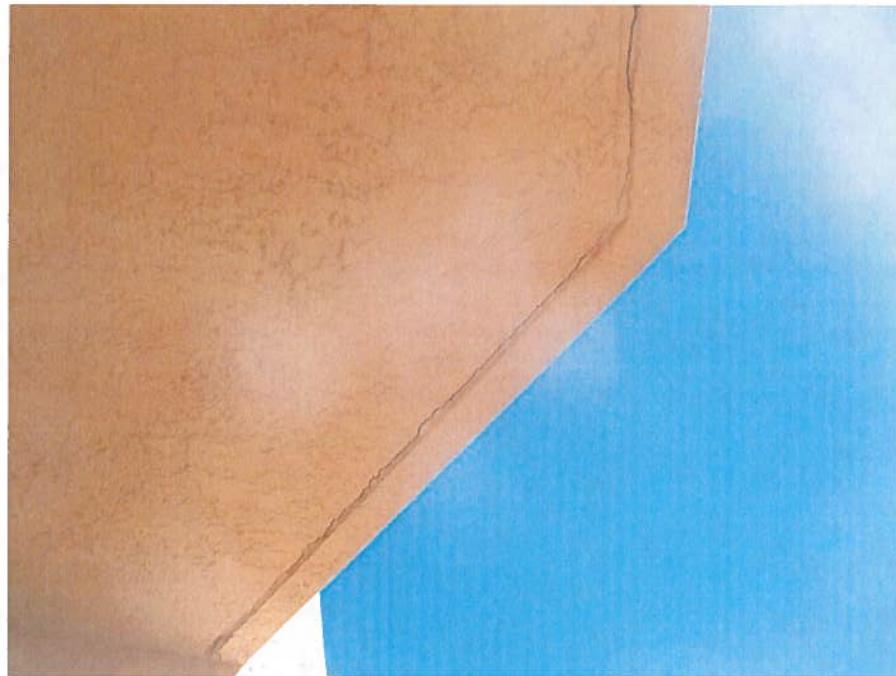
Photo #37 – Edge spall at the small balcony

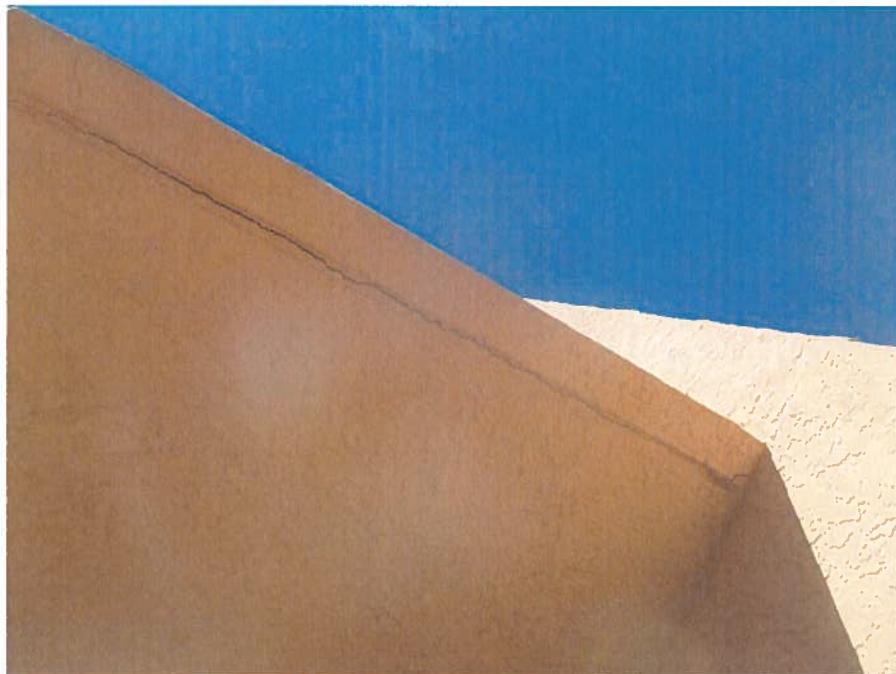
Photo #38 – Edge spall at the small balcony

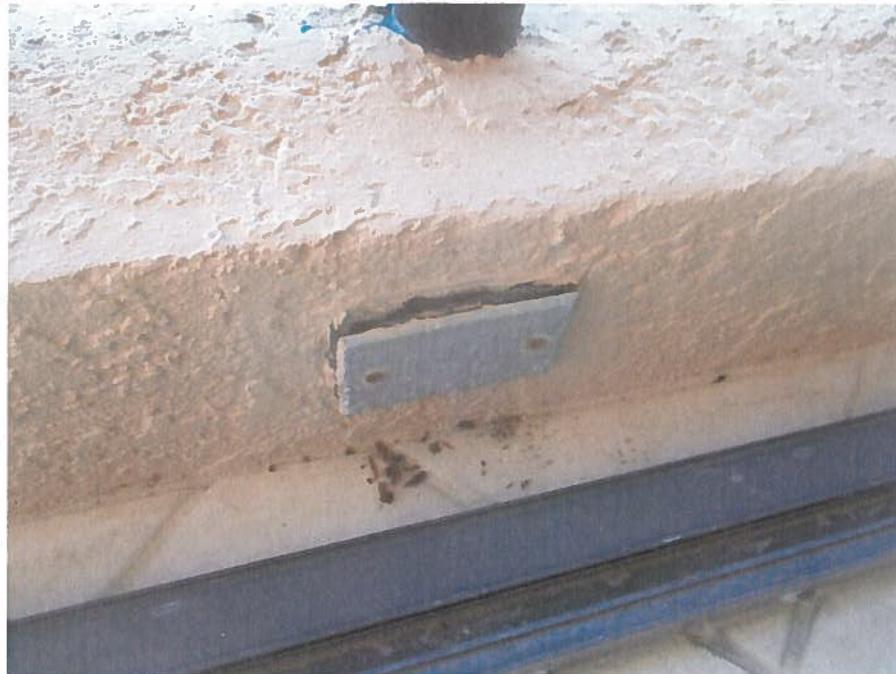
Photo #39 – Electric with corrosion

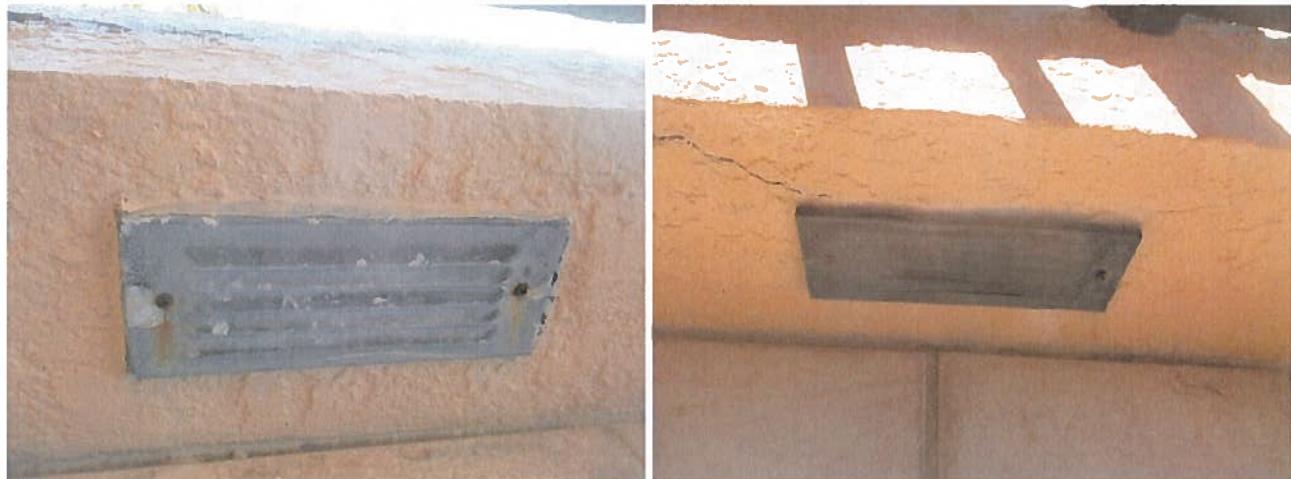
Photo #40: Balcony lights with failed sealant and rusted screws

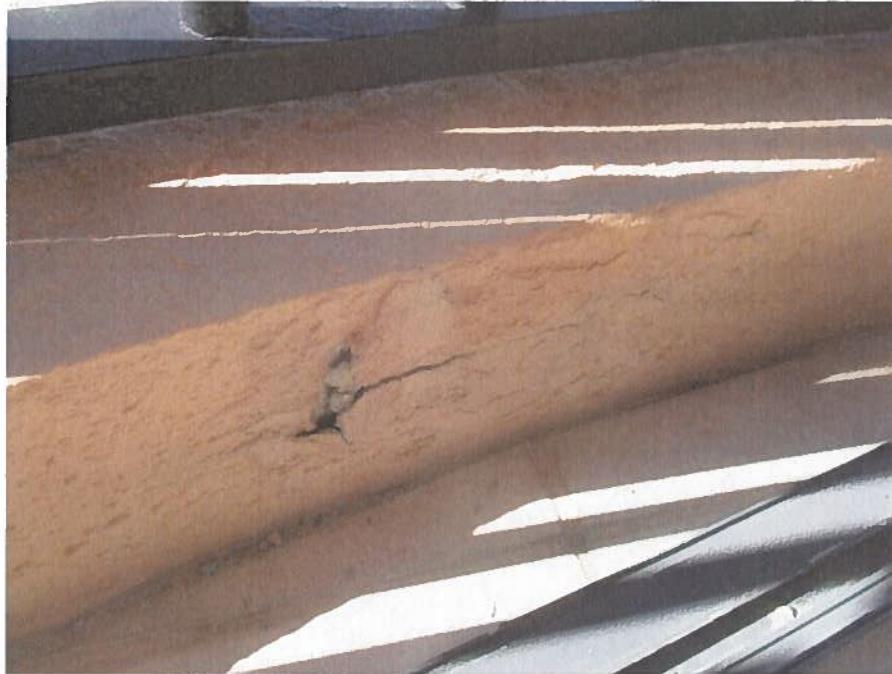
Photo #41 – Damaged stucco at balcony curb

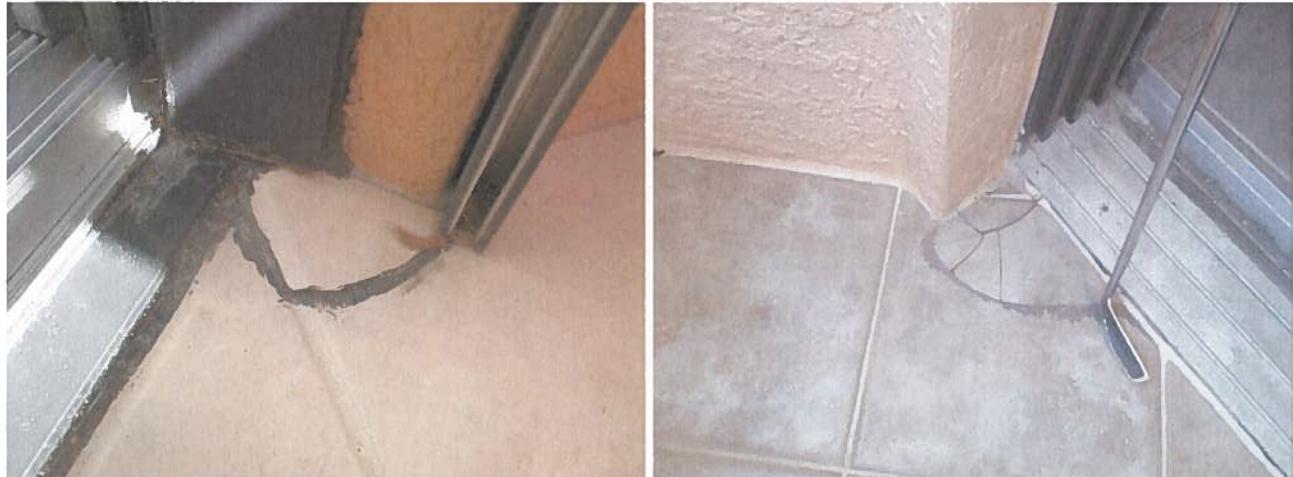
Photo #42 – Typical cracked tile under small balcony sliding glass door

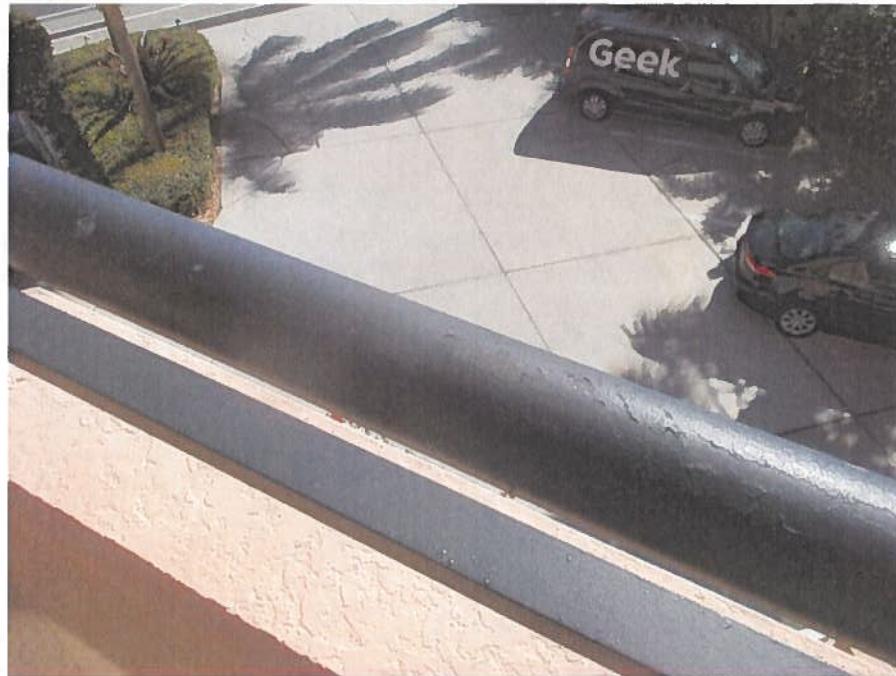
Photo #43 – Railing typical condition

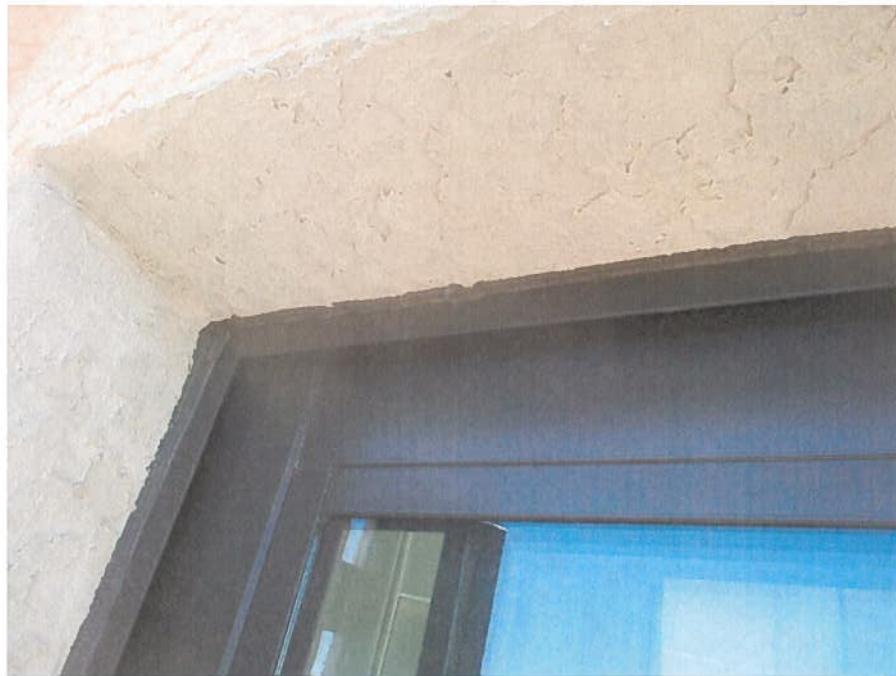
Photo #44 – Replaced SGD w/ bad stucco patch and failed selant

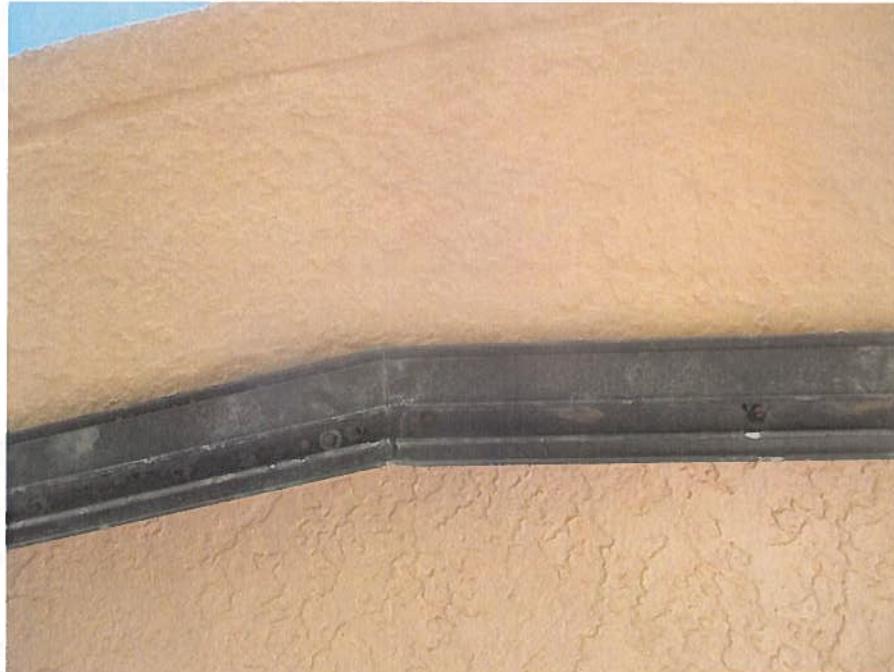
Photo #45 – Rusted screws attaching balcony storm shutter

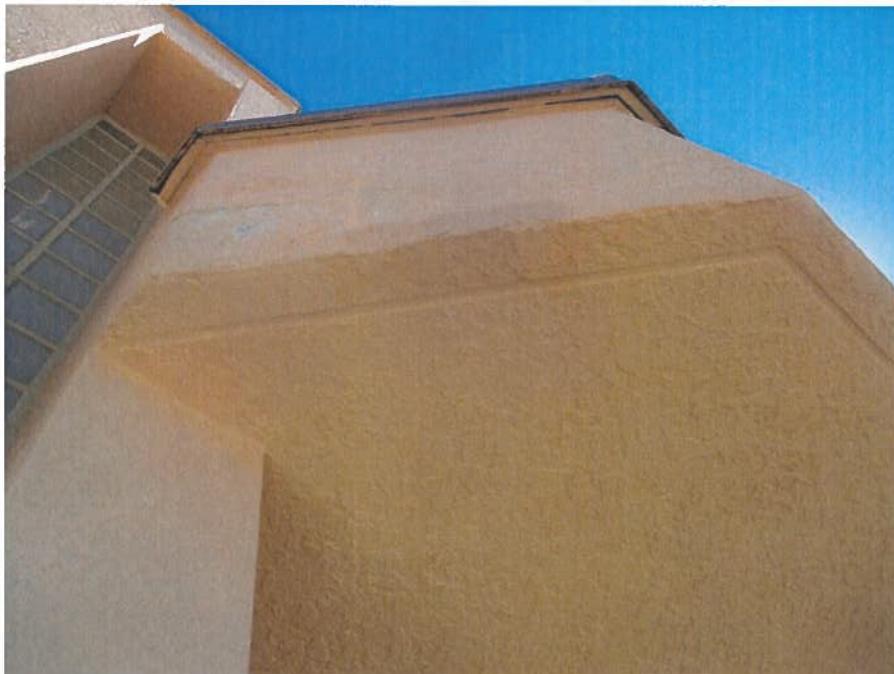
Photo #46 – Efflorescence at parapet above unit #501
