December 20, 2024

**RE: Holiday Villas II Condominium Association Inc. – Milestone Phase 1 Inspection Report
19610 Gulf Boulevard, Indian Shores, FL 33785
KEG File# 21RT-0721**

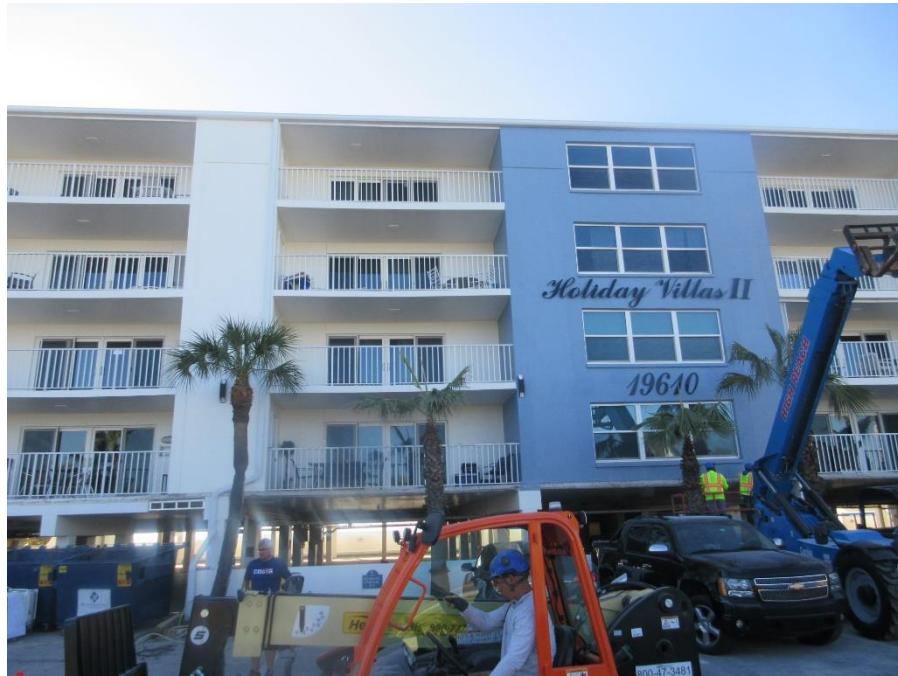
Photo #1 – East Elevation of Building.

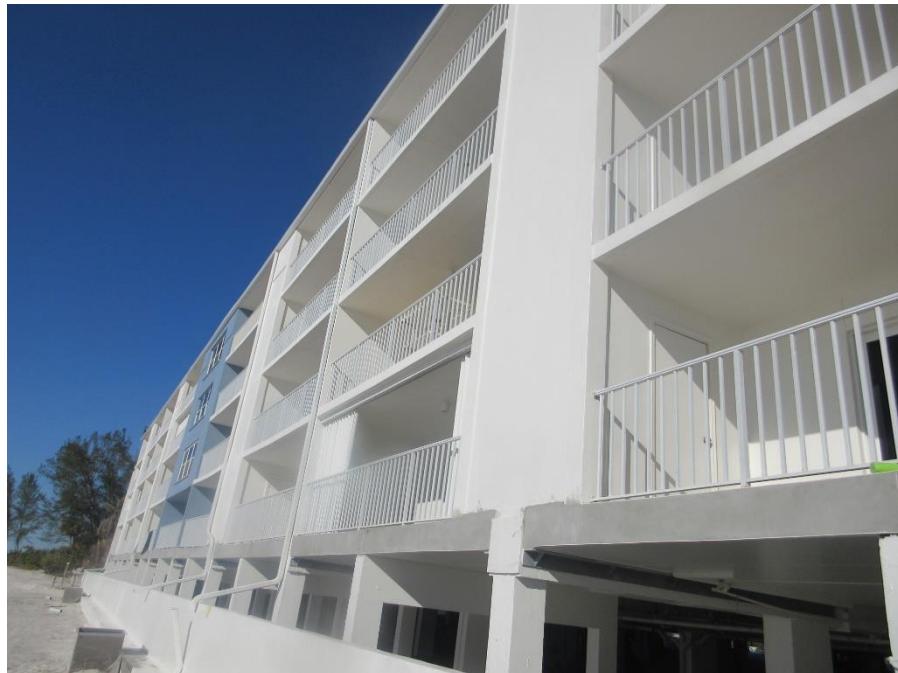
Photo #2 - West Elevation of Building.

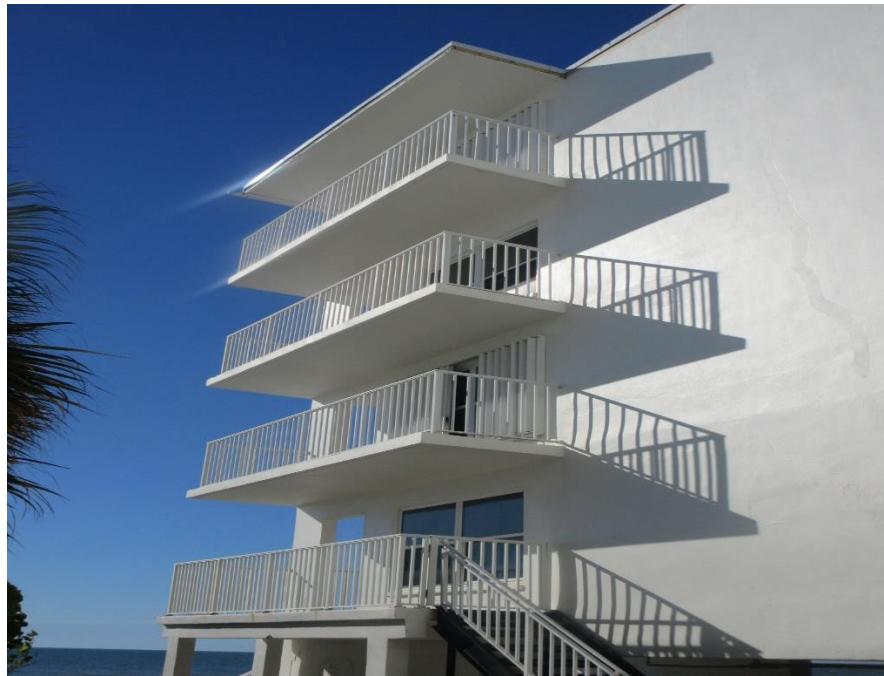
Photo #3 – Typical Side Elevation of Building.

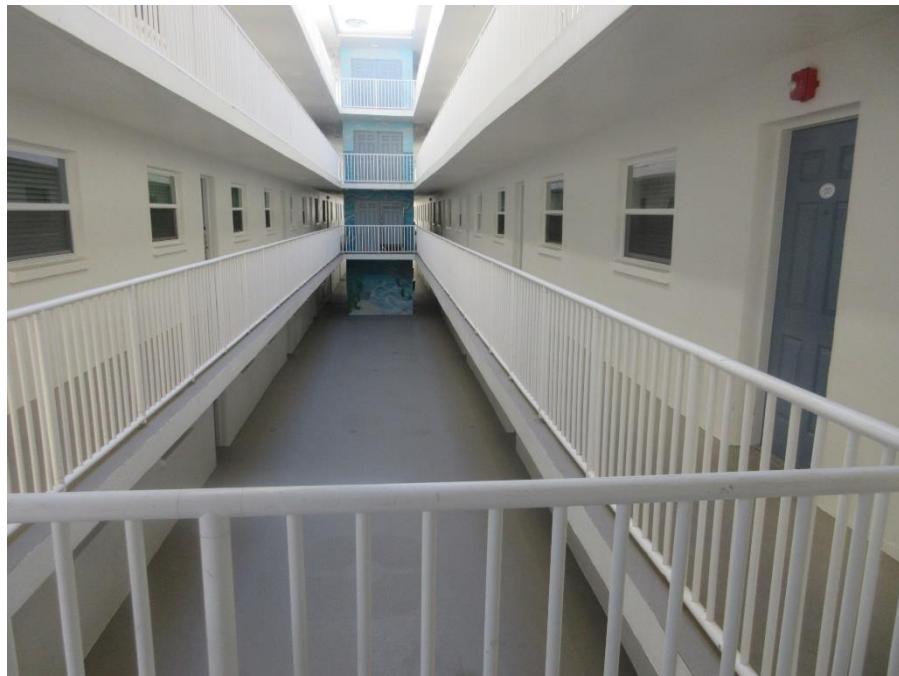
1. KE noted that during our initial survey and numerous inspections, there are isolated concrete spalls and concrete cracking at the common walkways and common stair towers. This work is planned to be addressed during the next Phase of restoration work commencing in Fall of 2025.

3. The stamped concrete finish at the walkways was found to be delaminated and failing at multiple locations at the common walkways. Full removal of the finish and waterproofing of the walkways is planned for the next Phase of restoration work commencing in Fall of 2025.

Photo #4 – Overview of Common Interior Walkways.

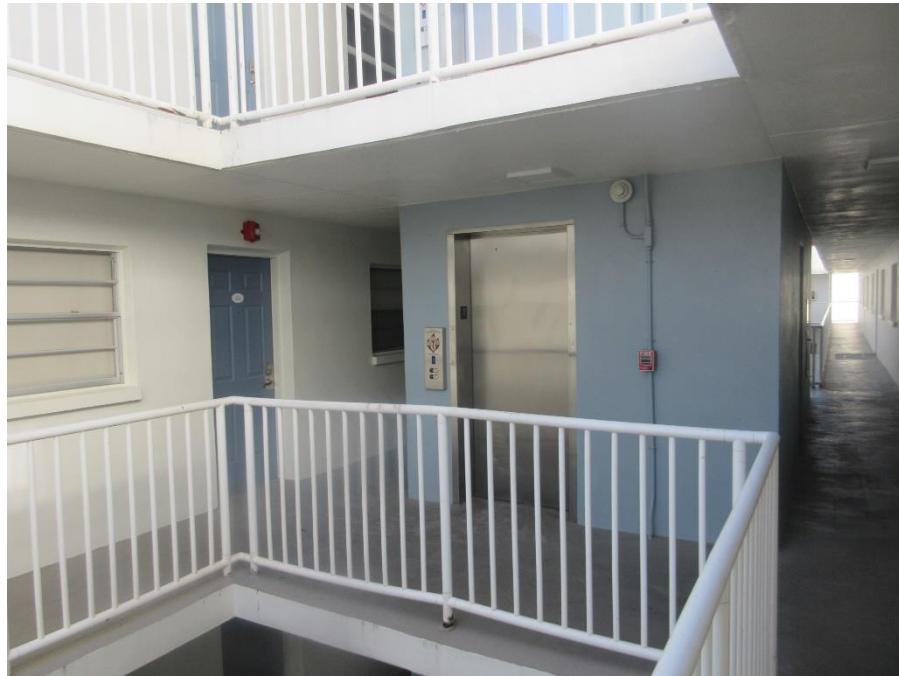
2. The concrete slab in the elevator pit was noted to be cracked and spalled. As a result, ground water is entering the elevator pit. For the time being, sump pumps are being used to remove water as it enters. Replacement of the pit slab is planned for the next Phase of restoration work commencing in Fall of 2025.

Photo #5 – Overview of Centrally Located Building's Elevator.

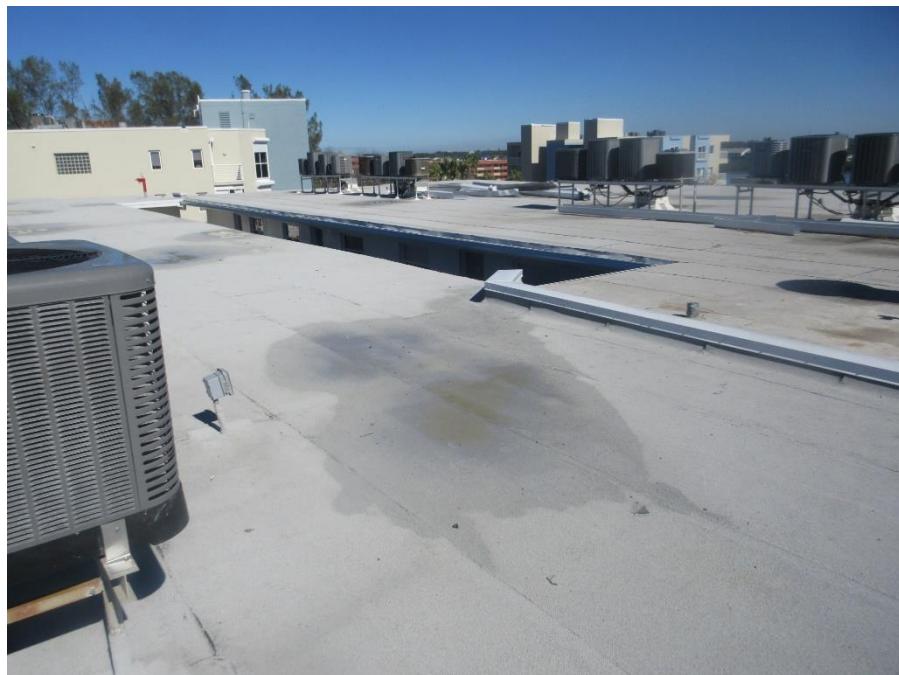
Photo #6 – Overview of Main Roofs Covered with Two-Ply Modified Bitumen Membrane.

6. Both roofs have been recently completed with the west section of roof having a 20-year NDL warranty. KE recommends that the Association have annual maintenance performed by the roofing contractor that installed the roof system(s) in order to maintain the warranties and address any minor repairs that are needed. Inspections should be conducted at least every 12 months.

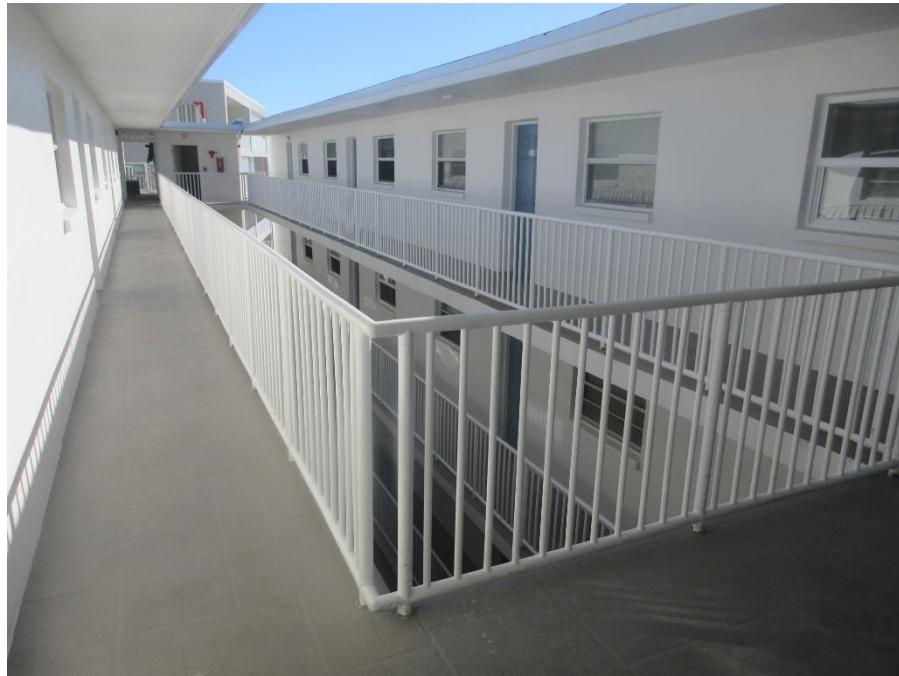
Photo #7 – Overview of PVC Railings on Walkways. (TYP.)

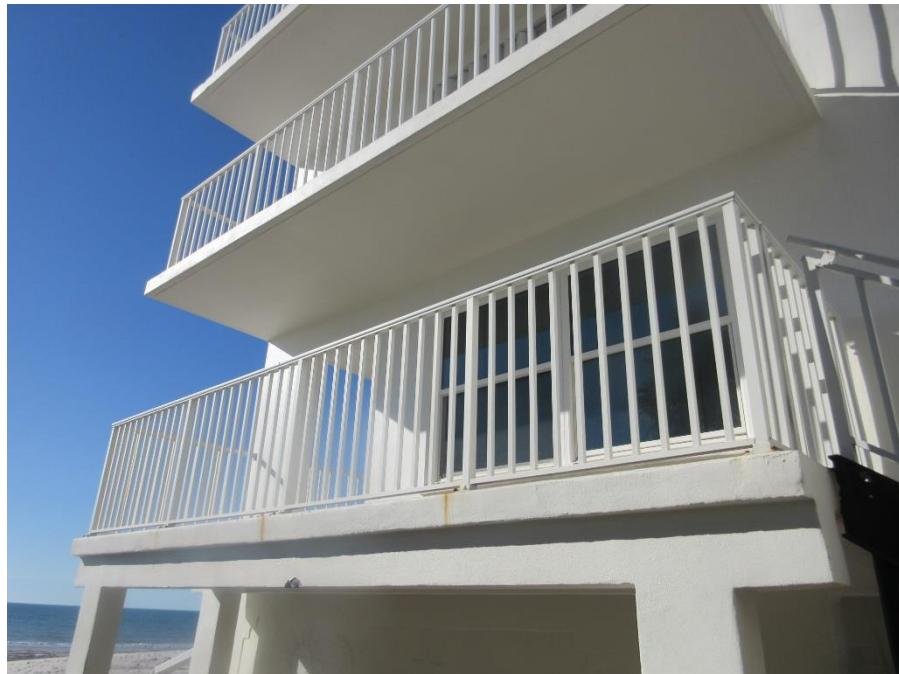
Photo #8 – Overview of Aluminum Railing on Private Unit Balconies. (TYP.)

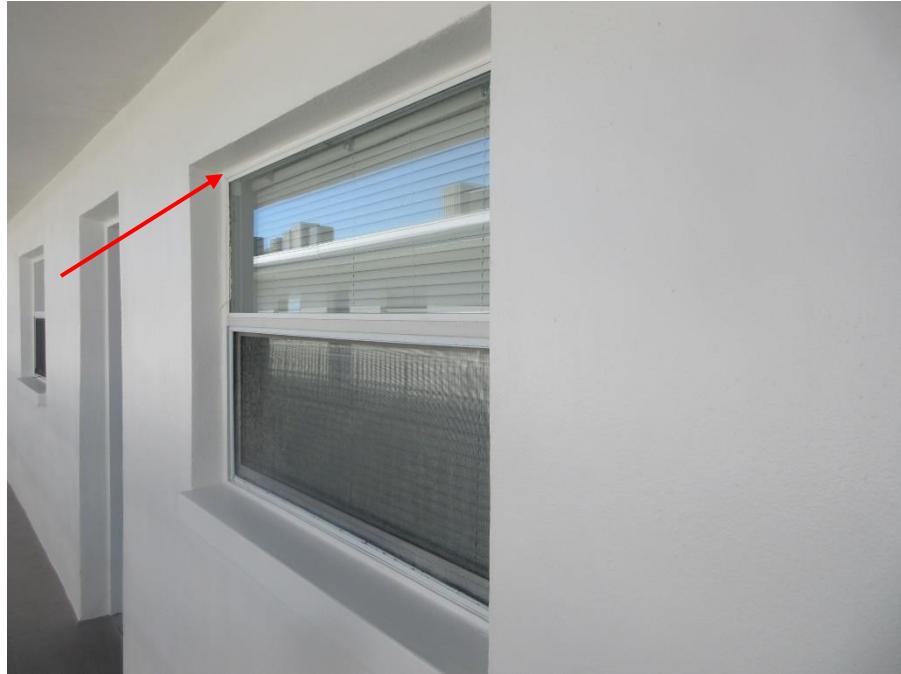
Photo #9 – Recently Updated Exterior Windows (2018) with New Perimeter Sealant Installed. (TYP)

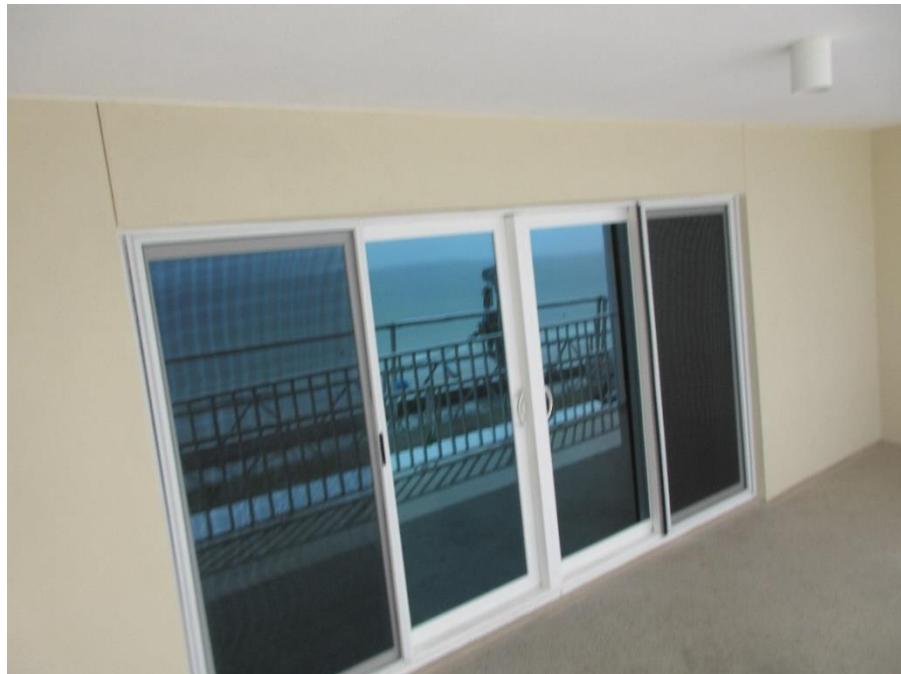
Photo #10 – Typical Overview of Recently Upgraded Sliding Glass Door in 2018.

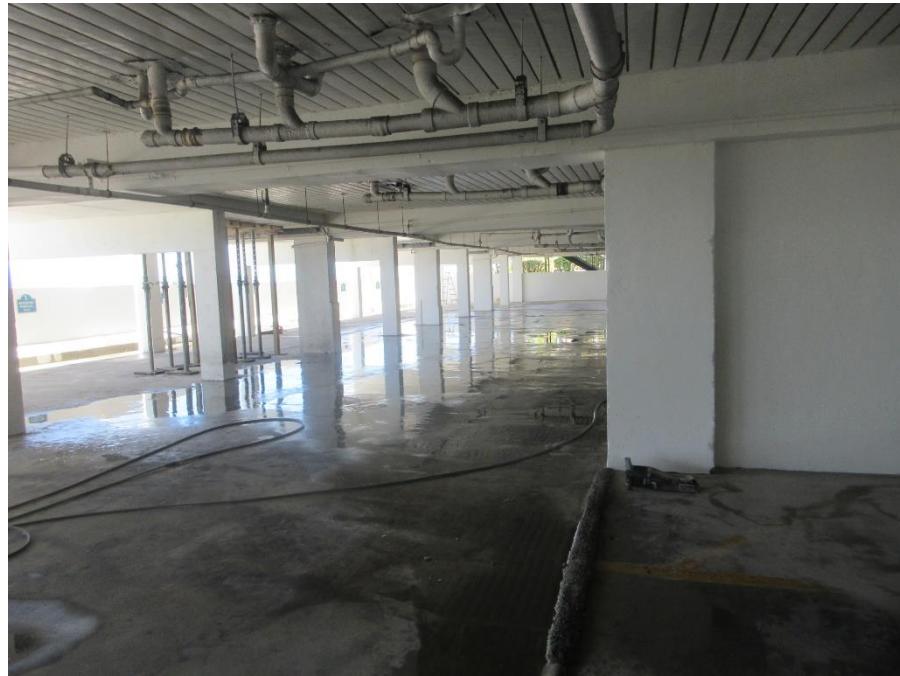
7. The composite metal deck in the parking garage was recently cleaned and coated with a commercial epoxy paint to prevent against future corrosion. KE recommends that the Association plan for annual maintenance of the coating to

Photo #11 – Northwest Overview of Underbuilding Parking Garage.

address and surface rust or bleed through. Annual maintenance of the coating will help prevent costly future repairs.
