January 16, 2023

RE: Beach Club of Indian Shores Condominium Association, Inc.
19616 Gulf Boulevard
Indian Shores, Florida 33785
KEG File #22RP-0940: Milestone Inspection

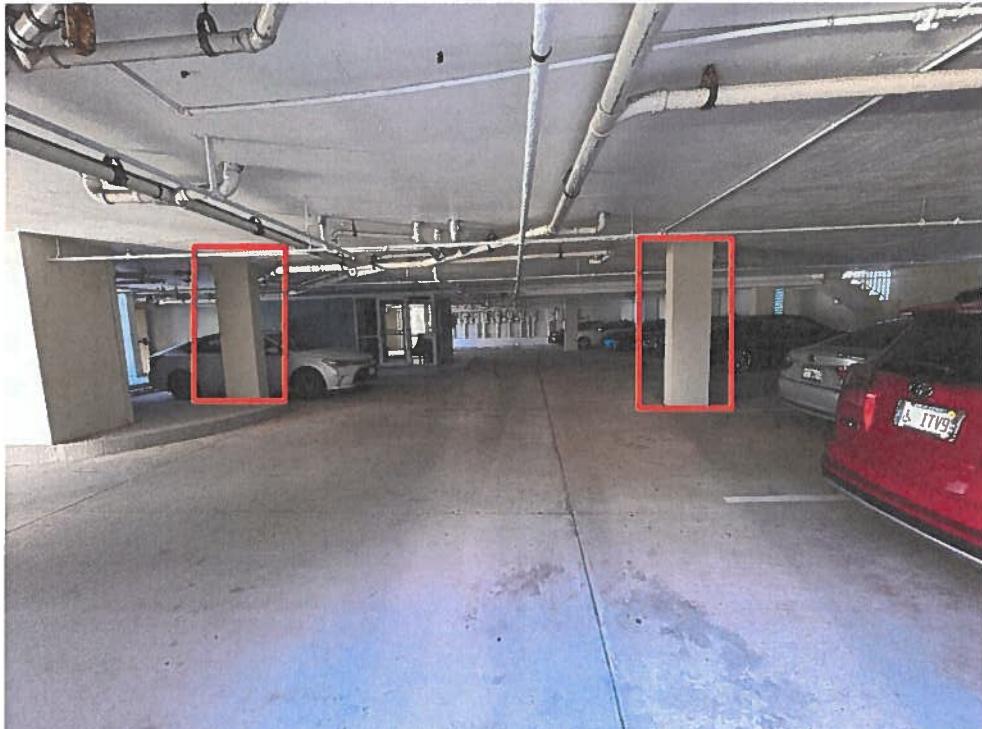
As noted above, the building plans that were provided to KEG state that the structure is constructed on a pile cap with piles deep foundation. KEG was not able to visually observe the foundation. Typically, foundations for a 6-story structure on the beach will be constructed of deep piles to provide sufficient support and eliminate the possibility of shallow foundations being eroded away.

KEG reviewed the structure for signs of differential settlement or excessive settlement. Based on our observations, KEG did not observe any signs of conditions that would indicate a failing foundation or settlement in excess of typical anticipated settlement. The slab on grade within the garage also appeared to be in good condition.

Visualization of Piles Foundation Supports in Garage

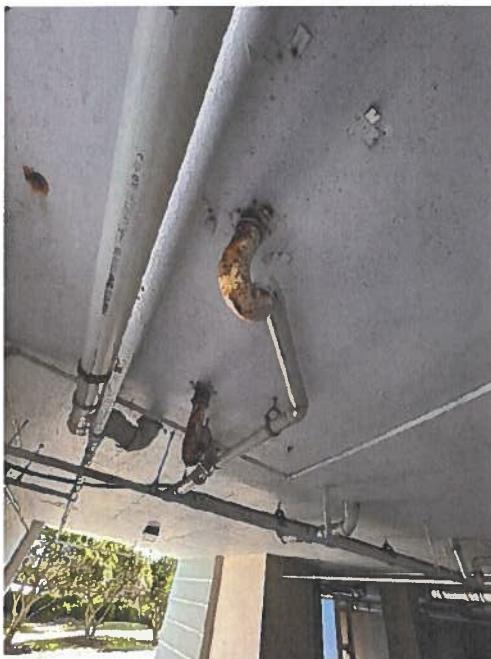
The exposed plumbing in the garage consisted of PVC and metal piping held up by metal fasteners and hangars. KEG noted that the hangars are in fair to poor conditions, appeared to be oxidizing and rusting. Typically, this is due to the Gulf salt air it is exposed to. Additionally, KEG noted the metal pipes to be experiencing the same oxidizing and rusting as the metal hangars. The Association may wish to investigate replacing the hangars with a stainless-steel product and coating the metal pipes with a marine grade epoxy paint.

Metal Pipes Showing Signs of Oxidizing and Rusting

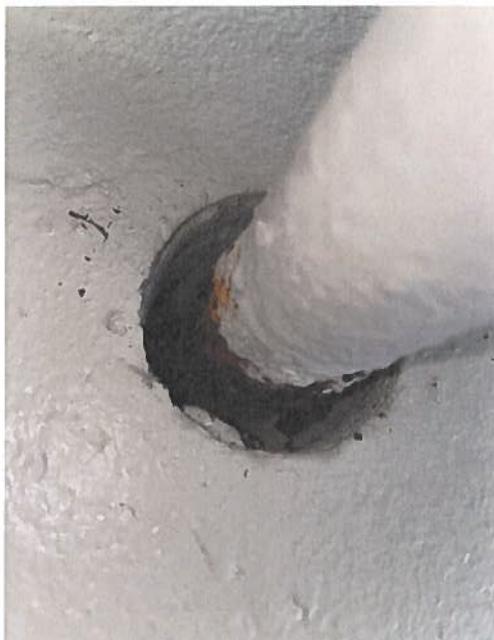
While KEG was visually inspecting the pipes and sprinkler lines, there appeared to be an absence of fire caulking at the penetrations leaving a void. Potentially the fire caulking was on the other end of the penetration, but KEG could not verify. Typically, these are in fire rated walls and slabs to help prevent fire or smoke from entering an emergency exit egress or between two types of occupancy, such as the garage and interior units.

Visualization of Sprinkler Line Missing Fire Caulking

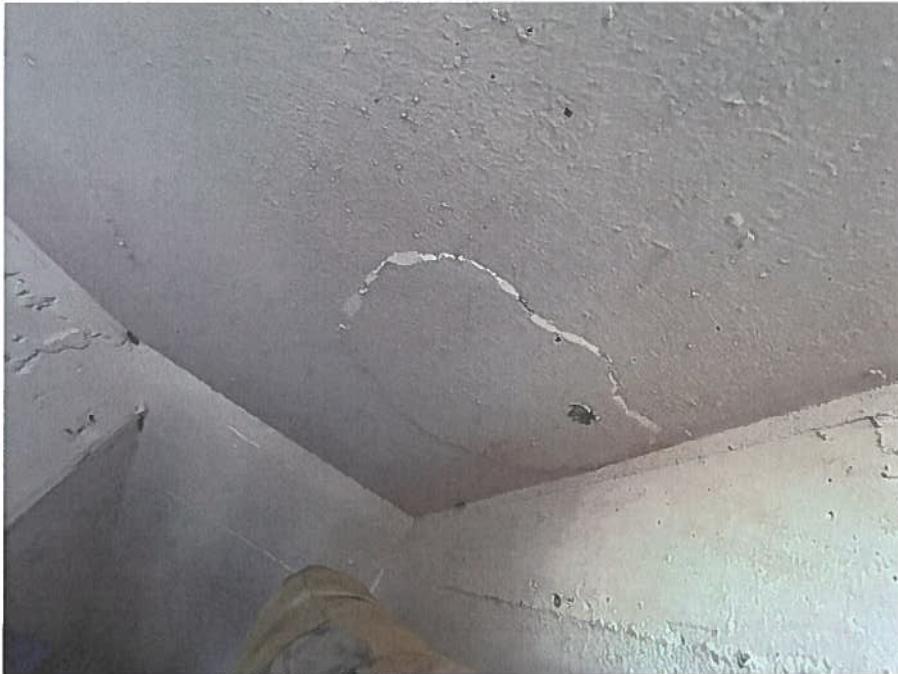
KEG noted the overall structure to be in generally good condition, however, a few minor spalls were located and observed at the west stairwell. The minor spalls were located in the storage area under the stairwell and on the 3rd floor at the exterior of stairwell. These spalls are minor and are not affecting the overall integrity of the structure, however, KEG would recommend the Association repair the spalls during the next restoration or paint project.

Spall Occurring Under West Stairwell

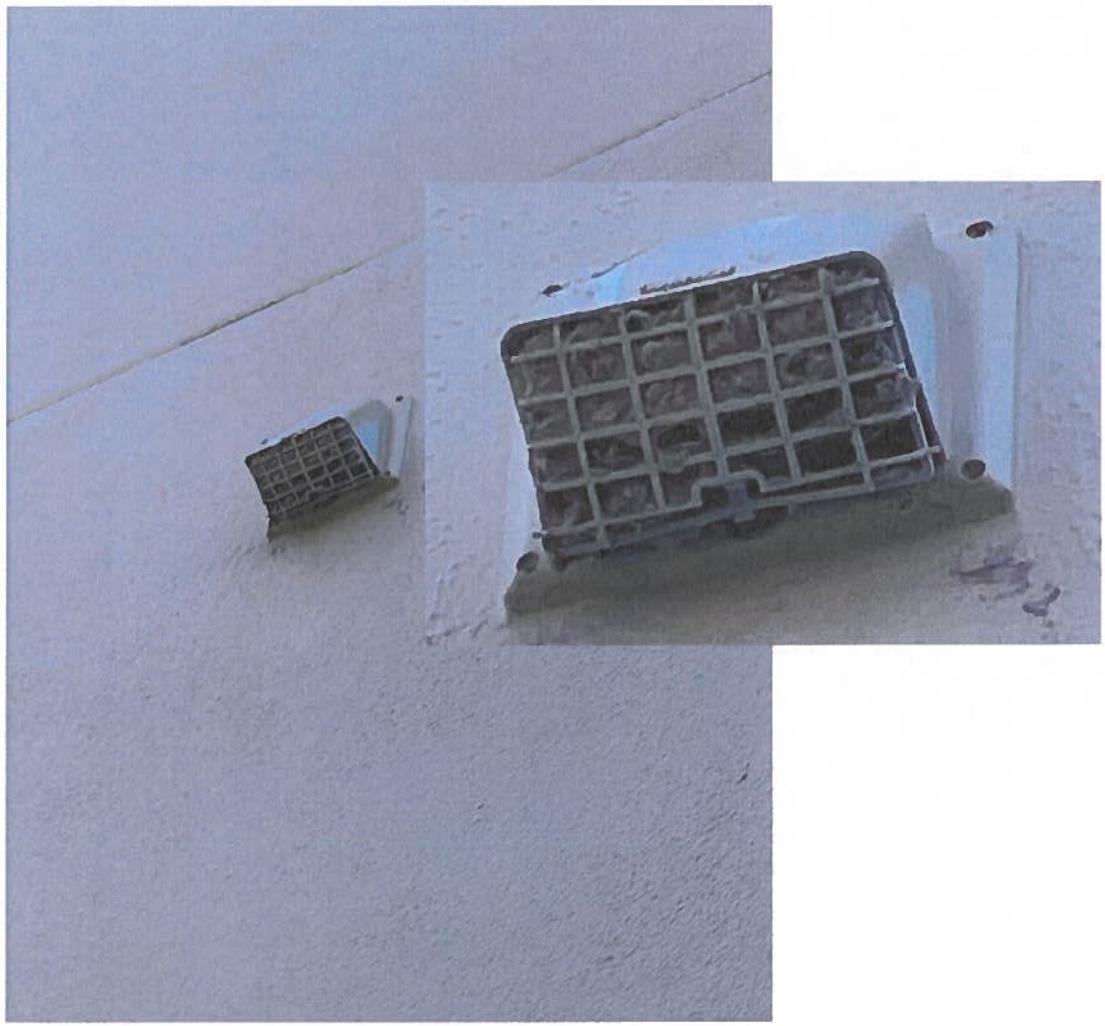
During the inspection of the overall structure, KEG noted that the north and south faces of the structure appeared to have dryer vents. On the north side of the structure, the lowest dryer vent screen appeared to be clogged with lint. KEG recommends the removal of the screens at the dryer vents to prevent screens clogging with lint and becoming a fire hazard or proper routine cleaning.

Observation of Dryer Vents on North Face of Structure with Trapped Lint

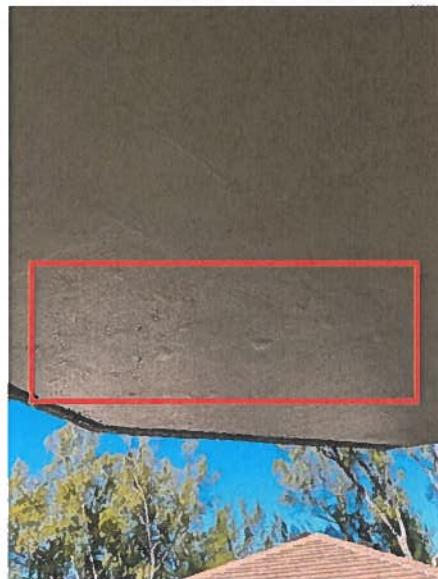
KEG noted the structural systems, including the masonry unit walls, concrete columns and beams appeared to be in generally good condition. KEG did not observe any significant cracking or spalling in any of the observed structural systems. The exterior walls and structural systems are finished with stucco and paint coating that form the primary moisture barrier. According to the Association, a new paint coating was applied to the building approximately a year ago. These systems appeared to be in generally good condition with minor cracks and bubbling occurring at the cementitious painted finish on the balcony ceilings. KEG noted that one of the unit balcony ceilings at Unit 302 was observed to not have the cementitious painted finish, however the balcony ceiling painted finish was bubbling.

Bubbling Painted Finish Observed at Balcony Ceiling

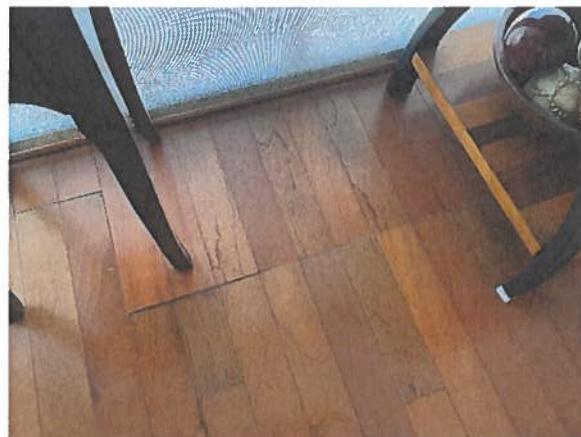
The interior finishes consisted of painted drywall within the condo units. As KEG inspected the interior of the units, KEG did not note any areas of significant water intrusion on the walls or ceilings. KEG noted water intrusion at the master bedroom floor to ceiling window systems. Water intrusion staining and water damage at the floor finishes adjacent to the window system. Unit owners stated that the windows primarily only are an issue during major wind events such as hurricanes and tropical storms.

Moisture Damage and Replacement of Wood next to Window System

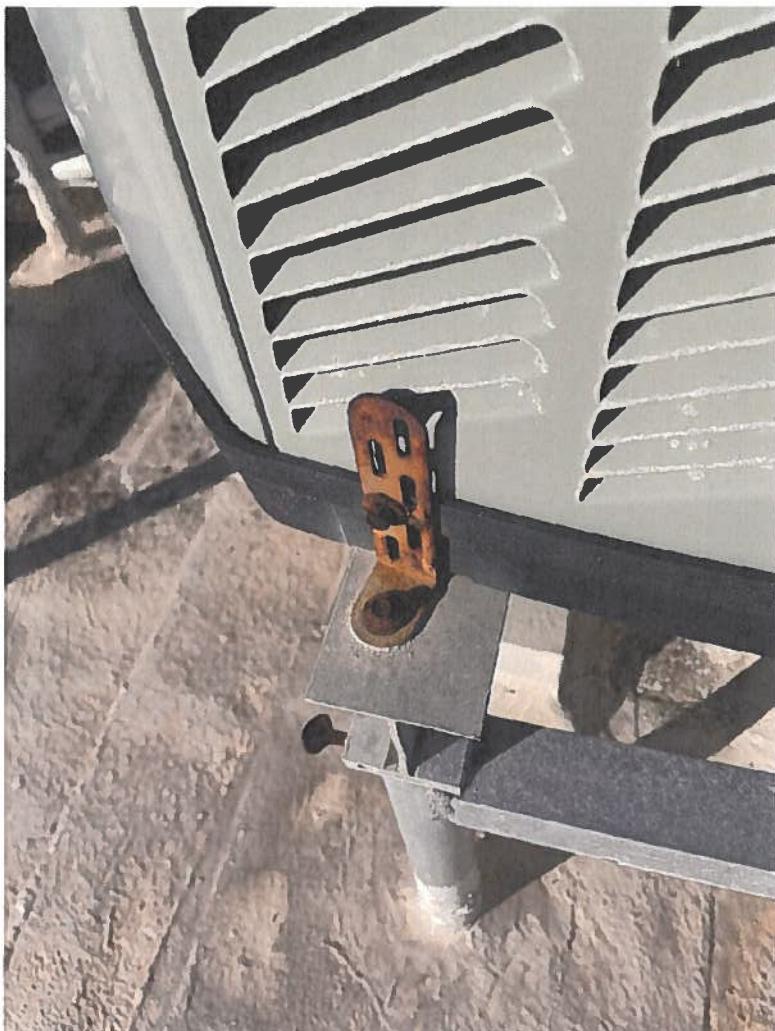
The main flat roof was observed to have HVAC systems installed on aluminum AC stands to meet the current standards of the Florida Building Code to maintain the roof under the HVAC equipment. KEG observed the AC unit hurricane straps and other metal type products appeared to be in fair to poor conditions, likely due to the constant exposure to the harsh Florida environment. Due to being exposed to the harsh Florida environment, this is typical for the metals to be oxidizing and rusting. KEG would recommend replacing all rusting and corroding metals on the roof with stainless steel products. Drainage for the roofs consisted of overflow scuppers and roof drains. KEG did not note any major signs of ponding water on the main roof.

Hurricane AC Strap Observed to be in Poor Condition

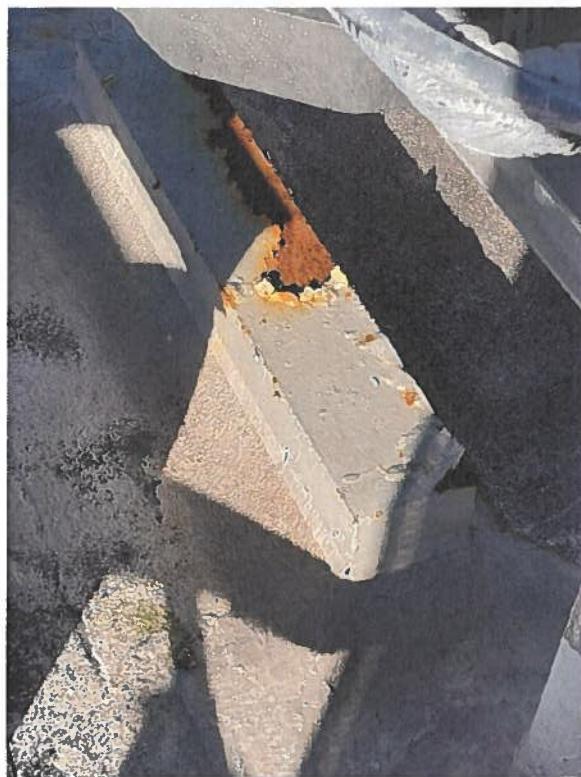
Old Metal Flashing at Existing Curb Corroding

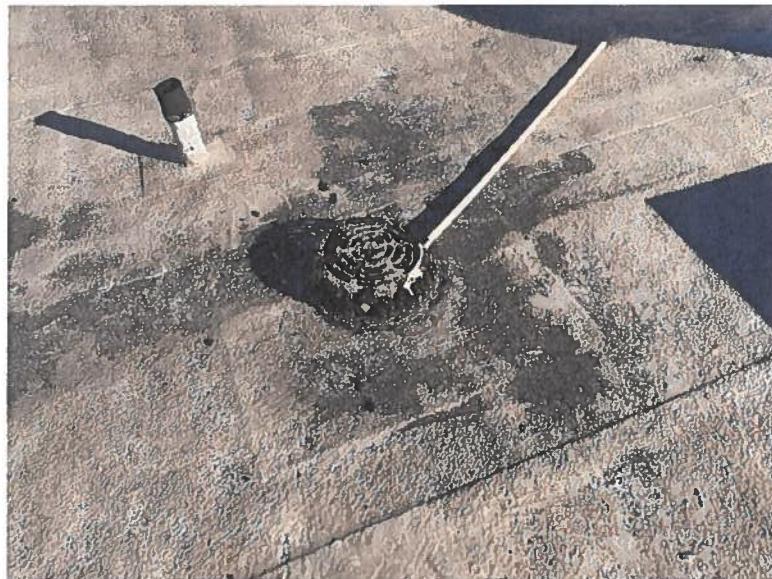
Roof Drain Cover with Significant Corrosion

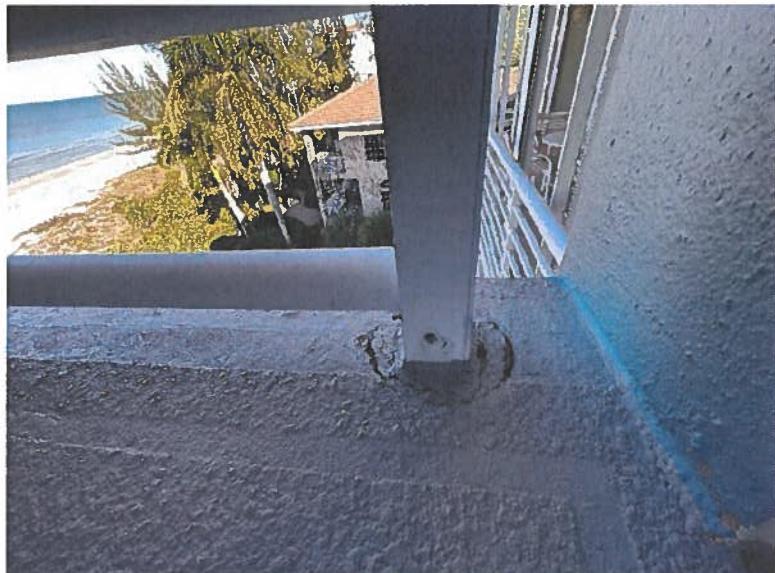
The railings located along the edge of the floor systems were observed to consist of an aluminum style guard rail. The aluminum railings appeared to be in generally good condition. The sealants at transition points of wall to railing were observed to show no signs of cracking or failing. However, a few post pockets at the railings were observed to be experiencing minor cracking. Although the cracking is minor, it can be the cause of future issues if not maintained properly or in a timely manner. Additionally, KEG noted several guardrails on the balconies to be flaking off its current coating. Typically for aesthetic purposes, the paint coatings on the guardrails help preserve the makeup of the rails. This is likely due to the excess use by the tenants on the balconies or due to the constant harsh Florida environment.

Cracking Sealant at Handrail in West Stairwell

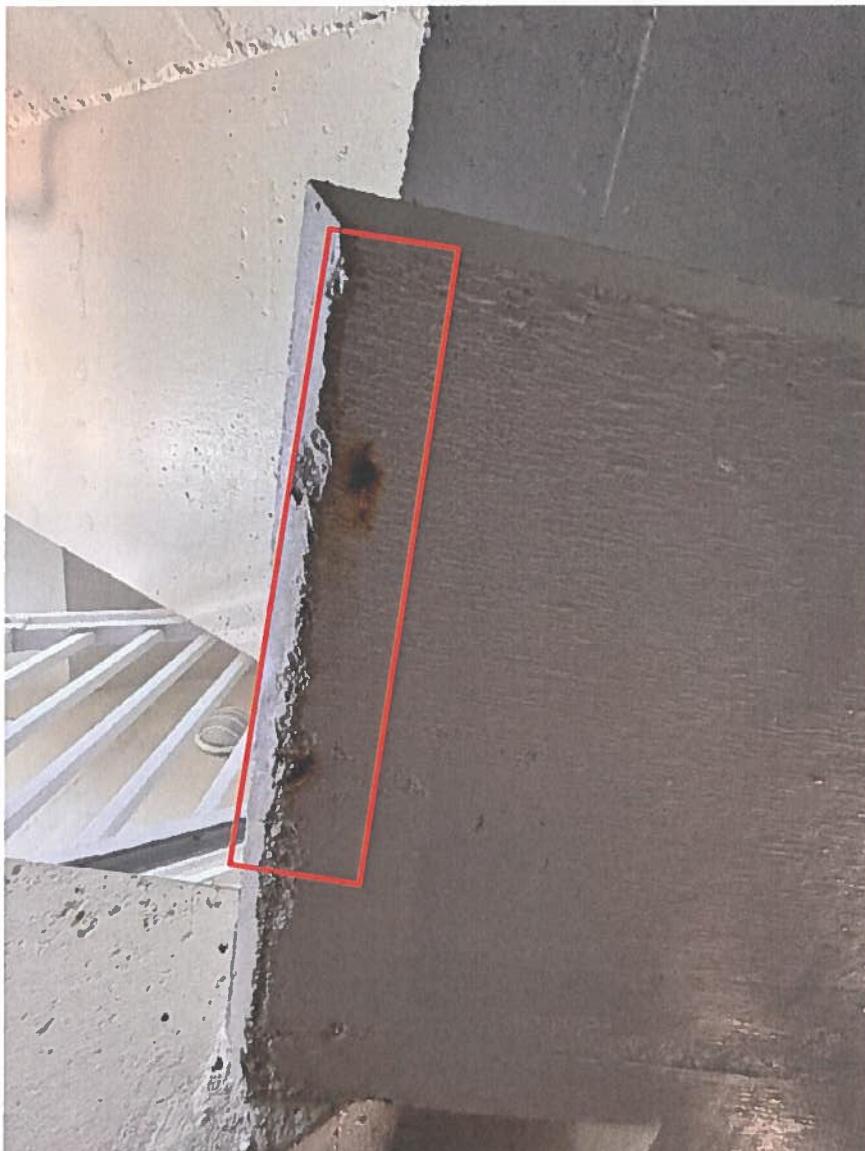
The beams and columns supporting the floor and roof slab systems were composed of reinforced concrete. Visual inspection of these elements was completed with no major signs of stress. However, KEG noted rusting stains appearing in one of the undersides of the concrete beams. This is likely to be where a chair or tie wire was used to tie together the steel reinforcement and does not pose any significant threat to the overall condition of the building structure or the building component.

Rust Stains at Concrete Beam

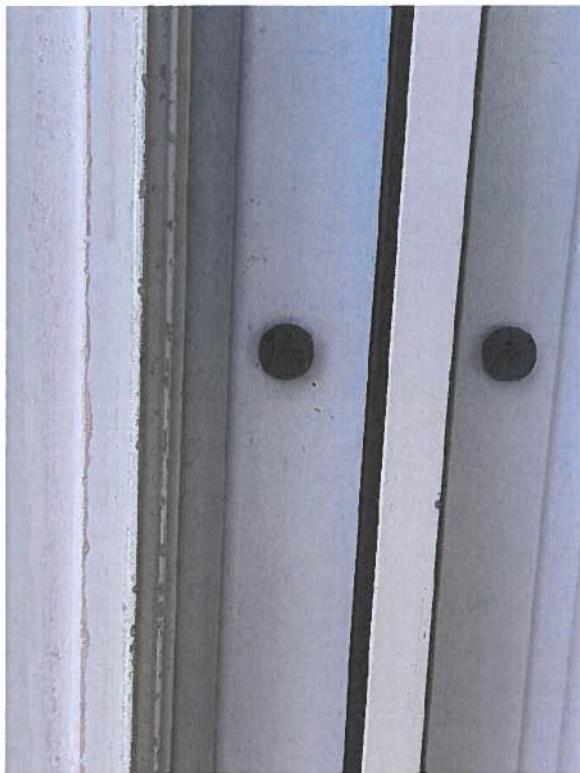
KEG's visual inspection included documentation of all windows and sliding glass doors of the structure. The sliding glass doors are protected by the overhang of the balcony above and storm shutter/ screens were also observed to help protect the sliding glass doors. The windows and sliding glass doors were generally in good condition. However, KEG noted moisture intrusion at the west elevation master bedroom windows to be typical during the inspection. This could likely be an installation issue of these floor to ceiling windows or a breakdown of interior components and sealants. Additionally, KEG noted the fasteners inside numerous sliding glass doors appeared to be rusting. This is common when using non stainless steel fasteners and can become an avenue for water intrusion.

Observed Fasteners Rusting at Sliding Glass Doors

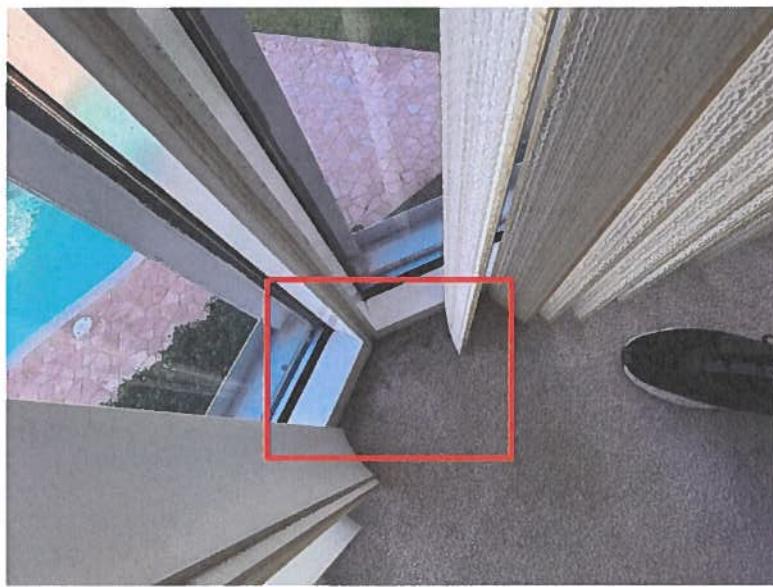
Water Stains Typical in Carpet at Master Bedroom Window

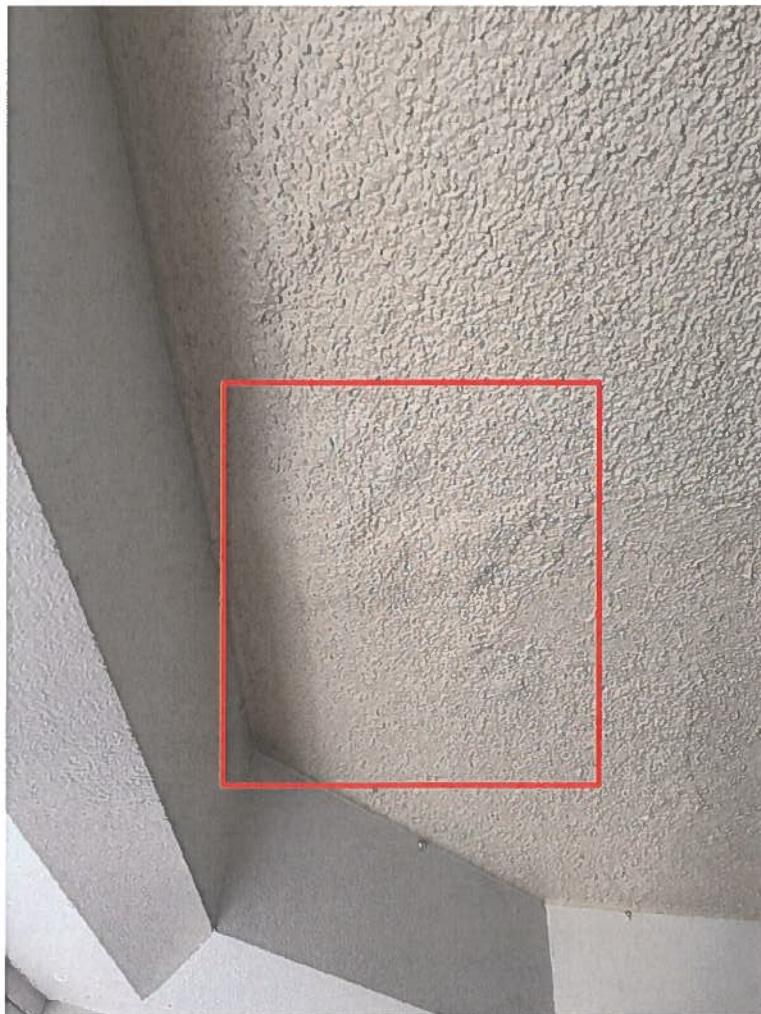
The ceilings of the balconies for a majority were a cementitious painted finished, however a few of the balcony ceilings were observed to be a painted finish directly to the concrete substrate. Upon the visual inspection, it appeared a few areas of the balcony ceilings were bubbling and sagging. KEG noted this to likely be water intrusion occurring at the balconies above and running down into the balcony ceilings.

Bubbling of Cementitious Painted Finish at Balcony Ceiling

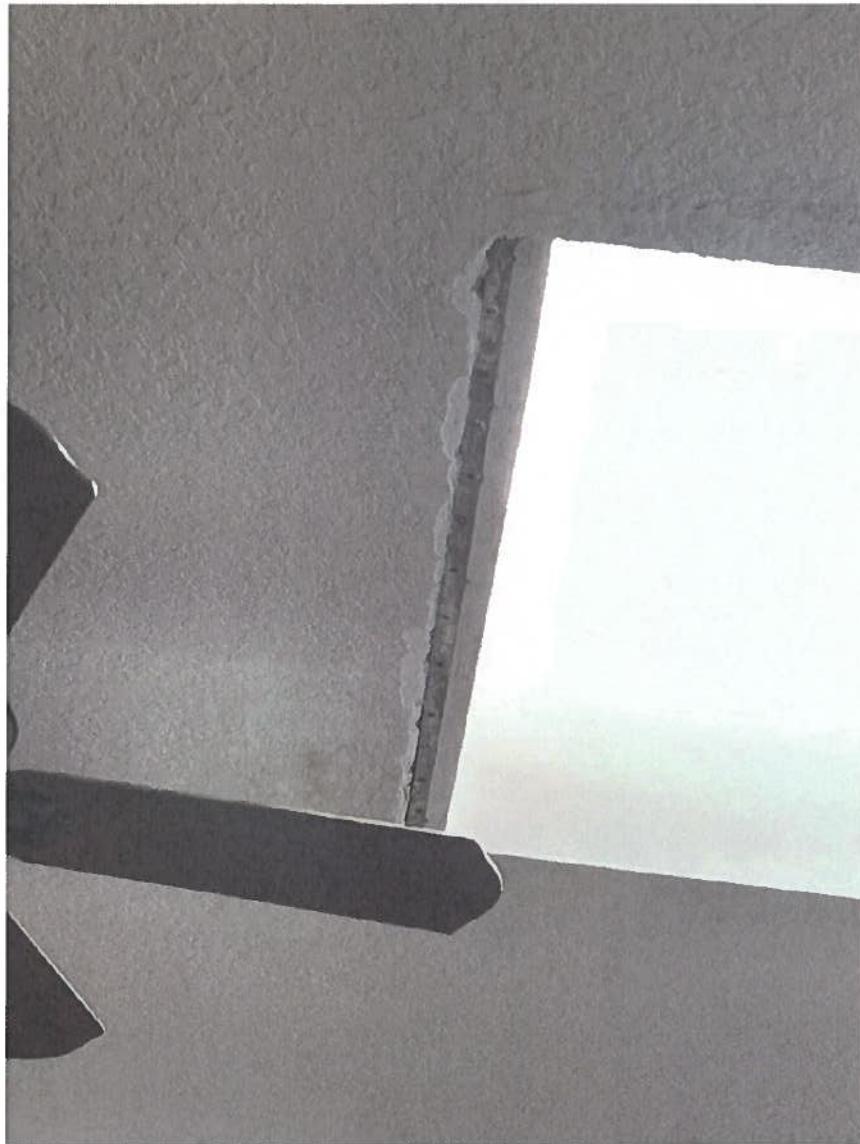
During these visual inspections, KEG noted majority of units to not have signs of moisture intrusion, water damage or major cracking of interior finishes. However, it was documented that in Unit 502, the tenant reported water damage to the ceiling where the skylight was located. This was likely due to the skylight having cracked sealants, KEG recommended resealing or replacement of the skylight to prevent further damage to the ceiling and water intrusion from occurring.

Drywall Damage at Ceiling Skylight, Unit 502
