# MILESTONE PHASE 1 CONDITION SURVEY REPORT

## 700 West Condominium

19700 Gulf Blvd., Indian Shores, Florida 33785

BillerReinhart Project No. 22 - 020

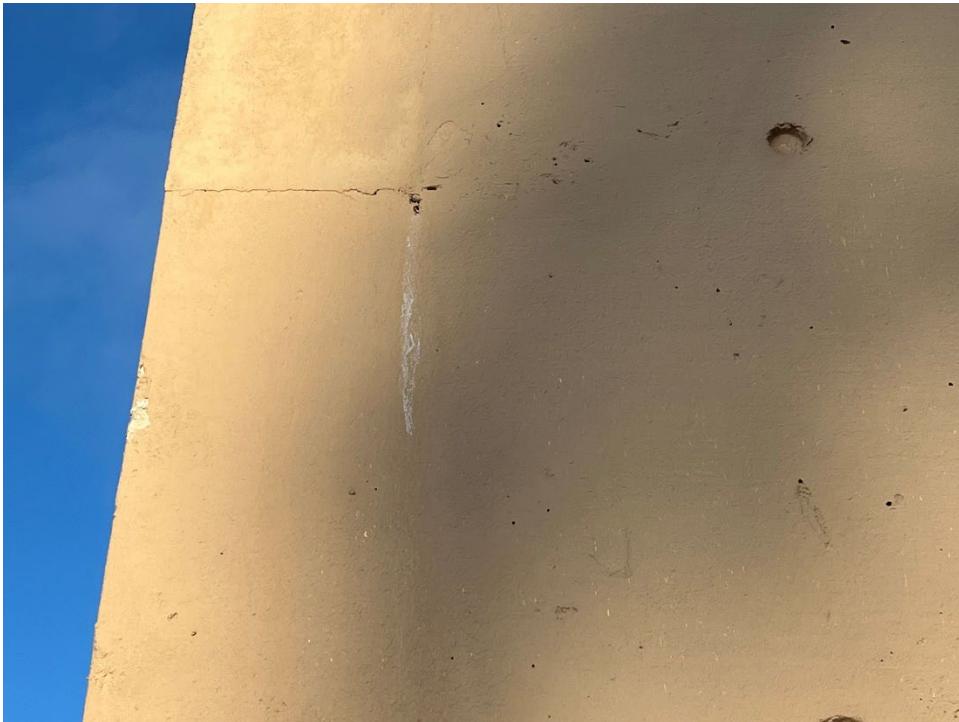
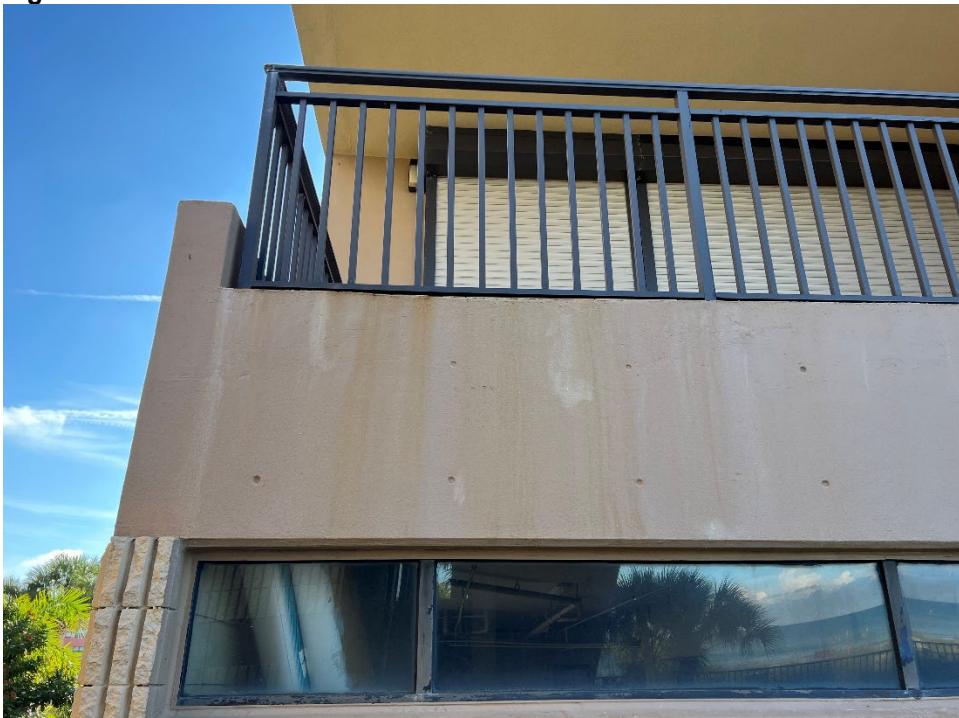
1. East elevation, north elevation, west elevation and south elevation exterior wall areas are shown in *Figure A-1* through *Figure A-4*, respectively.
2. Isolated area of concrete spalling was observed within a grade level west facing windowsill. Refer to *Figure A-5*.
3. Sporadic areas of corroded cornerbead were observed. Refer to *Figure A-6* and *Figure A-7*.
4. Sporadic areas of peeling paint were noted. Refer to *Figure A-8*.
5. Multiple areas of efflorescence and water staining were observed on the wall surfaces and slab edges. Refer to *Figure A-9* and *Figure A-10*.

restoration project be undertaken for the repair and maintenance of the exterior wall and parking garage areas including; deteriorated concrete structural elements, stucco, metal structural elements, sealants, and building painting. Restoration of the exterior wall areas should mitigate potential moisture intrusion and expose any structural deterioration of underlying structural elements in need of repair. BillerReinhart recommends the exterior wall restoration project be undertaken within the next year.

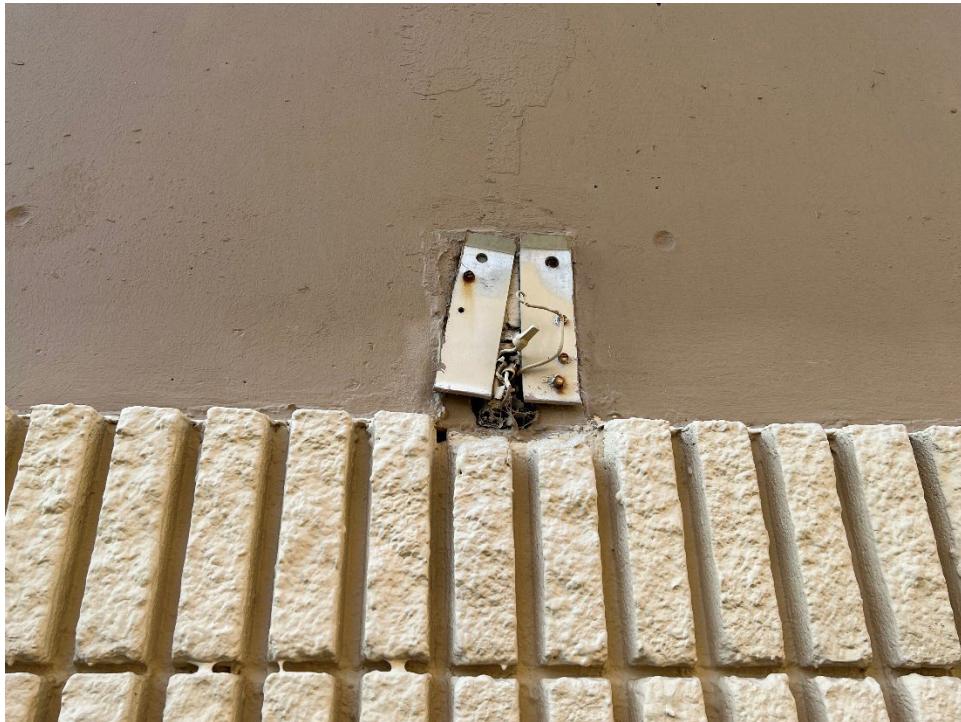
**Figure A-11**

6. An unsealed electrical box was observed. Refer to *Figure A-11*.
7. Corrosion was observed on the “Telephone Equipment Room” door. Refer to *Figure A-12*.
8. Wall cracking was observed on framed stucco repairs within the East elevation staircase entrance. Refer to *Figure A-13*.

- g. Unsealed wall and roof penetrations,
  - h. Sliding glass door track fasteners and fastener holes.
10. Remove and install a new waterproof deck membrane over chimney flue roof surfaces.

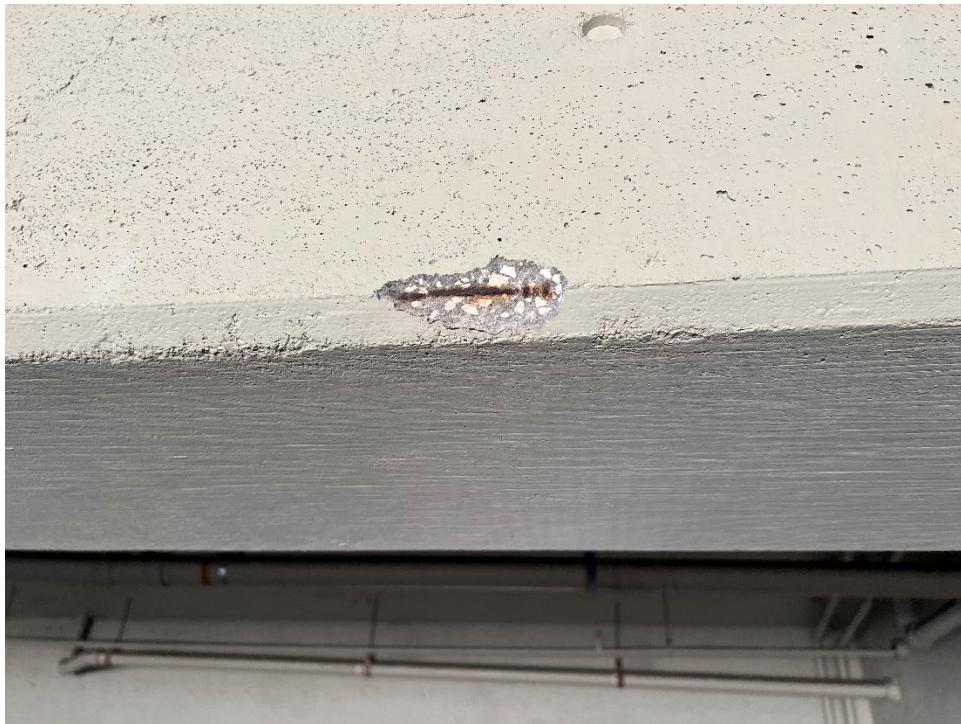
**Figure A-14**

1. Small isolated areas of concrete spalling were detected and observed on the concrete beams and girders. Refer to *Figure A-14* and *Figure A-15*.
2. Isolated hairline cracking was observed on the concrete beam members. Refer to *Figure A-16* and *Figure A-17*.
3. Corroded segments of open web steel joists were observed in the generator room. Refer to *Figure A-18*.
4. Corrosion and peeling paint were observed on the metal angles at the parking garage entrance. Refer to *Figure A-19* and *Figure A-20*.
5. Corroded metal reinforcement chairs were observed in the ceiling. Refer to *Figure A-21*.

- i. Delaminated areas, spalls, and exposed metal in beams, slab edges and overhead concrete ceiling surfaces.
- ii. Delaminated areas, spalls, and exposed metal in vertical concrete column surfaces.
- iii. Delaminated areas, spalls, and exposed metal in vertical concrete wall surfaces.
- iv. Concrete crack repair via epoxy injection - cracks in wall surfaces having widths equal to or greater than approximately 1/16".
- v. Concrete crack repair via routing and sealing with sealant for cracks in concrete wall surfaces having widths less than 1/16" (non-structural cracking).

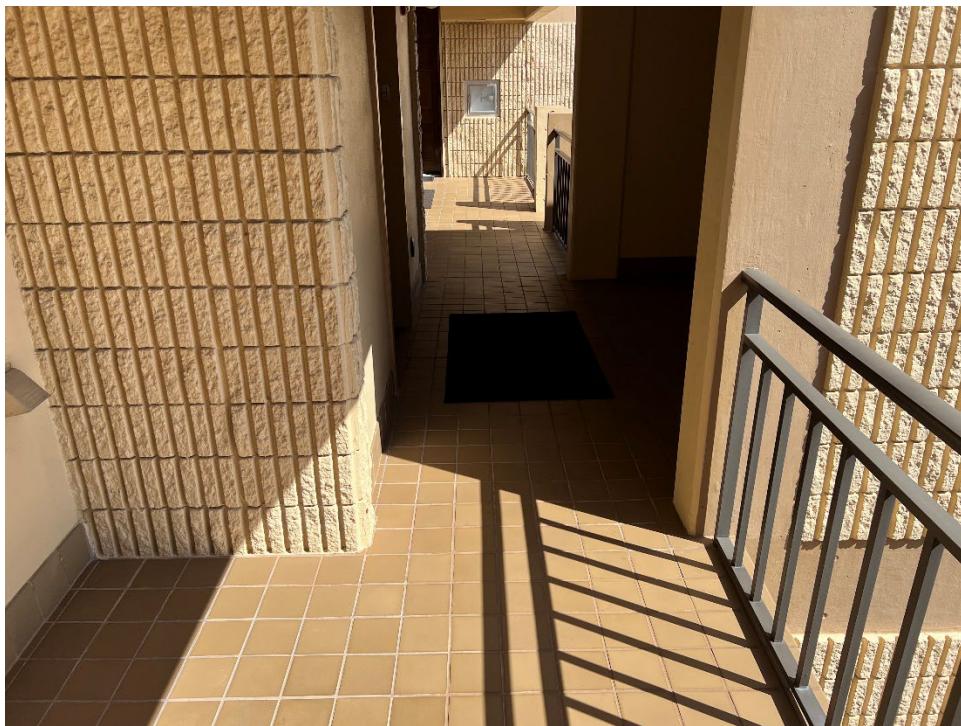
**Figure A-22**

1. The walkways were covered with a tile finish and visible elements were generally observed to be in good condition. Sporadic areas of delaminated tile were identified throughout the walkways. Refer to *Figure A-22*.
2. Isolated delaminated stucco was detected within a slab edge, ceiling and a column.
3. Sporadic areas of peeling paint were observed on the guardrails. Refer to *Figure A-23*.

The walkways and staircase structures generally appear to be in good condition. Based on observations made during the condition survey and age of the waterproofing membrane, BillerReinhart recommends a global walkway and staircase restoration and waterproofing membrane project during the next paint cycle. Limited restoration of the exposed slab edges, ceilings and columns should be performed as part of the upcoming restoration and waterproofing project.

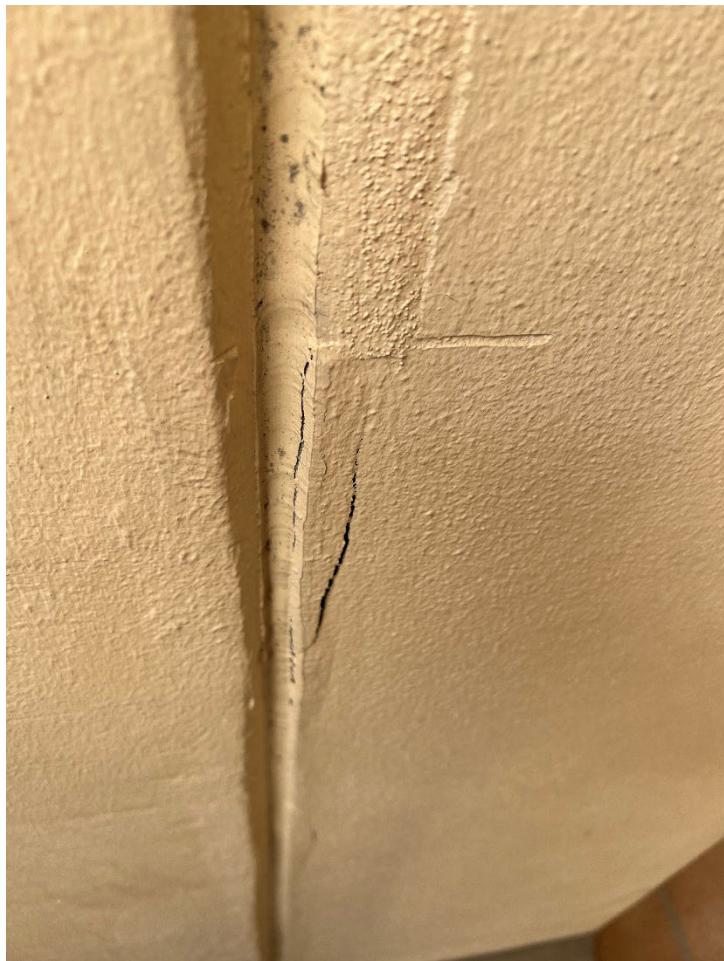
**Figure A-25**

1. The stair structures appeared to be in good condition. The waterproofing is nearing the end of its reasonable life expectancy but appeared to be in fair condition.
2. Localized areas of peeling paint were observed on the underside of the staircases.
3. Isolated delaminated stucco was detected within second-floor ceiling and column adjacent to the elevator.
4. Damaged framed wall stucco was observed at the second-floor plumbing chase. Refer to *Figure A-25*.

- a. Sounding and marking of exterior wall areas (including roof level walls), sliding glass door thresholds, and column surface areas to be repaired.
- b. Marked areas for repair shall be reviewed by the engineer prior to removal of unsound stucco to accommodate stucco repairs.
- c. Removal and replacement of deteriorated stucco areas, clearing or replacement of deteriorated corner bead, cleaning or replacement of deteriorated balcony ceiling trim and/or removal and replacement deteriorated metal lathe (if necessary) of stucco surfaced walls.

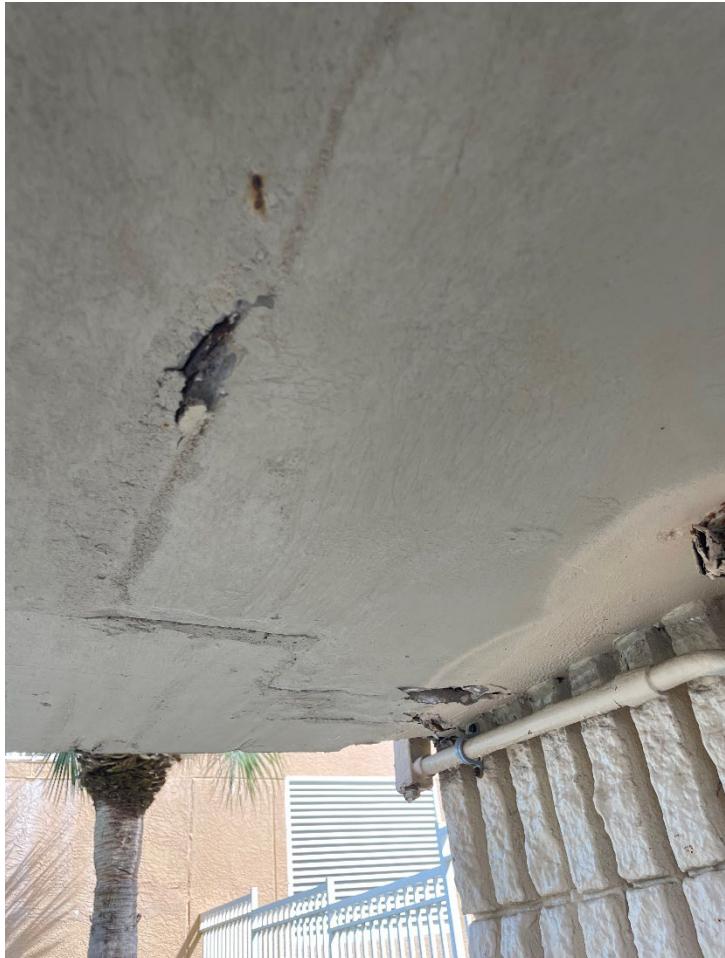
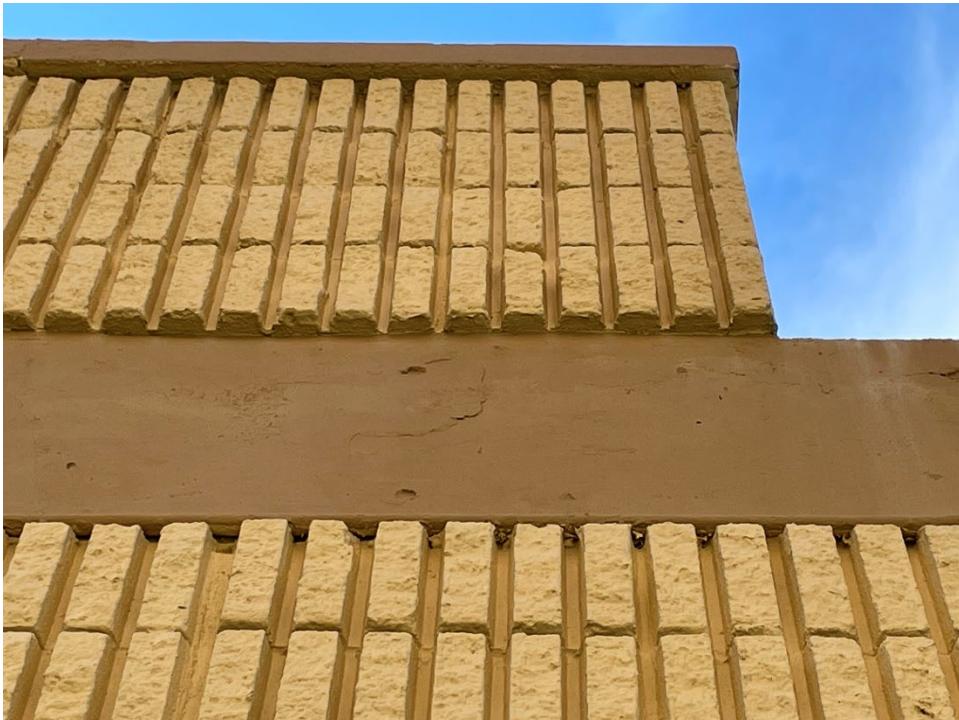
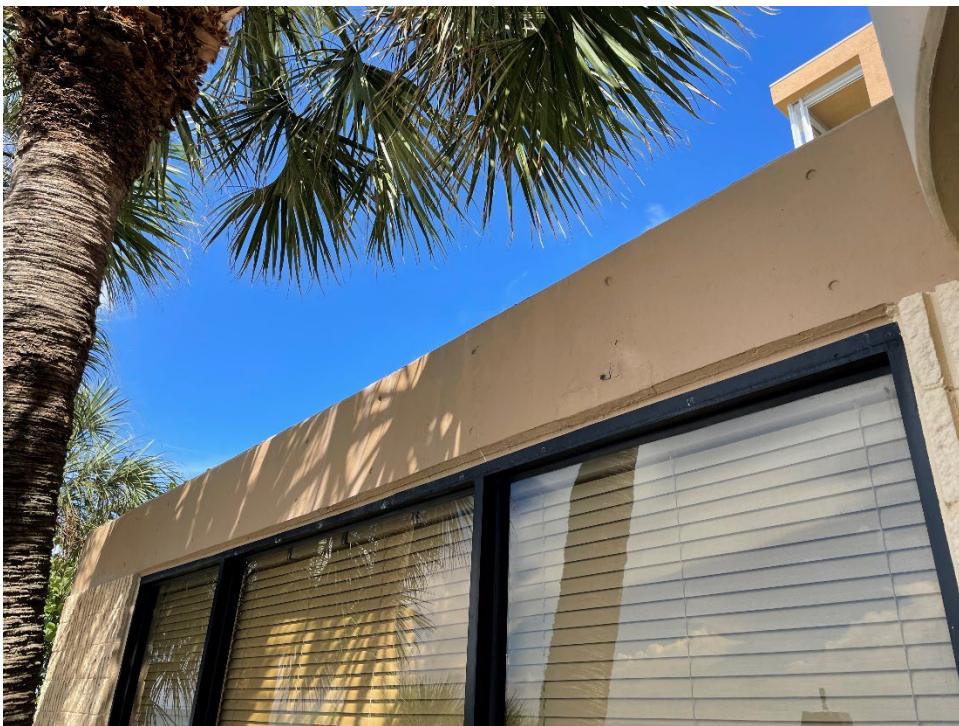
1. Isolated areas of concrete spalling were detected throughout the accessible wall areas of the building. Refer to *Figure B-1* through *Figure B-3*.
2. Multiple areas of peeling and blistering paint were observed. Refer to *Figure B-4* through *Figure B-6*.
3. The guardrails surrounding the perimeter of property were observed to be corroded with pickets exhibiting significant section loss. Refer to *Figure B-7*.
4. Separation between roof coping stones was observed. Refer to *Figure B-8*.
5. Missing fasteners were observed on the roof termination bar. Refer to *Figure B-9*.
6. An unsealed electrical box pitch pocket detail was observed on the roof. Refer to *Figure A-10*.
7. Corrosion was observed on the roof scupper. Refer to *Figure B-11*.

Based on the detection of sporadic areas of spalling, delamination, and peeling paint within the exterior wall areas, BillerReinhart recommends a restoration project be undertaken for the repair and maintenance of the exterior wall areas including; deteriorated stucco, concrete structural elements, sealants, and building painting. Restoration will mitigate potential moisture intrusion and expose any structural deterioration of underlying structural elements in need of repair. BillerReinhart recommends the exterior wall restoration project be undertaken with the planned condominium structure exterior wall restoration project.

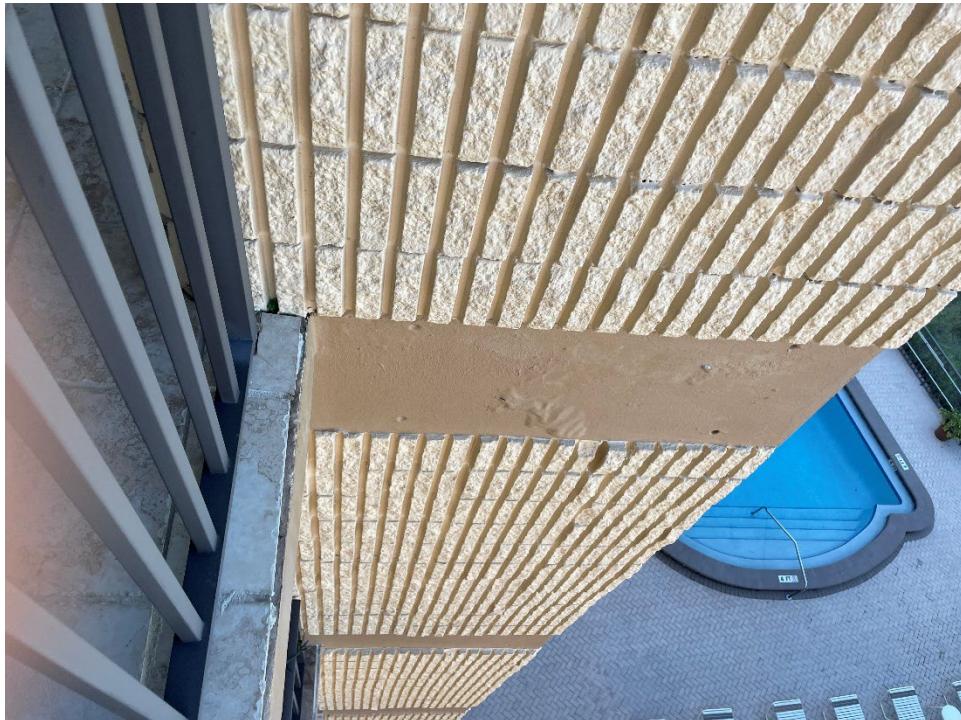
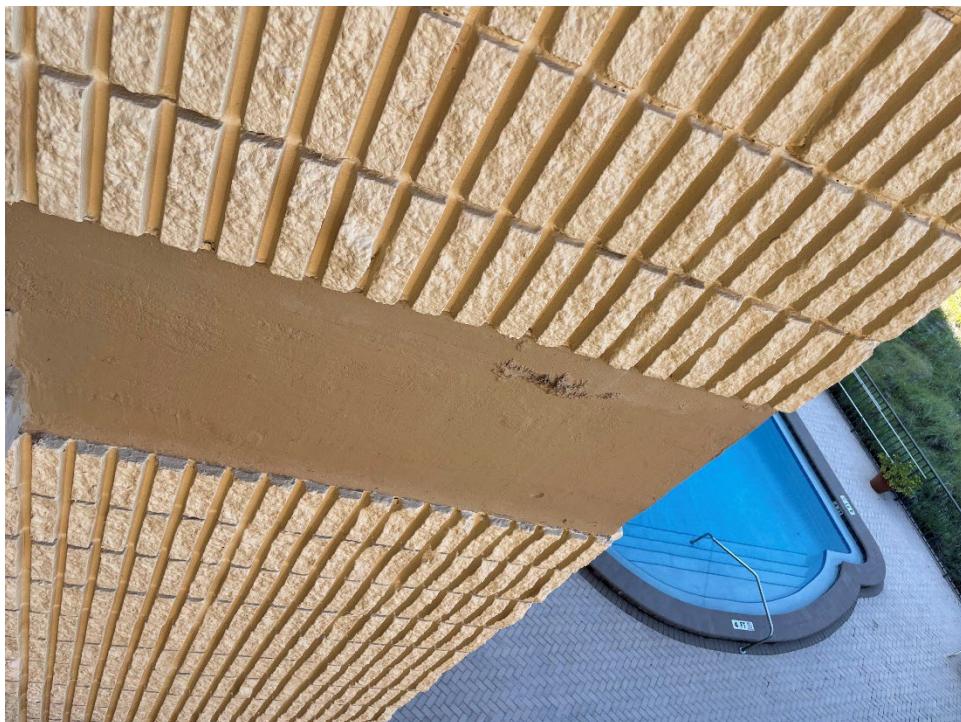
1. Majority of balconies were covered with a tile finish. Sporadic areas of delaminated tile were identified throughout the balconies. The remaining balconies appeared to be finished with a urethane waterproofing membrane.
2. Isolated areas of spalling were detected within the exterior faces of beams and walls. Refer to *Figure C-1* through *Figure C-3*.
3. Sporadic areas of stucco delamination were detected in wall and ceiling surfaces. Refer to *Figure C-4* through *Figure C-6*.
4. Isolated areas of curb spalling and heaved tile finish were observed at the sliding glass door threshold. Refer to *Figure C-7* and *Figure C-8*.
5. Sporadic corroded metal reinforcement chairs were observed. Refer to *Figure C-9* and *Figure C-10*.
6. Multiple areas of peeling/blistering paint were observed. Refer to *Figure C-11* and *Figure C-12*.

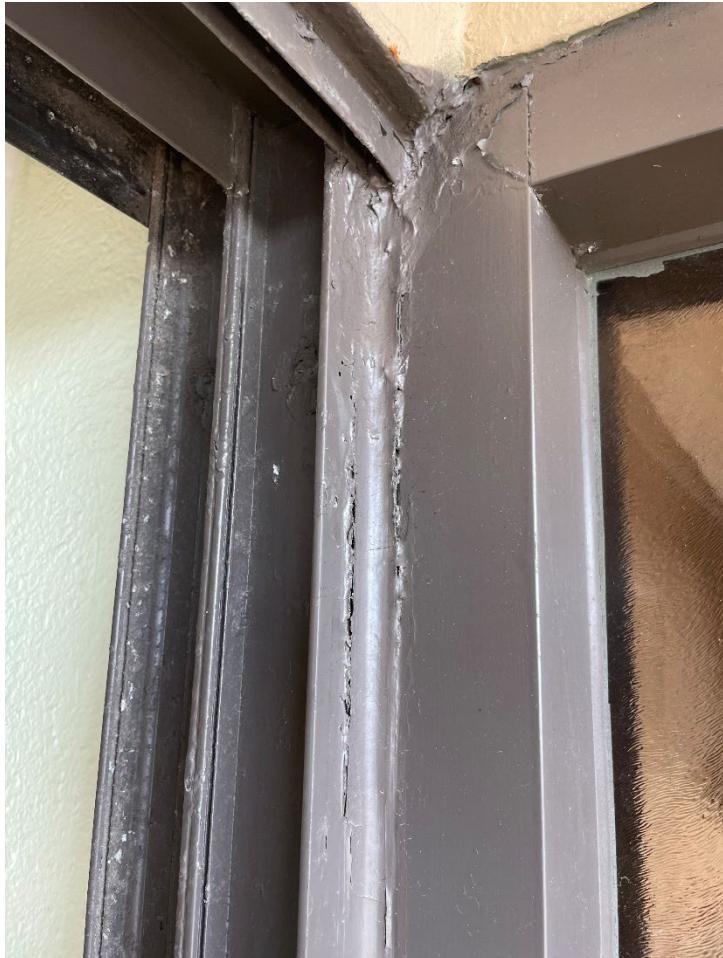
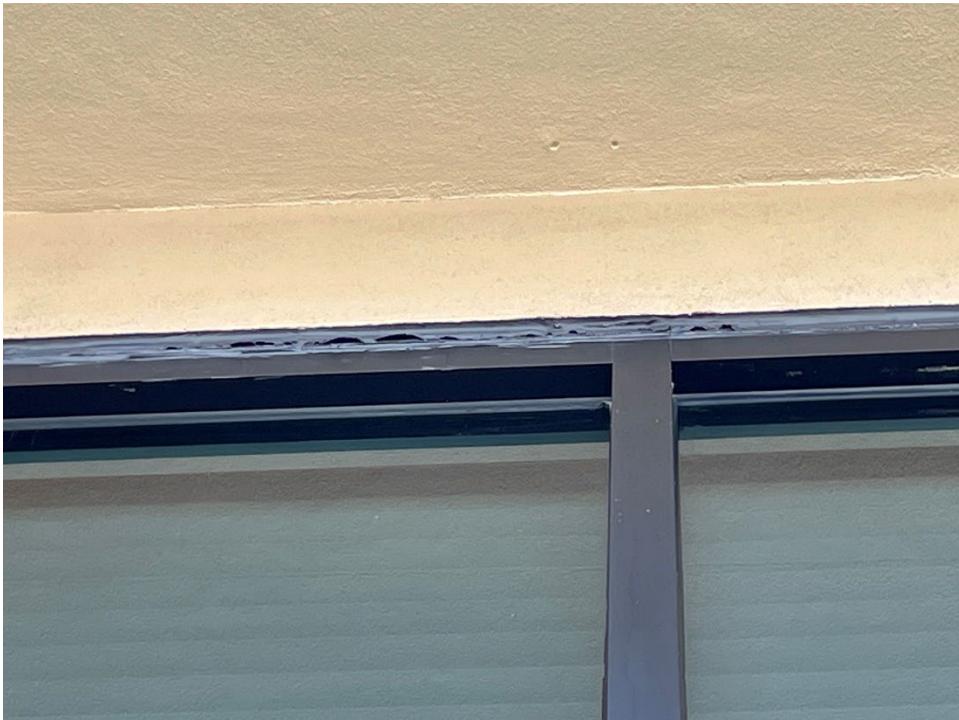
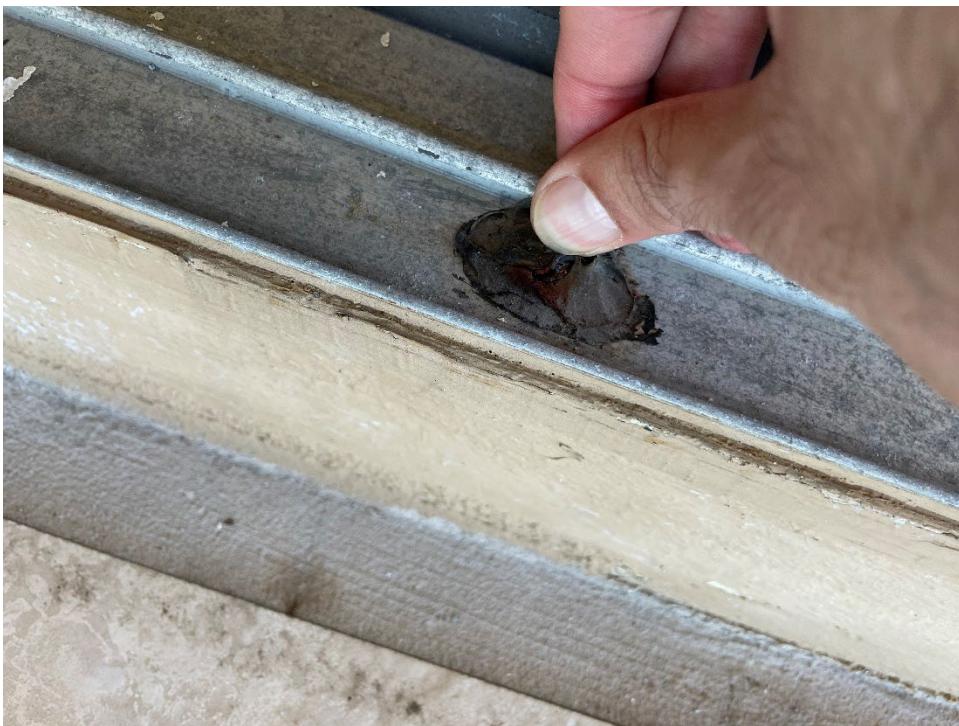
7. Multiple areas of deteriorated and peeling sealant were observed around the sliding glass doors. Refer to *Figure C-13* through *Figure C-15*.
8. Multiple corroded corner beads were observed. Refer to *Figure C-16* through *Figure C-18*.

9. Remove and replace joint sealants, including:
  - a. All perimeter window seals for the unit window systems, sliding glass door perimeter seals, common element window system perimeters,

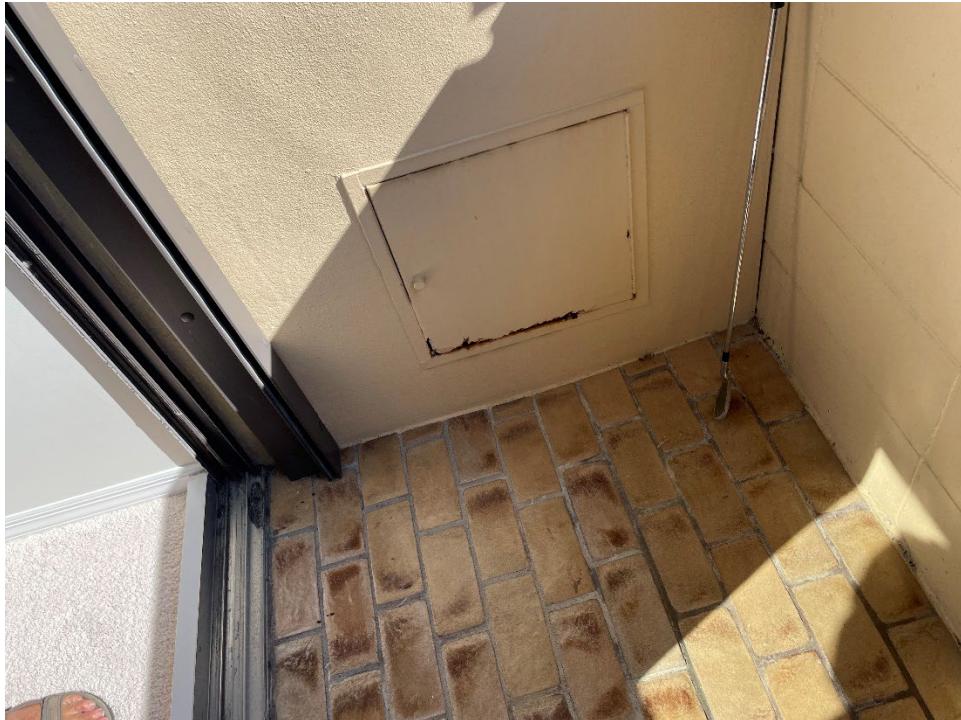
**Figure C-19**

9. Isolated metal access panels were observed to be corroded. Refer to *Figure C-19*.
10. Sporadic peeling paint on the guardrails was detected. Refer to *Figure C-20* and *Figure C-21*.

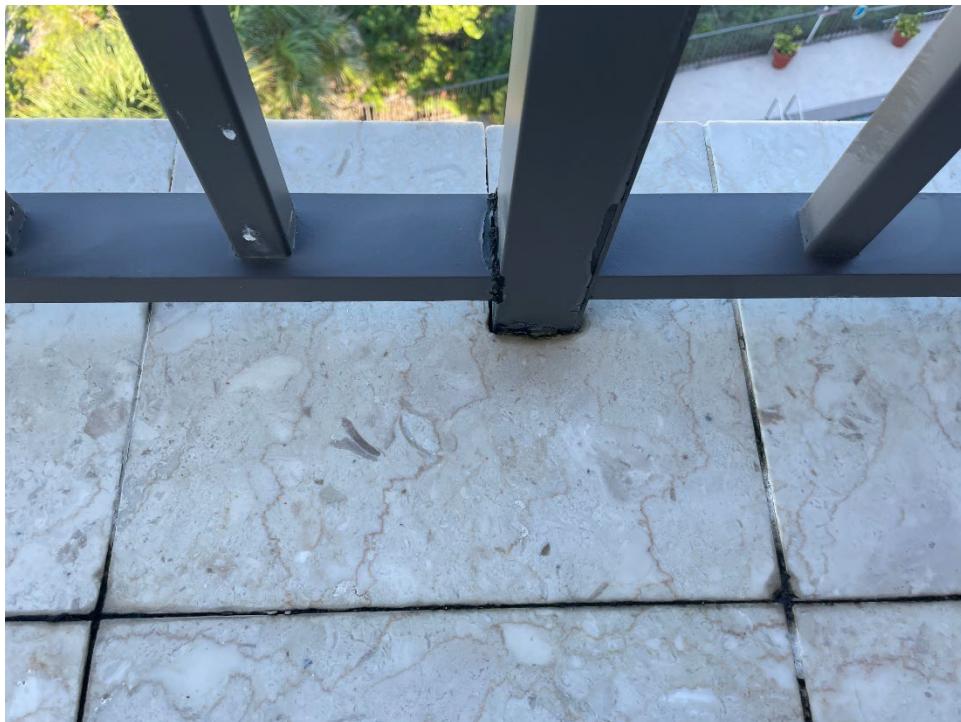
**Figure C-22**

11. Sporadic corrosion was observed on the guardrails. Refer to *Figure C-22*.
12. Sporadic corroded fasteners were observed on storm shutter housing and sliding glass door assemblies. Refer to *Figure C-23* and *Figure C-24*.

12. Re-coat via electrostatic application balcony and walkway metal guardrails after proper surface and substrate preparation.
13. Re-coat previously painted metal wall mounted vents/accessories, pipes/utilities after proper surface and substrate preparation.

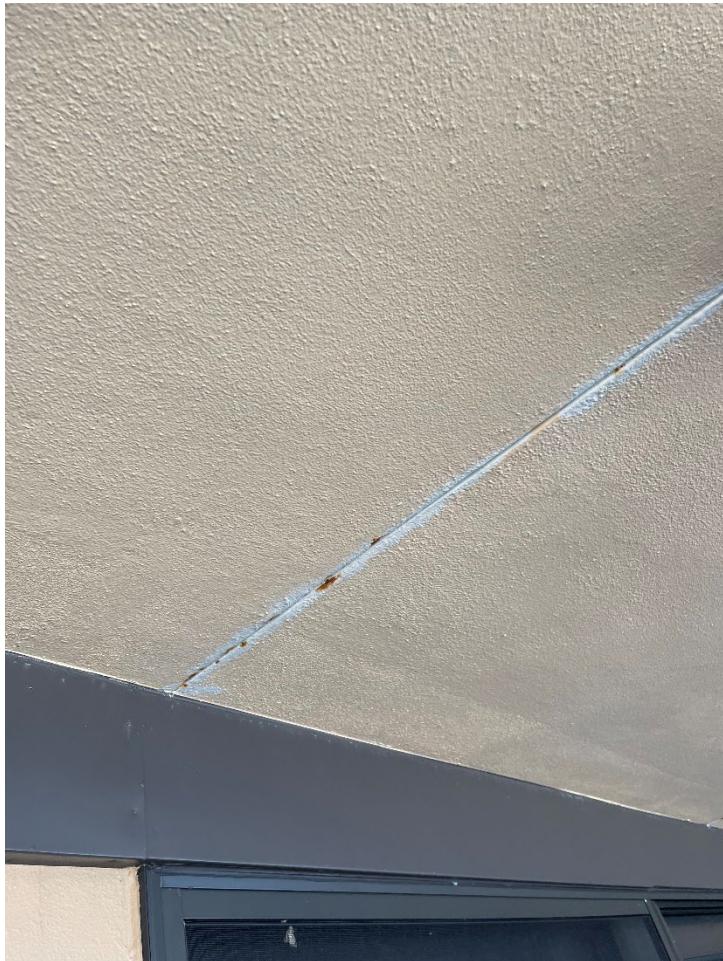
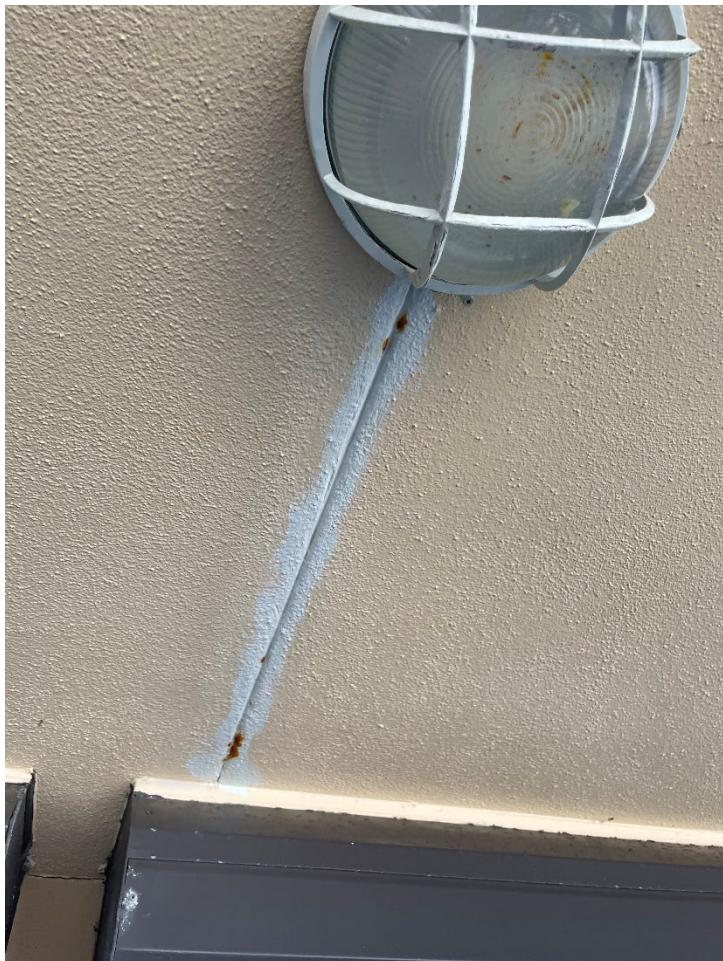
13. Unit 602 and Unit 601 balcony ceiling control joint accessory was noted to be corroded. Refer to *Figure C-25* and *Figure C-26*.
14. Unit 602 West bedroom window appeared to have experienced moisture intrusion and drywall damage. Refer to *Figure C-27*.

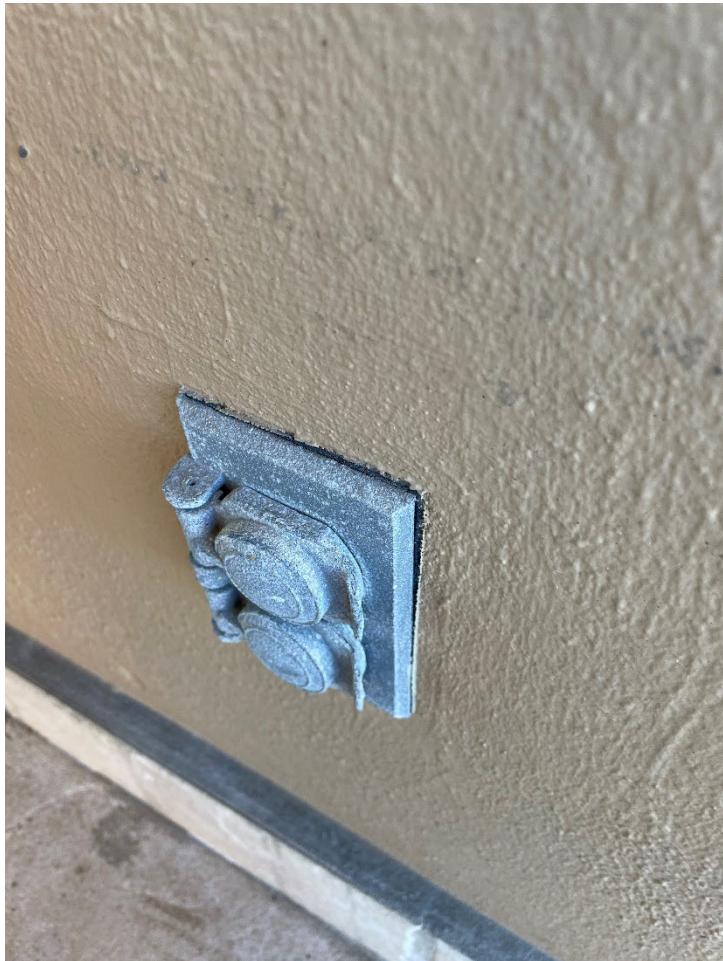
**Figure C-28**

15. An unsealed electrical box was observed in Unit 406. Refer to *Figure C-28*.
16. Unit 404 window frame paint was observed to be peeling/deteriorated. Refer to *Figure C-29*.

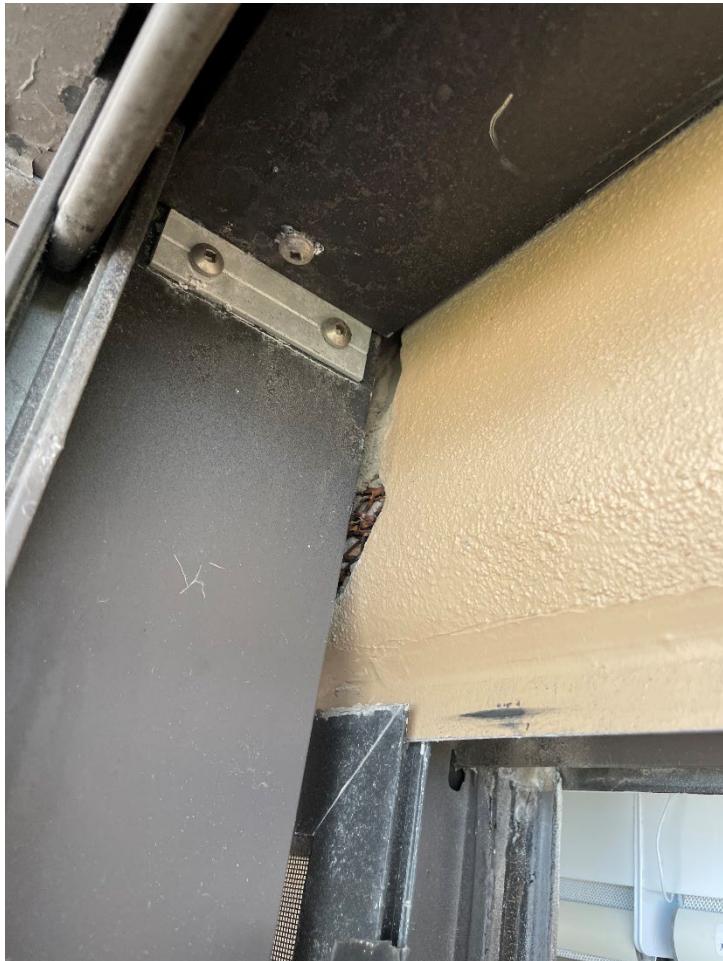
**Figure C-30**

17. Unit 401 stucco behind the sliding glass door storm shutter was noted to be missing with metal lath exposed. Refer to *Figure C-30*.
18. A repair to the ceiling was observed in Unit 306. Refer to *Figure C-31*.
