Westview Grande Condominium Association

19710 Gulf Blvd., Indian Shores, FL

Milestone Structural Assessment

October 17, 2023

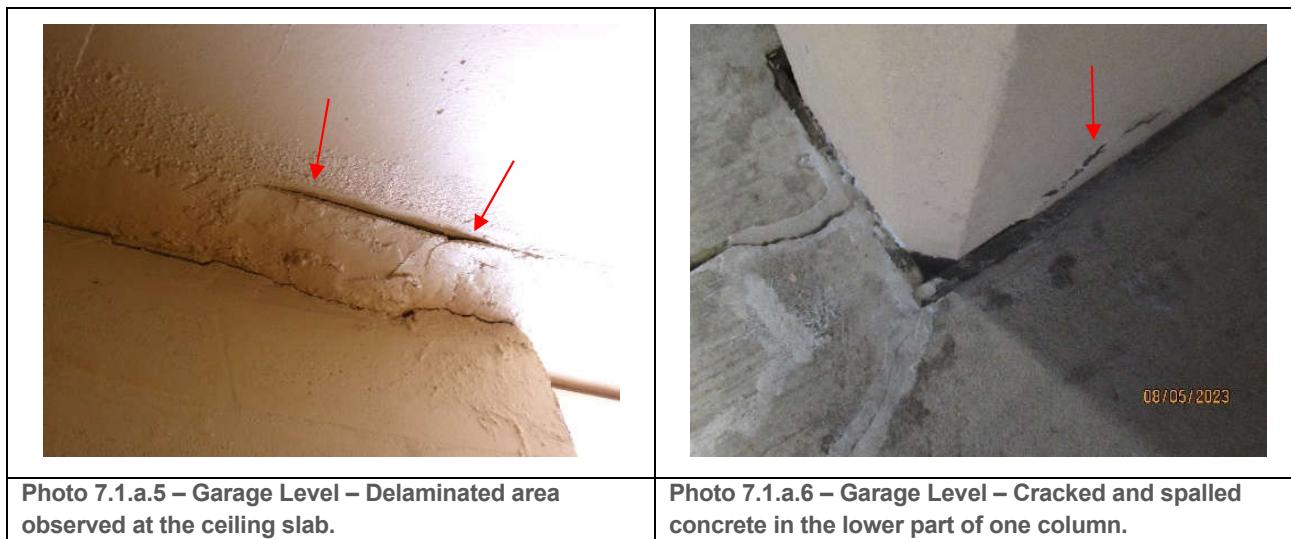
Localized and minimal instances of cracks, delamination and or spalling, particularly at the garage level, were observed. Locations include the underside of the post tense concrete slab and the lower part of one column. These deficiencies must be addressed to avoid deterioration of the structural elements.

Photo 7.1.a.5 – Garage Level – Delaminated area observed at the ceiling slab.

Photo 7.1.a.6 – Garage Level – Cracked and spalled concrete in the lower part of one column.

Weather in Florida (wind, salt, and moisture) is highly harmful to concrete. Therefore, concrete protection (waterproofing and painting) is essential for the longevity of concrete structures. Typical concrete repairs include the removal of all deteriorated concrete with chipping hammers, removing and replacing damaged steel, applying bonding agents to the old concrete, and patching or pouring the area back with special materials.

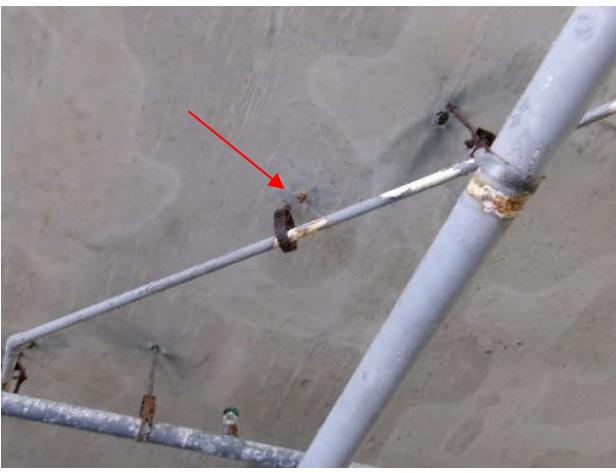
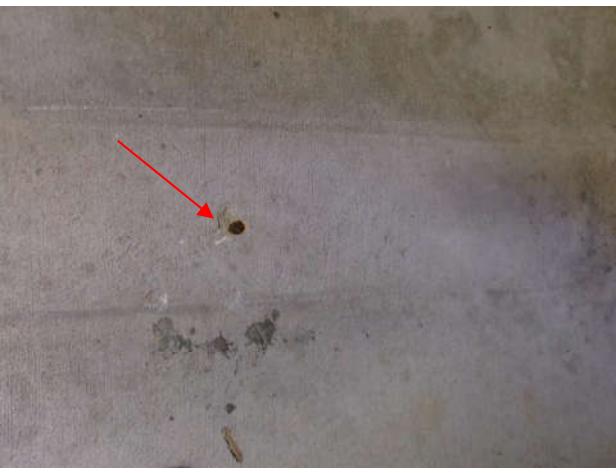
Localized rust spots were noted on the different structural elements on the garage's interior, the roof, the staircase, railing pockets, and some balconies. Rust spots on the exterior indicate that embedded ferrous material in the concrete or stucco is exposed to the weather. Corroded metals embedded in the concrete present a structural concern because this condition could lead to local concrete damage or spalling.

Photo 7.1.b.1 – Garage Level – Sprinkler system insert at the ceiling.	Photo 7.1.b.2 – Garage Level – Embedded rust metal at the slab on grade.

All observed rust spots or exposed ferrous materials should be removed and resulting voids adequately patched.

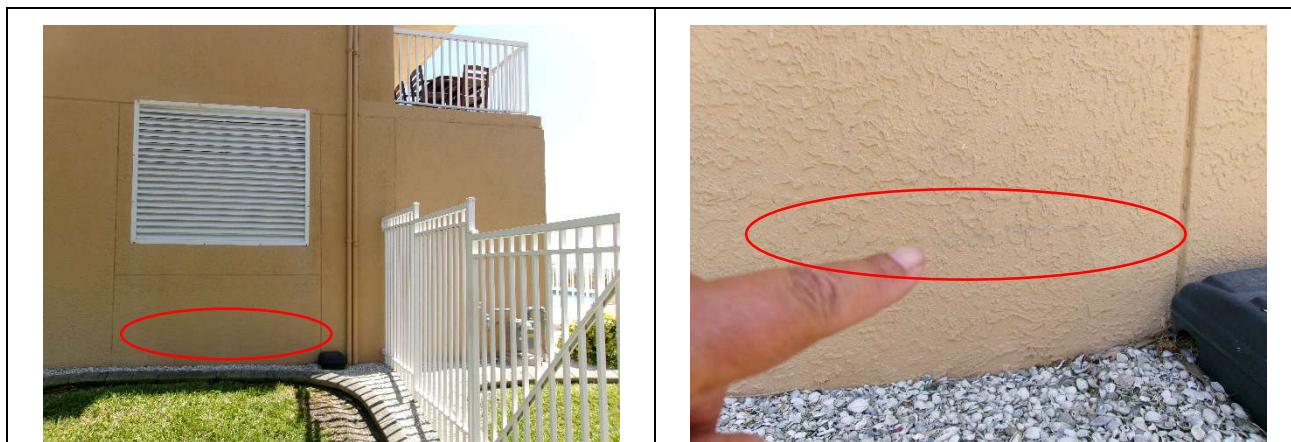
Hairline stucco cracks telegraphing in the paint coating were noted in some areas. Small cracks may be susceptible to water penetration due to wind-driven rain.

Evidence of efflorescence was observed in the interior side of the garage level and stairwells and some areas of the exterior walls. This indicates water intrusion and must be addressed in the following paint project.

Photo 7.2.a.5 – North façade hairline cracks and evidence of efflorescence.

Photo 7.2.a.6 – North façade hairline cracks and evidence of efflorescence.

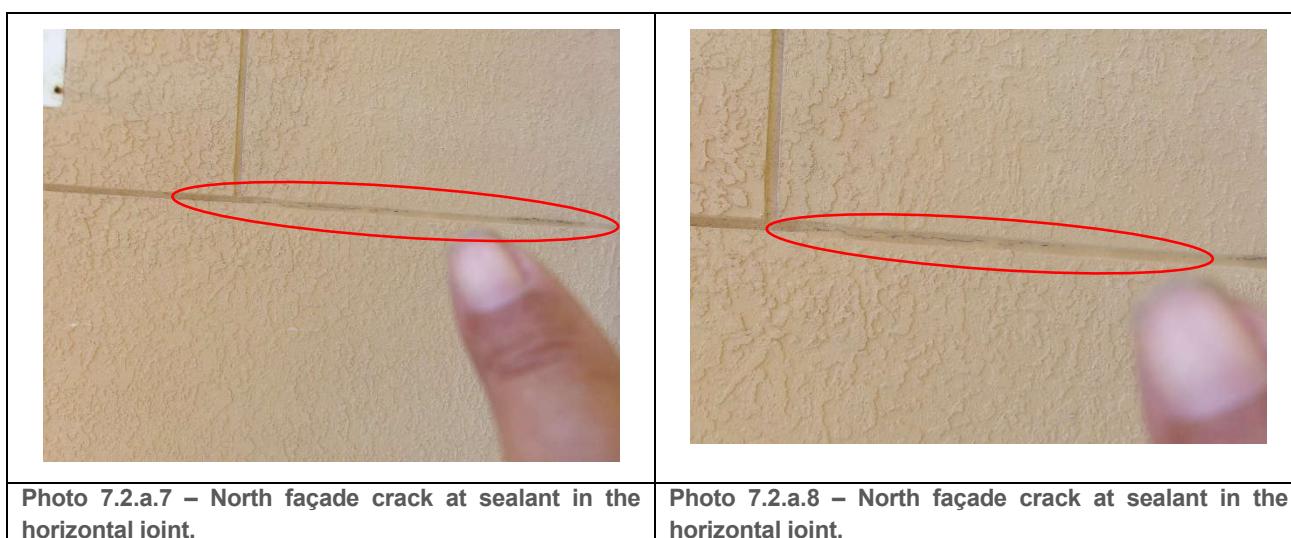
Photo 7.2.a.7 – North façade crack at sealant in the horizontal joint.

Photo 7.2.a.8 – North façade crack at sealant in the horizontal joint.

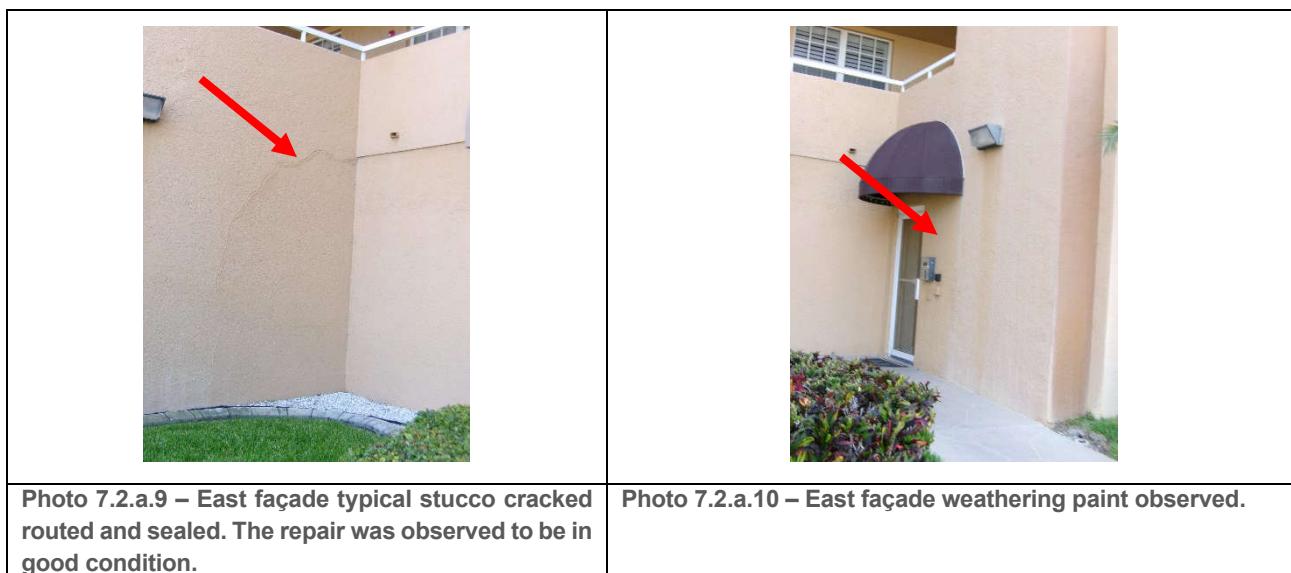
Photo 7.2.a.9 – East façade typical stucco cracked routed and sealed. The repair was observed to be in good condition.

Photo 7.2.a.10 – East façade weathering paint observed.

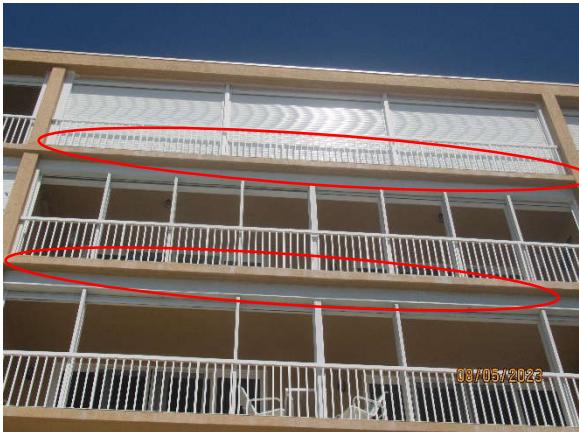
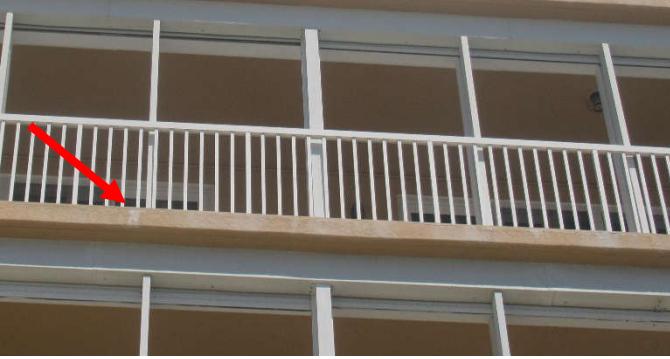
<p>Photo 7.2.a.11 – West façade evidence of efflorescence observed at the balcony's slab edges.</p>	<p>Photo 7.2.a.12 – West façade evidence of efflorescence observed at the balcony's slab edges.</p>

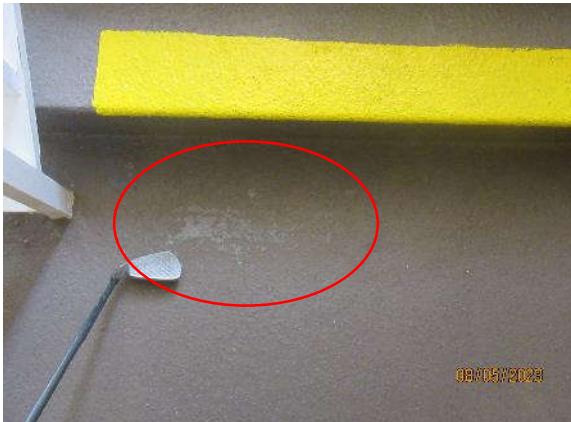
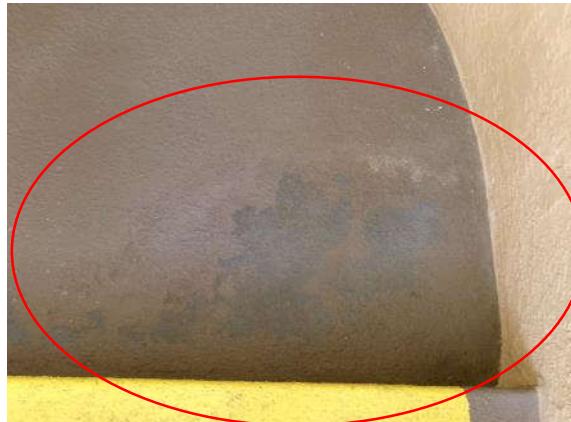
The front corridor and stairwells waterproofing varied from fair to poor condition in some areas where the membrane was peeling off, de-bonding, and adhesive failure to the substrate. Evidence of moisture was not observed in the ceilings of the corridor below and sounding of the ceilings in the corridors did not reveal hollow sounds indicative of stucco debonding.

<p>Photo 7.2.b.1 – Stairwell #2 – Waterproofing membrane peeling between 2nd and 3rd level</p>	<p>Photo 7.2.b.2 – Stairwell #1 – Evidence of ponding between the 3rd and 2nd levels.</p>

Based on the 2023 Westview Grande Condominium Association, Inc. Reserves Budget Plan issued on December 3, 2022, the building roof and waterproofing systems have met their estimated useful life. Therefore, the liquid-applied waterproofing membrane replacement should be scheduled before the end of 2024.

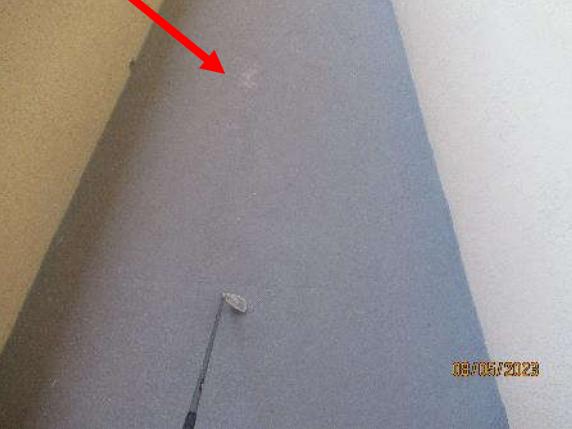
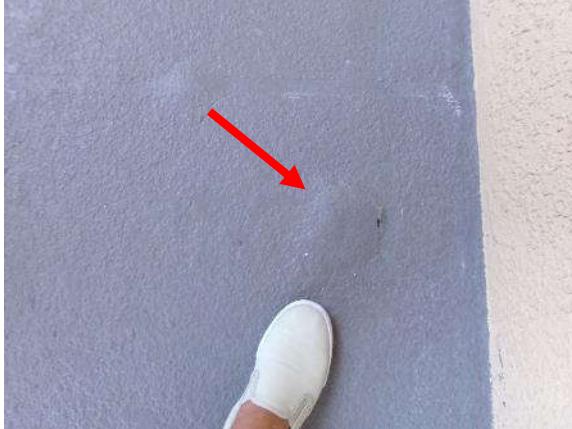
<p>Photo 7.2.b.11 – Front corridor level 1st – De-bonding and peeling off the waterproofing membrane.</p>	<p>Photo 7.2.b.12 – Front corridor level 1st – De-bonding waterproofing membrane.</p>

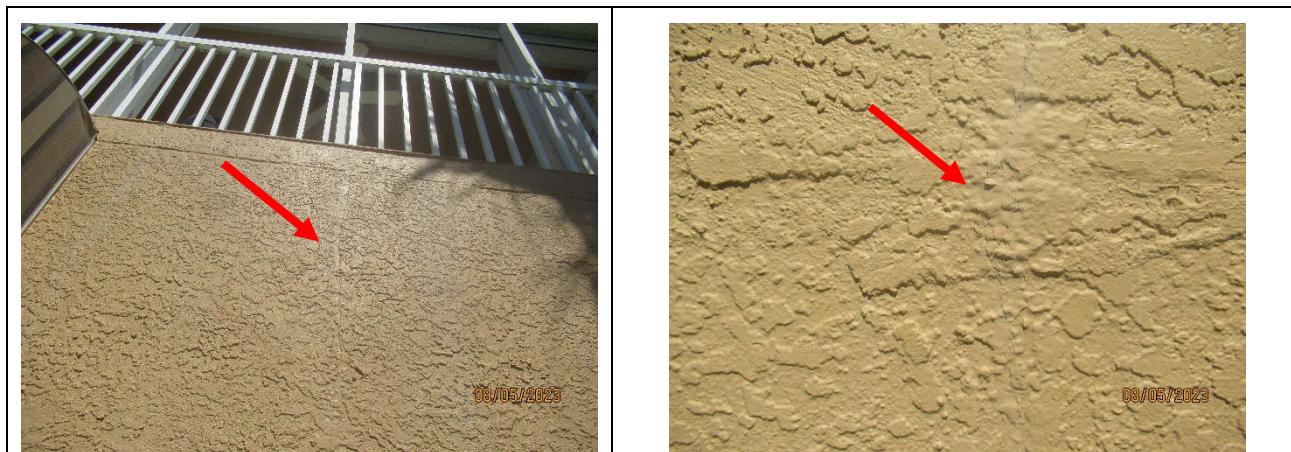
Photo 7.2.c.1 – West façade 1st level repaired stucco crack.

Photo 7.2.c.2 – West façade 1st level stucco hairline crack.

All visible cracks on the building façade should be properly repaired to prevent moisture and water intrusion, causing future stucco delamination and concrete spalling.

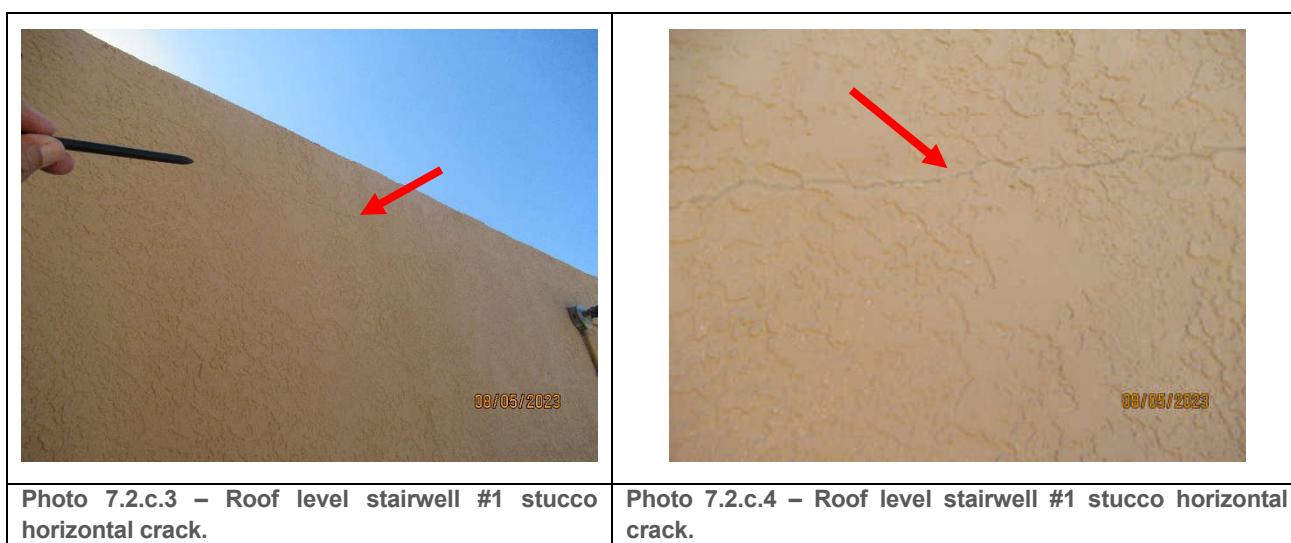
Photo 7.2.c.3 – Roof level stairwell #1 stucco horizontal crack.

Photo 7.2.c.4 – Roof level stairwell #1 stucco horizontal crack.

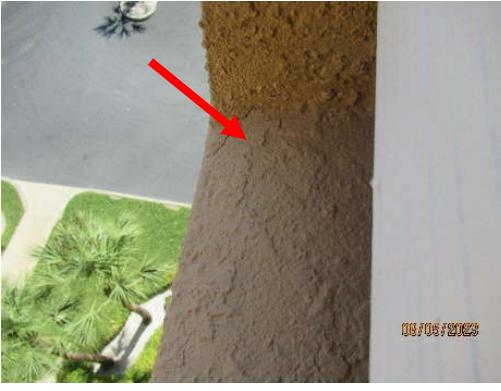
<p>Photo 7.2.c.5 – Stairwell #2 stucco hairline crack.</p>	<p>Photo 7.2.c.6 – Stairwell #2 stucco hairline crack.</p>

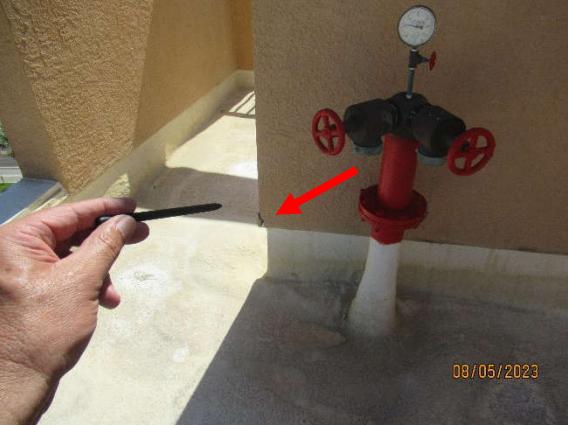
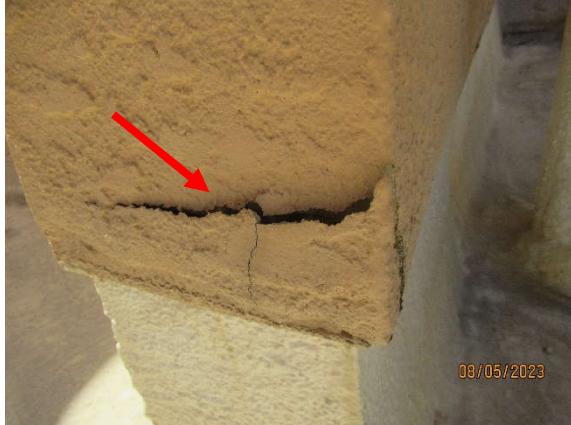
<p>Photo 7.2.c.7 – Roof level vent shaft southeast corner – Stucco crack and de-bonded.</p>	<p>Photo 7.2.c.8 – Roof level vent shaft southeast corner – Stucco crack and de-bonded.</p>

Where cracking exists, and stucco surfacing has de-bonded, such stucco areas would be removed and replaced. All these repairs should be performed in accordance with a Professional Engineer's specifications.

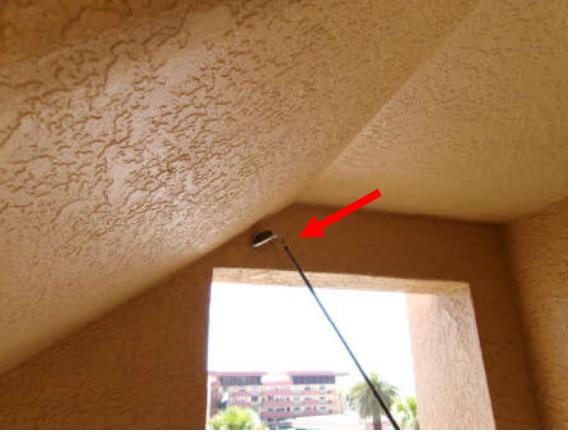
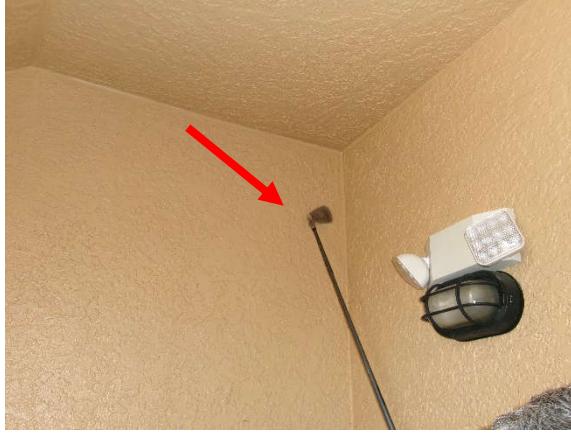
Tapping the stucco with a golf club revealed dull or hollow sounds in some areas. This might be indicative of stucco de-bonding or separation from the substrate. Spalling, loose plaster, or rust stains were not observed. However, these areas should be identified and repaired in the next façade and paint restoration project.

<p>Photo 7.2.c.9 – Stairwell I#1 Level 2nd – Tapping revealed a hollow sound in the stucco.</p>	<p>Photo 7.2.c.10 – Stairwell I#1 Level 2nd – Tapping revealed a hollow sound in the stucco.</p>

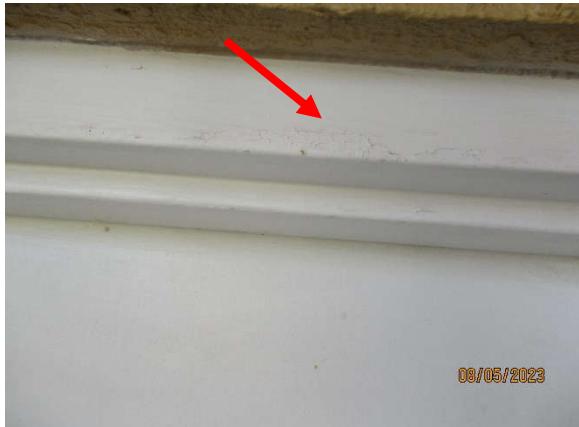
<p>08/05/2023</p>
<p>Photo 7.3.a.3 – Level 2nd trash room paint crack and peeling off.</p>	<p>Photo 7.3.a.4 – Level 2nd trash room paint peeling off.</p>

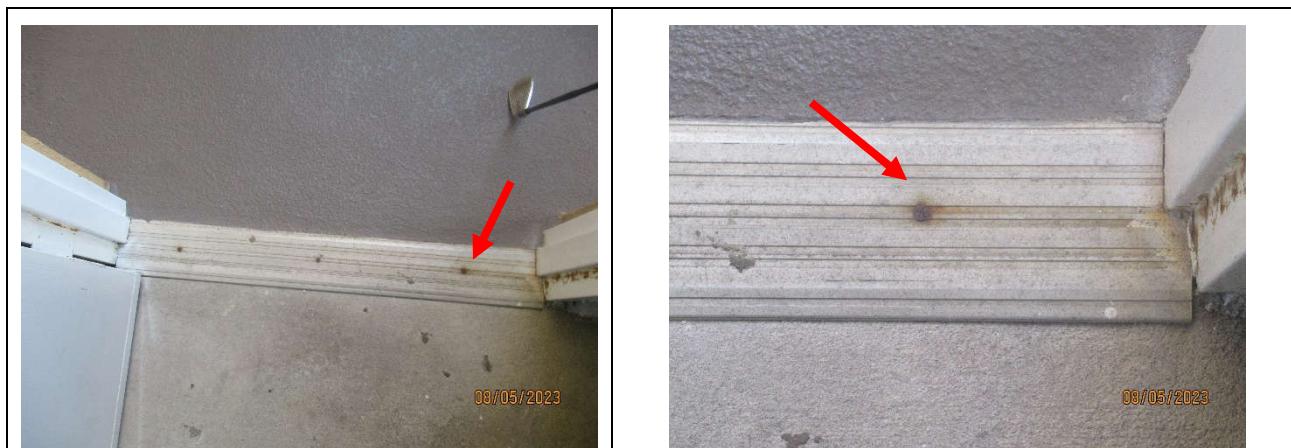
Overall, the fenestration systems appear in good condition with some localized deficiencies, specifically minimal corrosion of some of the door's components due to weathering, aging, and exposure to the coastal environment.

Photo 7.3.a.5 – Level 2nd trash room corroded fastener at the door threshold.

Photo 7.3.a.6 – Level 2nd trash room corroded fastener at the door threshold.

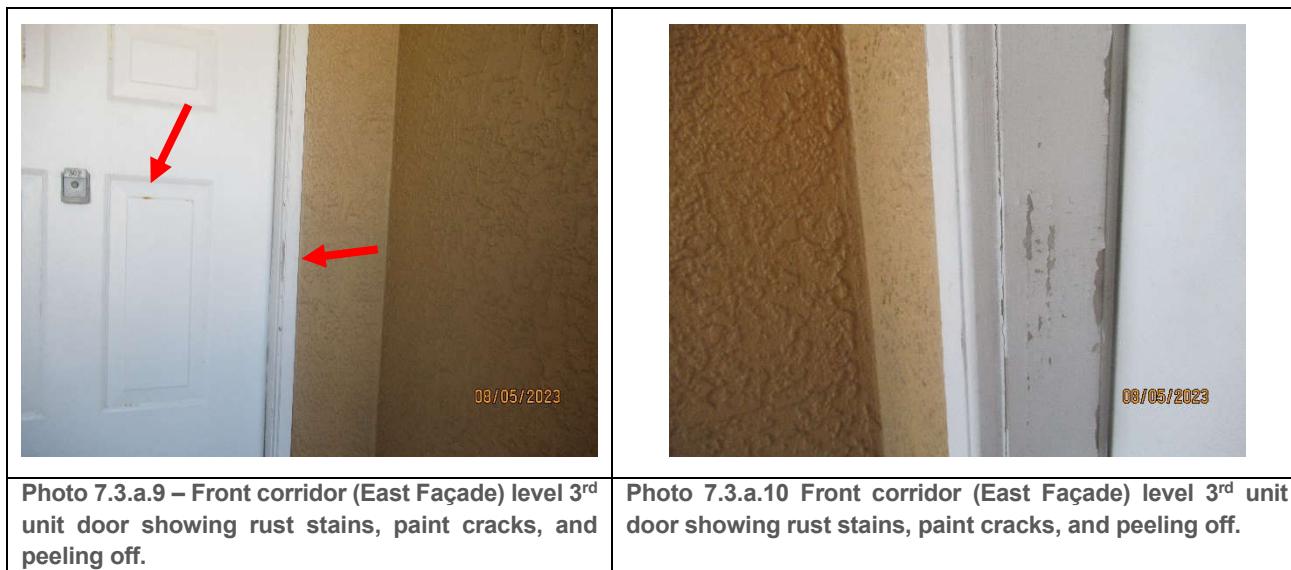
Photo 7.3.a.9 – Front corridor (East Façade) level 3rd unit door showing rust stains, paint cracks, and peeling off.

Photo 7.3.a.10 Front corridor (East Façade) level 3rd unit door showing rust stains, paint cracks, and peeling off.

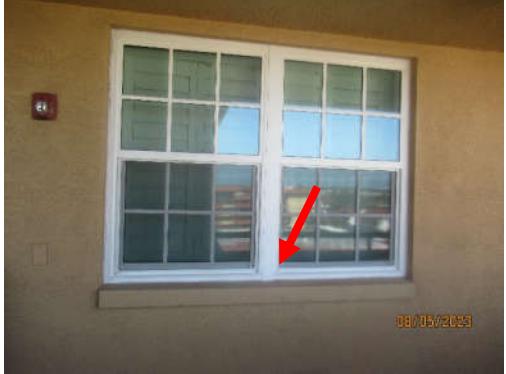
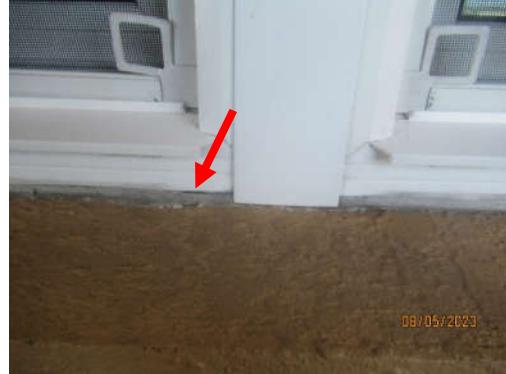
In general, sealants were installed at the perimeter of the sliding glass doors on balconies and windows of all elevations. Initial sealant failures, such as frame or substrate separation, were observed in some instances. Based on the visual assessment, the sealants and gaskets appear in good condition except for localized areas.

<p>Photo 7.3.b.1 – Front corridor (East Façade) Level 4th window perimeter sealant showing substrate and window frame separation</p>	<p>Photo 7.3.b.2 – West façade (Unit 503) typical sliding glass door observed in good condition.</p>

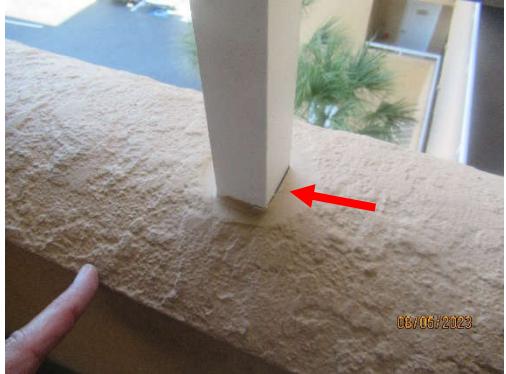
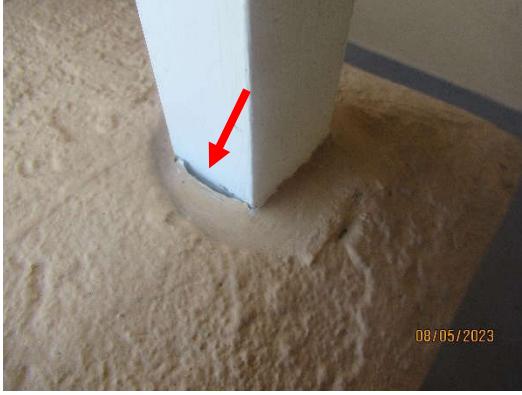
<p>Photo 7.3.b.3 – Front corridor (East Façade) Sealant separation in the base of the railing in the pocket.</p>	<p>Photo 7.3.b.4 – Front corridor (East Façade) Sealant separation in the base of the railing in the pocket</p>

The sealant at the base of the railing post in the pocket area must be addressed in the short term.

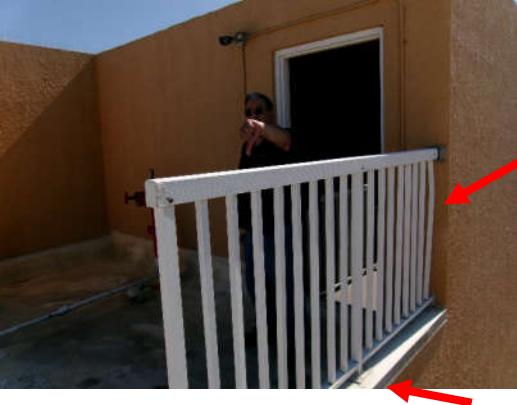
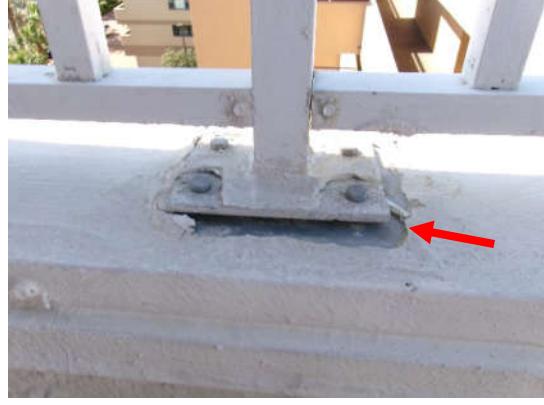
<p>Photo 7.4.5 – Roof level - a vertical picket was observed with deflection, and vertical post anchors were loosened.</p>	<p>Photo 7.4.6 – Roof level - a vertical picket was observed with deflection, and vertical post anchors were loosened.</p>

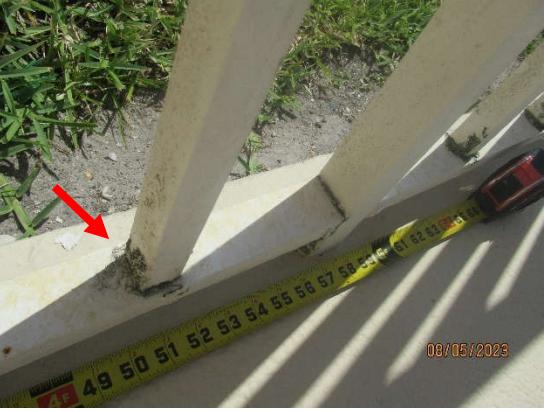
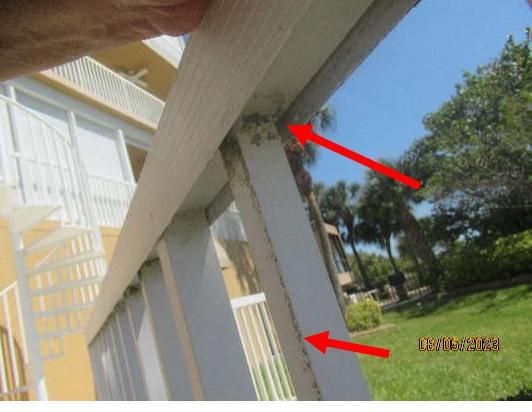
<p>Photo 7.4.7 – Pool deck railing with paint weathered and mild corrosion.</p>	<p>Photo 7.4.8 – Pool deck railing with paint weathered and mild corrosion.</p>

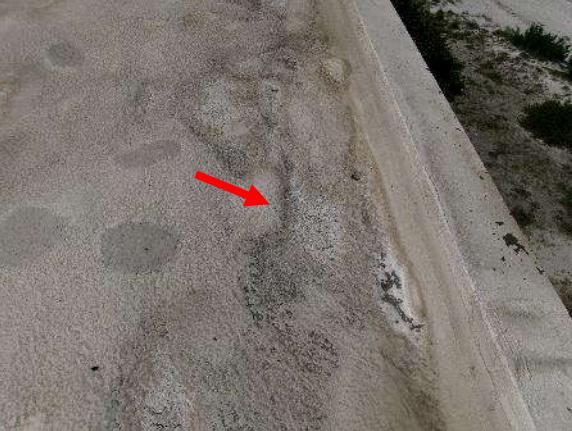
<p>Photo 7.6.1 – Roof level – Uneven surface and evidence of temporary water ponding.</p>	<p>Photo 7.6.2 – Roof level – Uneven surface and evidence of temporary water ponding.</p>

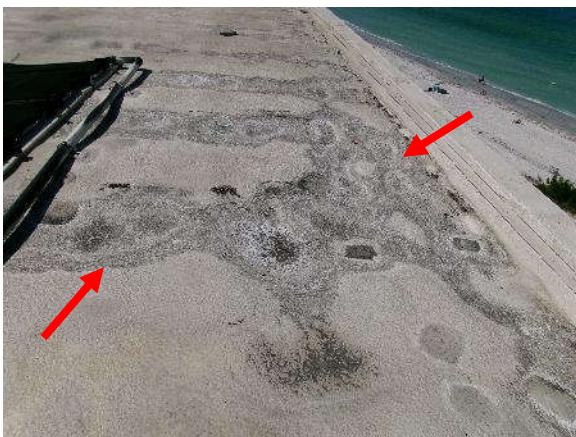
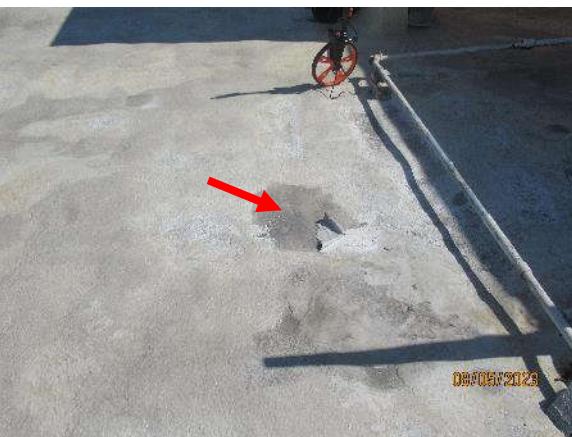
<p>Photo 7.6.3 – Roof level – Uneven surface and evidence of temporary water ponding.</p>	<p>Photo 7.6.4 – Roof level – Roof patch repairs were observed to be detached and peeled off.</p>

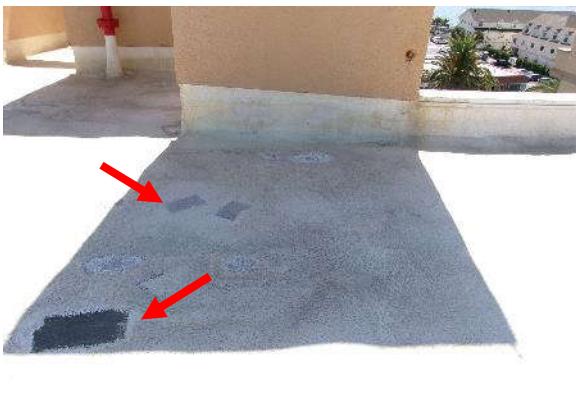
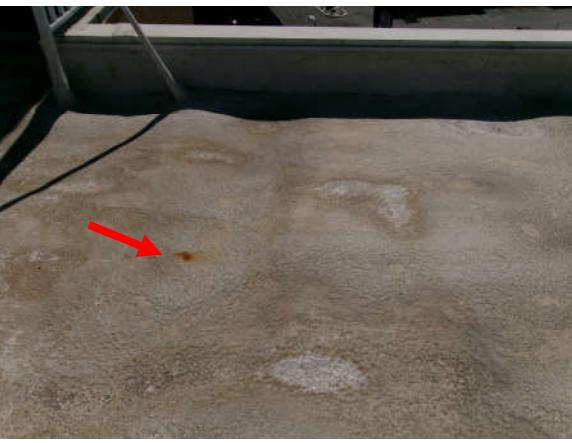
<p>Photo 7.6.5 – Roof level – Repair patch in good condition.</p>	<p>Photo 7.6.6 – Roof level – Rust spots observed.</p>

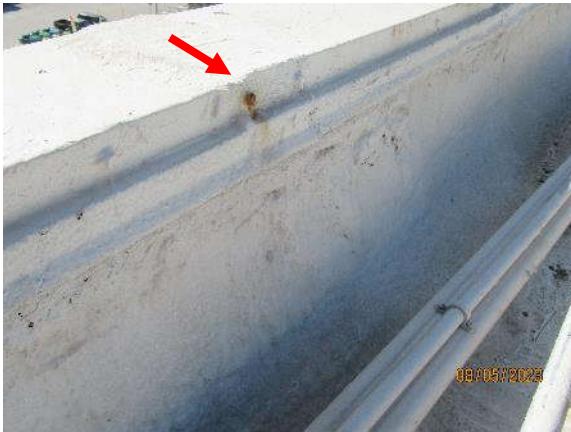
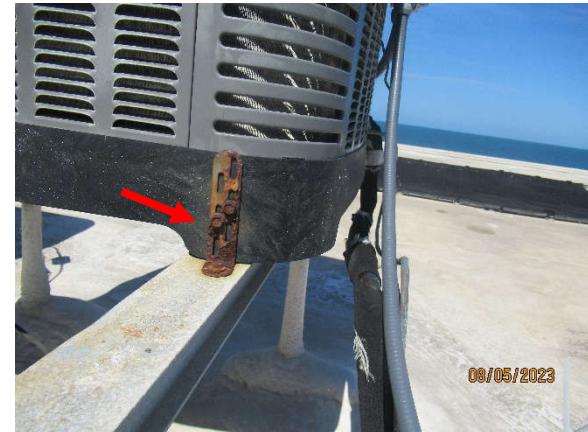
<p>Photo 7.6.7 – Roof level – Corrosion in the cap flashing fastener.</p>	<p>Photo 7.6.8 – Roof level – Rooftop equipment with corroded fasteners and steel angles.</p>

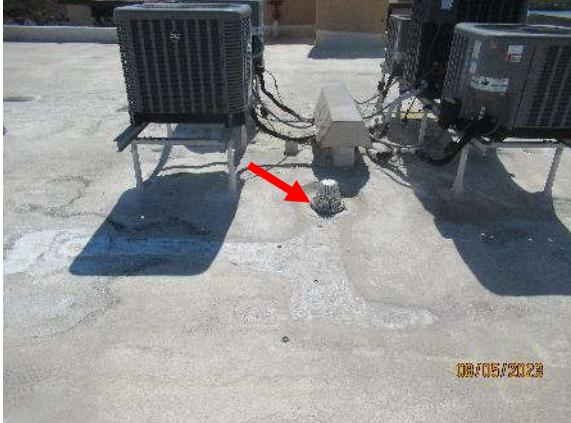
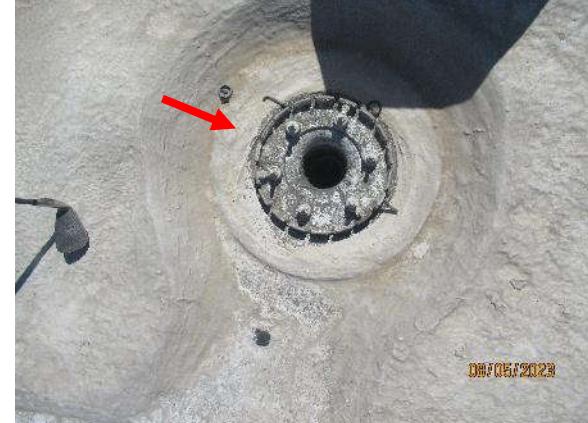
<p>Photo 7.6.9 – Roof level – Roof drain dome gate loose.</p>	<p>Photo 7.6.10 – Roof drain dome gate loss.</p>

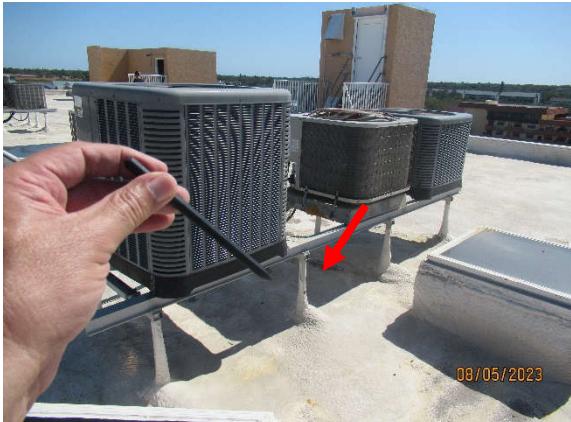
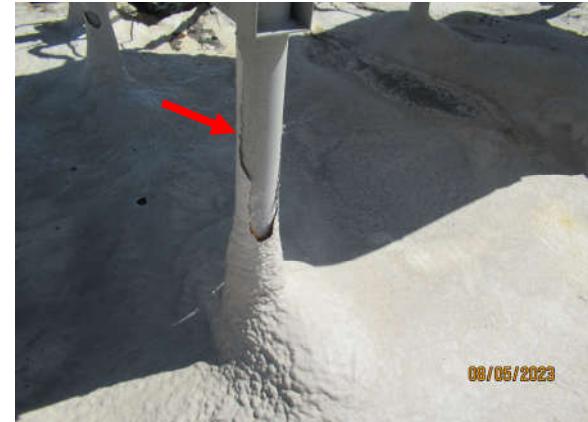
<p>Photo 7.6.11 – Roof level – Peeled off the coating in the rooftop structure base.</p>	<p>Photo 7.6.12 – Peeled off the coating in the rooftop structure base.</p>

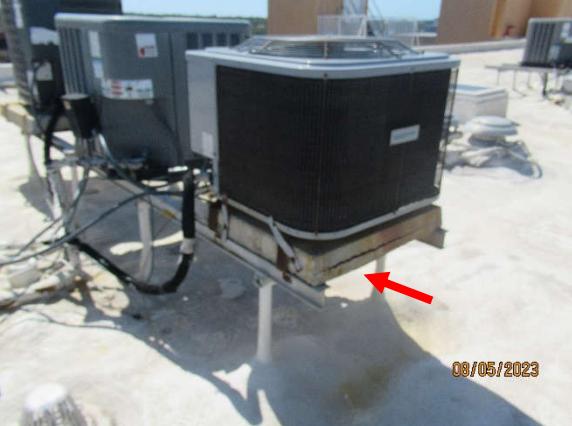
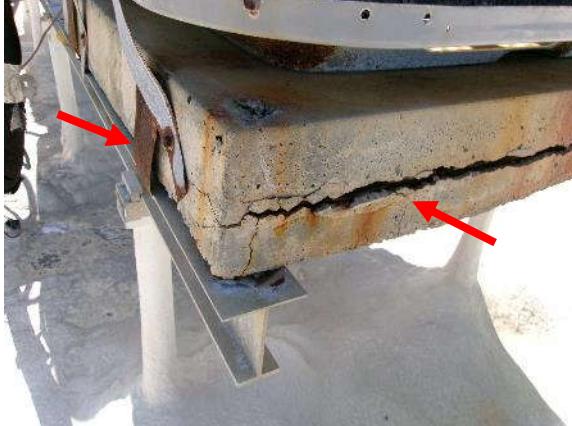
<p>Photo 7.6.13 – Roof level – Rooftop equipment with corroded fastener and concrete base damaged.</p>	<p>Photo 7.6.14 – Rooftop equipment with corroded fastener and concrete base damaged.</p>

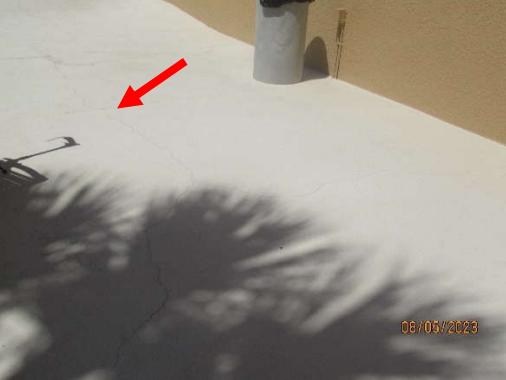
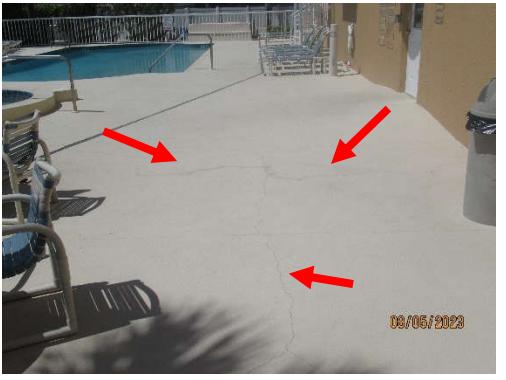
<p>08/05/2023</p>
<p>Photo 7.7.1 – Pool area - Concrete crack in the pool slab on grade.</p>	<p>Photo 7.7.2 – Pool area - Concrete crack in the pool slab on grade.</p>

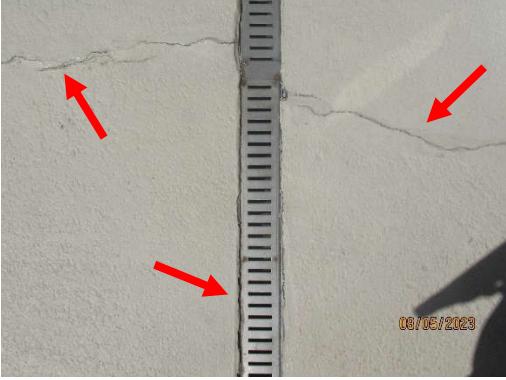
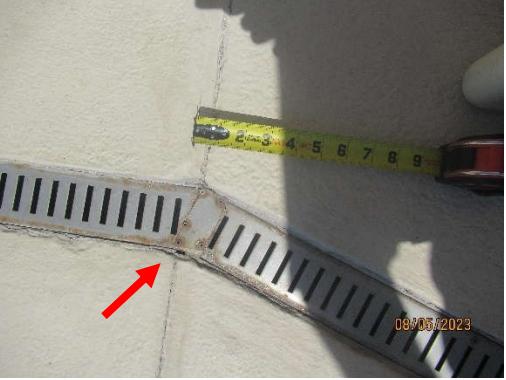
<p>08/05/2023</p>
<p>Photo 7.7.3 – Pool area - Concrete crack in the pool slab on grade.</p>	<p>Photo 7.7.4 – Pool area – Failure of sealant.</p>

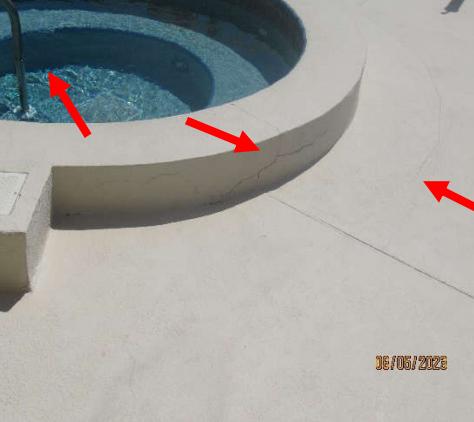
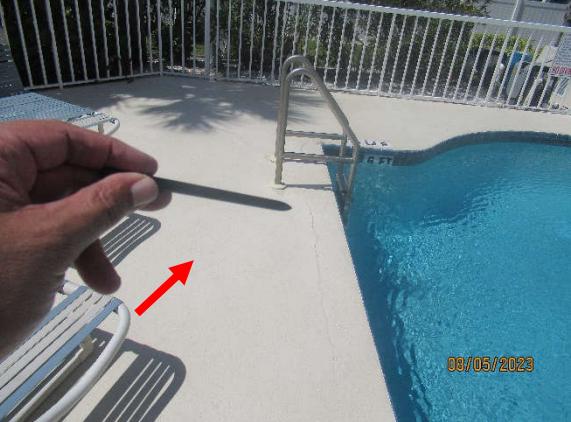
<p>08/05/2023</p>
<p>Photo 7.7.5 – Pool area - Concrete crack in the pool slab on grade. Concrete cracks in the spa curb.</p>	<p>Photo 7.7.6 – Pool area – Concrete crack in the pool slab on grade. Likely between the slab on the grade and the pool wall.</p>

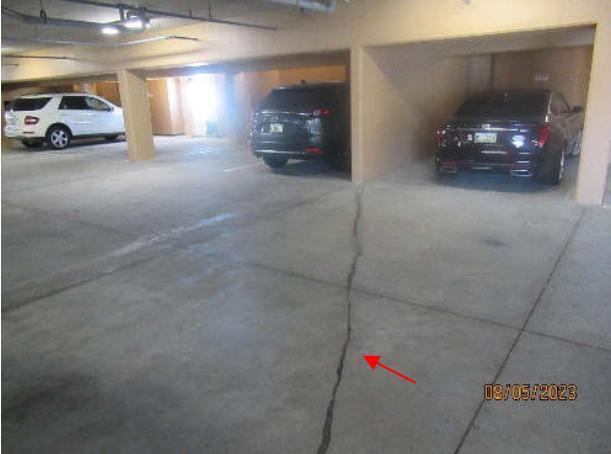
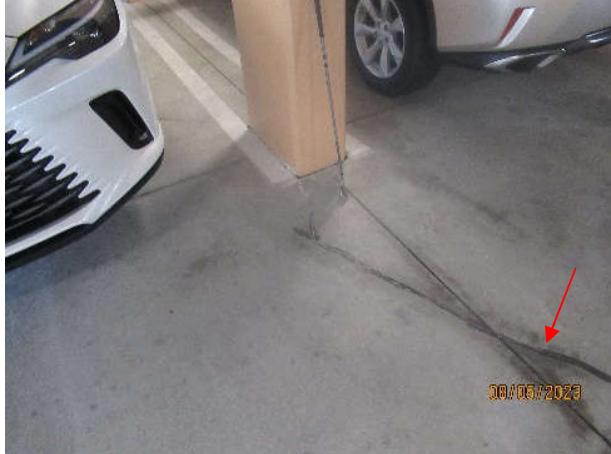
Overall, the condition of the concrete elements was found to be good to fair with localized instances of cracks of the slab-on-grade, which must be addressed to avoid deterioration of the concrete.

<p>Photo 7.8.a.1 – Garage Level – Drying shrinkage cracks observed at the slab on grade.</p>	<p>Photo 7.8.a.2 – Garage Level - Drying shrinkage cracks observed at the slab on grade.</p>

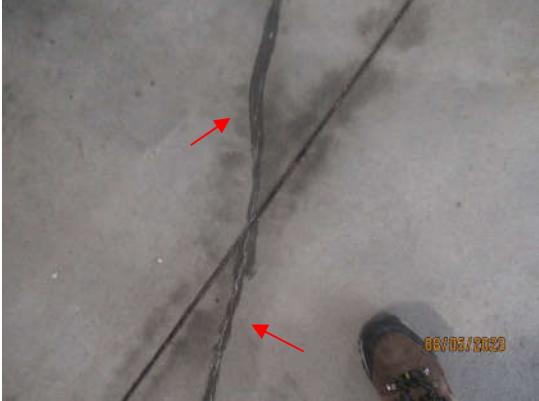
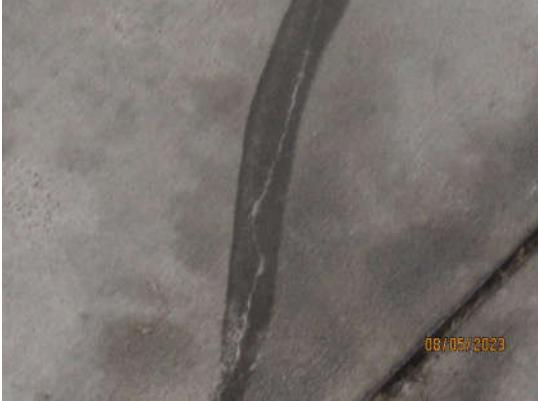
<p>Photo 7.8.a.3 – Garage Level – Drying shrinkage cracks observed at the slab on grade. The application of cementitious material to repair and seal the crack was observed.</p>	<p>Photo 7.8.a.4 – Garage Level - Drying shrinkage cracks observed at the slab on grade. The application of cementitious material to repair and seal the crack was observed.</p>

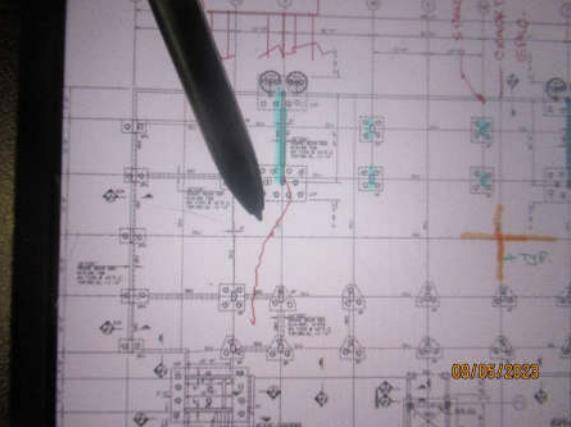
<p>Photo 7.8.a.5 – Garage Level – Drying shrinkage cracks observed at the slab on grade.</p>	<p>Photo 7.8.a.6 – Garage Level - Drying shrinkage cracks observed at the slab on grade.</p>

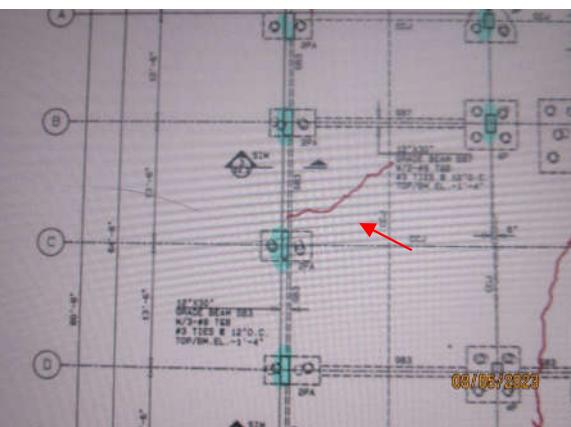
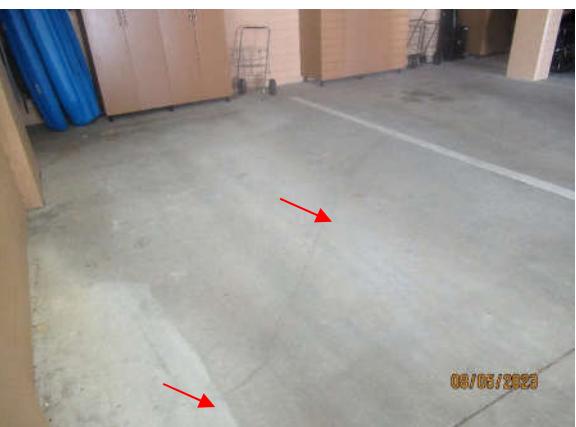
<p>Photo 7.8.a.7 – Garage Level – Plastic shrinkage cracks observed at the slab on grade.</p>	<p>Photo 7.8.a.8 – Garage Level - Drying shrinkage cracks observed at the slab on grade.</p>

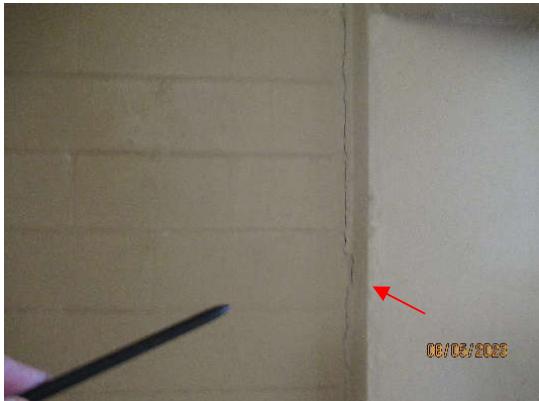
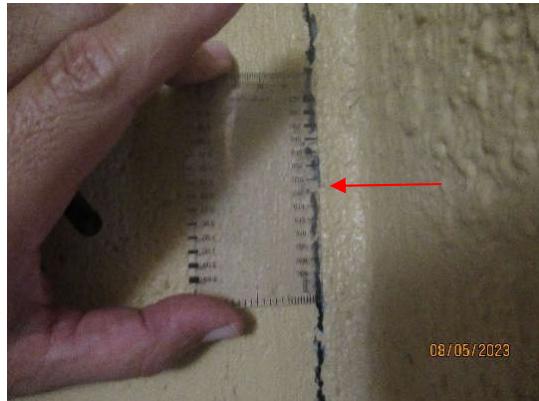
<p>Photo 7.8.b.1 – Garage Level – Anticipated building cracks usually result from restrained movement in buildings and building materials.</p>	<p>Photo 7.8.b.2 – Garage Level – Anticipated cracks in buildings and building materials typically result from restrained movement.</p>

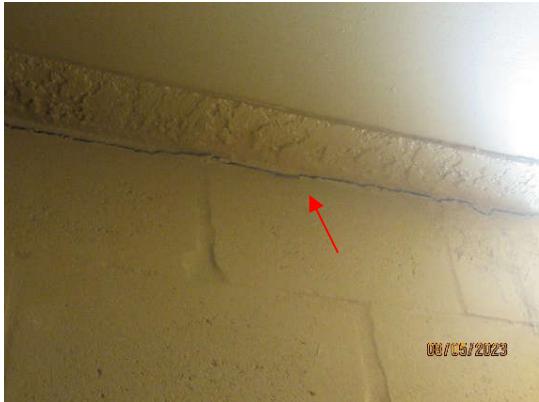
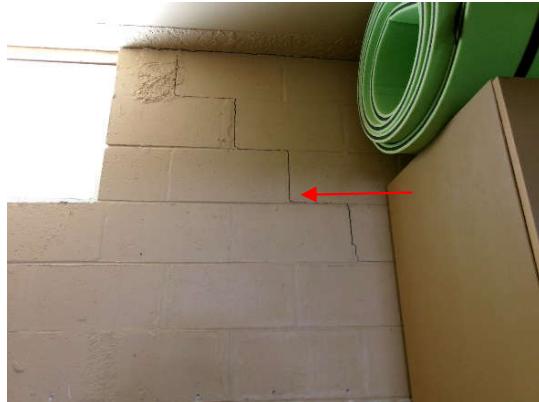
<p>Photo 7.8.b.3 – Garage Level – Anticipated cracks in buildings and building materials typically result from restrained movement.</p>	<p>Photo 7.8.b.4 – Garage Level – Anticipated cracks in buildings and building materials typically result from restrained movement.</p>

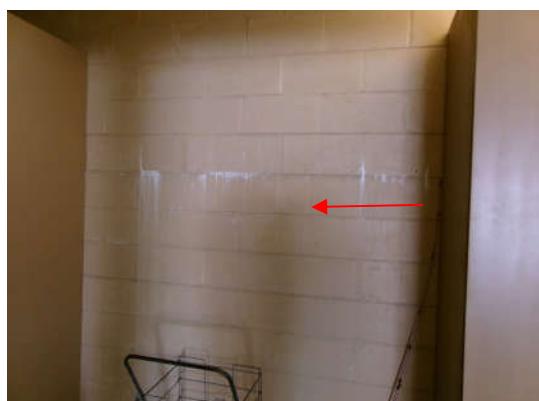
<p>Photo 7.8.b.5 – Garage Level – Evidence of efflorescence was observed through some of the walls in the garage level.</p>	<p>Photo 7.8.b.6 – Garage Level – Evidence of efflorescence was observed through some of the walls in the garage level.</p>
