SEA CLUB OF INDIAN SHORES

MILESTONE PHASE 1 INSPECTION SURVEY

November 15, 2023

Re: Milestone Phase 1 Inspection Survey
Sea Club of Indian Shores
19725 Gulf Blvd.,
Indian Shores, FL 33785

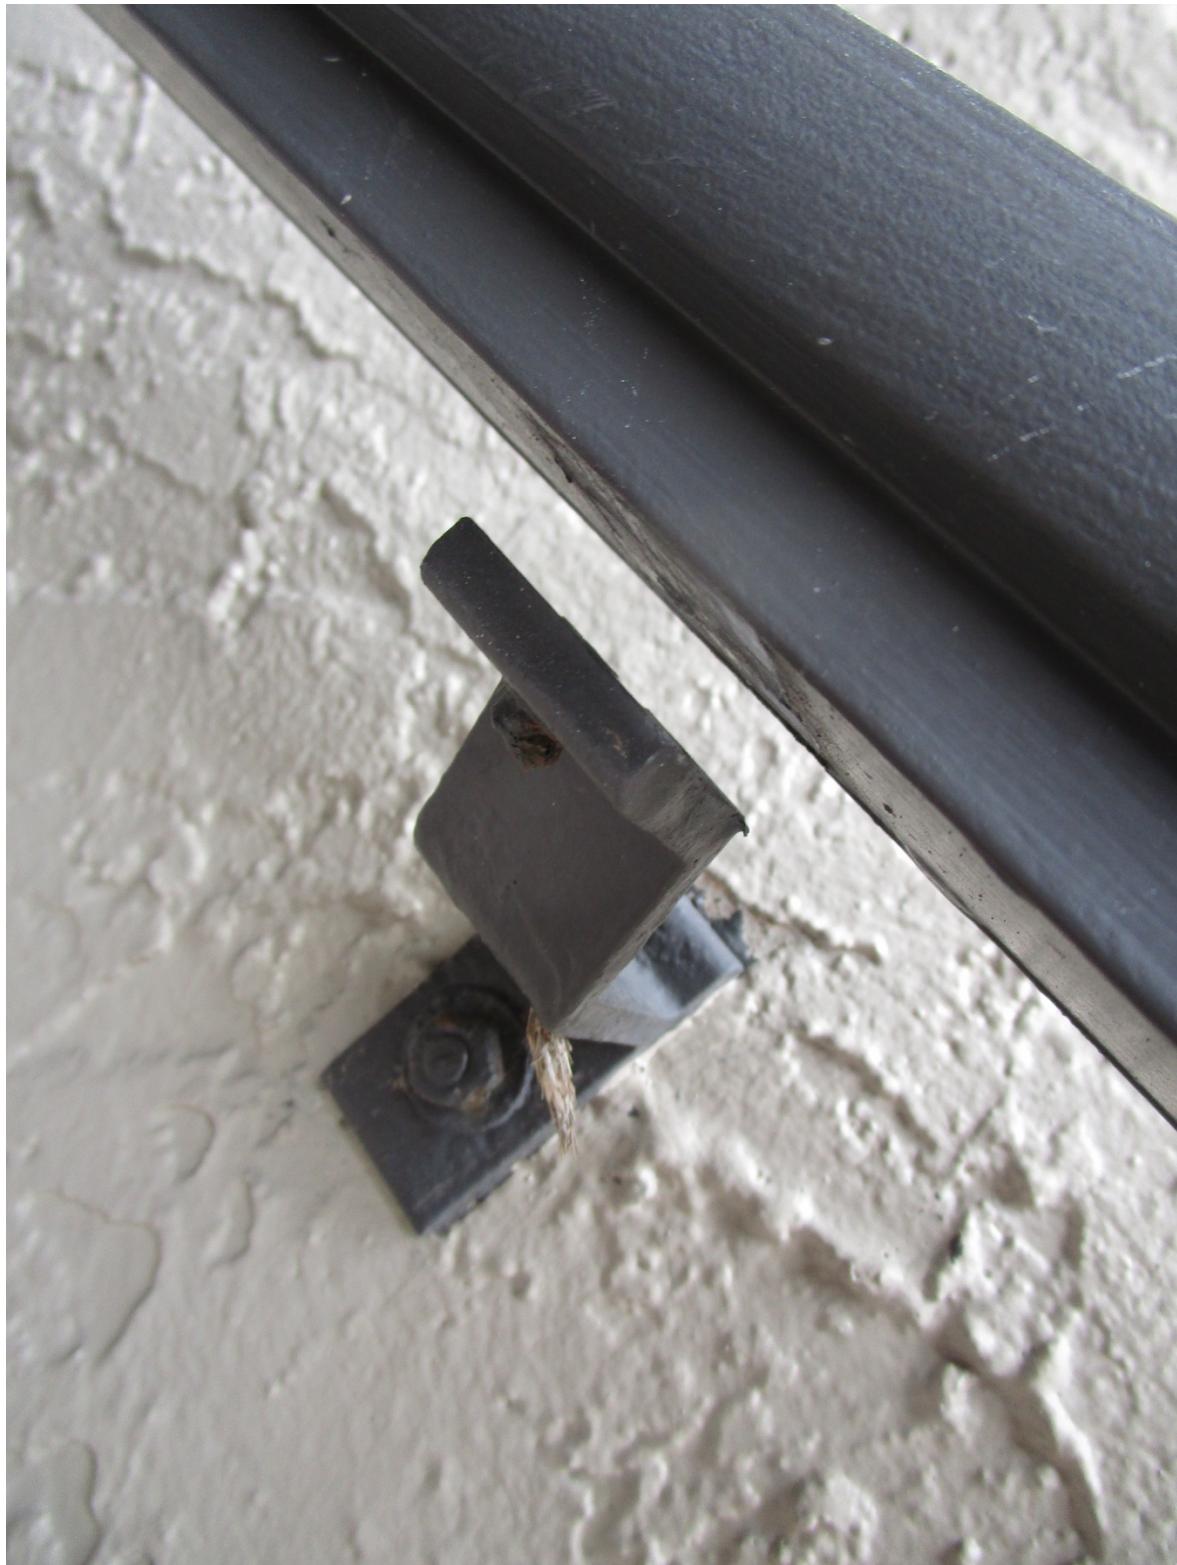
- 4) Specific and typical issues observed include the following. Photos corresponding to issues are provided following this section.
 - Building 8 – IMG_2571 – Handrail that is missing a fastener that needs repair.

Building 8, Missing Fastener at Handrail

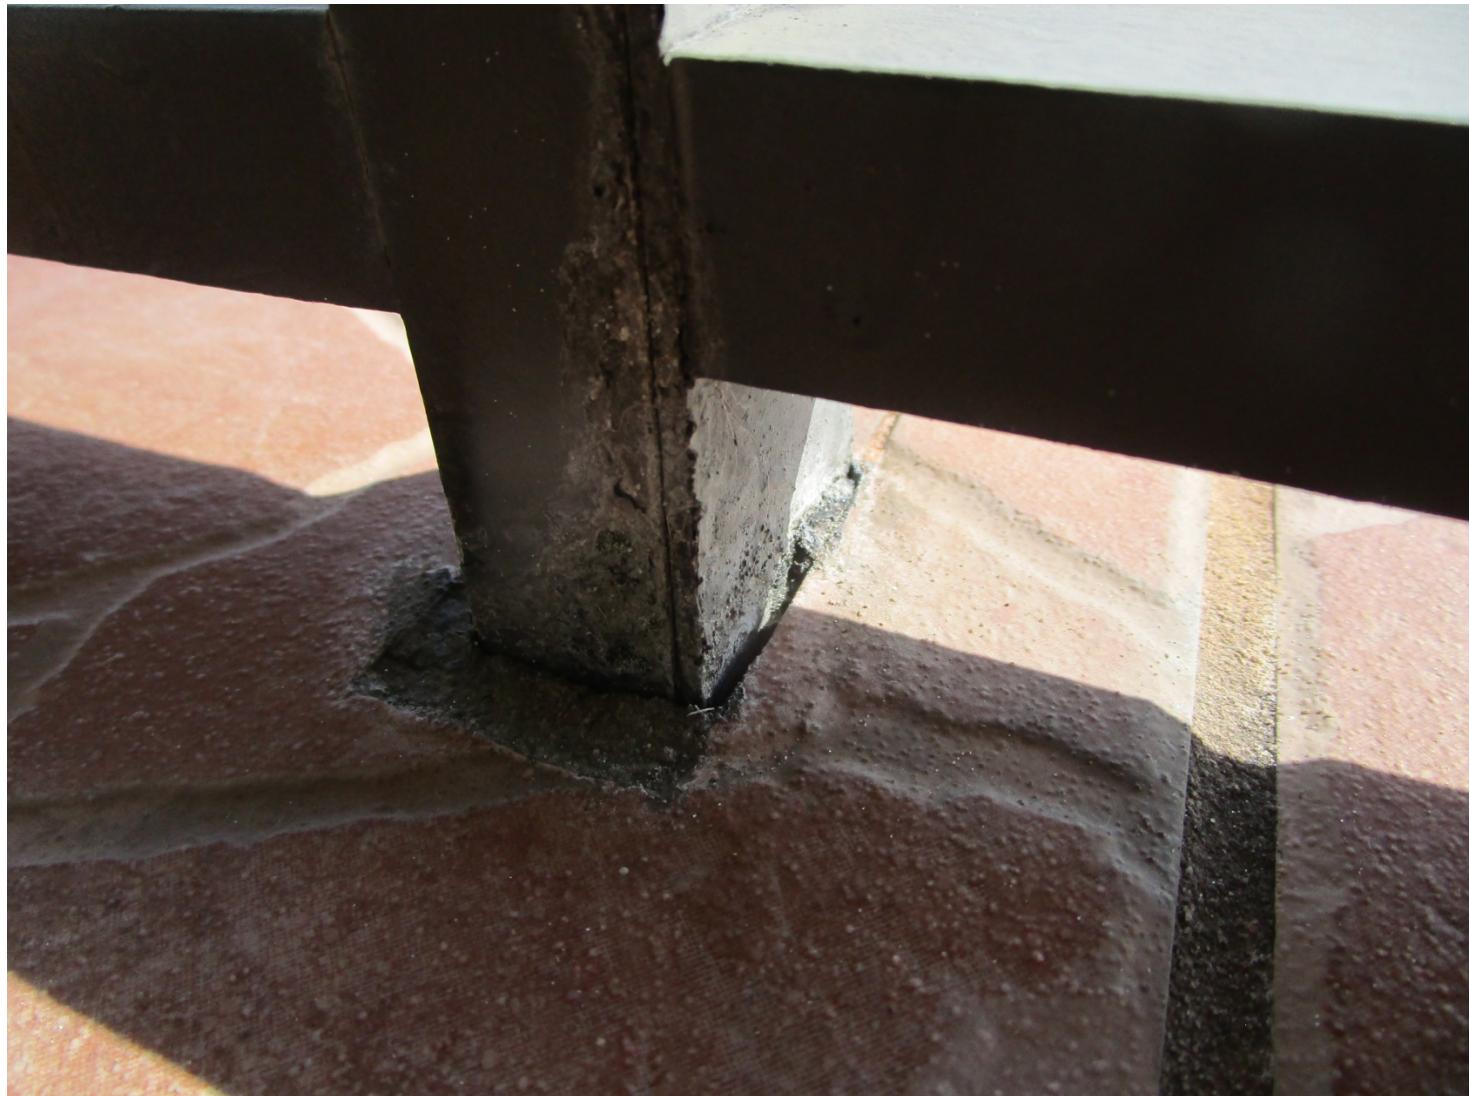
- Building 5 – Unit 502 – IMG_2428 – Example of post pocket that needs repair.
 - Building 5 – Unit 502 – IMG_2432 – Example of slider that is missing a fastener.

Typical “post pocket” requiring repair to re-anchor loose guardrail. Unit 502, Building 5.

- 2) Guardrails on the buildings are approaching the end of their useful lives. The Association should begin budgeting for replacement of the guardrails, and should perform regular maintenance and inspections on the guardrails to reduce the likelihood of failure. In some cases (noted below), guardrails require repair now in order to maintain safety. Guardrails are missing fasteners in some cases. In others, the guardrail "post pocket" or anchorage at the base of the rail is loose and needs to be reset.

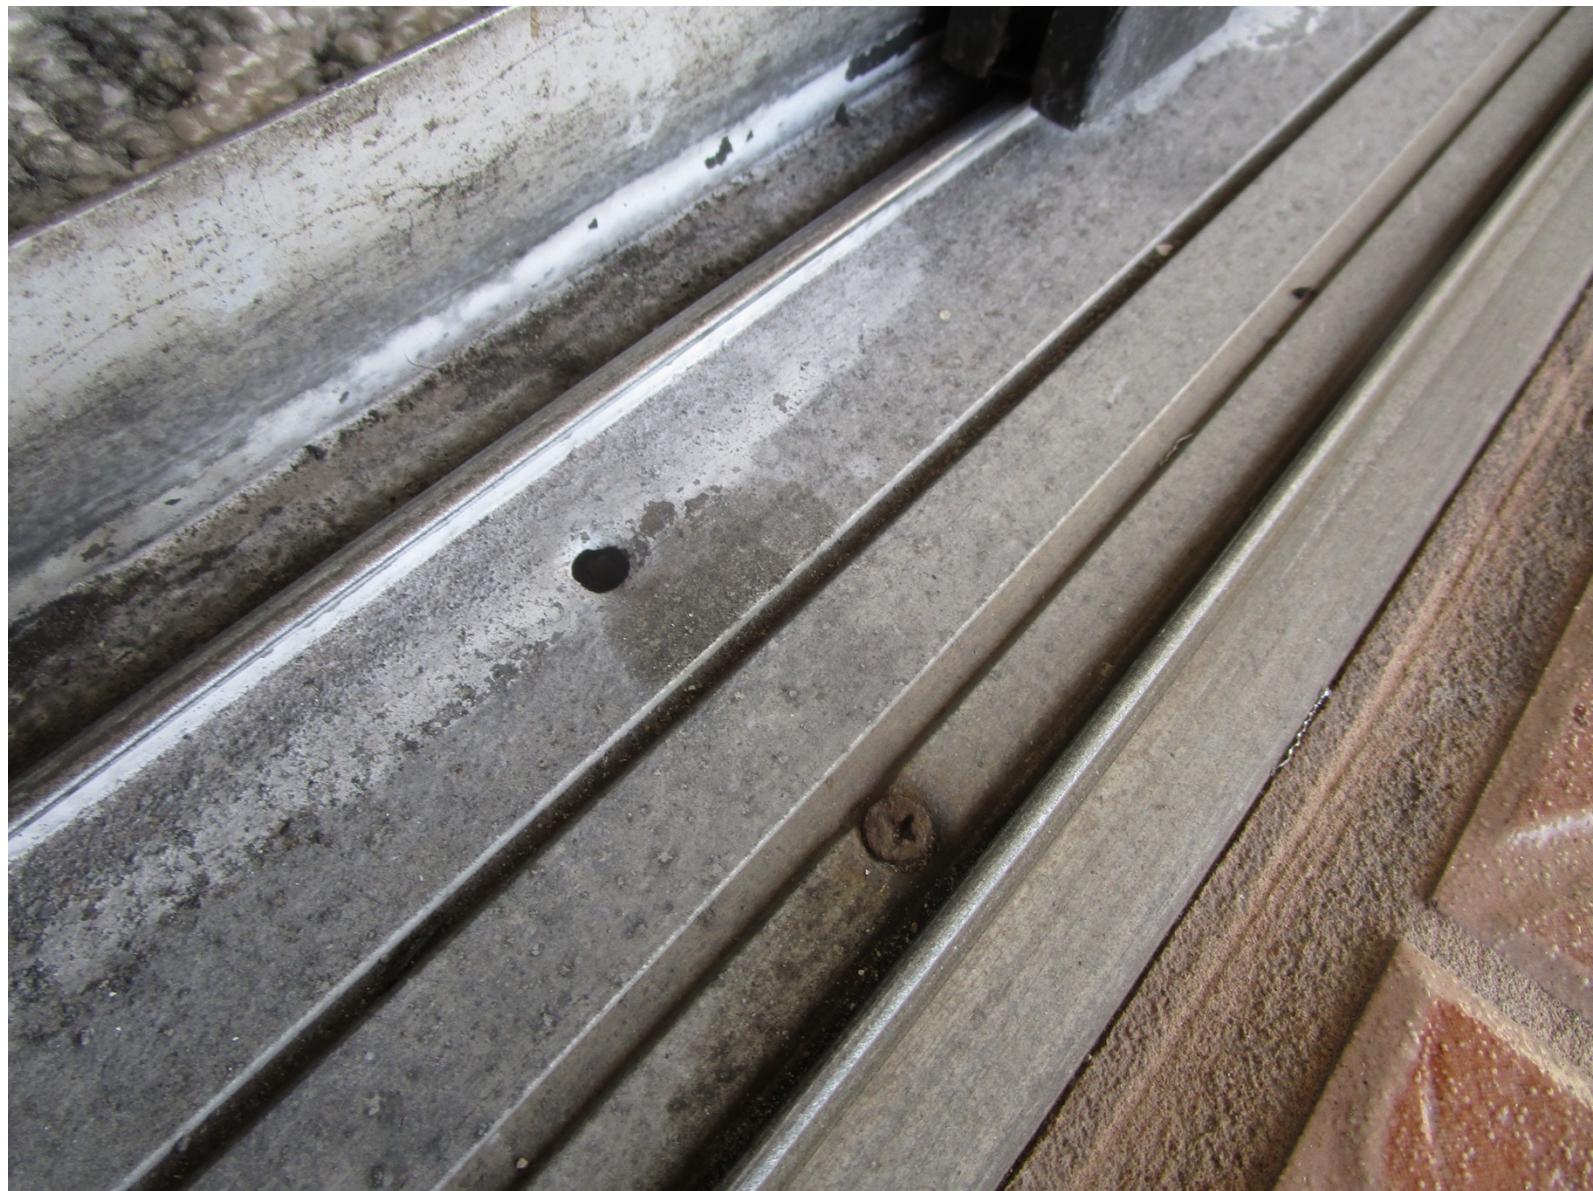
Typical sliding glass door threshold missing a fastener (screw). This will permit water intrusion into the slab and/or leaks into the building. Unit 502, Building 5.

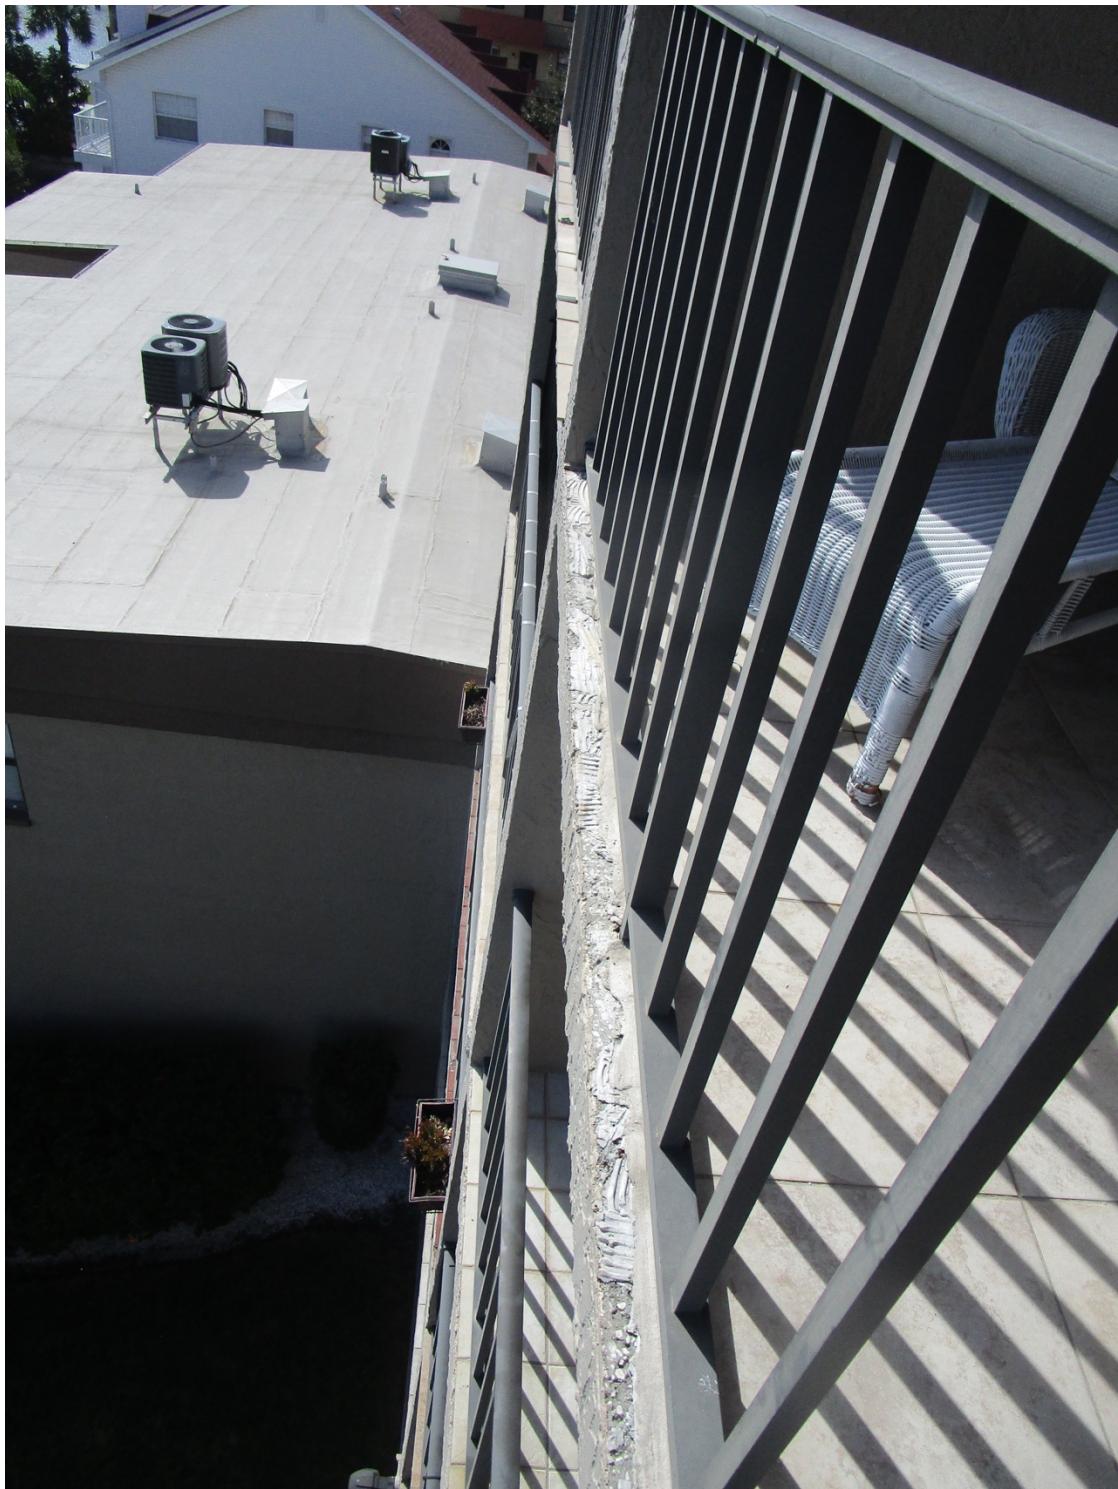
- Building 5 - Unit 404 – IMG-2462 – IMG_2466 – Balcony edge that has bare concrete exposed that need to be repaired.
 - Building 5 – IMG_2598 – IMG_2600 – Evidence of a crack in the ceiling with signs of water intrusion, as well as concrete spalls and corrosion of the rebar.

Balcony slab edge should be waterproofed to prevent corrosion deterioration of the concrete.
Building 5, Unit 404.

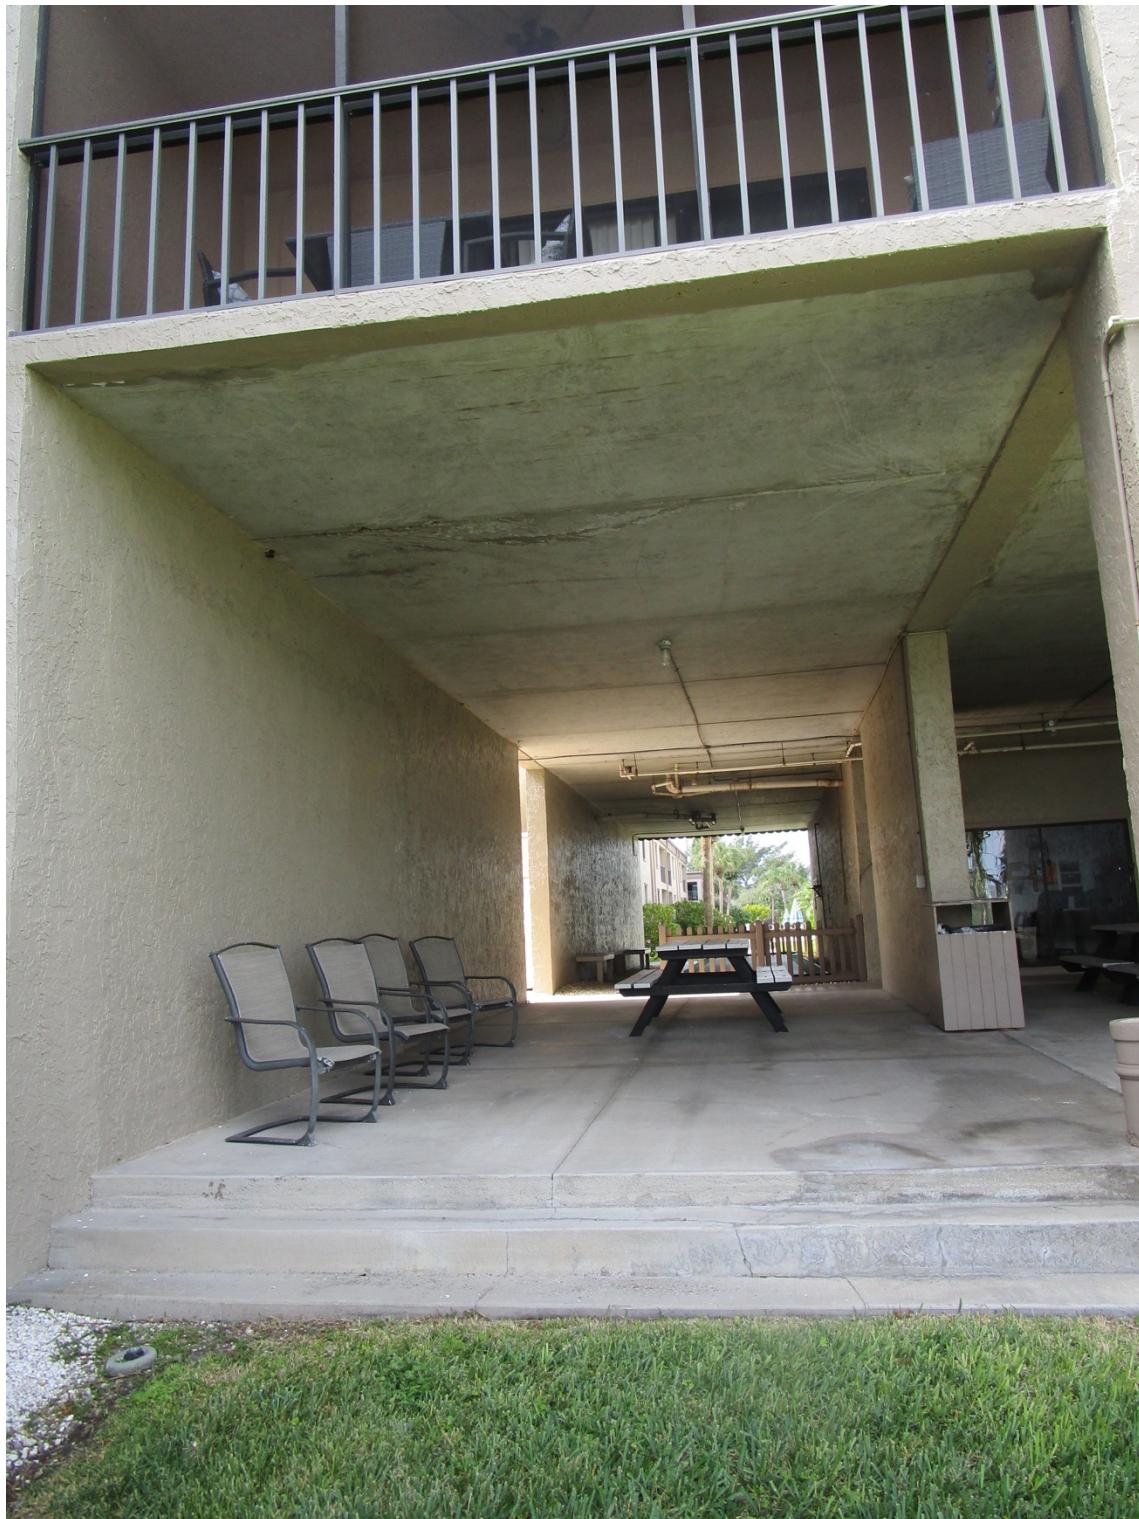
Precast concrete ceiling at ground level, Building 5. Minor concrete spalling observed.

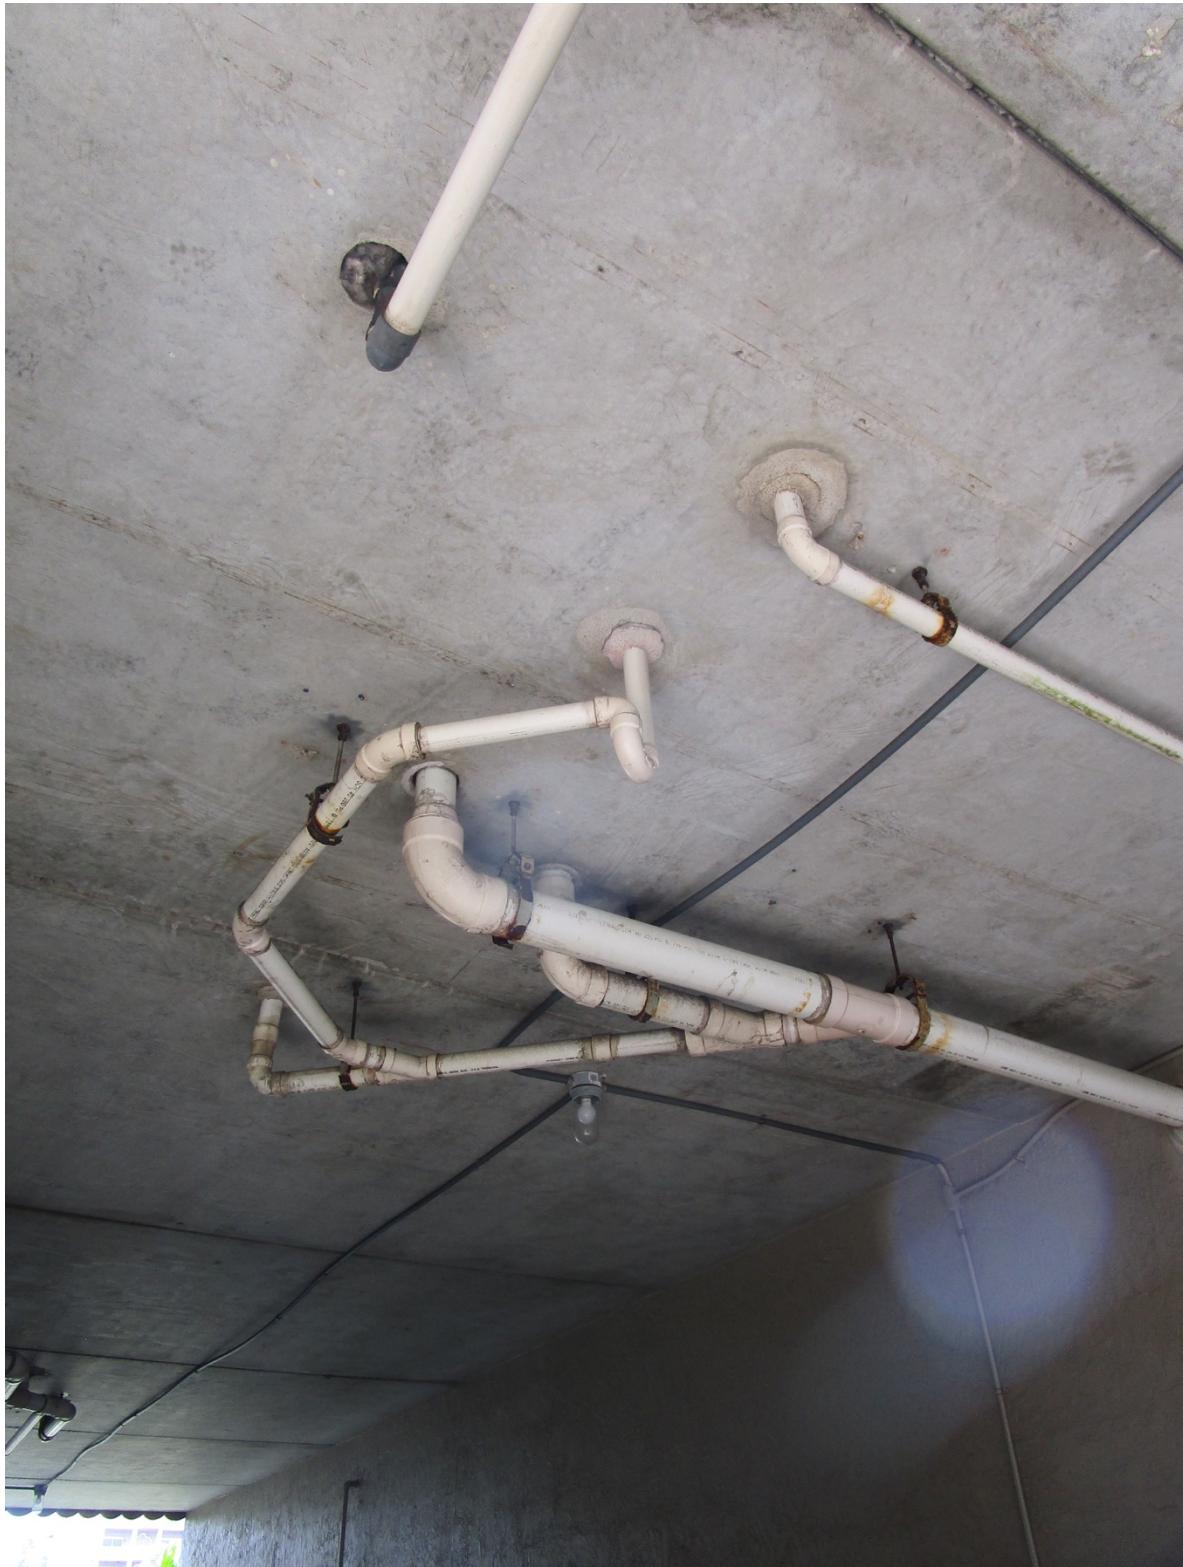
- Building 5 – IMG_2601 – IMG_2602 – Support clamps around the pipes exhibit significant corrosion and many are broken. This is a typical condition on the ground floor ceiling of building 5.

Support clamps around the pipes exhibit significant corrosion and many are broken. This is a typical condition on the ground floor ceiling of building 5.

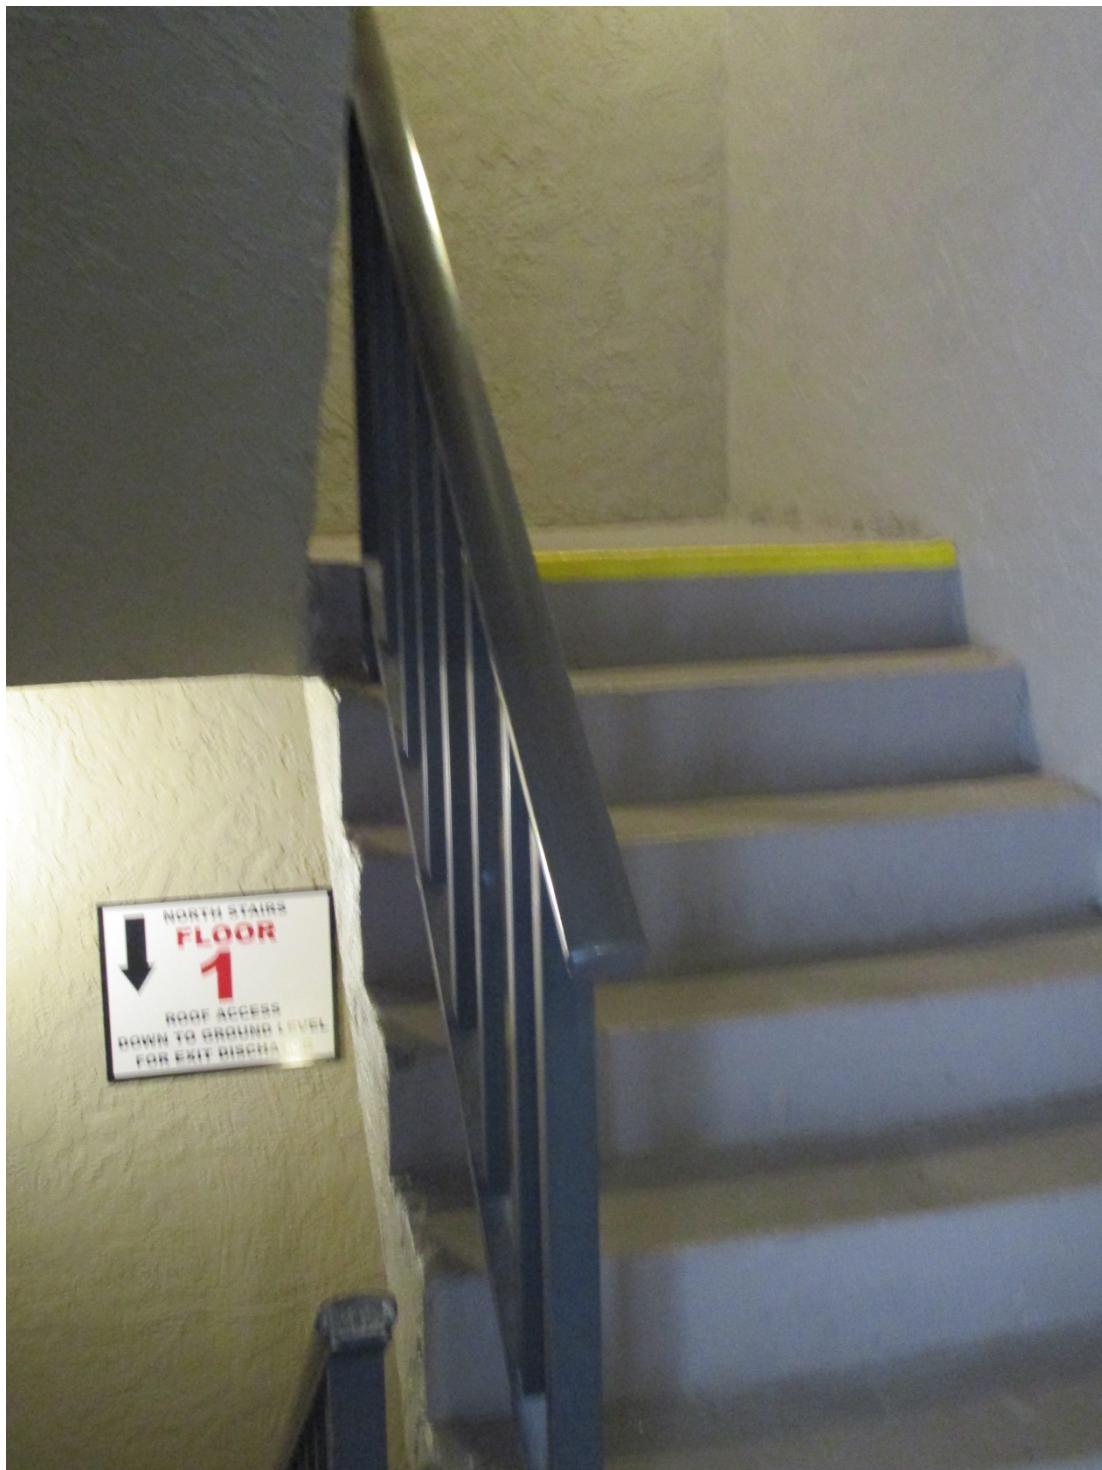
- Building 5 – IMG_2620 – Loose handrail in stairwell. North stairwell of building 5, nearest to unit 101

Loose handrail in stairwell. North stairwell of building 5, nearest to unit 101
