## Milestone Inspection – Phase 1

### Pipers Run Condominium Association

19812 Gulf Blvd, Indian Shores, Florida 33785

March 24, 2025

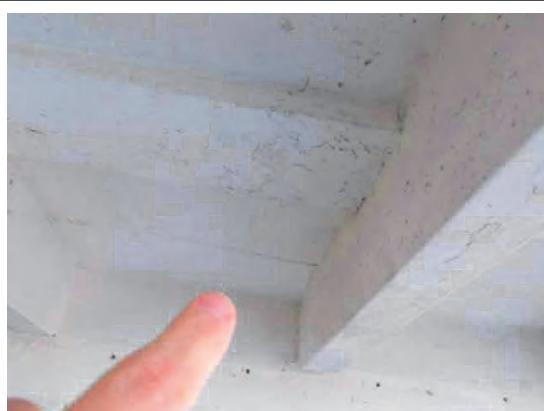
Left rear parking garage ceiling. See Photos #32,33

**32** Rear Garage Ceiling Cracks Repairs

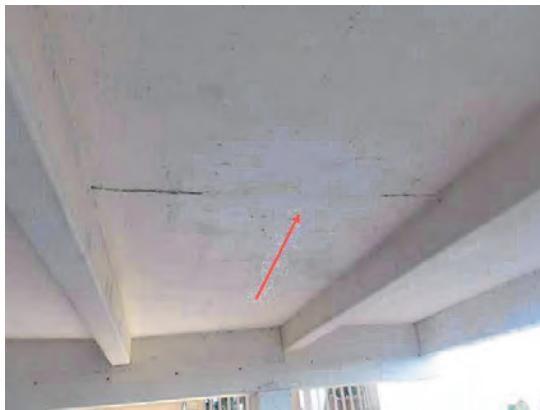
**33** Rear Garage Ceiling Cracks Repairs

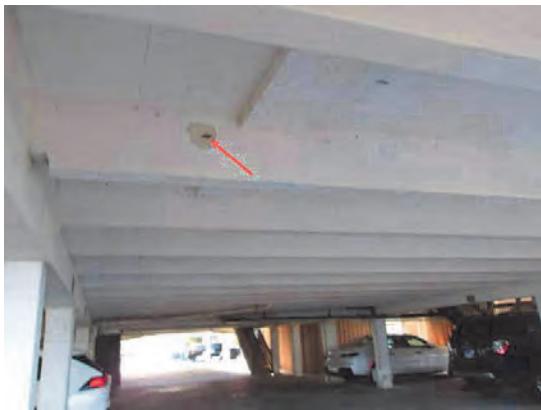
Cracking and exposed re-bar in a several locations throughout the parking garage.

**34** Right Middle Garage Cracking and exposed Re-Bar

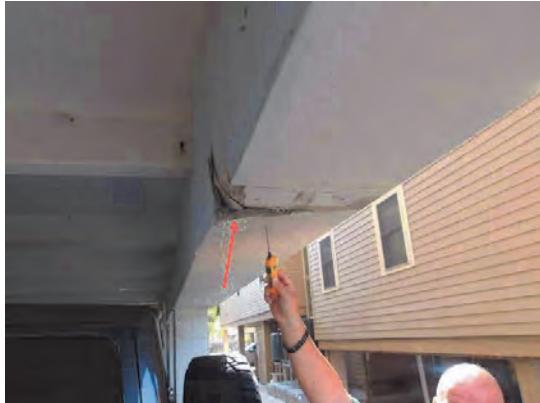
**35** Damage to Left Rear Garage Beam From Flood Wall

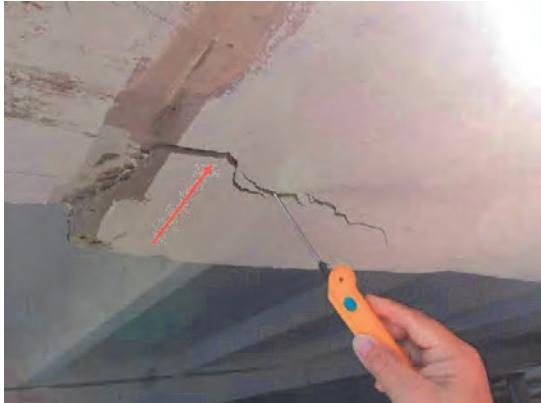
**36** Damage to Left Rear Garage Beam From Flood Wall

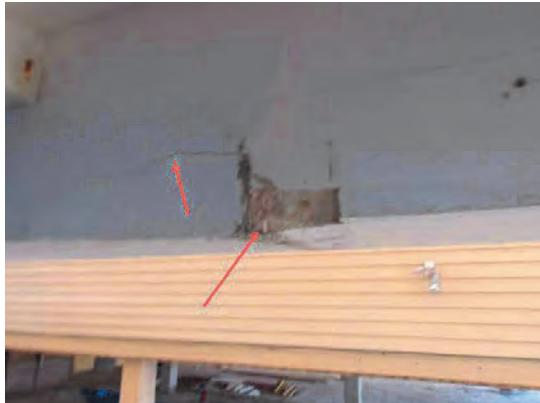
**37** Damage to Left Rear Garage Beam From Flood Wall

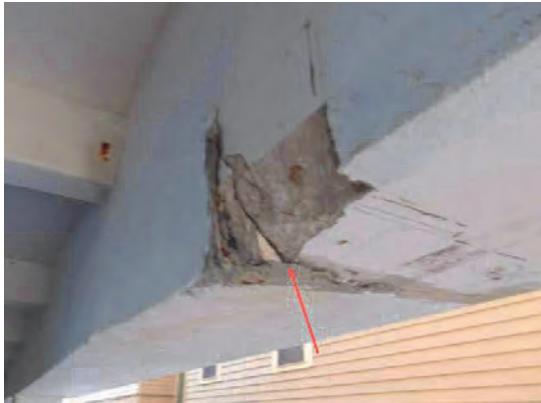
**38** Damage to Left Rear Garage Beam From Flood Wall

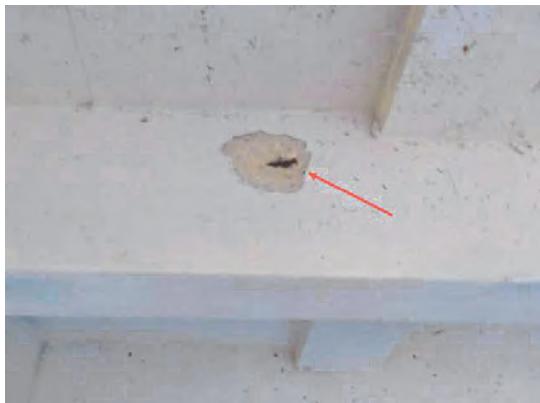
**39** Right Middle Garage Cracking and exposed Re-Bar

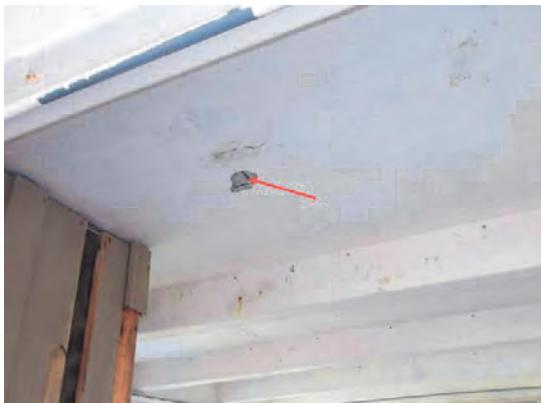
**40** Right Rear Garage Cracking and exposed Re-Bar

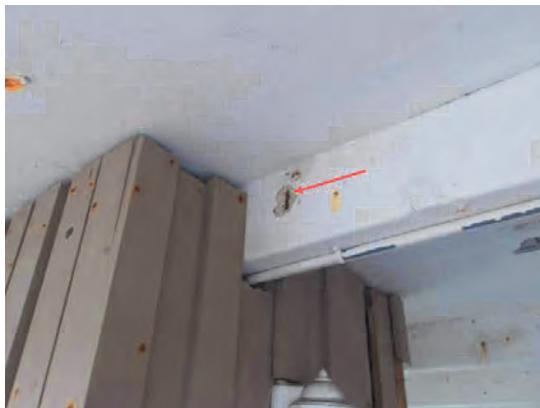
41 Right Rear Garage Cracking and exposed Re-Bar

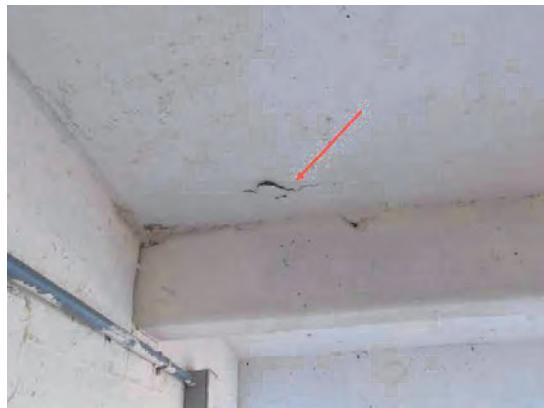
42 Right Rear Garage Cracking

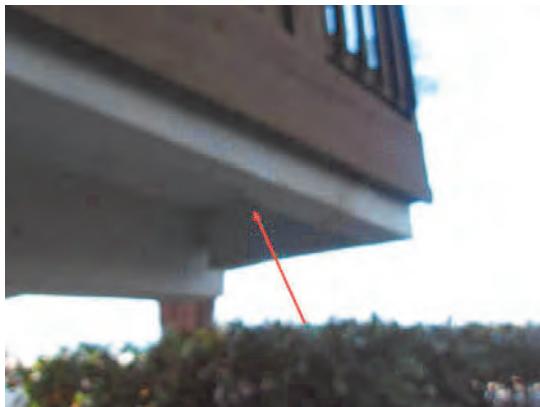
43 Left Rear Garage Cracking and exposed Re-Bar

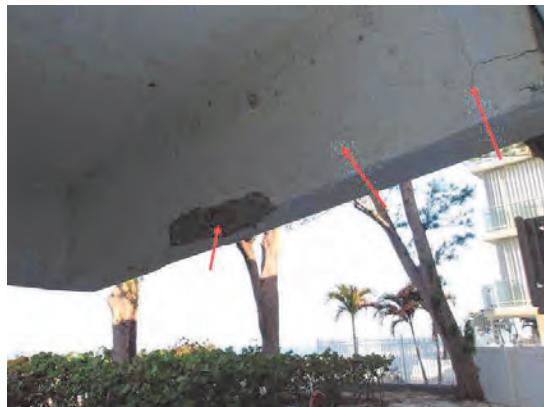
44 Left Rear Garage Cracking and exposed Re-Bar

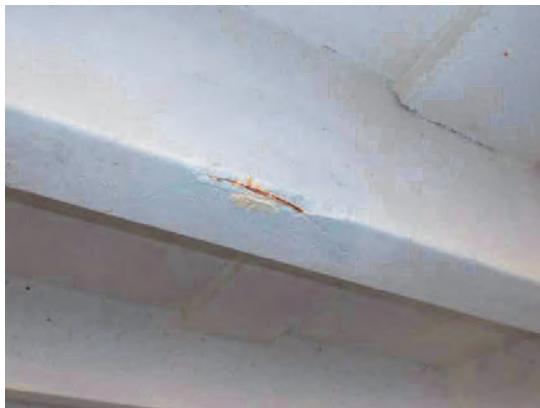
45 Left Rear Garage Cracking and exposed Re-Bar

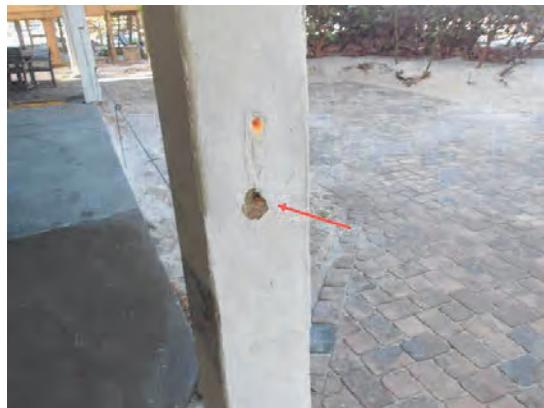
46 Rear Garage Pier Cracks and Exposed Re-Bar

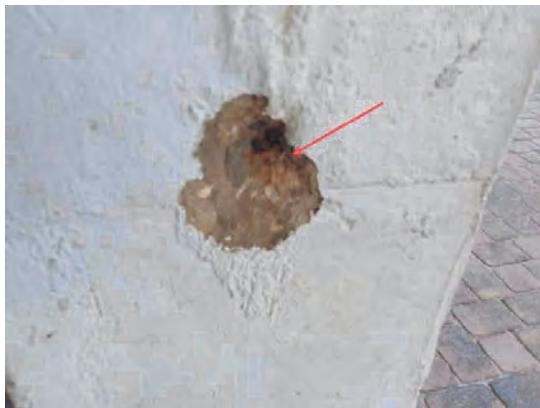
47 Rear Garage Pier Cracks and Exposed Re-Bar

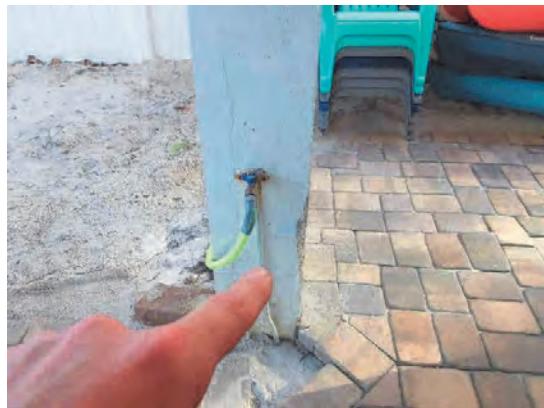
48 Rear Garage Pier Cracks

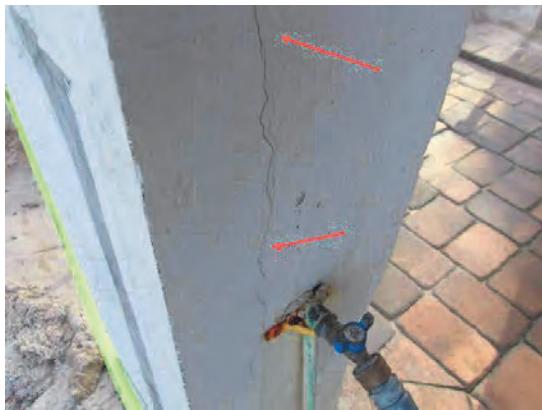
49 Rear Garage Pier Cracks

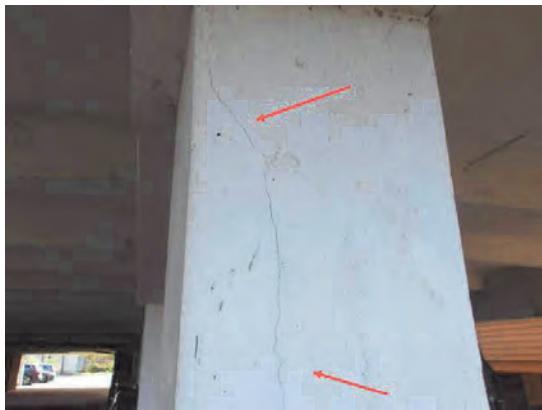
50 Rear Garage Pier Cracks

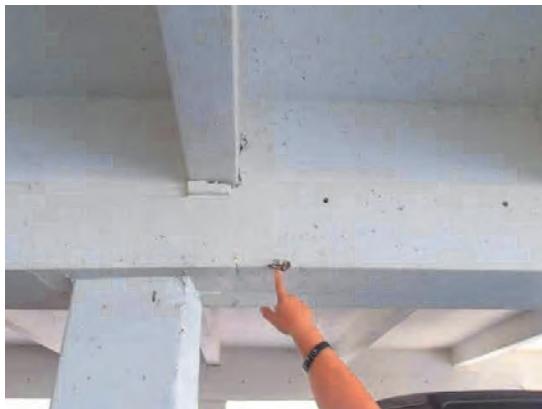
51 Middle Garage exposed re-Bar

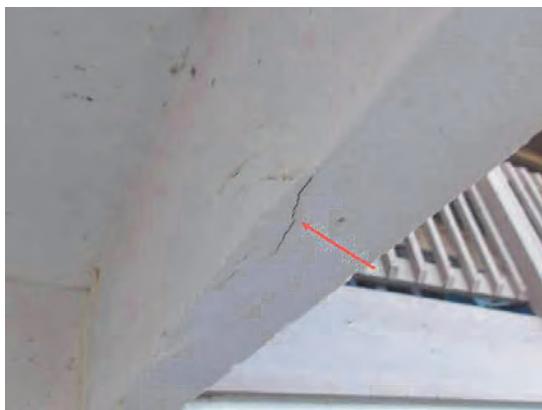
53 Rear Garage Beam Cracks

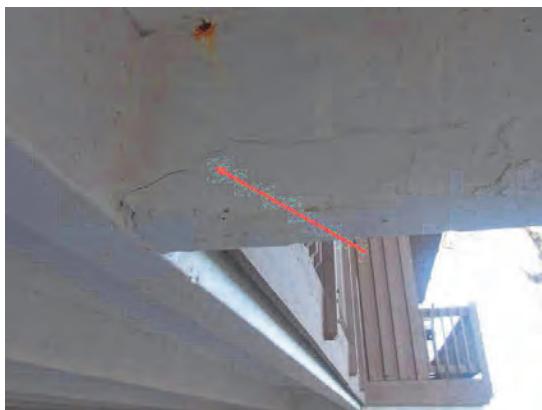
54 Rear Garage Beam Cracks

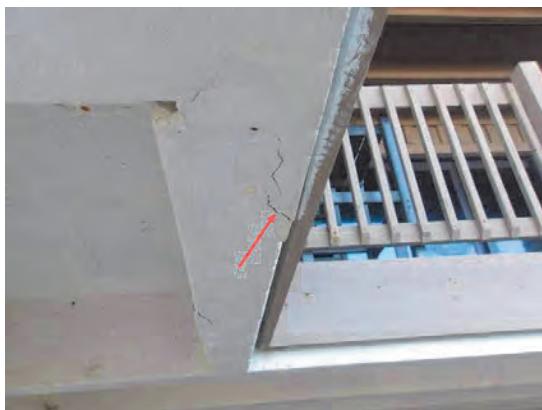
55 Rear Garage Beam Cracks

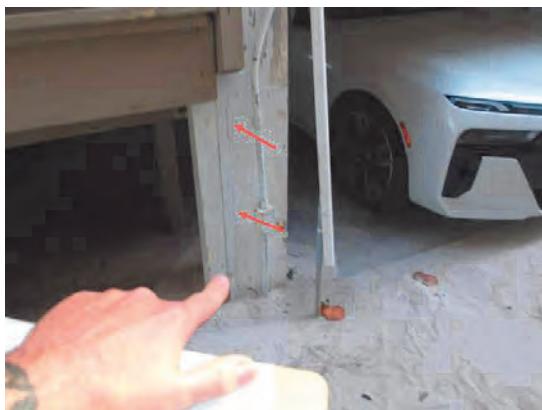
56 Left Side Garage Pier Cracks

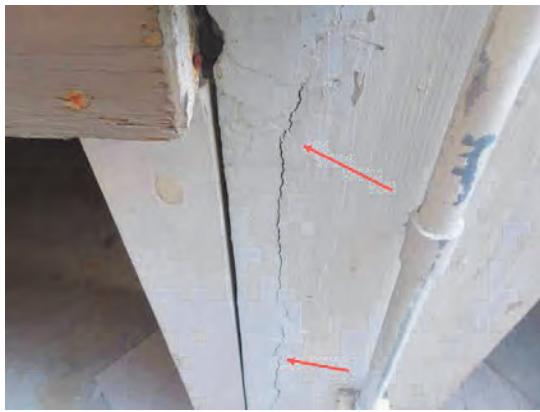
57 Left Side Garage Pier Cracks

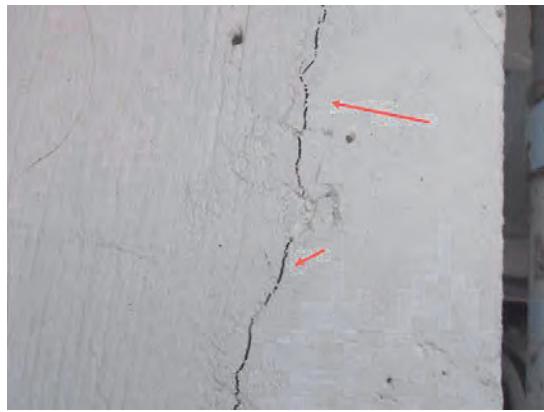
58 Left Side Garage Pier Cracks

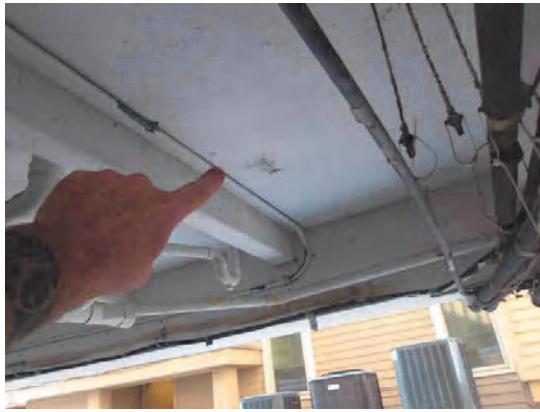
59 Left Side Garage Exposed Re-Bar

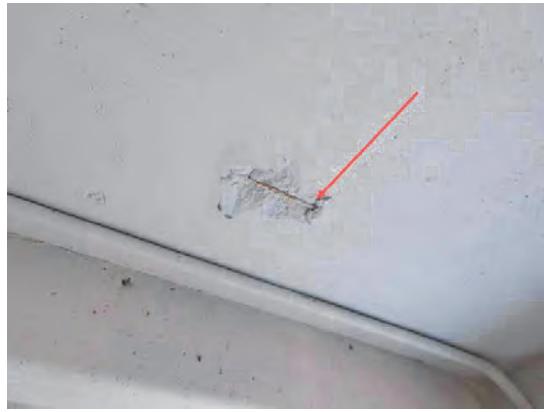
60 Left Side Garage Exposed Re-Bar

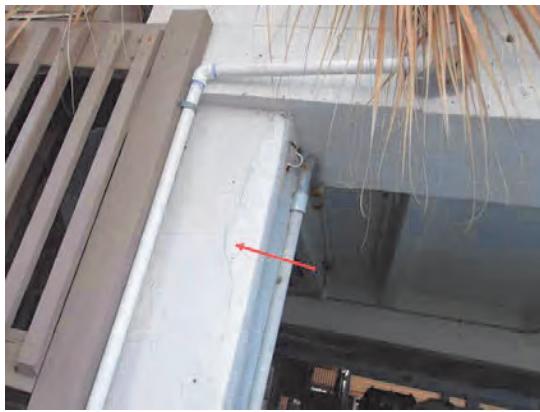
61 Right Side Garage Pier Cracks

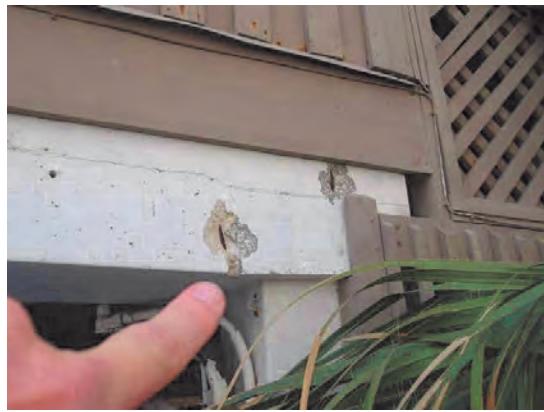
62 Right Front Garage Exposed Re-Bar

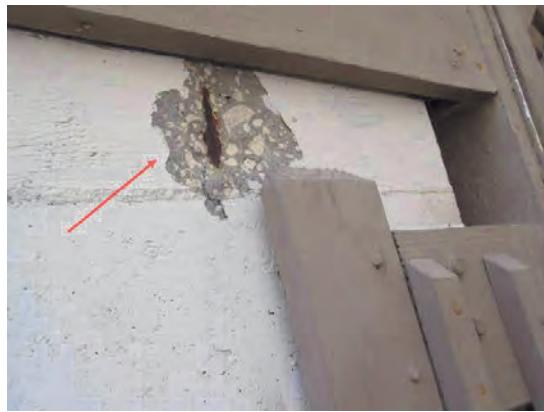
64 Right Front Garage Exposed Re-Bar

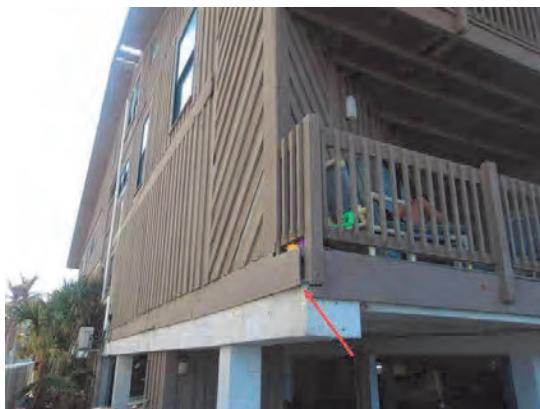
Right rear concrete support beam under the balcony of unit 4 had excessive cracking, bulging and deflection. See Photos #65 - 68

67 Right Rear Beam Cracking, Bulging and Rusting

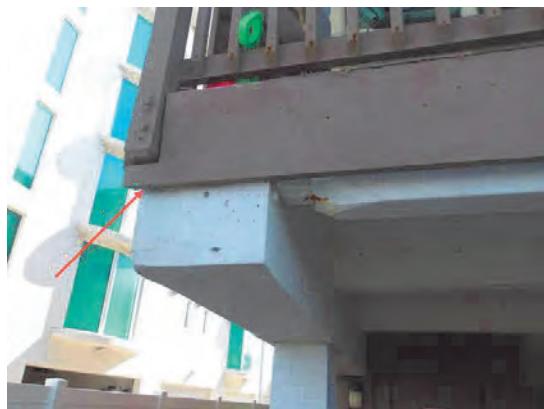
68 Right Rear Beam Cracking, Bulging and Rusting

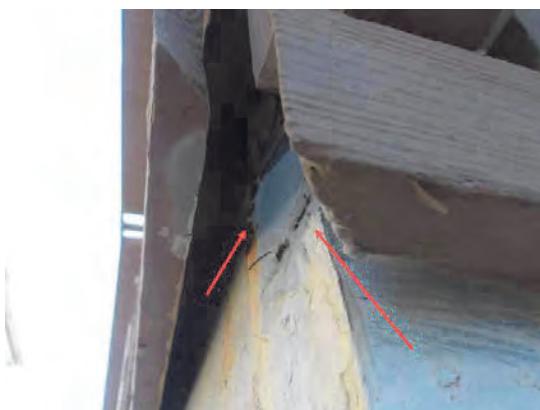
69 Right Rear Beam Cracking, Bulging and Rusting

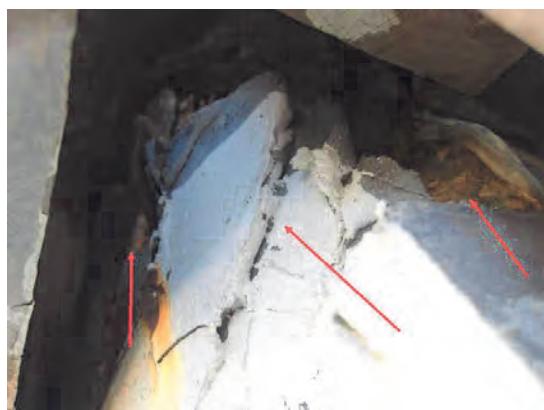
70 Right Rear Beam Cracking, Bulging and Rusting

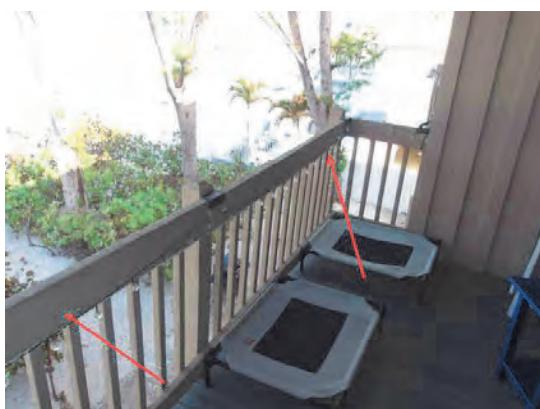
71 Loose Handrail Unit 6

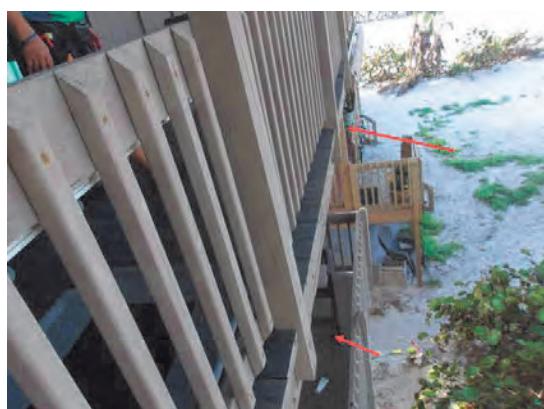
72 Loose Handrail Unit 6

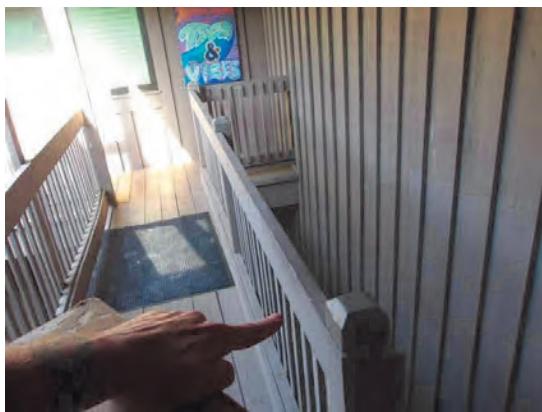
73 Loose Handrail Unit 8

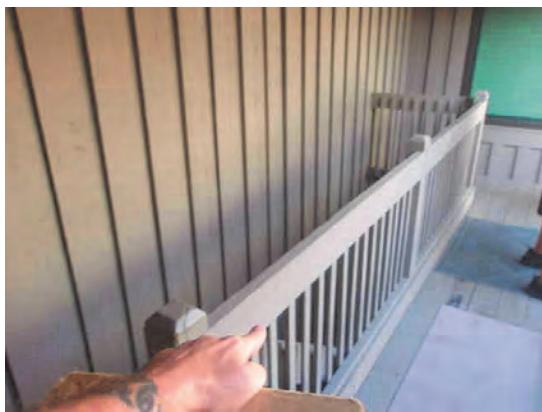
74 Loose Handrail Unit 5

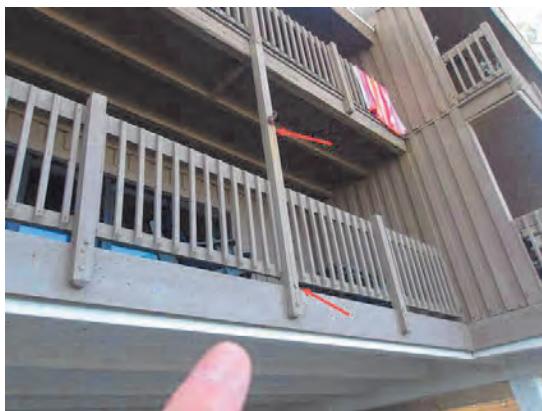
75 Loose and Cracked Handrail Unit 3

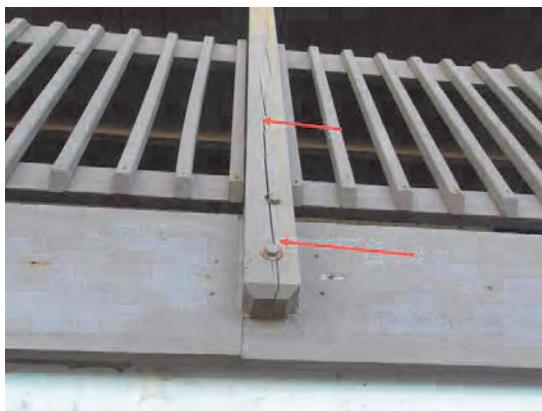
76 Loose and Cracked Handrail Unit 3

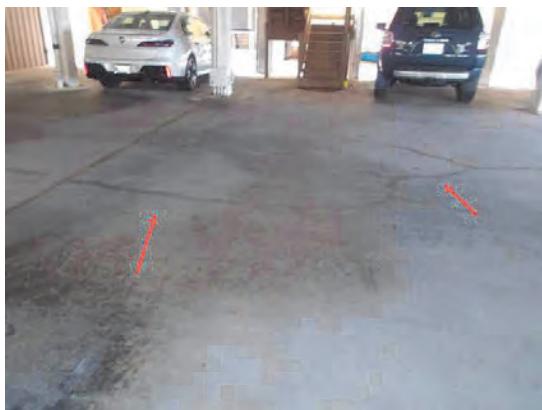
77 Garage Slab Cracks

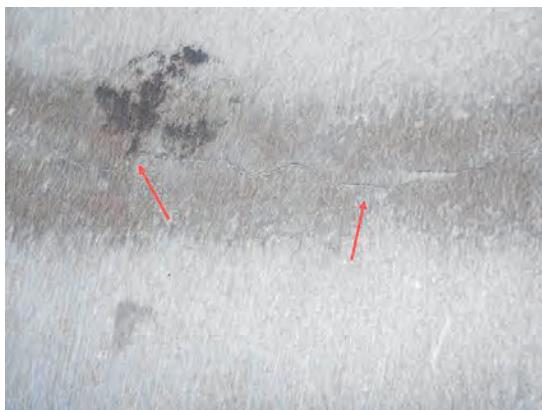
78 Garage Slab Cracks

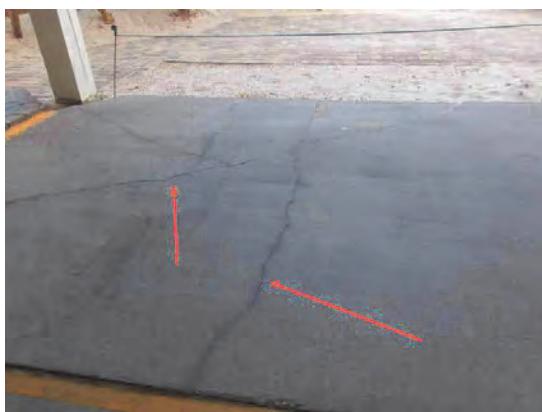
79 Garage Slab Cracks

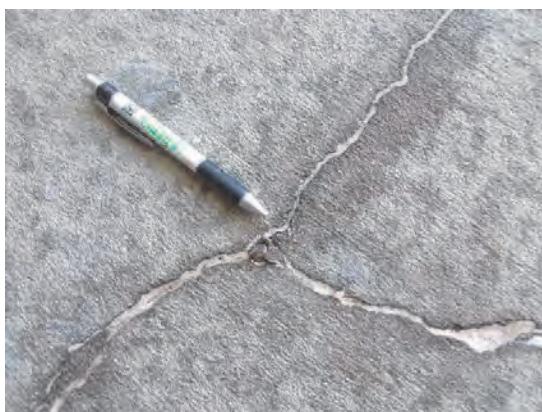
80 Garage Slab Cracks

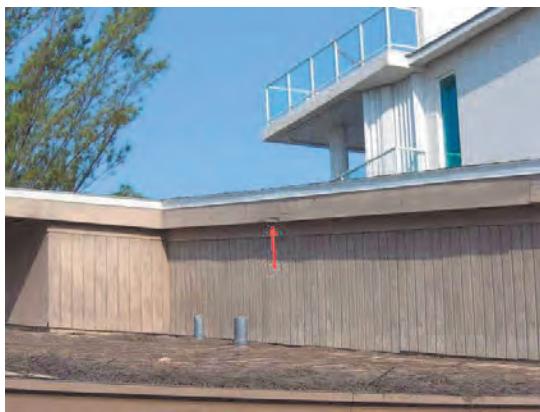
81 Right Rear Facia Deterioration

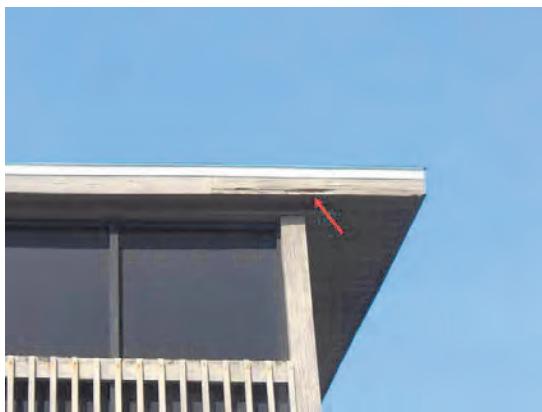
82 Right Front Facia Deterioration

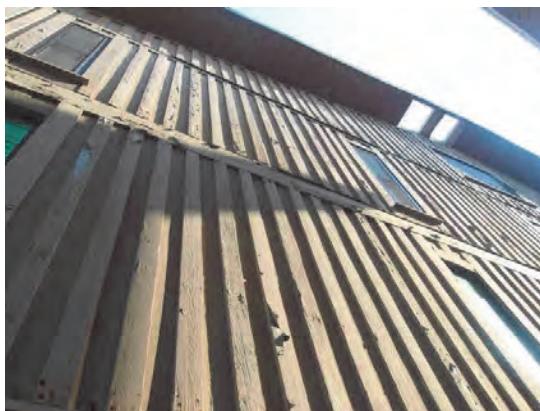
Deterioration and buckling of the wood siding throughout exterior. See Photos #83 - 99

83 Wood Siding Peeling and Buckling

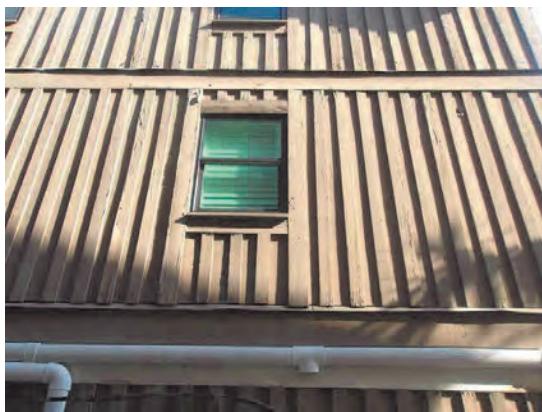
86 Wood Siding Peeling and Buckling

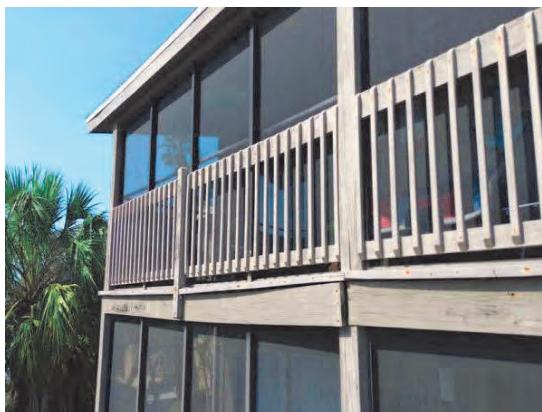
88 Wood Trim Peeling and Buckling

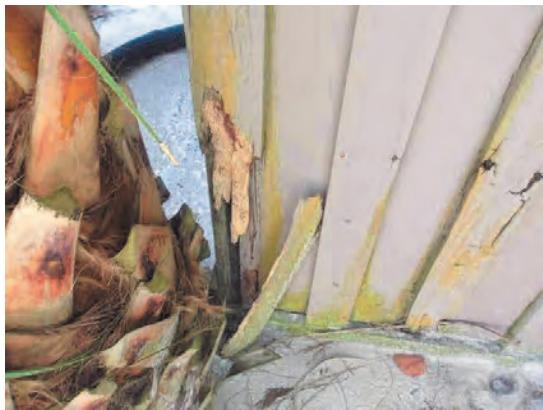
**93** Wood Siding Deterioration

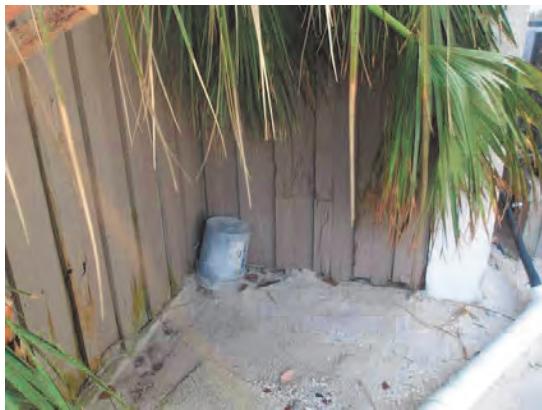
**94** Wood Siding Deterioration

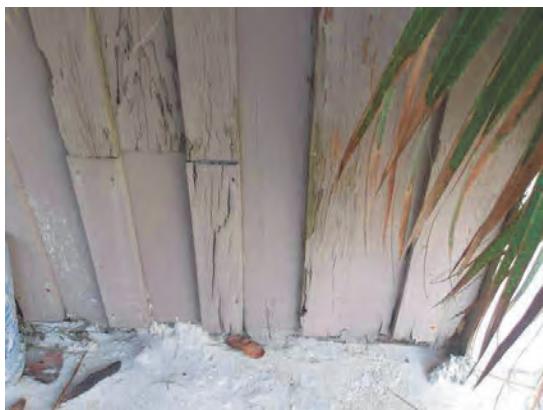
**95** Wood Siding Deterioration

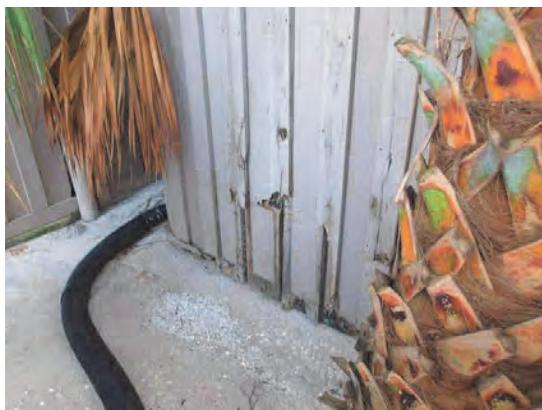
**96** Wood Siding Deterioration

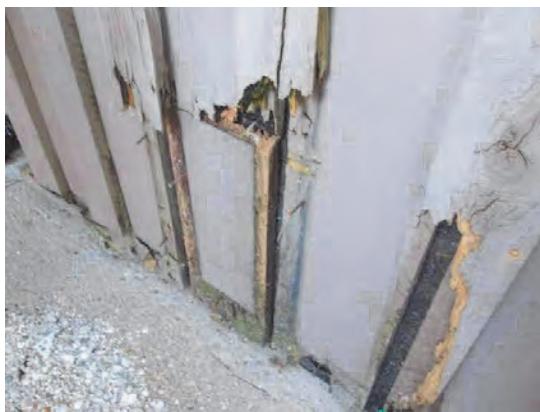
**97** Wood Siding Deterioration

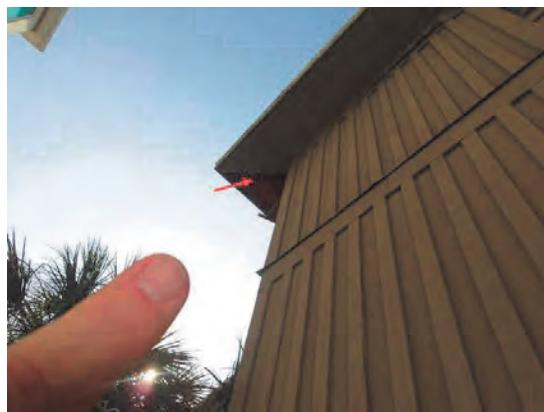
**98** Right Front Soffit Damage

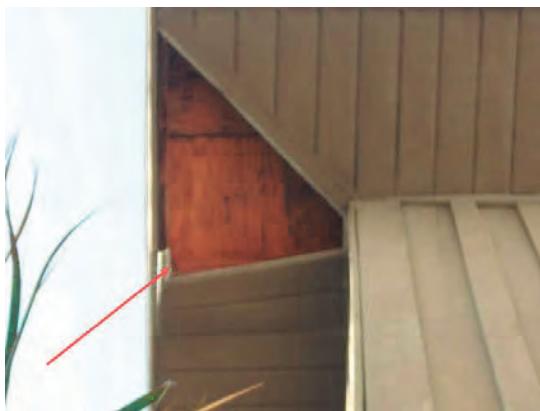
**99** Right Front Soffit Damage

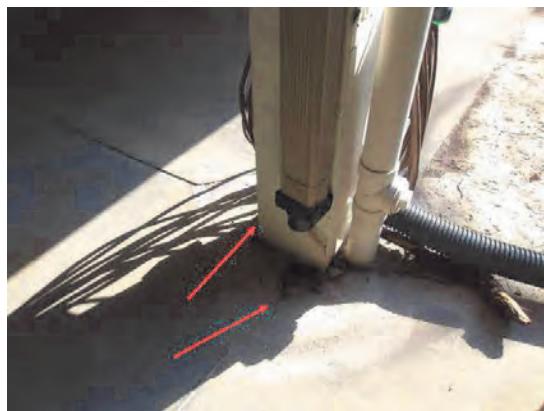
Left side gutter downspout discharged at the base of the foundation pier. See Photos #100 - 102

**100** Left Front Gutter Downspout Discharge at Pier Footing

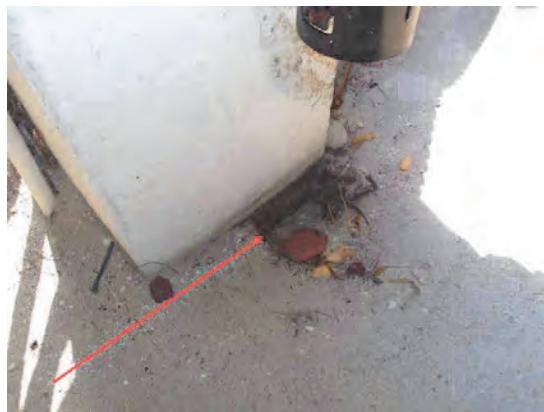
**102** Left Front Gutter Downspout Discharge at Pier Footing

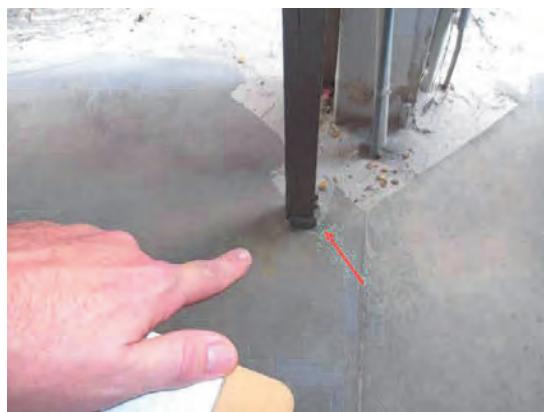
**104** Right Front Stairs 4x4 Posts Not Secured to Slab

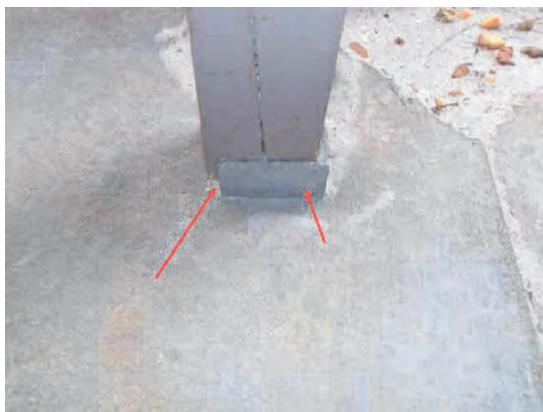
Loose railings at least 3 locations. See photos #103, 105 - 112

105 Right Front Stairs 4x4 Posts Not Secured to Slab

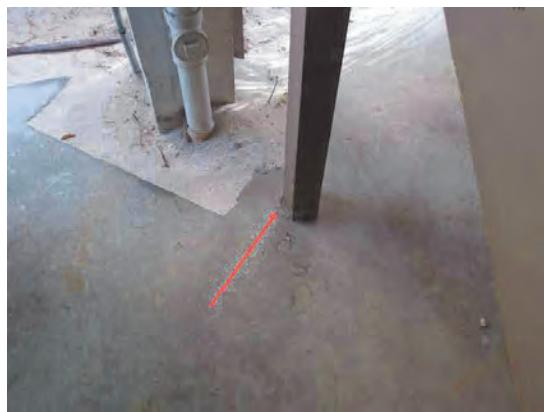
106 Right Front Stairs 4x4 Posts Not Secured to Slab
