## RESIDENTIAL REPORT

Plover Place Condominium Association, Inc.  
19824 Gulf Blvd  
Indian Shores, Florida 33785

Phase One Milestone Inspection

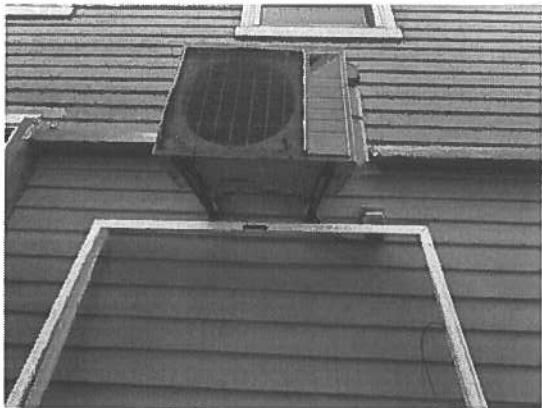
1.p.1

1. Moderate rust/corrosion to bracket supporting mini-split unit on the left side of the building.
2. Minor cracking in concrete slab of the garage parking area.
3. Minor corrosion to electrical meters.
4. Minor deterioration to ceiling above pool equipment.
