PHASE I MILESTONE INSPECTION

Piper's Bay Condominium

19843 Gulf Blvd

UES Project No: 0811.2300027.0000 – Task 16

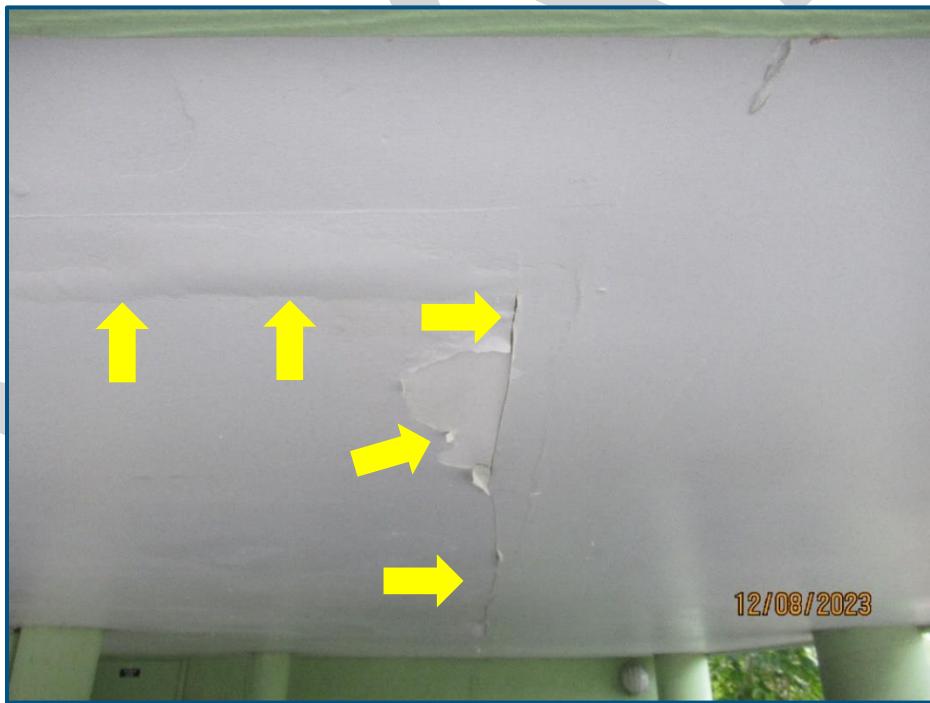
- Surface imperfections such as peeling of paint finishes, bubbling of paint finishes, holes, delamination, and scuff marks were observed on the exterior drywall ceiling in multiple locations. See **Appendix B** Photographs No. 8, 10, and 18.

Photograph No. 8: View of a crack, paint peeling, and bubbling paint in the drywall ceiling of the parking area.

- UES recommends removing, replacing, and repainting surface imperfections.
- UES recommends hiring a licensed structural engineer to provide repair drawings for the moisture damaged wood beam.
- UES recommends replacing all corroded hangers observed on both staircases. See referenced Photographs No. 15, 16, and 20 in **Appendix B**.

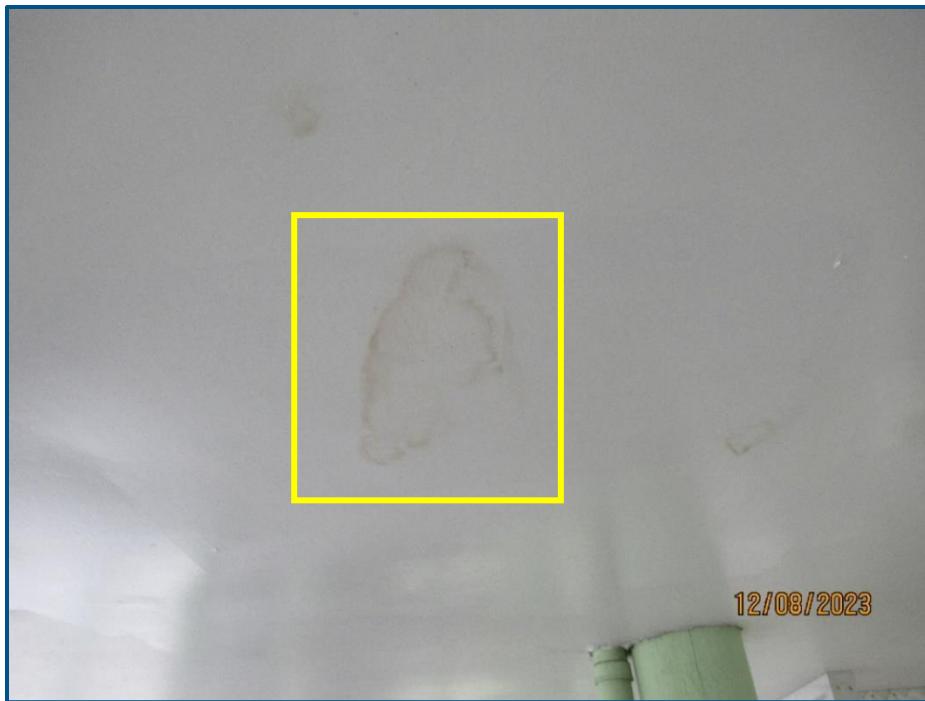
- A moisture stain was observed in the drywall ceiling finishes located in the parking area. See **Appendix B** Photograph No. 9
- Separation in the wall and ceiling finishes was observed in the storage room for Unit 2 on the ground level. See **Appendix B** Photograph No. 12.

Photograph No. 9: View of a moisture stain in the drywall ceiling located in the parking area.

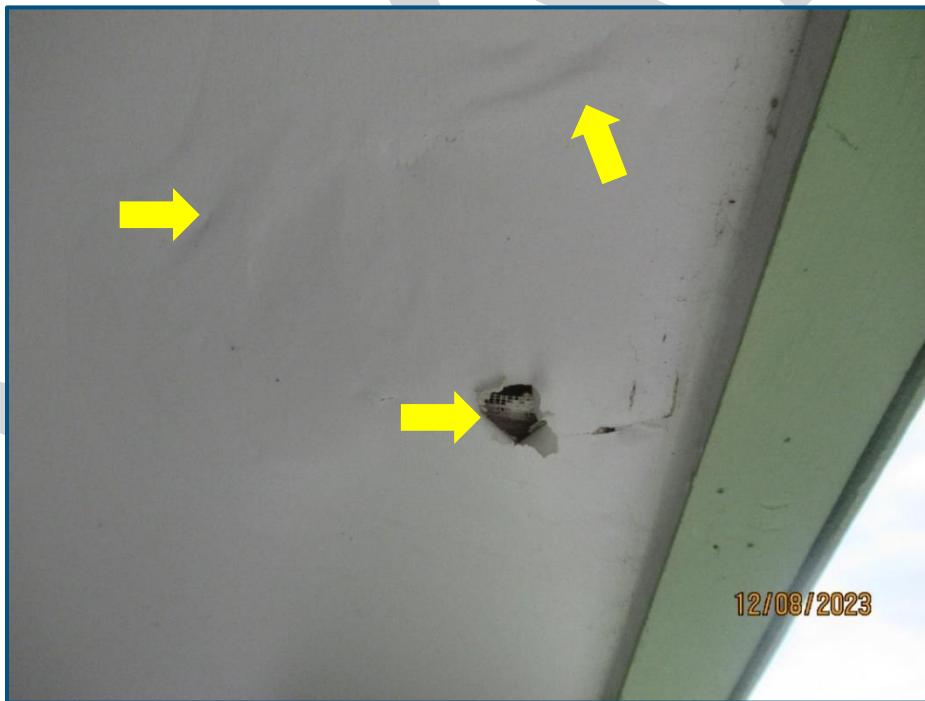
Photograph No. 10: View of bubbling paint and damage to the drywall ceiling located in the parking area.

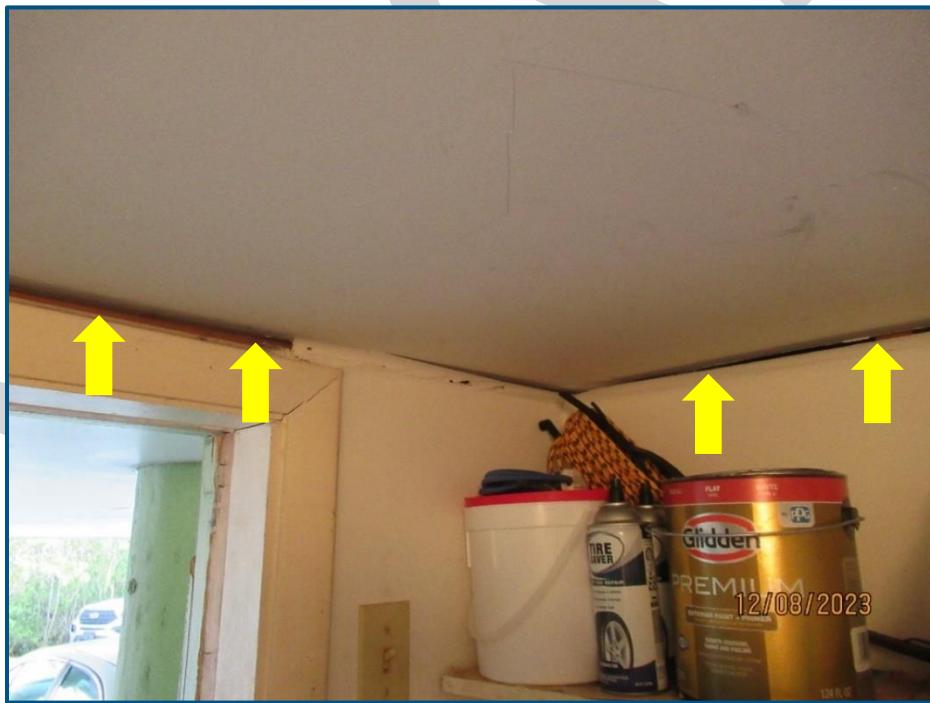
Photograph No. 12: Separation between the wall and ceiling in the Unit 2 storage room.

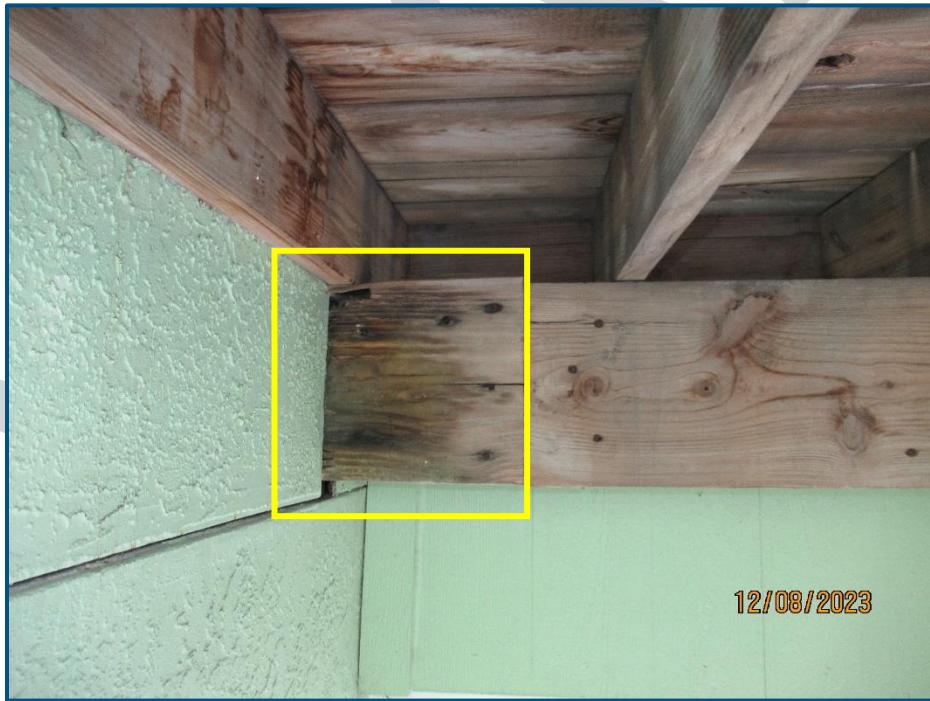
- Moisture damage was observed in the wood beam beneath the 2nd floor on the east elevation. See **Appendix B** Photographs No. 14 and 25.
- Corrosion on metal hangers was observed in multiple locations. See **Appendix B** Photographs No. 15, 16, and 20.

observed to a wood beam located on the east elevation. See **Appendix B** Photographs 14 and 25.

Photograph No. 14: View of moisture damage to a wood beam located below the 2nd floor stair landing on the east elevation.

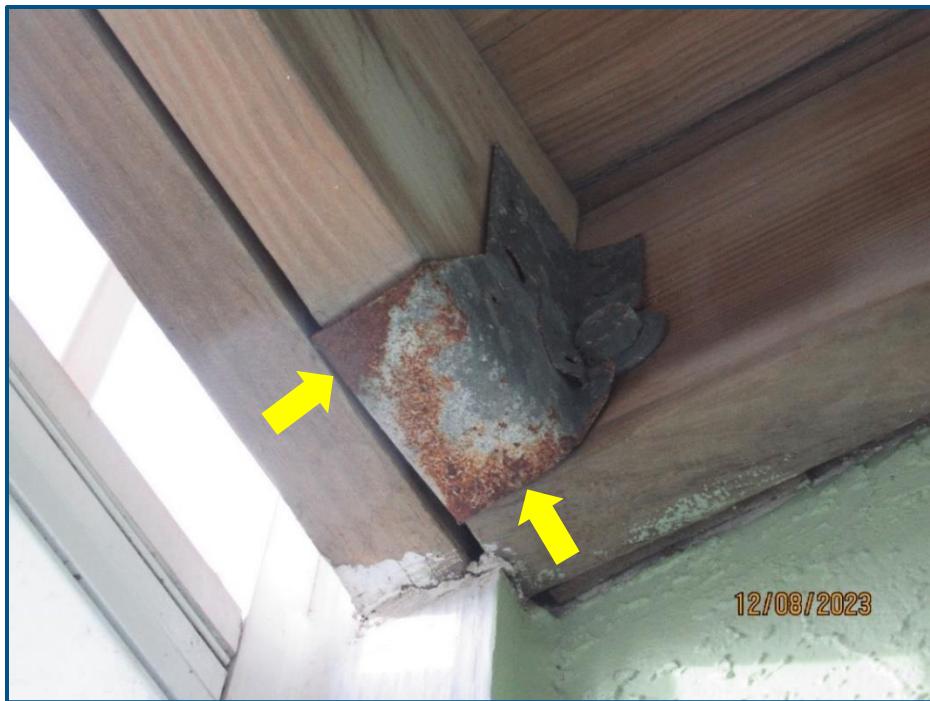
Photograph No. 15: View of corroded metal hanger beneath the stair landing on the east elevation.

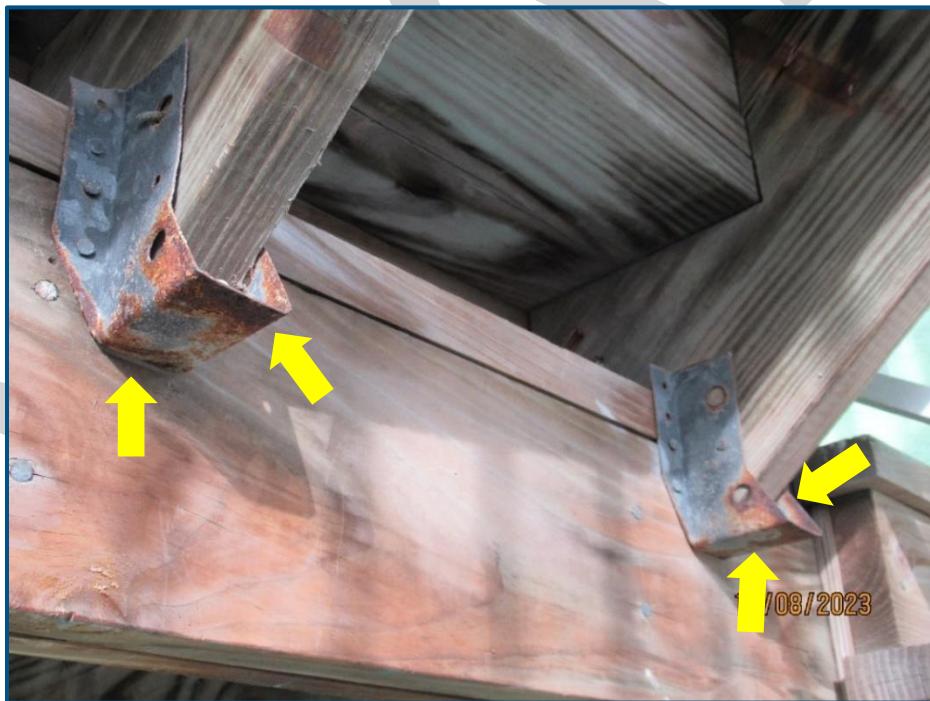
Photograph No. 16: View of corroded metal hangers under the stairs on the east elevation.

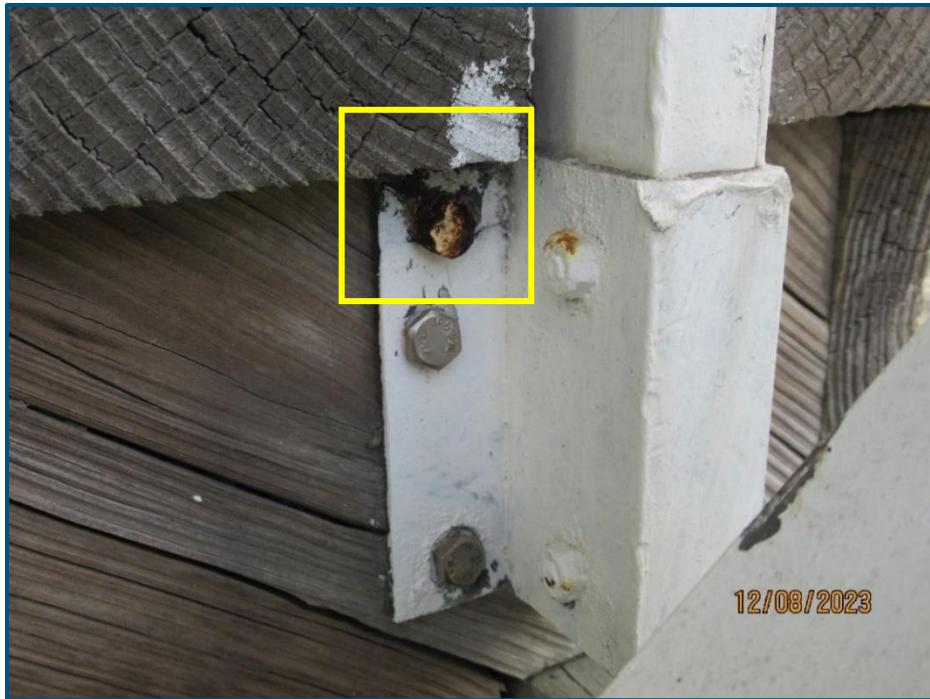
- Corrosion was observed on the steel fasteners in multiple locations. See **Appendix B** Photographs No. 17, 21, 26, and 27.
- Termite damage in the wood beam under the 2nd floor stair landing was observed on the west elevation. See **Appendix B** Photograph No. 19.

Photograph No. 17: View of a corroded fastener in a metal handrail located on the 2nd floor stairs on the east elevation.

- UES recommends removing corrosion from all steel fasteners using a wire brush then applying an approved protective coating. Depending on the extent of corrosion, new fasteners may be required.
- UES recommends hiring a termite exterminator to get rid of any potential termites. UES also recommends applying an approved structural wood filler at the observed termite damage area.

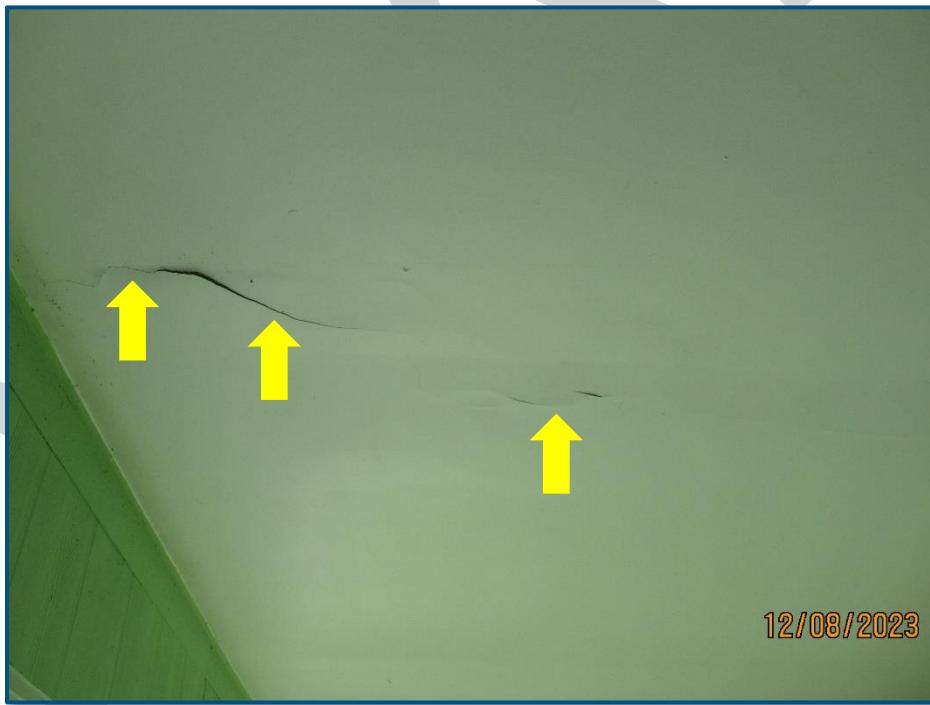
Photograph No. 18: View of paint delamination in the ceiling of the 3rd floor landing area on the east elevation.

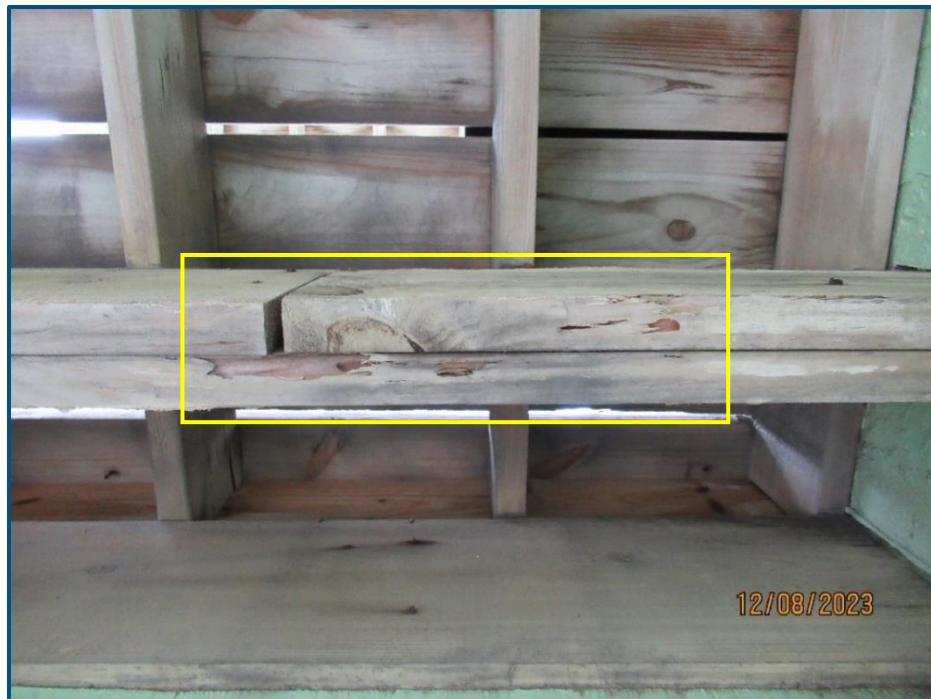
Photograph No. 19: View of termite damage in a wood beam located under the 2nd floor landing on the west elevation.

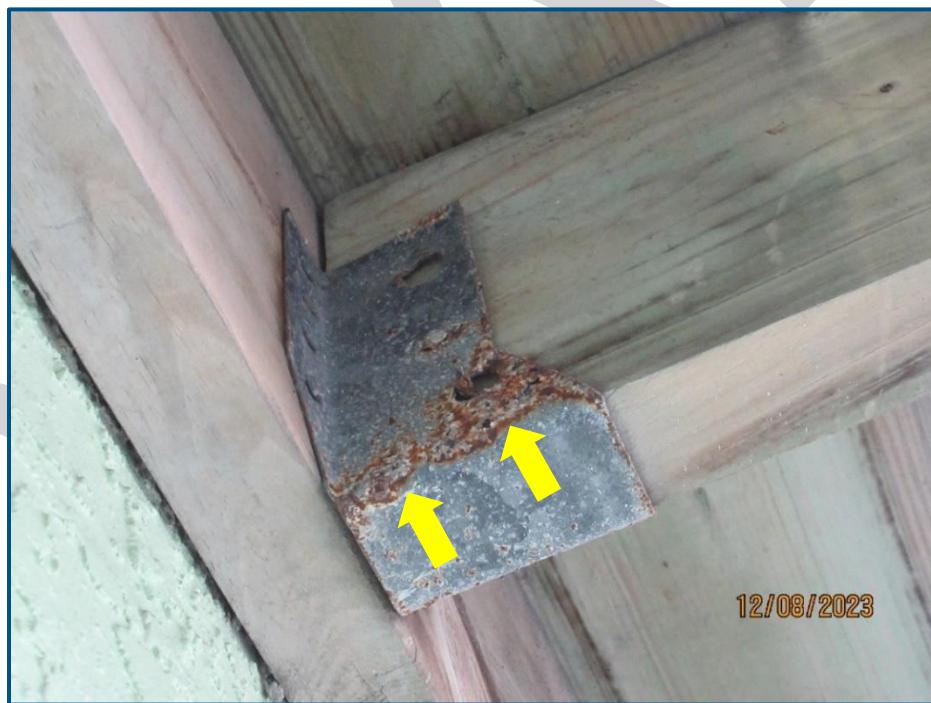
Photograph No. 20: View of a corroded metal hanger beneath the 3rd floor landing on the west elevation.

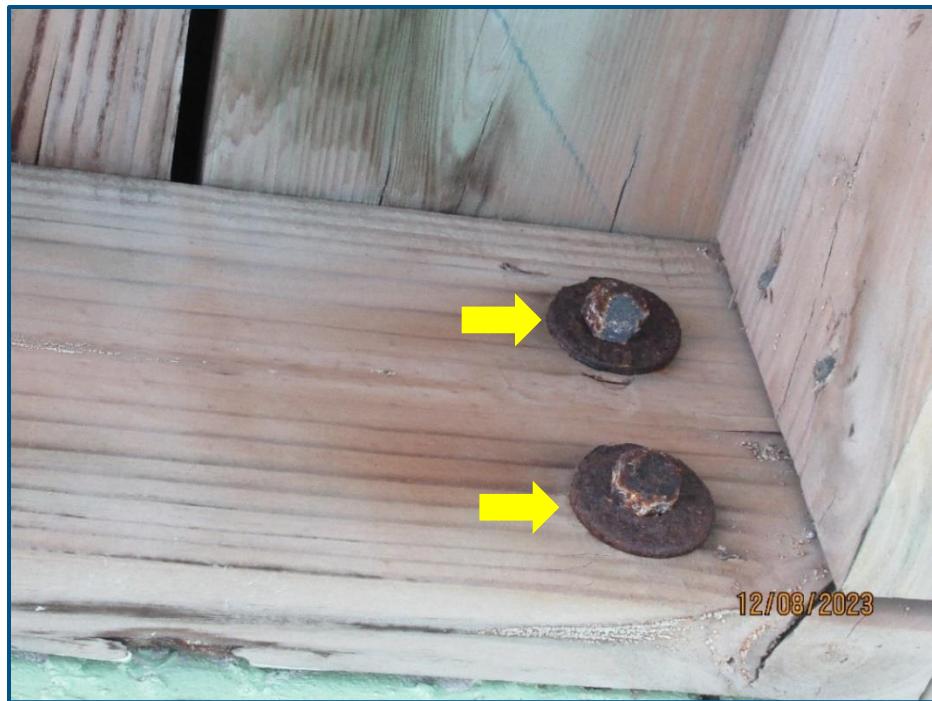
Photograph No. 21: View of corroded bolts under the 3rd floor landing on the west elevation.

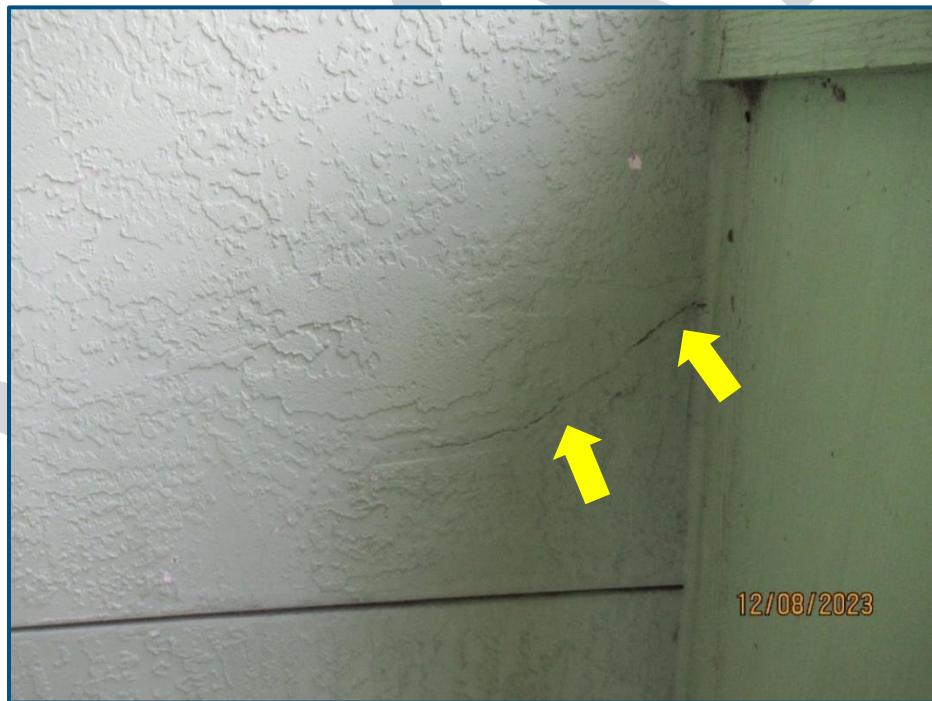
- A crack in the exterior stucco finish on the west elevation was observed. See **Appendix B** Photograph No. 22.

Photograph No. 22: View of a crack in the exterior stucco finish on the west elevation.

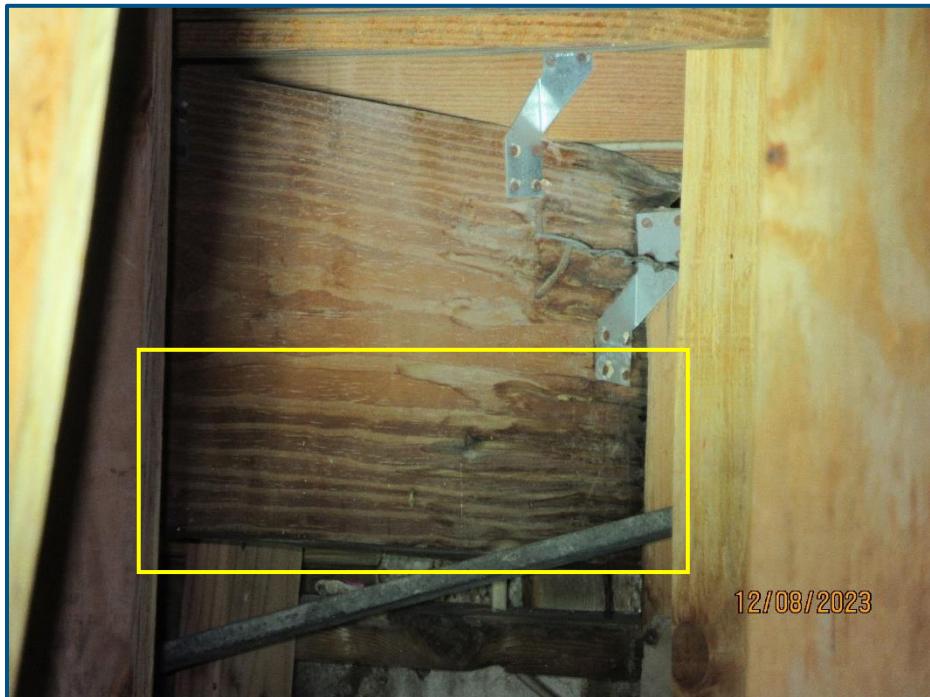
Photograph No. 25: View of moisture damage in the wood beam located in the attic space above the parking area (same beam shown in Photograph No. 14).

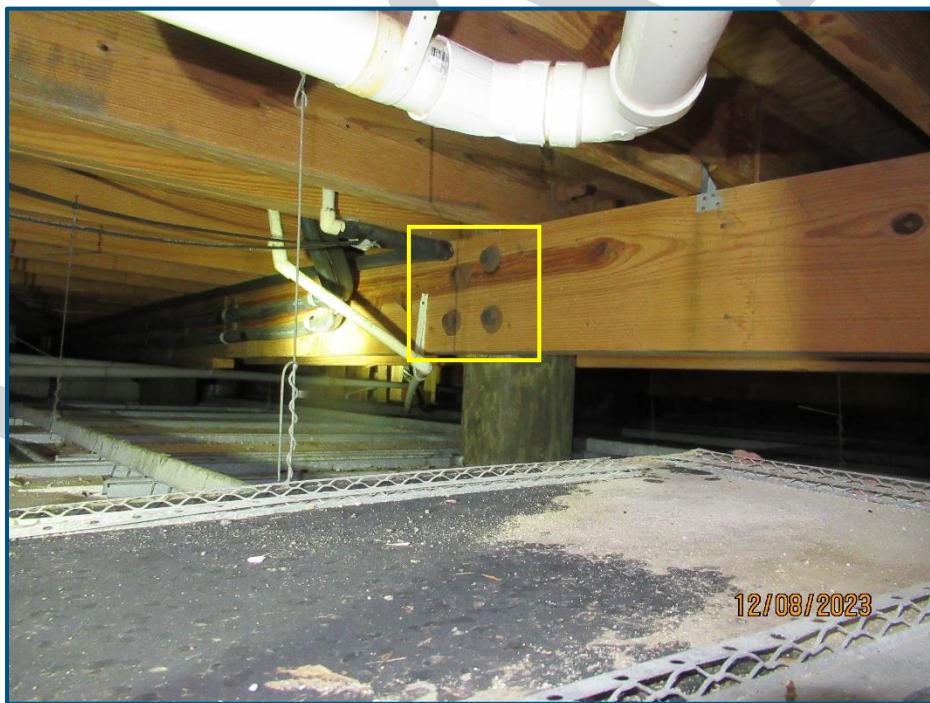
Photograph No. 26: View of corroded bolts in the wood beam to column connection located in the attic space above the parking area.
