# PHASE I MILESTONE INSPECTION

## Piper's Nest Condominiums

**19920 Gulf Boulevard**

**Report Date** January 3, 2025

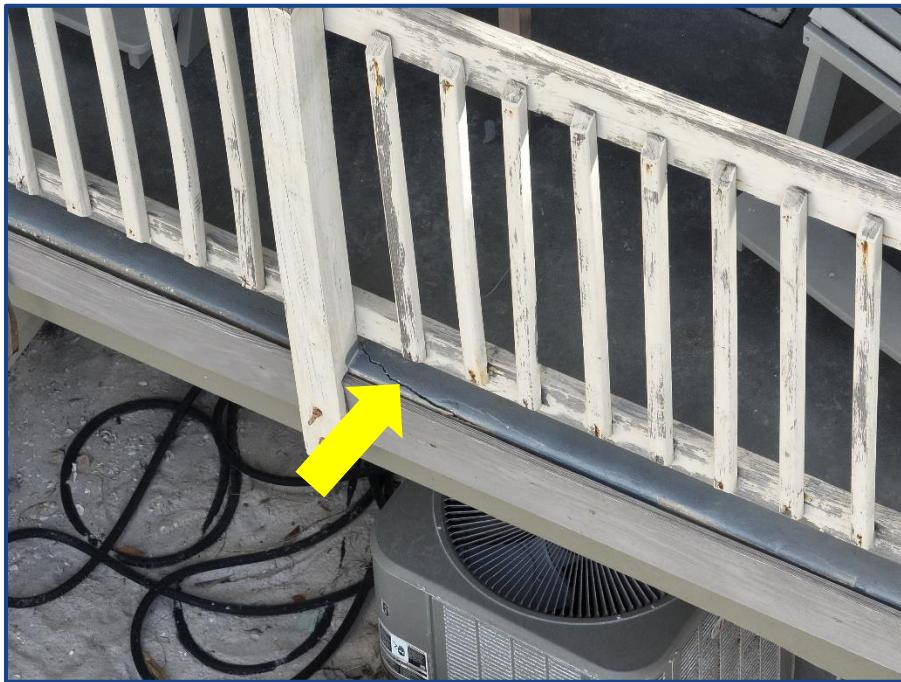
- A crack was observed in the southern balcony slab in Unit 1. See **Appendix B** Photograph No. 6. This deficiency is a preventative maintenance item.

Photograph No. 6: Crack in the southern concrete balcony slab in Unit 1.

- UES recommends sealing the cracks in the concrete slabs, beams, and columns using an approved crack sealant product.
- UES recommends removing and replacing the deteriorated wood balcony deck boards on the balcony in Unit 7 and stair stringer in the southeast stairway.

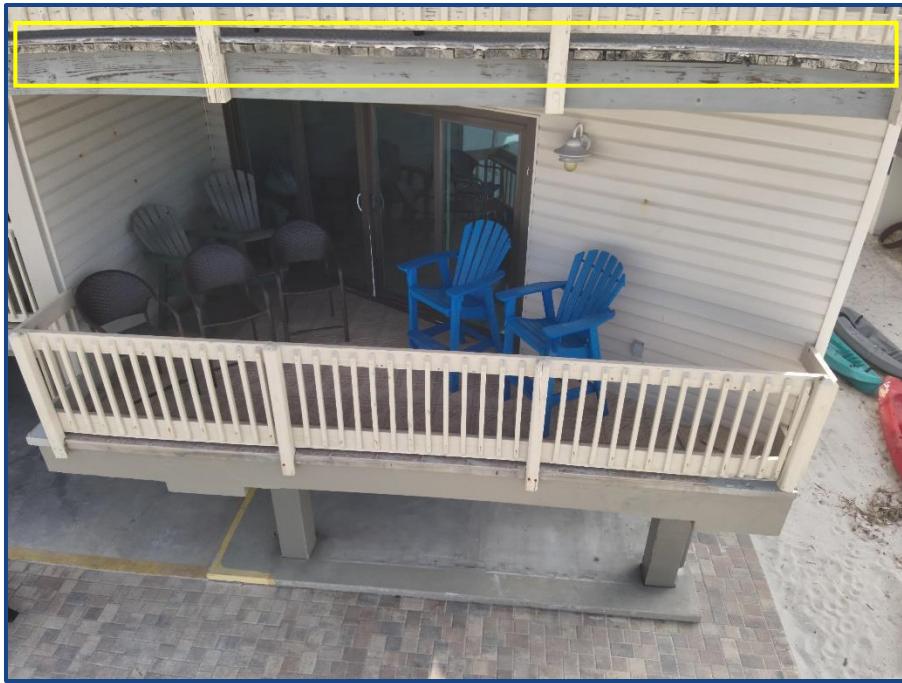
- Deteriorated wood balcony deck boards were observed on the balcony in Unit 7. See **Appendix B** Photograph No. 7. This deficiency is a preventative maintenance item.

Photograph No. 7: Deteriorated wood balcony deck boards on the balcony in Unit 7.

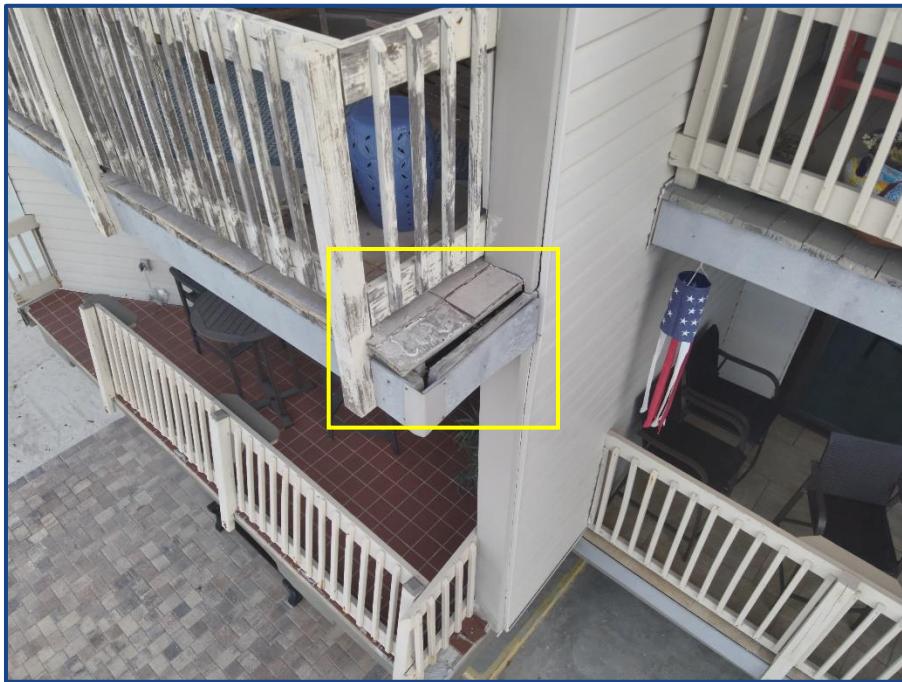
- A detached wood joist was observed on the balcony in Unit 9. See **Appendix B** Photograph No. 8. This deficiency is an immediate action item.
- The guardrails located on the balcony in Unit 4 were observed with missing and detached sections. See **Appendix B** Photograph No. 9. This deficiency is an immediate action item.

Photograph No. 8: Detached wood joist on the balcony in Unit 9.

- UES recommends securing the detached wood joist on the balcony in Unit 9.
- UES recommends replacing the damaged/missing guardrails on the balcony in Unit 4.

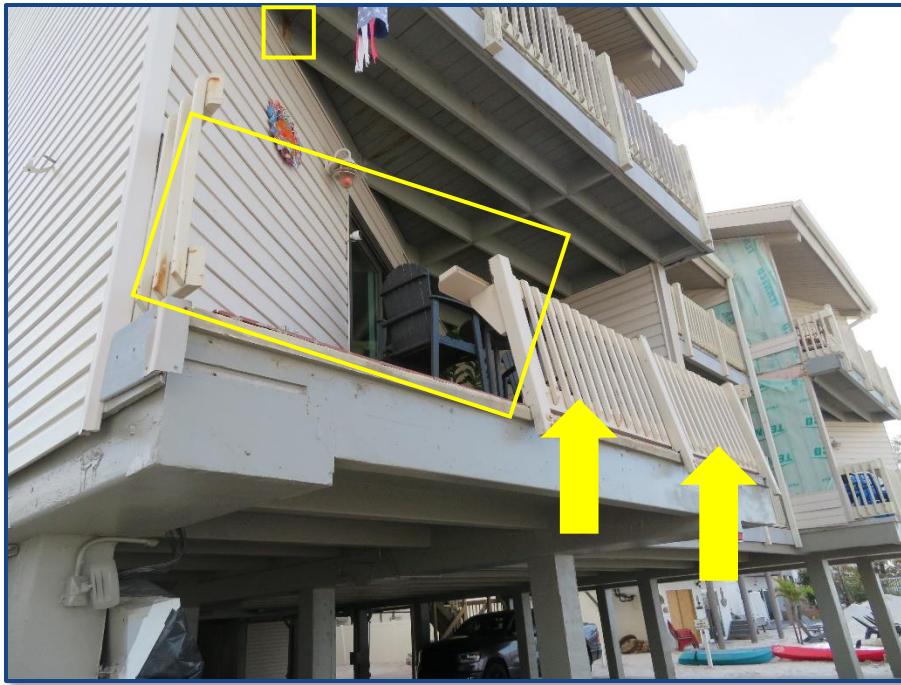
Photograph No. 9: Missing and detached guardrails on the balcony in Unit 4 and missing metal bracket on the balcony framing in Unit 9.

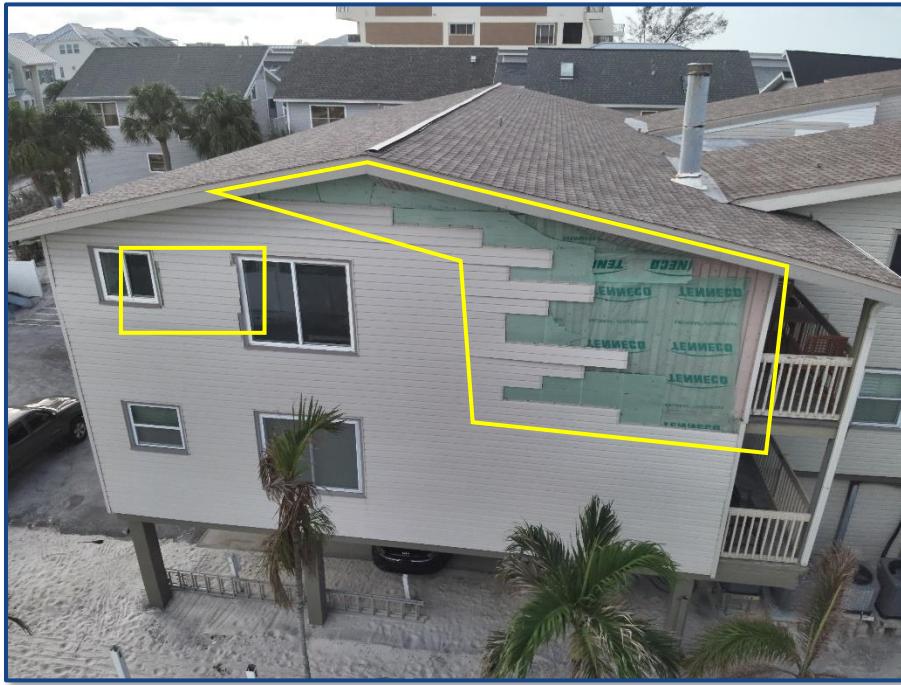
- The exterior vinyl siding panels were observed to be missing and displaced in multiple locations with exposed and damaged housewrap. See **Appendix B** Photographs No. 10 and 24. This deficiency is an immediate action item.

Photograph No. 10: Missing and displaced siding panels, damaged housewrap, and detached soffit panel on the north elevation of the building.

- UES recommends replacing all missing siding and damaged housewrap on the exterior walls.
- UES recommends removal of all loose and broken concrete from the spalled concrete areas using a hammer and a chisel and removing all corrosion from the exposed steel reinforcement using a wire brush and then applying an approved concrete patch product.

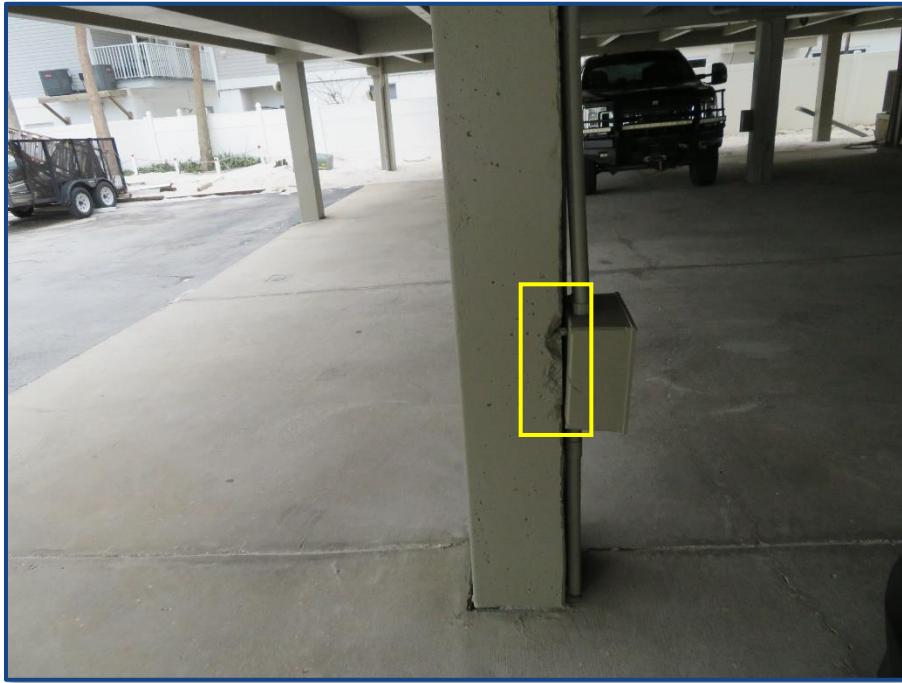
- Spalled concrete and cracks were observed in multiple columns, beams, and slabs in the parking garage. See **Appendix B** Photographs No. 12 through 14, 17 through 20, 22, and 23. This deficiency is an immediate action item.

Photograph No. 12: Spalled concrete column in the northeast corner of the parking garage.

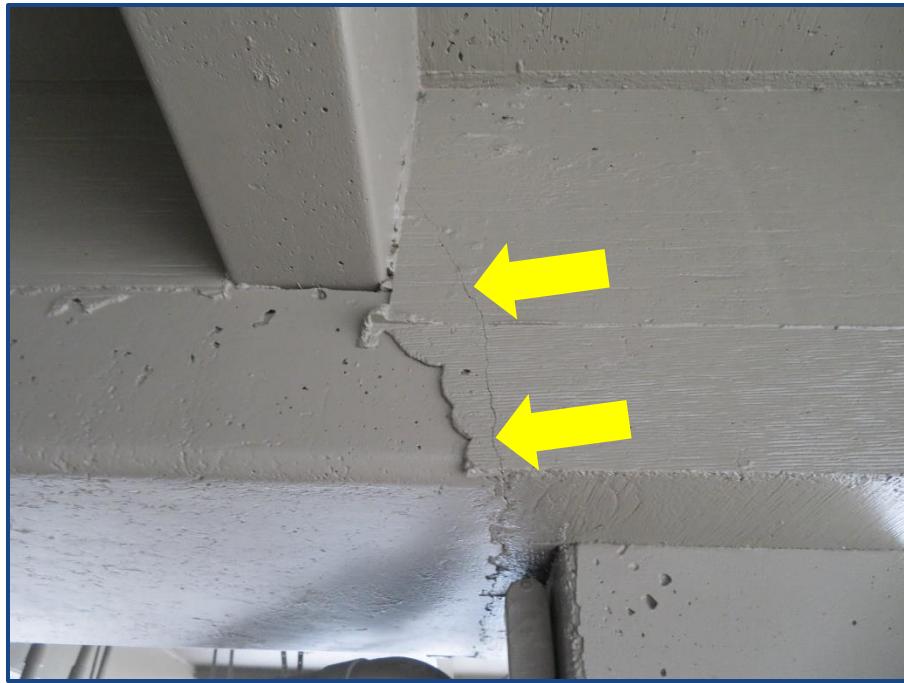
Photograph No. 13: Crack in a concrete beam in the northeast corner of the parking garage.

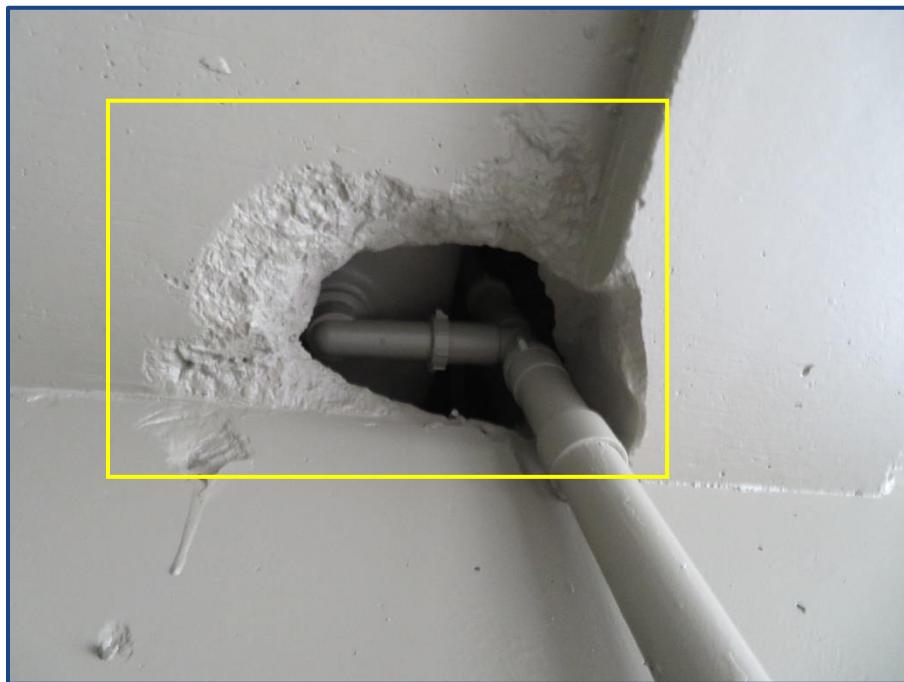
Photograph No. 14: Spalled concrete in the 2nd floor slab around a pipe penetration below Unit 1.

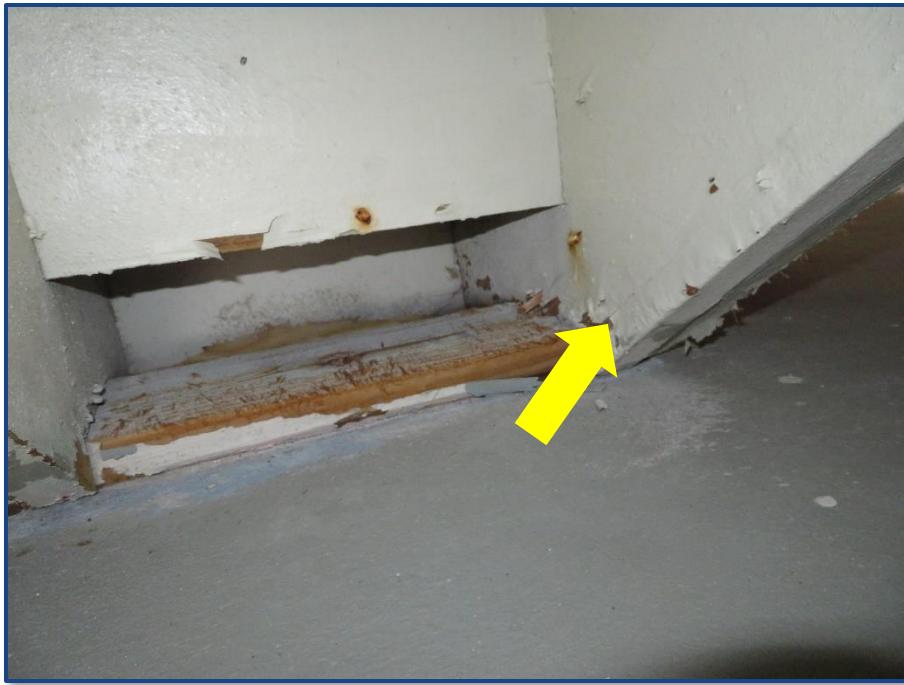
- A wood stair stringer located at the bottom of the southeastern stairway was observed to be decayed. See **Appendix B** Photograph No 15. This deficiency is a preventative maintenance item.

Photograph No. 15: Decayed wood stair stringer at the bottom of the southeastern stairway.

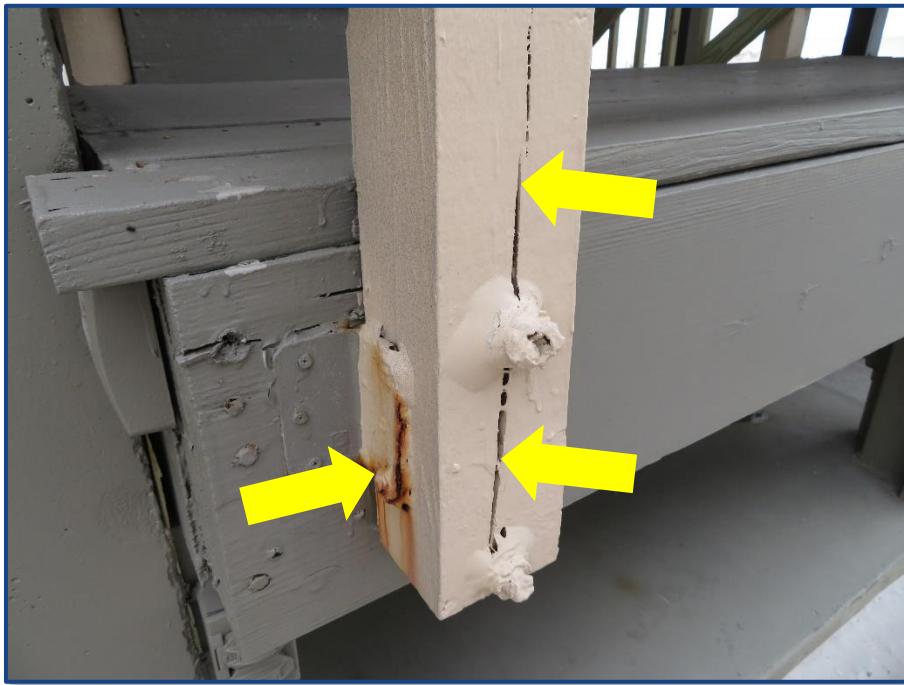
- Multiple wood guardrail posts were observed to be split located on the stairways, walkways, and balconies. See **Appendix B** Photographs No. 16, 26, and 27. This deficiency is a preventative maintenance item.

- Corroded fasteners, brackets, and joist hangers were observed in multiple locations including the stairways, walkways, balconies, and the pergola at the roof level. See **Appendix B** Photographs No. 16, 21, 25 through 29, and 32. This deficiency is an immediate action item.

Photograph No. 16: Split wood guardrail post and corroded metal bracket in the northwest stairway at the 1st floor.

- UES recommends applying structural wood filler to wood guardrail posts that have split. Where necessary replacement of the posts is recommended.
- UES recommends removing and replacing all split guardrail posts and corroded fasteners located on the balconies, walkways, and stairways.

- UES recommends replacing all corroded metal brackets and joist hangers with new ones of the same type.
- UES recommends removing and replacing all torn shingles on the roof.

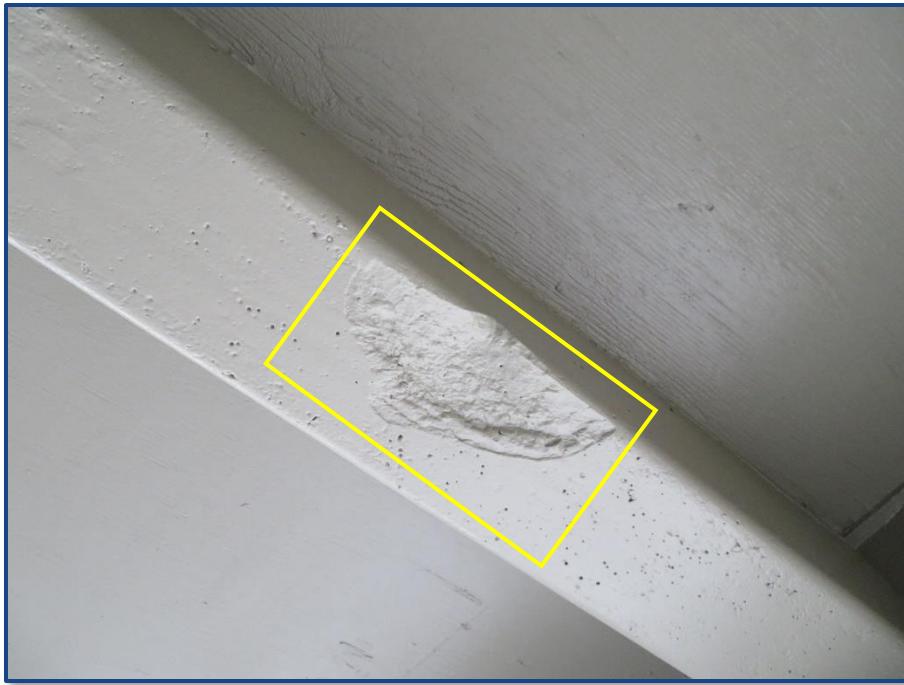
Photograph No. 17: Spalled concrete beam in the parking garage near the northwestern stairway.

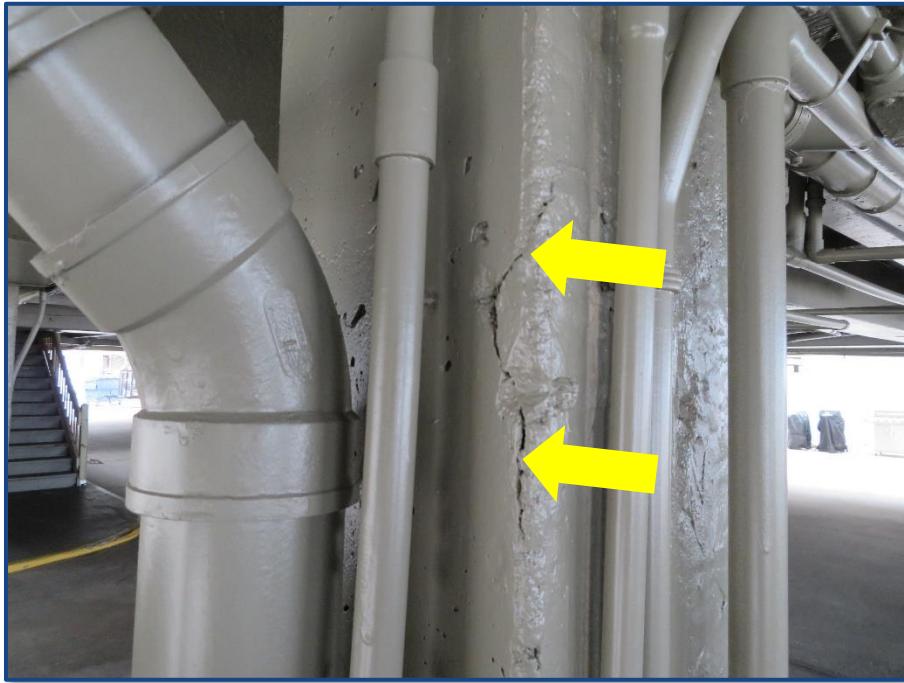
Photograph No. 18: Crack in a concrete column in the parking garage between the northern stairways.

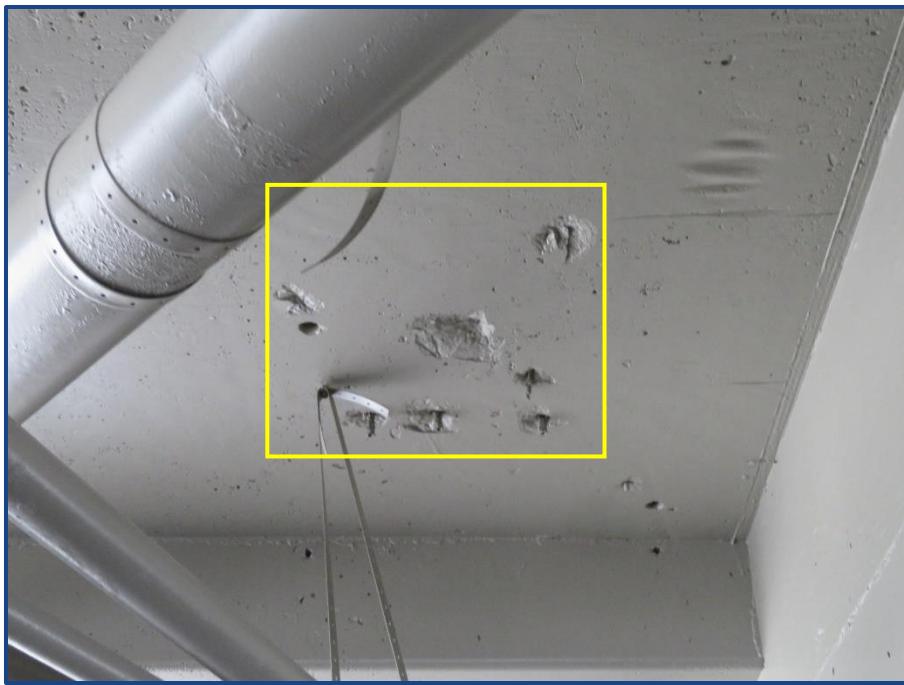
Photograph No. 19: Spalled concrete in the underside of the 2nd floor slab below Unit 4.

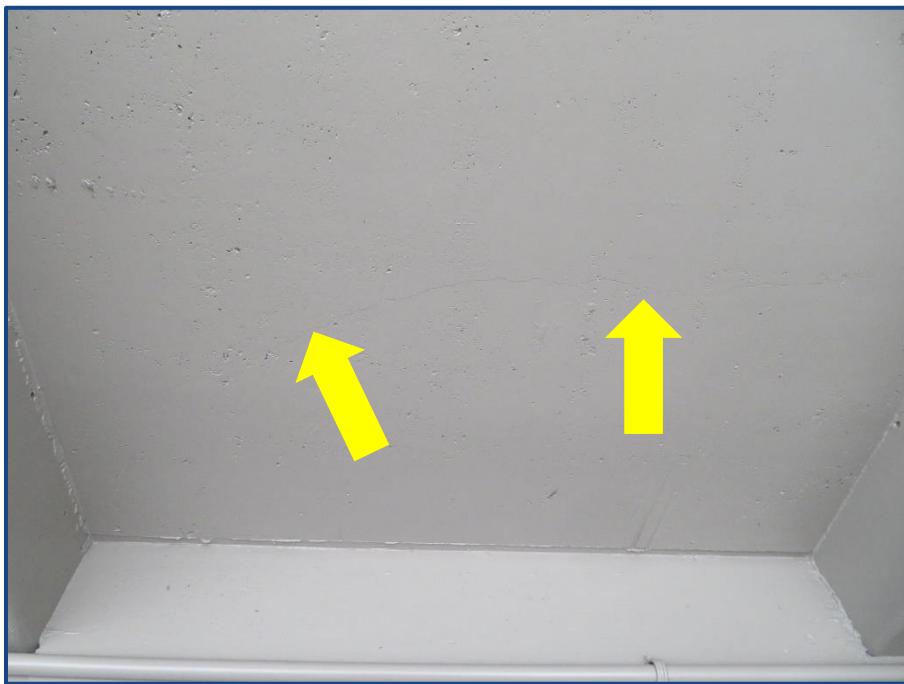
Photograph No. 20: Crack in the 2nd floor slab below Unit 2.

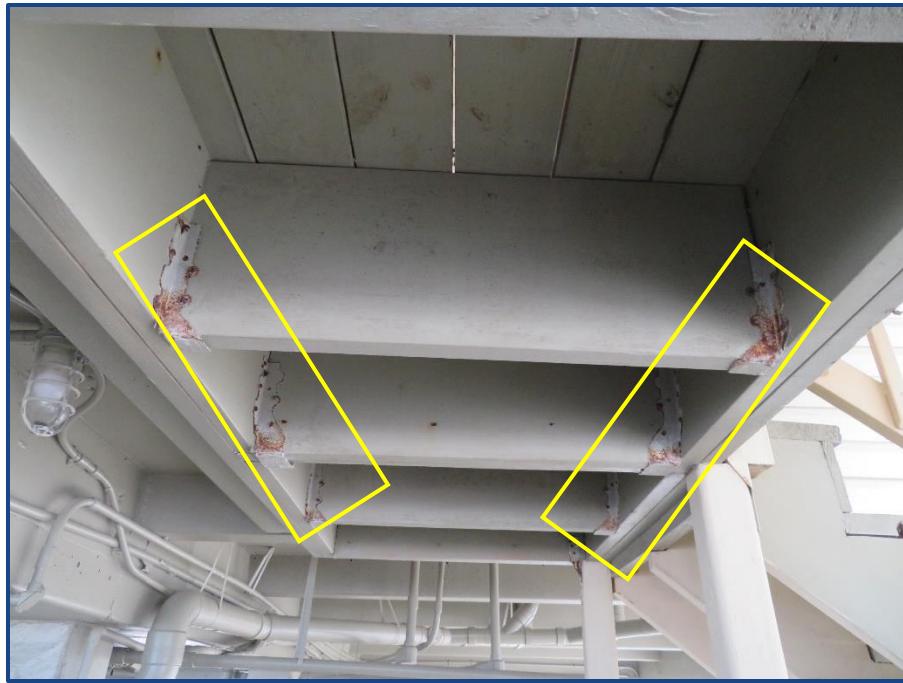
Photograph No. 21: Corroded joist hangers in the southwestern stairway on the 2nd floor.

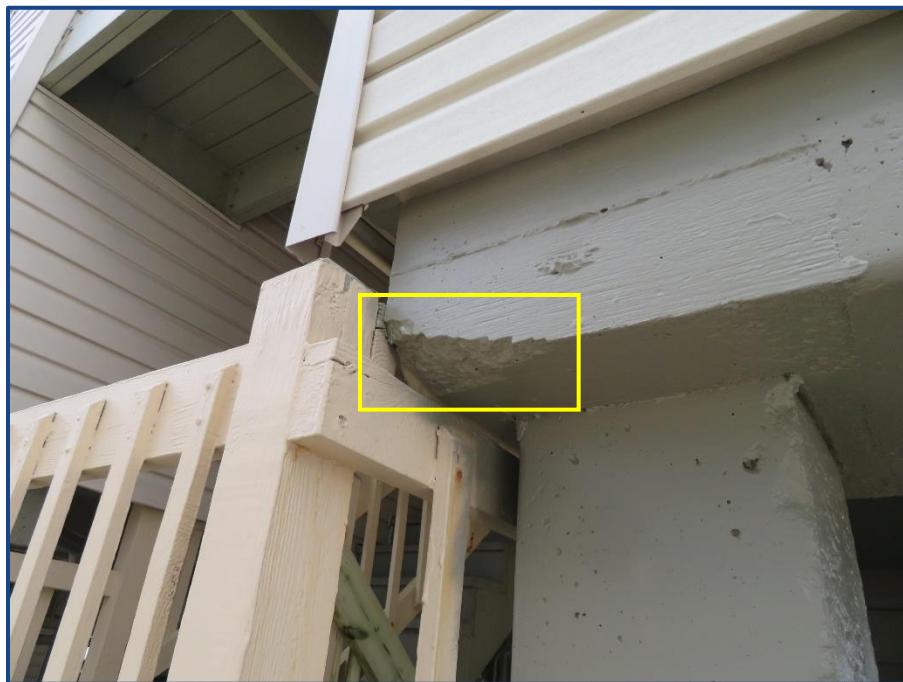
Photograph No. 22: Spalled concrete beam near the northwestern stairway.

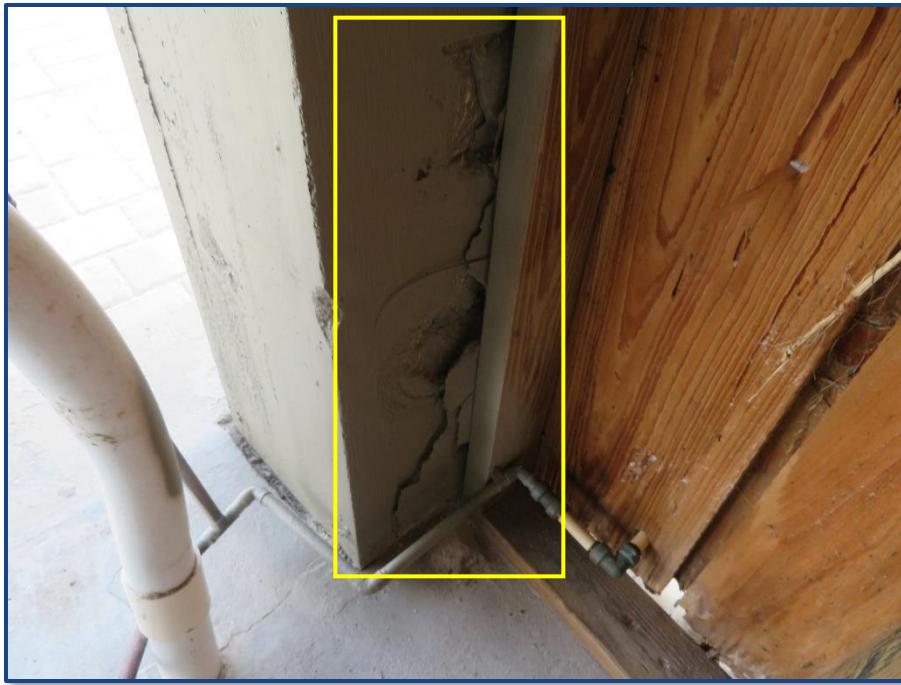
- Exposed corroded steel reinforcement was observed in the spalled concrete column in the northwest corner of the parking garage. See **Appendix B** Photograph No. 23. This deficiency is an immediate action item.

Photograph No. 23: Spalled concrete column with exposed corroded steel reinforcement at the northwest corner of the parking garage.

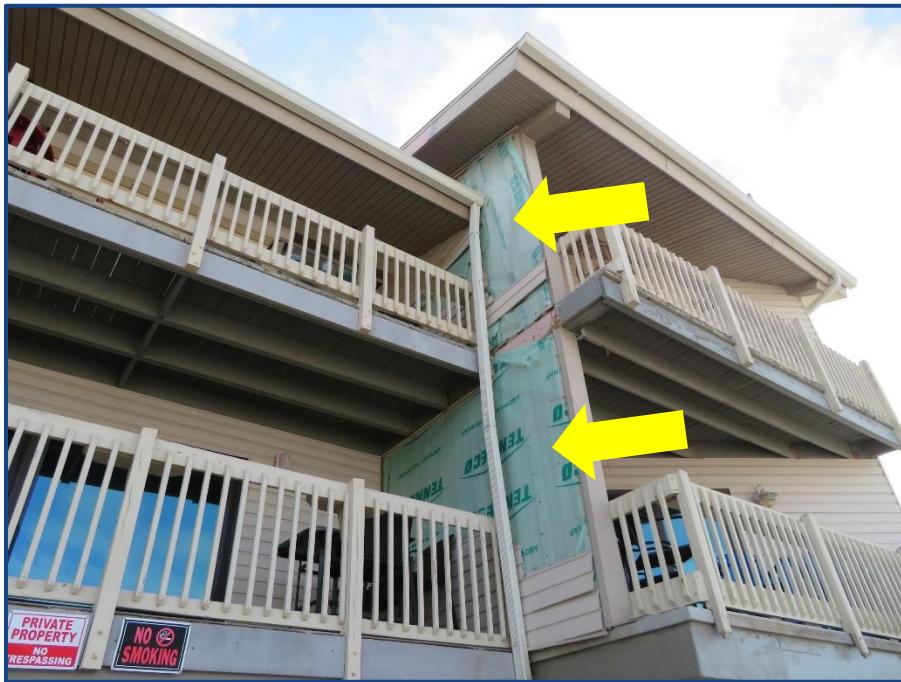
Photograph No. 24: Missing siding panels on the southern balcony partition wall at the west elevation of the building.

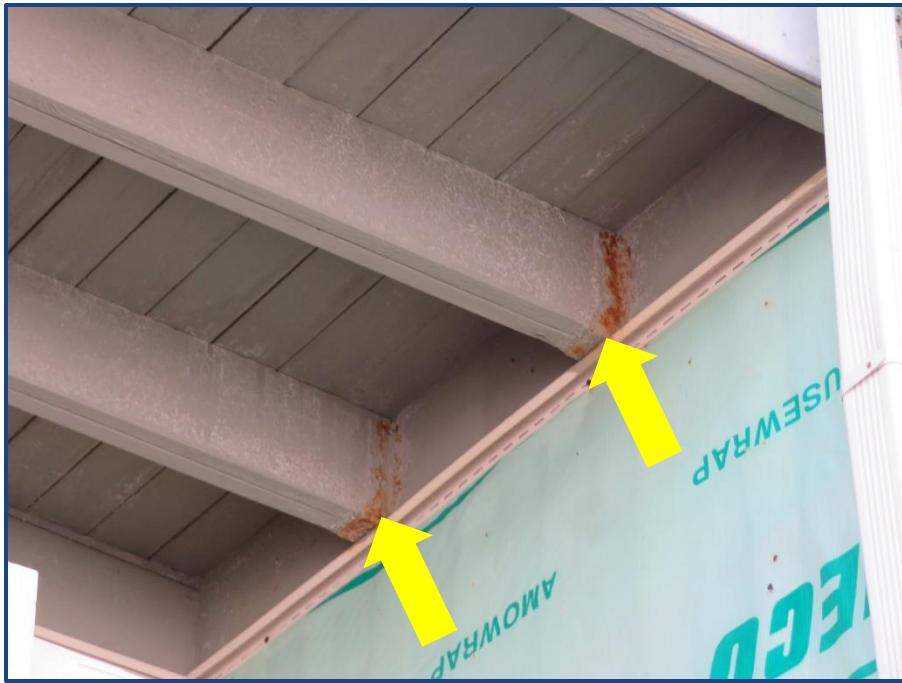
Photograph No. 25: Corroded joist hangers on the balcony in Unit 7.

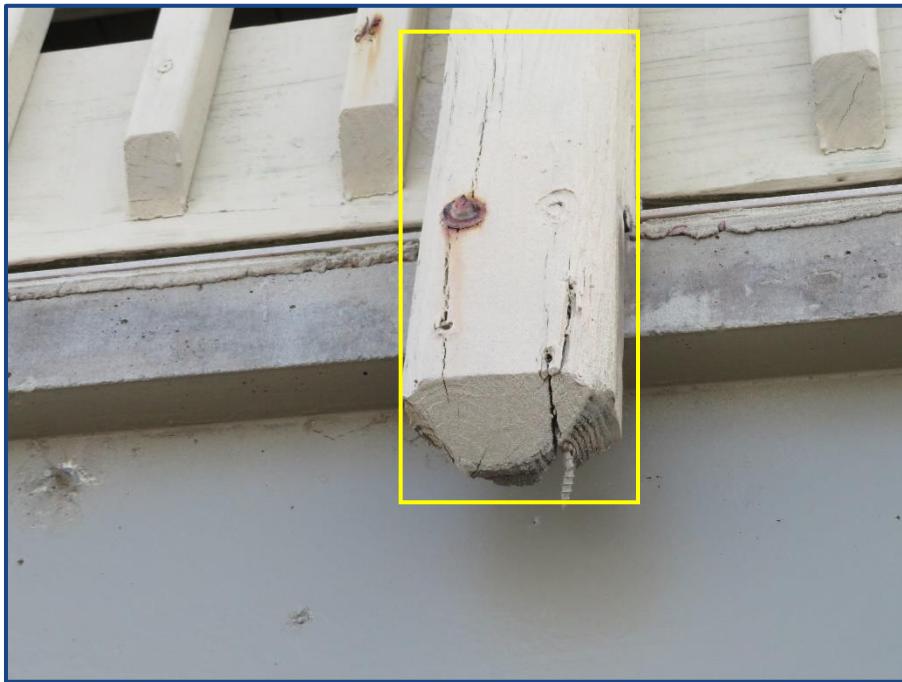
Photograph No. 26: Split guardrail post and missing and corroded guardrail post fasteners on the balcony in Unit 2.

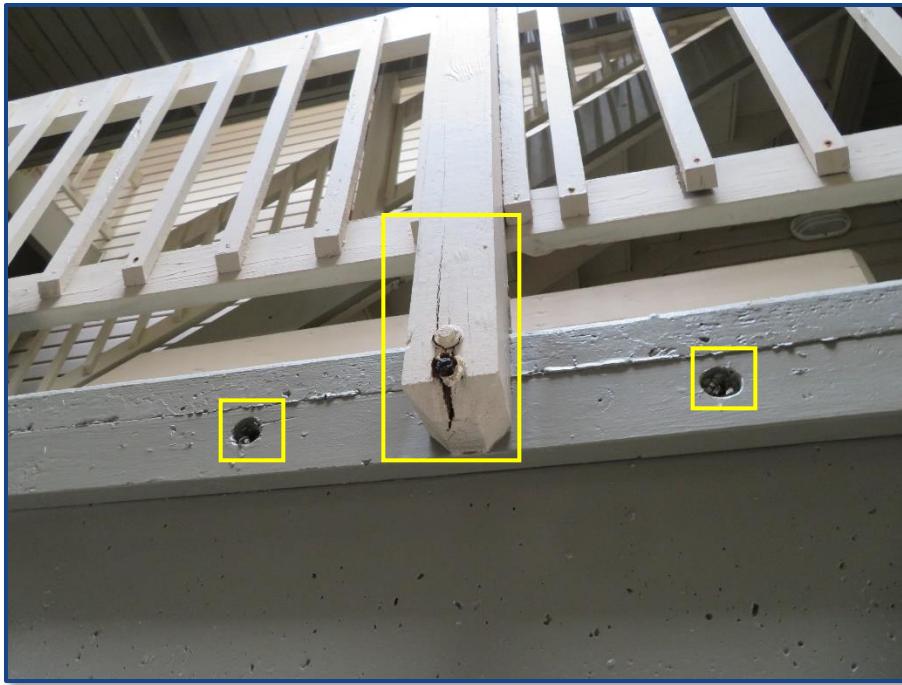
Photograph No. 27: Split guardrail post and corroded fasteners on the 2nd floor walkway.

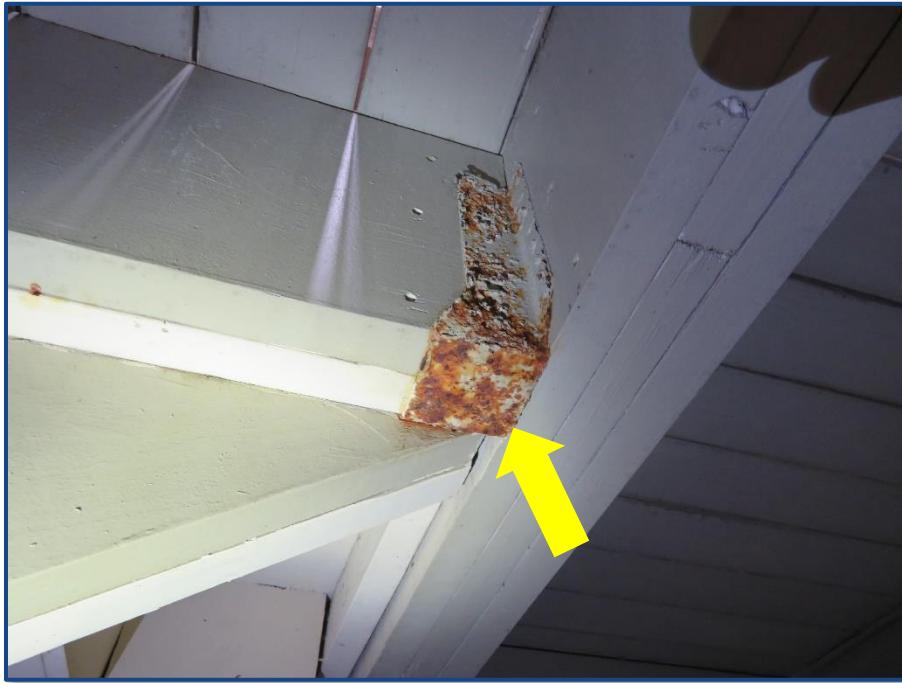
Photograph No. 28: Corroded joist hanger on the 3rd floor walkway.

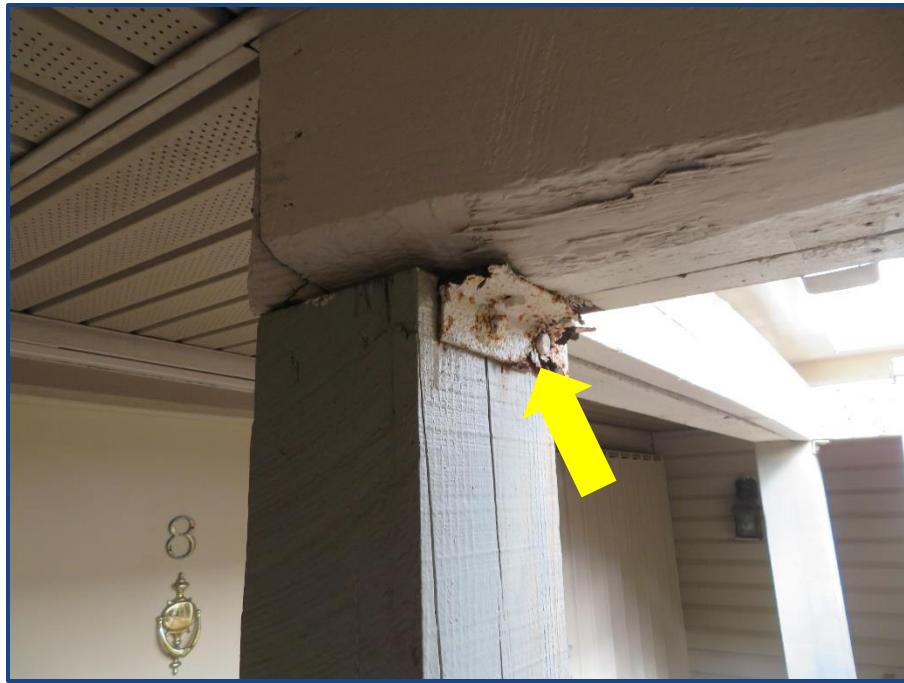
Photograph No. 29: Corroded post to beam bracket below the roof on the 3rd floor walkway.

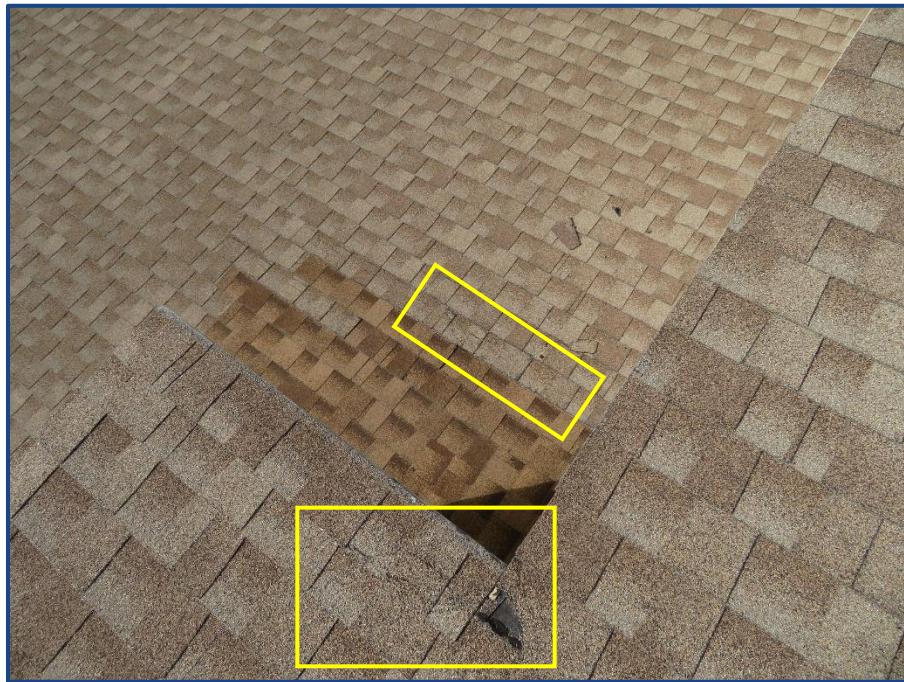
- Torn and creased shingles were observed in multiple locations on the roof. See **Appendix B** Photographs No. 30 and 31. This deficiency is a preventative maintenance item.

Photograph No. 30: Torn and creased shingles and previously replaced shingles on the roof above Unit 9.

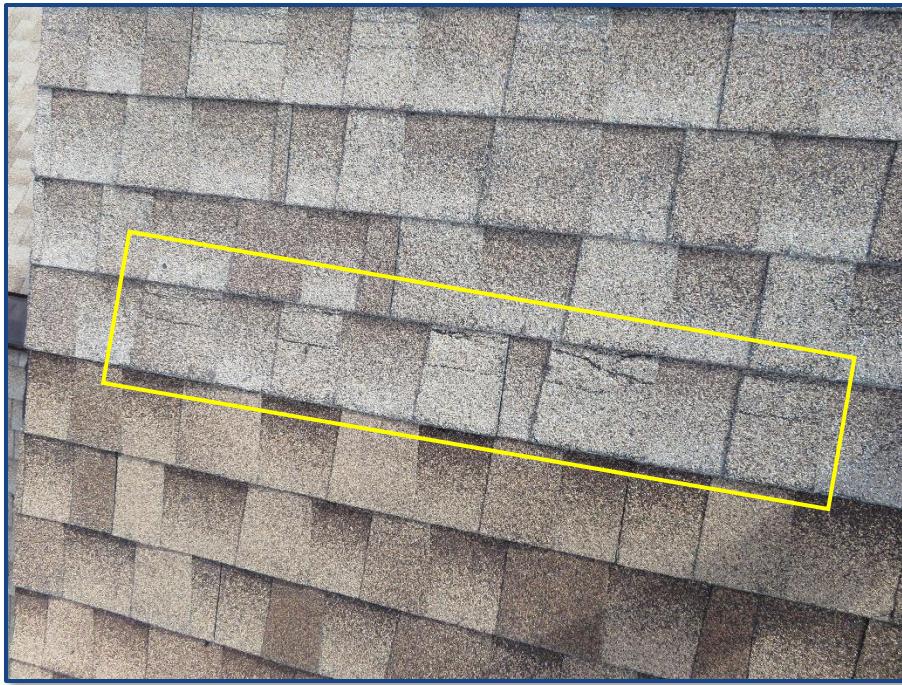
Photograph No. 31: Creased shingles on the roof above Unit 7.

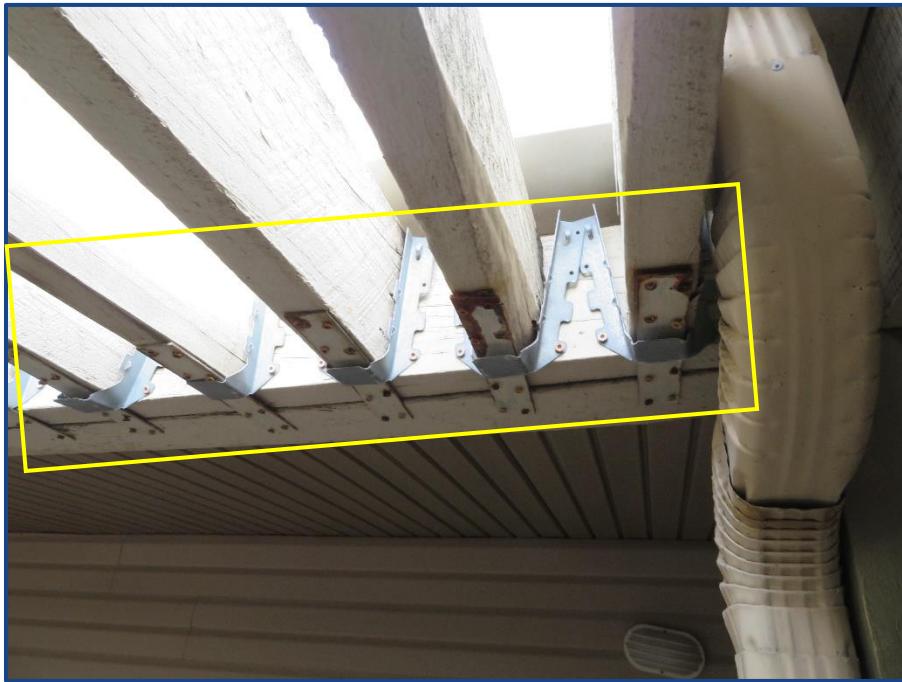
- The joist hangers supporting the pergola members at the roof level were observed to be improperly installed. See **Appendix B** Photograph No. 32. This deficiency is a preventative maintenance item.

Photograph No. 32: Corroded metal brackets and improperly installed joist hangers at the pergola at the roof level.
