Water View Condominiums  
19925 Gulf Blvd.  
Indian Shores, FL 33785

Regarding: Water View Condominiums – Phase I Milestone Inspection

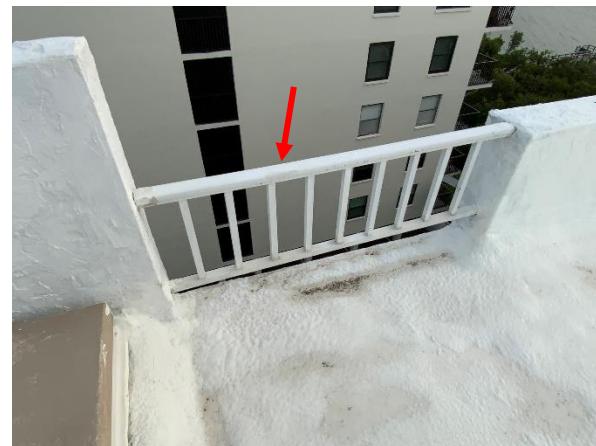
- 3.2.1 BECI identified several safety concerns regarding guard rails within the premises. Isolated areas of loose-fitting guard rails were observed on the roof of the West building and at the first-floor North stairwell of the same building. Additionally, the East building lacked guard rails around the perimeter of the Atrium. Furthermore, it was noted that the spacing between balcony railing pickets exceeded the maximum allowable limit of 4 inches, as specified by the Florida Building Code, Section 1015.4. This creates potential safety hazards to occupants, visitors, and maintenance workers. Due to the age of the building and potential grandfathering status, the current railing configuration may have been acceptable at the time of construction but does not meet current code requirements. ***BECI recommends that the isolated loose fitting guard rails be repaired immediately by a licensed Florida contractor and that they be done so in compliance with FBC Section 1015.4.*** (Reference Photo Exhibit Nos. 11 through 18).

**Photo 11**  
West Building - North Elevation – Roof - Overall view of loose-fitting guard rail.

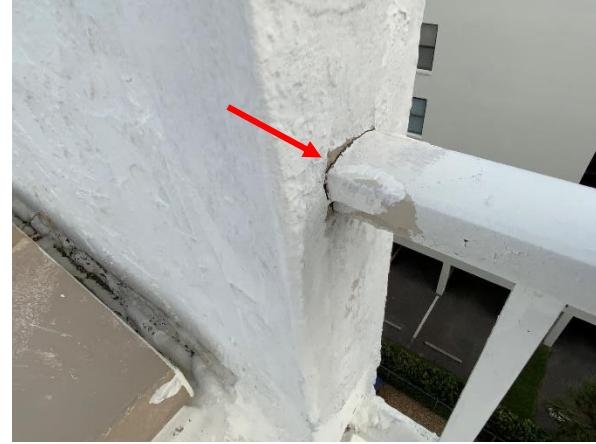
**Photo 12**  
West Building - North Elevation – Roof - Overall view of loose-fitting guard rail.

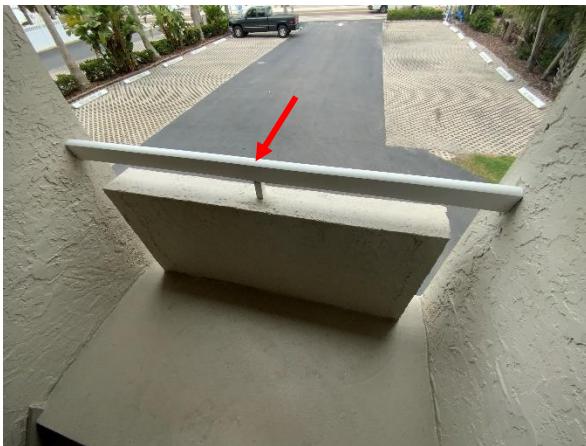
**Photo 13**  
West Building - West Elevation – 1<sup>st</sup> Floor -  
Overall view of loose-fitting guard rail.

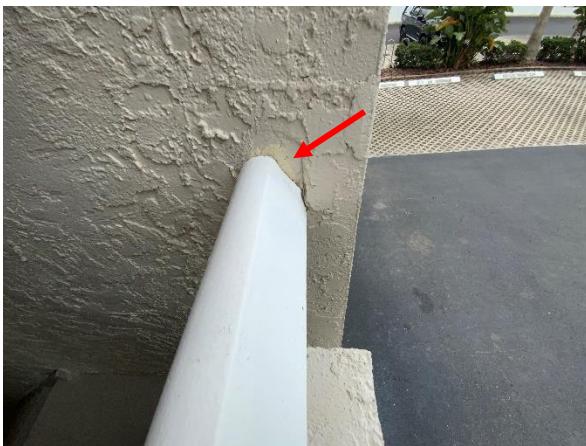
**Photo 14**  
West Building - West Elevation – 1<sup>st</sup> Floor -  
Overall view of loose-fitting guard rail.

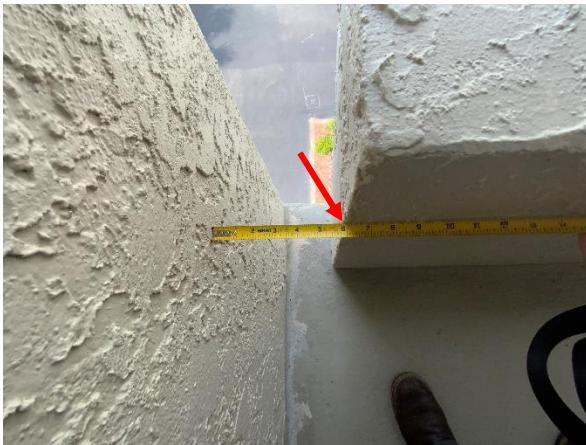
**Photo 15**  
East Building - South Elevation – 4<sup>th</sup> Floor -  
Overall view of the stair well landing parapet  
wall spacing over 4 inches.

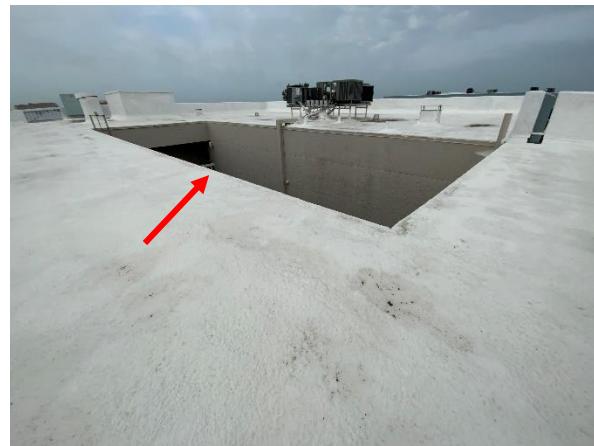
**Photo 16**  
East Building - West Elevation – Roof -  
Overall view of no guard rails installed at the  
atrium opening.

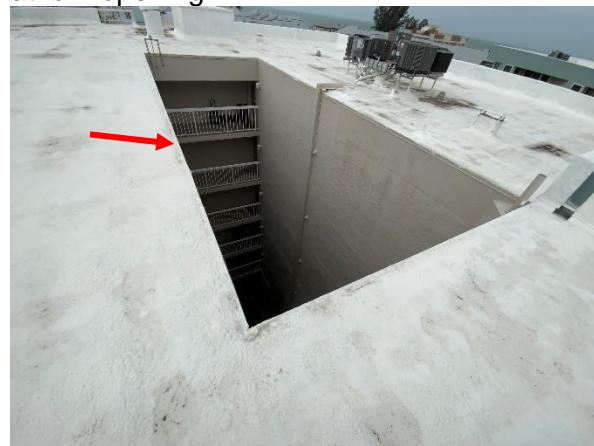
**Photo 17**  
East Building - West Elevation – Roof -  
Overall view of no guard rails installed at the  
atrium opening.

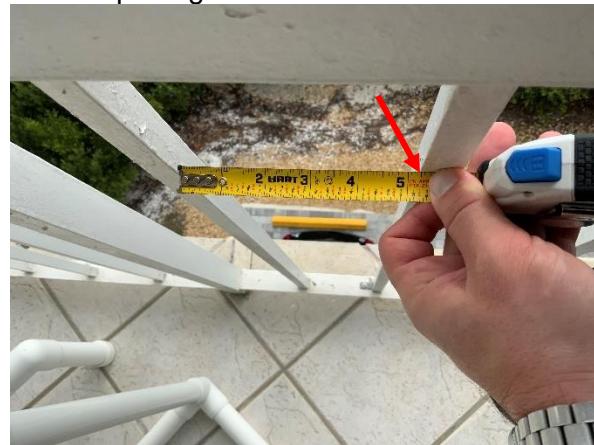
**Photo 18**  
East Building – Unit 301 - Overall view of the  
guard rail picket spacing over 4 inches.

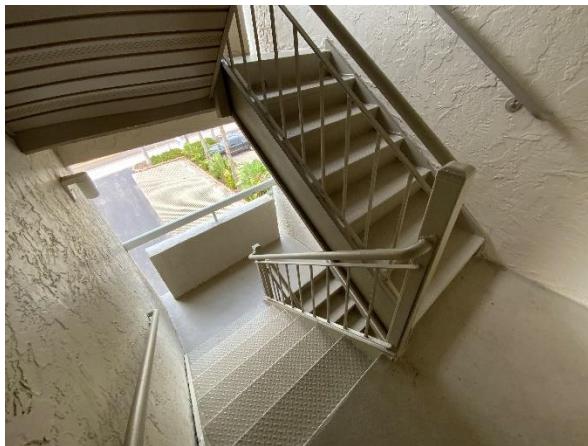
3.2.2 BECI observed corrosion and degradation at the metal staircase landing risers, stringers, newels and handrails across both buildings' North and South elevations. Isolated areas exhibited heavy corrosion and scaling, visibly compromising the integrity of the landing risers, with isolated areas of compromised railing balusters and base rails. Additionally, corrosion was evident at the roof access hatches in both buildings. This deterioration poses potential safety hazards to occupants and visitors. ***BECI recommends the corroded metal staircases and roof hatch components be removed and replaced within the next year by a licensed Florida contractor.*** (Reference Photo Exhibit Nos. 19 through 30).

**Photo 19**  
West Building - South Elevation – 3<sup>rd</sup> Floor -  
Overall view of the metal stair case.

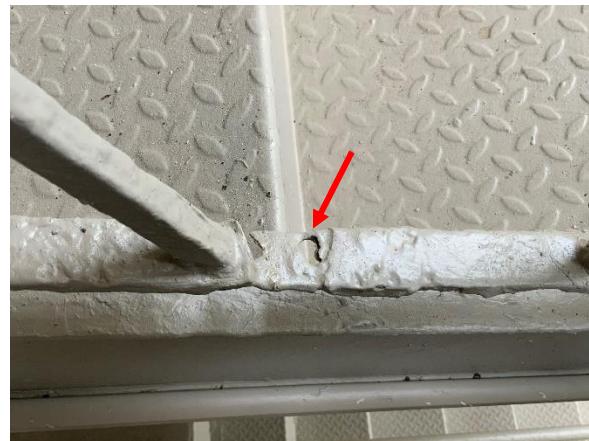
**Photo 22**  
West Building - South Elevation – 2<sup>nd</sup> Floor -  
Overall view of corroded staircase base rail.

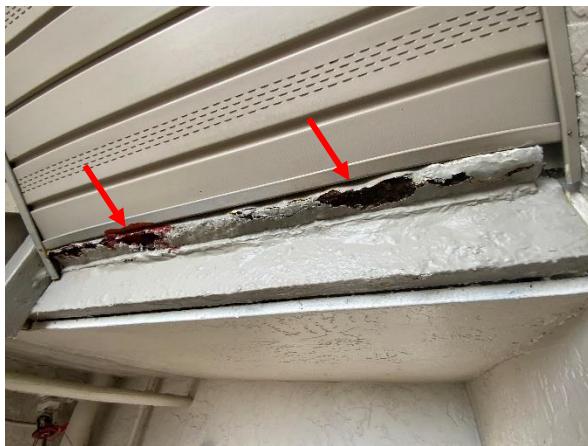
**Photo 20**  
West Building - North Elevation – 3<sup>rd</sup> Floor -  
Overall view of corrosion at the staircase landing.

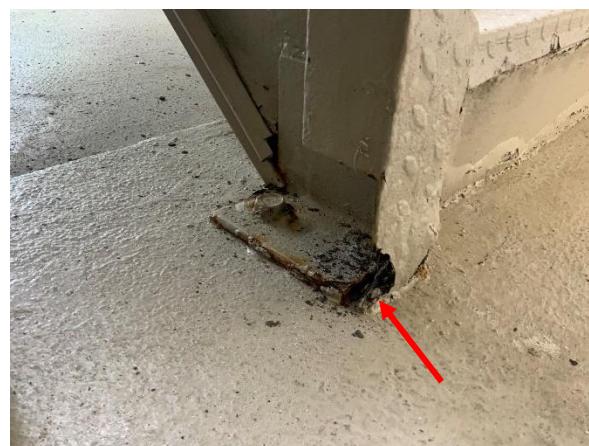
**Photo 23**  
West Building - South Elevation – Ground  
Floor - Overall view of corroded staircase  
stringer base plate.

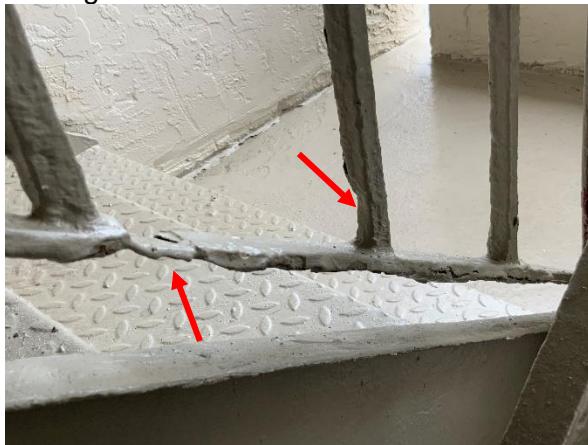
**Photo 21**  
West Building - South Elevation – 2<sup>nd</sup> Floor -  
Overall view of corroded staircase base rail  
and baluster.

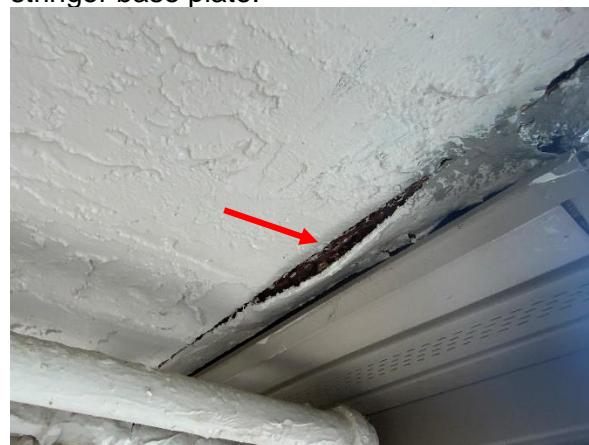
**Photo 24**  
East Building - North Elevation – 1<sup>st</sup> Floor -  
Overall view of corrosion at the staircase  
landing.

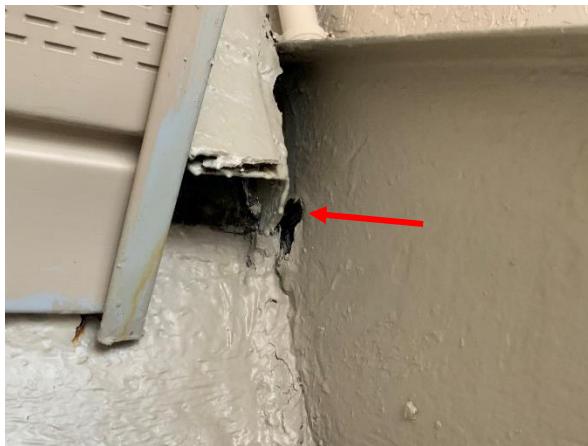
**Photo 25**  
 East Building - North Elevation – 1<sup>st</sup> Floor -  
 Overall view of corroded staircase stringer.

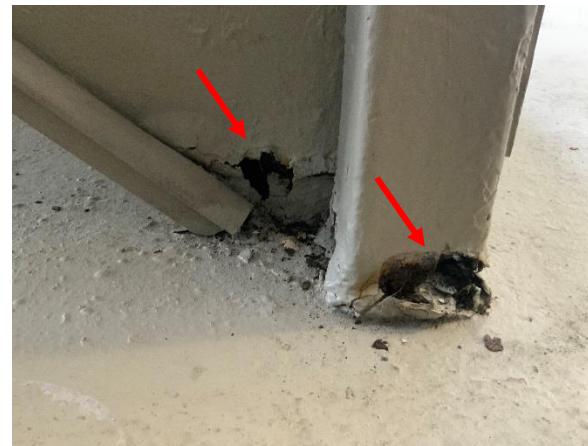
**Photo 28**  
 East Building - South Elevation – Ground  
 Floor - Overall view of corroded staircase  
 stringer base plate.

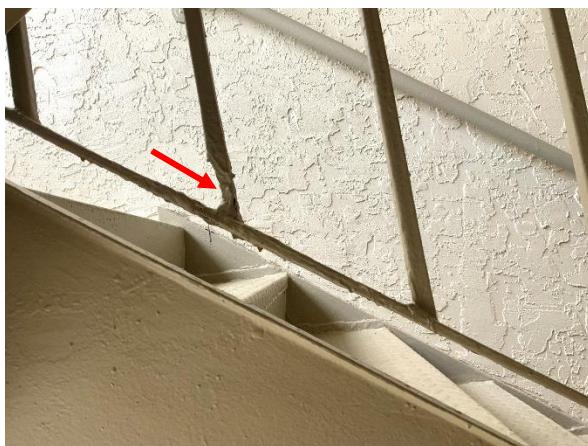
**Photo 26**  
 East Building - North Elevation – 2<sup>nd</sup> Floor -  
 Overall view of corroded staircase baluster.

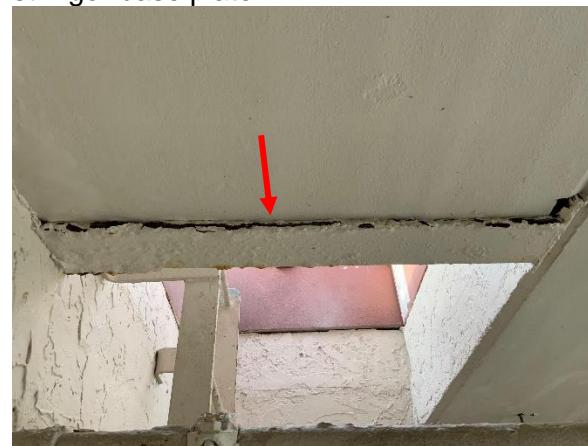
**Photo 29**  
 West Building - South Elevation – 5<sup>th</sup> Floor -  
 Overall view of corroded metal framing at the  
 roof access hatch.

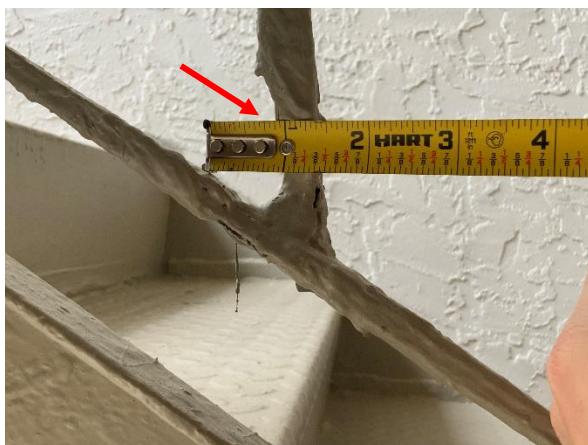
**Photo 27**  
 East Building - North Elevation – 2<sup>nd</sup> Floor -  
 Overall view of corroded staircase baluster.

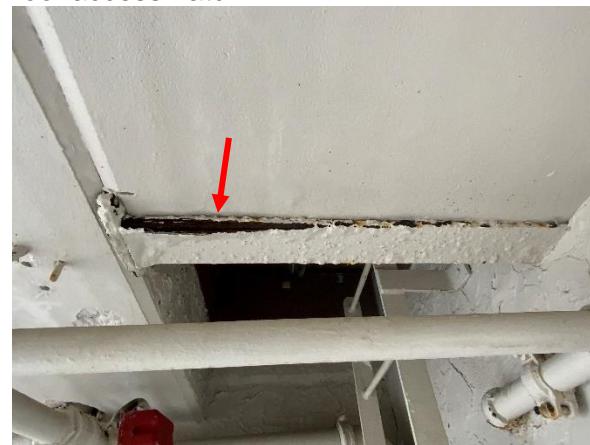
**Photo 30**  
 West Building - North Elevation – 5<sup>th</sup> Floor -  
 Overall view of corroded metal framing at the  
 roof access hatch.

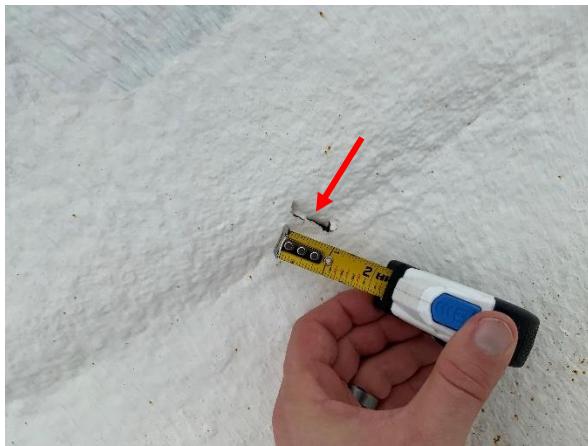
3.2.3 BECI observed isolated punctures in the roofing membrane at both buildings with isolated areas that were holding water. These punctures can lead to moisture damage, microbial growth, reduced roofing lifespan and deterioration of the roof substrate. ***BECI recommends the punctures in the roofing membrane be sealed immediately to avoid further moisture intrusion*** (Reference Photo Exhibit Nos. 31 through 34).

**Photo 31**  
West Building - Roof – Overall view of punctures in the roof coating.

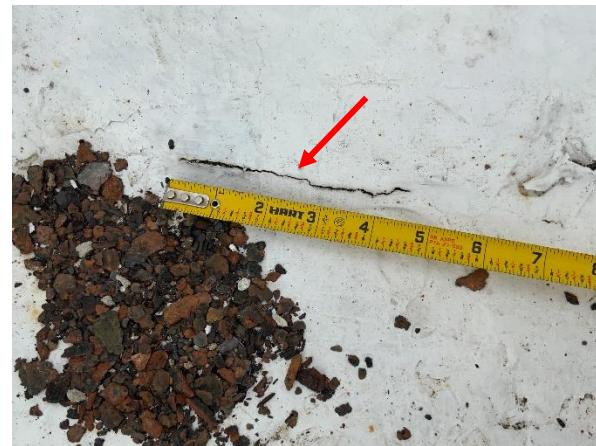
**Photo 34**  
East Building - Roof – Overall view of punctures in the roof coating.

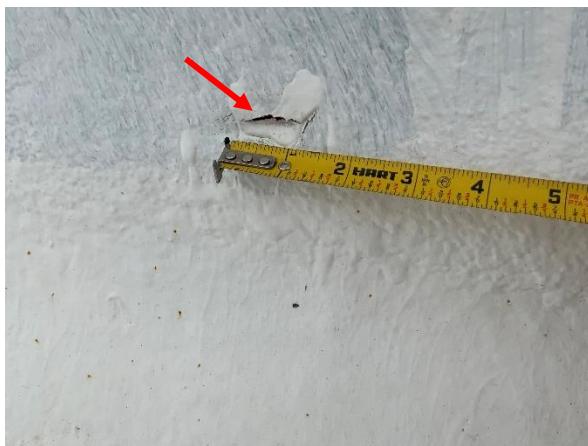
**Photo 32**  
West Building - Roof – Overall view of punctures in the roof coating.

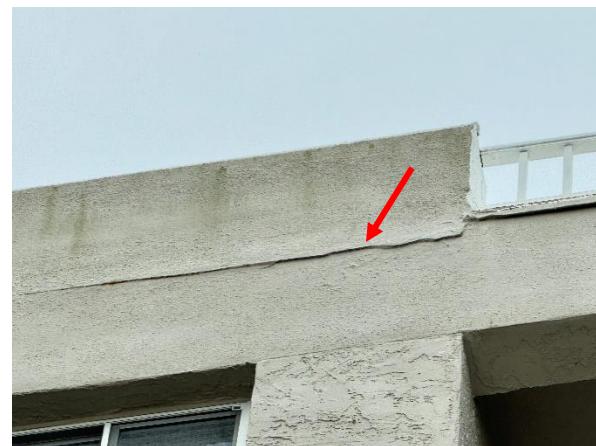
3.2.4 Furthermore, BECI observed isolated areas of damaged and cracking cement plaster throughout both buildings. These damaged areas can allow for moisture intrusion which can potentially cause delamination of the cement plaster and surrounding exterior coatings if not repaired. ***BECI recommends that the damaged cement plaster be repaired within the next year by a licensed Florida contractor.*** (Reference Photo Exhibit Nos. 35 through 46).

**Photo 35**  
West Building – North Elevation – Roof - Overall view of cracking cement plaster.

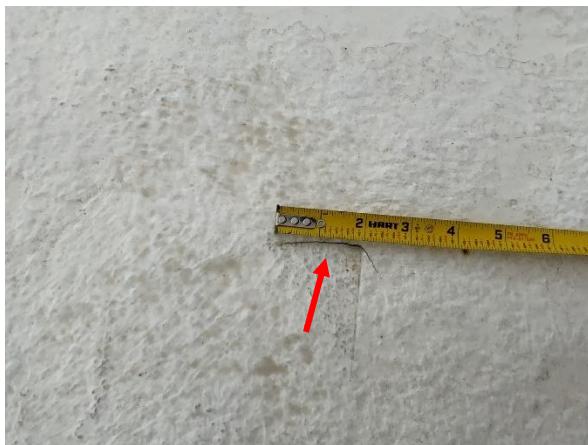
**Photo 33**  
East Building - Roof – Overall view of punctures in the roof coating.

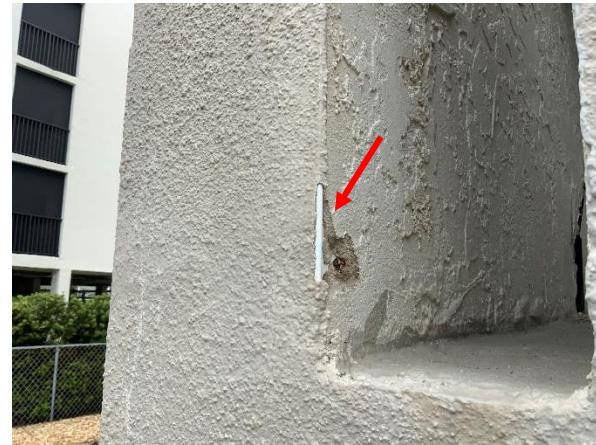
**Photo 36**  
West Building – West Elevation – Ground Floor - Overall view of damaged cement plaster.

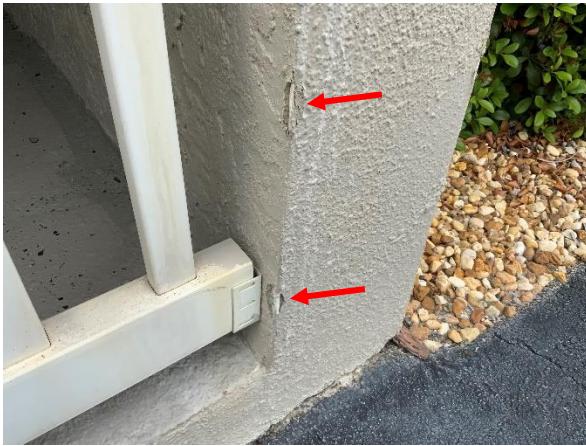
**Photo 37**  
 West Building – West Elevation – Ground Floor - Overall view of damaged cement plaster.

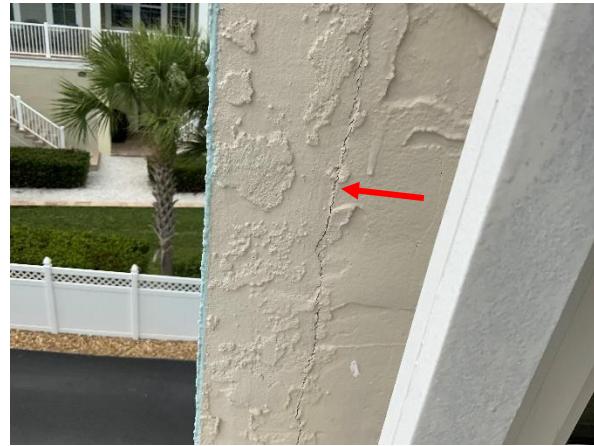
**Photo 40**  
 West Building – Unit 306 – Overall view of cracking cement plaster.

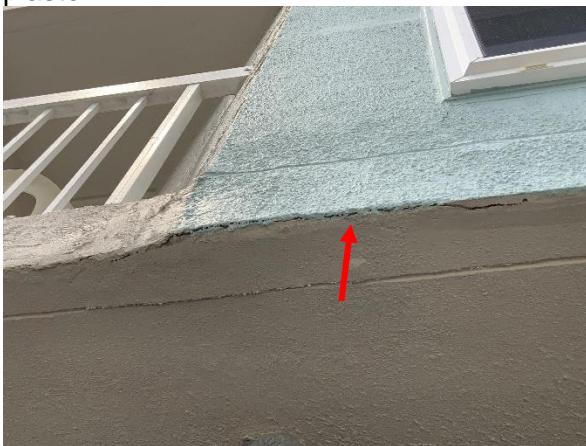
**Photo 38**  
 West Building – East Elevation – 1<sup>st</sup> Floor - Overall view of cracking cement plaster.

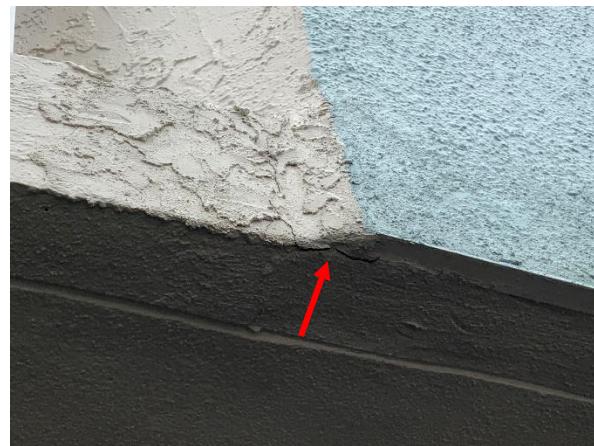
**Photo 41**  
 East Building – West Elevation – 1<sup>st</sup> Floor - Overall view of cracking cement plaster.

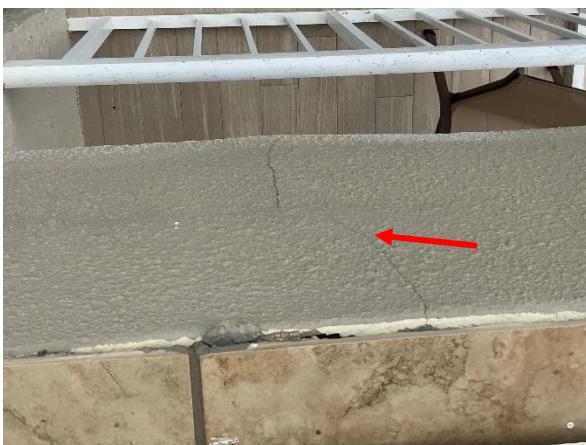
**Photo 39**  
 West Building – Unit 402 – Overall view of cracking cement plaster.

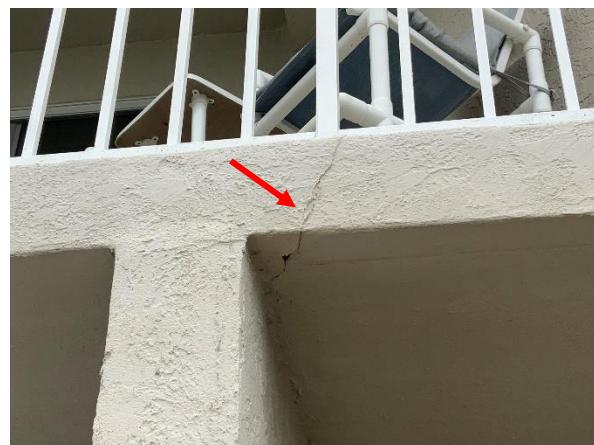
**Photo 42**  
 East Building – East Elevation – 1<sup>st</sup> Floor - Overall view of cracking cement plaster.

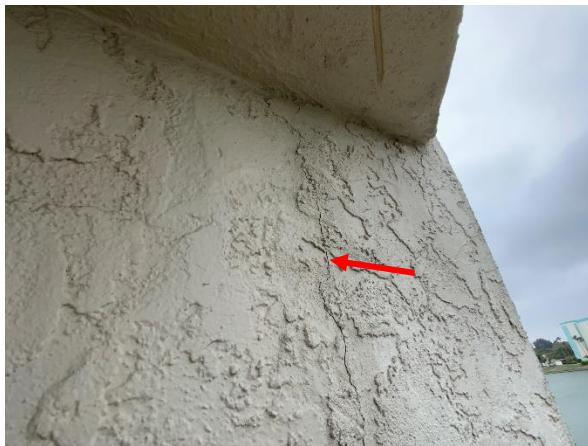
**Photo 43**  
East Building – Unit 303 – Overall view of cracking cement plaster.

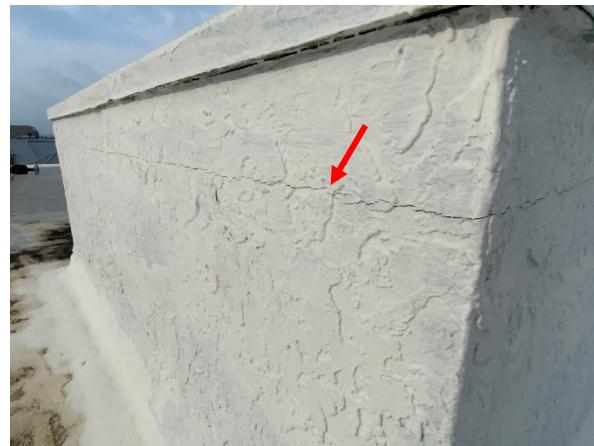
**Photo 46**  
East Building – Roof – Overall view of cracking cement plaster.

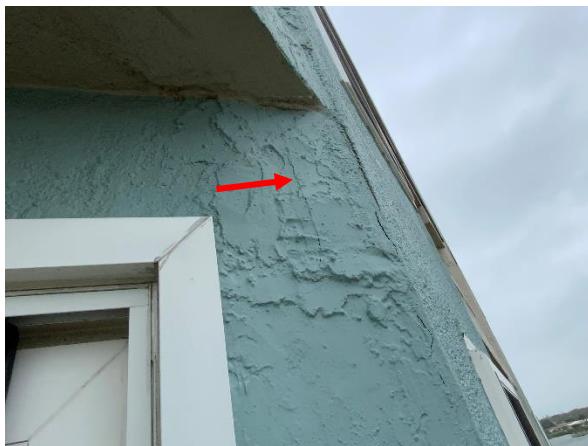
**Photo 44**  
East Building – Unit 305 – Overall view of cracking cement plaster.

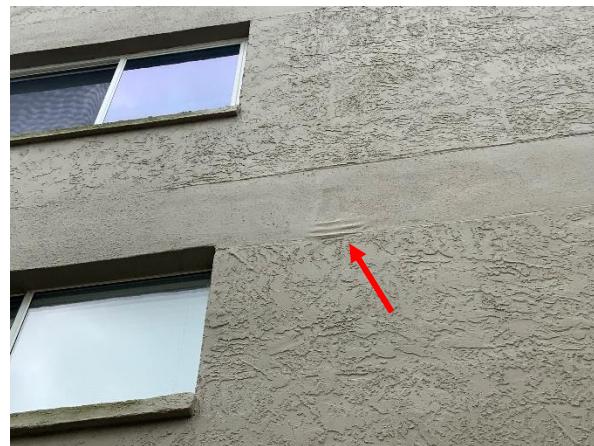
3.2.5 BECI also observed isolated areas of delaminating and bubbling exterior coatings at both buildings. Delamination and bubbling are typically indicative of moisture intrusion in the surrounding cladding. Delaminating and bubbling exterior coatings not only compromise the aesthetics of the buildings but also serve as a warning sign of potential underlying moisture issues, which can lead to further damage such as microbial growth, and deterioration of underlying materials. ***BECI recommends that the deteriorated and delaminated exterior coatings be repaired within the next 2 years by a licensed Florida contractor.*** (Reference Photo Exhibit Nos. 47 through 52).

**Photo 47**  
West Building – North Elevation – 2<sup>nd</sup> Floor – Overall view of delaminated exterior coating.

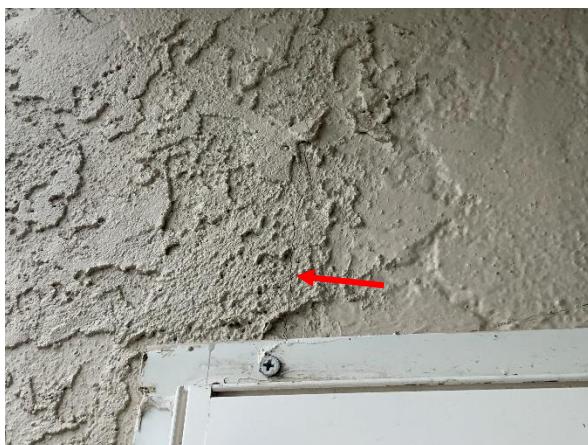
**Photo 45**  
East Building – Unit 401 – Overall view of cracking cement plaster.

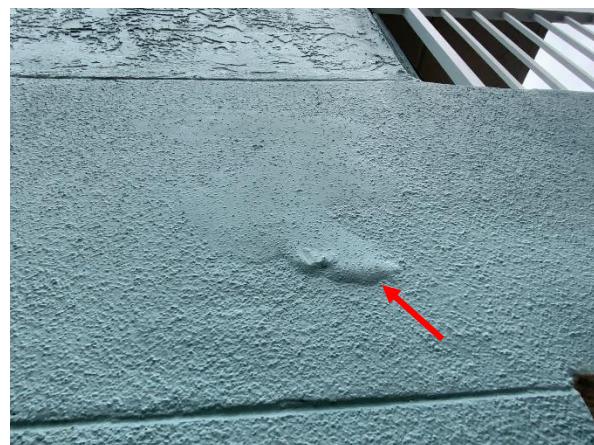
**Photo 48**  
East Building – South Elevation – 1<sup>st</sup> Floor – Overall view of delaminated exterior coating.

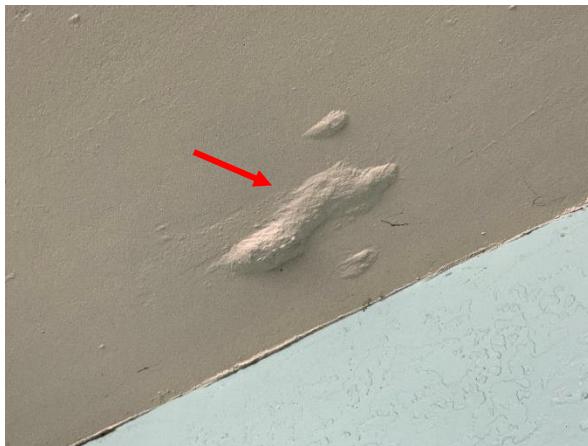
**Photo 49**  
East Building – Ground Parking – Overall view of delaminated exterior coating.

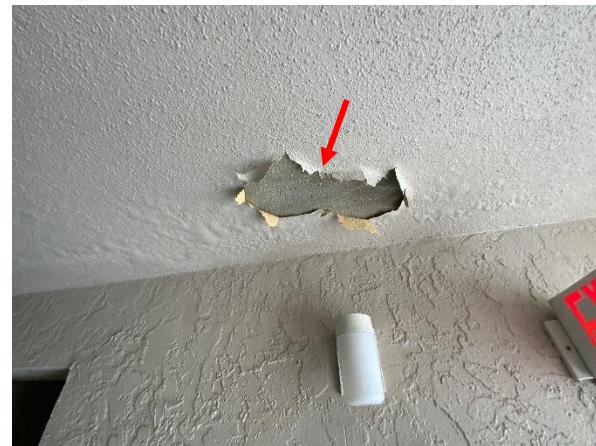
**Photo 52**  
East Building – Unit 301 – Overall view of delaminated exterior coating.

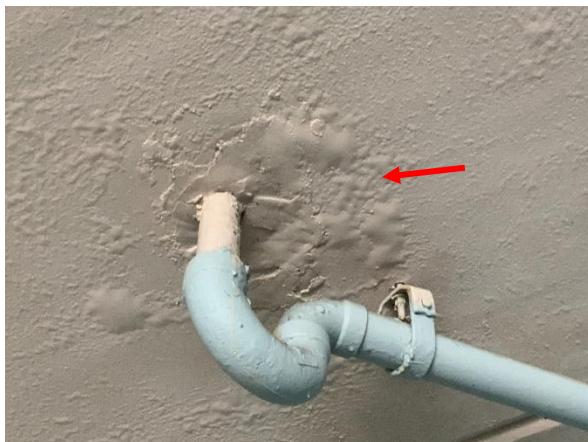
**Photo 50**  
East Building – Ground Parking – Overall view of delaminated exterior coating.

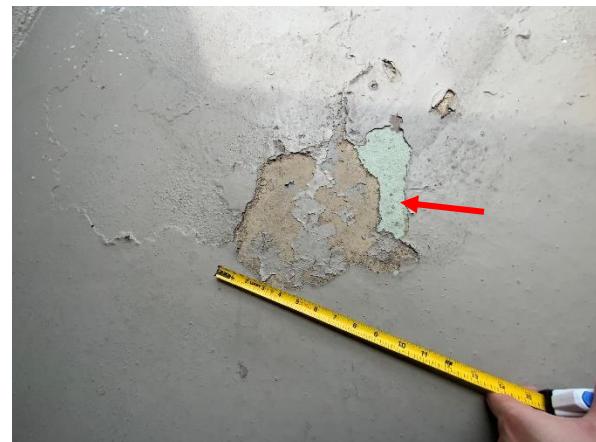
3.2.6 Lastly, BECI observed multiple areas at the common walkways of both buildings where the walkway traffic coatings had become delaminated and were beginning to fail. This deterioration poses a concern for the concrete at these locations. Delamination and failing of walkway traffic coatings expose the underlying concrete substrate to moisture intrusion, which can lead to accelerated degradation of the concrete. ***BECI recommends that the deteriorated and delaminated walkway traffic coatings be repaired within the next 2 years by a licensed Florida contractor.*** (Reference Photo Exhibit Nos. 53 and 54).

**Photo 53**  
West Building – 1<sup>st</sup> Floor – Overall view of delaminated walkway traffic coating.

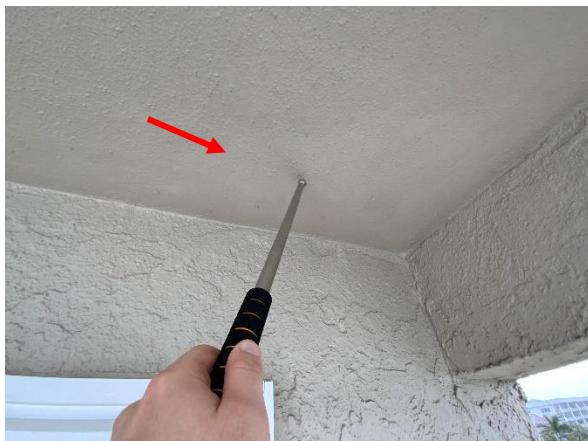
**Photo 51**  
East Building – Unit 301 – Overall view of delaminated exterior coating.

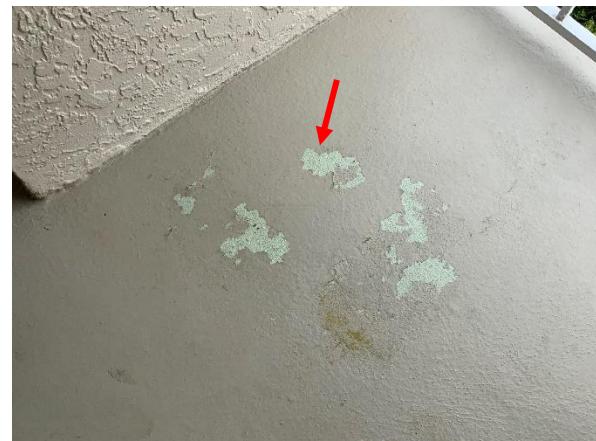
**Photo 54**  
East Building – 4<sup>th</sup> Floor – Overall view of delaminated walkway traffic coating.
