STRUCTURAL CONDITION REPORT MILESTONE INSPECTION HB5D - PHASE 1

PELICANS POINTE CONDOMINIUMS BUILDINGS 1-5

19930 Gulf Blvd, Indian Shores, FL 33785

REPORT# 23-066.SCR.HB5D.PH1.001

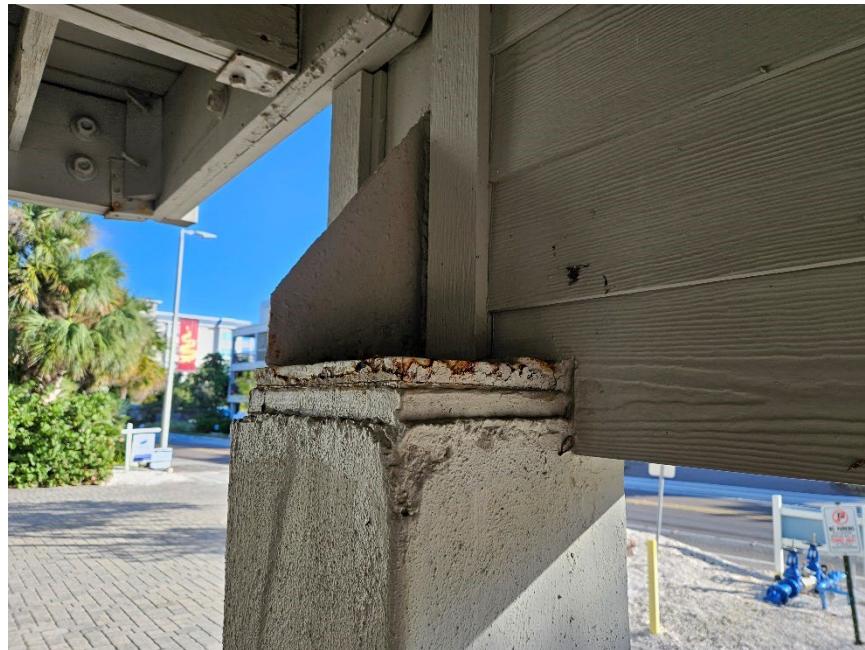
1. In general, the condition of the main vertical supports is good. Observable cracking or stucco delamination of at the base and body of the main supports at grade was not evident. Steel connection baseplates at the top of exposed columns were showing signs of rusting and flaking of the base metal.
2. Wire-brushing of the deteriorated parts of the steel plates and repainting with direct to metal (DTM) paint should be performed as part of a general maintenance schedule.
3. The tops and corners of the exposed concrete columns at the west side of the building appear to have been damaged and repaired. The repair noted is consistent with delamination due to rebar expansion. Repairs appear to be adequate but should be monitored for future deterioration.

PLATE DAMAGE - BLDG #I

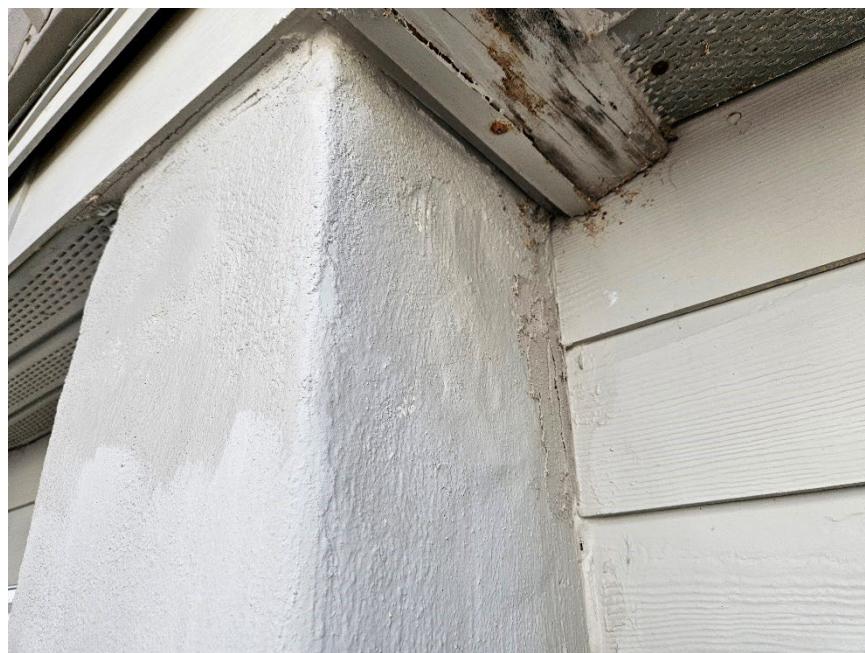
CONCRETE COLUMN PREVIOUSLY REPAIRED

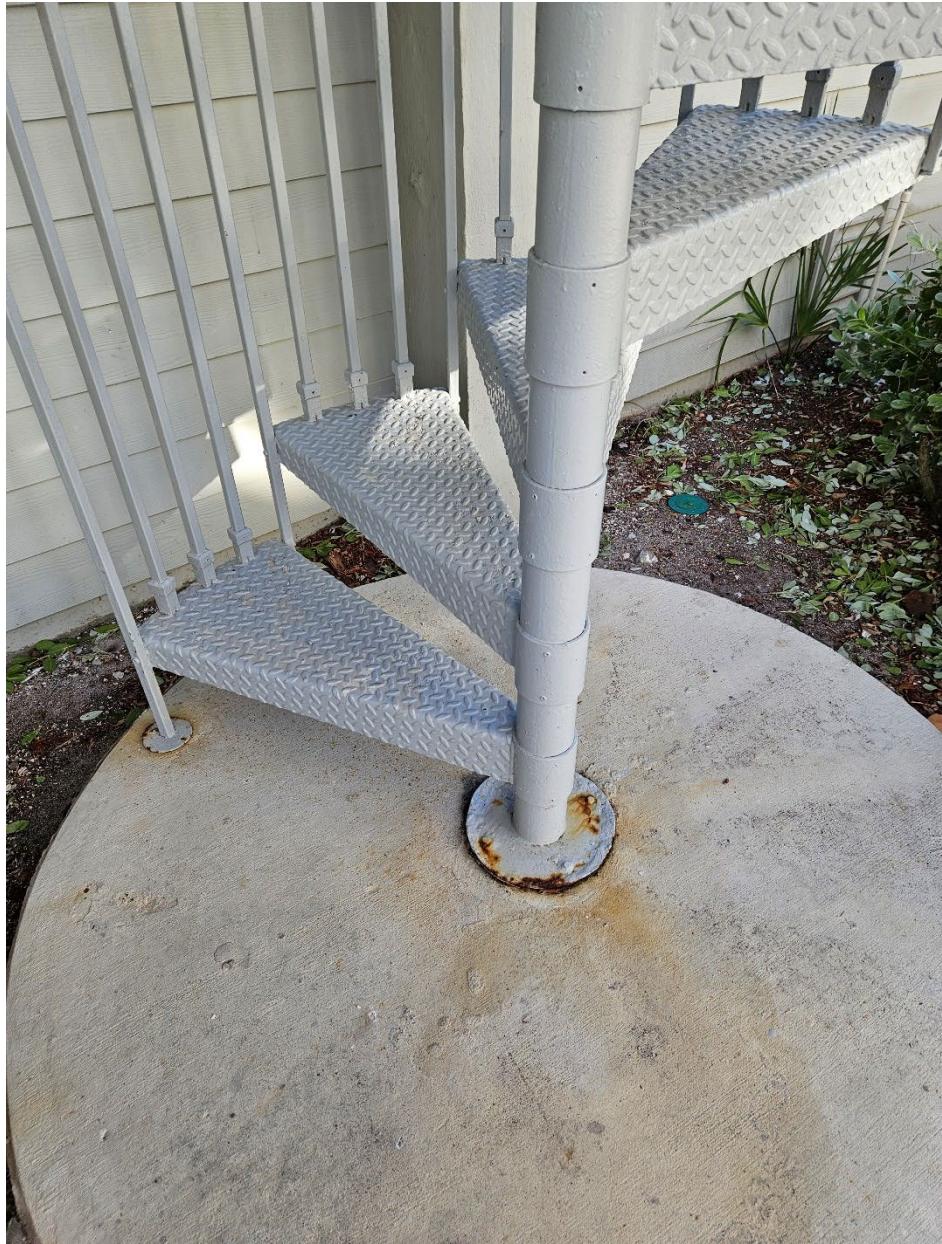
Note: The base connection plate of all of the spiral staircases at the west side of each building is rusting and starting to show signs of flaking and delamination. All base connection plates shall be wire-brushed and repainted with corrosion inhibiting DTM paint. If more than 20% of the plate thickness is damaged, the entire plate and connections shall be replaced.

SPIRAL STAIR BASE PLATE DETERIORATION - COMMON AT ALL BUILDINGS

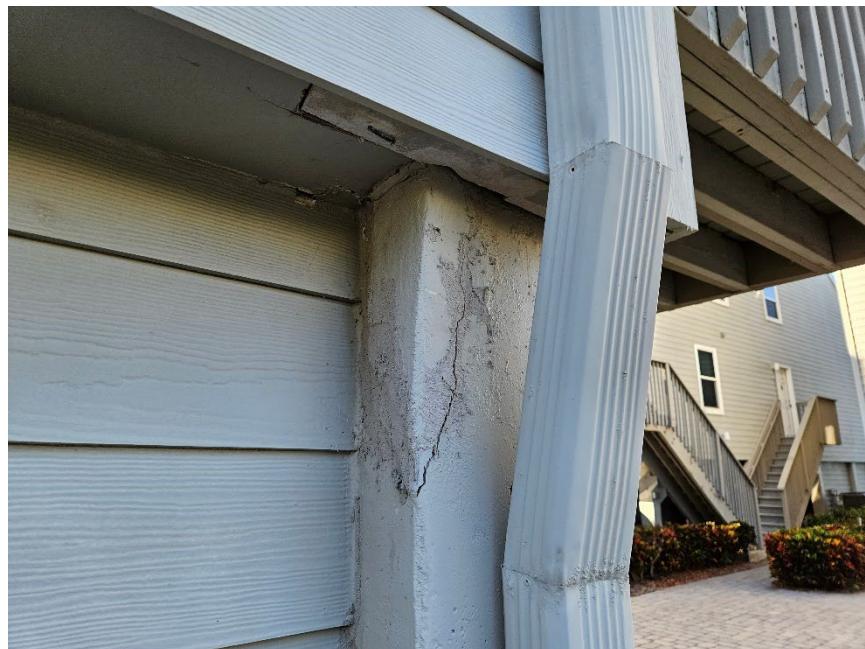
1. In general, the condition of the main vertical supports is good. Observable cracking at the top of one of the 1st level columns located on the NW corner of the building was noted. Delamination is approximately 12" long and 6" wide and is consistent with a deterioration and expansion of the underlying steel reinforcing steel. The delaminated concrete should be removed, and all of the exposed steel should be wire-brushed to bare white metal. Coat the reinforcing steel with corrosion inhibiting primer and re-form the column corner with high strength non-shrink repair grout suitable for the depth and application. **The repair should be performed as soon as possible.**

CONCRETE COLUMN DAMAGE

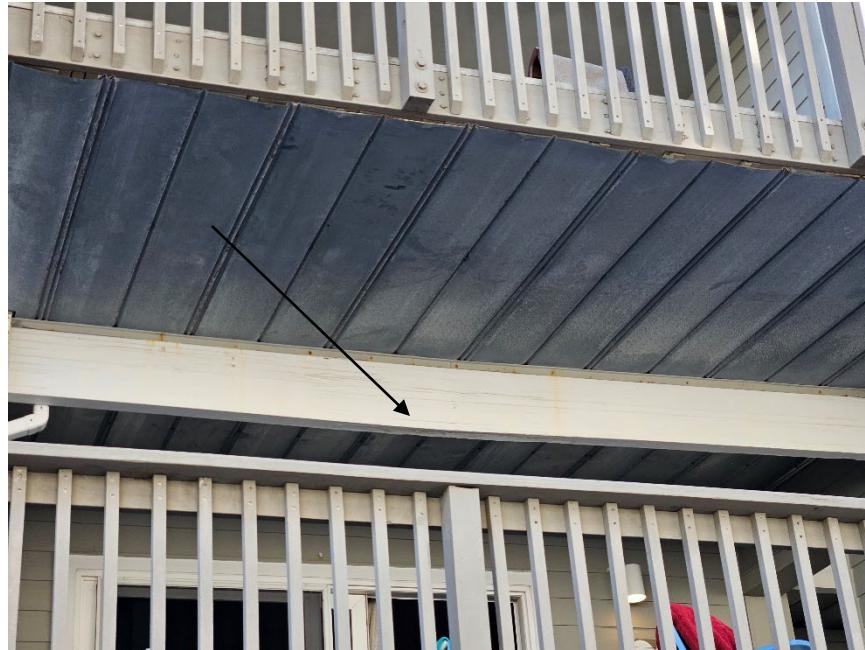
2. (2 locations) It was noted that the engineered beams supporting the 3rd floor balcony on the west side of the building has deflected approximately 2 inches at the center of the beams. The noted deflection appears to be in excess of what would normally be expected for this member. The underside of the 3rd floor balcony has been covered with metal sheeting. This metal sheeting may be trapping excess moisture at the underside of the balconies and may be contributing to the excessive deflections noted in the support beams. It is not known how long these beams have been in this deflected state. Monitoring of these beams should be performed, and additional deflections made known to the EOR for further evaluation. It is recommended that the metal sheeting be removed to prevent any additional damage from occurring.

METAL SHEET PANS INSTALLED UNDER 3RD FL FRAMING
2" DEFLECTION NOTED IN BEAM

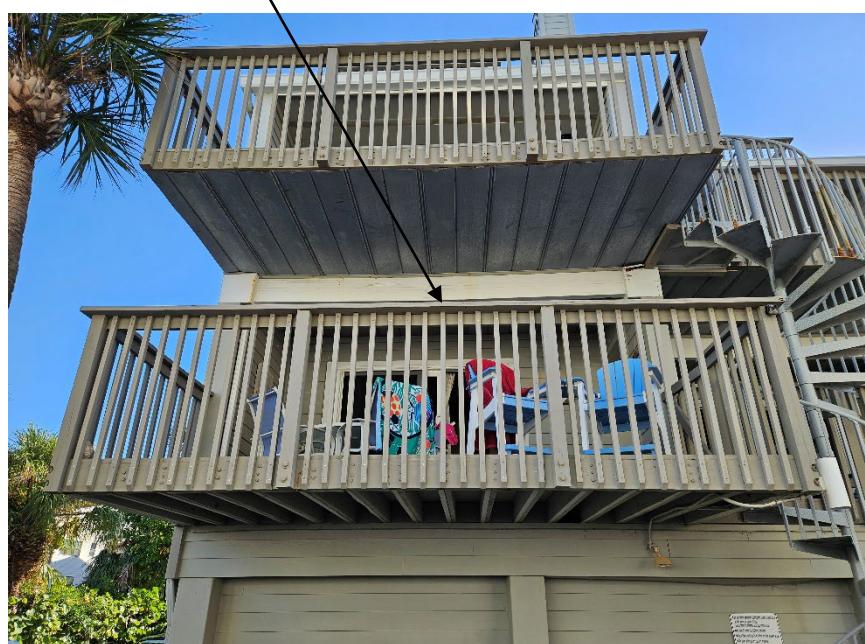
BEAM DEFLECTION

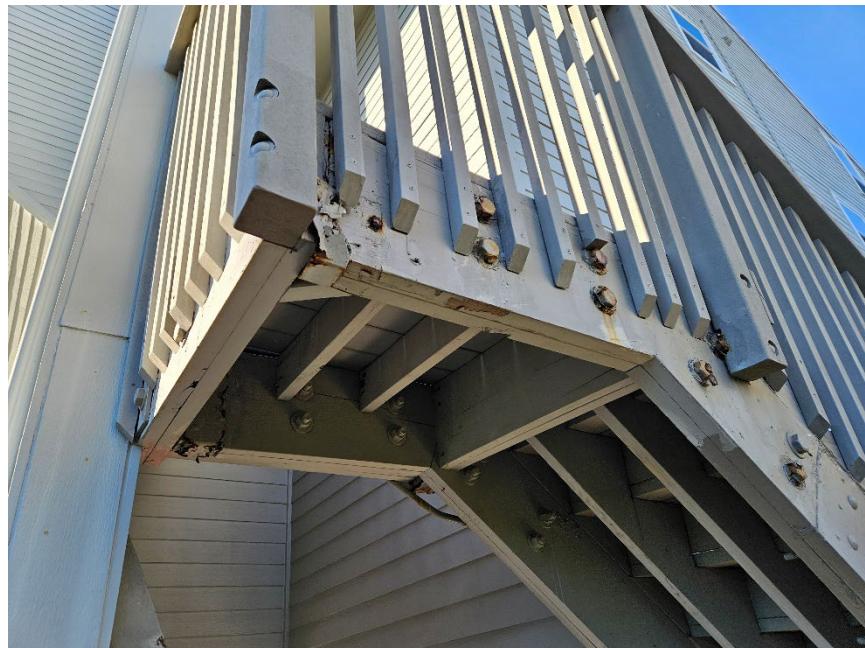
DAMAGED STAIR CONNECTIONS

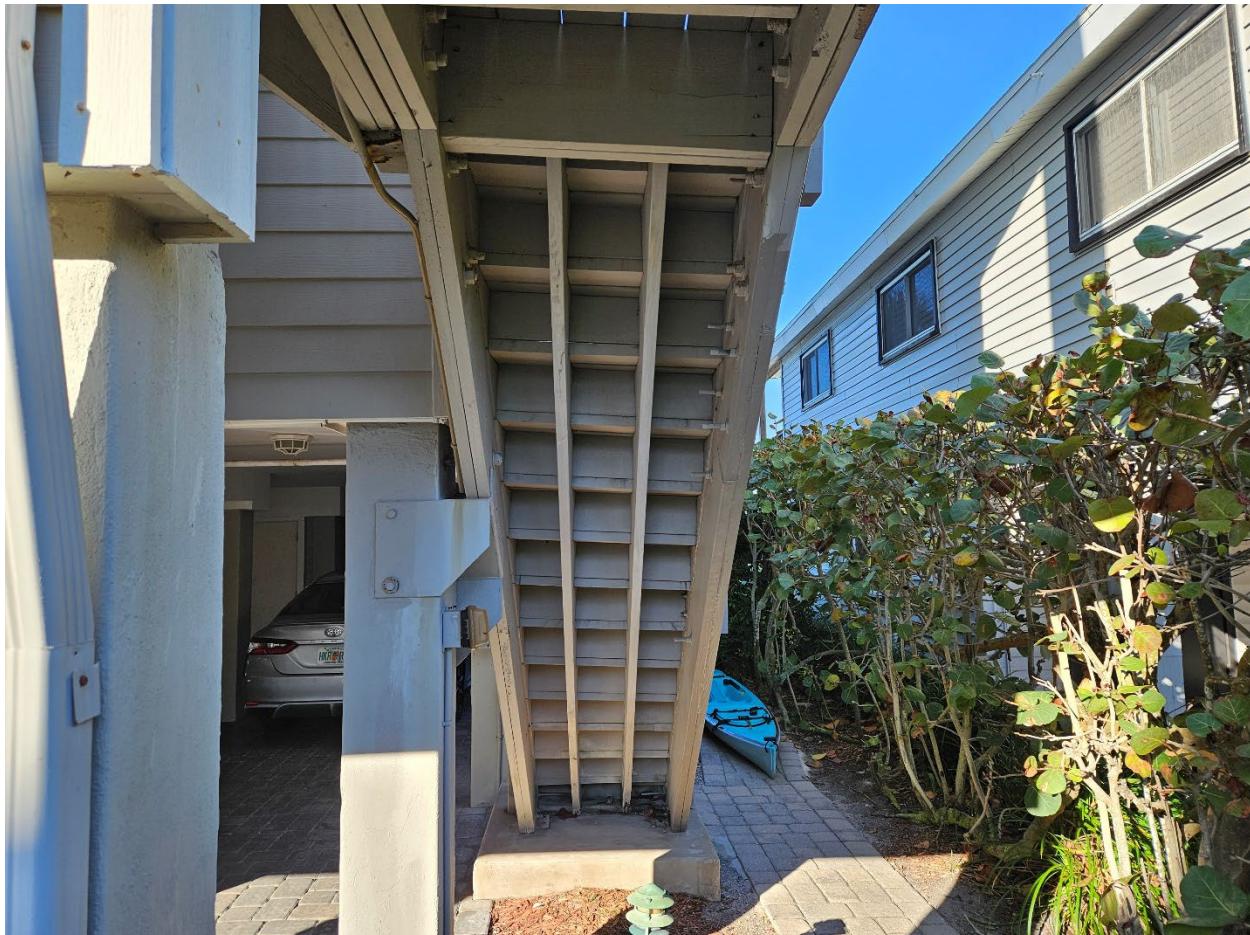
DEFLECTED STAIR FRAMING RUN

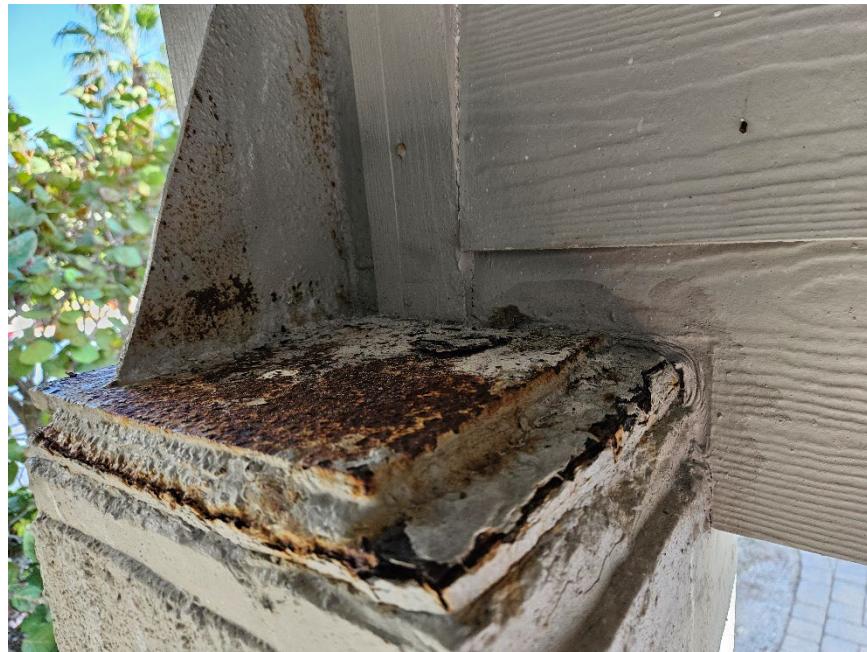
DAMAGED PLATE / BEAM CONNECTION

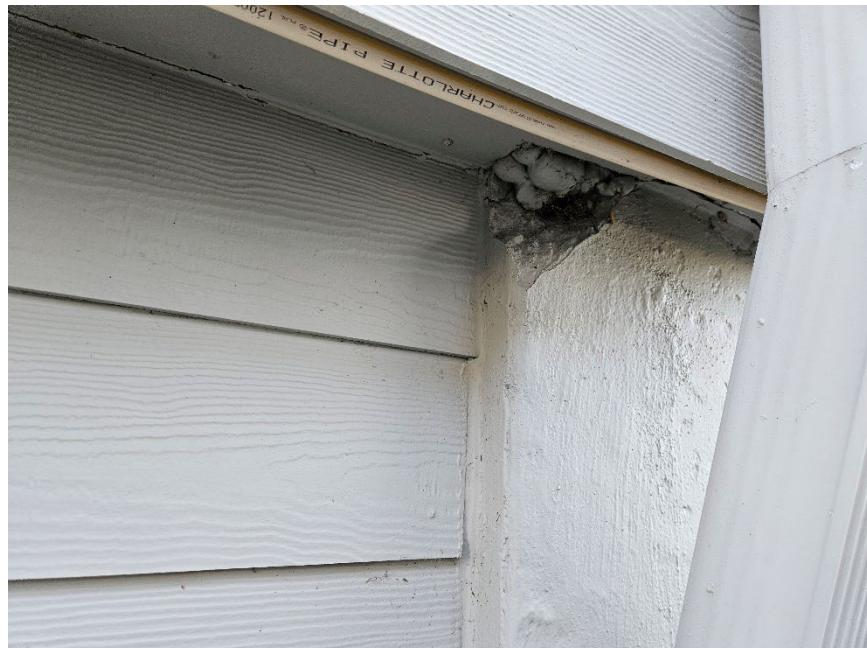
1. In general, the condition of the main vertical supports is good. An observable corner crack at the top of one of the 1st level columns located on the NW corner of the building was noted. The missing concrete section is approximately 6" long and 6" wide and is consistent with a deterioration and expansion of the underlying steel reinforcing steel. The exposed steel should be wire-brushed to bare white metal. Coat the reinforcing steel with corrosion inhibiting primer and re-form the column corner with high strength non-shrink repair grout suitable for the depth and application. **The repair should be performed as soon as possible.**

DAMAGED COLUMN CORNER

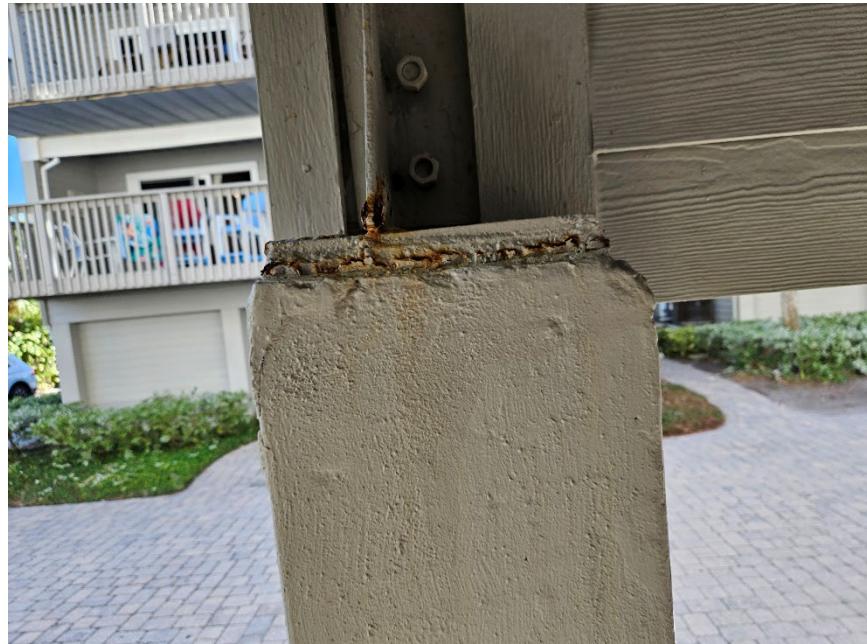
DAMAGED PLATE CONNECTION

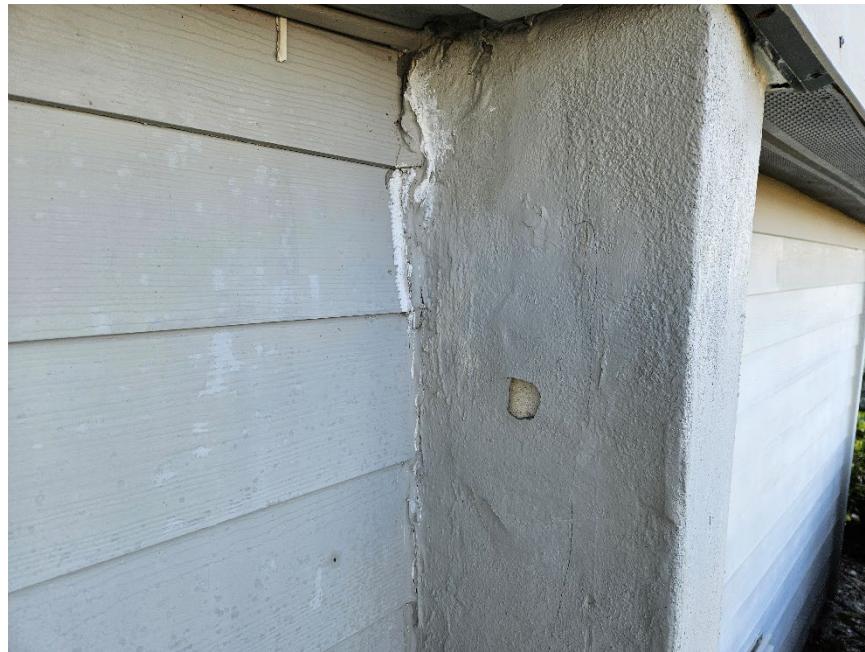
1. In general, the condition of the main vertical supports is good. Observable cracking or stucco delamination of at the base and body of the main supports at grade was not evident. Steel connection baseplates at the top of exposed columns were showing signs of rusting and flaking of the base metal.
2. Wire-brushing of the deteriorated parts of the steel plates and repainting with direct to metal (DTM) paint should be performed as part of a general maintenance schedule.
3. Delaminating stucco observed at the columns on the west side of the building. Remove and repair.

DELAMINATING STUCCO ON WEST SIDE OF BUILDING.

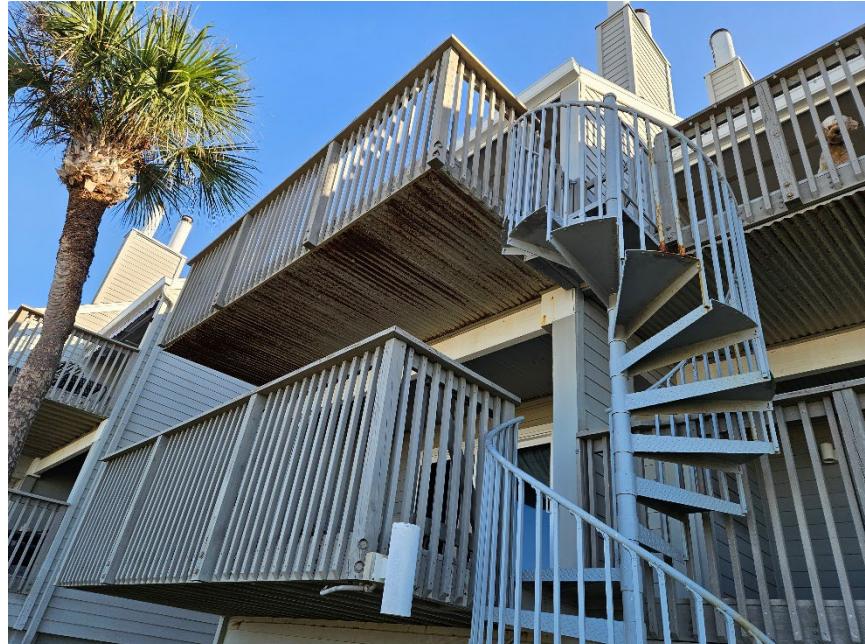
2. (2 locations) It was noted that the engineered beams supporting the 3rd floor balcony on the west side of the building has deflected approximately 1 inch at the center of the beams. The underside of the 3rd floor balcony has been covered with metal sheeting. This metal sheeting may be trapping excess moisture at the underside of the balconies and may be contributing to the excessive deflections noted in the support beams. It is not known how long these beams have been in this deflected state. Monitoring of these beams should be performed, and additional deflections made known to the EOR for further evaluation. It is recommended that the metal sheeting be removed to prevent any additional damage from occurring.

METAL PAN SHEETING

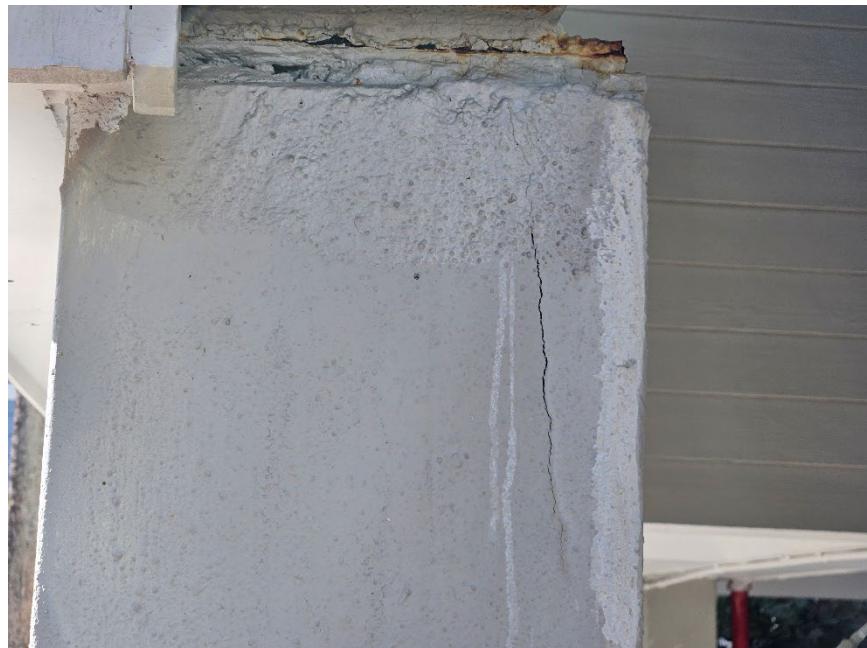
3. Observable cracking at the top of one of the 1st level columns located on the **NE** corner of the building was noted. Delamination is approximately 12" long and 4" wide and is consistent with a deterioration and expansion of the underlying steel reinforcing steel. The delaminated concrete should be removed, and all of the exposed steel should be wire-brushed to bare white metal. Coat the reinforcing steel with corrosion inhibiting primer and re-form the column corner with high strength non-shrink repair grout suitable for the depth and application. **The repair should be performed as soon as possible.**

NE COLUMN DELAMINATION AND PLATE DAMAGE

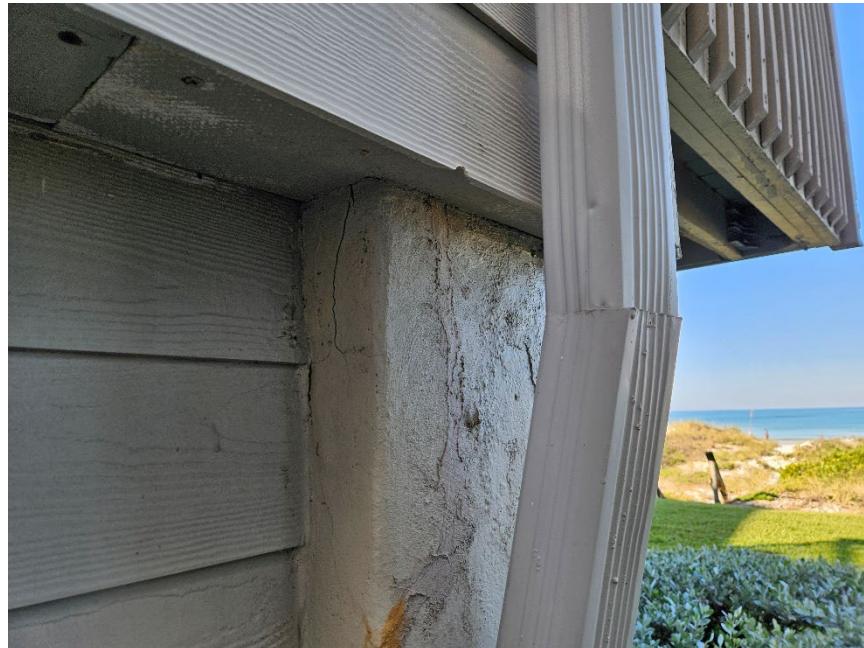
4. Observable cracking at the top of one of the 1st level columns located on the NW corner of the building was noted. Delamination is approximately 18" long and 12" wide and is consistent with a deterioration and expansion of the underlying steel reinforcing steel. The delaminated concrete should be removed, and all of the exposed steel should be wire-brushed to bare white metal. Coat the reinforcing steel with corrosion inhibiting primer and re-form the column corner with high strength non-shrink repair grout suitable for the depth and application. **The repair should be performed as soon as possible.**

DAMAGE AND DELAMINATION AT NW COLUMN

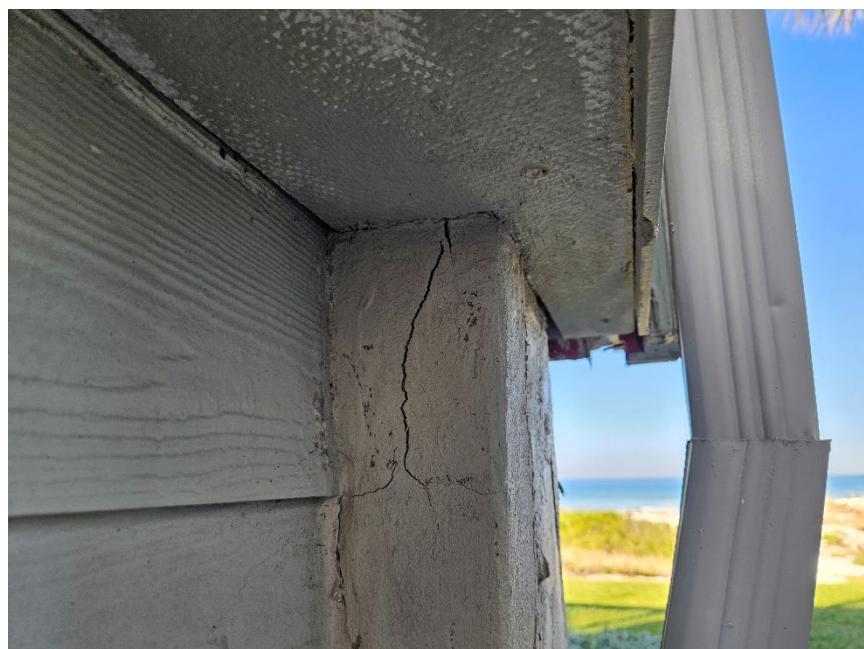
NW COLUMN DAMAGE

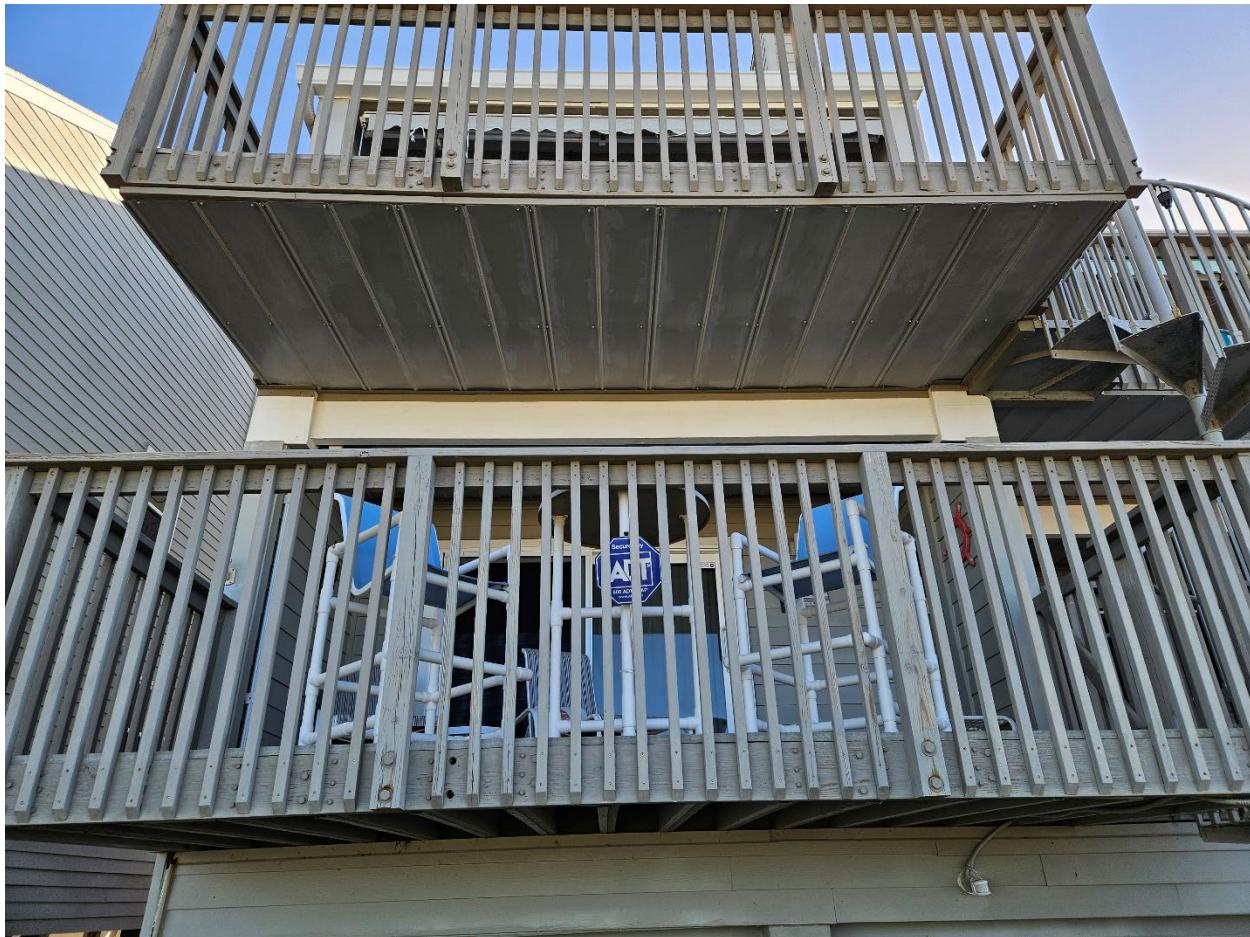
1. Framing connections observed at the underside of the floor framing are exhibiting signs of minor rust damage. All areas of rust should be wire-brushed and repainted as part of a general maintenance program.
2. It was noted that metal sheet panels have been installed under the 3rd floor balconies. It is recommended that the metal sheeting be removed to prevent any future damage to the framing or connections from occurring.
3. Framing members observed: All framing members exposed appeared to be in good condition. Apparent rot, active water staining, or other deterioration was not observed at the time of our site visit. Some repairs and installation of additional framing members of floor members has been performed and appear to be functioning as intended (Framing members not exposed at the time of or site visit are excluded from this report)

METAL PAN SHEETING - RECOMMEND REMOVING ALL LOCATIONS
