December 19, 2024

**RE: Phase One Milestone Inspection Report for
Quiet Waters Condominium Association, Inc.
19931 Gulf Boulevard,
Indian Shores, Florida 33785
KEG File #21RT-0726**

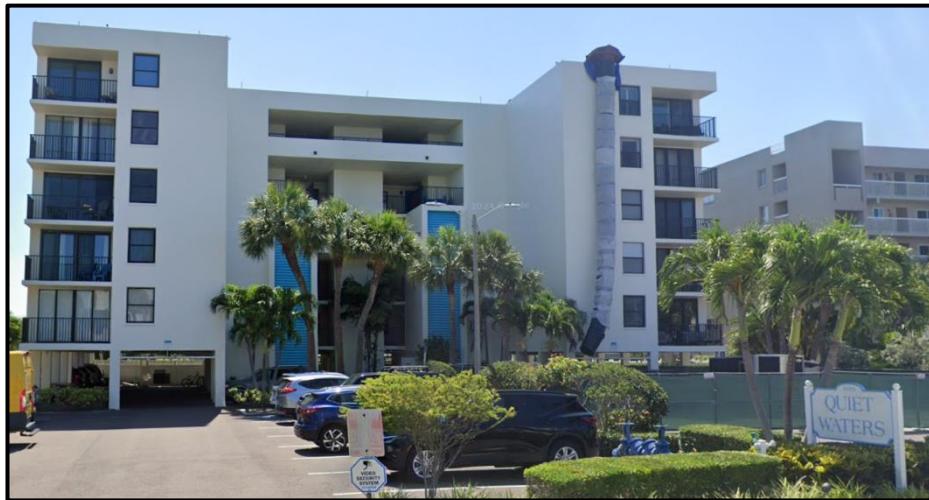
Figure 1: West Overview of Property.

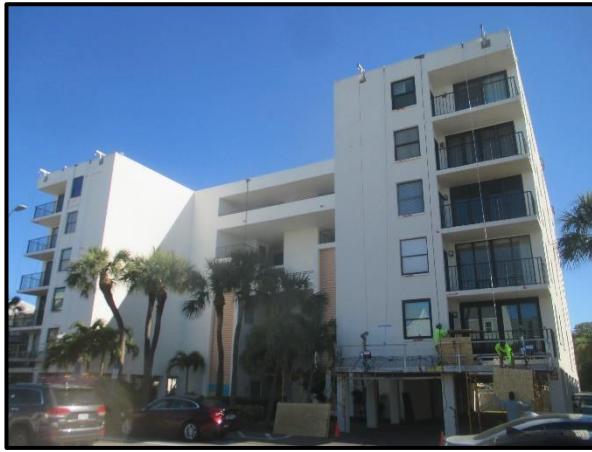
Fig. 1 – Overview of West Elevation of Building.

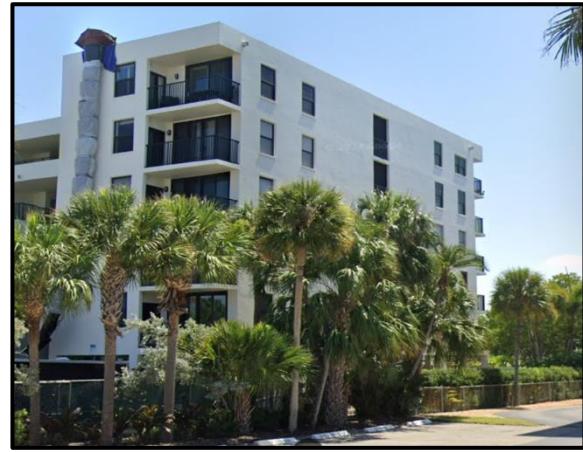
Fig. 2 – Typical Overview of Side Elevations of Building.

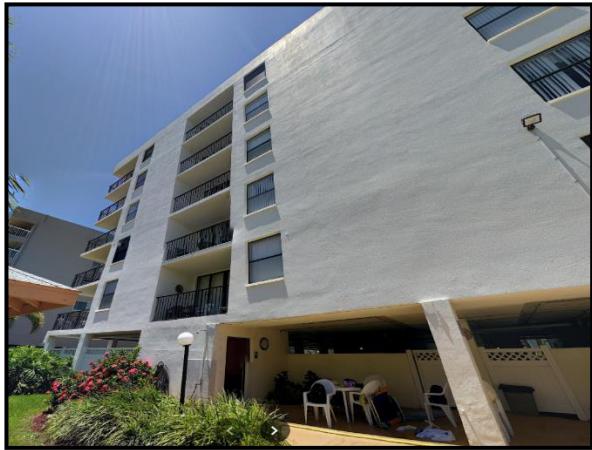
Fig.3 – South Overview of East Elevation of Building.

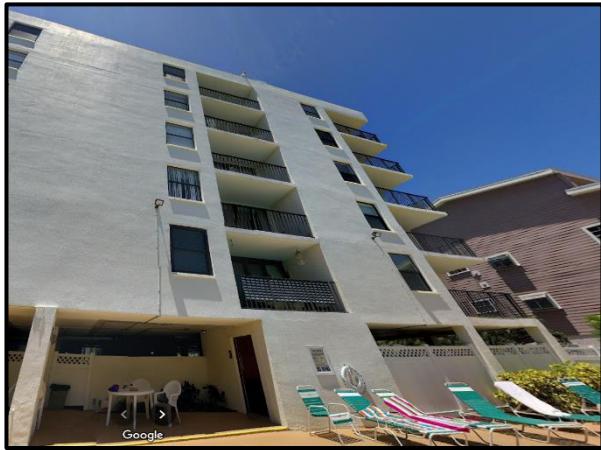
Fig.4 – North Overview of East Elevation of Building.

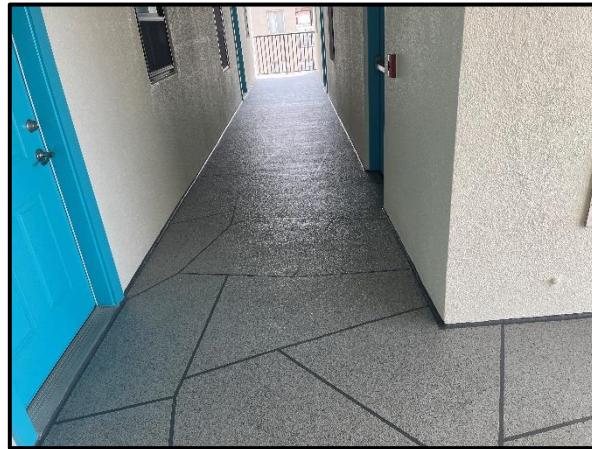
Fig.5 – Typical Gemstone Waterproofing Coating at Walkways.

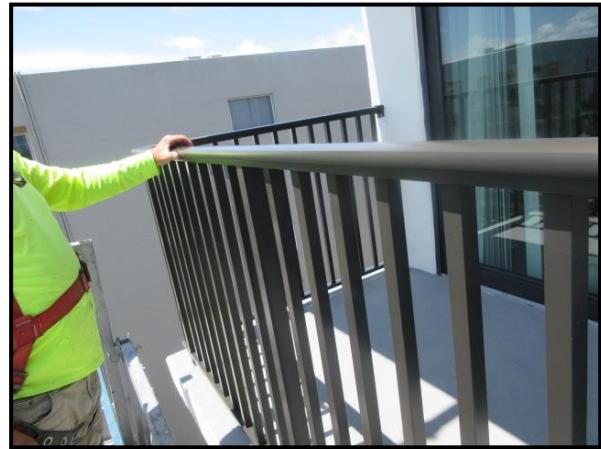
Fig.6 – New Railing System Installed at Balconies (42" Height – 4" Picket Spacing).

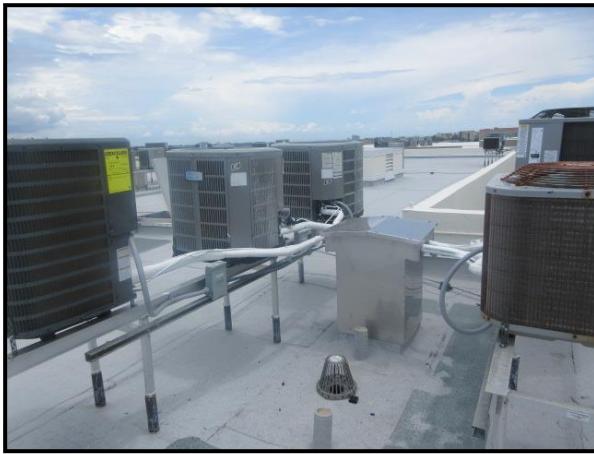
Fig.7 – Overview of New Modified Bitumen Roofing System.

1. The roof has been recently completed and has a 20-year NDL warranty. KE recommends that the Association have annual maintenance performed by the roofing contractor that installed the roof system in order to maintain the warranties and address any minor repairs that are needed. Inspections should be conducted at least every 12 months.
2. The complete building restoration has been recently completed. Therefore, KE recommends that the Association plan for annual inspections to identify any possible warranty repairs and address isolated new damaged as needed. KE has found that periodic inspections and smaller repair projects reduce the need for larger restoration projects in the future.

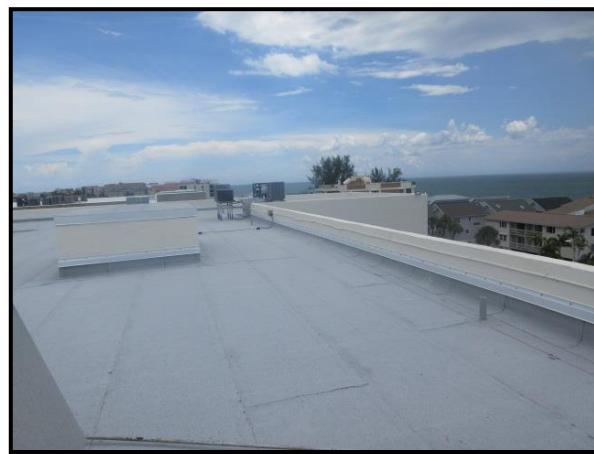
Fig.8 – Overview of New Modified Bitumen Roofing System.

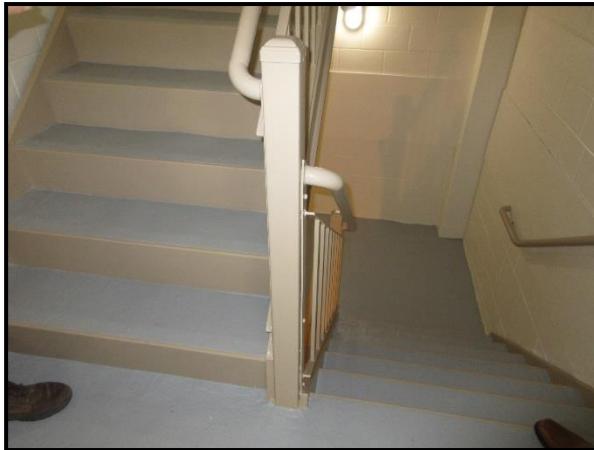
Fig.9 – Typical Metal Stairwells with Concrete Topping Slab.

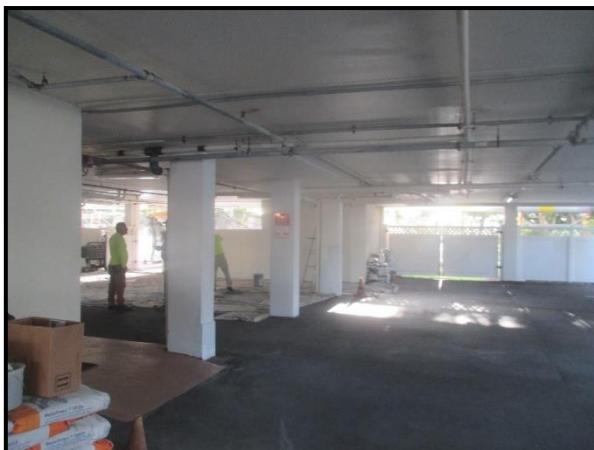
Fig.10 – Typical Overview of Under-Building Parking.
