February 16, 2023

Port Royale of Indian Shores Condominium Association, Inc.  
19941 Gulf Boulevard  
Indian Shores, FL 33785

Structural Integrity Reserve Study (SIRS)  
UES Project No: 2211.2200005

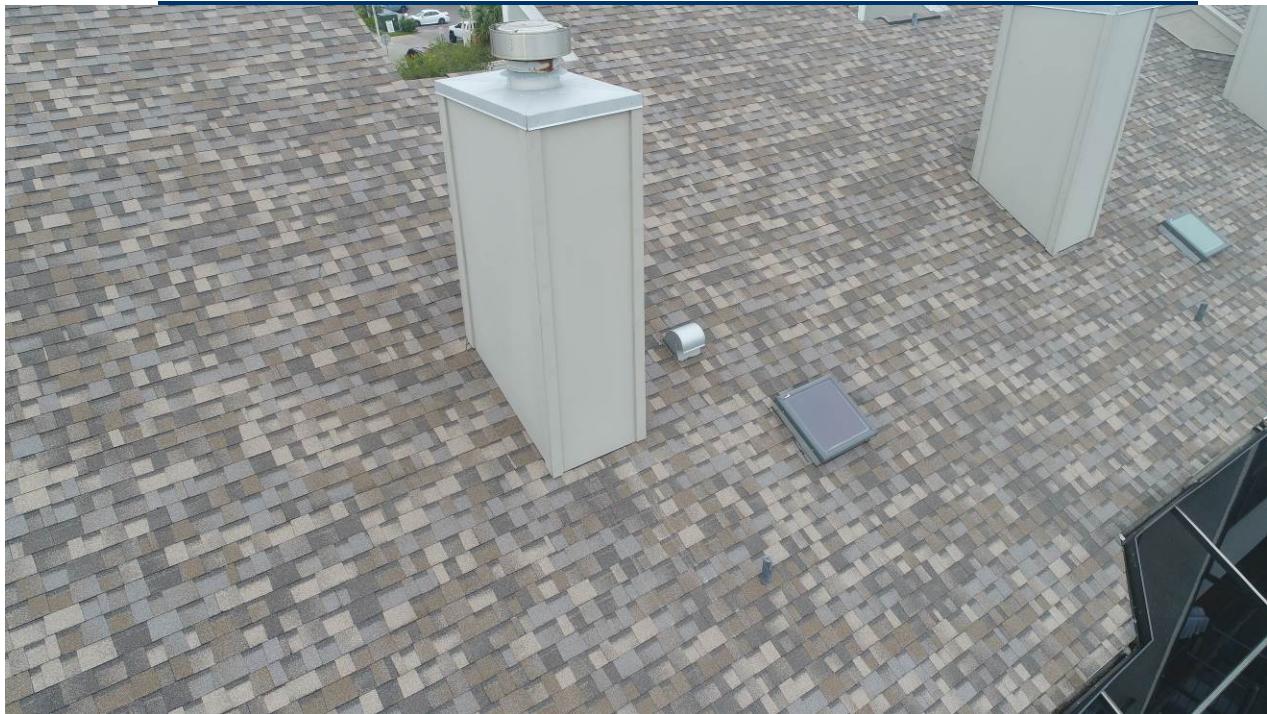
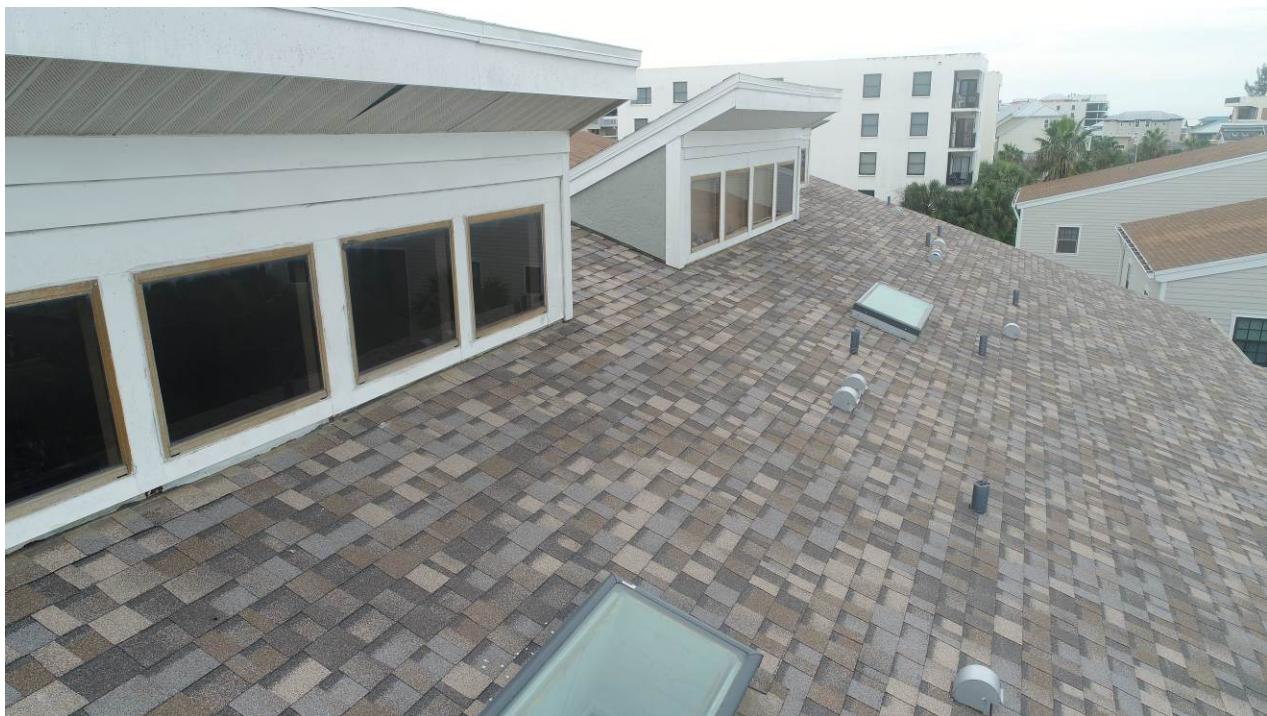
The existing roofing shingles were replaced in 2019 as reported. The existing roofing was observed to be in good condition. No issues were detected.

Typical Roof Covering – Reported was Replaced about 3 years ago

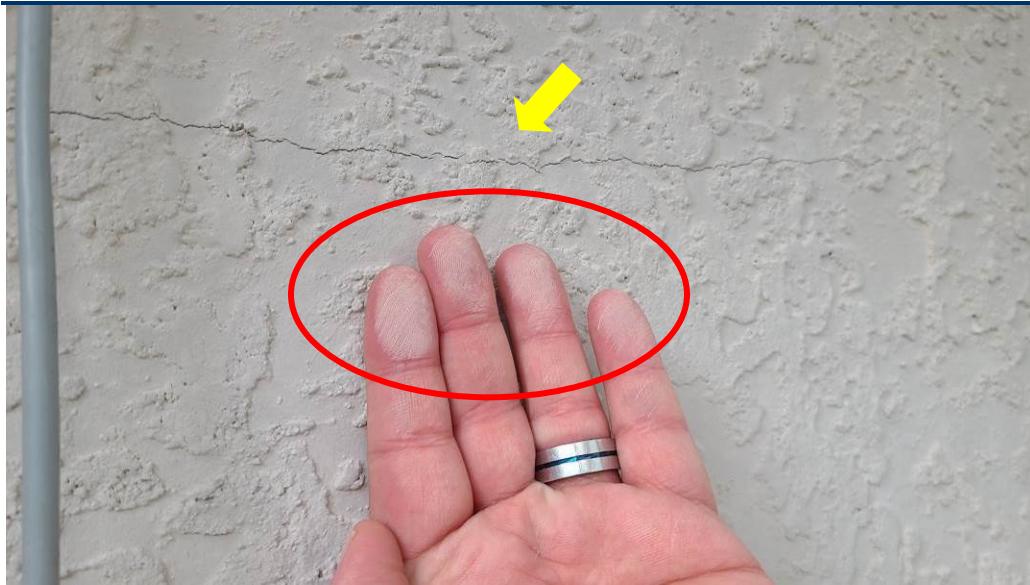
Photograph 7: Unit A 3<sup>rd</sup> Level Balcony – Hairline Stucco Crack on the Exterior Frame Wall (NOT Structural) with Chalking Paint Condition on Building Rear Walls

In general, paint coating can last and be warrantied up to 10 years, depends on manufacturer and the applied layer thickness. However, most will start to exhibit fade color and chalk in year seven or eight. Therefore, it is recommended to have the paint repeating in seven – eight years cycle.

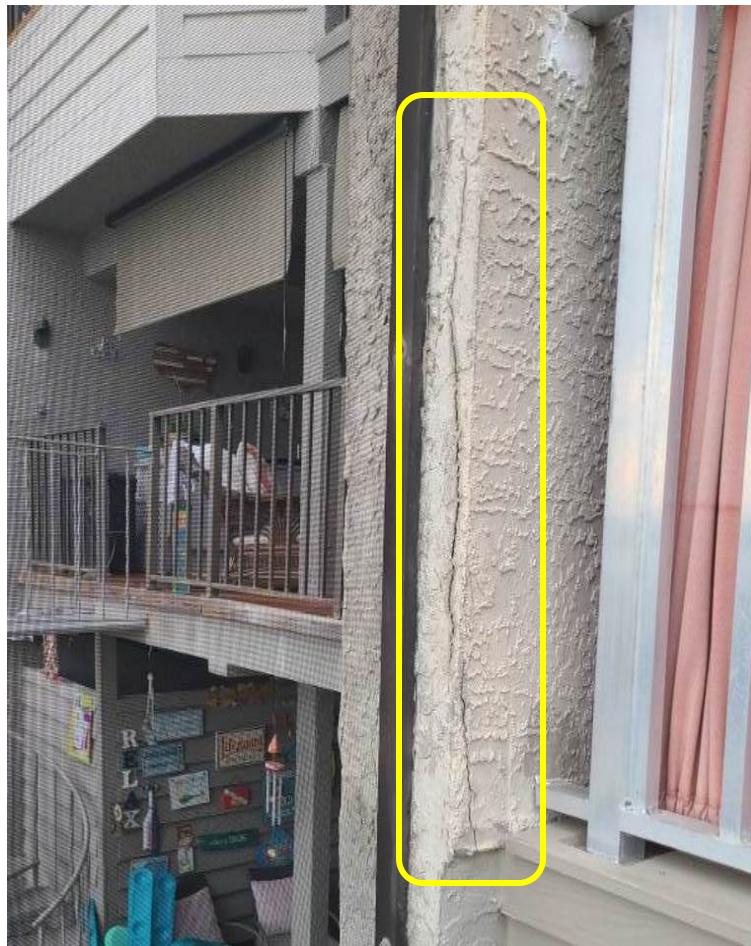
Wall Between Unit A & B at 3<sup>rd</sup> Level Balcony (Rear Elevation) – Hairline Stucco Crack on the Exterior Frame Wall (NOT Structural)

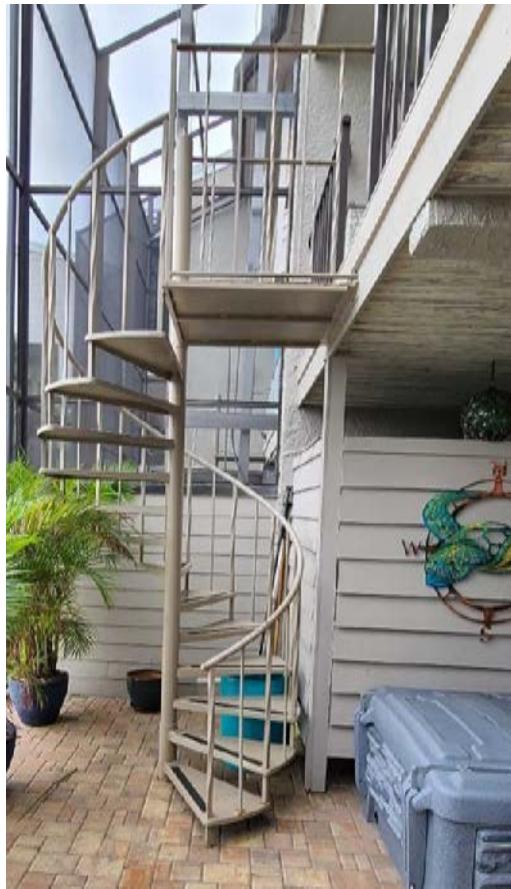
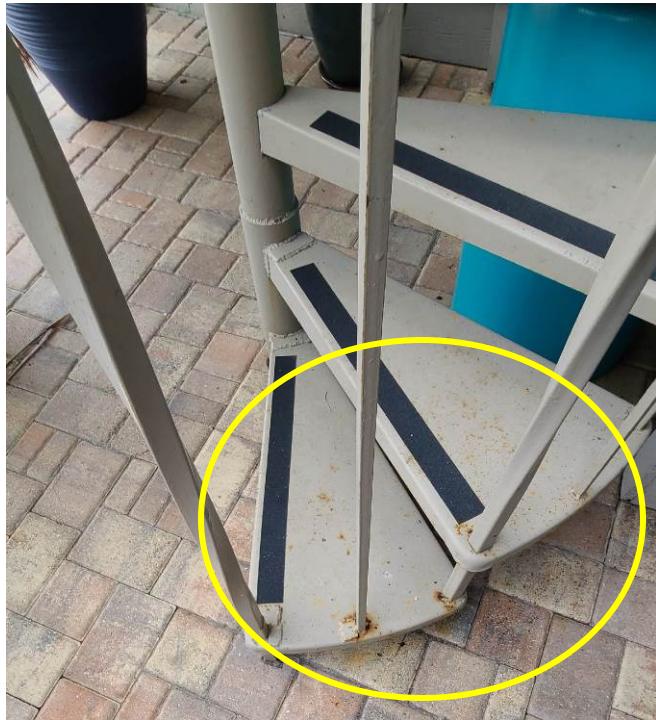
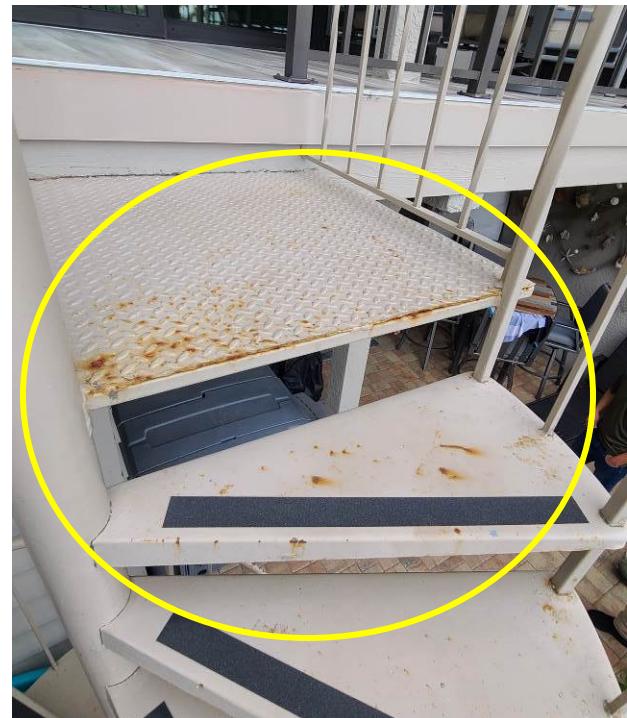
- No deficiencies were detected during our survey. Although the exterior metal spiral staircases that are located on the back elevation are for individual owners' responsibility. UES advises the Association to take into consideration the remediation of the specific staircases due to rust and corroded members we observed during our survey.

Unit #C at Rear Elevation – Metal Spiral Staircase with Signs of Rusted Members,  
Regular Maintenance by Unit Owner is Recommended

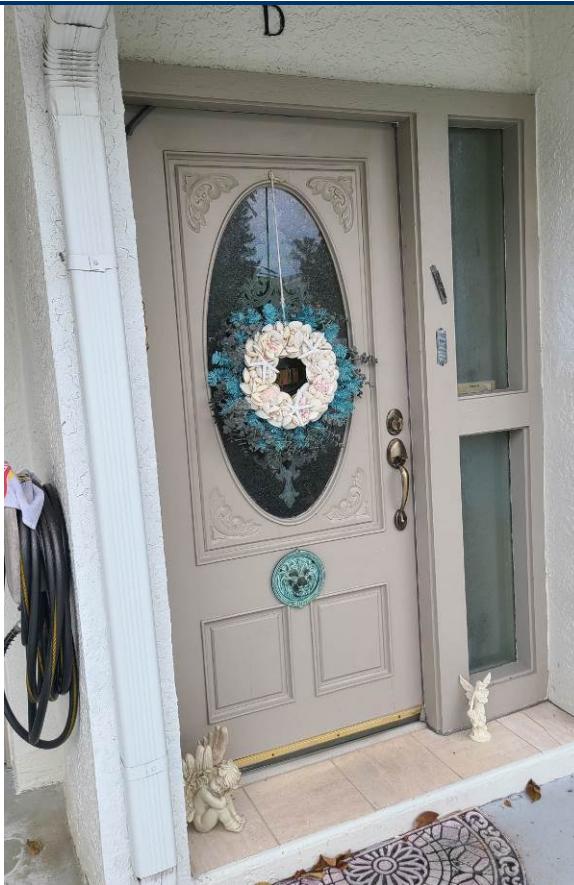
Unit Exterior Front (Main)Door – Units B, C & E Front Doors Reported to be New. Replacing the Original Front Doors for Unit A & D is Recommended but NOT Obligated

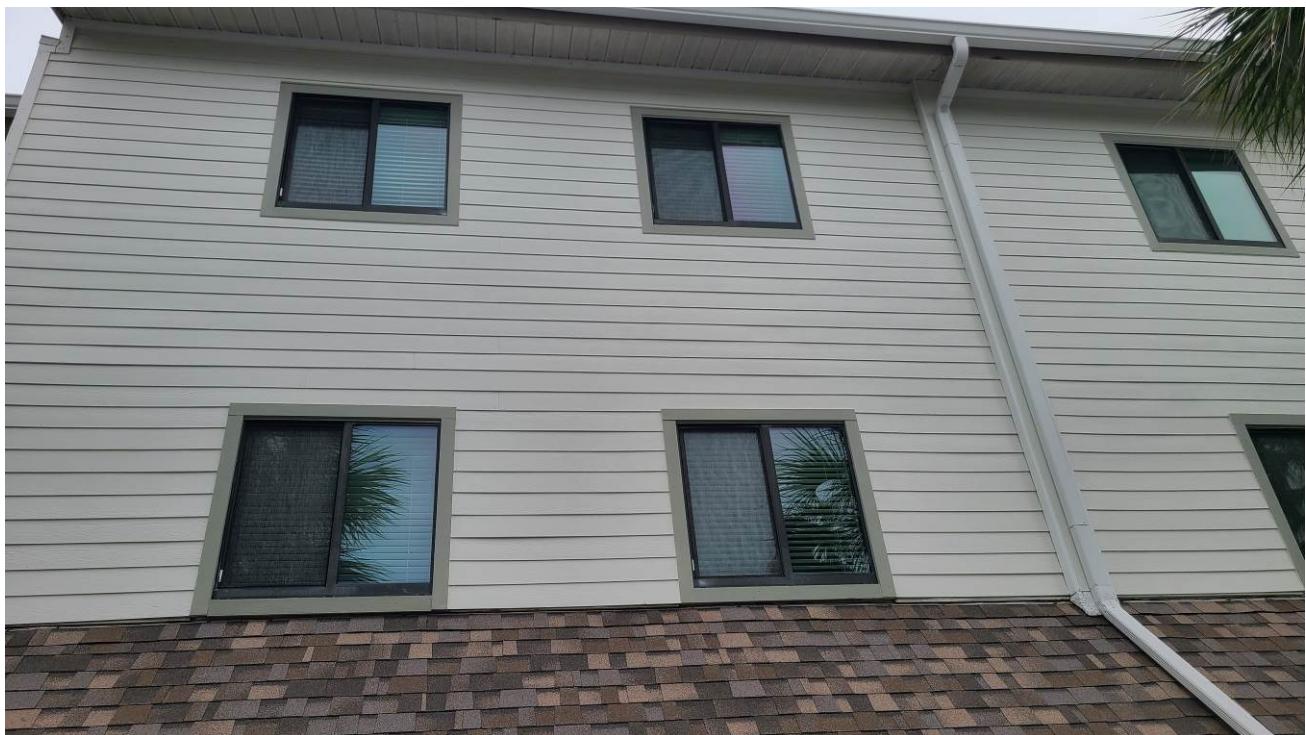
Exterior Front Windows – Reported to be New

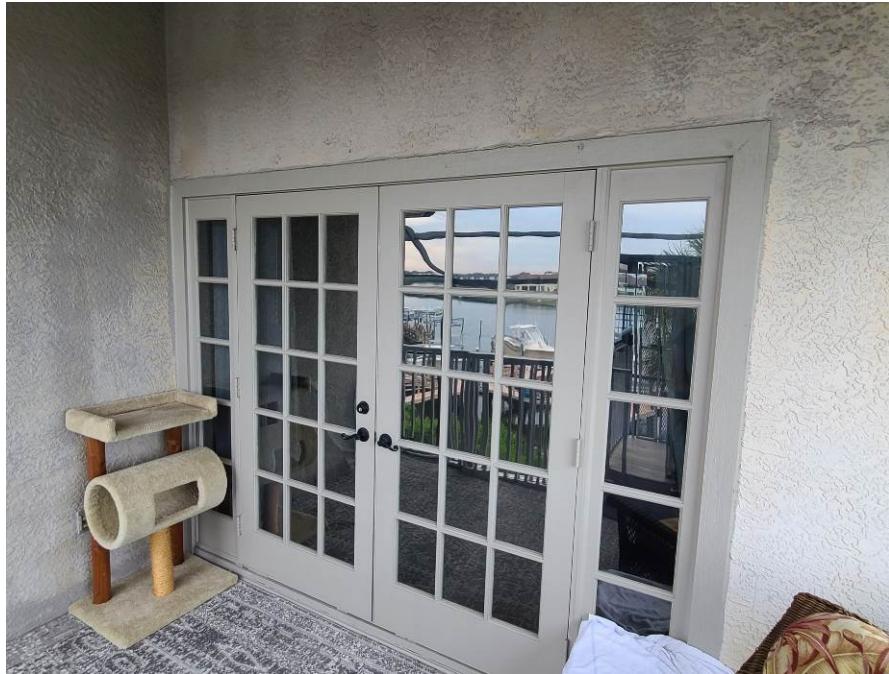
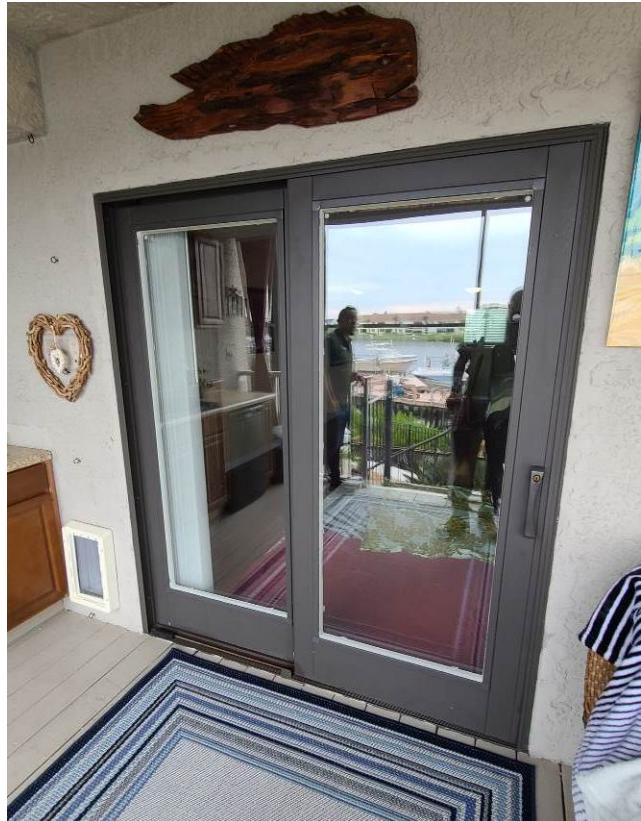
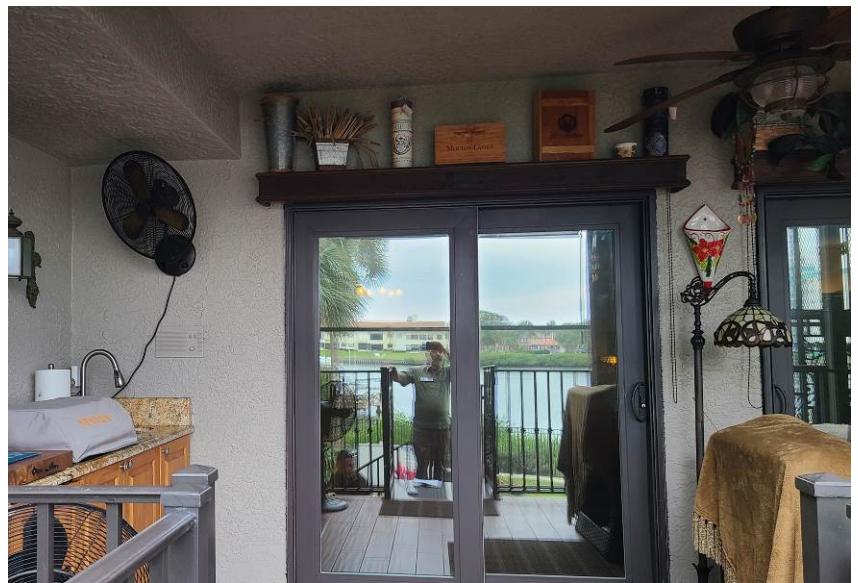
Typical Unit Sliding Glass Doors (SGD) on Backside –  
No Issues were Observed

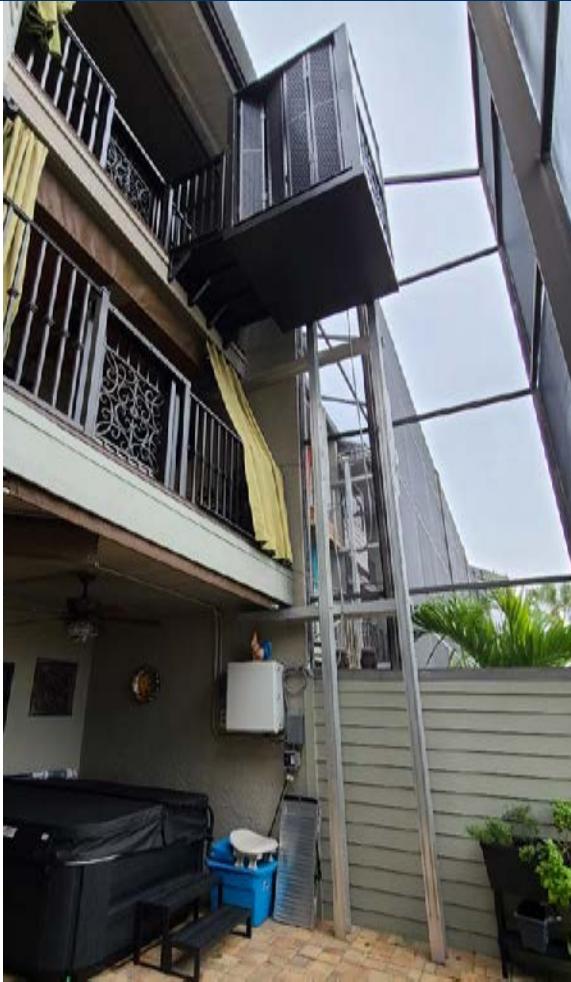
Horizontal Member  
Anchored to  
Adjacent Frame Wall

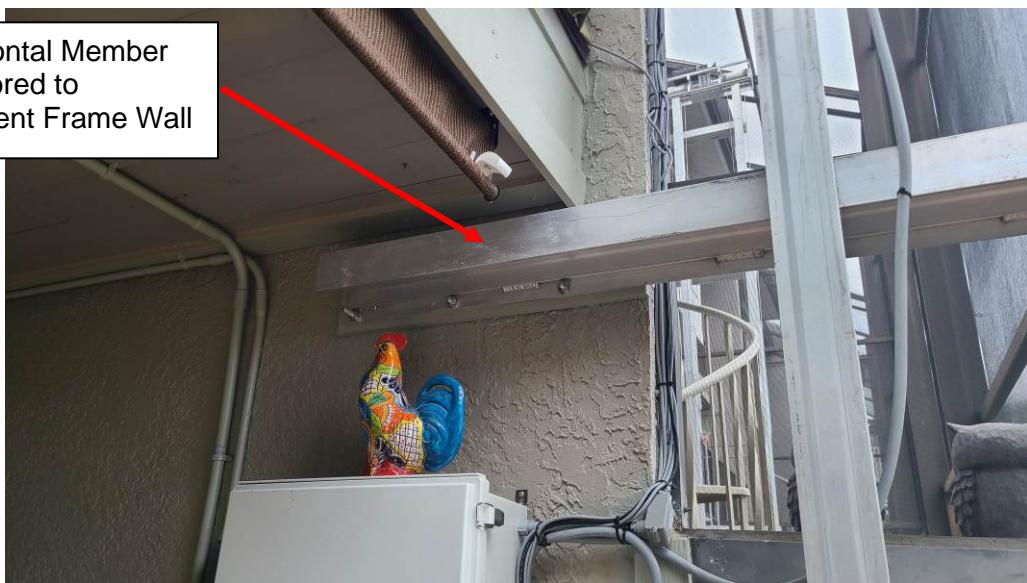
Unit #E – Exterior Private Elevator at Rear Side. Elevator has a Separate Concrete Footing and Its Horizontal Members Anchored to Exterior Frame Wall, Per Provided Installation Plans

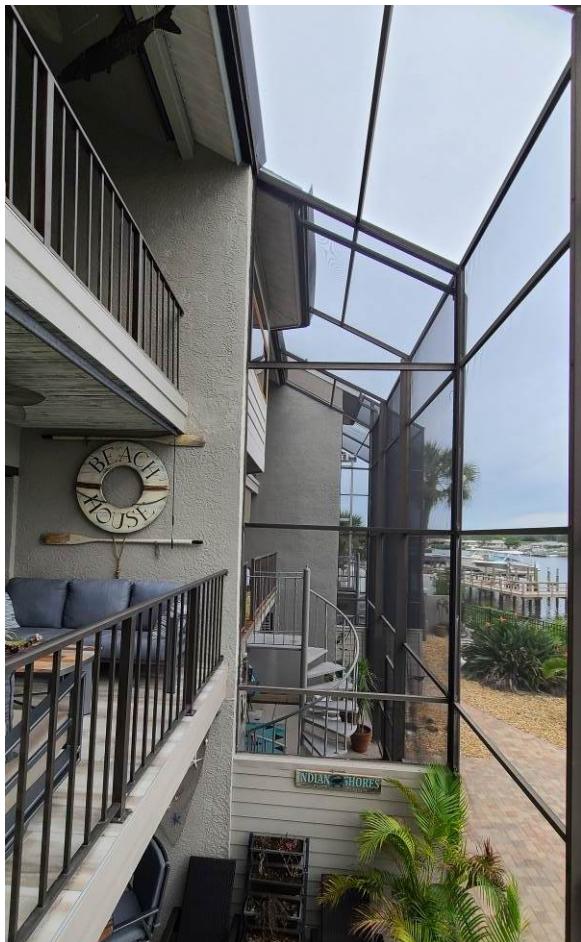
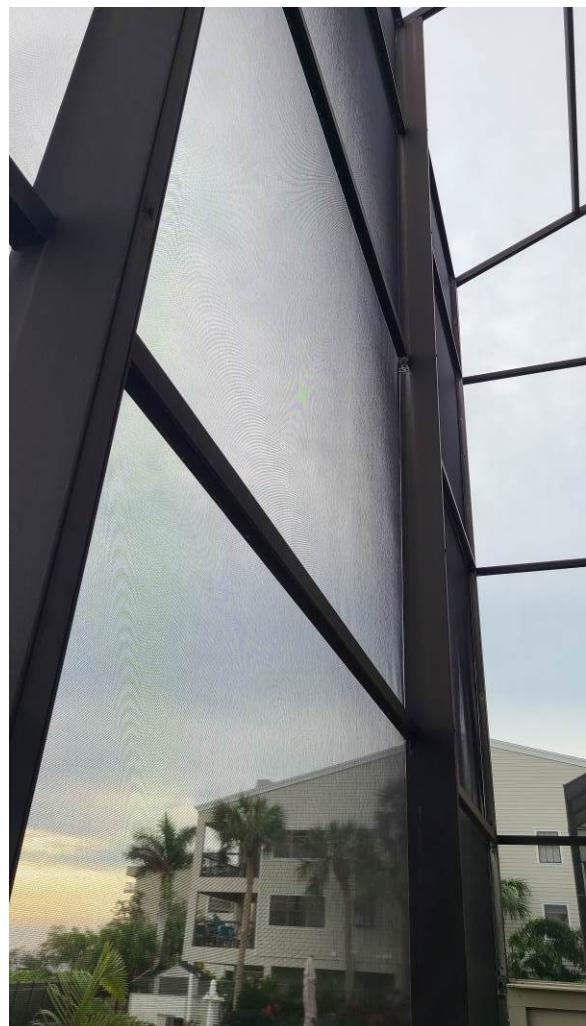
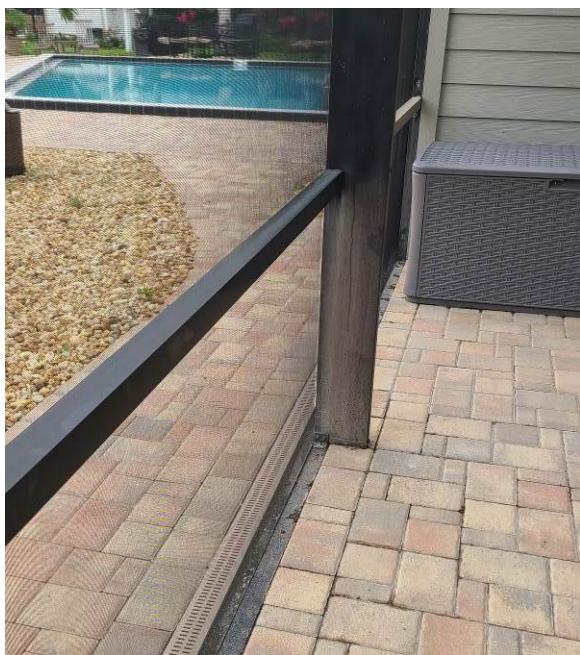
Backside Screens – No Issues were Observed
