RE: Sand Castle 1 Condominium – Milestone Inspection Report
20000 Gulf Boulevard
Indian Shores, FL 33785
KEG File# 21RT-0728

EXECUTIVE SUMMARY:

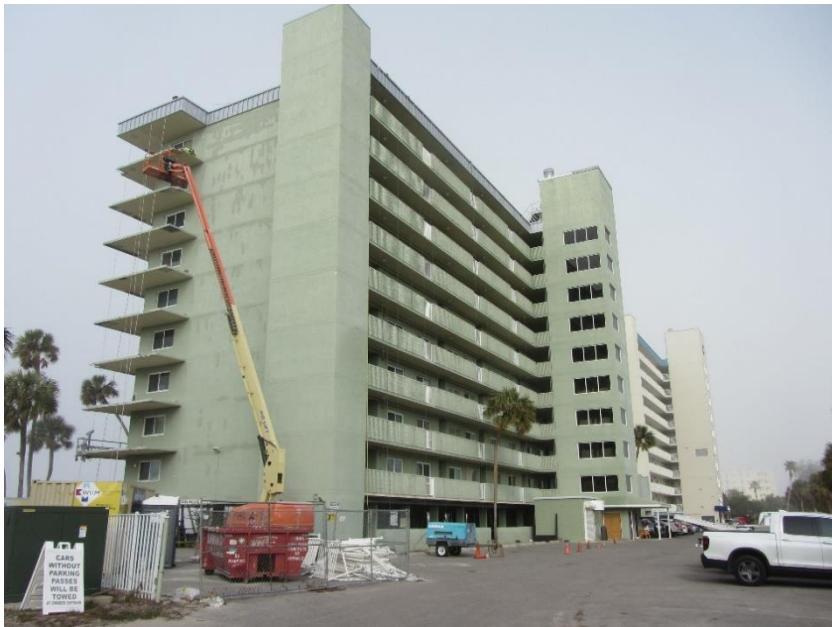
Photo #1 – Overview of Southeast Portion of Building during Restoration.

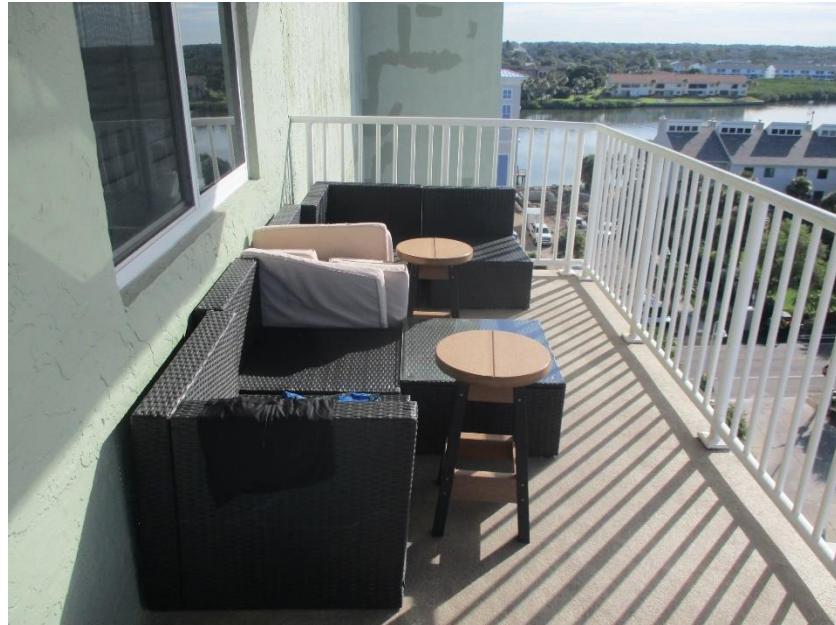
Photo #4 – Typical 01 Stack Balcony prior to Restoration.

1. Completion of the ongoing building wide concrete restoration, waterproofing, partial railing replacement, stair repair, and painting project in accordance with the contract schedule. The unit balcony's concrete restoration is planned for completion in Phase 1 and is on-going.

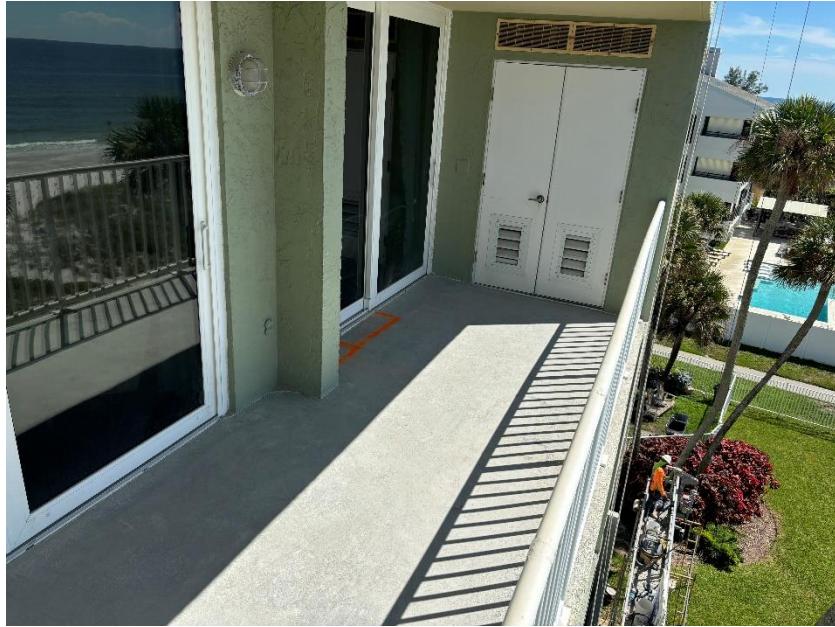
Photo #5 – Typical Unit Balcony During Restoration.

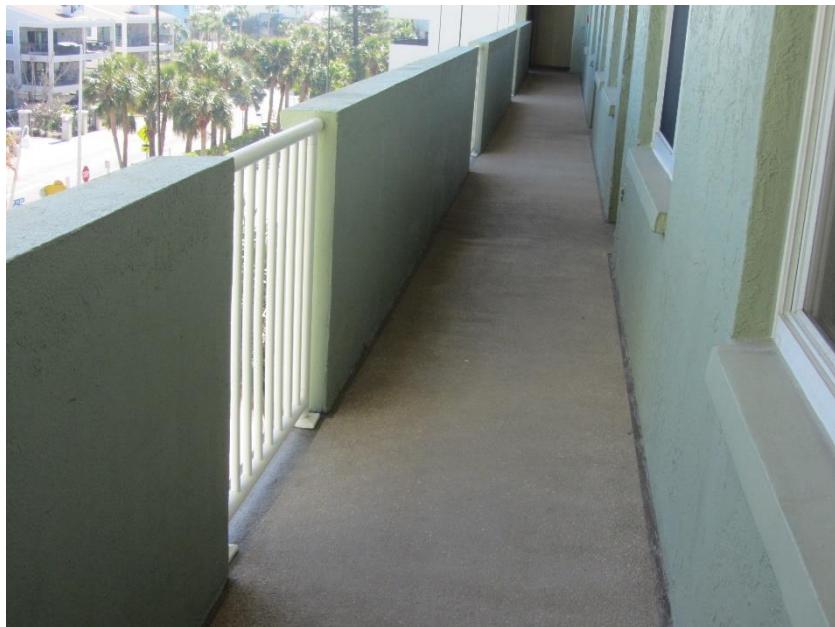
Photo #6 – Overview of Walkway Railing, Knee Wall and Floor Coating.

1. The existing railings at the balconies and walkways were left in place during the recent restoration projects with the exception of the "01" and "08" balcony locations. They currently meet 2023 FBC dimensional requirements. KE recommends that they be periodically inspected for corrosion and damage. The Association should plan for replacement of all balcony railing in approximately 4 years and the walkway guardrails within 6 years. The exact replacement timeline will be dependent on the results of future inspections and in accordance with the schedule set forth in the Association's Structural Integrity Reserve Study (SIRS).

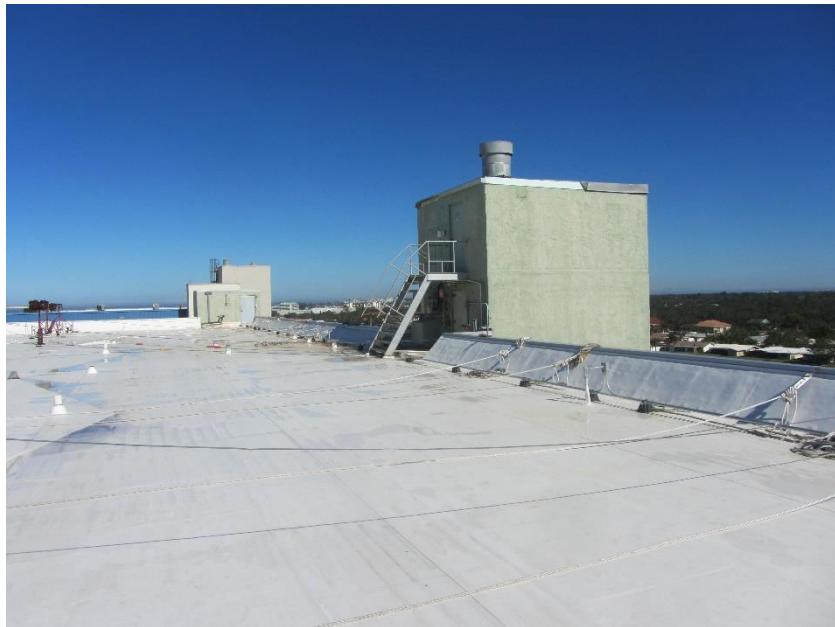
Photo #9 – Overview of TPO Roof, Has Been Installed for Approximately 2 Years.

3. The main roof system was recently replaced in 2022 with a TPO roof covering. The Association should perform regular inspections and perform warranty, maintenance and repairs as needed in order to repair any minor damage that may occur and maintain the warranty from the manufacturer.

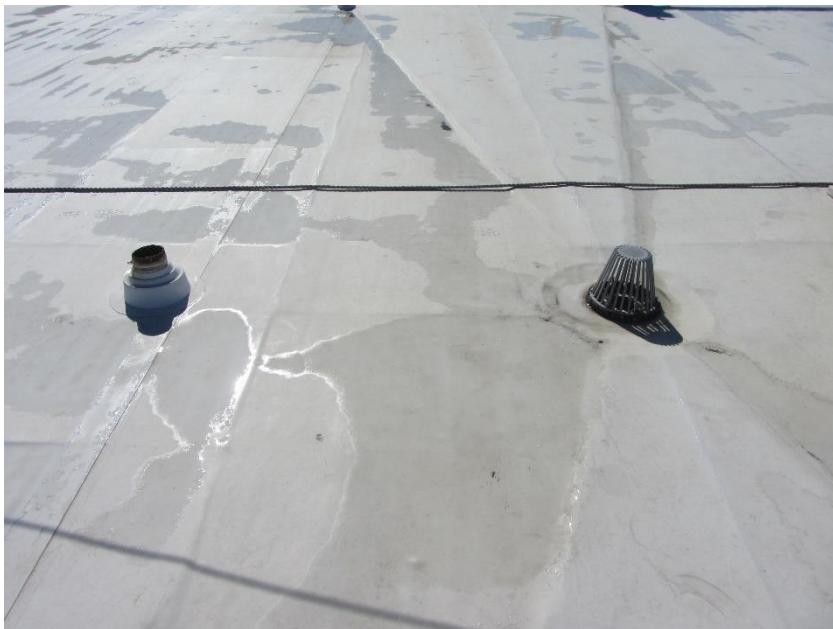
Photo #10 – Close Up Of Roof Drain and Vent Stack with TPO Boot.

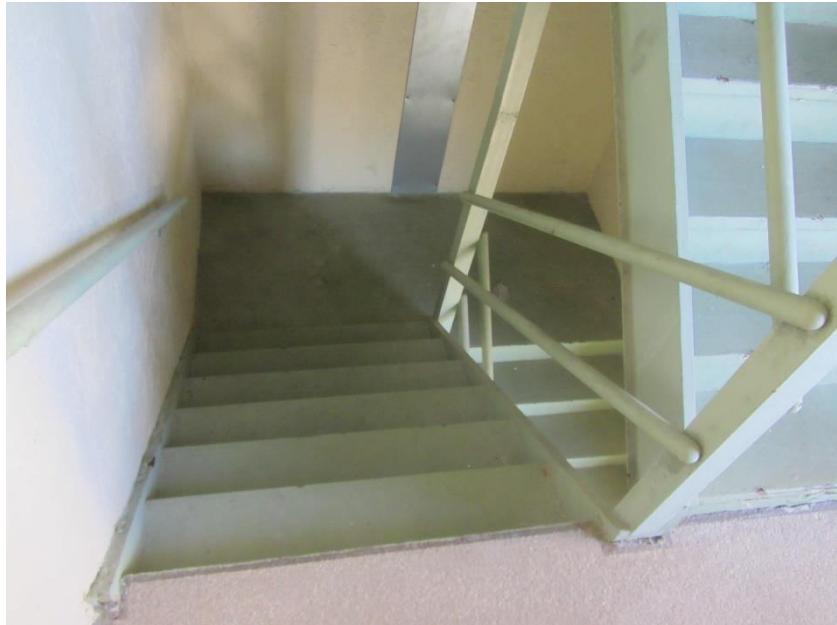
Photo #11 – Overview of North Stairway Prior to Repairs and Painting

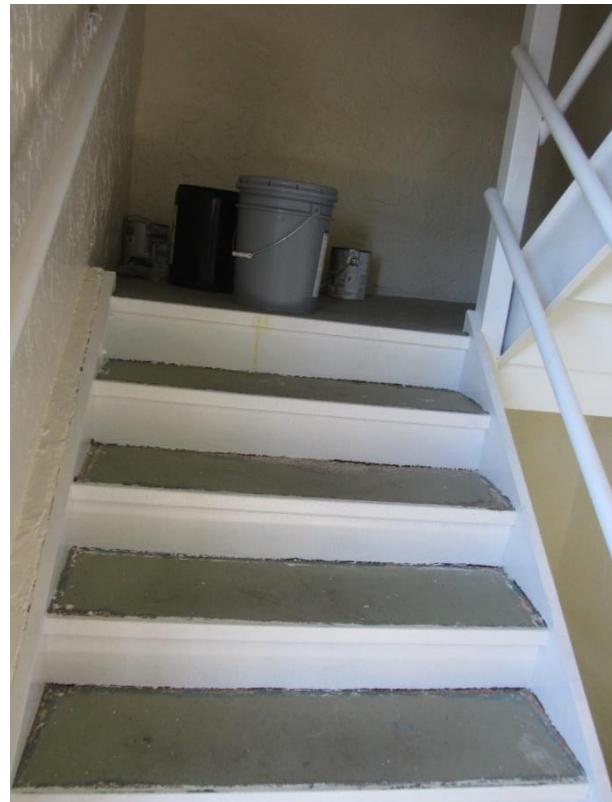
Photo #12 – Overview of Steel Stairwell at North End with Partial Repairs and Painting In Progress.

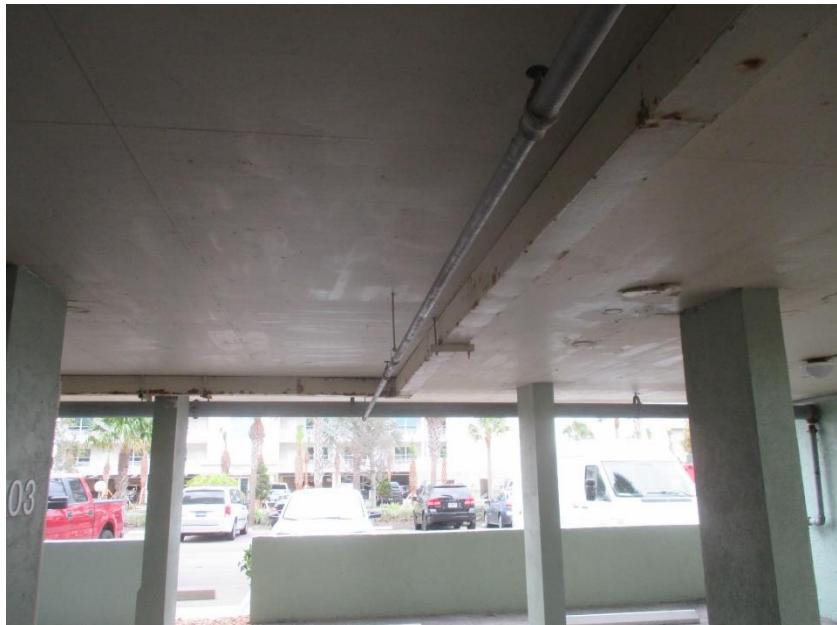
Photo #14 – Overview of Garage Ceiling Prior to Restoration.
