April 3<sup>rd</sup>, 2024

THIS MILESTONE PHASE 1 INSPECTION REPORT WAS PRODUCED FOR PIER HOUSE CONDOMINIUM ASSOCIATION, INC. LOCATED AT 20019 GULF BLVD, INDIAN SHORES, FL 33785

## PIER HOUSE

### MILESTONE PHASE 1 INSPECTION SURVEY

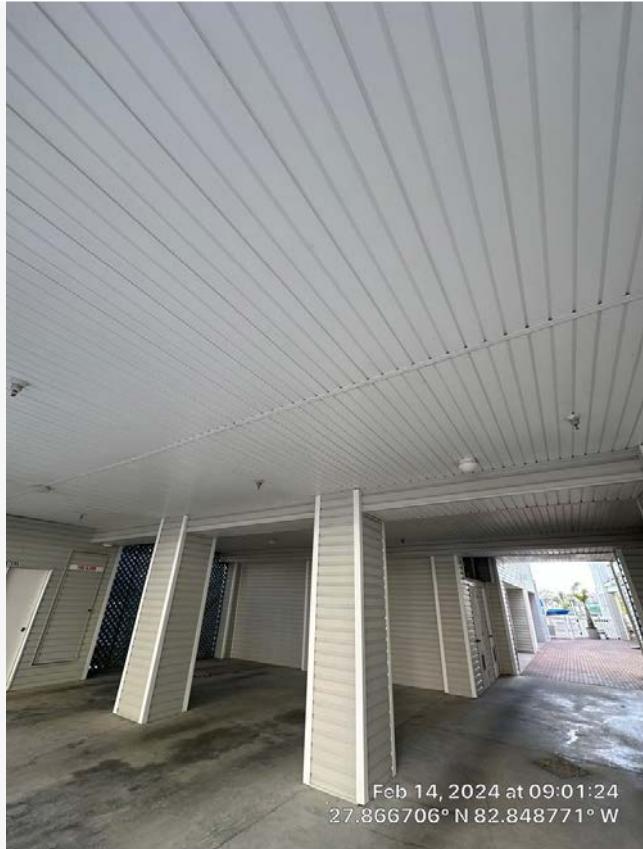
Ground level parking garage under living space. Exterior siding and garage ceiling is in good condition.

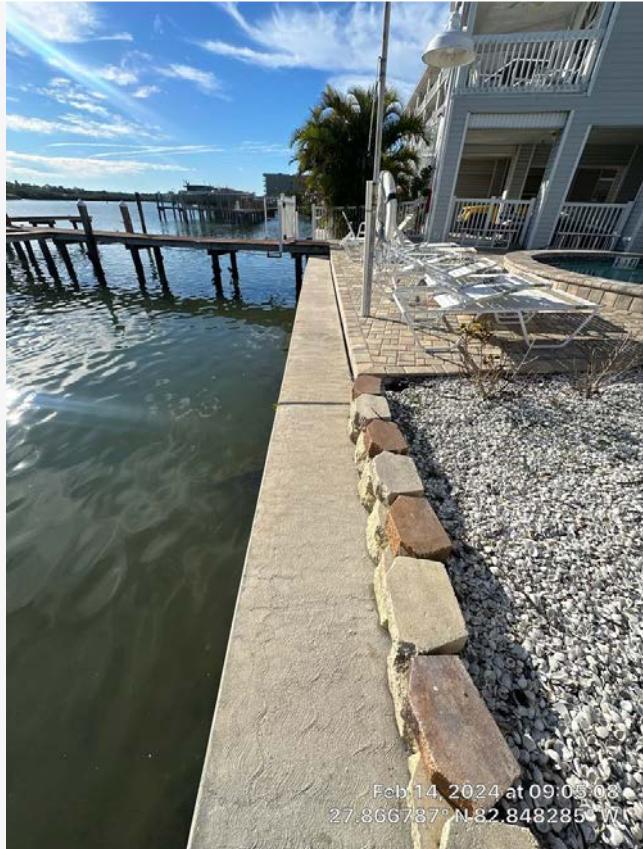
Seawall is in good condition.

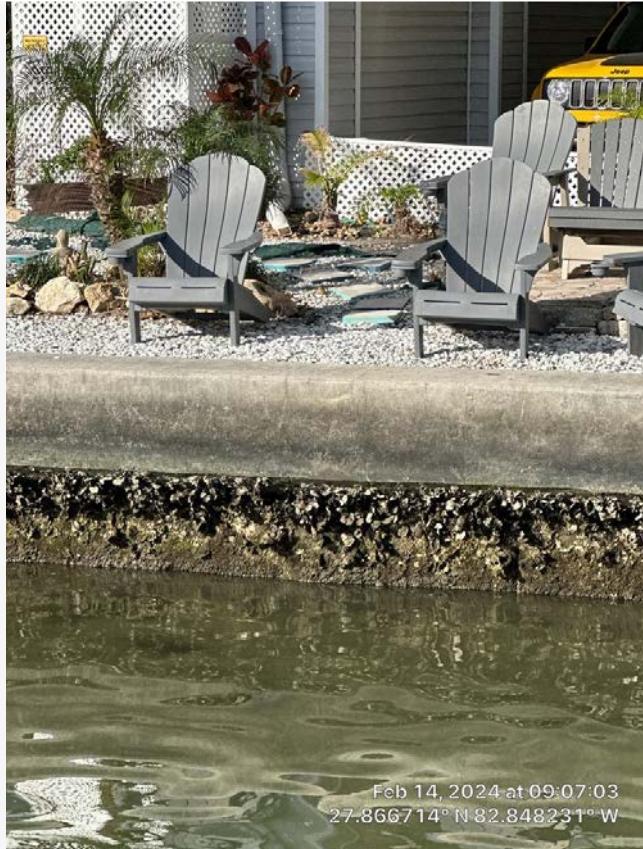
Seawall is in good condition.

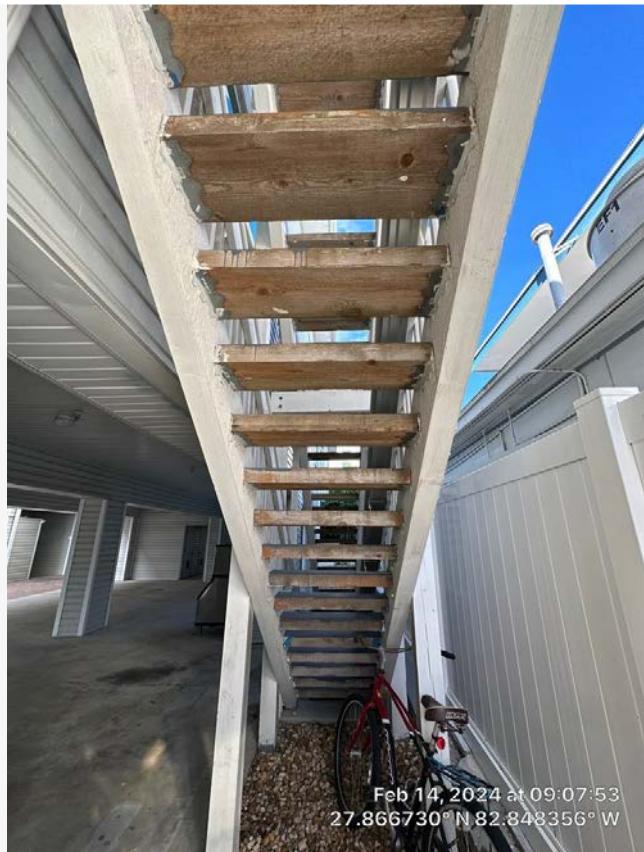
Exterior stairs, North side. Good condition.

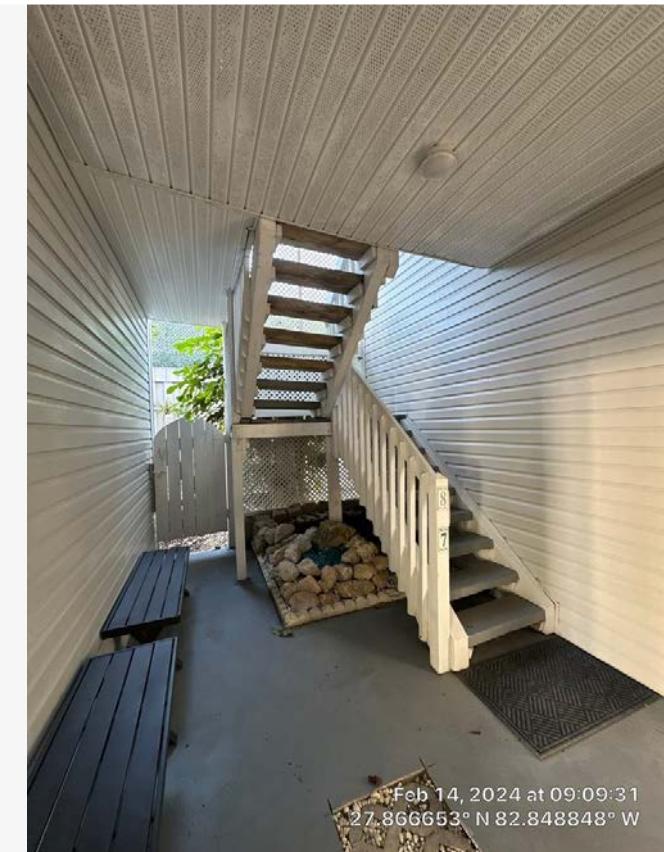
- 1) Stairwell wood framing deterioration observed at North-West Corner, West stairwell on North side, East stairs on South Side, Center stairs, and South stairs.
- 2) Railing repair location previously noted above.

Exterior stairwell, north west corner of building. Stairs are in fair condition. Rusting fasteners observed at top of stairs, which is typical for wood framing in this coastal environment. It appears that the Association has been performing regular maintenance and wood framing repairs on these locations.

- 1) Continue with maintenance repairs and upkeep to exterior wood stairwell framing on an as-needed basis.

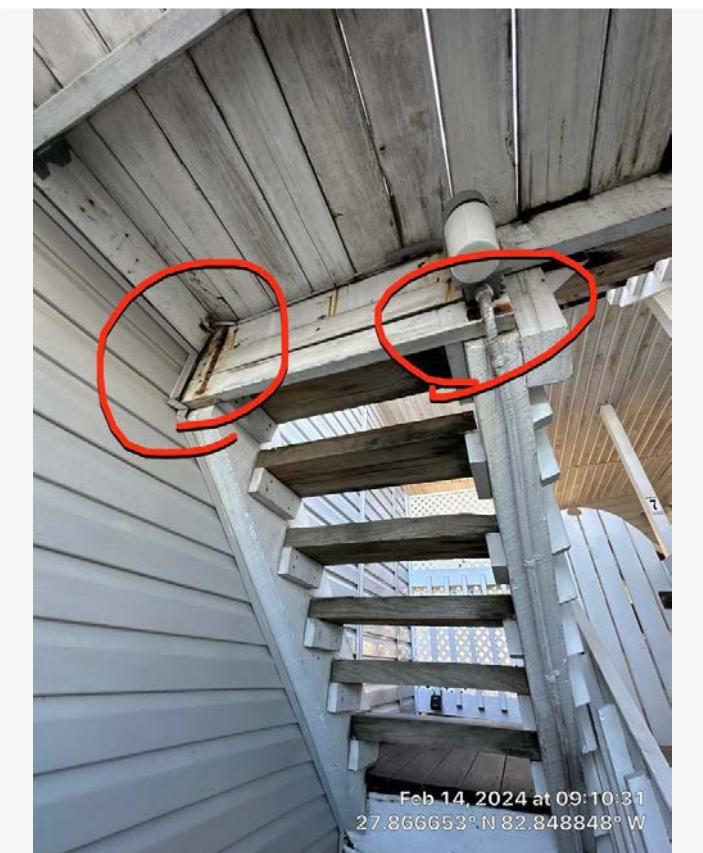
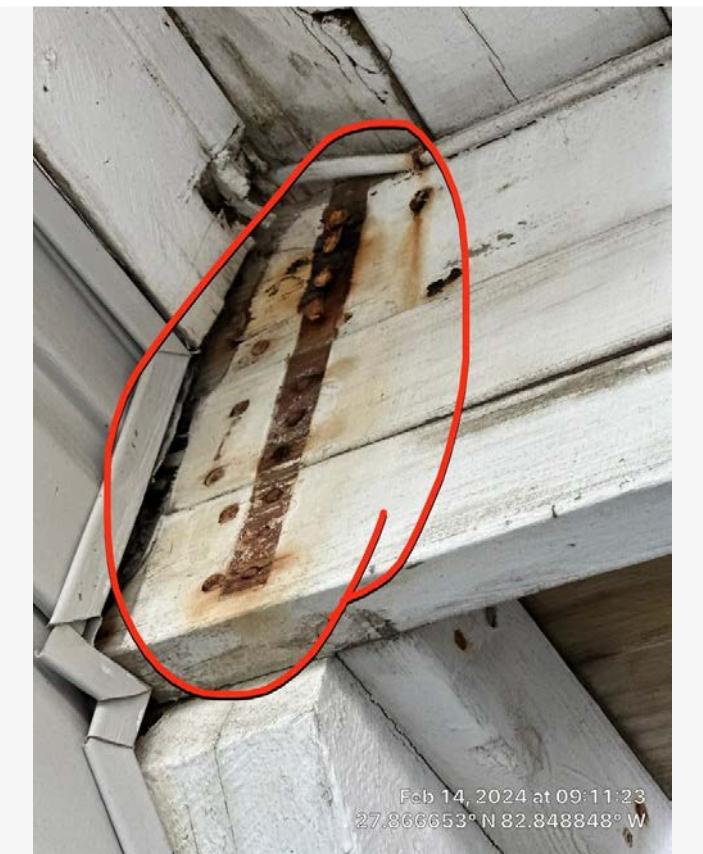
Rusting and missing fasteners West stairwell, North side of building. These locations will require repair and/or replacement of the fasteners.

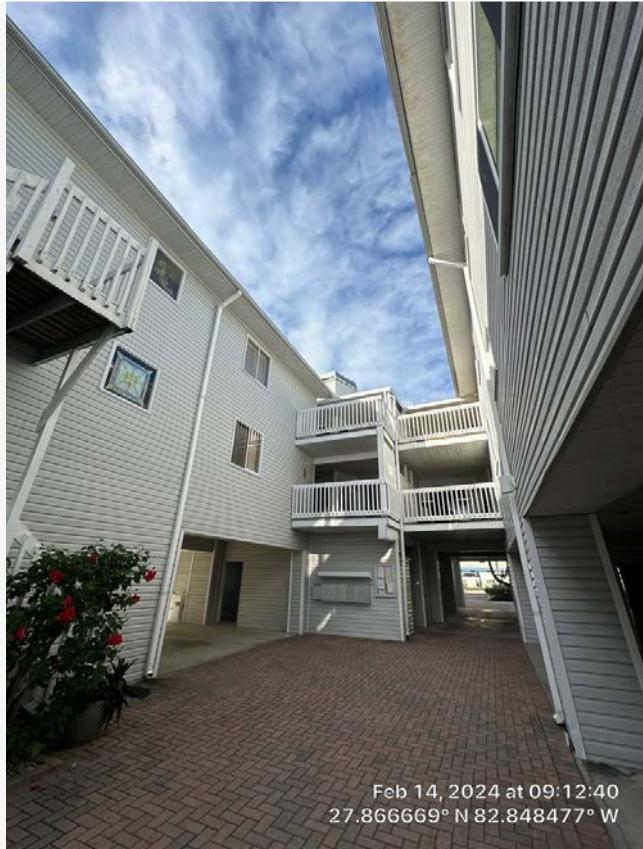
Center courtyard, looking West. Exterior siding is in good condition.

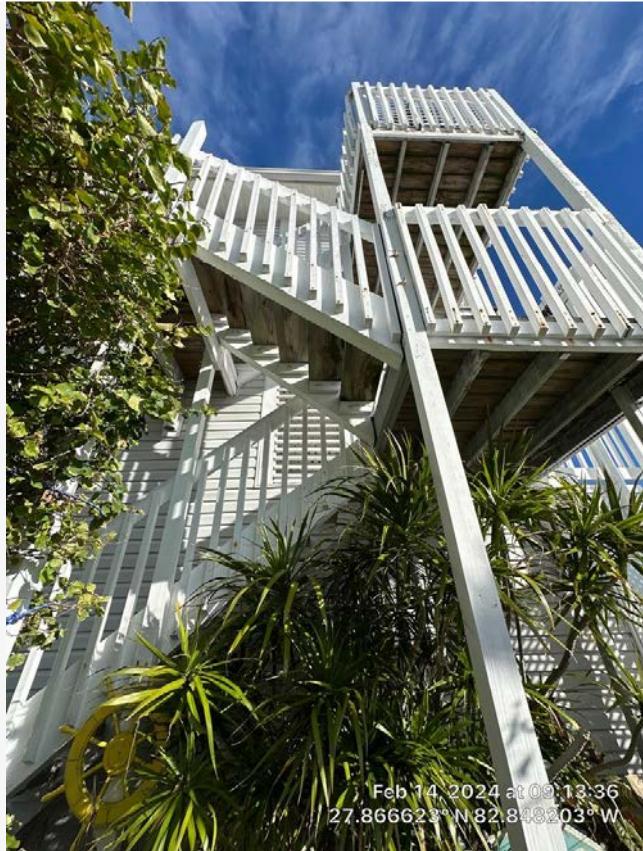
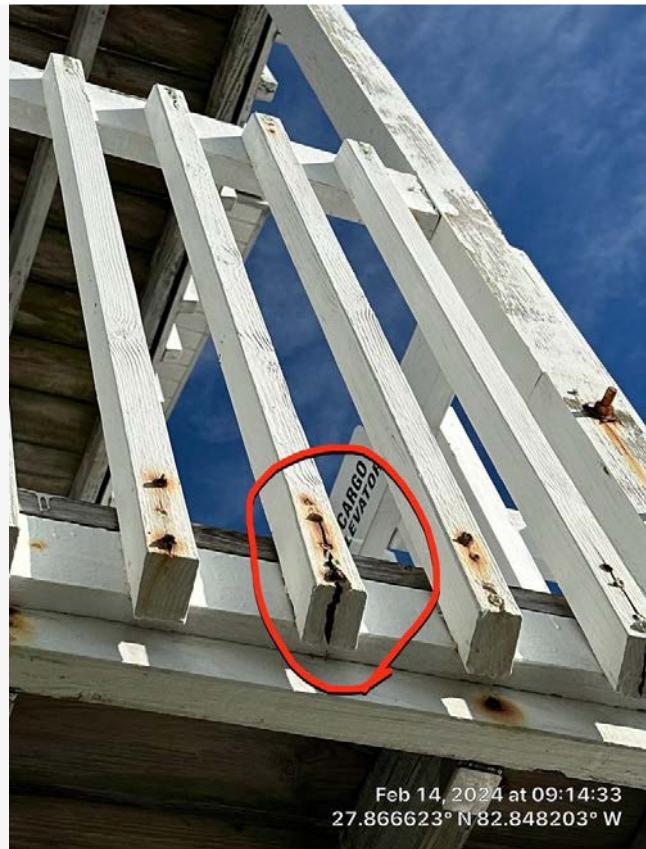
East stairs, South side of building. The wood framing is in fair condition. Rusting fasteners and split wood framing observed.

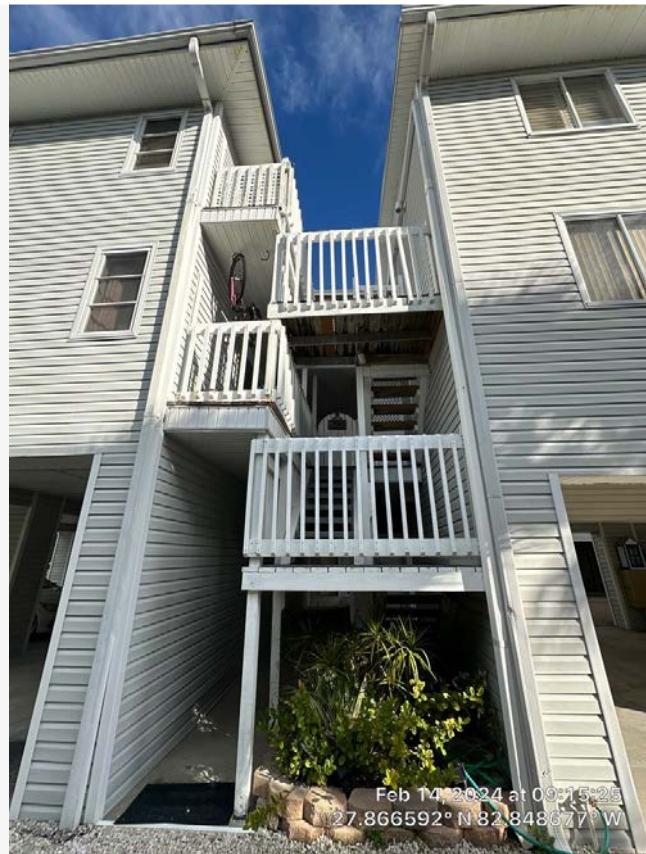
West stairs, South side of building. Fair condition. Rusting fasteners observed. Stairs are generally in fair condition on this building, and they need ongoing maintenance through the years. Wood members will occasionally have to be repaired or replaced, which is typical for wood in this coastal environment. Ongoing maintenance repairs are evident, and the Association just needs to continue performing this work on an as-needed basis.

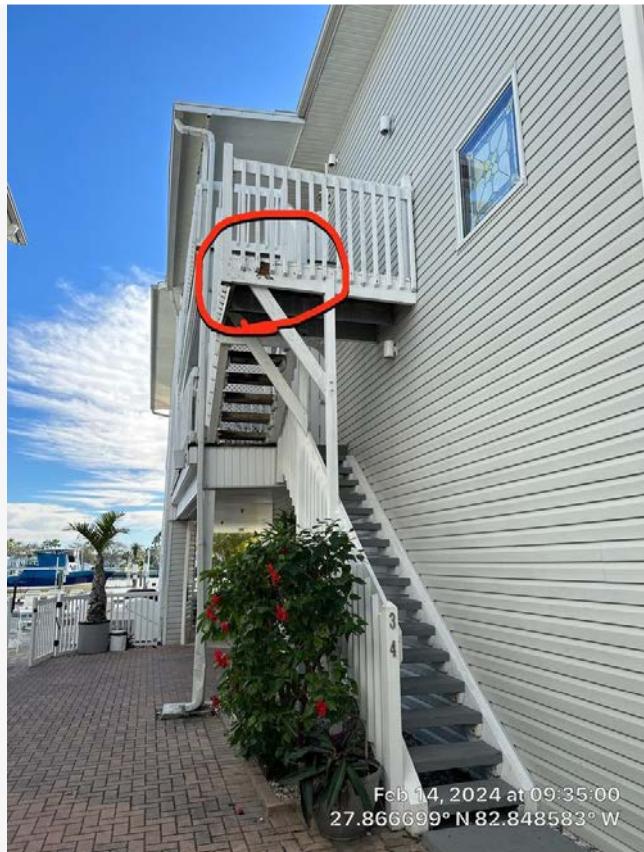
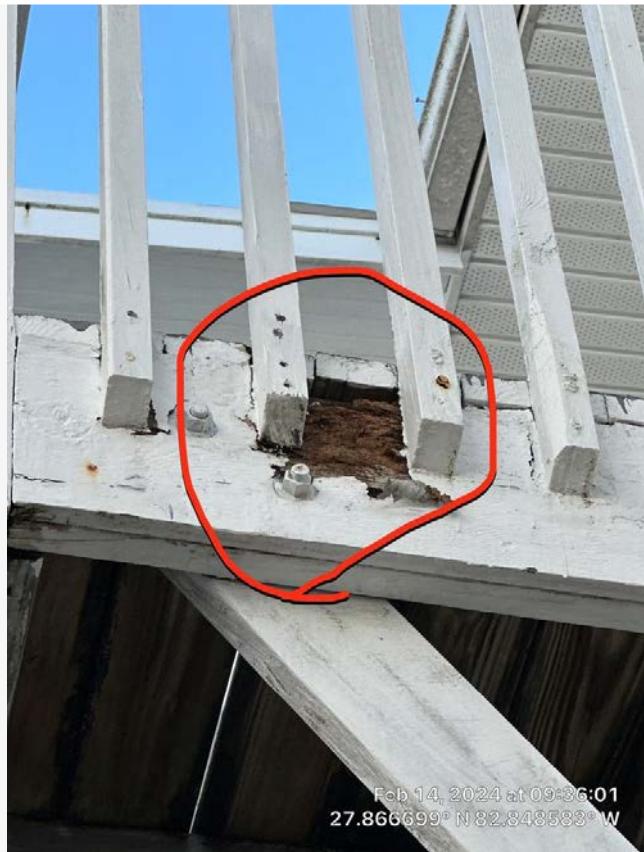
Unit 34, Center stairs. This location requires a repair to beam at top landing.

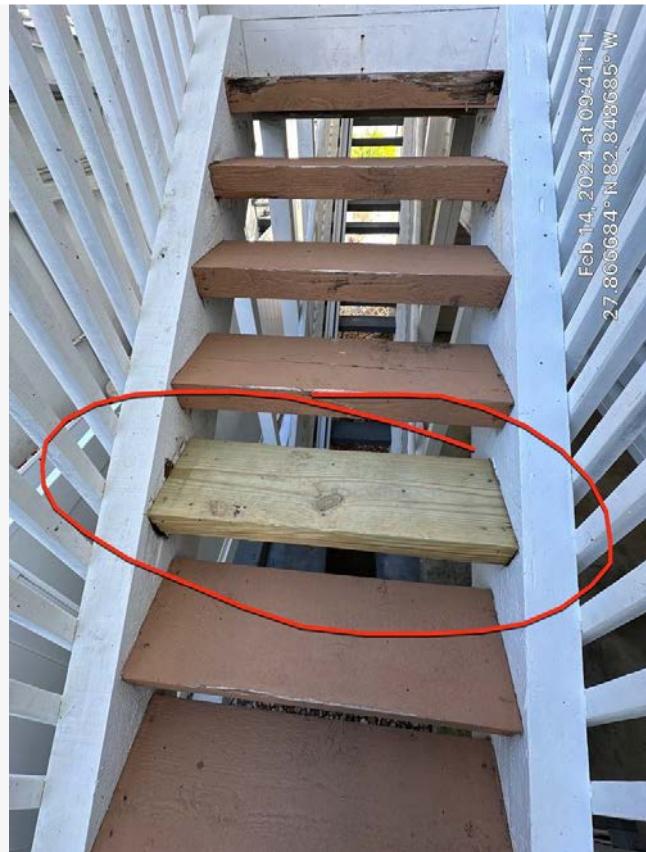
Wood framing repairs appear to have been made on an ongoing basis as required.

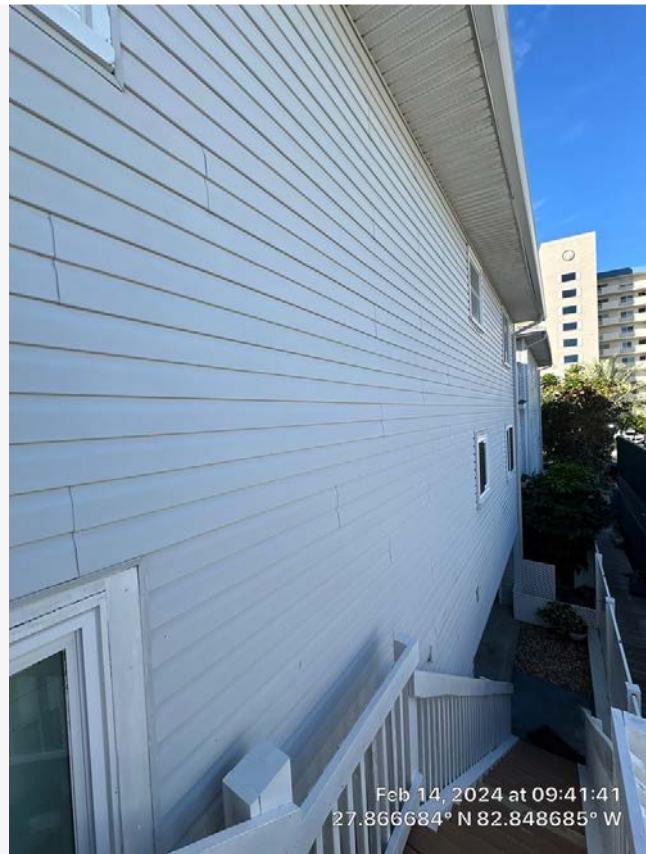
North elevation. Exterior siding is in good condition.

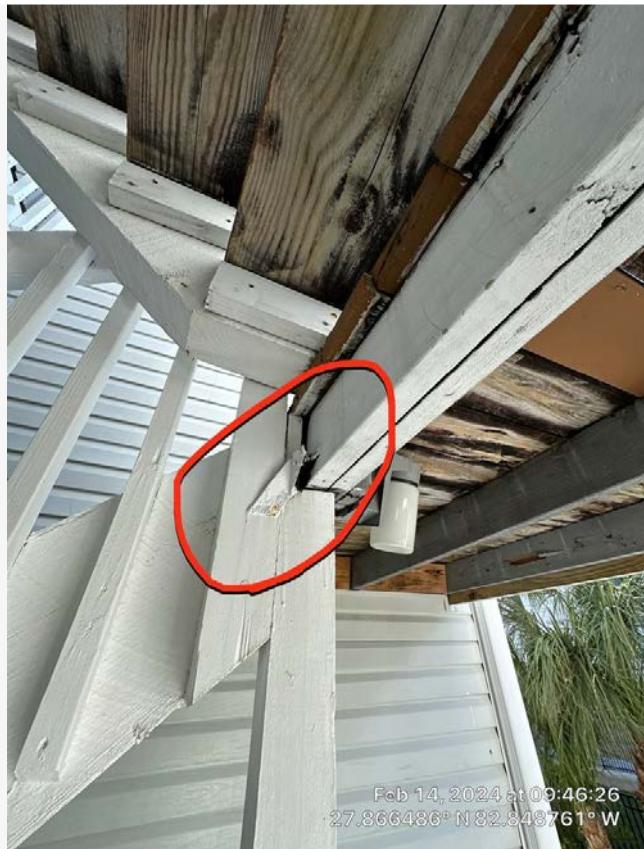
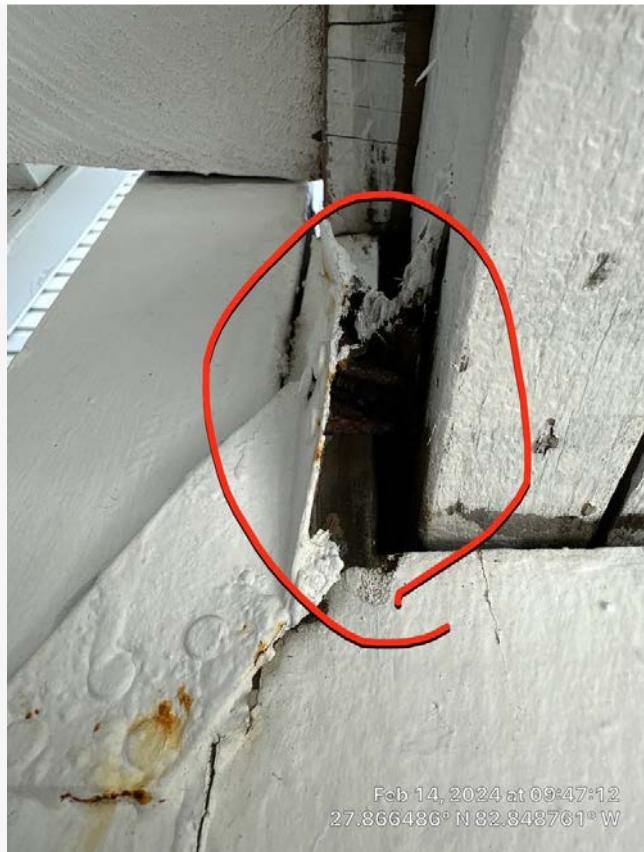
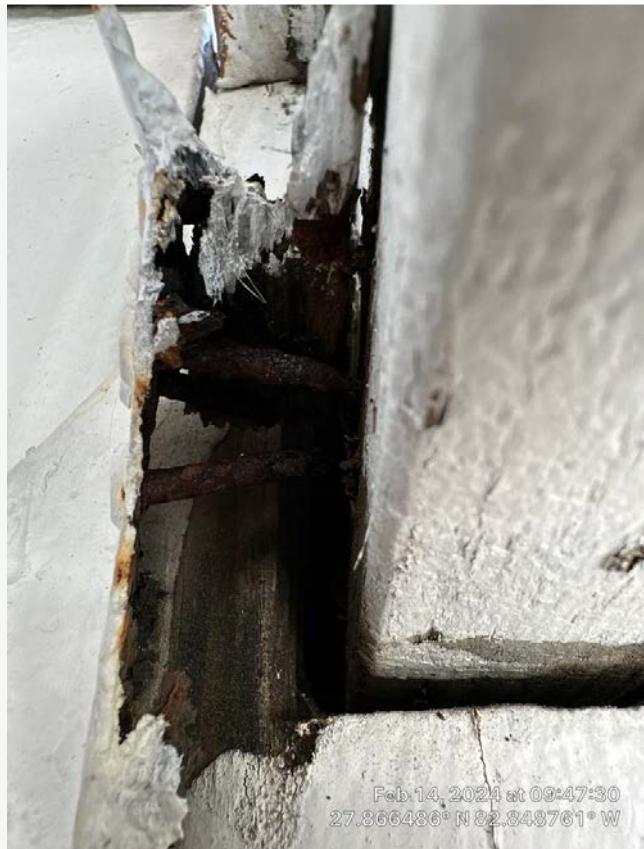
South stairwell at 2nd living level, hurricane clip needs replacement. Wood framing repair may be required in this location as well.

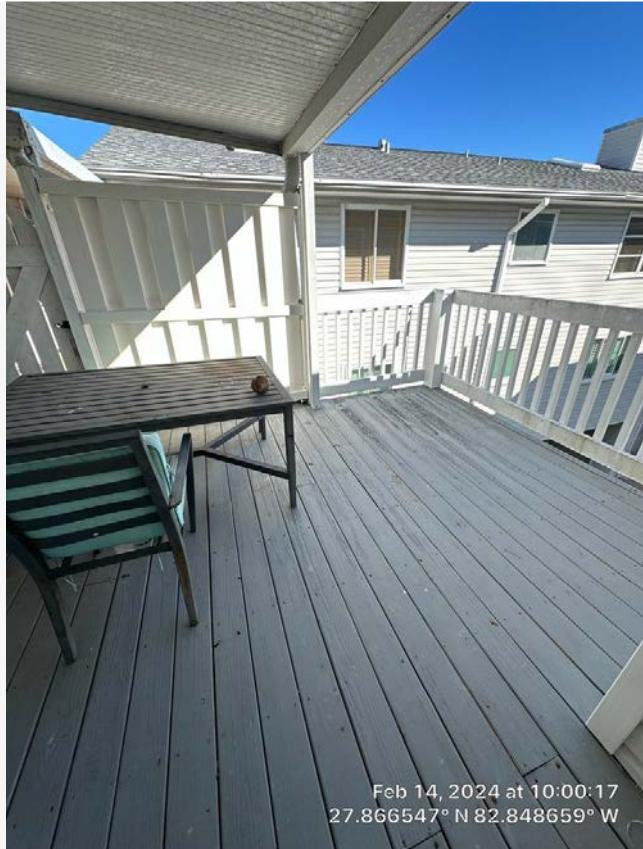
Unit 6 balcony deck is in good condition.

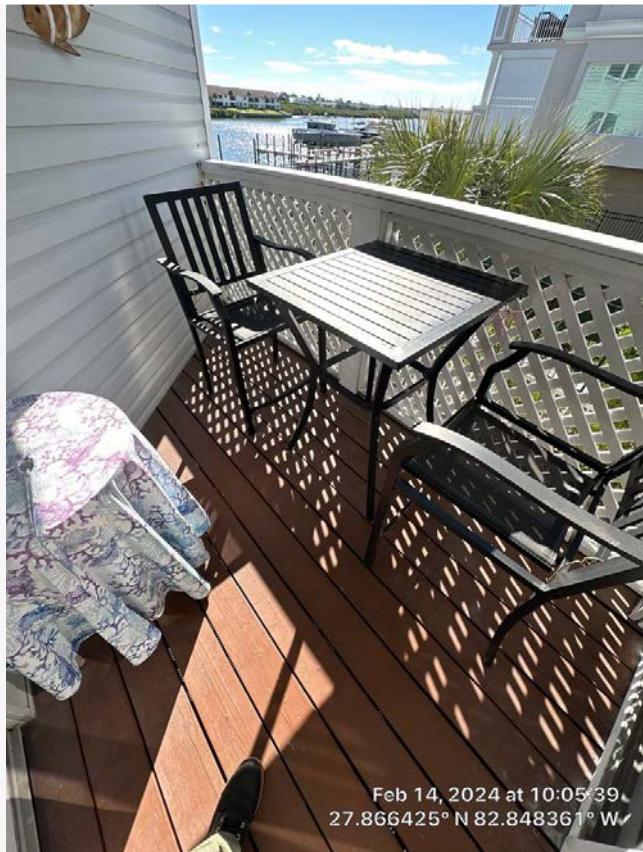
Unit 3 balcony deck is in good condition.

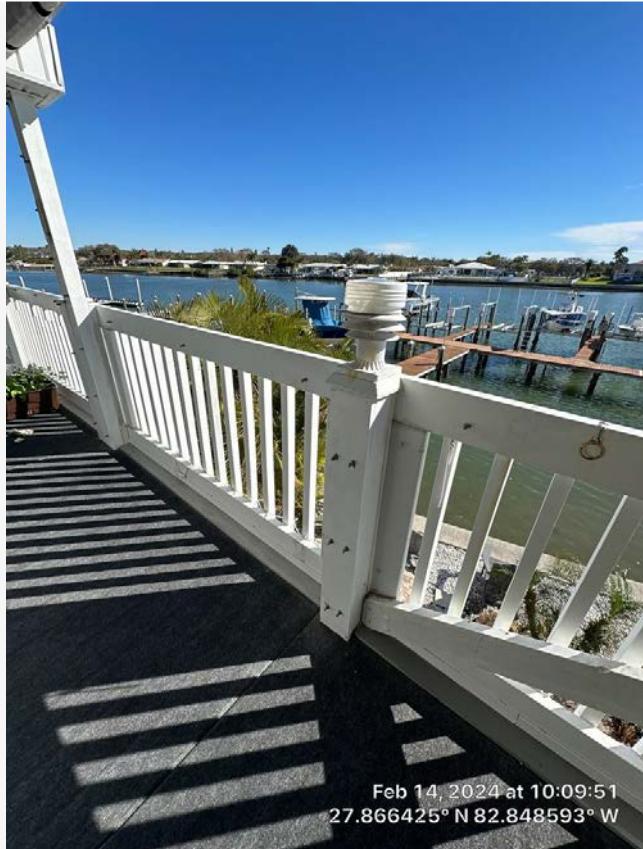
Unit 1 balcony deck is in good condition.

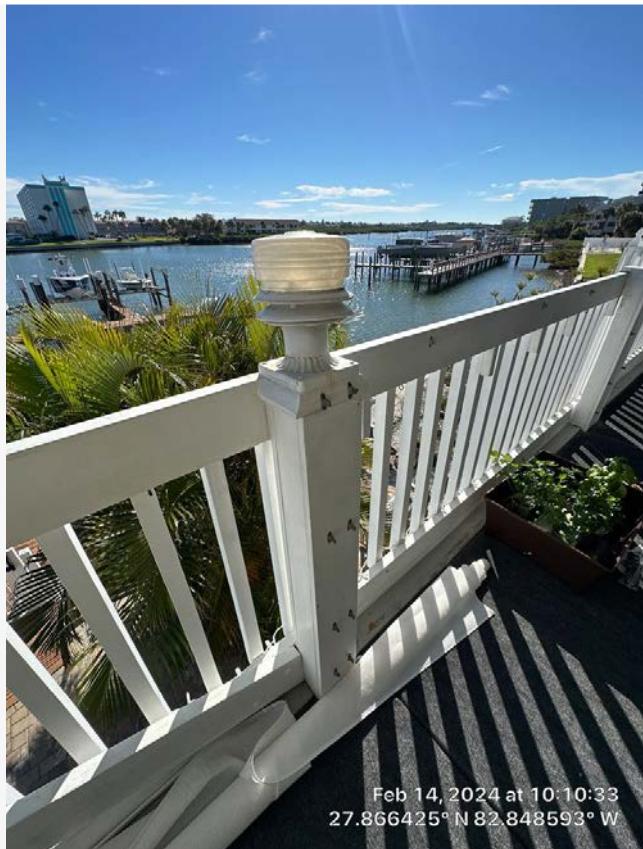
- 1) Exterior wood frame stairs require minor wood frame repairs and upkeep.
- 2) Unit 1 East railing balcony railing requires repair to attachment anchorage.

Unit one railing on East elevation is in fair condition, however, somewhat loose. The railing should be re-nailed or repaired where applicable.

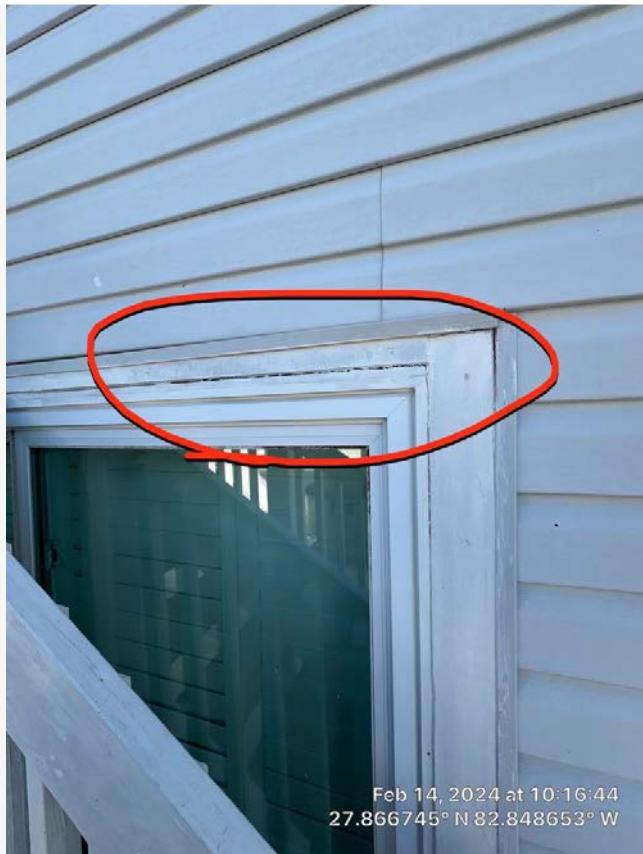
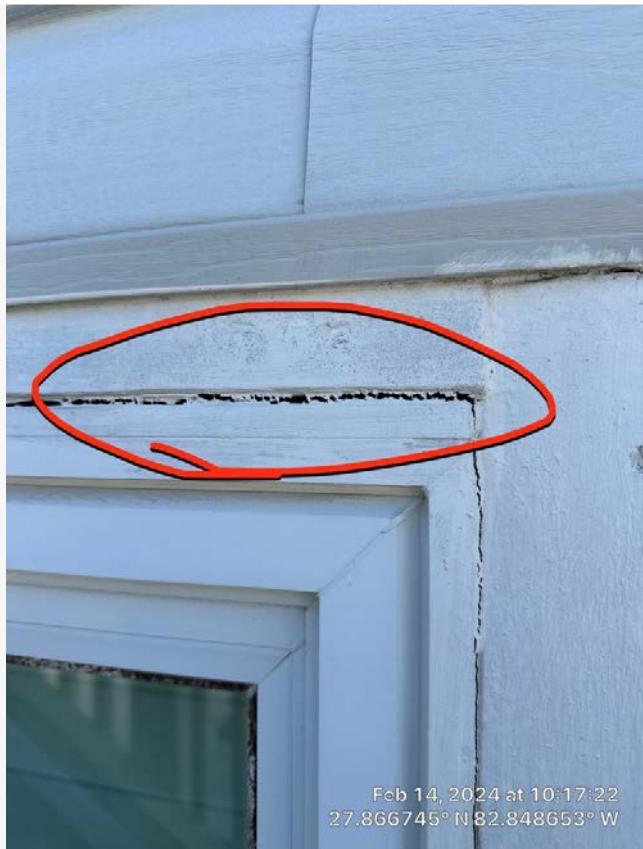
Open joints at window perimeter need resealing, located on the stairs to unit 10.

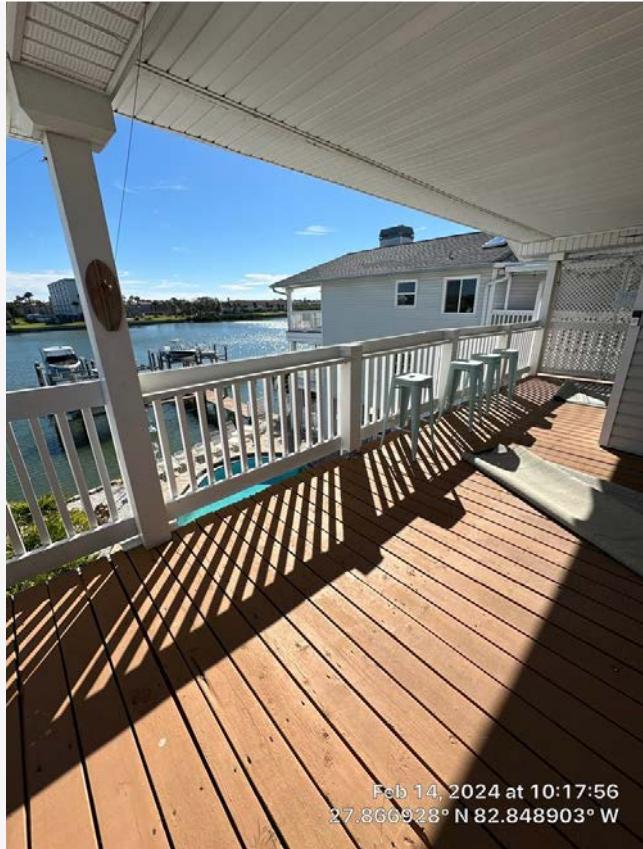
Unit 10 balcony is in good condition.

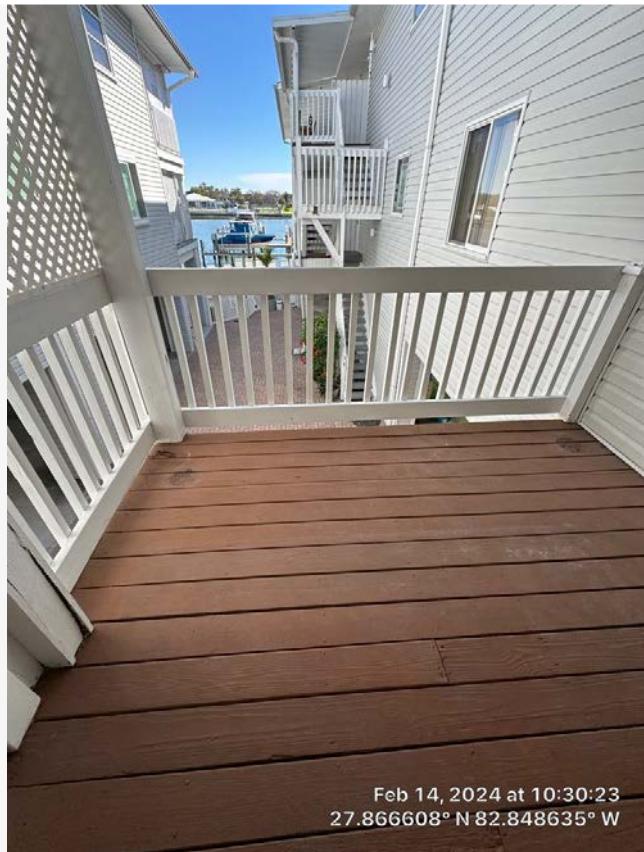
Unit five balcony is in good condition.

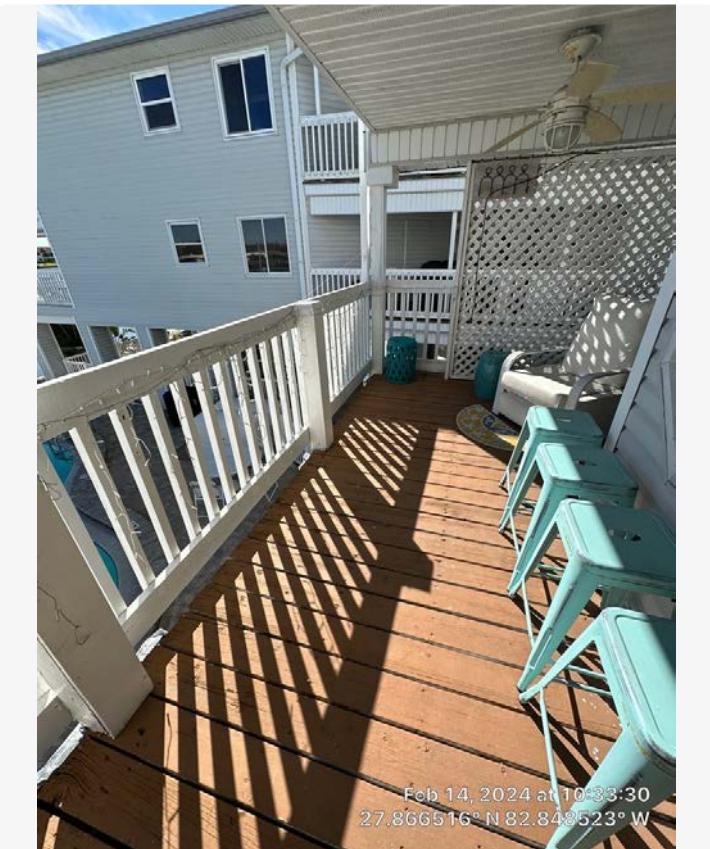
Unit 9 balcony is in good condition.
