August 10th, 2024

**RE: Sand Castle 2 – Milestone Inspection Report
20002 Gulf Boulevard,
Indian Shores, FL
KEG File# 21RT-0187**

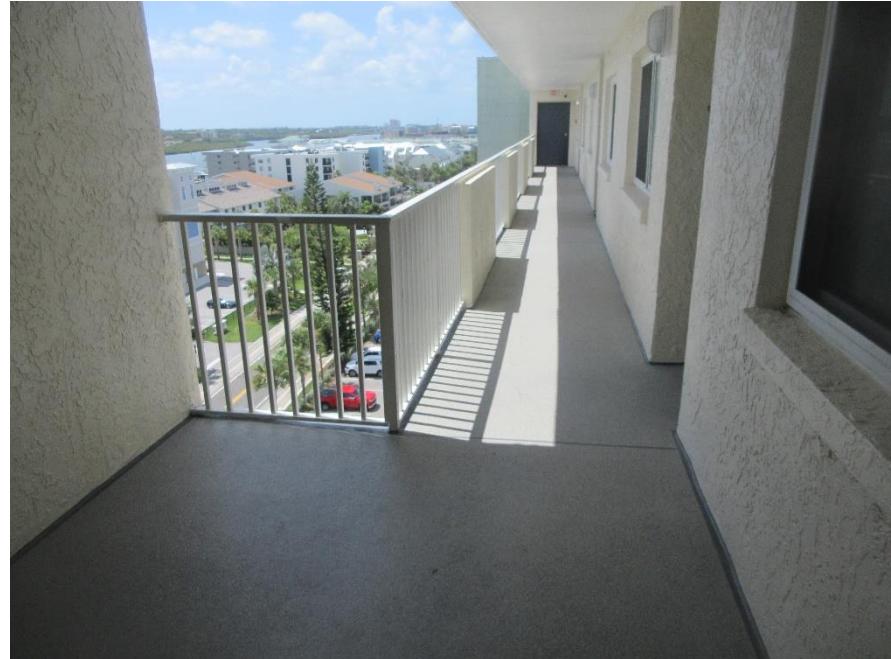
Photo #6 – Overview of Elevated Walkways' Deck. (TYP.)

2. The Association should conduct an inspection of a portion of the balconies and walkways annually to identify any concrete deterioration or other issues that should be addressed. Following the inspection, a contractor should make minor repairs as needed. Note that some of these repairs may fall under WKM's warranty. The inspection should be conducted by a licensed engineer that specializes in restoration and waterproofing.

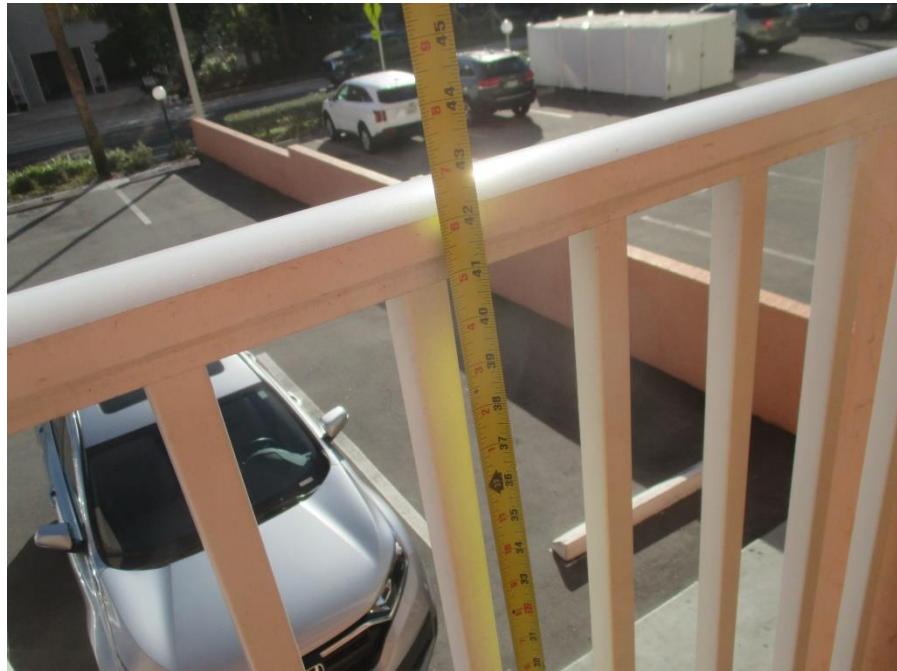
Photo #7 – Railing Height Appears to Be per Code ($\geq 42''$).

1. The existing railings at the balconies and walkways were left in place during the recent restoration projects. They currently meet 2023 FBC dimensional requirements. KE recommends that they be periodically inspected for corrosion and damage. The Association should plan for replacement of all railing in approximately 10 years. The exact replacement timeline will be dependent on the results of future inspections and in accordance with the schedule set forth in the Association's Structural Integrity Reserve Study (SIRS), by others.

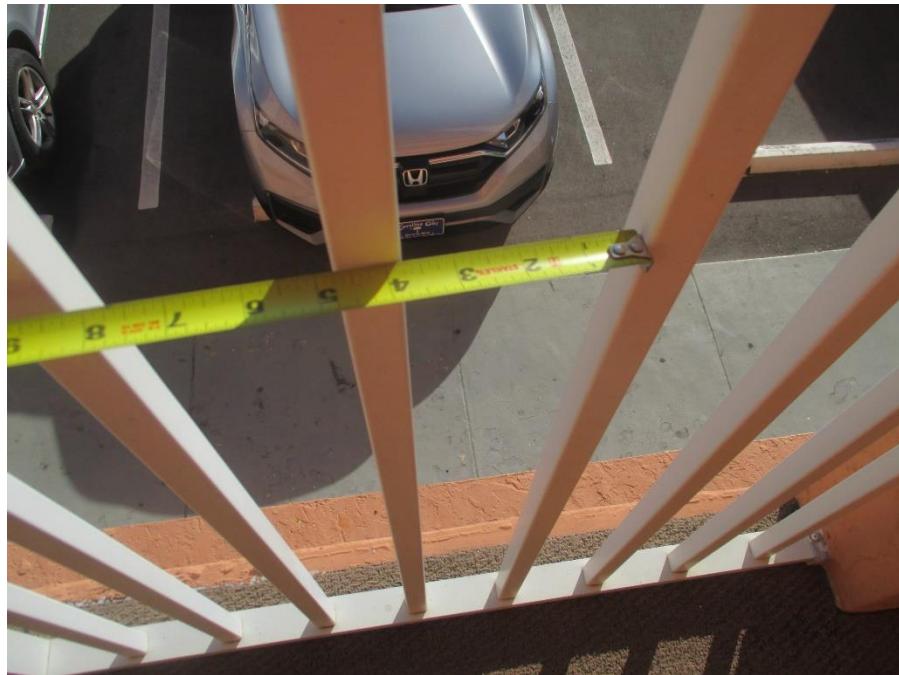
Photo #8 – Picket Spacing Appears to Be per Code ($\leq 4''$)

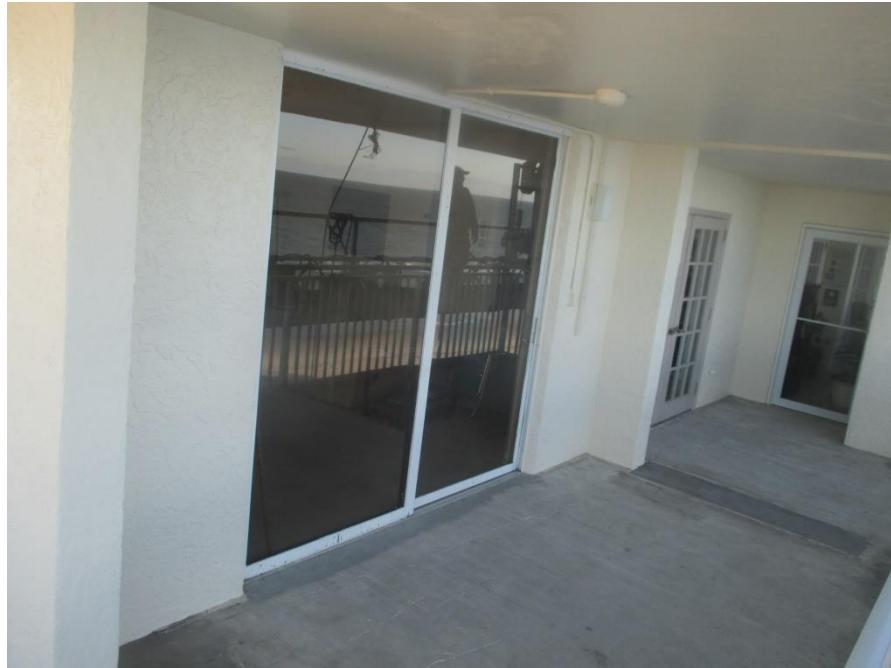
Photo #10 – Overview of Unit's Balcony. (TYP.)

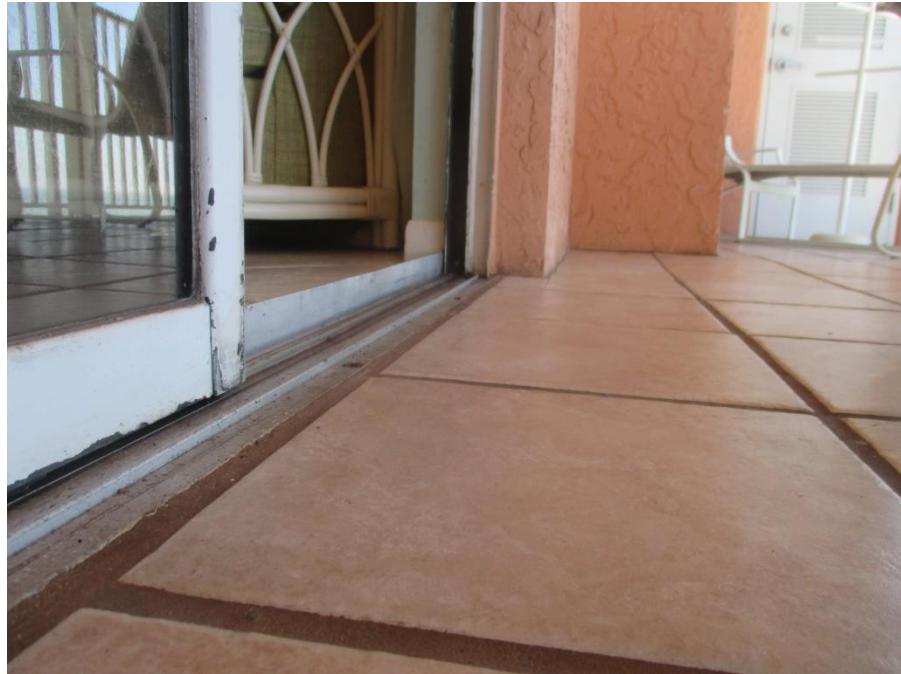
Photo #11 – SGD's Track Installed per Manufacturer's Recommendations. (TYP.)

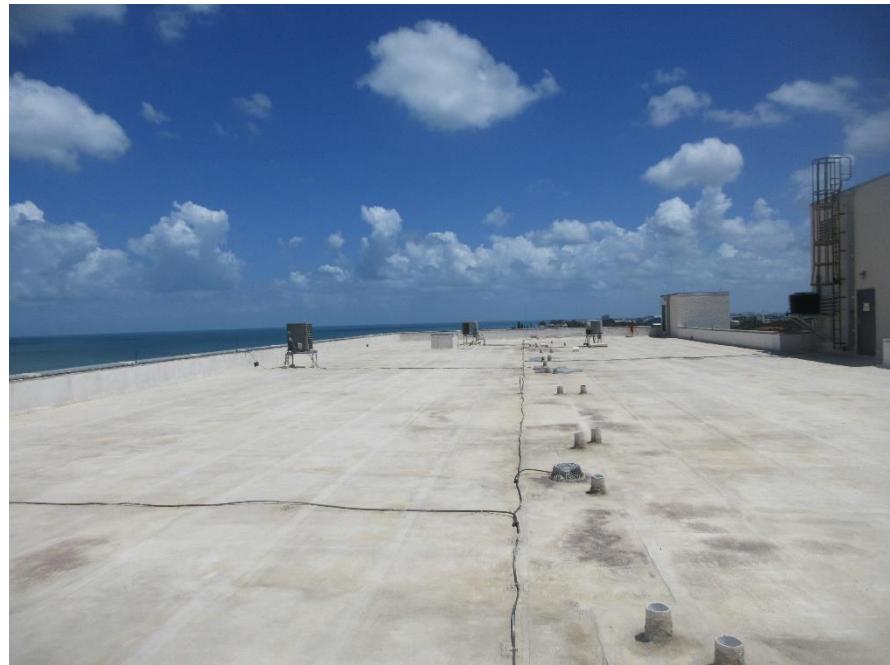
Photo #13 – Overview of Roof System - Modified Bitumen Coated with VFI Liquid Applied #990 Silicone.

3. The main roof system was recently coated in 2020 with a silicone coating. The Association should perform regular maintenance and repairs as needed in order to repair any minor damage that may occur and maintain the warranty from the manufacturer.

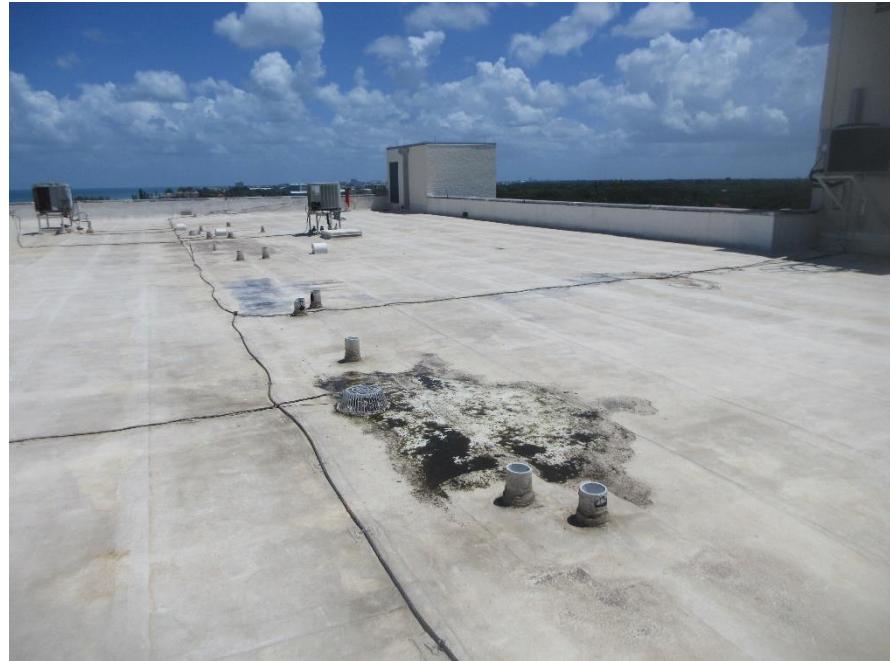
Photo #14 – Overview of Some Ponding Water Areas Observed at All Roof Levels.
