Milestone Inspection – Phase 1

**Prepared for the Board of Directors for the
Sandcastle III COA**

This Report contains Milstone Inspeciton - Phase 1 for the
Property with Address of:
20040 Gulf Blvd, Indian Shores, FL 33785

April 19, 2023

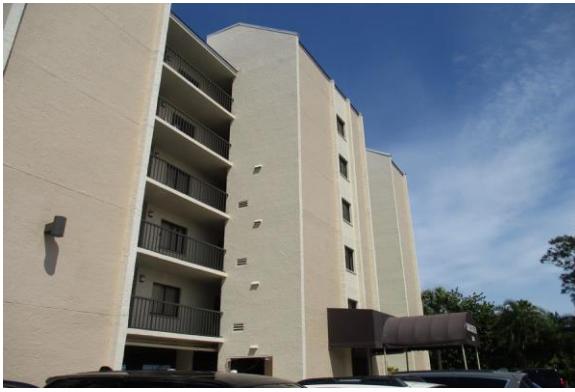
1 Front

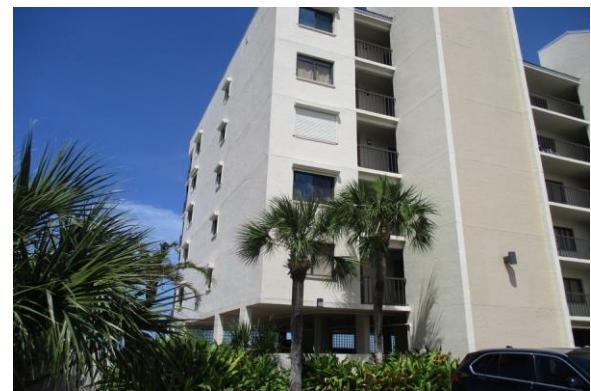
2 Right Side

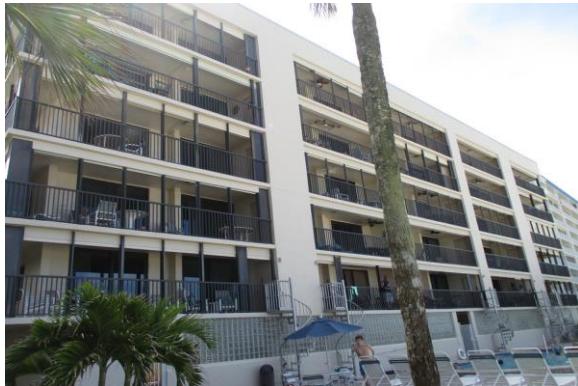
3 Rear

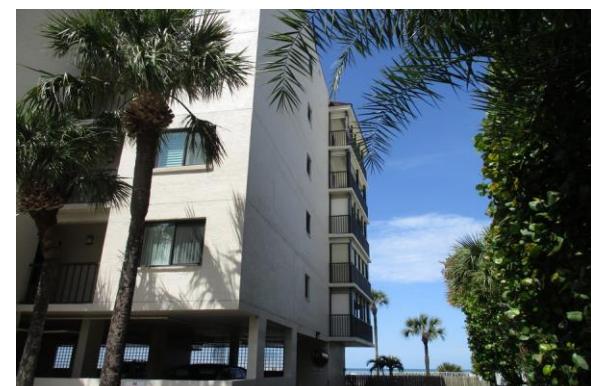
4 Left Side

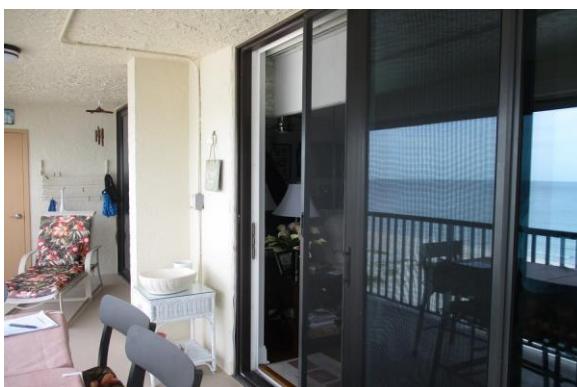
5 Balcony Overview

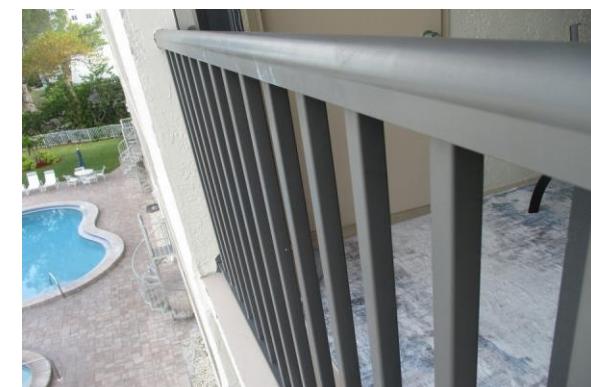
8 Railing Overview

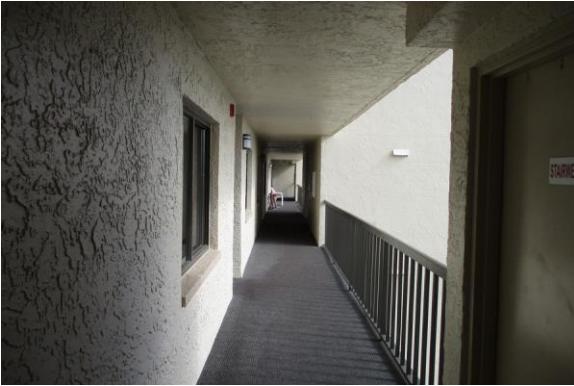
9 Walkway Overview

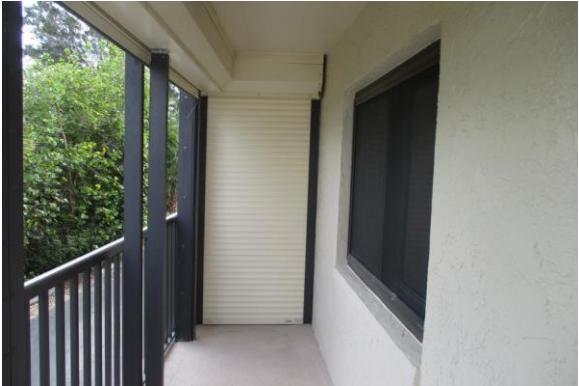
19 Balcony Overview

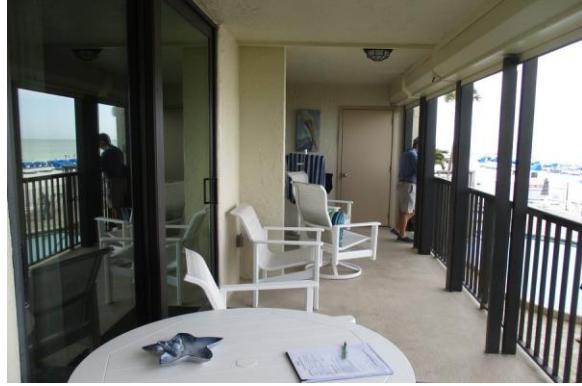
20 Balcony Overview

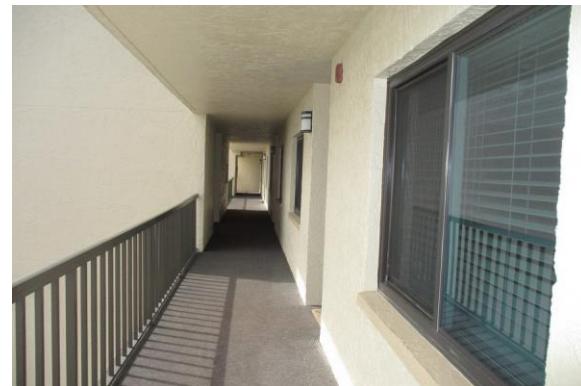
36 Walkway Overview

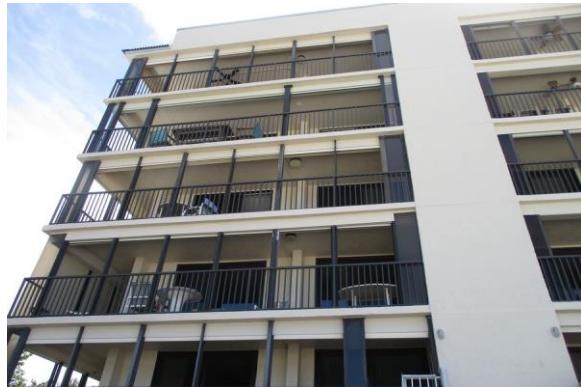
40 Balcony Overview

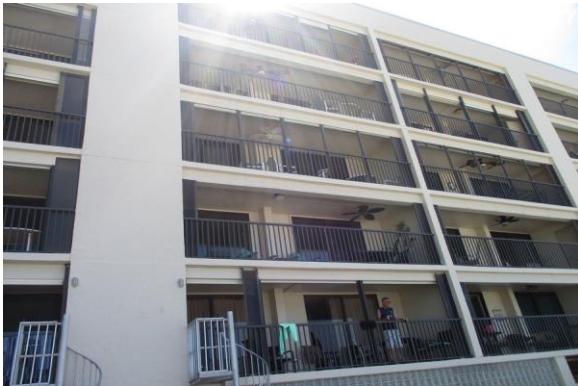
41 Exterior Overview

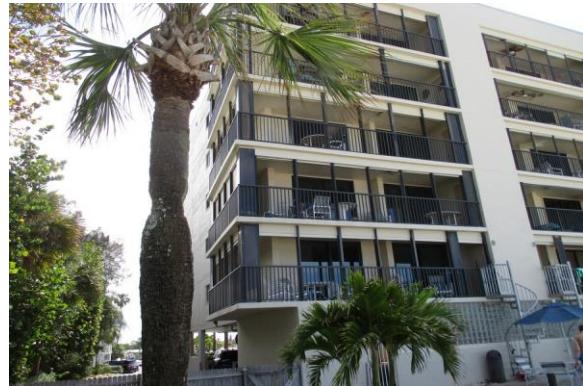
42 Balcony Overview
