MILESTONE INSPECTION REPORT FORM PHASE 2

a.	Name on Title: Pointe Condominium		
b.	Street Address: 19236 Gulf Blvd., Indian Shores, FL 33785		
c.	Legal Description: Pointe Condominium Association, inc.

Re: Pointe Condominiums – 19236 Gulf Boulevard, Indian Shores
Concrete Beam Evaluation

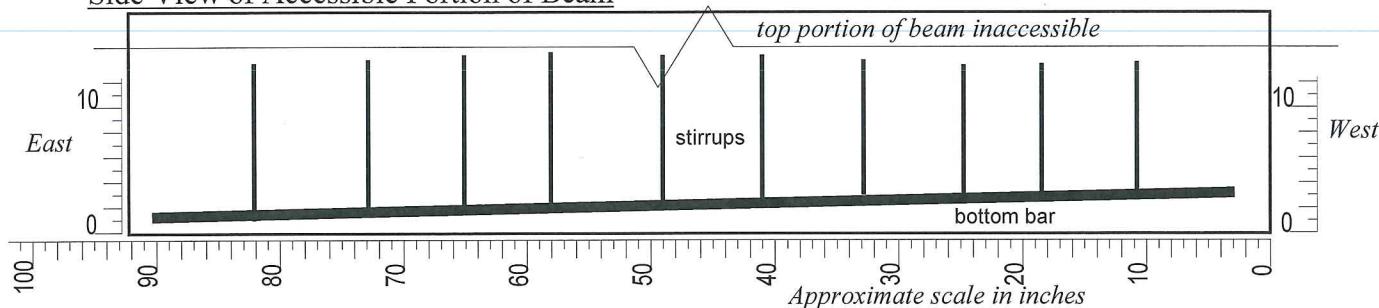
Side View of Accessible Portion of Beam

Based on our review of the scans completed, it appears that the beam has 2 horizontal bottom bars of steel reinforcement in the 8 inch wide concrete beam, and 10 vertical stirrups along the 92 inch long section of accessible beam scanned. The stirrup spacing varied from approximately 7 inches to approximately 12 inches along the beam. Any top reinforcement within the beam could not be observed due to access limitations. The total height of the beam was approximately 24 inches. The steel reinforcement cage did not appear to be centered within the cast-in-place concrete beam. Along the accessible portion of the beam in the pump room, the bottom reinforcing steel was within an inch of the bottom of the beam near the east wall of the room, and approximately 4 inches from the bottom of the beam near the west end. The steel reinforcement cage was also closer to the south edge of the beam than the north edge. See sketches below.

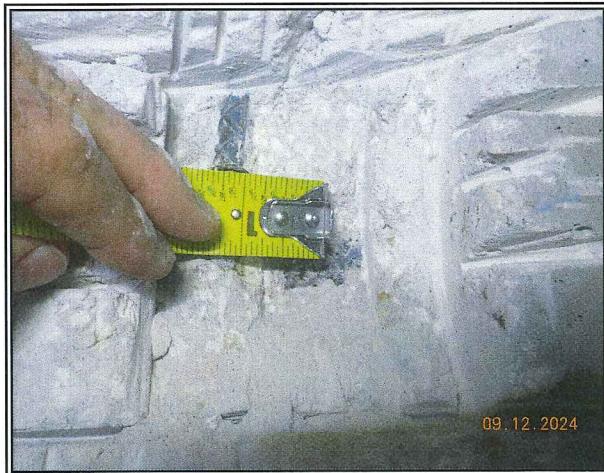
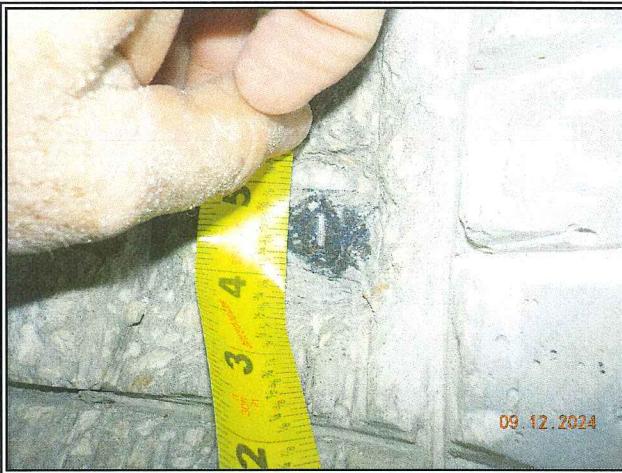
The testing measured the vertical stirrups were found to be No. 3 rebar (3/8" diameter), and the bottom bars were No. 8 rebar (1" in diameter). Only one area was used to measure the steel, therefore the other bars of similar function are assumed to be the same size.
