MILESTONE INSPECTION REPORT FORMS - STRUCTURAL BSIP INSPECTION FORM

MILESTONE INSPECTION REPORT FORM PHASE 1

PHASE 1 Milestone Inspection

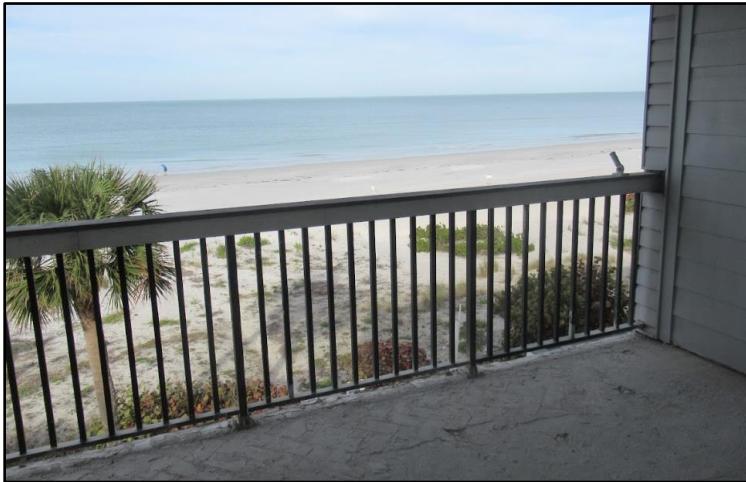
PHOTO 1: Observed the need to repair loose railings on Unit 4 balcony.

Repair required.

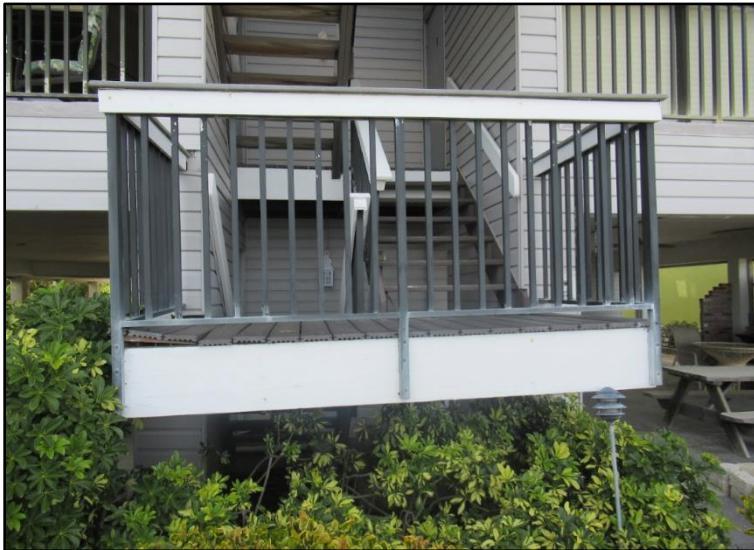
PHOTO 2: Observed sag to the northwest corner of the lower stair landing.

Immediate repair/replacement required. Please block off this stairwell to prevent injury.

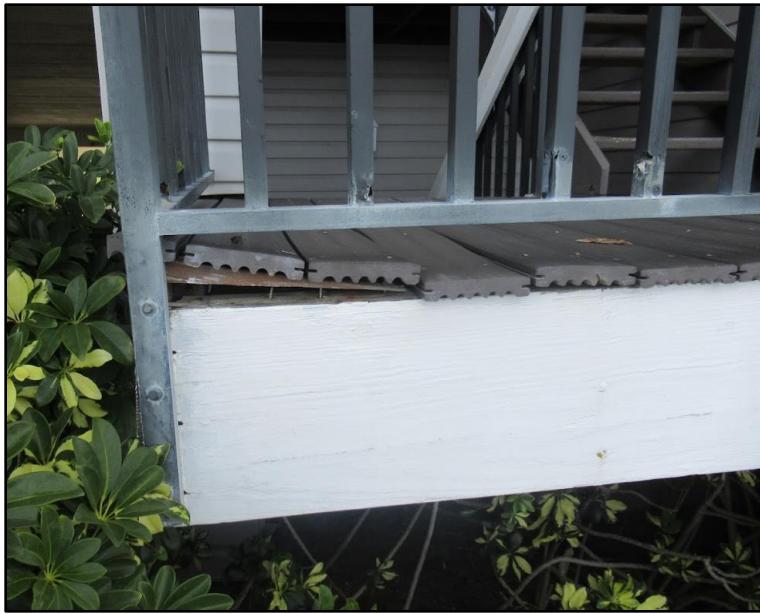
PHOTO 3: Observed sag to the northwest corner of the lower stair landing. (Close up of photo 2)

Immediate repair/replacement required. Please block off this stairwell to prevent injury.

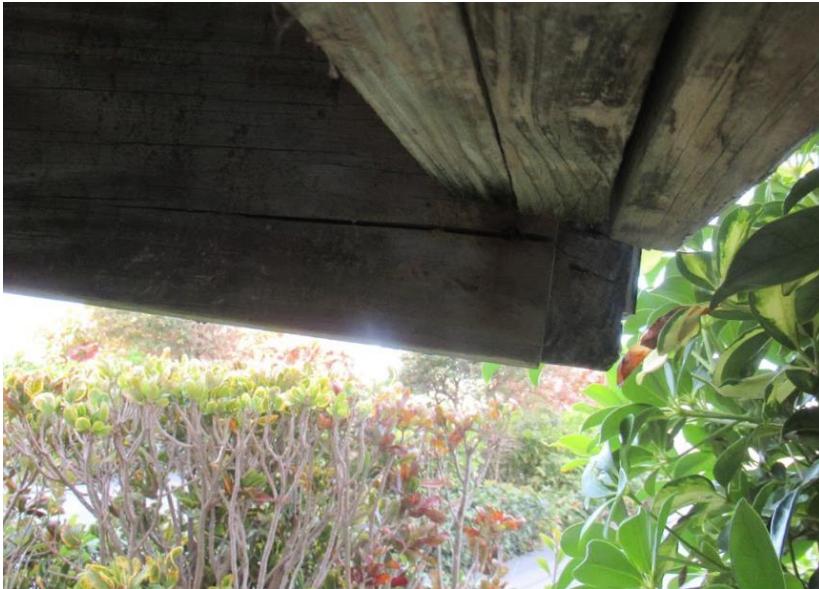
PHOTO 4: Observed cracked main perimeter carry beam.

Immediate repairs required. Please block off this stairwell to prevent injury.

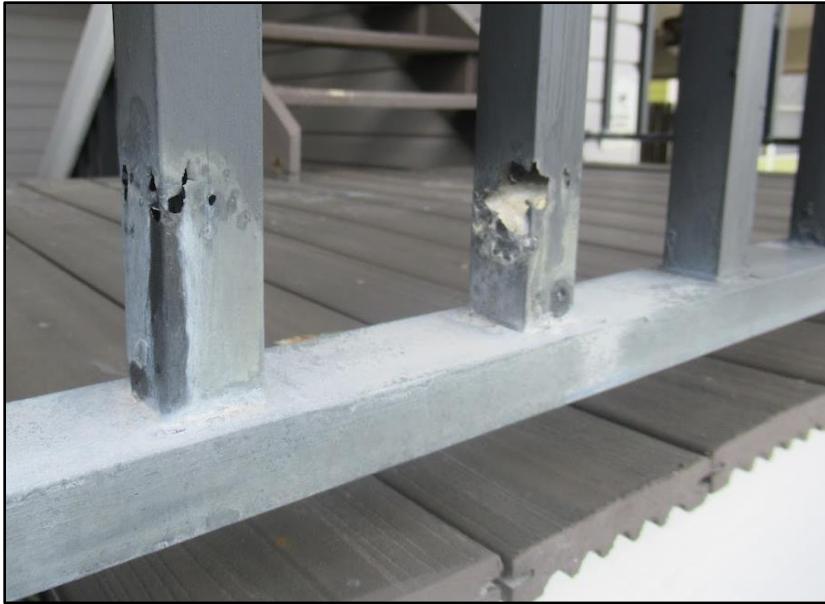
PHOTO 5: Observed the need to replace stairwell railing systems in the lower landing on the east stairwell. (Typical)

Immediate replacement required. Please block off this stairwell to prevent injury.

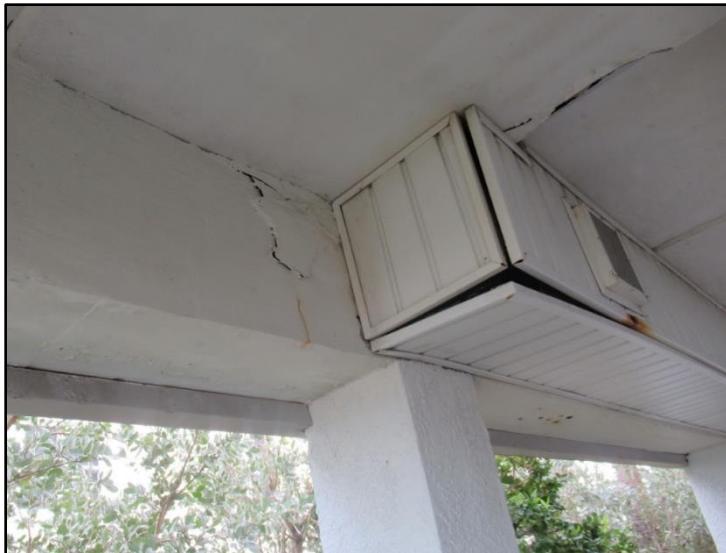
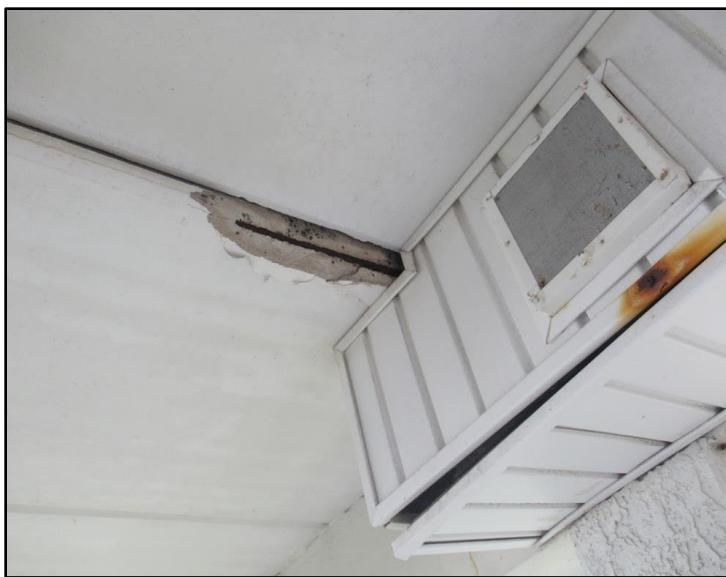
PHOTO 6: Observed the need for repairs to the spalling concrete perimeter beam in the covered parking garage. Located along both the NW and NE corners.

Repairs required.

Note: Damaged wood soffit area will need to be replaced to access the needed repair areas.

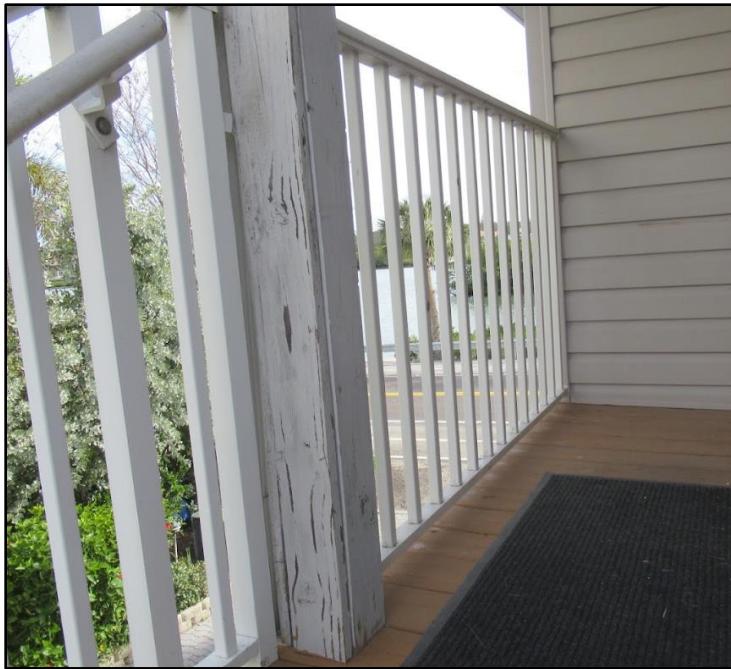
PHOTO 4: Observed the need for replacement to the rotten wood beam in the upper landing of the west stairwell.

Replacement required.
