January 16, 2023

RE: Beach Club of Indian Shores Condominium Association, Inc.
19616 Gulf Boulevard
Indian Shores, Florida 33785
KEG File #22RP-0940: Milestone Inspection

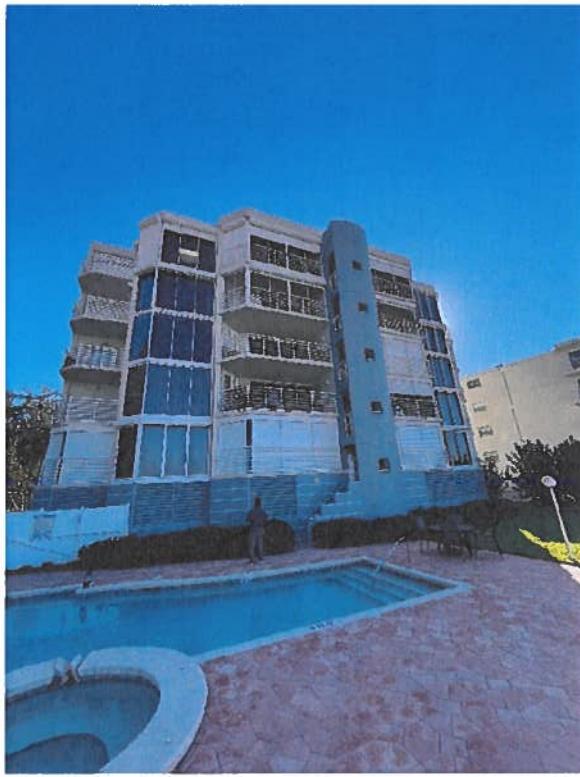
Rear Elevation of Structure (Facing Gulf of Mexico)

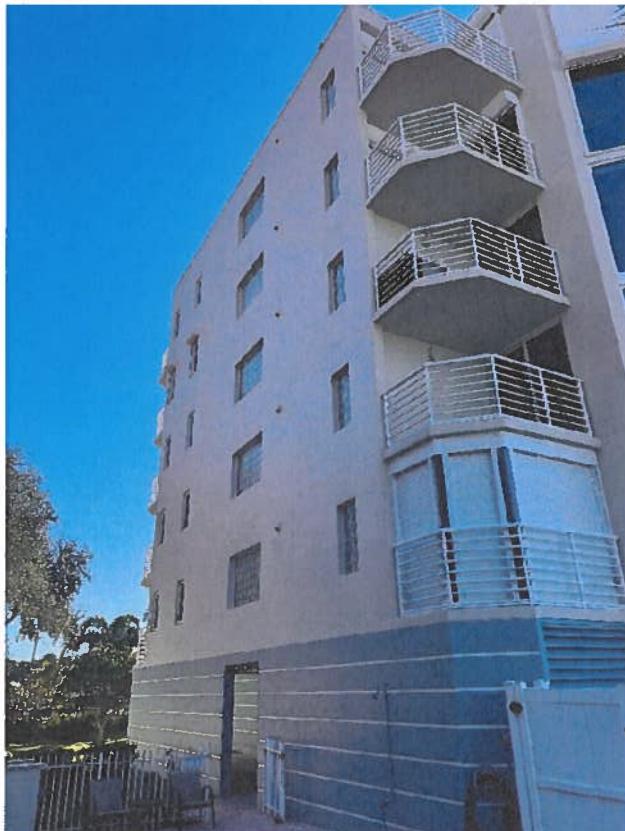
Beach Club Condominium Observed from Adjacent Grade

The overall structure appeared to be in good condition with no visual signs that would be considered significant to the structural integrity of the structure.

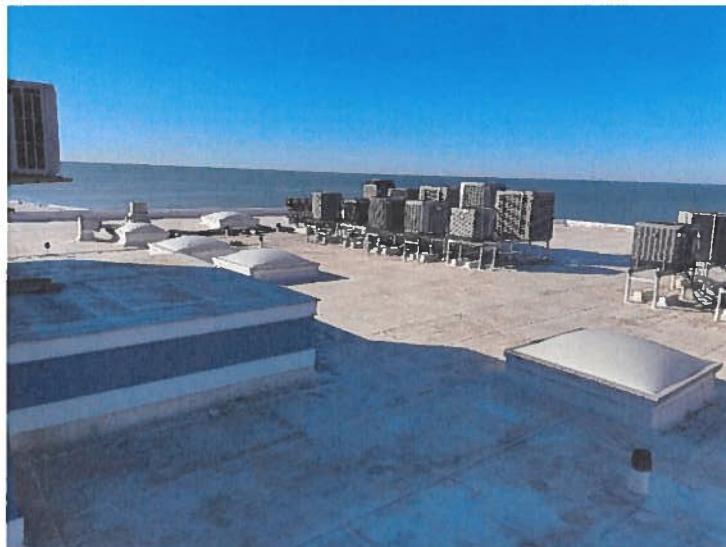
KEG noted the building consisted of one main flat roof with a parapet wall perimeter. The top of the stairwells and elevator tower also had a flat roof, however KEG was unable to observe. The main roof had a modified bitumen system with a maintenance covering installed as the primary roofing system. This system, according to the drawings provided by the Association, appeared to have been installed over the post tension concrete slab. However, KEG did not conduct any roof cores.

Observation of Main Roof

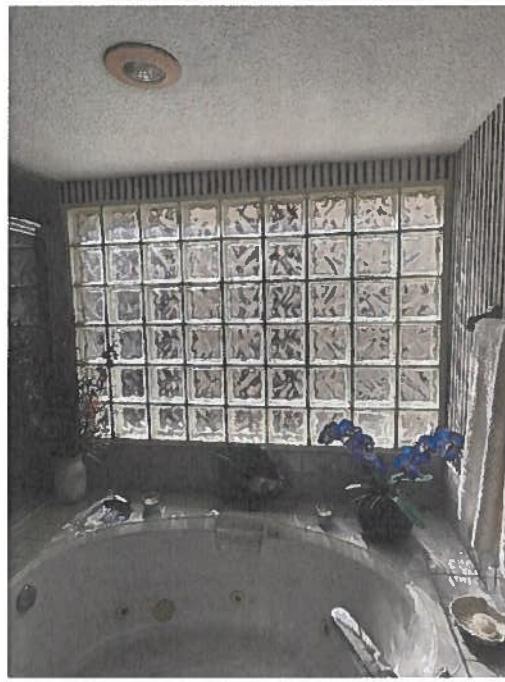
The north and south elevations of the building contained glass block windows. Typically, these were found in the master bathrooms and walk in closet areas of the interior units. KEG noted the glass blocks to be in generally good condition. According to the Association, all glass block windows were resealed before the recent storms of Hurricane Ian and Tropical Storm Nicole.

Glass Blocks Typical in Master Bathroom
