# MILESTONE PHASE 1 CONDITION SURVEY REPORT

## 700 West Condominium

19700 Gulf Blvd., Indian Shores, Florida 33785

BillerReinhart Project No. 22 - 020

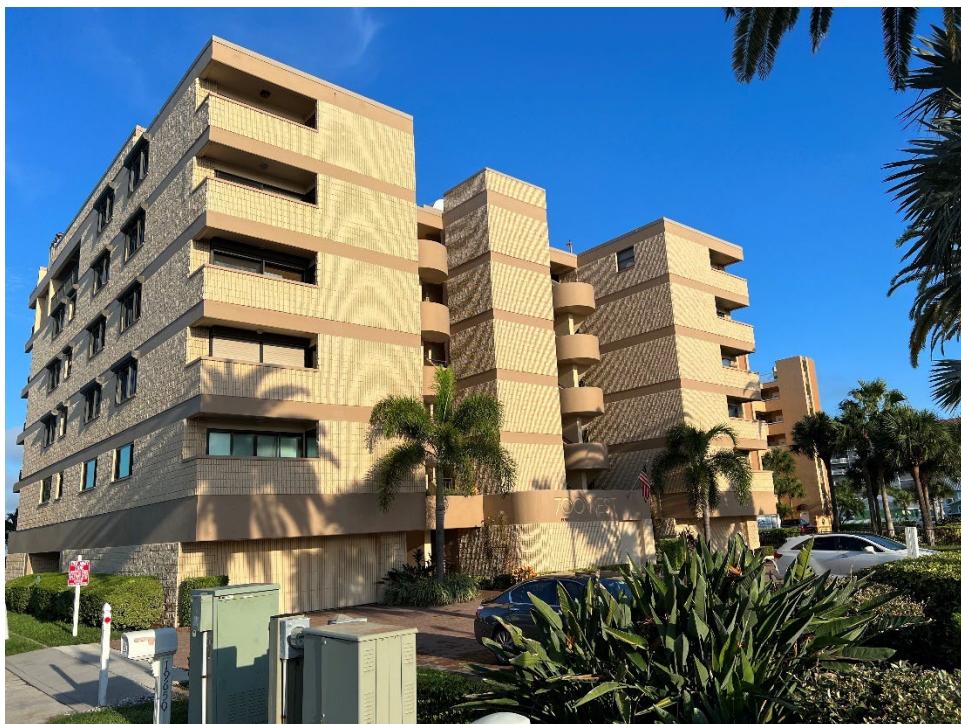
**Figure A-1**

1. East elevation, north elevation, west elevation and south elevation exterior wall areas are shown in *Figure A-1* through *Figure A-4*, respectively.
2. Isolated area of concrete spalling was observed within a grade level west facing windowsill. Refer to *Figure A-5*.
3. Sporadic areas of corroded cornerbead were observed. Refer to *Figure A-6* and *Figure A-7*.
4. Sporadic areas of peeling paint were noted. Refer to *Figure A-8*.
5. Multiple areas of efflorescence and water staining were observed on the wall surfaces and slab edges. Refer to *Figure A-9* and *Figure A-10*.

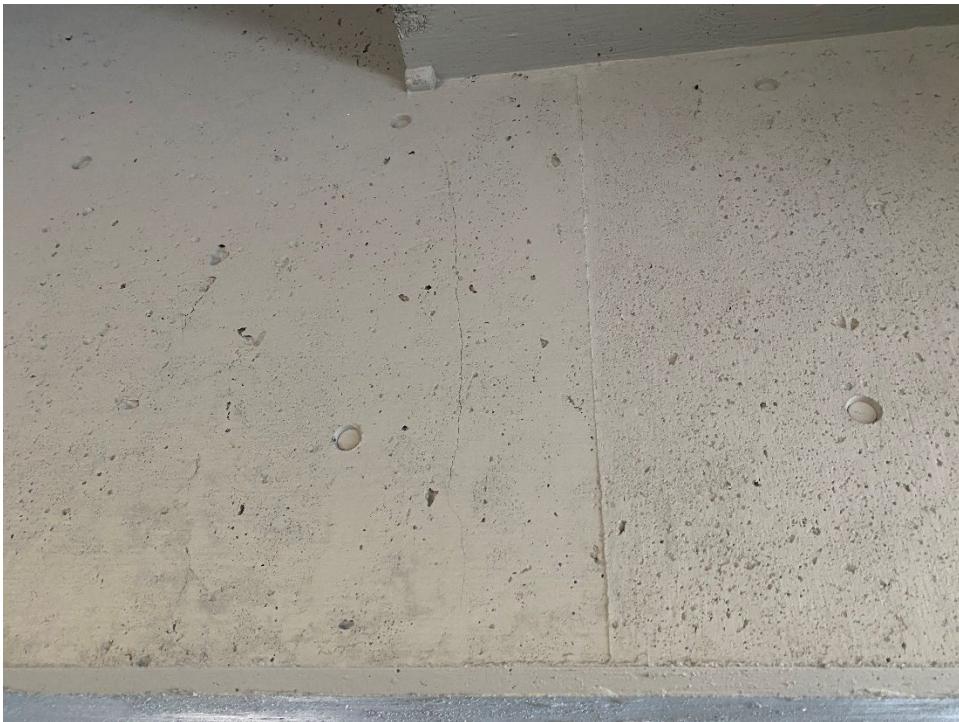
**Figure A-16**

1. Small isolated areas of concrete spalling were detected and observed on the concrete beams and girders. Refer to *Figure A-14* and *Figure A-15*.
2. Isolated hairline cracking was observed on the concrete beam members. Refer to *Figure A-16* and *Figure A-17*.
3. Corroded segments of open web steel joists were observed in the generator room. Refer to *Figure A-18*.
4. Corrosion and peeling paint were observed on the metal angles at the parking garage entrance. Refer to *Figure A-19* and *Figure A-20*.
5. Corroded metal reinforcement chairs were observed in the ceiling. Refer to *Figure A-21*.

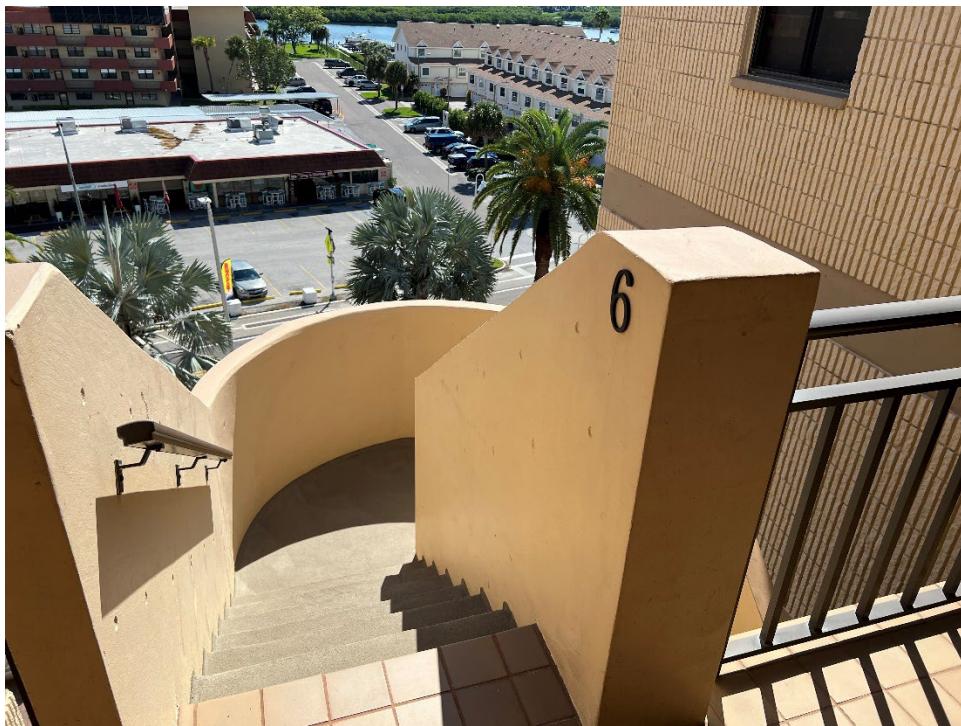
**Figure A-24**

1. The stair structures appeared to be in good condition. The waterproofing is nearing the end of its reasonable life expectancy but appeared to be in fair condition.
2. Localized areas of peeling paint were observed on the underside of the staircases.
3. Isolated delaminated stucco was detected within second-floor ceiling and column adjacent to the elevator.
4. Damaged framed wall stucco was observed at the second-floor plumbing chase. Refer to *Figure A-25*.

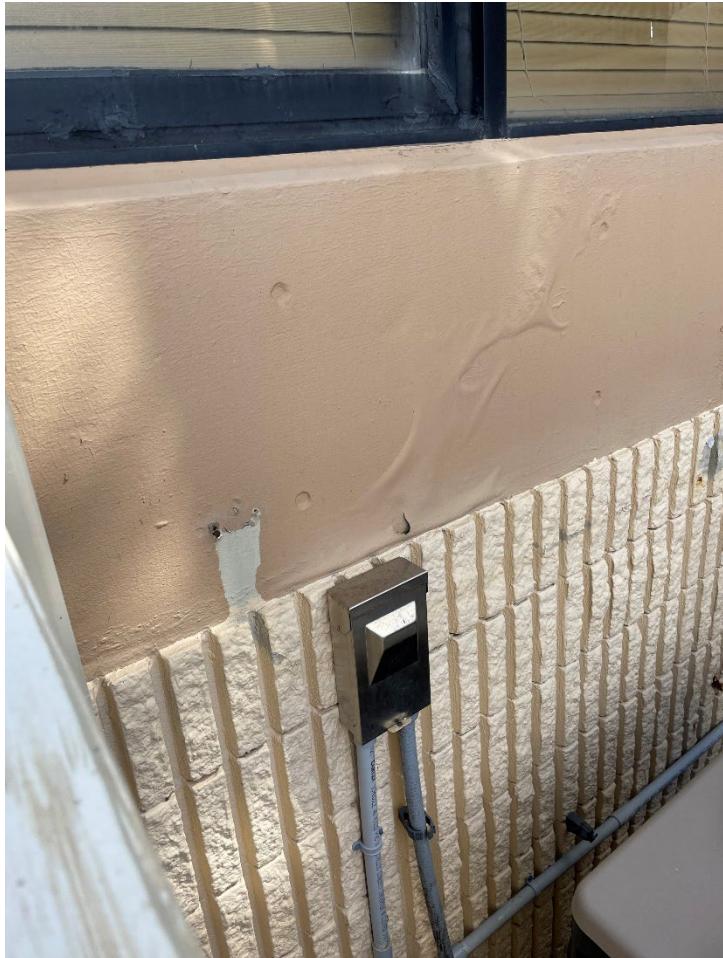
**Figure B-4**

1. Isolated areas of concrete spalling were detected throughout the accessible wall areas of the building. Refer to *Figure B-1* through *Figure B-3*.
2. Multiple areas of peeling and blistering paint were observed. Refer to *Figure B-4* through *Figure B-6*.
3. The guardrails surrounding the perimeter of property were observed to be corroded with pickets exhibiting significant section loss. Refer to *Figure B-7*.
4. Separation between roof coping stones was observed. Refer to *Figure B-8*.
5. Missing fasteners were observed on the roof termination bar. Refer to *Figure B-9*.
6. An unsealed electrical box pitch pocket detail was observed on the roof. Refer to *Figure A-10*.
7. Corrosion was observed on the roof scupper. Refer to *Figure B-11*.

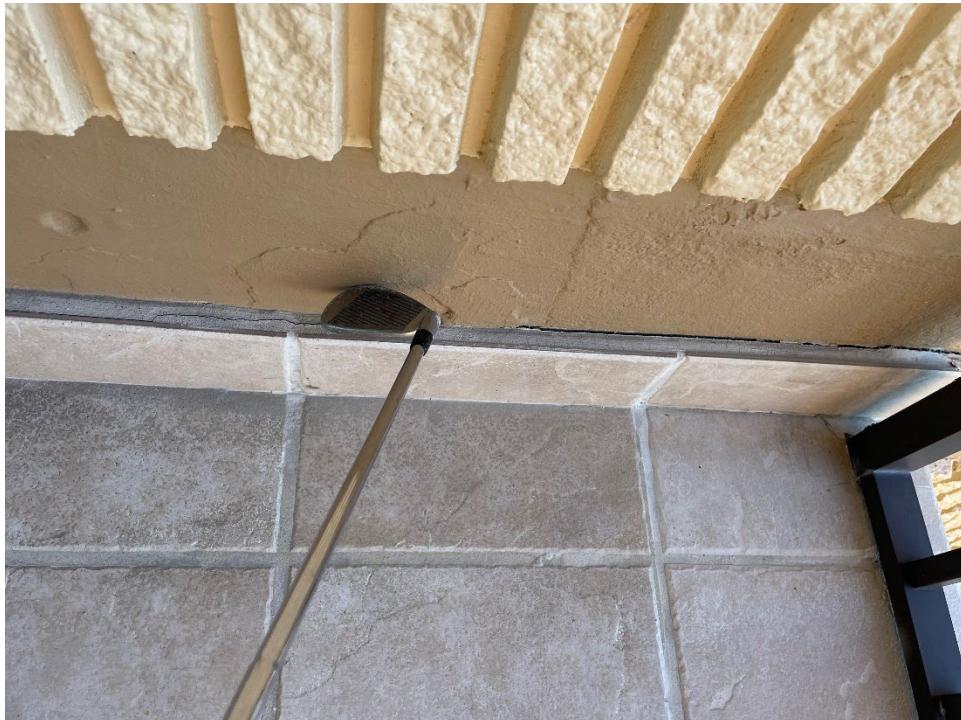
**Figure C-1**

1. Majority of balconies were covered with a tile finish. Sporadic areas of delaminated tile were identified throughout the balconies. The remaining balconies appeared to be finished with a urethane waterproofing membrane.
2. Isolated areas of spalling were detected within the exterior faces of beams and walls. Refer to *Figure C-1* through *Figure C-3*.
3. Sporadic areas of stucco delamination were detected in wall and ceiling surfaces. Refer to *Figure C-4* through *Figure C-6*.
4. Isolated areas of curb spalling and heaved tile finish were observed at the sliding glass door threshold. Refer to *Figure C-7* and *Figure C-8*.
5. Sporadic corroded metal reinforcement chairs were observed. Refer to *Figure C-9* and *Figure C-10*.
6. Multiple areas of peeling/blistering paint were observed. Refer to *Figure C-11* and *Figure C-12*.
