Westview Grande Condominium Association

19710 Gulf Blvd., Indian Shores, FL

Milestone Structural Assessment

October 17, 2023

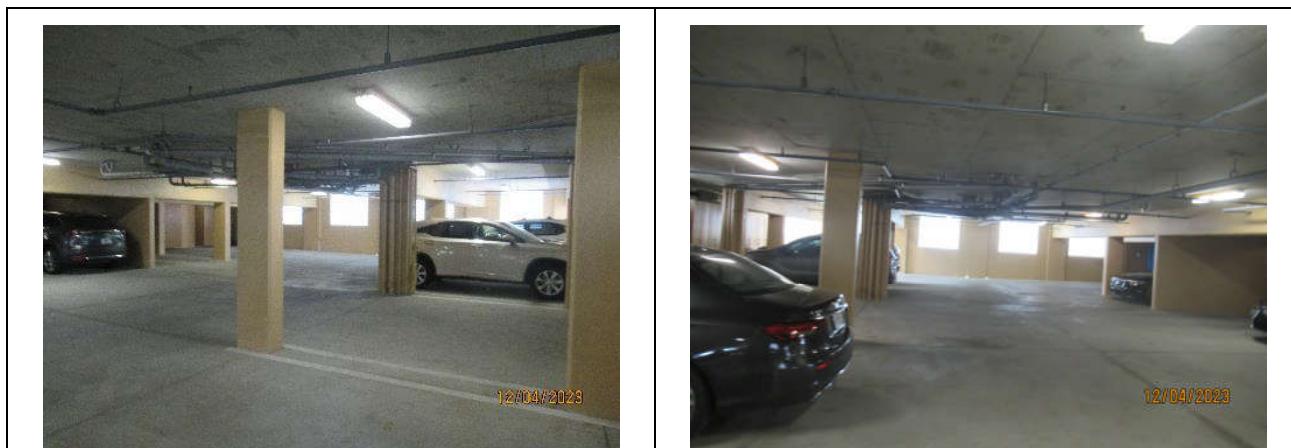
Photo 7.1.a.1 – Garage Level - Overview of the primary structural elements observed in good condition.

Photo 7.1.a.2 – Garage Level - Overview of the primary structural elements observed in good condition.

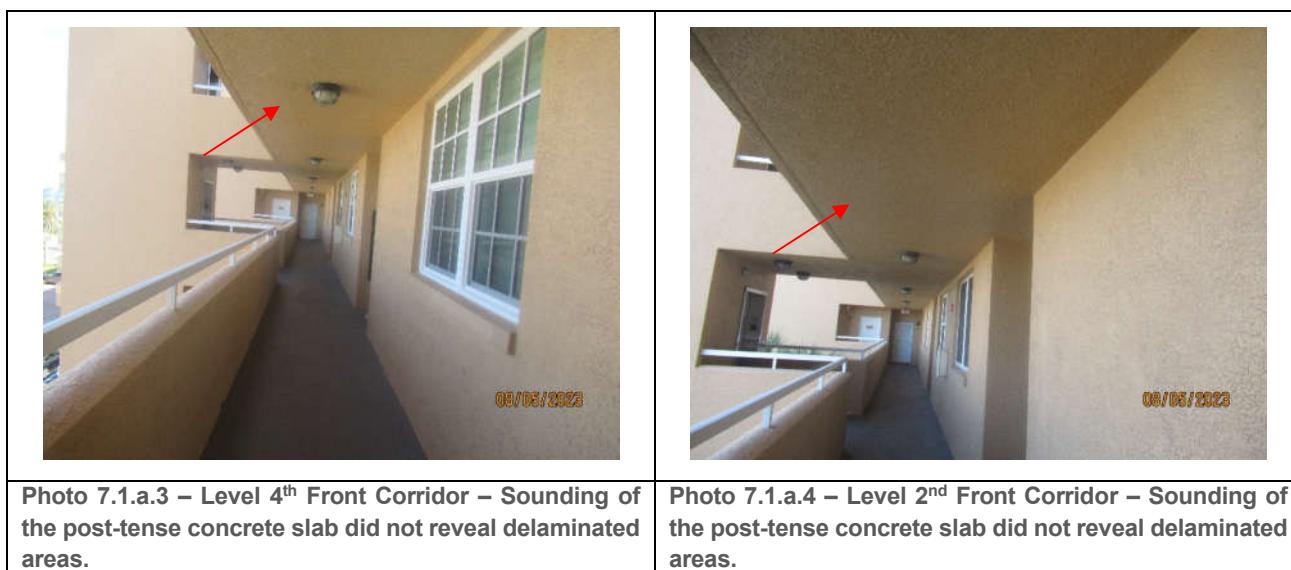
Photo 7.1.a.3 – Level 4th Front Corridor – Sounding of the post-tense concrete slab did not reveal delaminated areas.

Photo 7.1.a.4 – Level 2nd Front Corridor – Sounding of the post-tense concrete slab did not reveal delaminated areas.

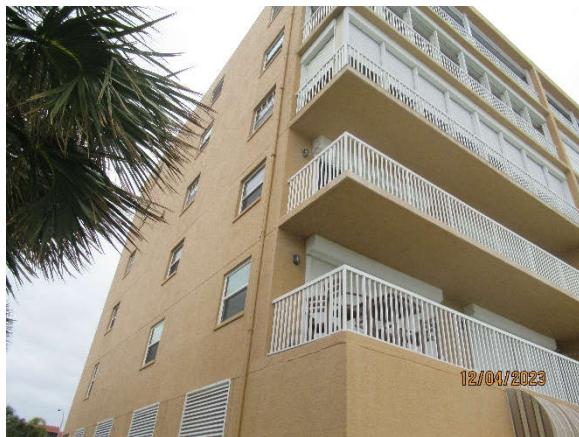
Photo 7.2.a.1 – Overview of North façade.

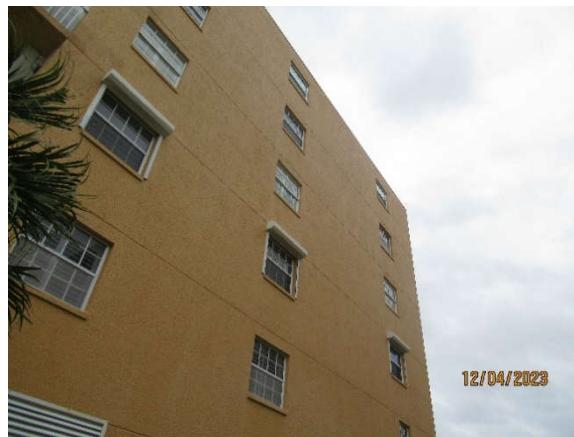
Photo 7.2.a.2 – Overview of South façade.

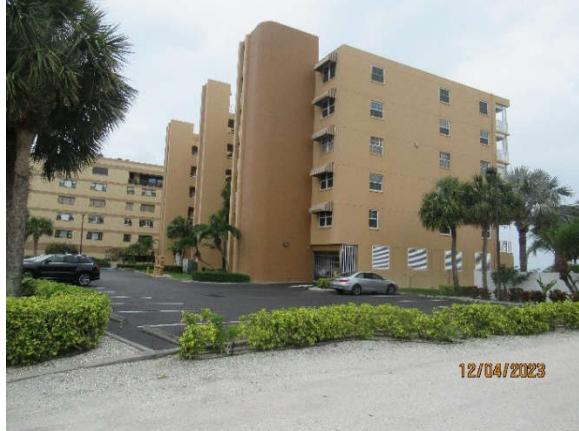
Photo 7.2.a.3 – Overview of East façade.

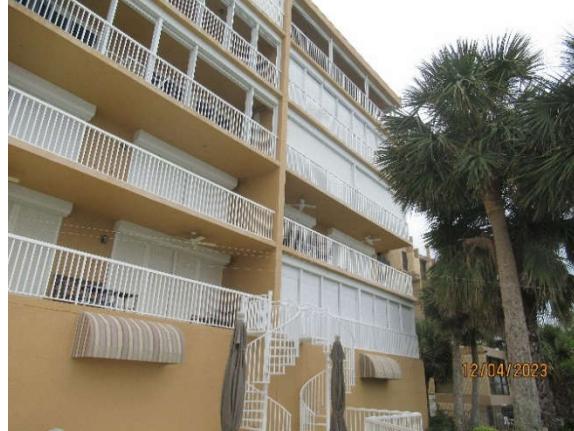
Photo 7.2.a.4 – Overview of West façade.

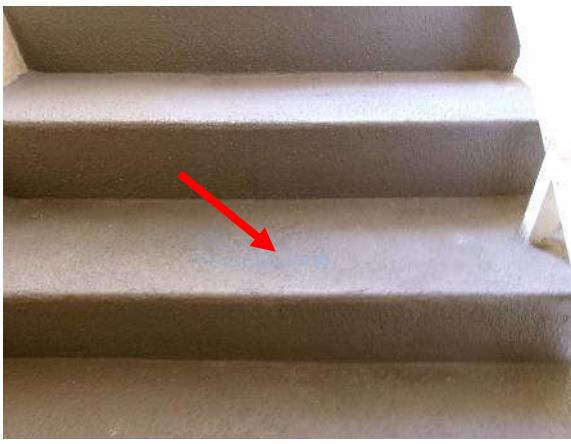
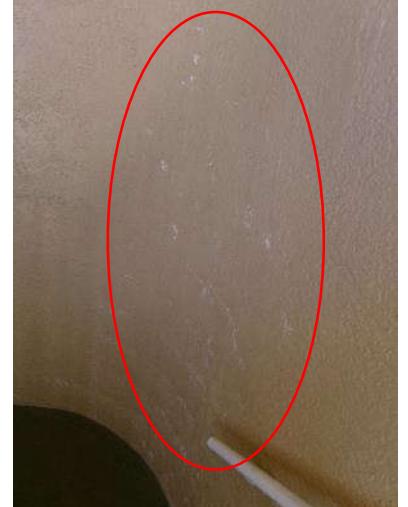
<p>Photo 7.2.b.3 – Stairwell #1 – Waterproofing membrane between 2nd and 1st level.</p>	<p>Photo 7.2.b.4 – Stairwell #1 – Evidence of efflorescence between the roof and the 4th levels.</p>

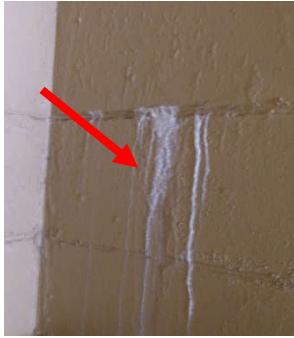
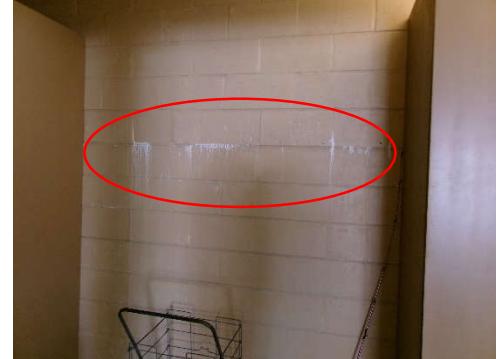
Evidence of efflorescence was observed in the interior side of the garage level and stairwells and some areas of the exterior walls. This indicates water intrusion and must be addressed in the following paint project.

<p>Photo 7.2.b.5 – Garage level – Evidence of efflorescence.</p>	<p>Photo 7.2.b.6 – Garage level – Evidence of efflorescence.</p>

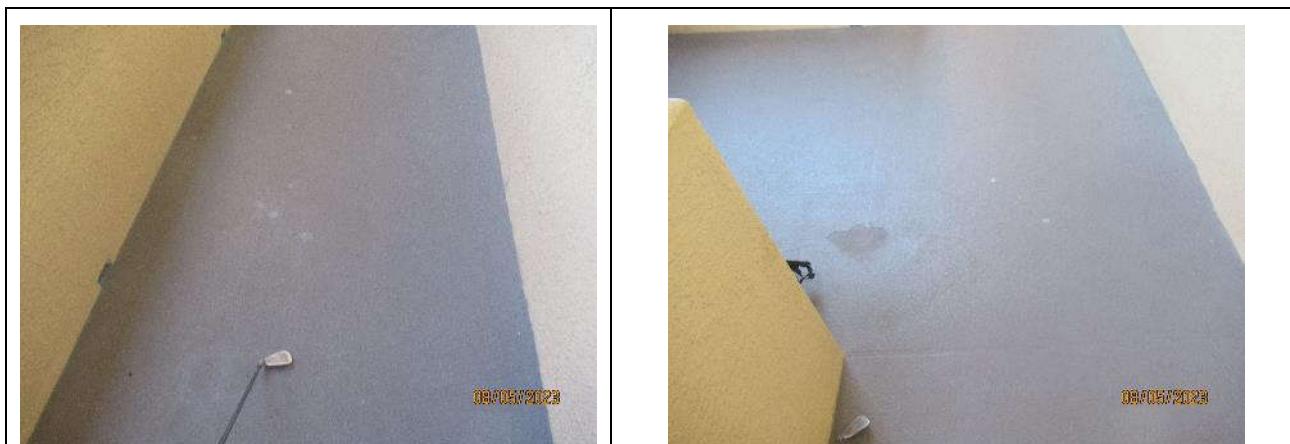
Photo 7.2.b.7 – Front corridor level 4th – De-bonding waterproofing membrane.

Photo 7.2.b.8 – Front corridor level 4th – Delaminated waterproofing membrane.

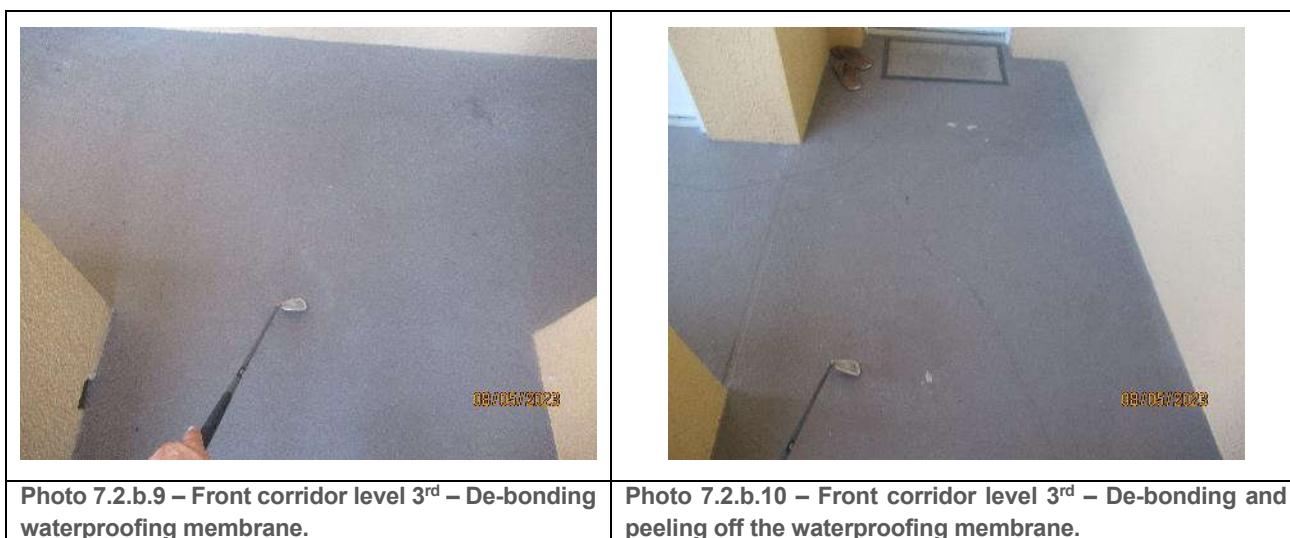
Photo 7.2.b.9 – Front corridor level 3rd – De-bonding waterproofing membrane.

Photo 7.2.b.10 – Front corridor level 3rd – De-bonding and peeling off the waterproofing membrane.

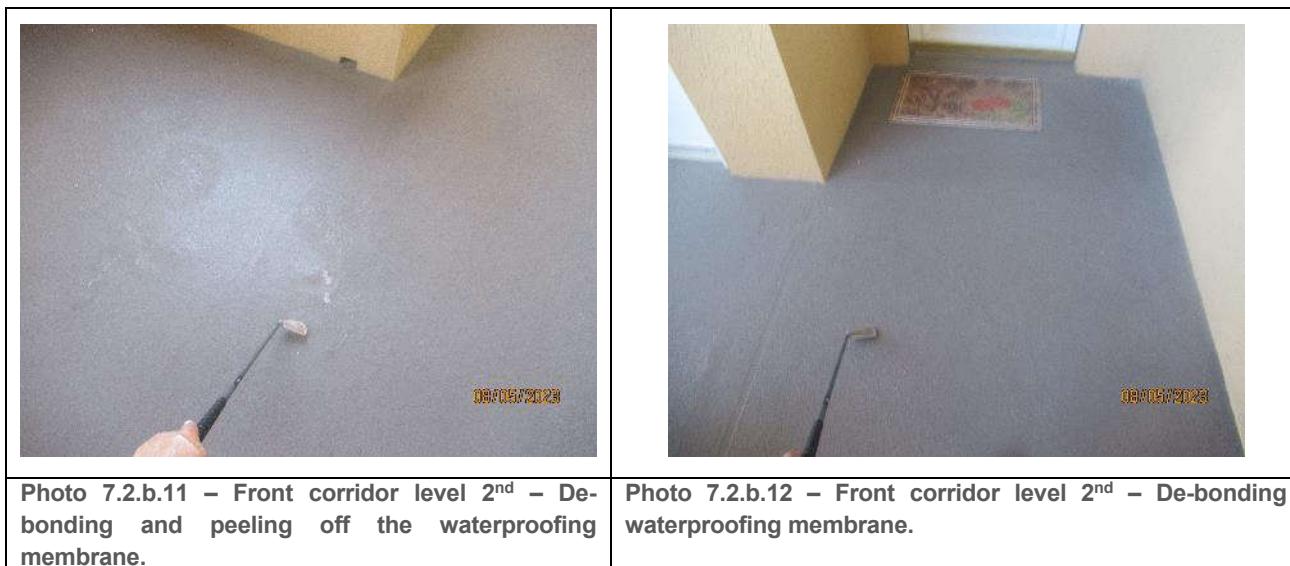
Photo 7.2.b.11 – Front corridor level 2nd – De-bonding and peeling off the waterproofing membrane.

Photo 7.2.b.12 – Front corridor level 2nd – De-bonding waterproofing membrane.

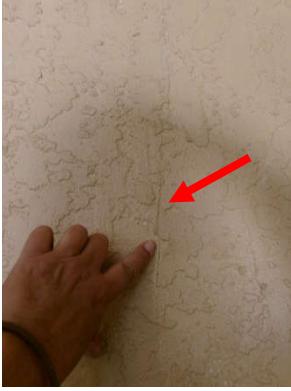
<p>Photo 7.2.c.5 – Stairwell #2 stucco hairline crack.</p>	<p>Photo 7.2.c.6 – Stairwell #2 stucco hairline crack.</p>

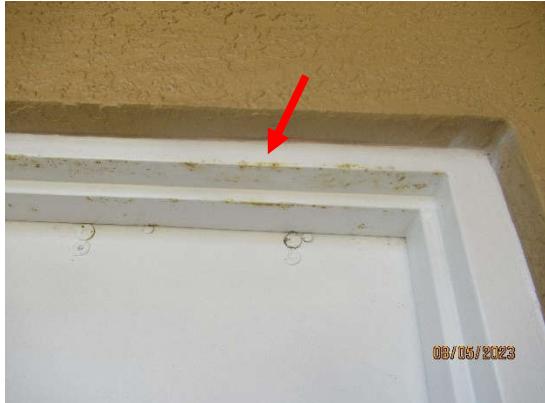
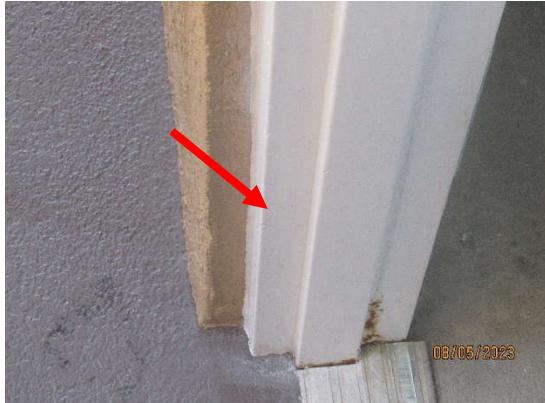
Overall, the fenestration systems appear in good condition with some localized deficiencies, specifically minimal corrosion of some of the door's components due to weathering, aging, and exposure to the coastal environment.

<p>08/05/2023</p>
<p>Photo 7.3.a.1 – Level 3rd trash room door.</p>	<p>Photo 7.3.a.2 – Level 3rd trash room door.</p>

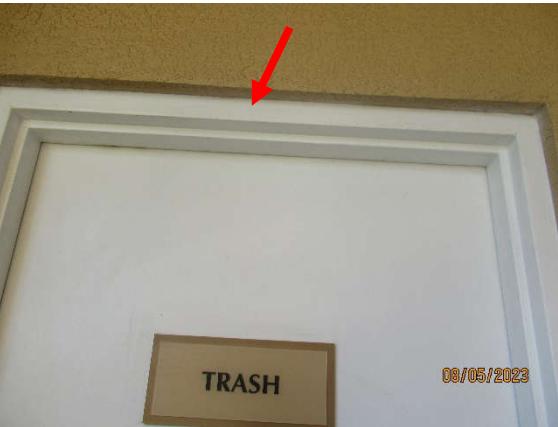
<p>08/05/2023</p>
<p>Photo 7.3.a.3 – Level 2nd trash room paint crack and peeling off.</p>	<p>Photo 7.3.a.4 – Level 2nd trash room paint peeling off.</p>

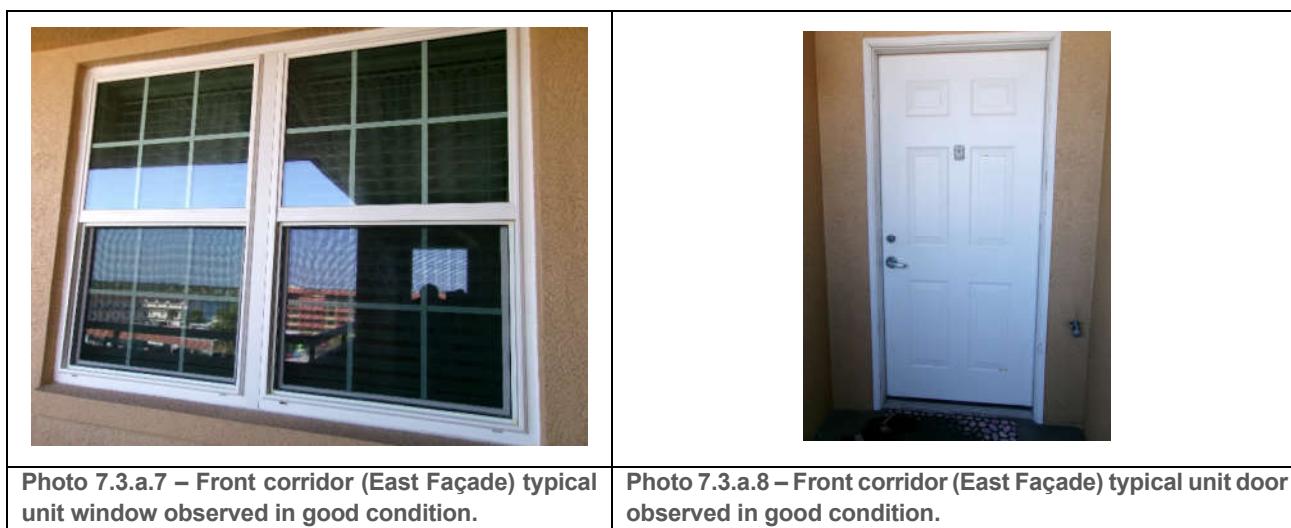
Photo 7.3.a.7 – Front corridor (East Façade) typical unit window observed in good condition.

Photo 7.3.a.8 – Front corridor (East Façade) typical unit door observed in good condition.

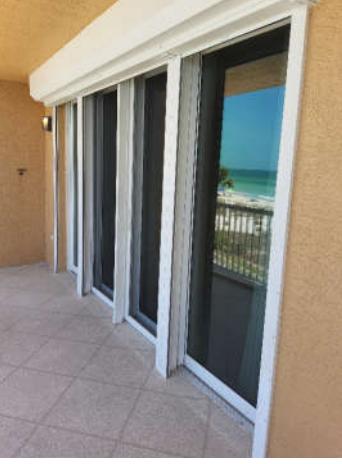
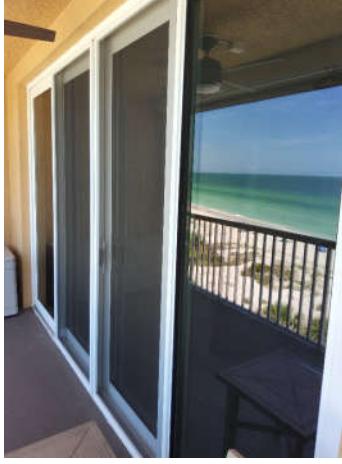
<p>Photo 7.3.a.11 – West façade (Unit 202) typical sliding glass door observed in good condition.</p>	<p>Photo 7.3.a.12 – West façade (Unit 503) typical sliding glass door observed in good condition.</p>

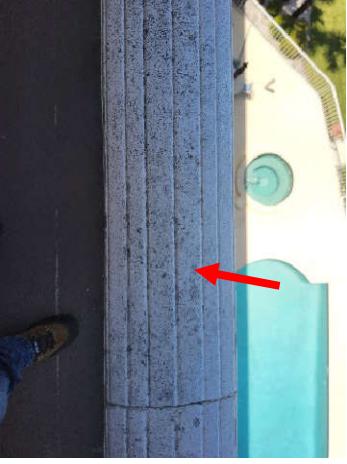
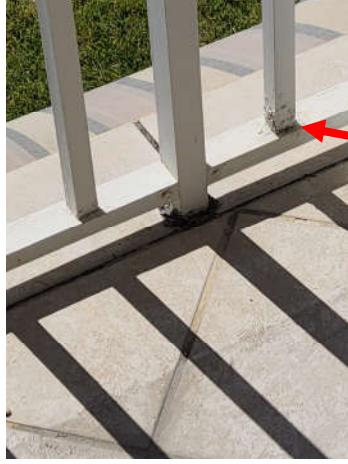
<p>Photo 7.4.1 – Unit 503 - Handrail Balcony paint failure and mild corrosion.</p>	<p>Photo 7.4.2 – Unit 101 - Handrail Balcony paint failure and mild corrosion.</p>

Based on the 2023 Westview Grande Condominium Association, Inc. Reserves Budget Plan issued on December 3, 2022, the balcony railing's current age is 25 years, and the useful life was estimated as 26 years. Overall, the paint coating was found to be in fair condition. At a minimum, replacing corroded elements that show cross-section loss and painting is recommended.

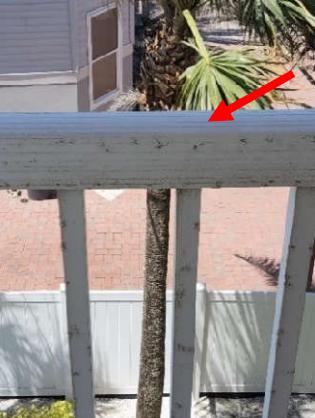
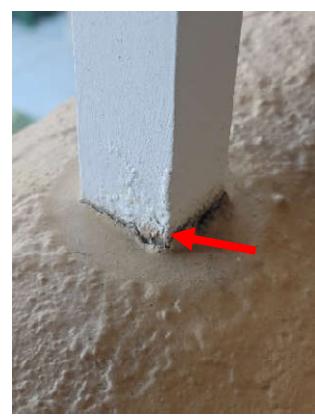
<p>Photo 7.4.3 – Unit 204 - Handrail Balcony with mild corrosion.</p>	<p>Photo 7.4.4 – Front corridor (East Façade) corrosion in the base of the railing.</p>

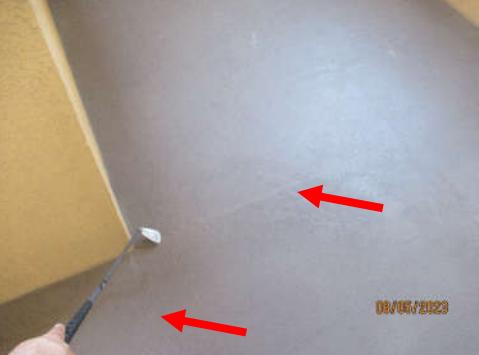
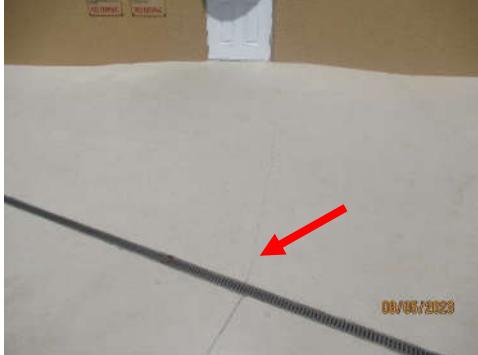
<p>Photo 7.5.1 – Front corridor – Observed joint likely related to installing a cementitious topping or installing the waterproofing membrane. These joints were observed to be in good condition.</p>	<p>Photo 7.5.2 – Pool Deck - Visual assessment showed joint construction deficiencies such as cracks and de-bonding.</p>

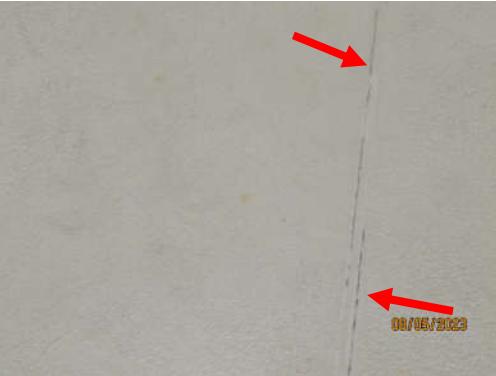
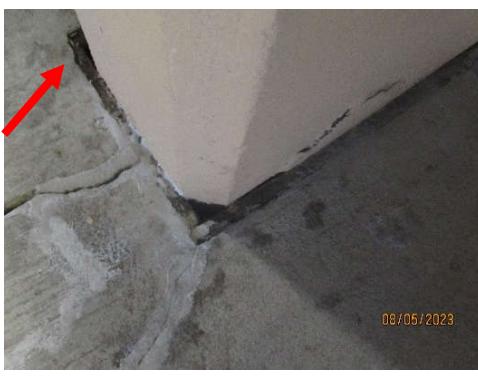
<p>Photo 7.5.3 – Pool Deck - Visual assessment showed construction joint deficiencies such as cracks and de-bonding.</p>	<p>Photo 7.5.4 – Garage level isolation joint. In good condition.</p>

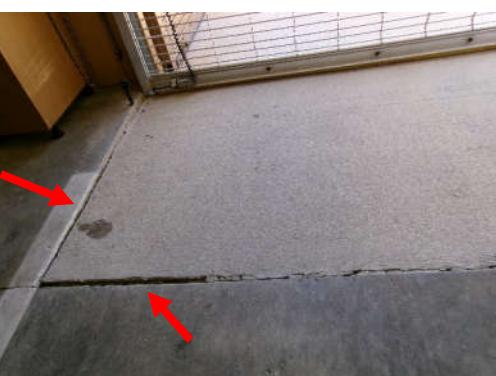
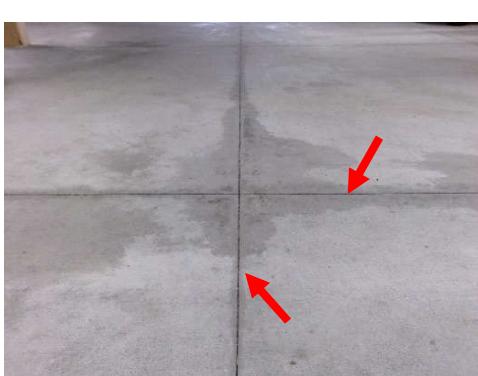
<p>Photo 7.5.5 – Garage level isolation joint. In good to fair condition.</p>	<p>Photo 7.5.6 – Garage level saw cut contraction joint in good condition.</p>

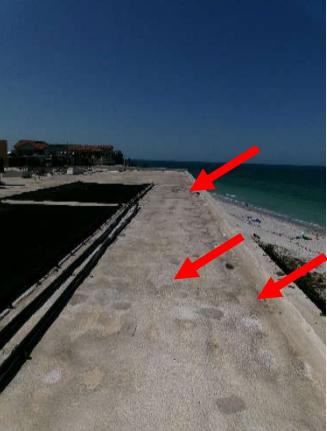
<p>Photo 7.6.1 – Roof level – Uneven surface and evidence of temporary water ponding.</p>	<p>Photo 7.6.2 – Roof level – Uneven surface and evidence of temporary water ponding.</p>

Based on the visual assessment and maintenance records, Falcon understands that the most cost-effective approach to maintaining the watertight integrity of the building roof will be an entire roof covering replacement. Continuous roof covering maintenance should continue in order to extend the roof's useful life and address any deficiency that could lead to water intrusion issues. This project should be scheduled in the short term.

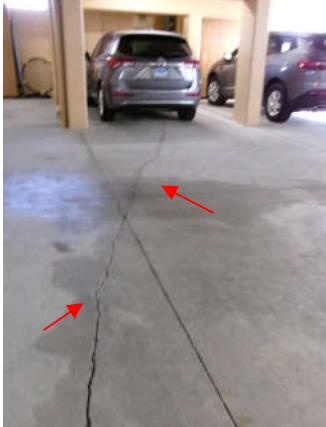
<p>Photo 7.8.a.5 – Garage Level – Drying shrinkage cracks observed at the slab on grade.</p>	<p>Photo 7.8.a.6 – Garage Level - Drying shrinkage cracks observed at the slab on grade.</p>

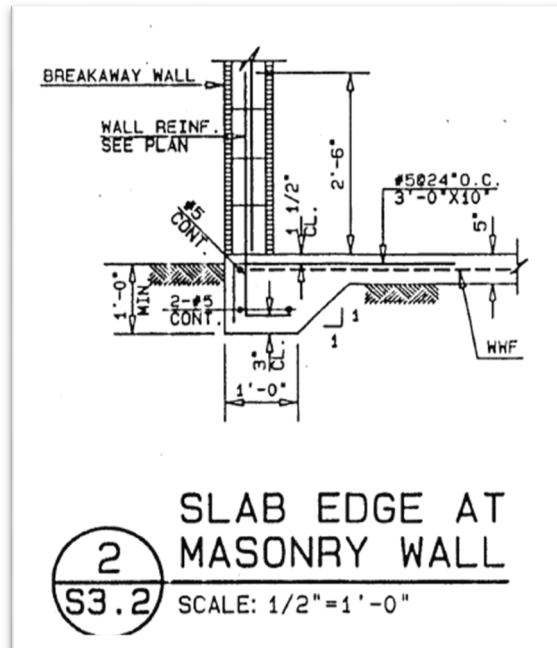
Figure 6: Slab Edge at Masonry Wall – Excerpt from sheet A3.2 Sections & Details, Detail 2 S3.2 (8/11/1997).

Figure 6 on the next page shows the slab edge at the masonry wall detail used at the ground level. A review of this detail shows that the concrete block walls at the garage level between the ground floor and the underside of the first-floor structure were designed as a breakaway wall.

For the concrete masonry to structurally perform as intended, the walls must be restrained to the base or slab-on-grade. Further, filled cells provide additional restraint within the division. These restraints also prevent or restrict concrete masonry assemblies from expanding or contracting, thereby resulting in the buildup of internal stresses. Relief of these internal stresses leads to cracking or separations within and between the assembly's constituent parts (i.e., between the concrete masonry units, adjacent to internally filled cells, and adjacent to the mortar to hold the masonry in place). While this cracking and separation may constitute distress, it does not typically compromise the wall's structural integrity.¹¹

The observed cracks noted in this report are not structurally concerning. Cracks, if left unattended could lead to more extensive damage, water intrusion, and/or potentially local failure of elements in extreme situations.

Overall, the limited areas observed with exposed masonry were in good to fair condition. Falcon recommends routing and sealing of repair of the 1/2" horizontal and vertical joint separation between the breakaway walls and the superstructure. In addition, for minimal cracking confined primarily to the mortar's joints, and relatively stable in width, it can be readily repaired by conventional tuckpointing (also called repointing) methods.

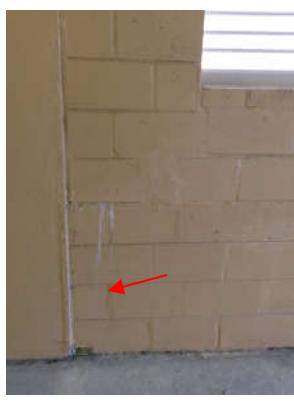
Evidence of efflorescence was observed through some of the walls at the garage level. This indicates water intrusion or moisture within the masonry cavity walls. Therefore, repairs to seal the masonry wall crack must be performed.

<p>Photo 7.8.b.5 – Garage Level – Evidence of efflorescence was observed through some of the walls in the garage level.</p>	<p>Photo 7.8.b.6 – Garage Level – Evidence of efflorescence was observed through some of the walls in the garage level.</p>
