MILESTONE INSPECTION REPORT FORM PHASE 2

a.	Name on Title: Pointe Condominium		
b.	Street Address: 19236 Gulf Blvd., Indian Shores, FL 33785		
c.	Legal Description: Pointe Condominium Association, inc.

Re: Pointe Condominiums – 19236 Gulf Boulevard, Indian Shores
Concrete Beam Evaluation

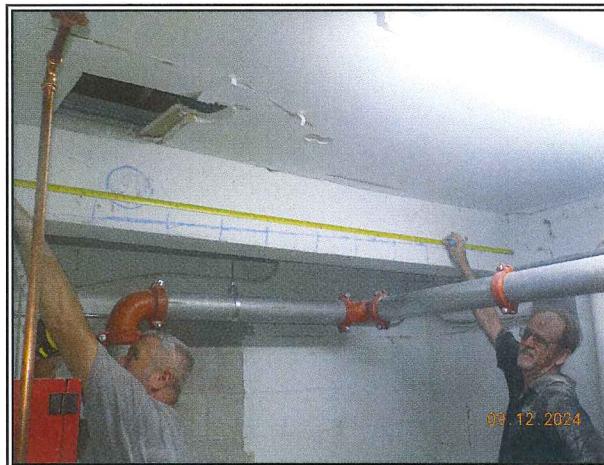
Side View of Accessible Portion of Beam

Based on our review of the scans completed, it appears that the beam has 2 horizontal bottom bars of steel reinforcement in the 8 inch wide concrete beam, and 10 vertical stirrups along the 92 inch long section of accessible beam scanned. The stirrup spacing varied from approximately 7 inches to approximately 12 inches along the beam. Any top reinforcement within the beam could not be observed due to access limitations. The total height of the beam was approximately 24 inches. The steel reinforcement cage did not appear to be centered within the cast-in-place concrete beam. Along the accessible portion of the beam in the pump room, the bottom reinforcing steel was within an inch of the bottom of the beam near the east wall of the room, and approximately 4 inches from the bottom of the beam near the west end. The steel reinforcement cage was also closer to the south edge of the beam than the north edge. See sketches below.
