March 28, 2024

THIS MILESTONE PHASE 1 INSPECTION REPORT WAS PRODUCED FOR SHORE HOUSE CONDOMINIUM ASSOCIATION, INC. LOCATED AT 19106 GULF BLVD., INDIAN SHORES, FL 33785.

SHORE HOUSE

MILESTONE PHASE 1 INSPECTION SURVEY

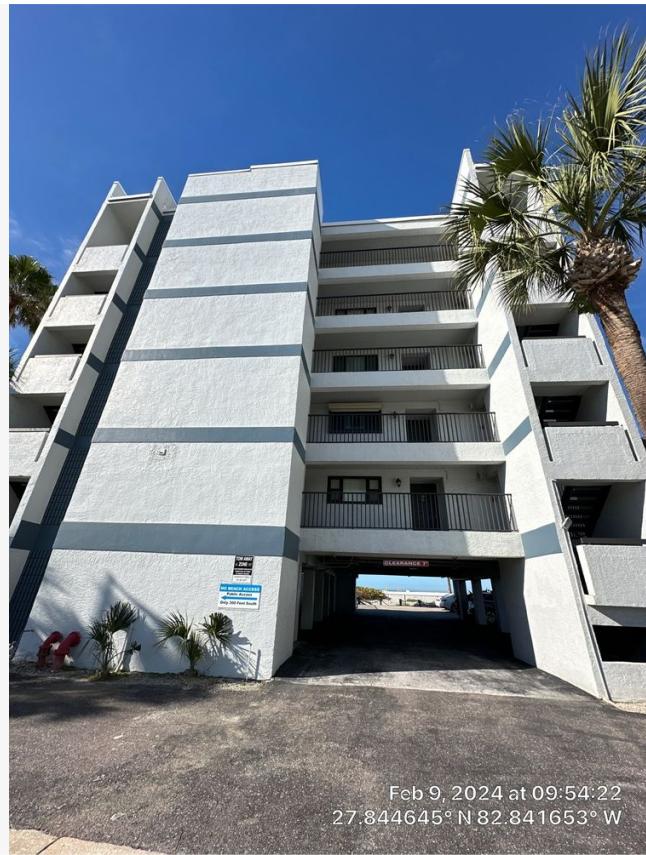
Front East elevation.

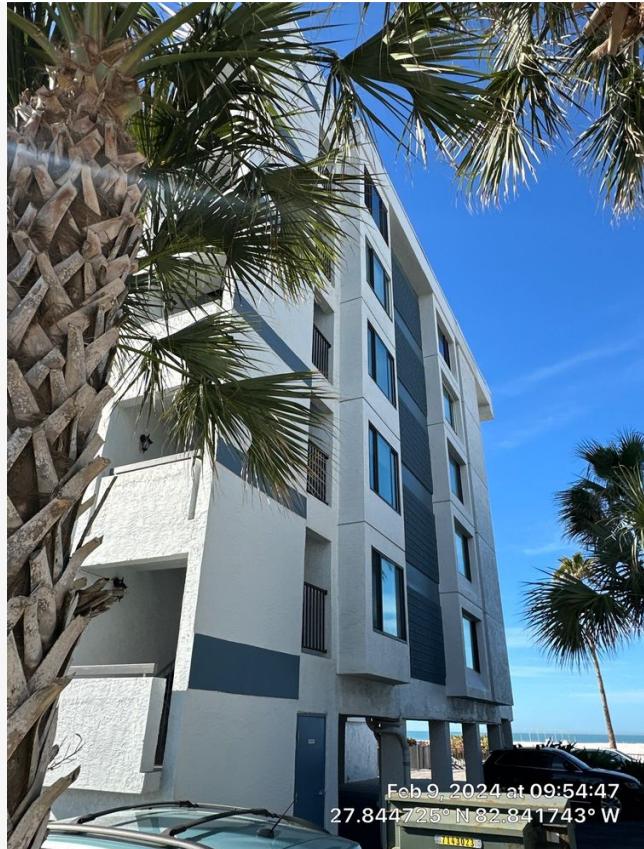
North elevation

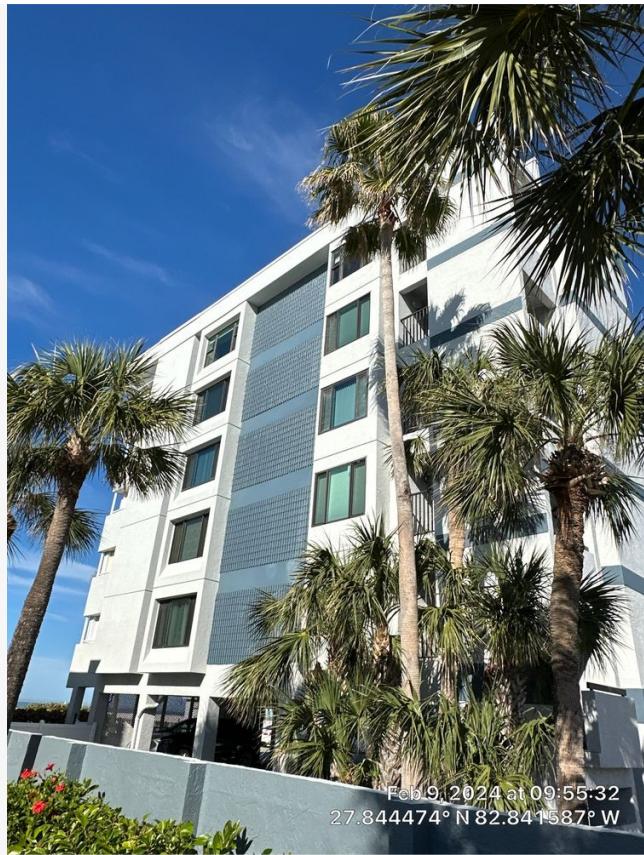
South elevation

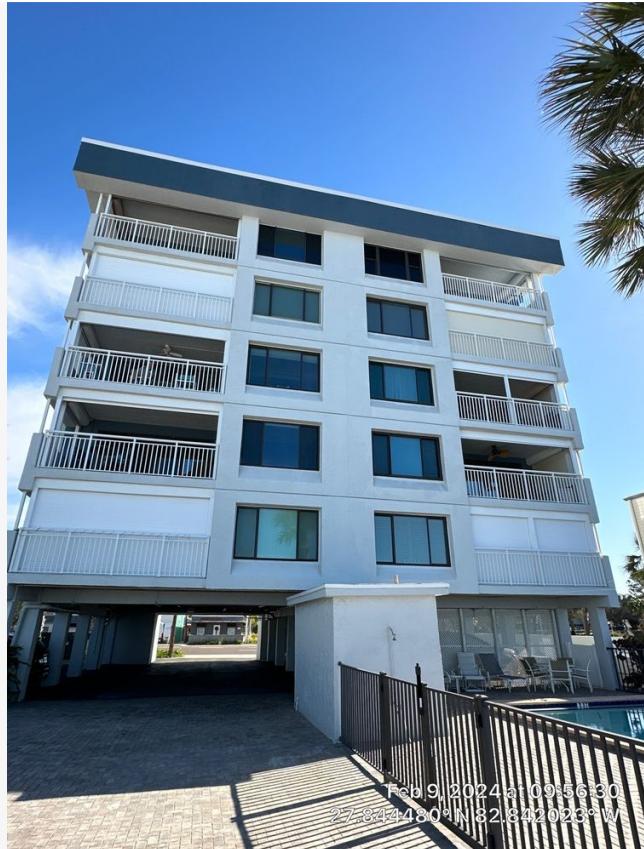
West (rear) elevation.

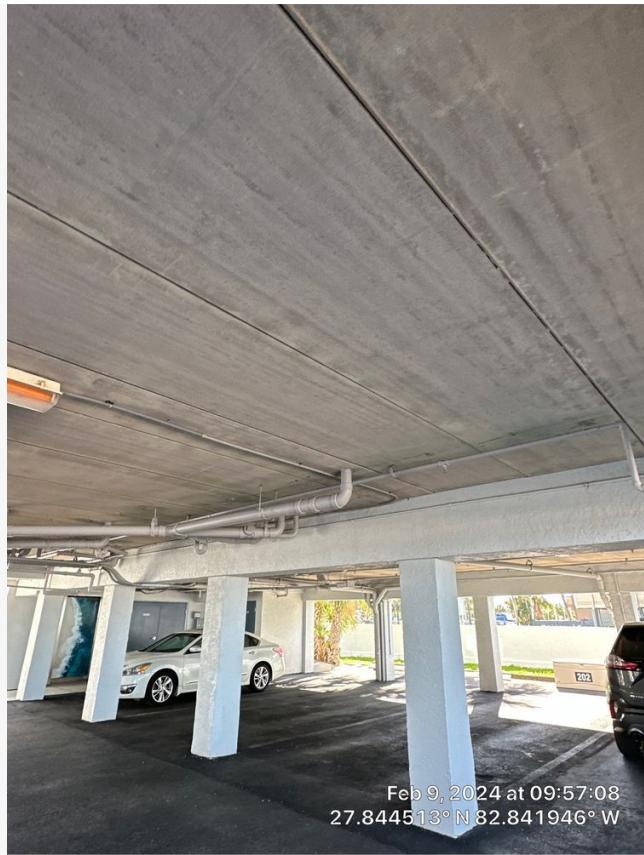
Parking garage ground level, underneath living space.

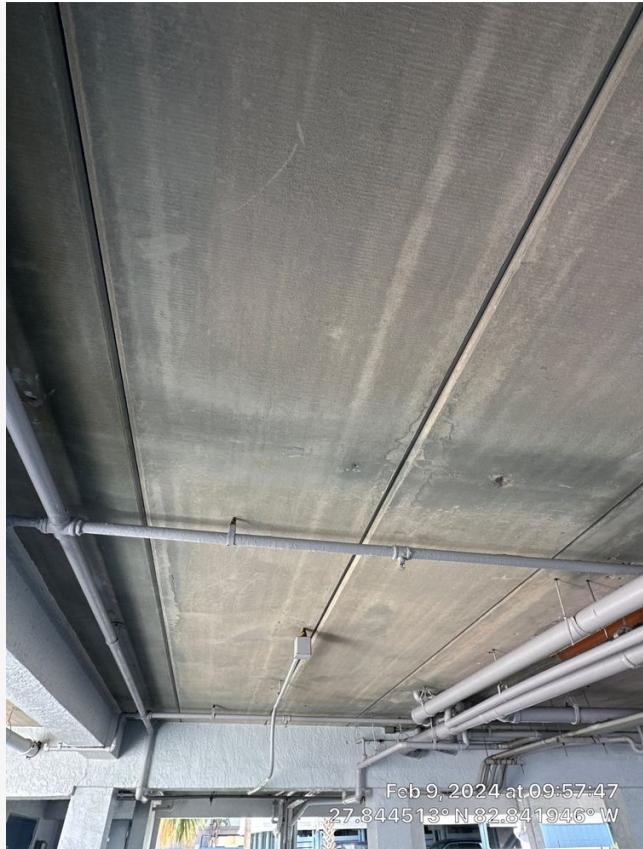
Precast concrete floor slabs comprise the parking garage ceiling / floor of first living level.

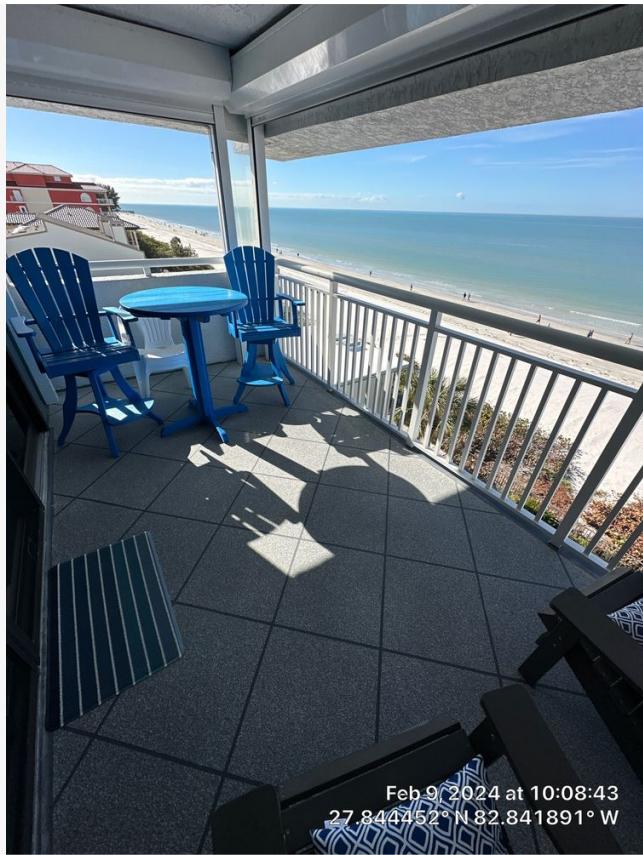
Unit 501 balcony

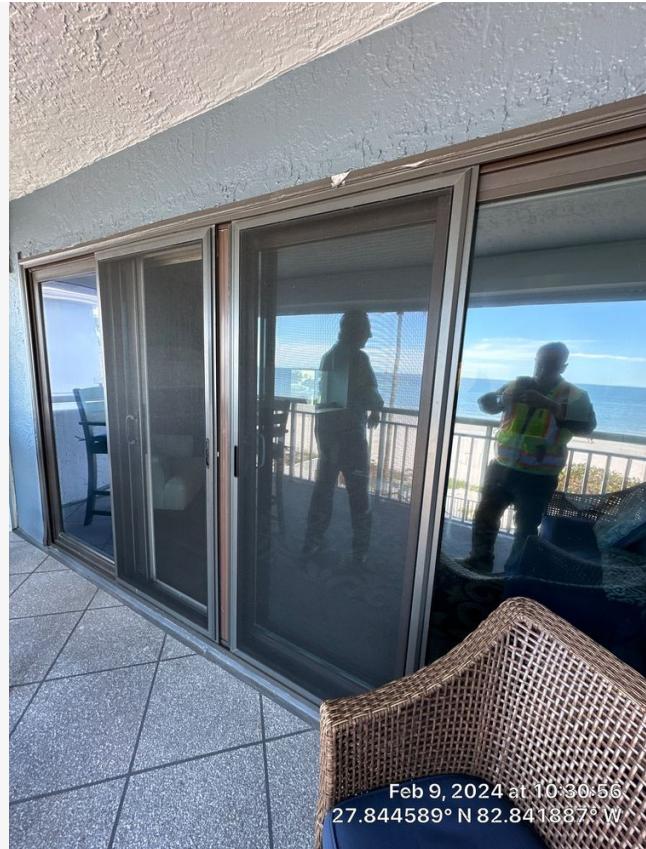
Unit 202 balcony
