## Milestone Inspection – Phase 1

### Pipers Run Condominium Association

19812 Gulf Blvd, Indian Shores, Florida 33785

March 24, 2025

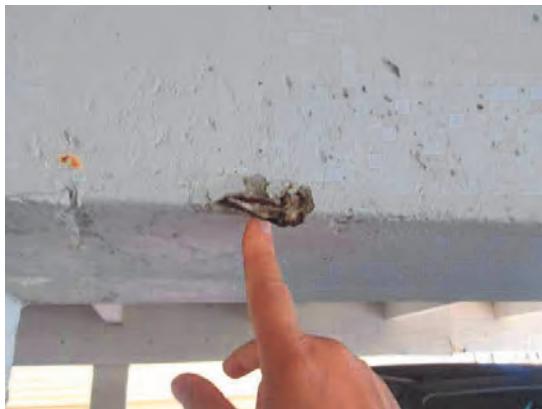
Cracking and exposed re-bar in a several locations throughout the parking garage.

52 Middle Garage exposed re-Bar

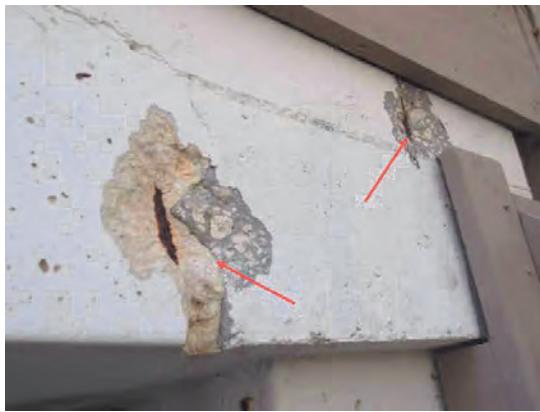
63 Right Front Garage Exposed Re-Bar

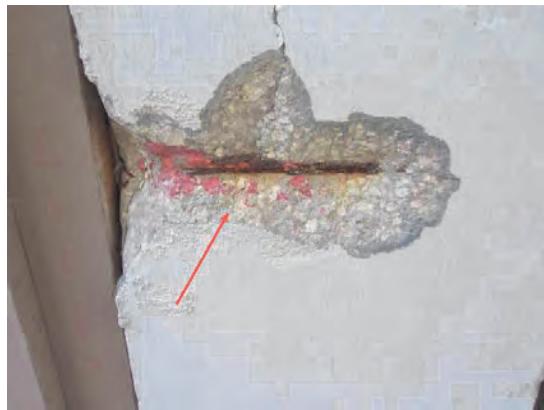
Right rear concrete support beam under the balcony of unit 4 had excessive cracking, bulging and deflection. See Photos #65 - 68

66 Right Front Garage Exposed Re-Bar

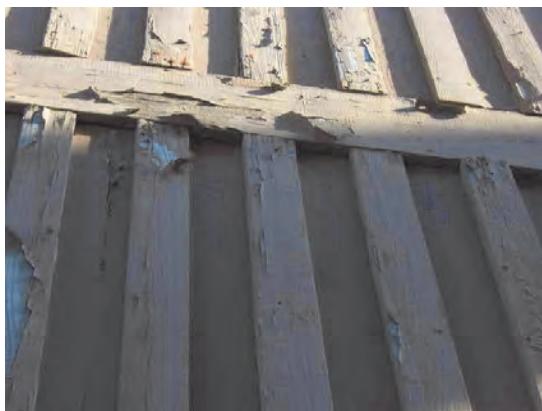
Deterioration and buckling of the wood siding throughout exterior. See Photos #83 - 99

84 Wood Siding Peeling and Buckling

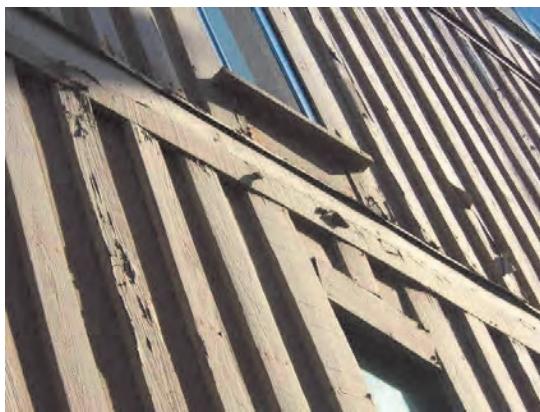
85 Wood Siding Peeling and Buckling

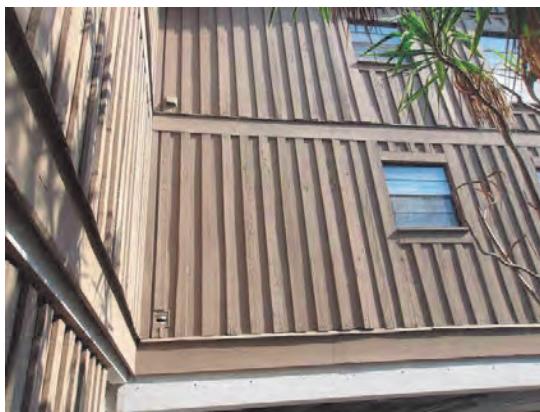
87 Wood Siding Peeling and Buckling

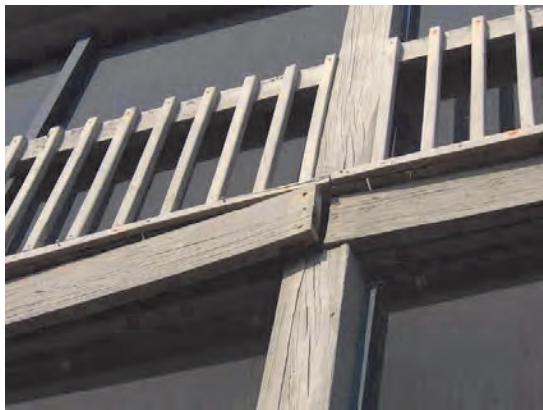
**89** Wood Trim Peeling and Buckling

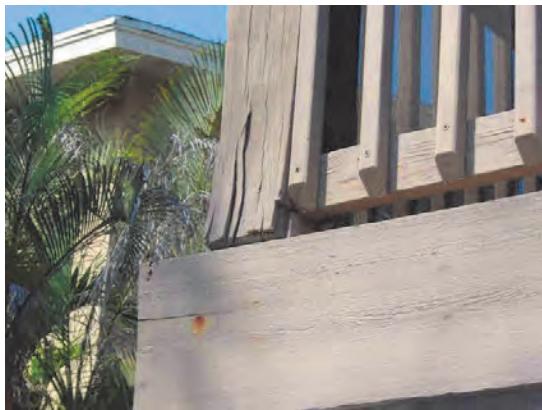
**90** Wood Trim Peeling and Buckling

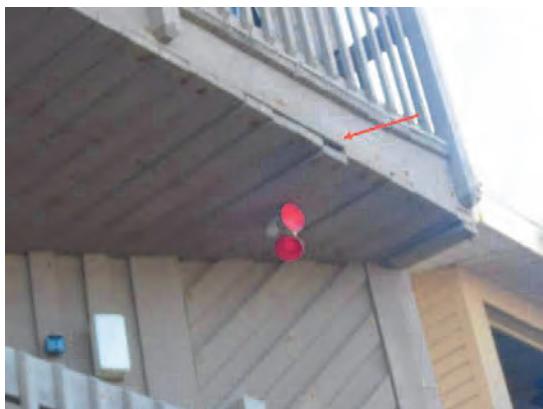
**91** Rear Soffit Buckling

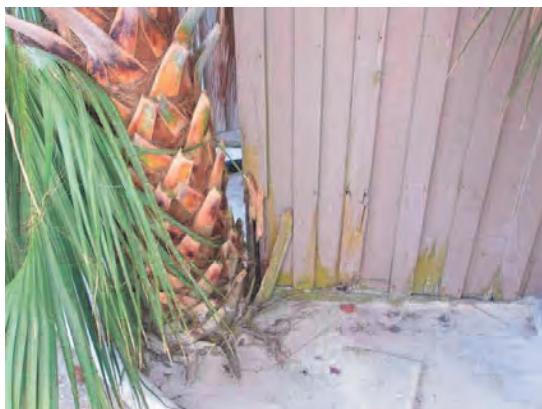
**92** Wood Siding Peeling and Buckling

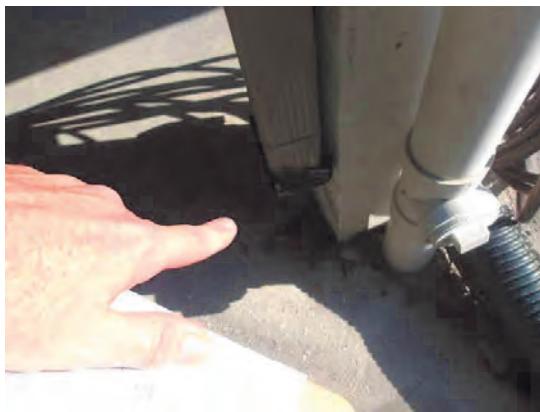
**101** Left Front Gutter Downspout Discharge at Pier Footing

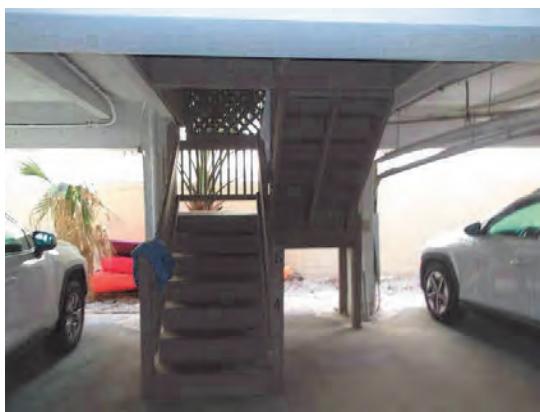
**103** Right Front Stairs 4x4 Posts Not Secured to Slab

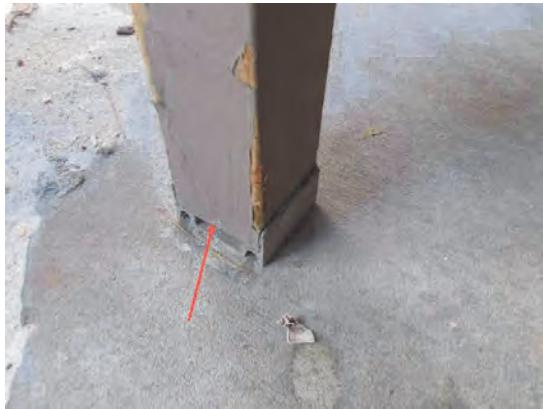
107 Right Front Stairs 4x4 Posts Not Secured to Slab

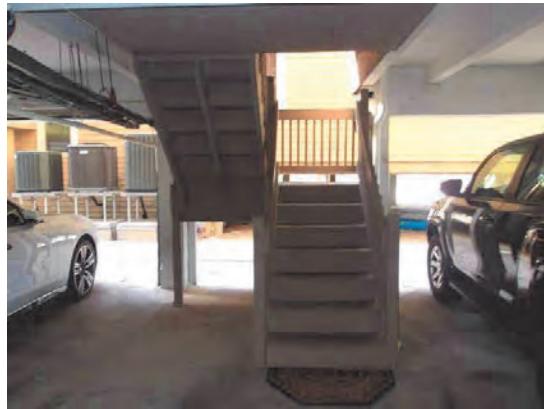
108 Left Front Stairs 4x4 Posts Not Secured to Slab

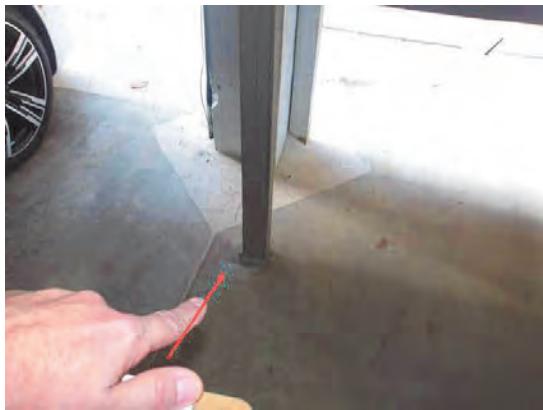
109 Left Front Stairs 4x4 Posts Not Secured to Slab

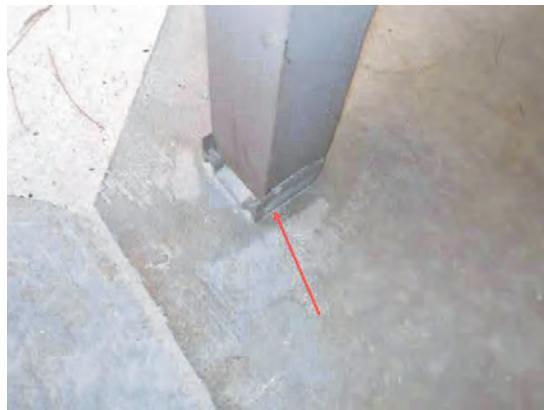
110 Left Front Stairs 4x4 Posts Not Secured to Slab

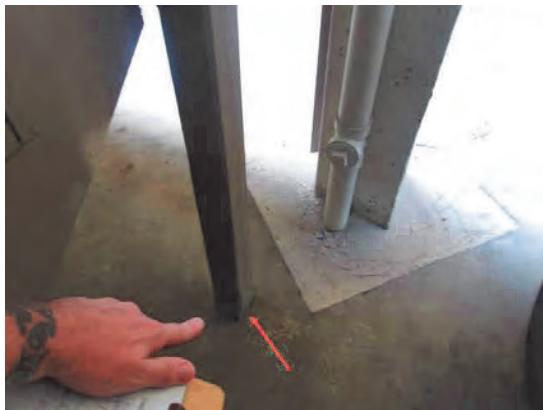
111 Left Front Stairs 4x4 Posts Not Secured to Slab

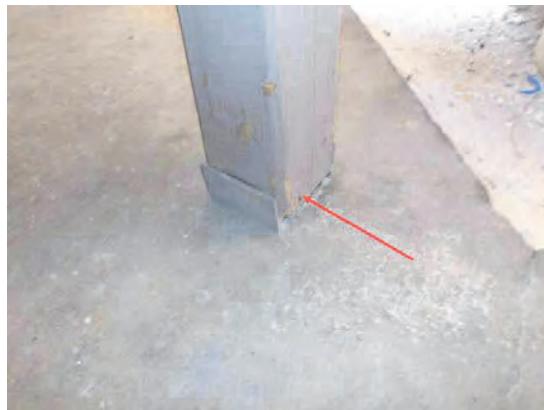
112 Left Front Stairs 4x4 Posts Not Secured to Slab

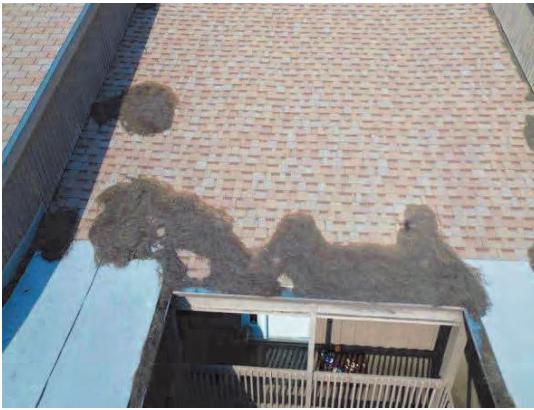
## 113 Clogged Gutters and Debris on Roof

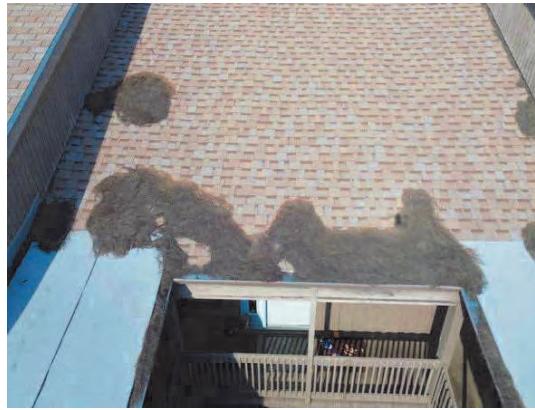
## 114 Clogged Gutters and Debris on Roof

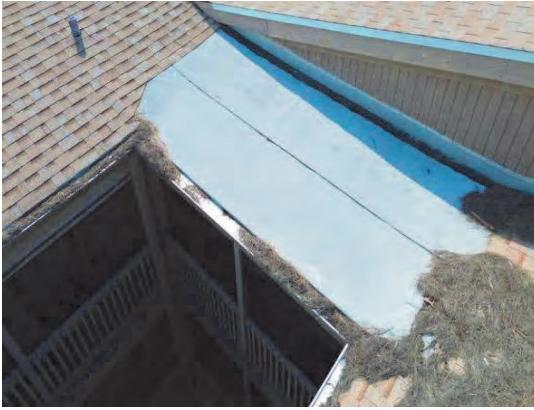
## **115 Clogged Gutters and Debris on Roof**

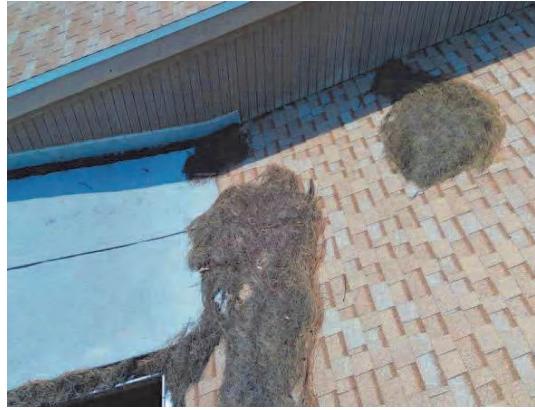
## **116 Clogged Gutters and Debris on Roof**

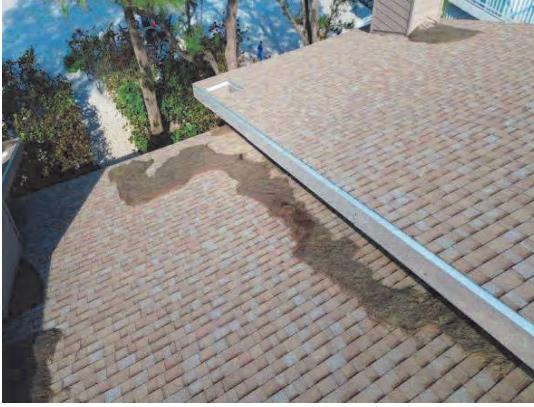
## 117 Clogged Gutters and Debris on Roof
